CENTRAL VALLEY FLOOD MANAGEMENT PLANNING PROGRAM

Flood Control System Status Report Appendix A – Levee Status

December 2011

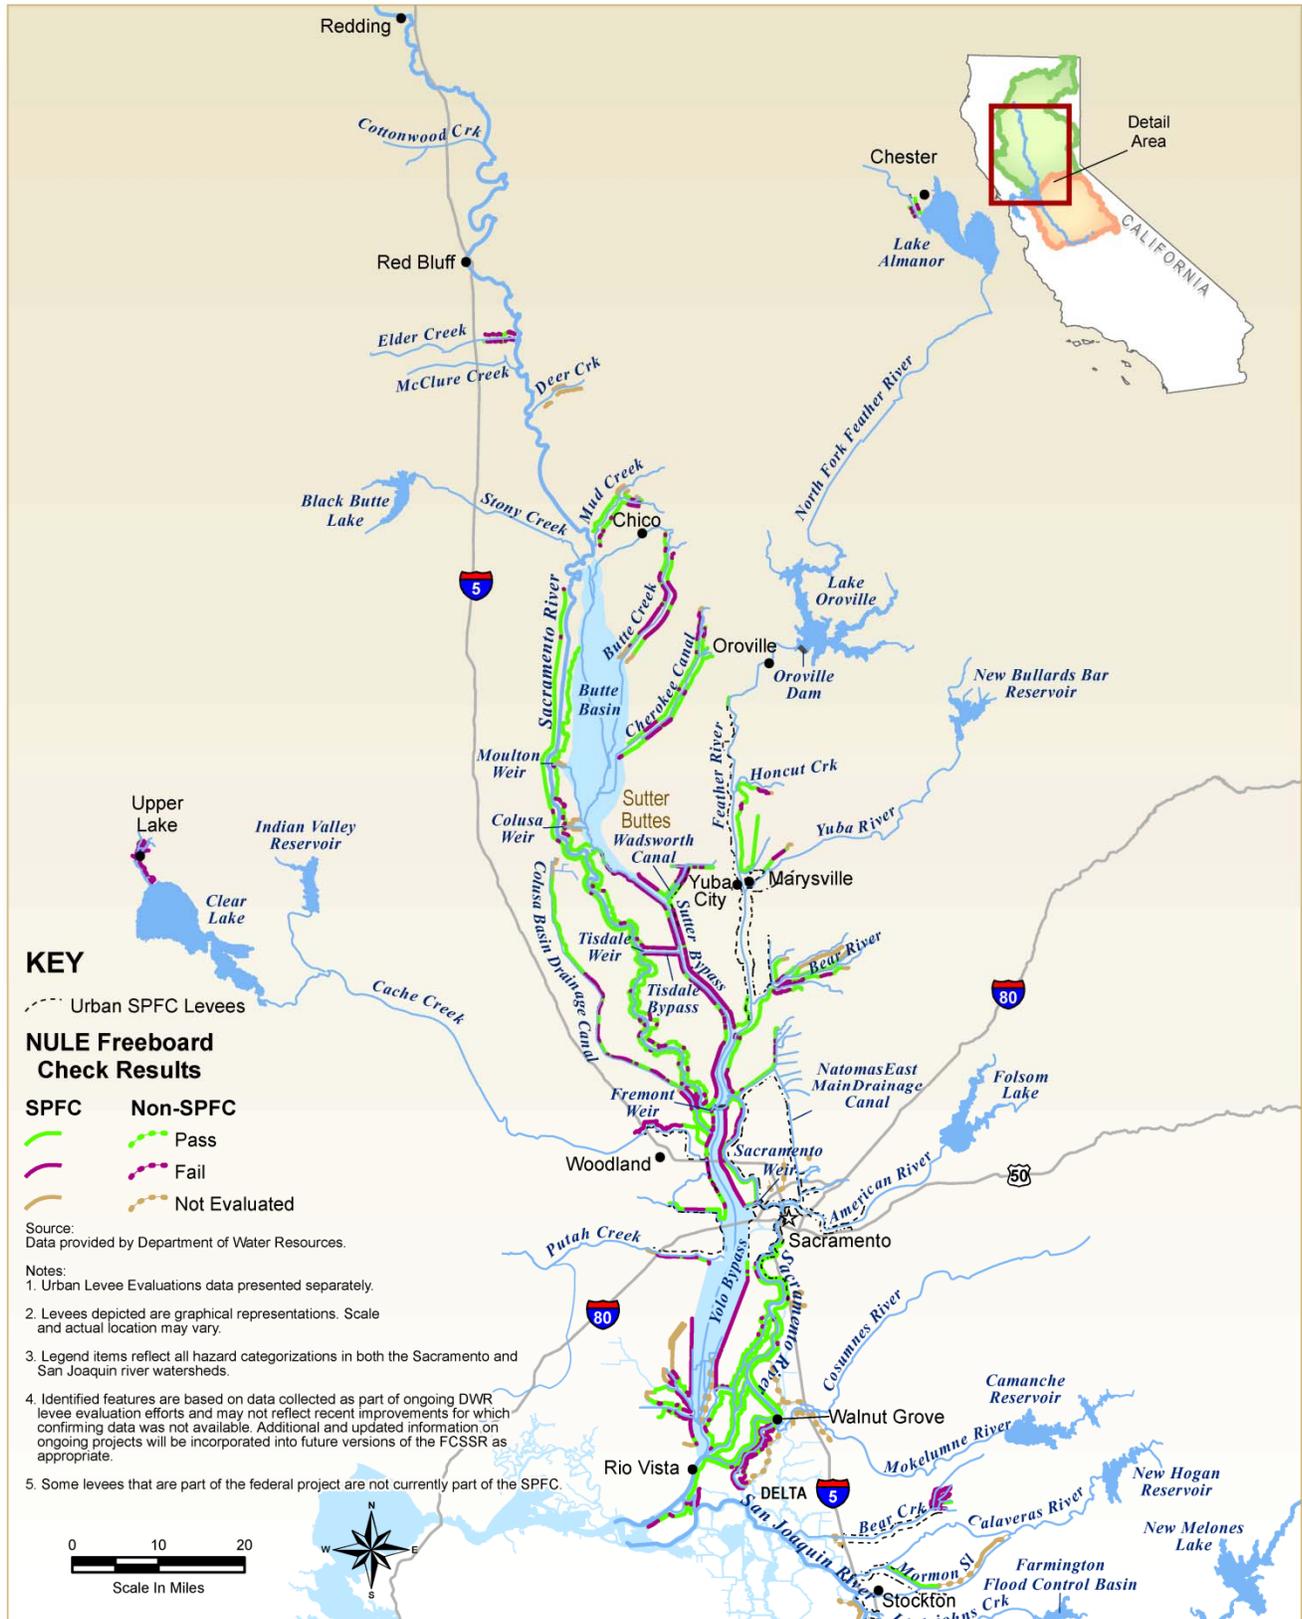
Figure A-7. NULE Freeboard Check Results in Sacramento River Watershed

Figures A-7 and A-8 show a pass or fail result for NULE levee segments in both the Sacramento and San Joaquin river watersheds regarding whether they meet freeboard requirements. Freeboard results show that portions of both banks of the Sutter Bypass, both banks of the Yolo Bypass, Butte Creek, Colusa Basin Drainage Canal, and the Bear River do not meet freeboard criteria. Compliance with freeboard criteria is variable in other areas within the Sacramento River watershed. In the San Joaquin River watershed, levee reaches along the lower Stanislaus River, lower Tuolumne River, San Joaquin River downstream of Merced River, upper Bear Creek and Paddy Creek do not meet freeboard criteria.

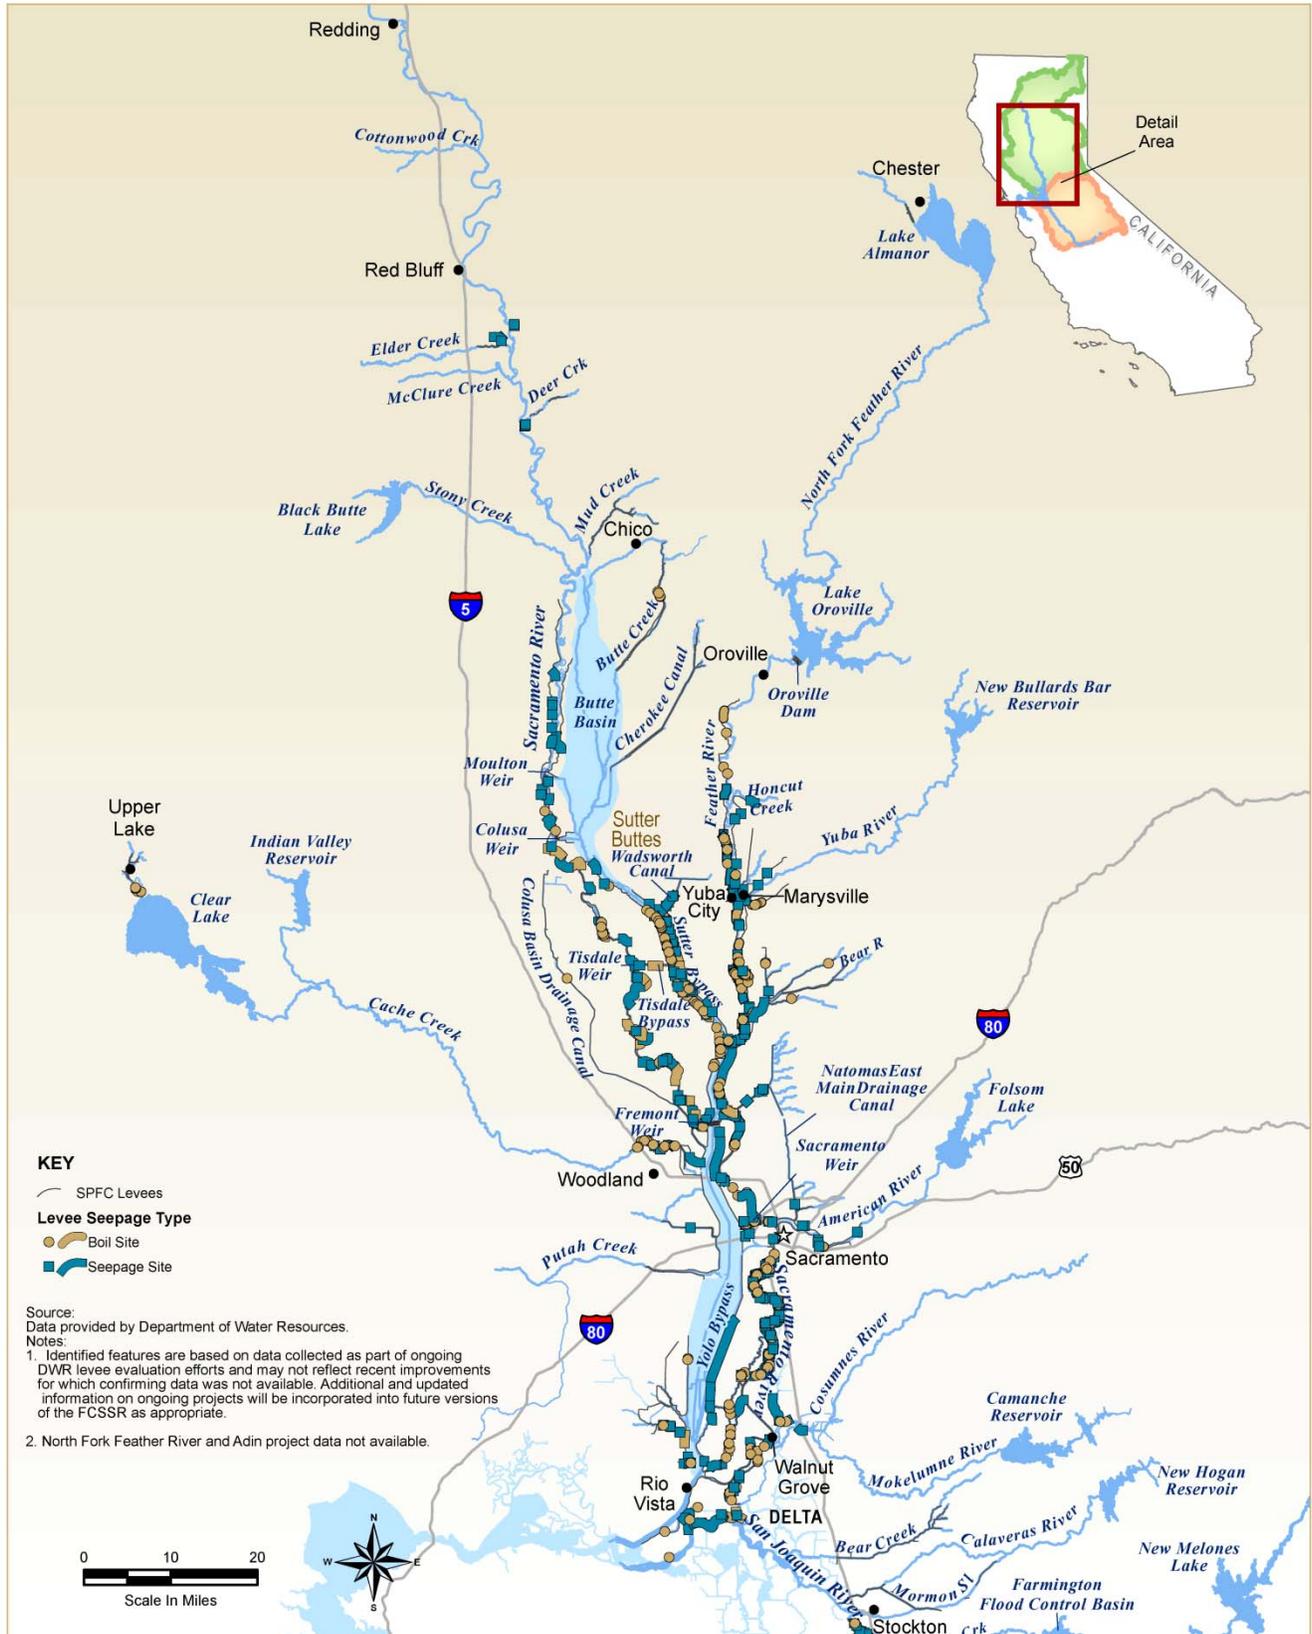
Figure A-11. Historical Seepage Occurrences in Sacramento River Watershed

improvements. Figures A-11 and A-12 show historical seepage occurrences collected by the ULE and NULE projects in the Sacramento and San Joaquin river watersheds, respectively. In the Sacramento River watershed, historical seepage occurrences were located throughout the system and were particularly prevalent along the Sutter Bypass and Sacramento River south of Sacramento. In the San Joaquin River watershed, most historical seepage occurrences were along the San Joaquin River and Eastside Bypass.

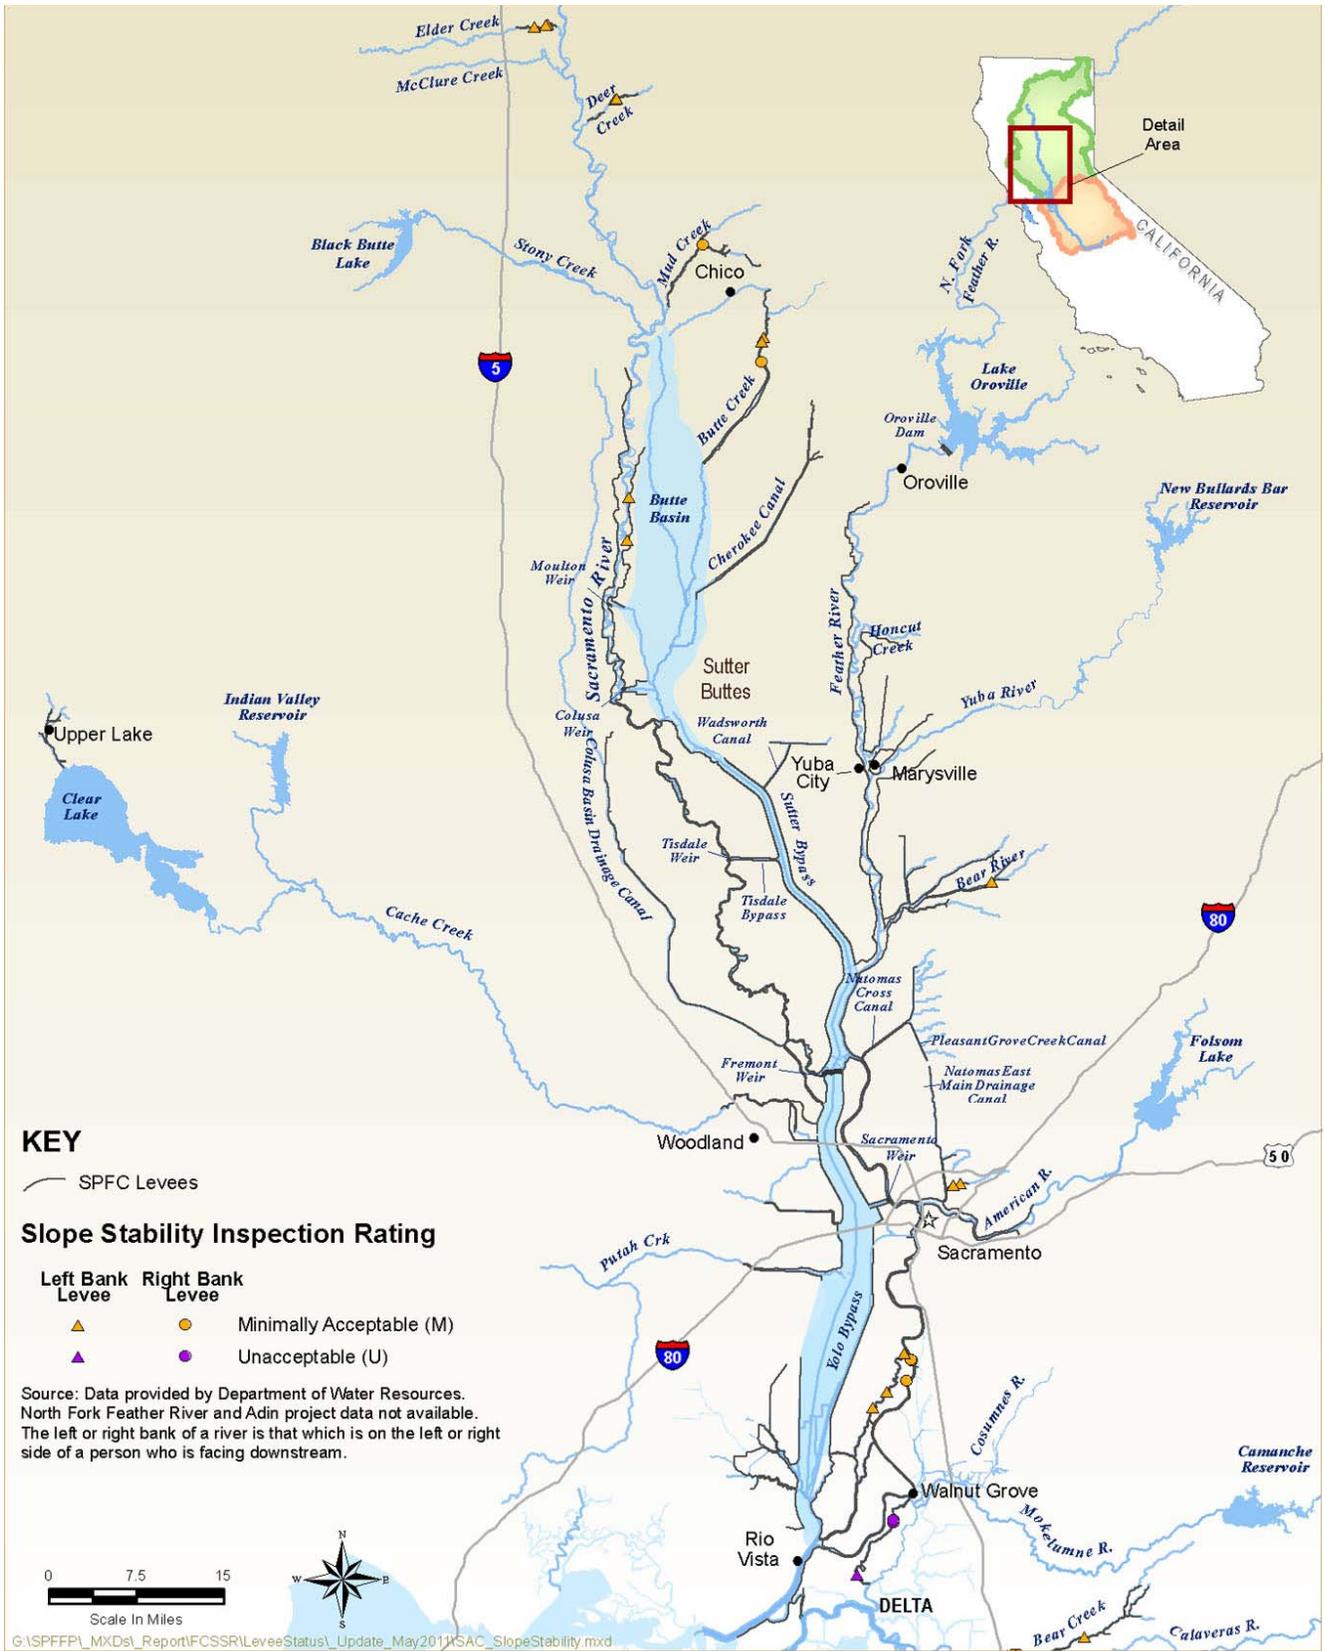
Figure A-17. 2009 Slope Stability Inspection Ratings in Sacramento River Watershed

are shown on Figures A-17 and A-18. Two sites with Unacceptable ratings for slope stability are located in the Delta. In the Sacramento River watershed has no Unacceptable ratings, but several sites, in various locations, have Minimally Acceptable ratings. In the San Joaquin River, Minimally Acceptable ratings are located on the lower San Joaquin River, Bear Creek, Mormon Slough, and Littlejohns Creek.

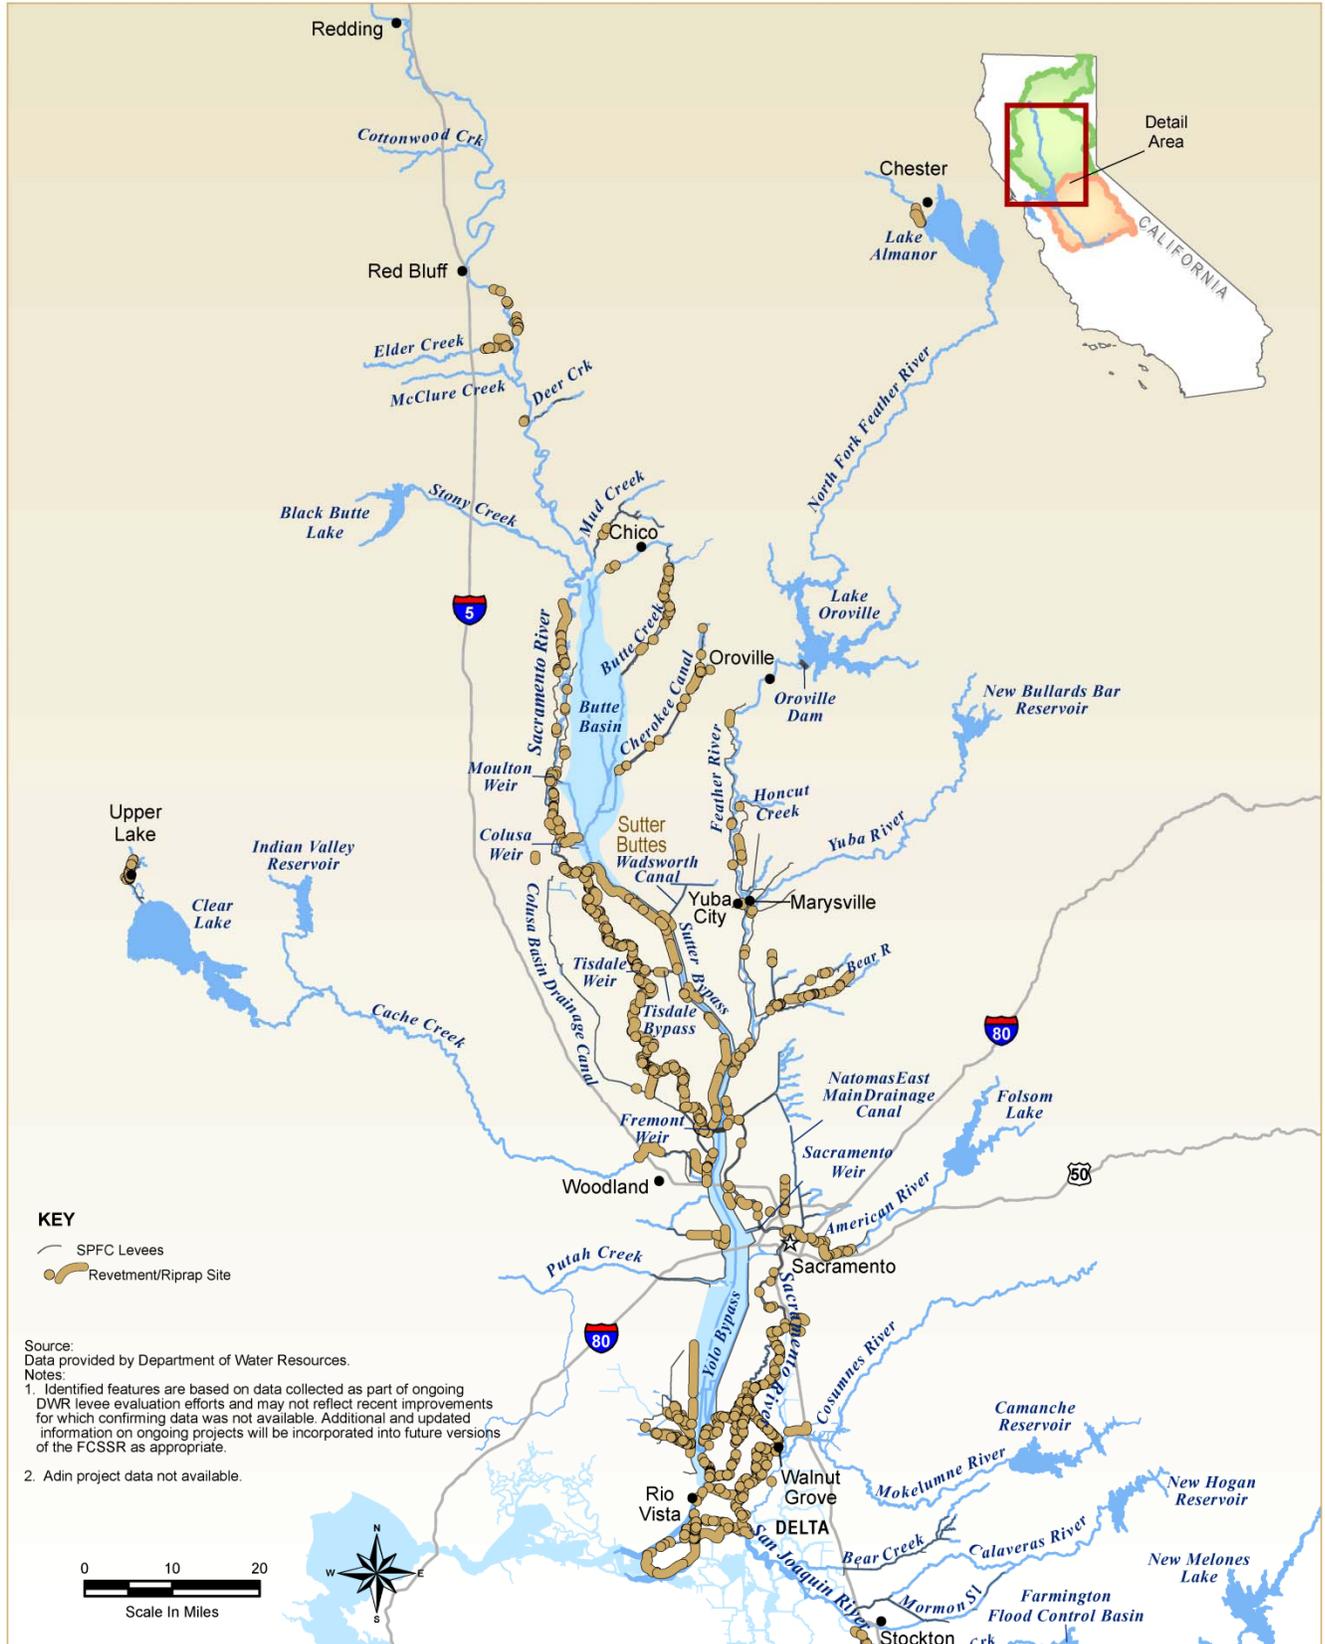
Figure A-25. Levee Revetment Sites in Sacramento River Watershed

Information on observed revetment and riprap sites was collected and cataloged as part of the data collection efforts for the ULE and NULE projects, as described in this section. Figures A-25 and A-26 show observed revetment and riprap sites for the Sacramento and San Joaquin river watersheds, respectively. Revetment and riprap have been placed throughout the Sacramento and San Joaquin river watersheds.
