## 4.0 Levee Status

## Flood Control System Status Report

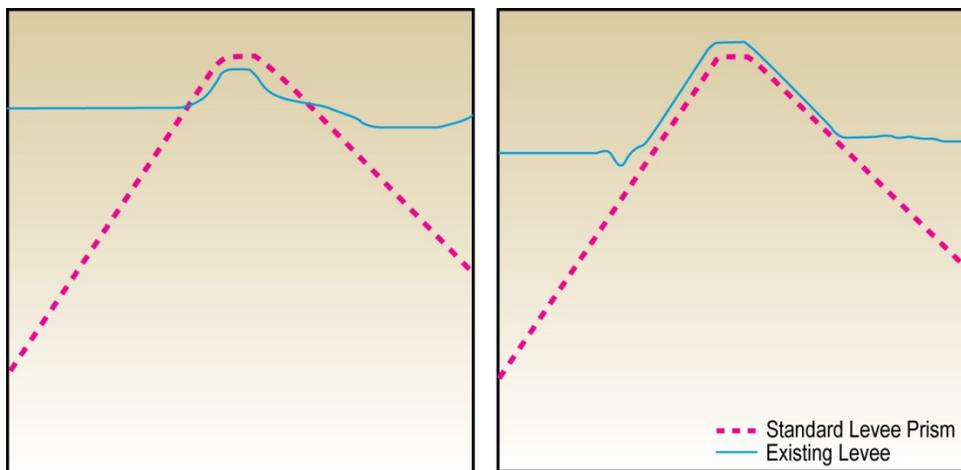
Figure 4-1 demonstrates a levee cross section that deviates from the standard design prism and a levee cross section that conforms to the standard levee design prism.

**Levee Cross Section That Deviates from Standard Levee Design Prism**

**Levee Cross Section That Conforms to Standard Levee Design Prism**

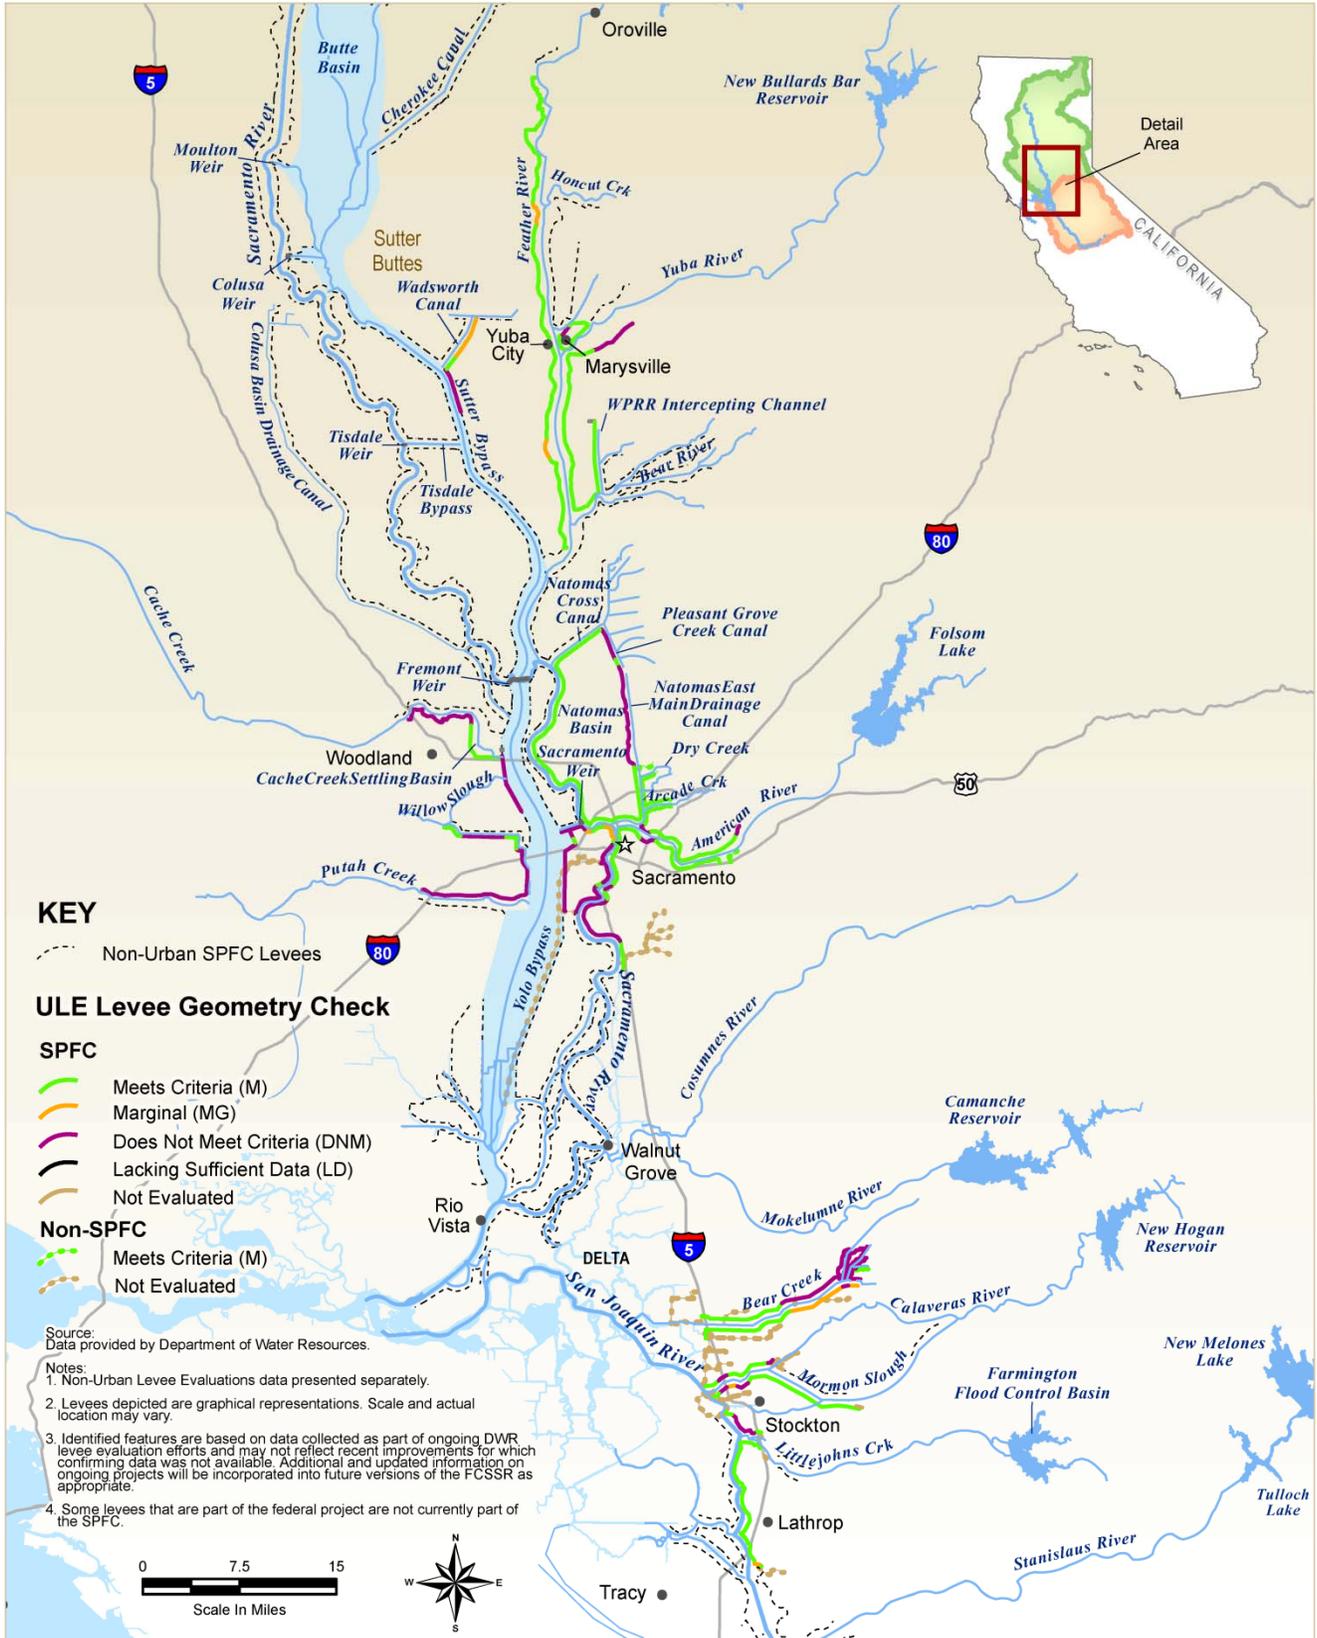
Figure 4-2. ULE Levee Geometry Check

Results of the geometry check for SPFC ULE levees are shown in Figure 4-2. The majority of SPFC ULE levees along the Feather River, American River, and Sacramento River north of the City of Sacramento were found to meet standard levee design prism geometry criteria. Approximately one-third of SPFC ULE levees deviate from current standard levee design prism geometry. These levees were located along bypass features and associated tributaries to the west, and along the Sacramento River south of Sacramento. Results for SPFC ULE levees in the San Joaquin River watershed and elsewhere in the Sacramento River watershed varied.

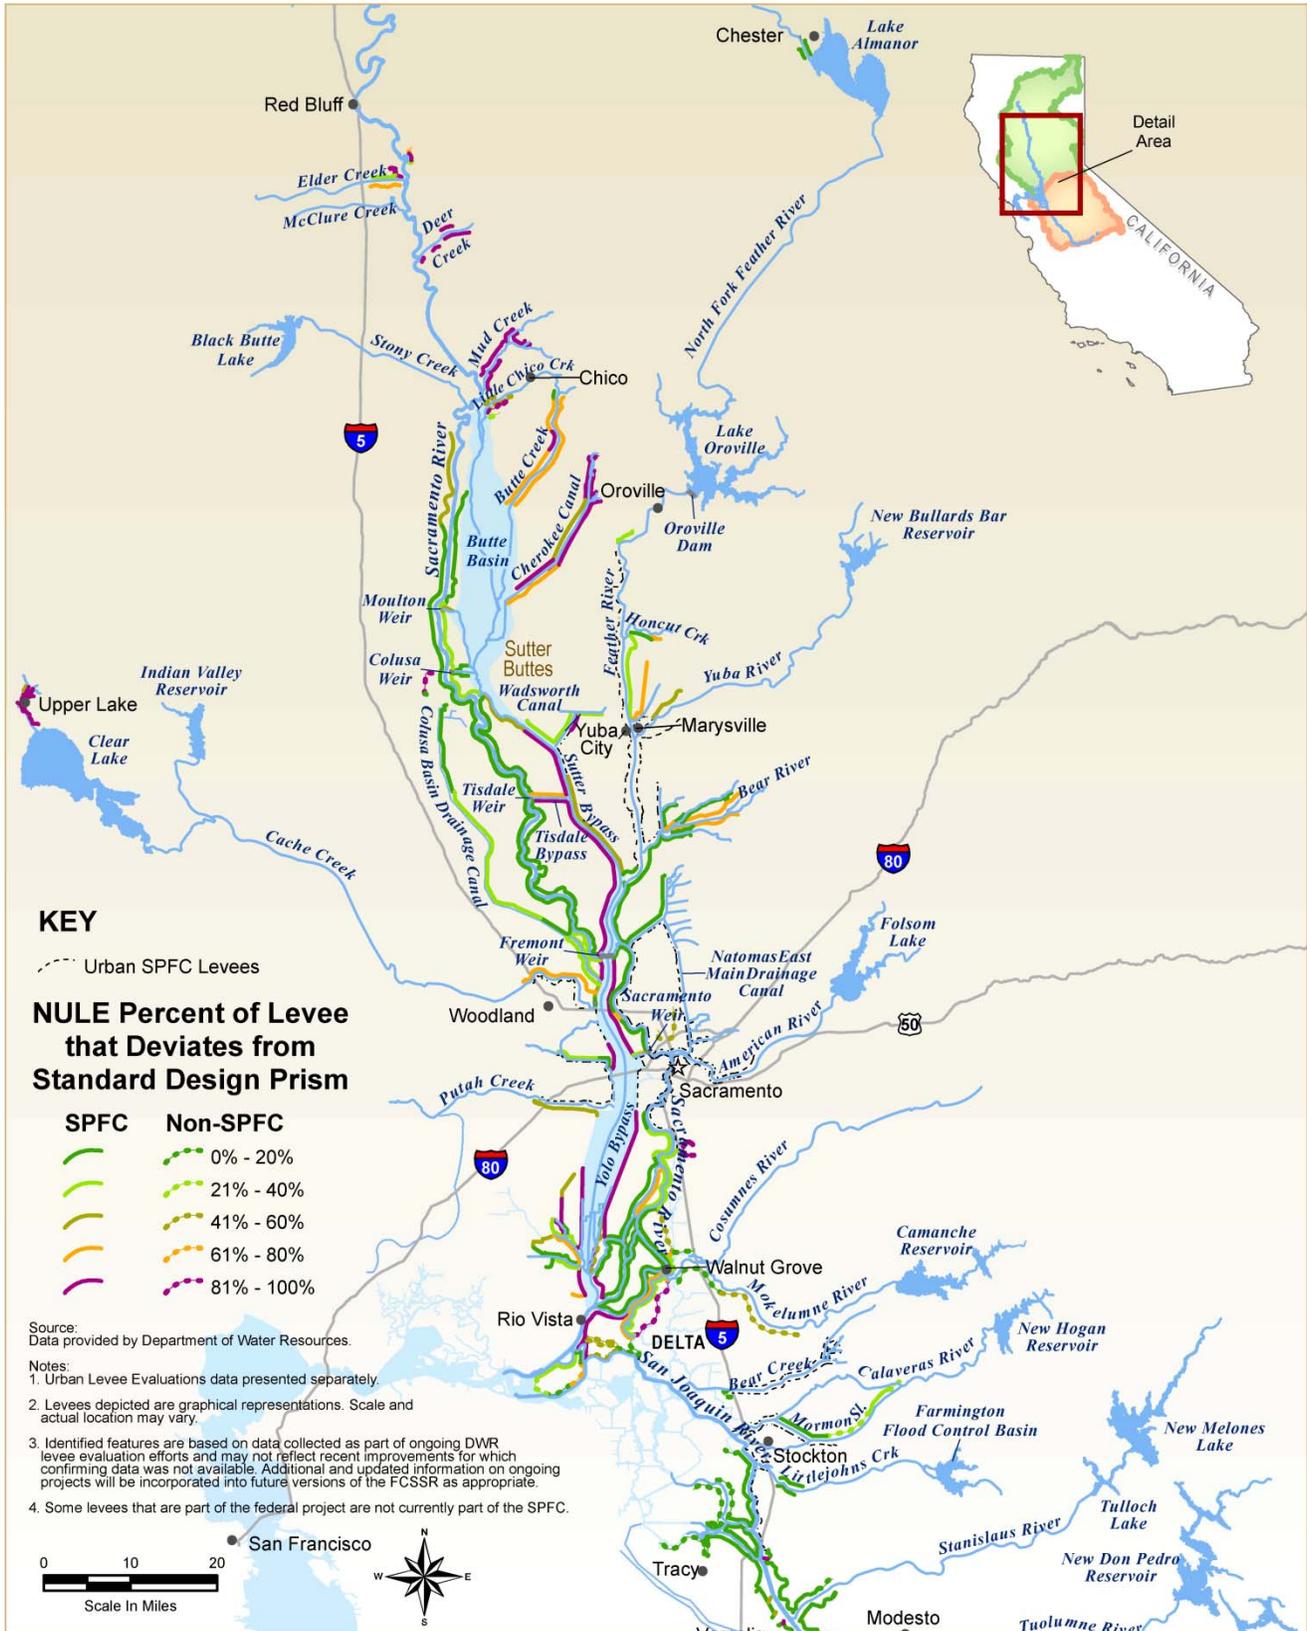
Figure 4-3. NULE Levee Geometry Check in Sacramento River Watershed

Sacramento and San Joaquin river watersheds. Results suggest that the San Joaquin river watershed and Sacramento River have the highest percentage of levees that conform to standard levee design prism geometry. Further, levees along the bypasses and along the tributary streams to the Sacramento River in the northern Sacramento River watershed have the lowest percentage of NULE levee segments that conform to standard levee design prism geometry. Results elsewhere along NULE levees are variable.

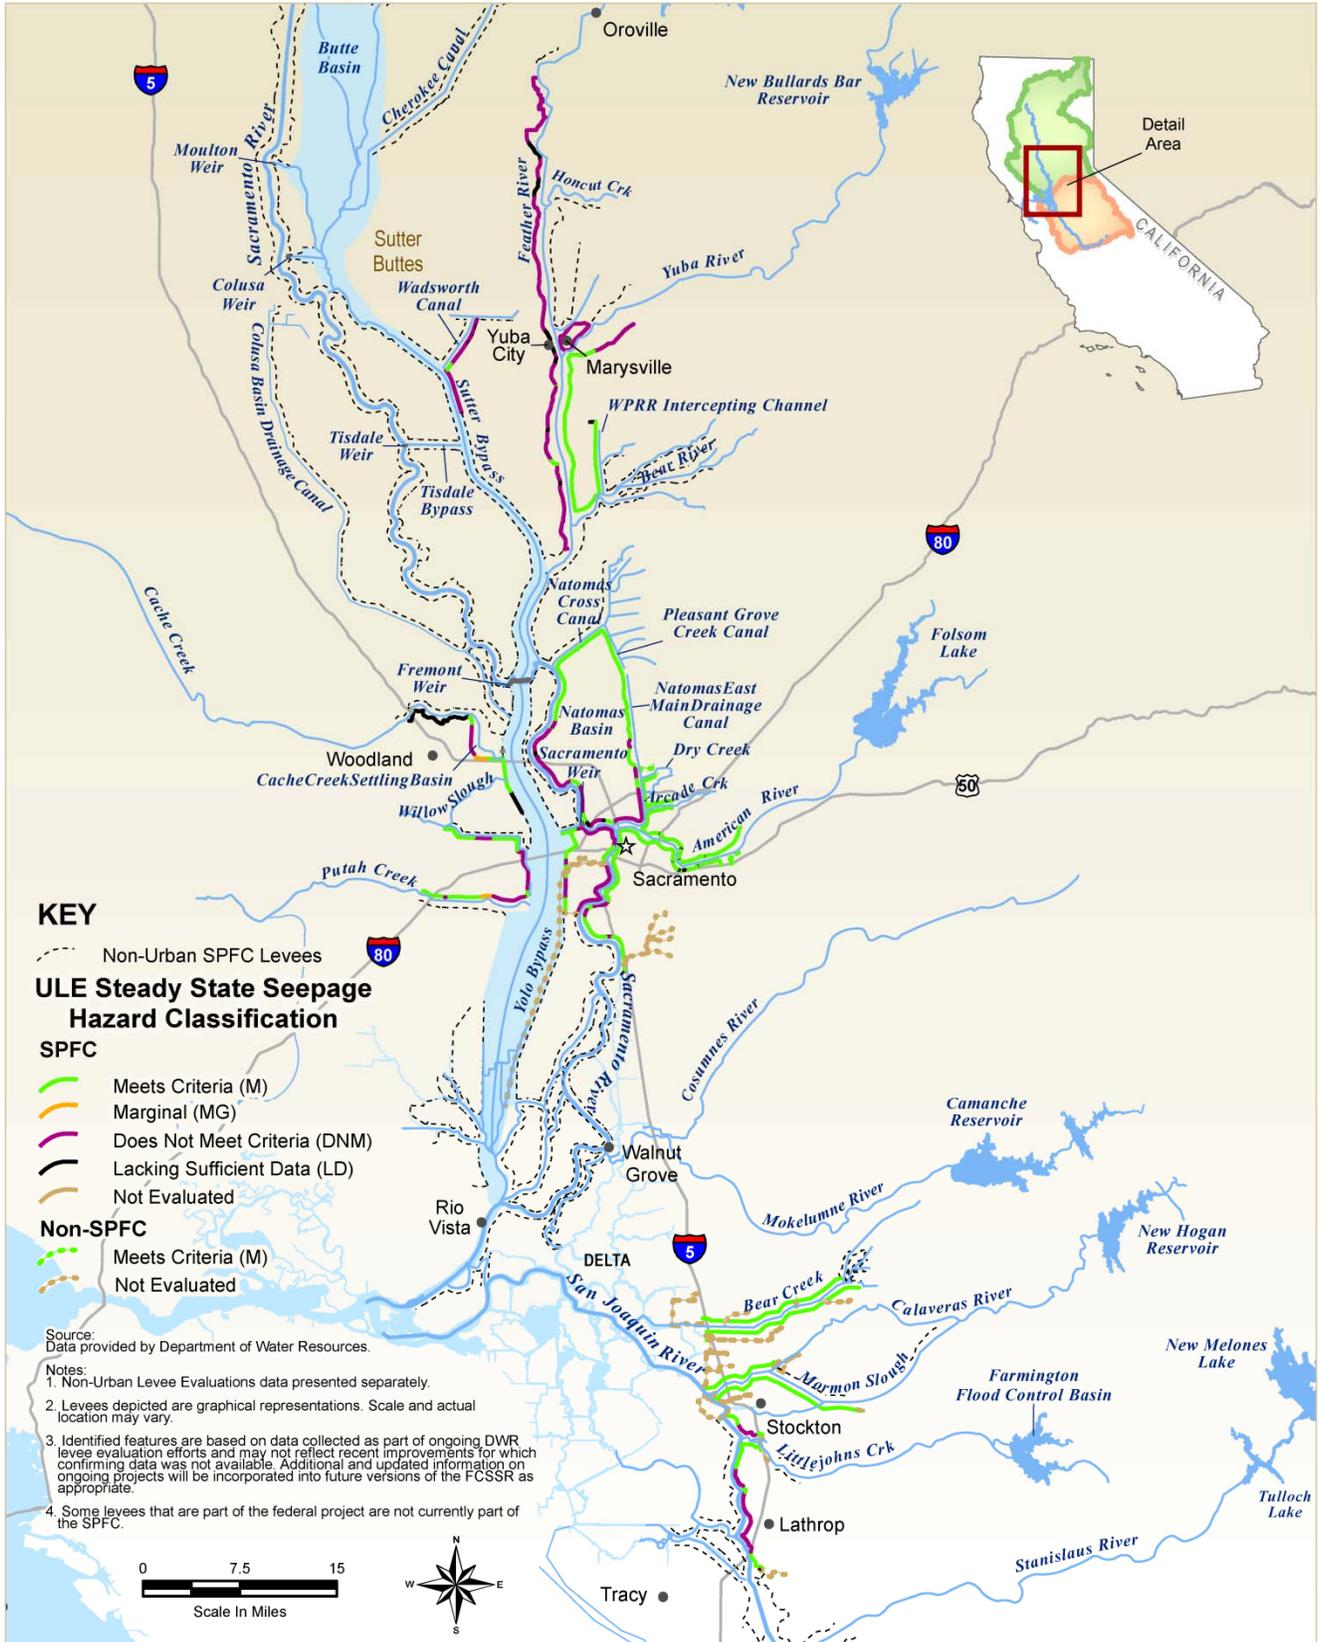
Figure 4-5. ULE Steady State Seepage Hazard Classifications

Results of the ULE steady state seepage hazard classifications are shown in Figure 4-5. Based on these results, SPFC ULE levee segments that generally meet seepage criteria include the rehabilitated portions of the Reclamation District 784 levees in Yuba County, the American River levees, the Natomas East Main Drainage Canal and Cross Canal levees, and Bear Creek levees in San Joaquin County. The longest segments that do not meet seepage criteria are along the west side of the Feather River. Results elsewhere among the ULE Project levees varied. Overall, approximately one-third of SPFC ULE levees evaluated do not meet current seepage design criteria.

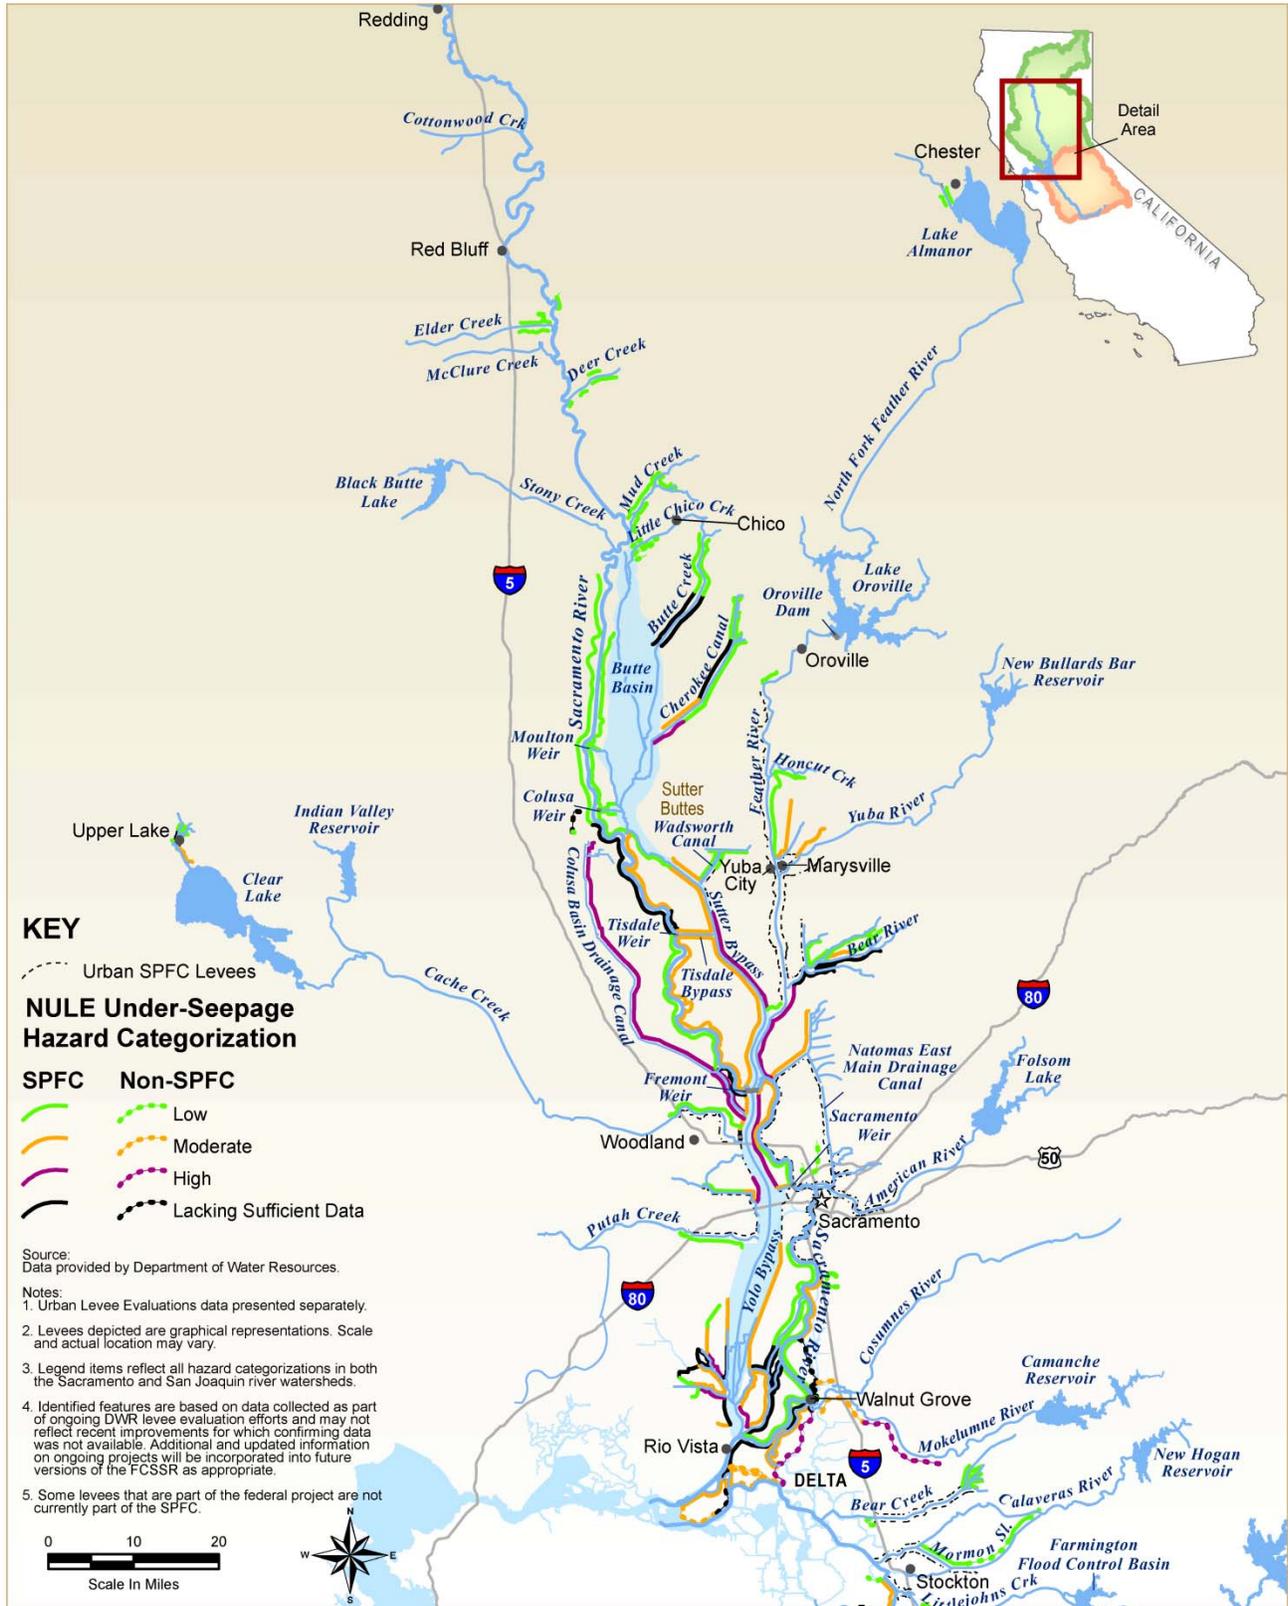
Figure 4-6. NULE Under-Seepage Hazard Categorizations in Sacramento River Watershed

Results of the NULE under-seepage and through-seepage hazard categorizations are shown in Figures 4-6 through 4-9. Figures 4-6 and 4-7 show the under-seepage hazard categorizations for NULE levees in the Sacramento and San Joaquin river watersheds, respectively. Figures 4-6 and 4-7 show that approximately one-third of SPFC NULE levees in the Sacramento River watershed and almost two-thirds in the San Joaquin River watershed have a high under-seepage hazard. Figures 4-8 and 4-9 show through-seepage hazard categorizations for NULE levees in the two watersheds. In general, through-seepage is less prevalent than under-seepage; approximately one-eighth of SPFC NULE levees in the Sacramento River watershed and approximately half in the San Joaquin River watershed have a high through-seepage hazard.

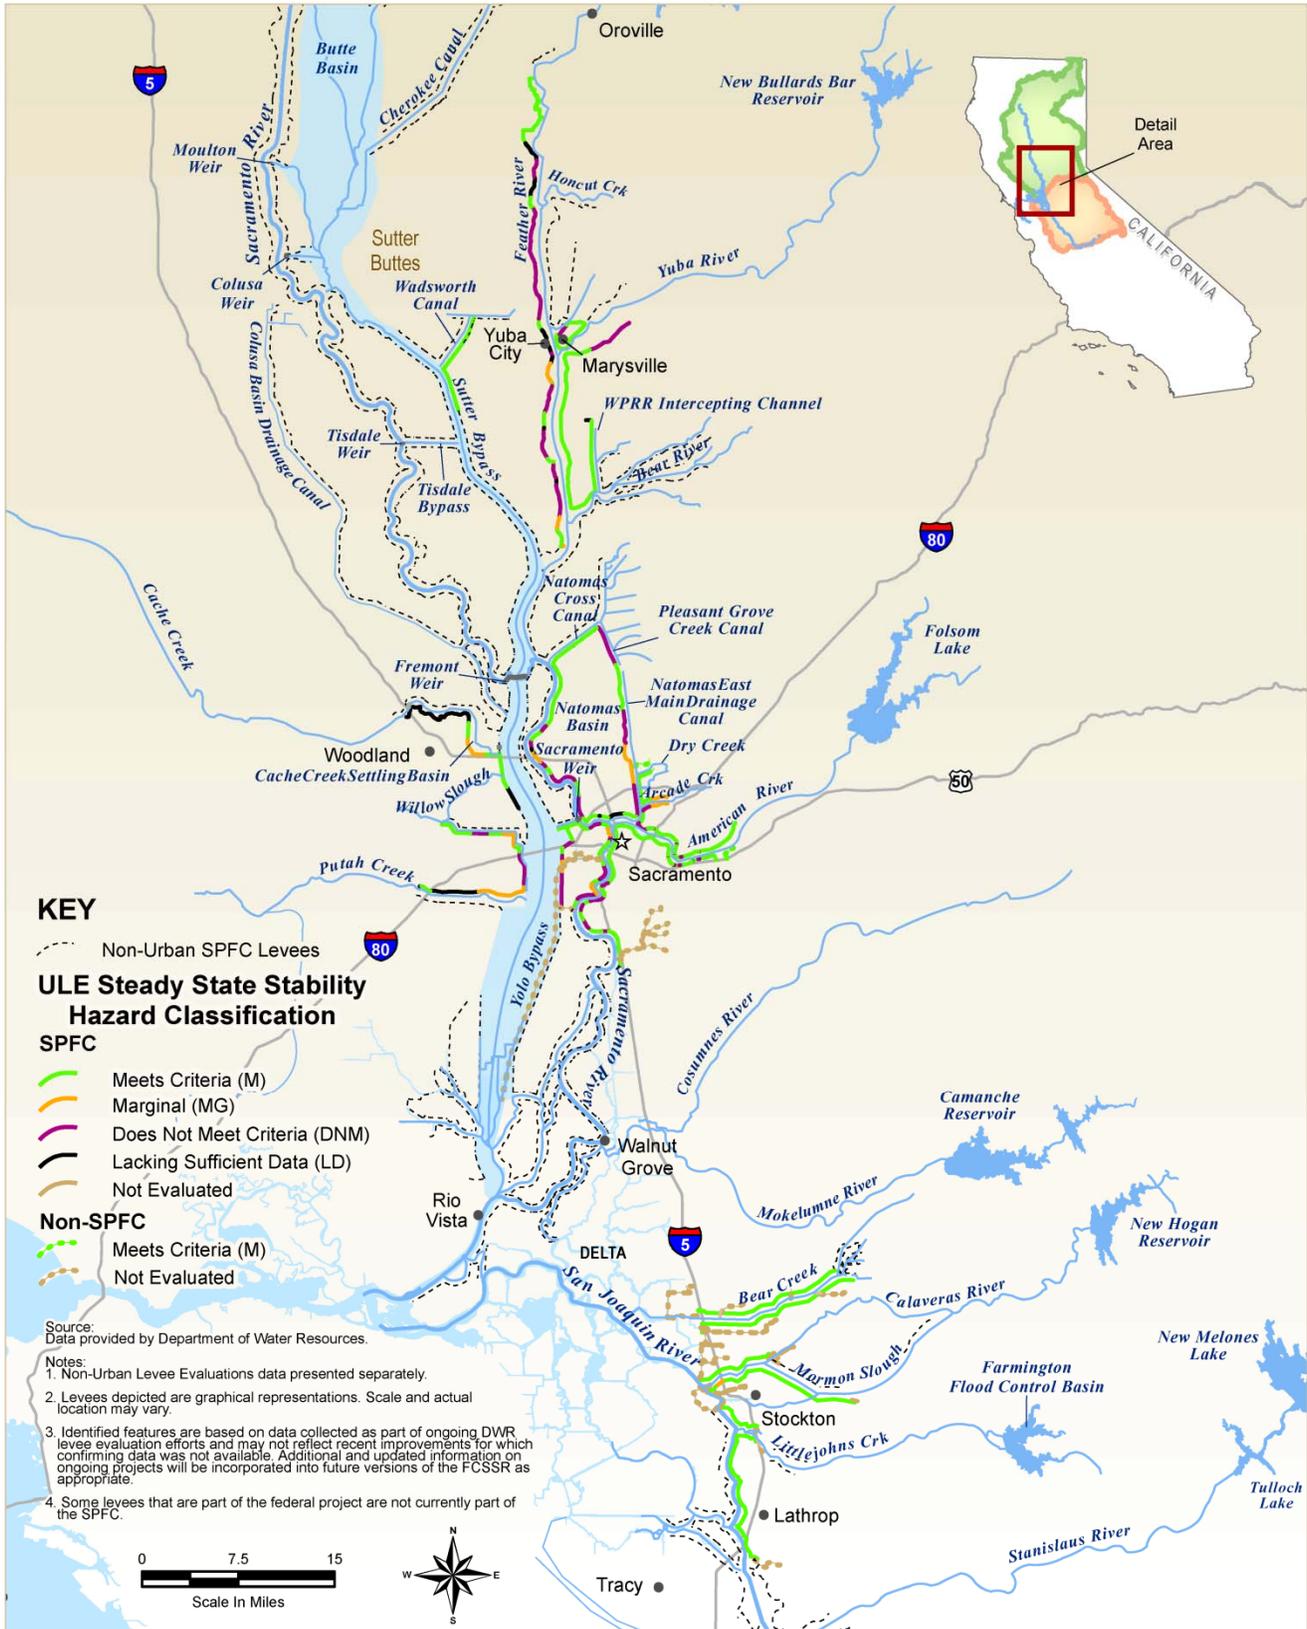
Figure 4-10. ULE Steady State Stability Hazard Classifications

Results of the ULE Project steady state stability hazard classifications are shown in Figure 4-10. Based on these results, an estimated one-fifth of SPFC ULE levees do not meet geotechnical criteria for slope stability at the design water surface elevation. In general, SPFC ULE levees in the San Joaquin river watershed, along the American River, and along rehabilitated reaches of the Natomas basin and east of the Feather River meet slope stability criteria. Results along the remaining SPFC ULE levees vary.

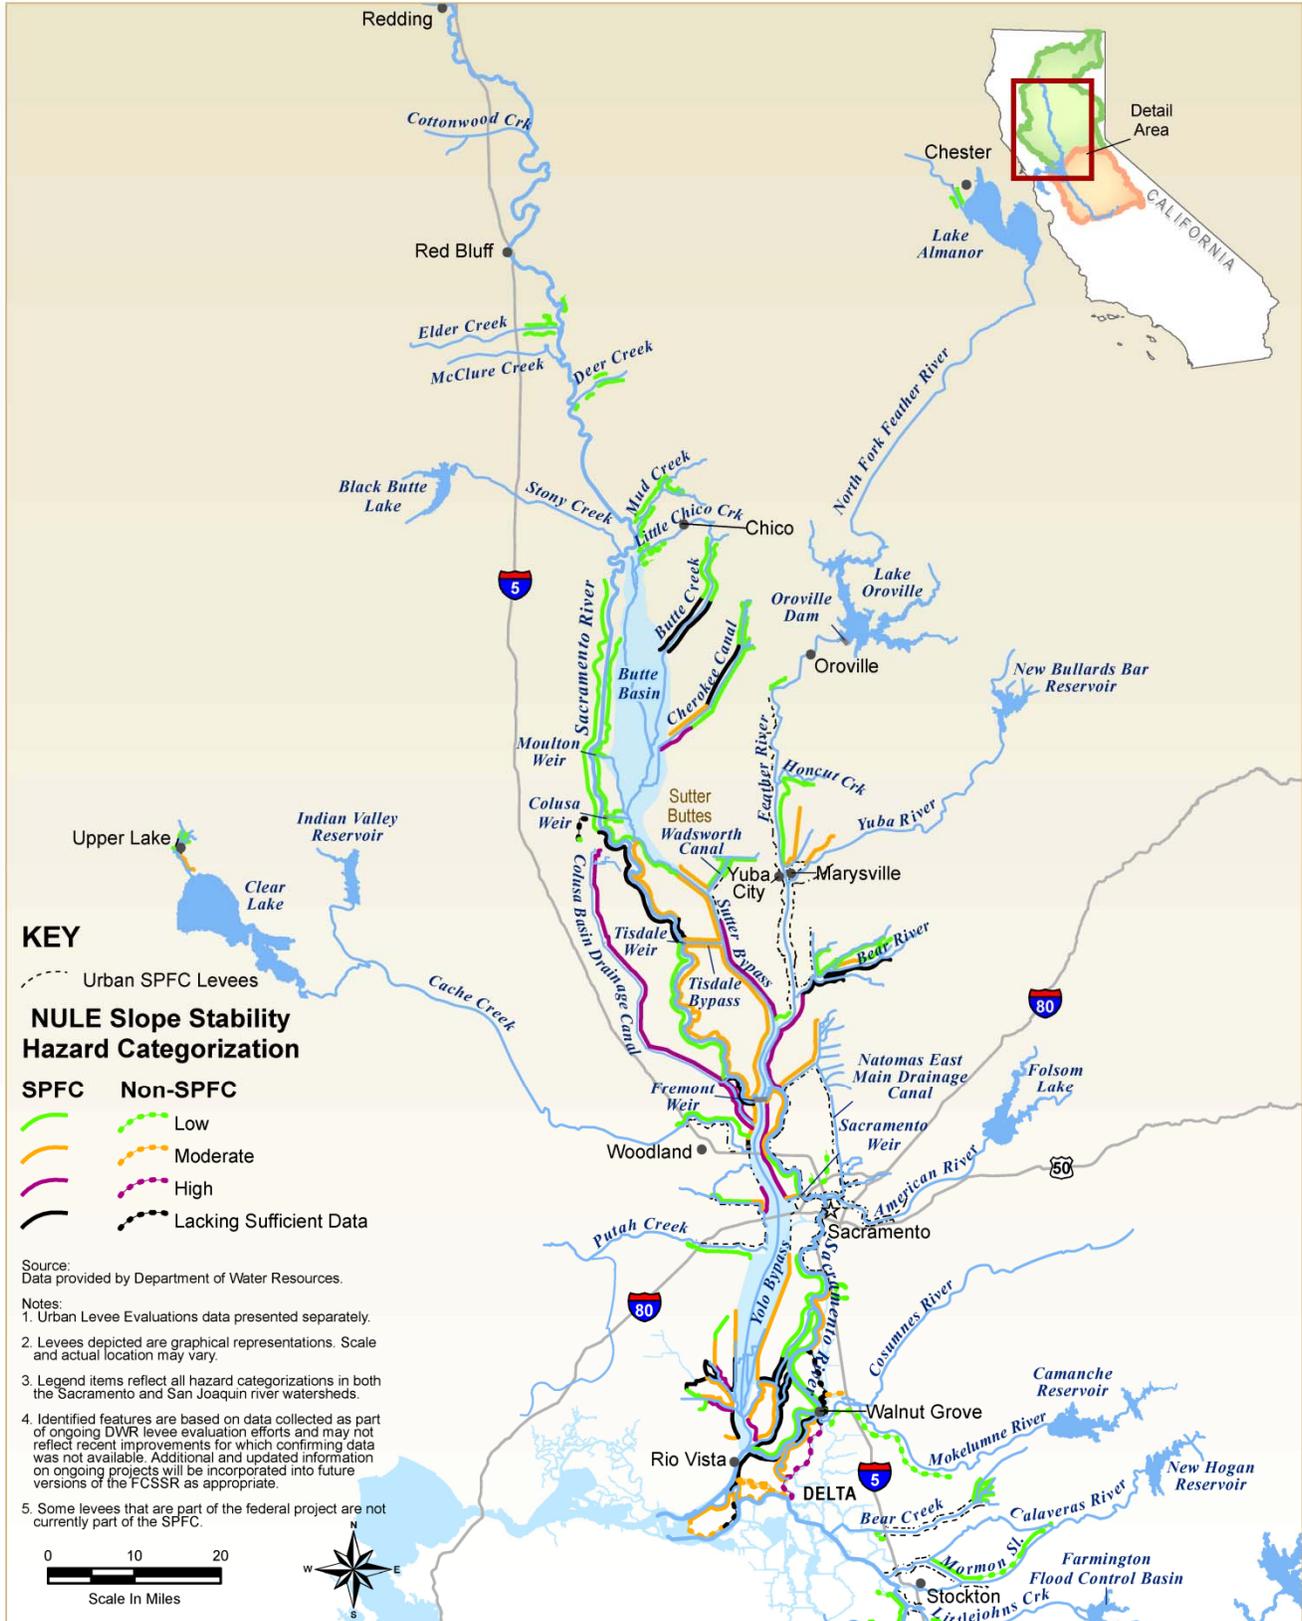
**Figure 4-11. NULE Slope Stability Hazard Categorizations in Sacramento River Watershed**

Slope stability hazard categories are shown in Figures 4-11 and 4-12. As shown, there is generally a higher slope stability hazard for levees in the Sacramento River watershed compared to the San Joaquin River watershed. Approximately one-eighth of SPFC NULE levees in the Sacramento River watershed and 1 percent in the San Joaquin River watershed have a high slope stability hazard.

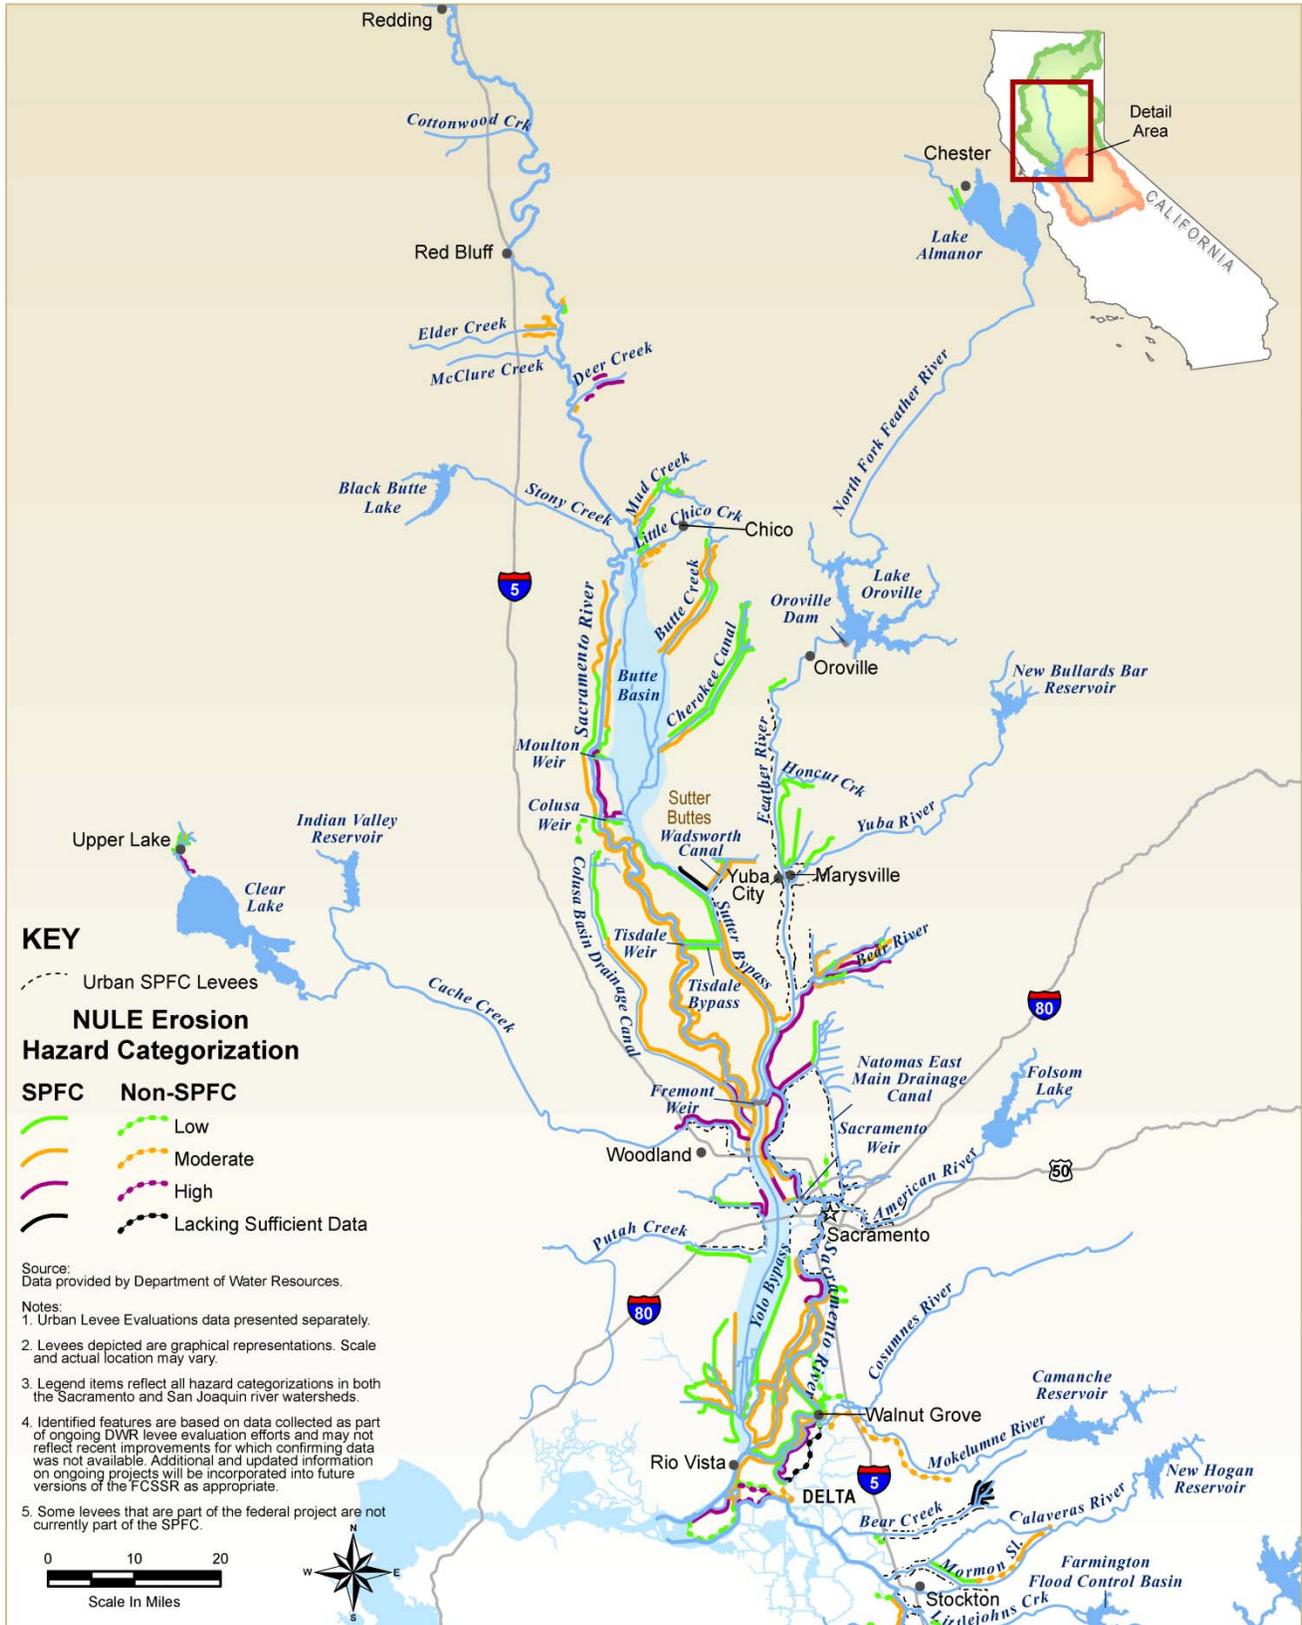
Figure 4-13. NULE Erosion Hazard Categorizations in Sacramento River Watershed

high erosion hazard. NULE levee segments with high erosion hazard in the Sacramento River watershed are predominantly located in the area between the City of Sacramento and the Bear River in Yuba County.

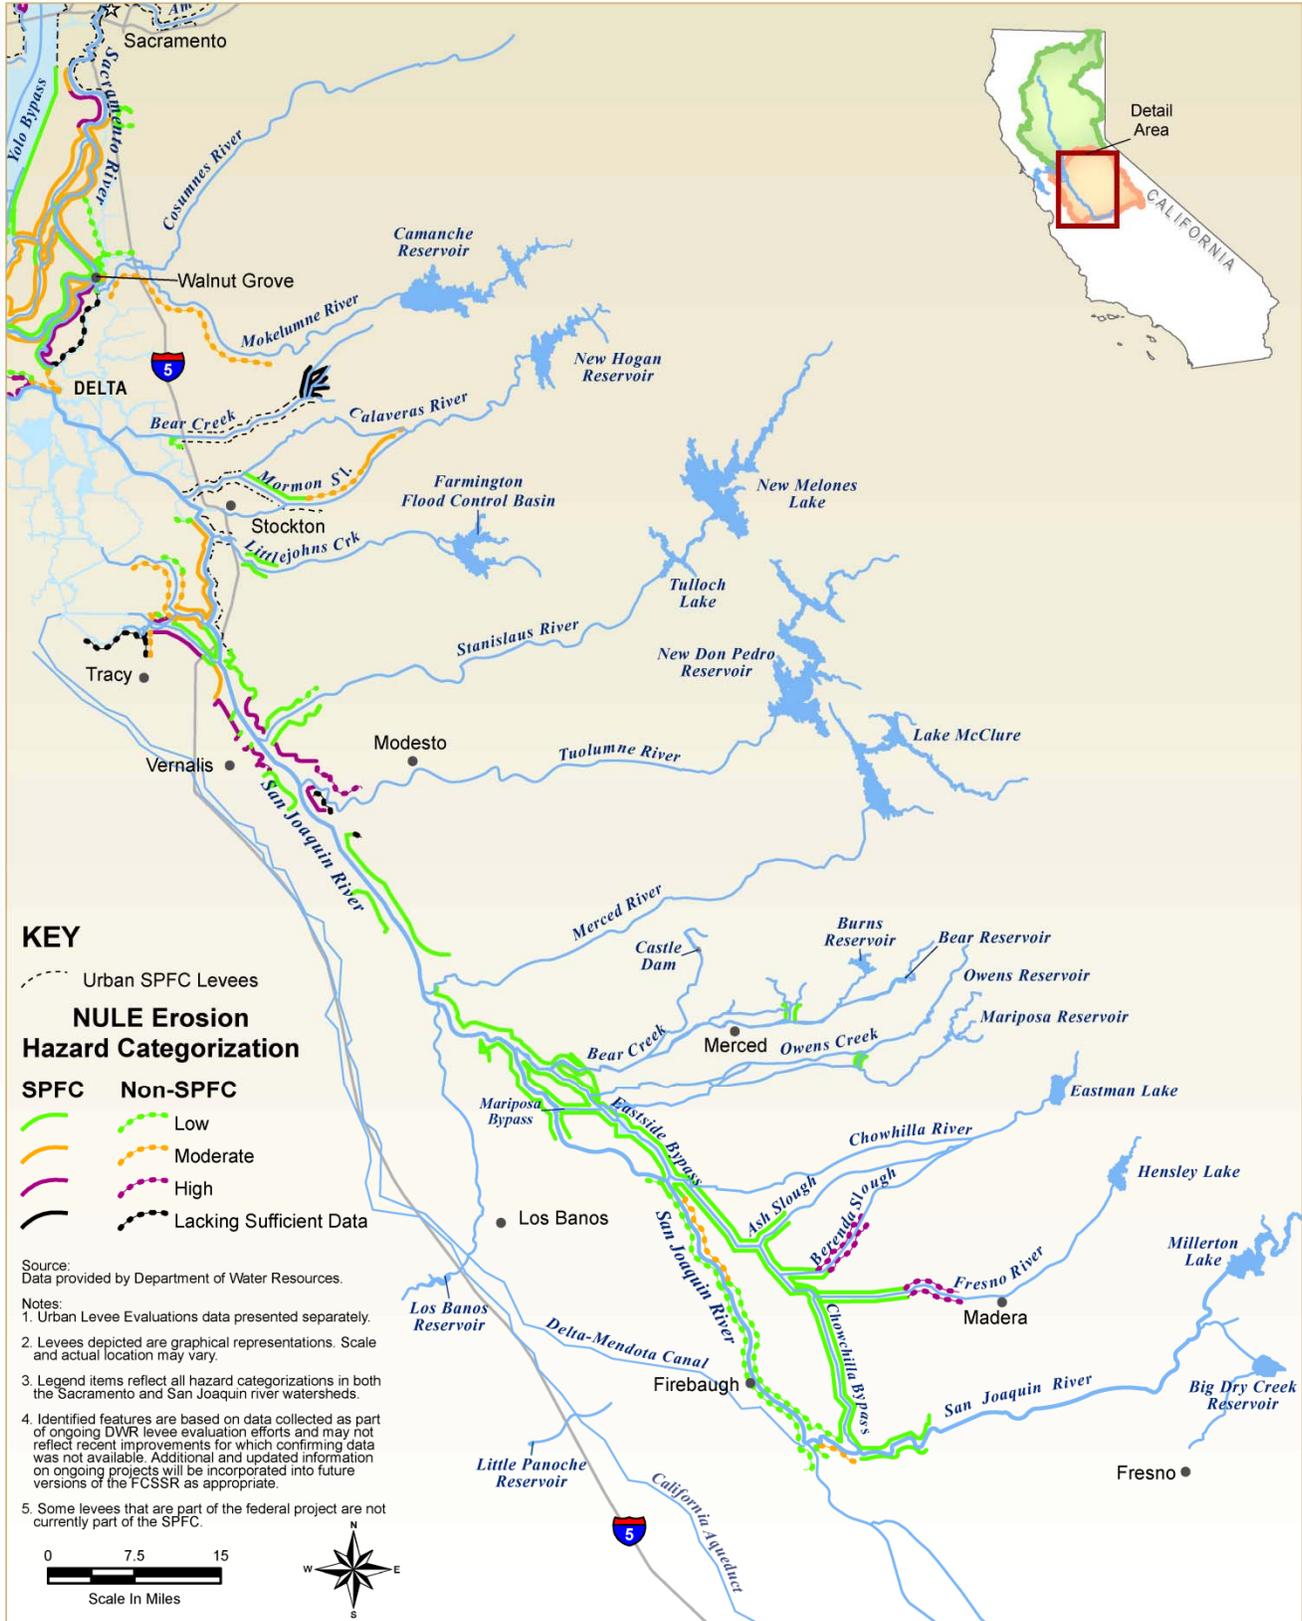
Figure 4-14. NULE Erosion Hazard Categorizations in San Joaquin River Watershed

The majority of NULE levees in the San Joaquin River watershed were categorized as having a low erosion hazard. The approximately one-eighth of SPFC NULE levee segments with high erosion hazard are predominantly located on the lower San Joaquin River (downstream from the Tuolumne River confluence), Berenda Slough, and Fresno River.

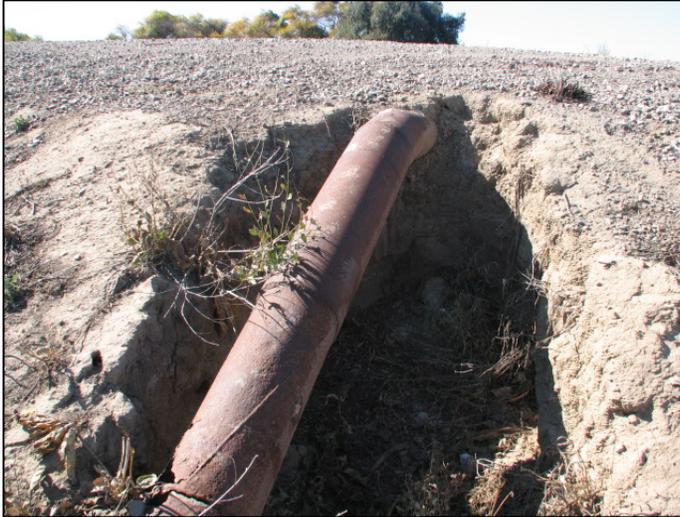
Penetrations can be potential pathways for seepage

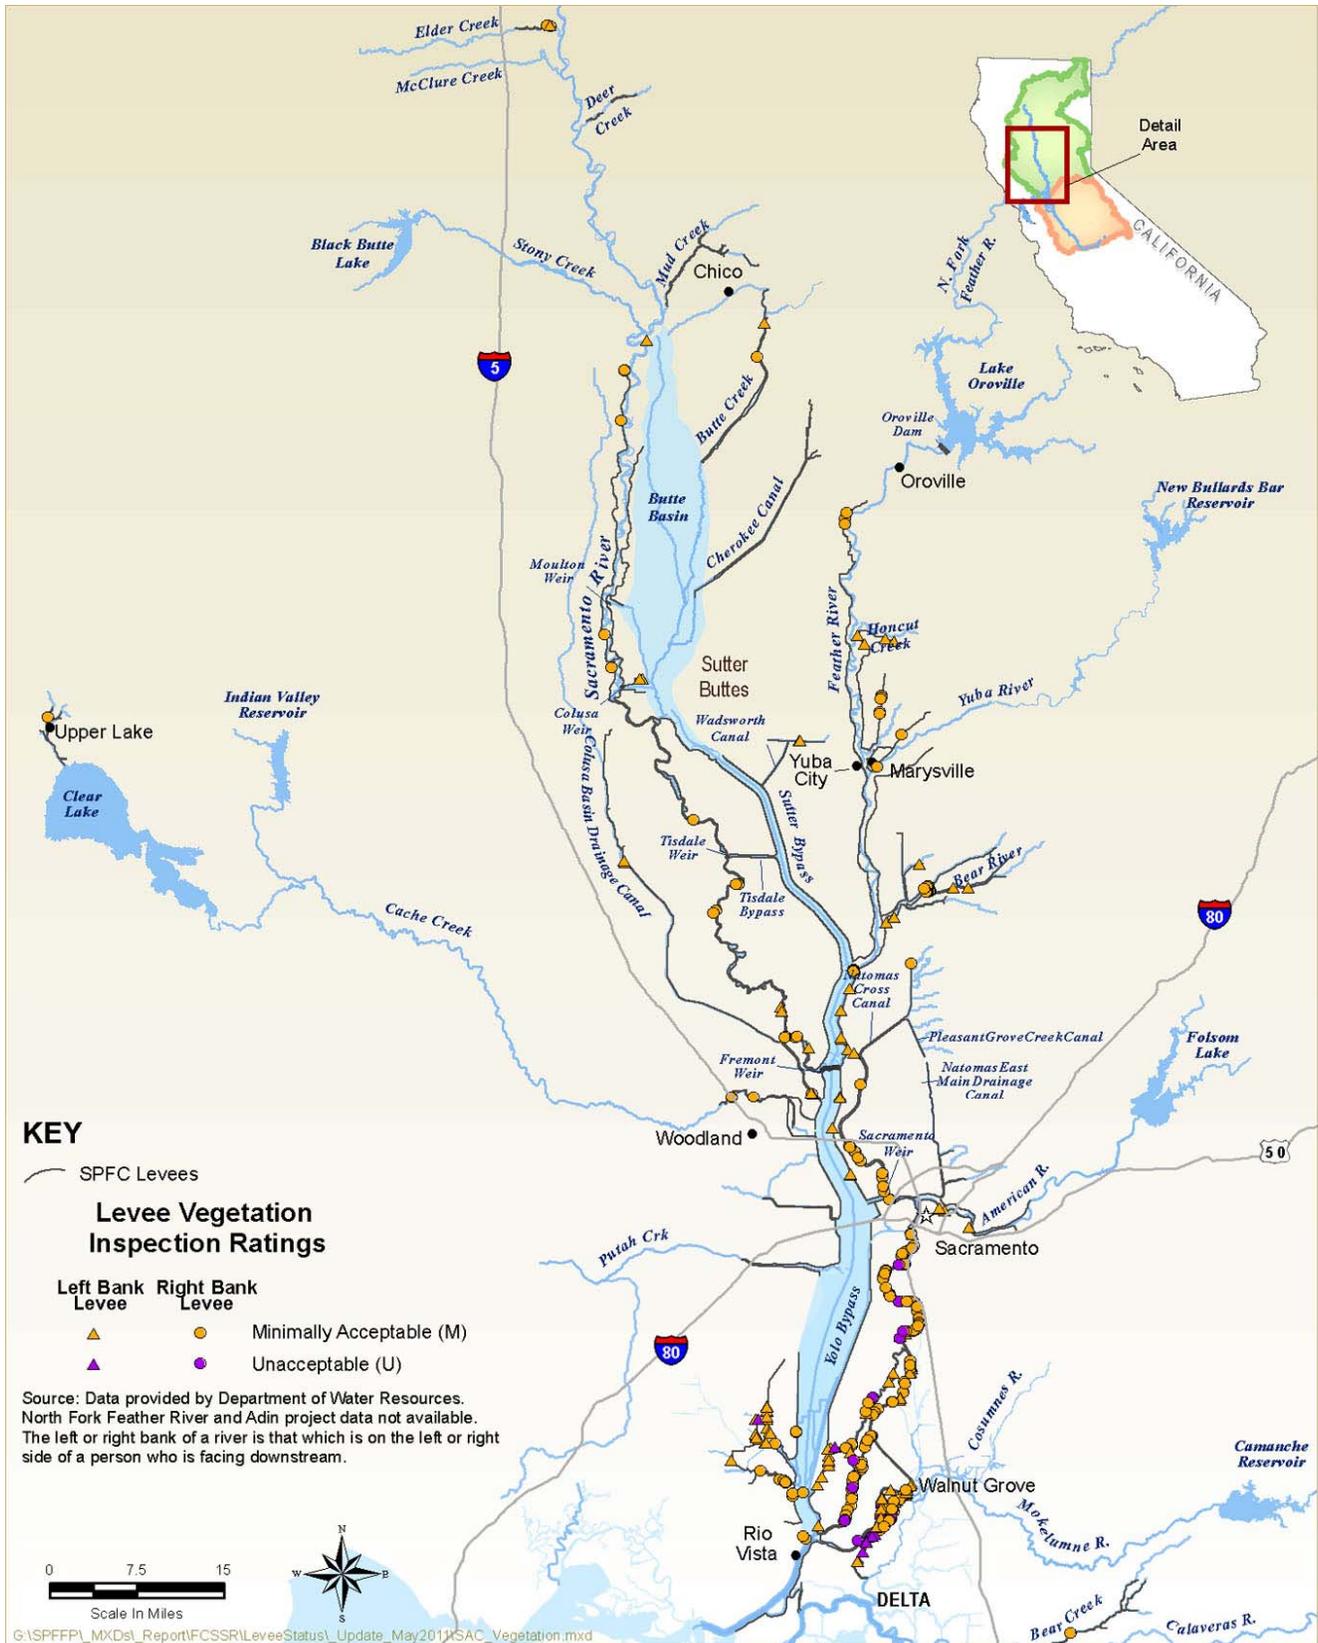
Figure 4-19. 2009 Levee Vegetation Inspection Ratings in Sacramento River Watershed

Although difficult to determine from the figures because of the scale of the maps, levee reaches with Unacceptable ratings include approximately 15 total miles of levees. Levees with Unacceptable ratings had brush and weeds, trees needing trimming/thinning, and approximately 111 elderberry shrubs requiring thinning or removal. Elderberry shrubs are host plants for the valley elderberry longhorn beetle (*Desmocerus californicus dimorphus*), federally listed as threatened. Most of the Unacceptable ratings for levee vegetation and trimming/thinning of trees were located on the Sacramento River south of Sacramento, and in the Sacramento-San Joaquin Delta.
