## 4.0 Levee Status

## Flood Control System Status Report

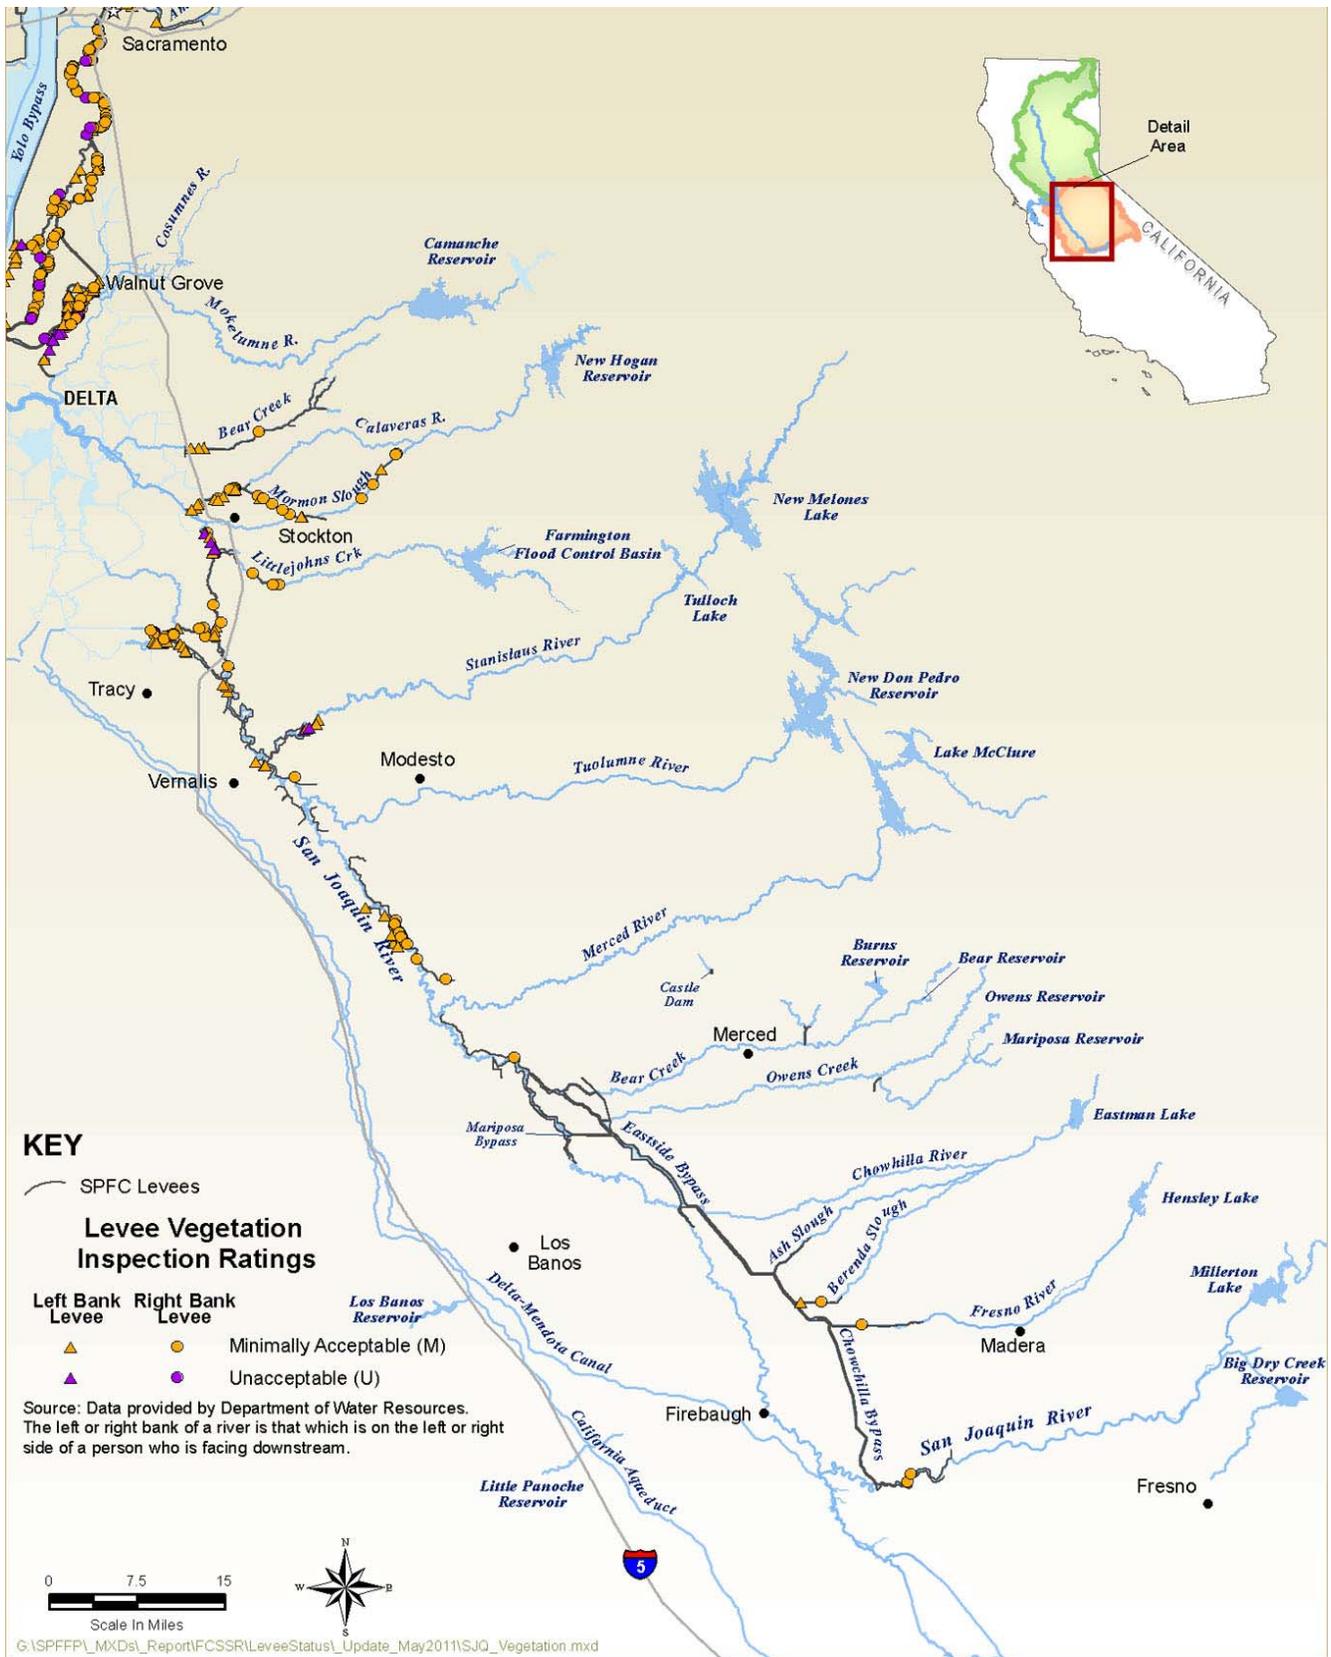
**Figure 4-20. 2009 Levee Vegetation Inspection Ratings in San Joaquin River Watershed**

Although difficult to determine from the figures because of the scale of the maps, levee reaches with Unacceptable ratings include approximately 15 total miles of levees. Levees with Unacceptable ratings had brush and weeds, trees needing trimming/thinning, and approximately 111 elderberry shrubs requiring thinning or removal. Elderberry shrubs are host plants for the valley elderberry longhorn beetle (*Desmocerus californicus dimorphus*), federally listed as threatened. Most of the Unacceptable ratings for levee vegetation and trimming/thinning of trees were located on the Sacramento River south of Sacramento, and in the Sacramento-San Joaquin Delta.

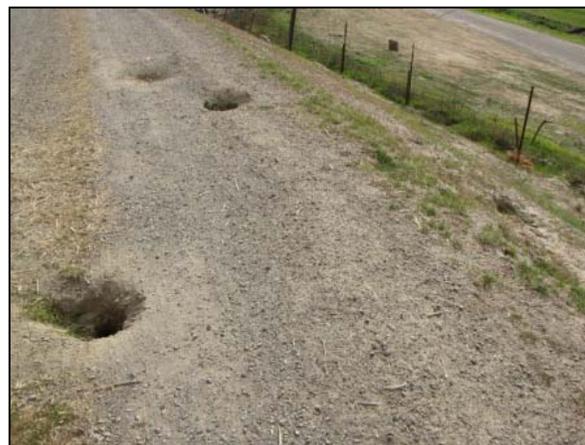
Animal burrows can increase seepage through a levee

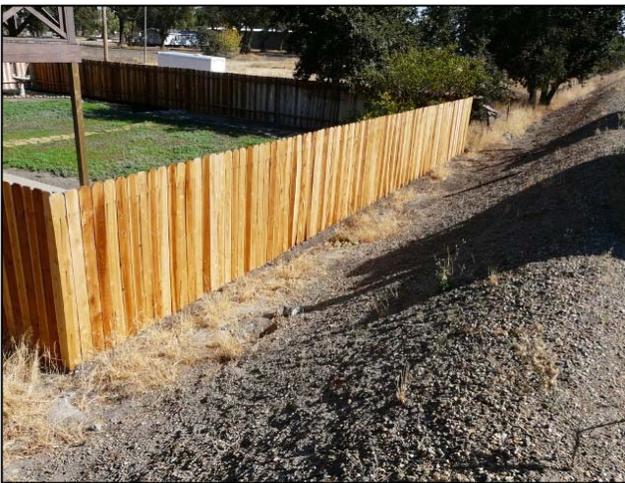
Encroachments can interfere with floodfighting, inspection, and maintenance
