Improving Seismic Safety of Dams in California

Donald H. Babbitt, M.ASCE ¹

Abstract

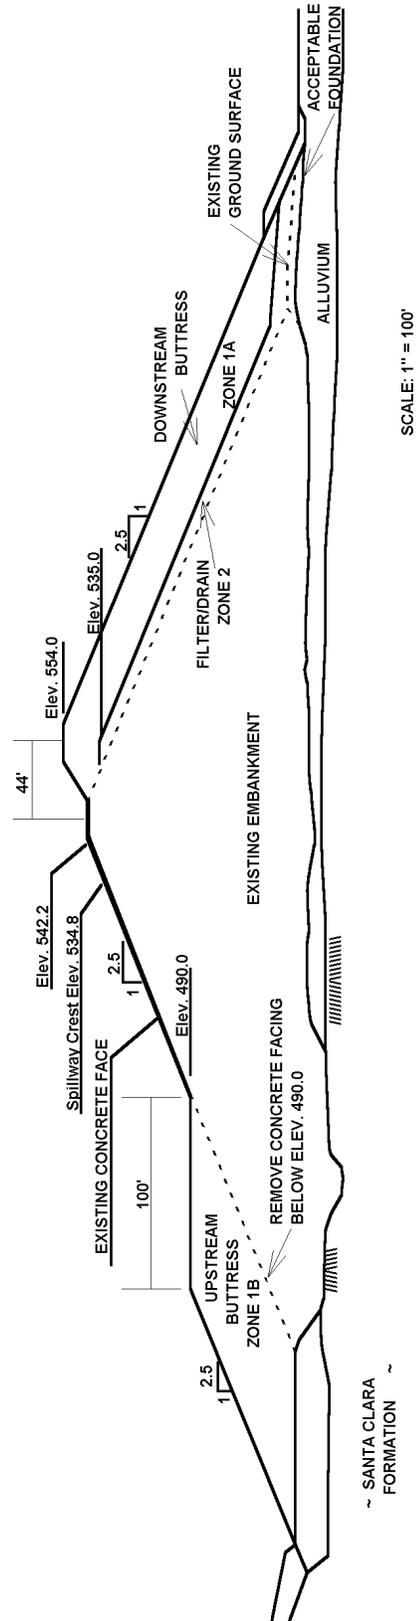
FIGURE 1 - STEVENS CREEK DAM REHABILITATION PLAN

An embankment rehabilitation consisting of upstream and downstream soil berms was designed to limit strain potentials determined by cyclic triaxial testing and dynamic finite element analyses (Fig.1). Strain potentials computed for the central and downstream portions of the modified embankment and the alluvium were relatively low. The strain potentials for the upstream portion of the dam and the upstream berm exceeded 20 percent. This was taken to mean the upstream areas will probably be subject to spreading and slumping during the design earthquake. Post earthquake stability analysis of the remainder of the embankment, using post cyclic triaxial test results, indicated acceptable performance. A Makdisi-Seed

simplified analysis indicated a total deformation of approximately 10 feet. The chimney drain between the original dam and the downstream buttress is intended to act as a crack stopper as well as to keep the buttress from becoming saturated. Note that the downstream berm is 12 feet higher than the dam crest.

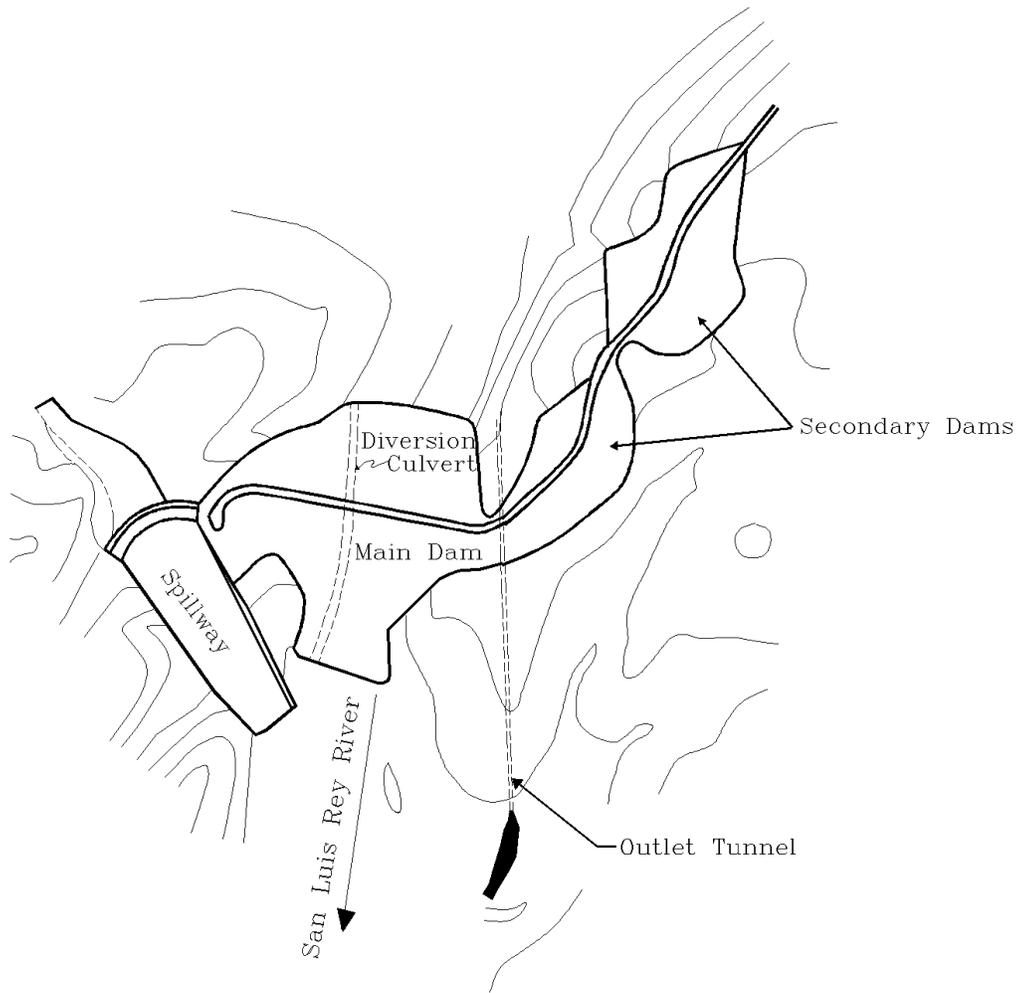
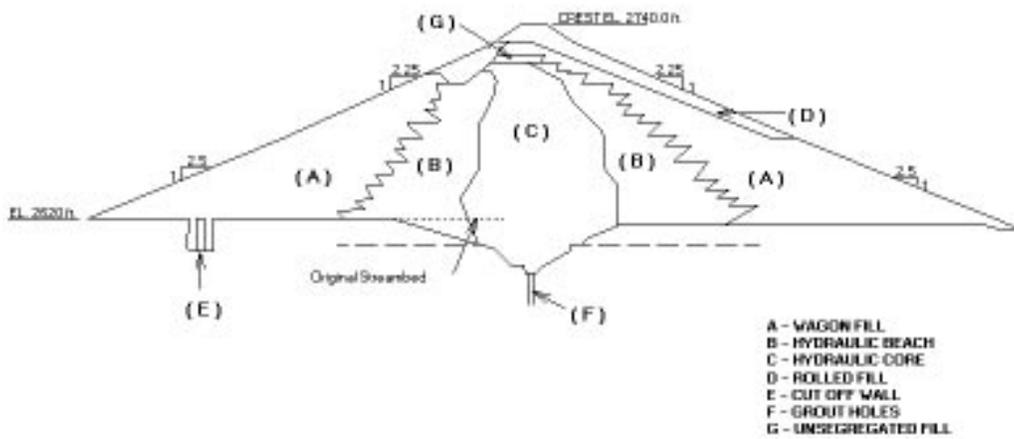
FIGURE 2 - HENSHAW DAM BEFORE MODIFICATION

Henshaw Dam, a hydraulic fill, (Fig.2) had another serious problem. It is located in the 8 to 12 mile wide active Elsinore fault zone. Traces of the fault trend diagonally under the main dam embankment (Bischoff 1985). The fault is deemed capable of producing a Magnitude 7.0 earthquake with potential fault rupture displacements, at the dam, of up to 5 feet in either the vertical or horizontal direction and or up to 7 feet in an oblique direction.

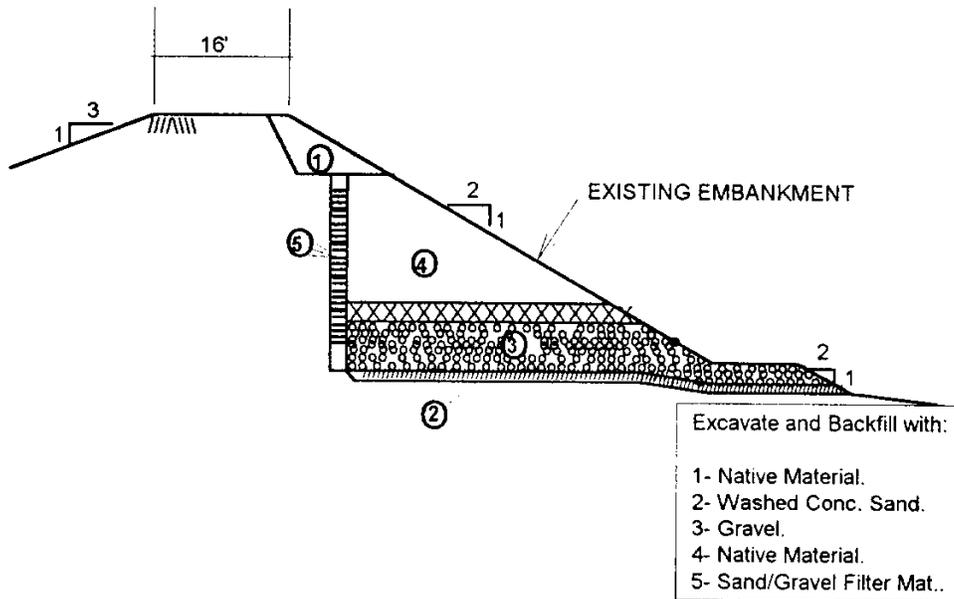
FIGURE 6 - PIGEON PASS DAM, CHIMNEY DRAIN INSTALLATION

In December 1978, transverse cracks were discovered in the embankment. The causes of the cracks were determined to be a combination of embankment shrinkage and differential foundation settlement due to hydrocompaction and possibly seismic shaking. The largest crack was repaired by excavating and placing compacted embankment. The proximity of a nearby active fault, the San Jacinto at 4 miles, dictated that

repairs include more than treating identified cracks. Cracks could rapidly reopen or new ones form in the rather brittle embankment during an earthquake, particularly where the dam is founded on cohesionless soils. A chimney drain was placed in a trench in the downstream slope to act as a crack stopper. Gallery drains were provided as outfalls from the chimney (Fig.6).

The work was safely accomplished in a short time without the aid of trench supports. The chimney material is a well graded minus 1-1/2 inch concrete mix. It was dumped in place, wet, from ready mix trucks. The gallery material is 3/8 inch pea gravel; it is filtered by concrete sand.

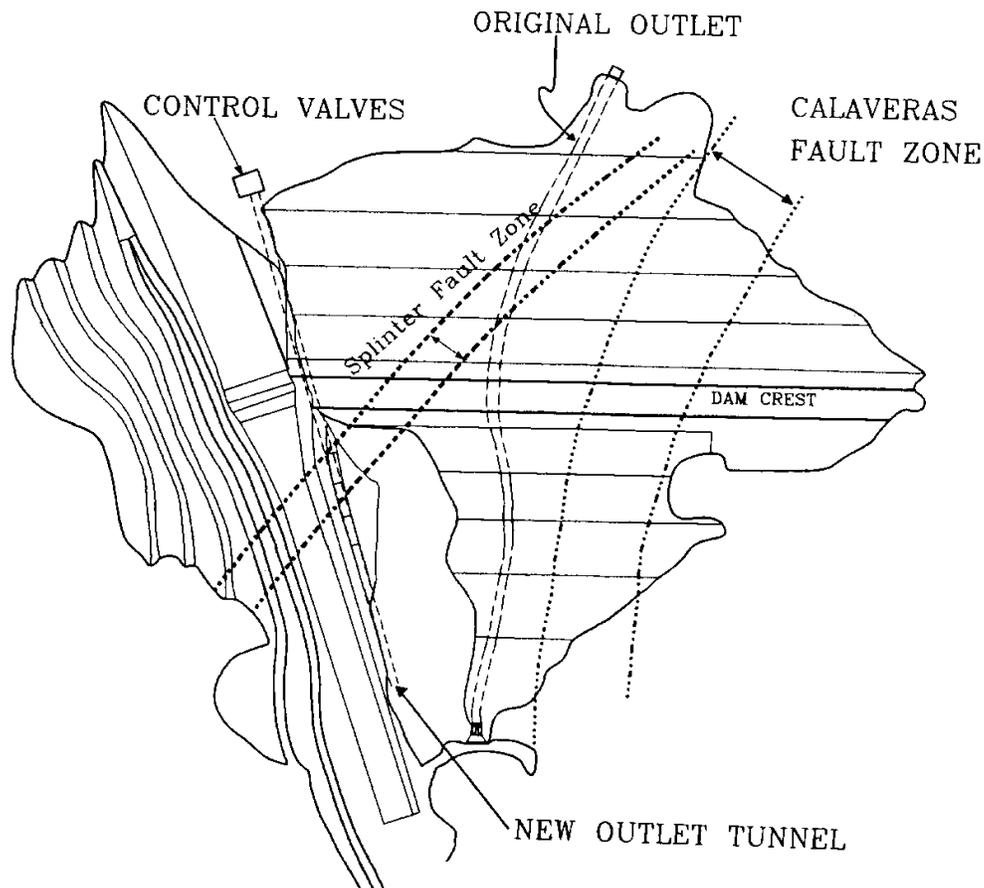
FIGURE 7 - COYOTE DAM, PLAN VIEW

Coyote Dam is a 140-foot high zoned embankment dam completed in 1936 across the known active Calaveras fault in southern Santa Clara County. The apparent active fault trace was mapped on the excavated foundation surface and a 50-inch diameter outlet conduit was aligned to avoid it. A control valve was installed at the upstream end so that the steel-lined reinforced concrete conduit would not be under pressure if it was ruptured by splinter faulting or a slight shift in the active fault trace.

While the new outlet virtually eliminates the conduit rupture hazard, DSOD is concerned about piping occurring through upper abutment and/or embankment cracking caused by fault movement. A reservoir

for regulation, a valve was installed on the downstream end of the conduit. However, pressurization of the conduit was restricted to times when the contents of the reservoir could be captured by Leroy Anderson Reservoir located 3 miles downstream. When, in the late 1980s, continued accumulation of sediments necessitated another outlet modification, an outlet tunnel was constructed through the right abutment just above the level of the sediments. The new outlet tunnel is 200 to 300 feet farther from the active fault trace (Fig.7). The control valves are located upstream of a splinter fault crossing the tunnel alignment so that the tunnel is free flowing when crossing this feature. The tunnel is articulated into 10-foot long segments connected by water stops through the splinter fault zone.
