# Budiselich Flashboard Dam Fish Passage Improvement Project

Randy Beckwith, Senior Engineer

CA Department of Water Resources

Fish Passage and Protection Workshop

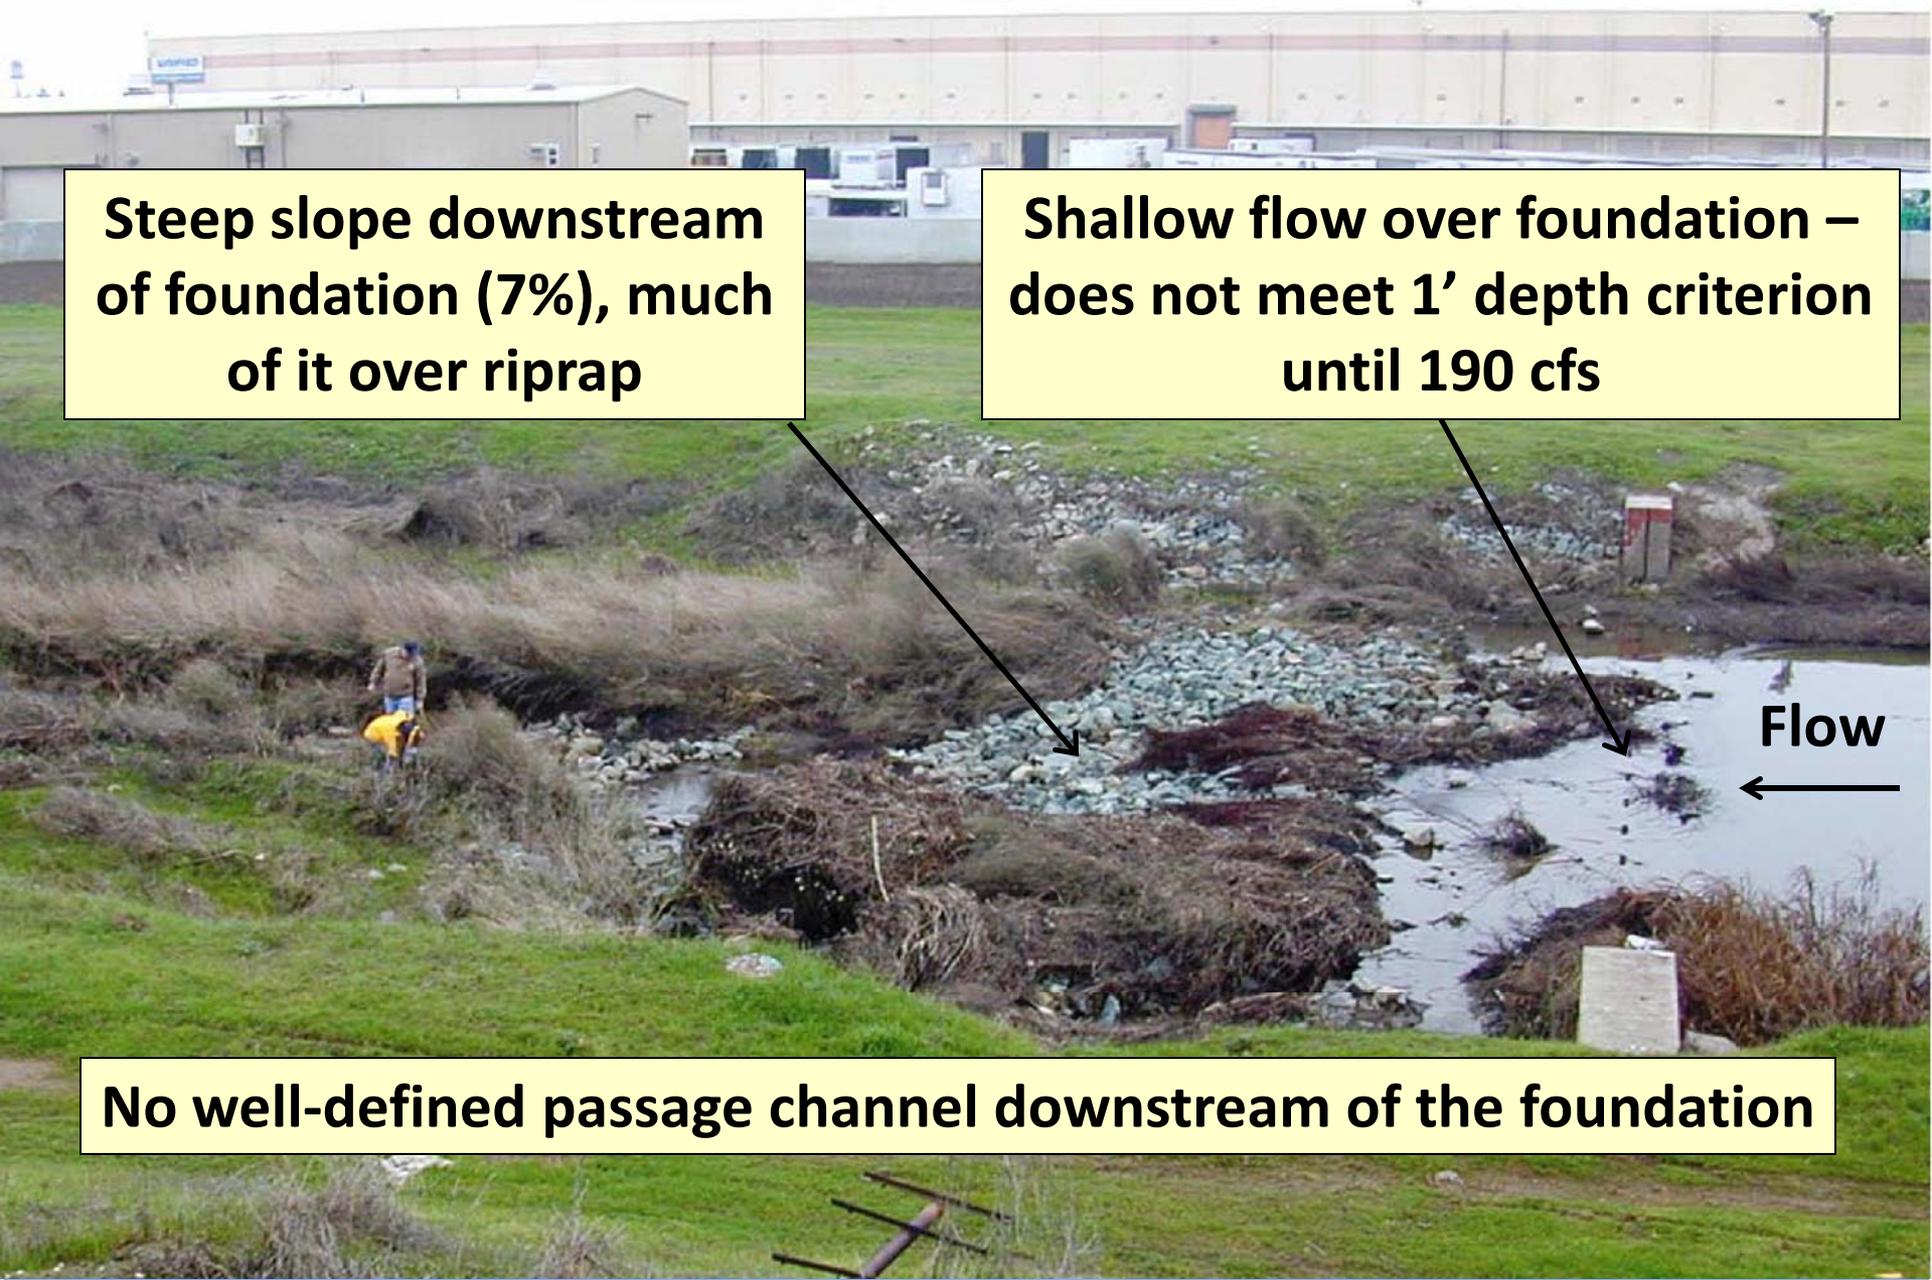
**Steep slope downstream of foundation (7%), much of it over riprap**

**Shallow flow over foundation – does not meet 1' depth criterion until 190 cfs**

**No well-defined passage channel downstream of the foundation**

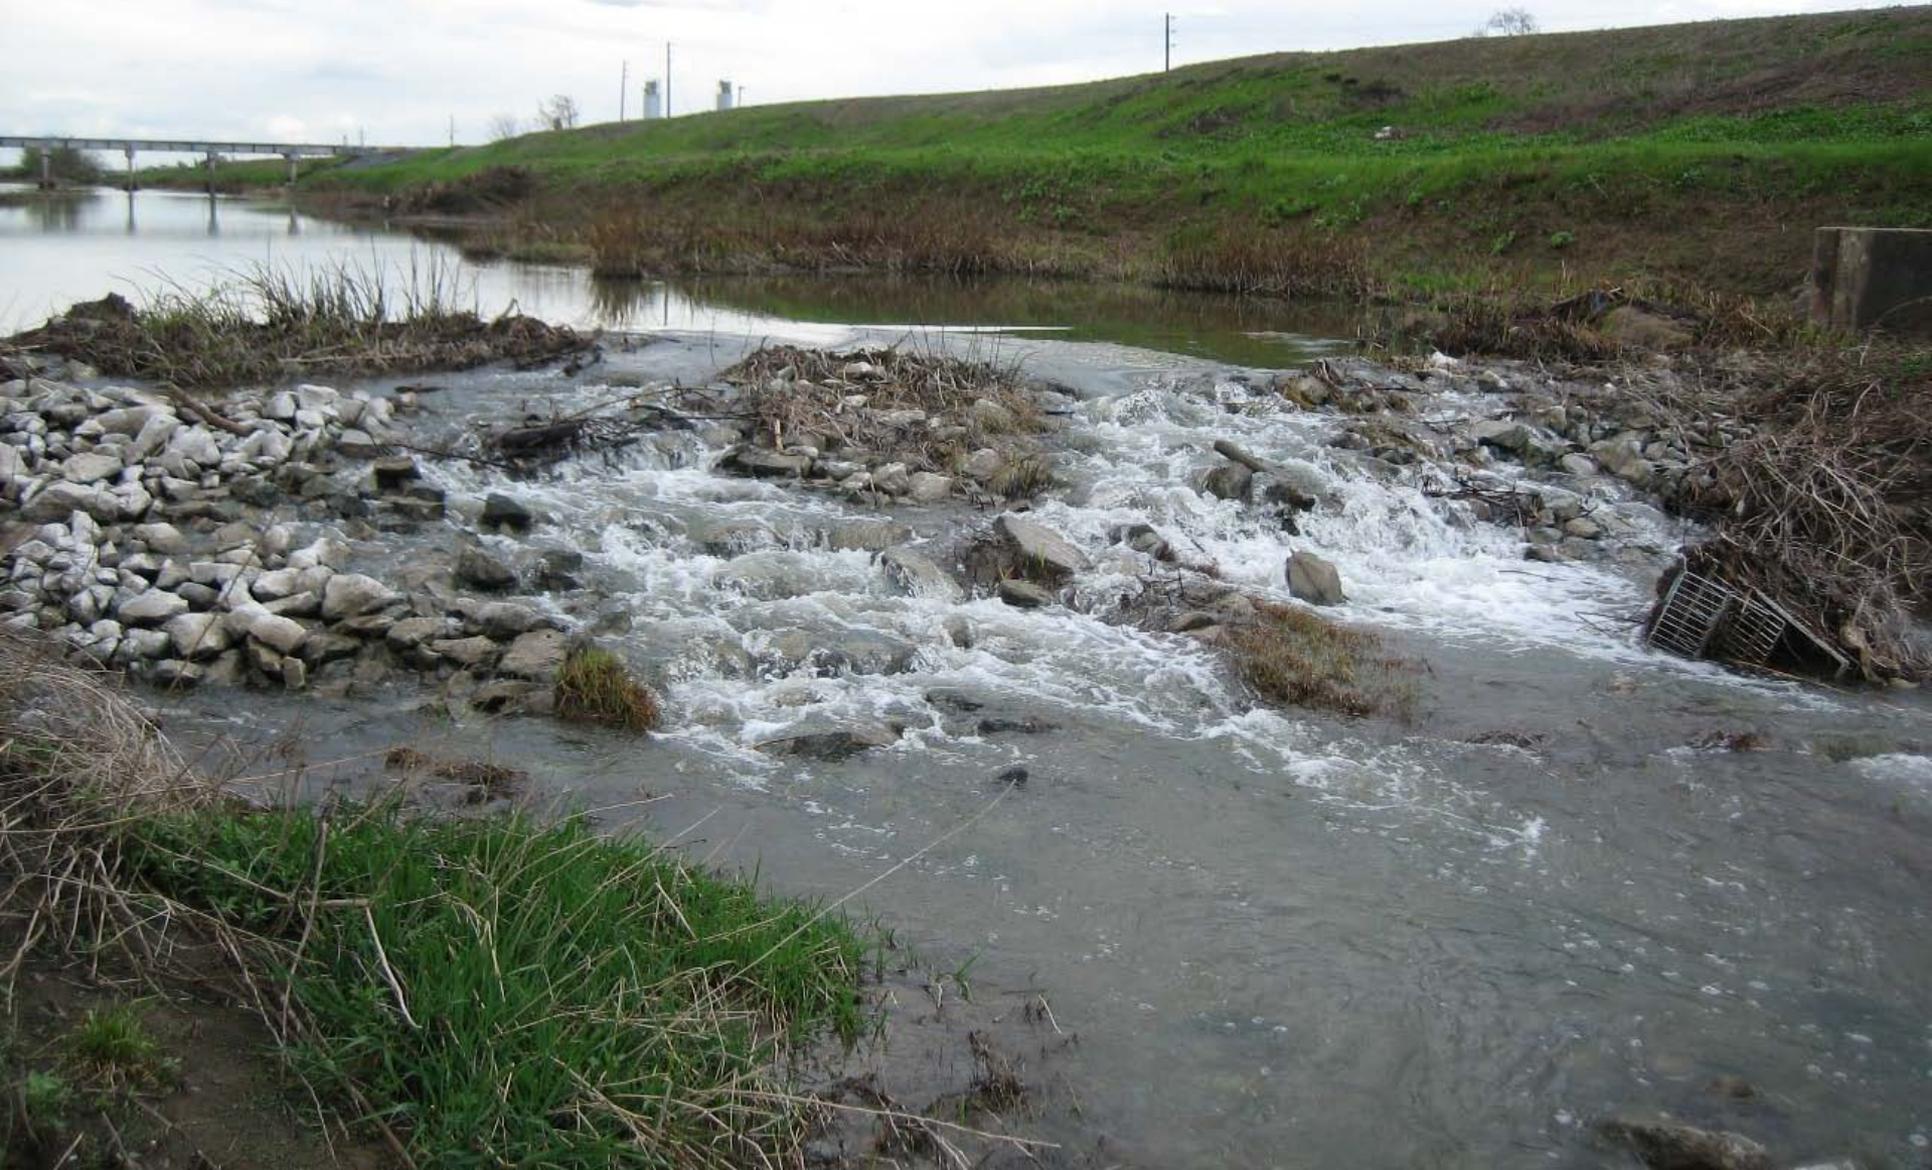
**February 28, 2006 – Flow Magnitude Unknown**

**Steep slope and riprap**

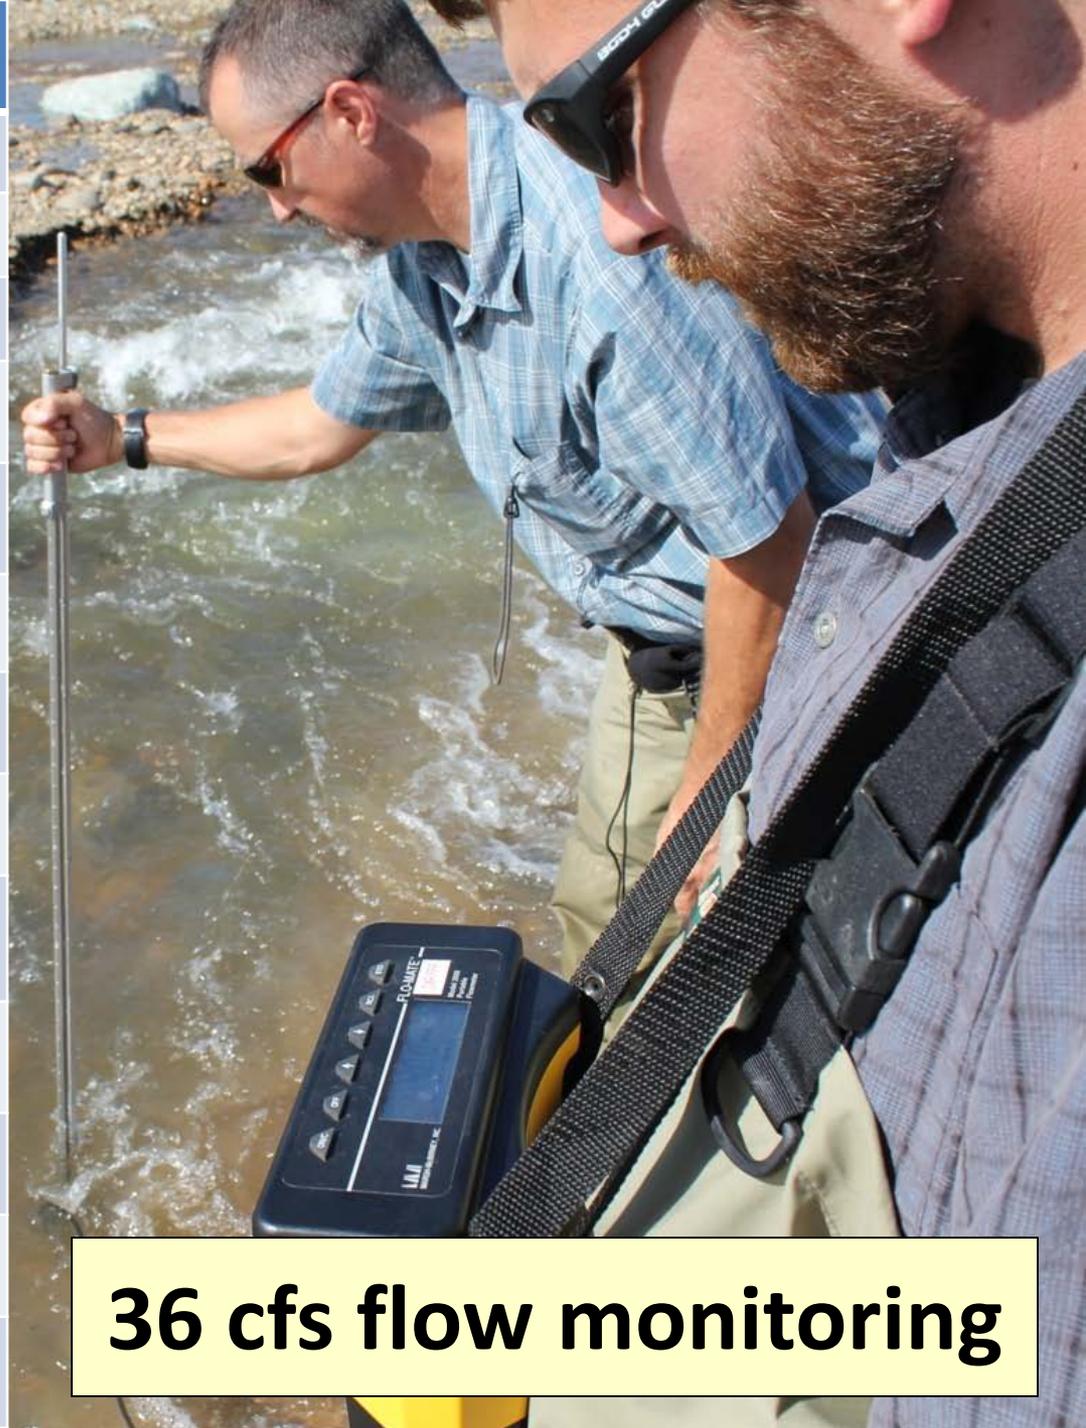
Station (ft)	Depth (ft)	Velocity (ft/s)	Notes
	<b>1.15</b>	<b>0.83</b>	<b>dam foundation</b>
0	0.9	3.06	weir 1
6	1.3	5.33	downstream of weir 1
17	1.4	6.12	at constricting boulders
<b>33</b>	<b>0.9</b>	<b>7.70</b>	<b>at weir 2</b>
33	0.8	3.36	2' from left edge
49	1.3	3.84	at constricting boulders
65	1.1	5.37	at weir 3
87	1.5	6.54	at boulder between weirs 3 and 4
98	1.0	5.68	at weir 4
121	1.0	5.14	between weirs 4 and 5
135	1.0	5.02	at weir 5
155	2.6	0.58	in backwater area

**36 cfs flow monitoring**

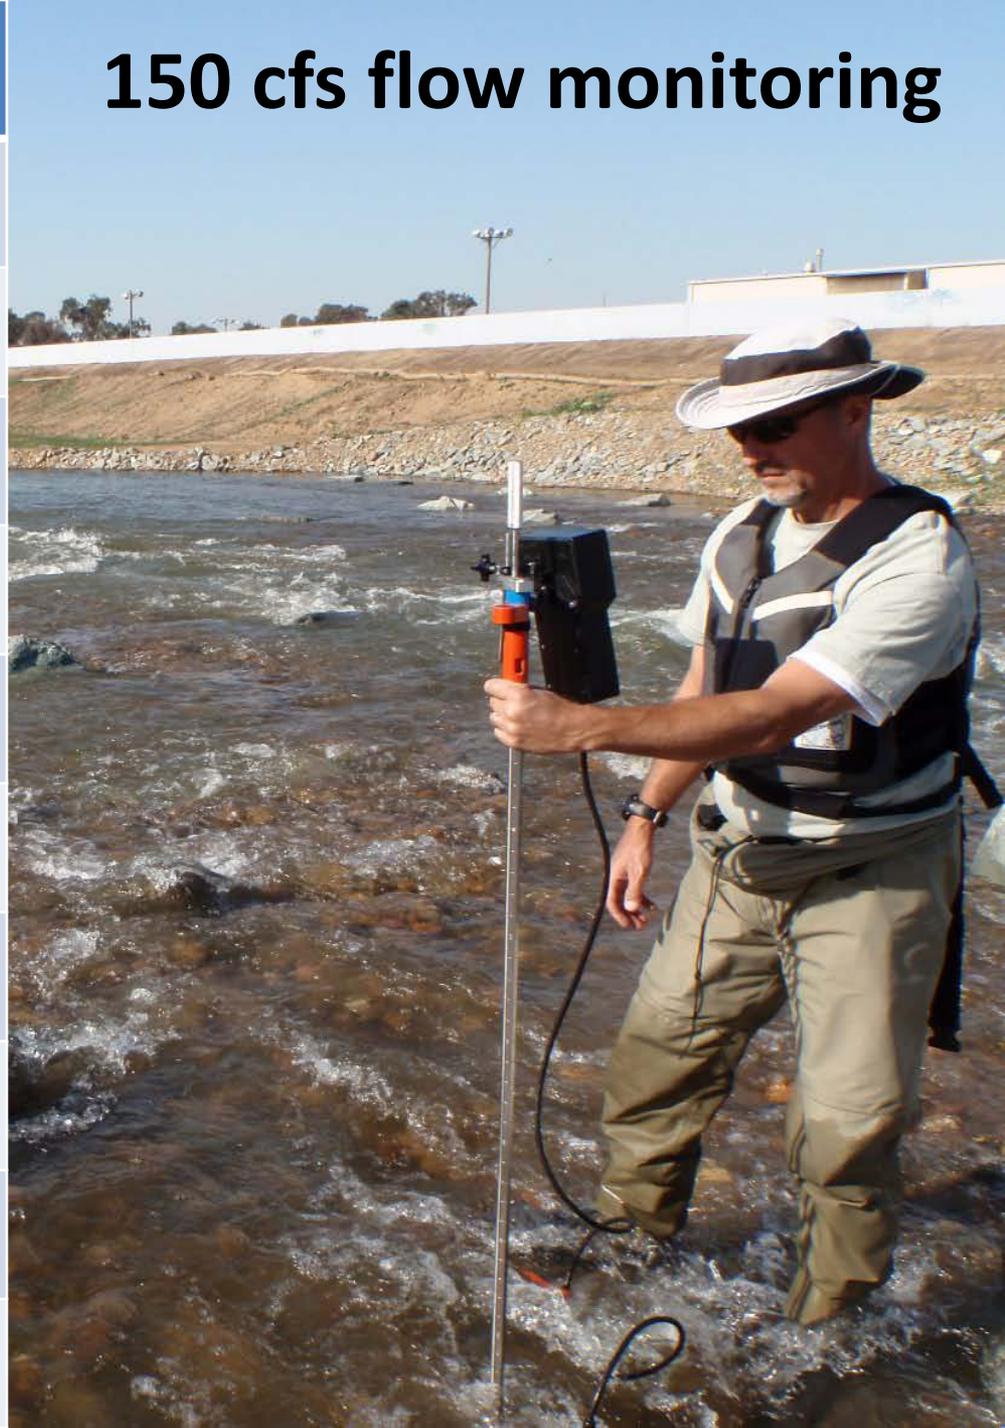
Station (ft)	Depth (ft)	Velocity (ft/s)	Notes
0	1.6	2.3	Dam foundation
5	1.0	4.6	at weir 1 (fish observed passing)
10	1.3	4.8	5' downstream of weir 1
20	1.2	5.0	at constricting boulders
38	1.6	6.0	at weir 2
50	2.4	4.8	3' upstream of boulders between weirs 2 and 3
53	2.1	7.4	at boulders between weirs 2 and 3
66	2.1	6.3	6' upstream of weir 3
72	2.1	6.1	at weir 3
87	2.9	3.3	midway between weirs 3 and 4

# 150 cfs flow monitoring

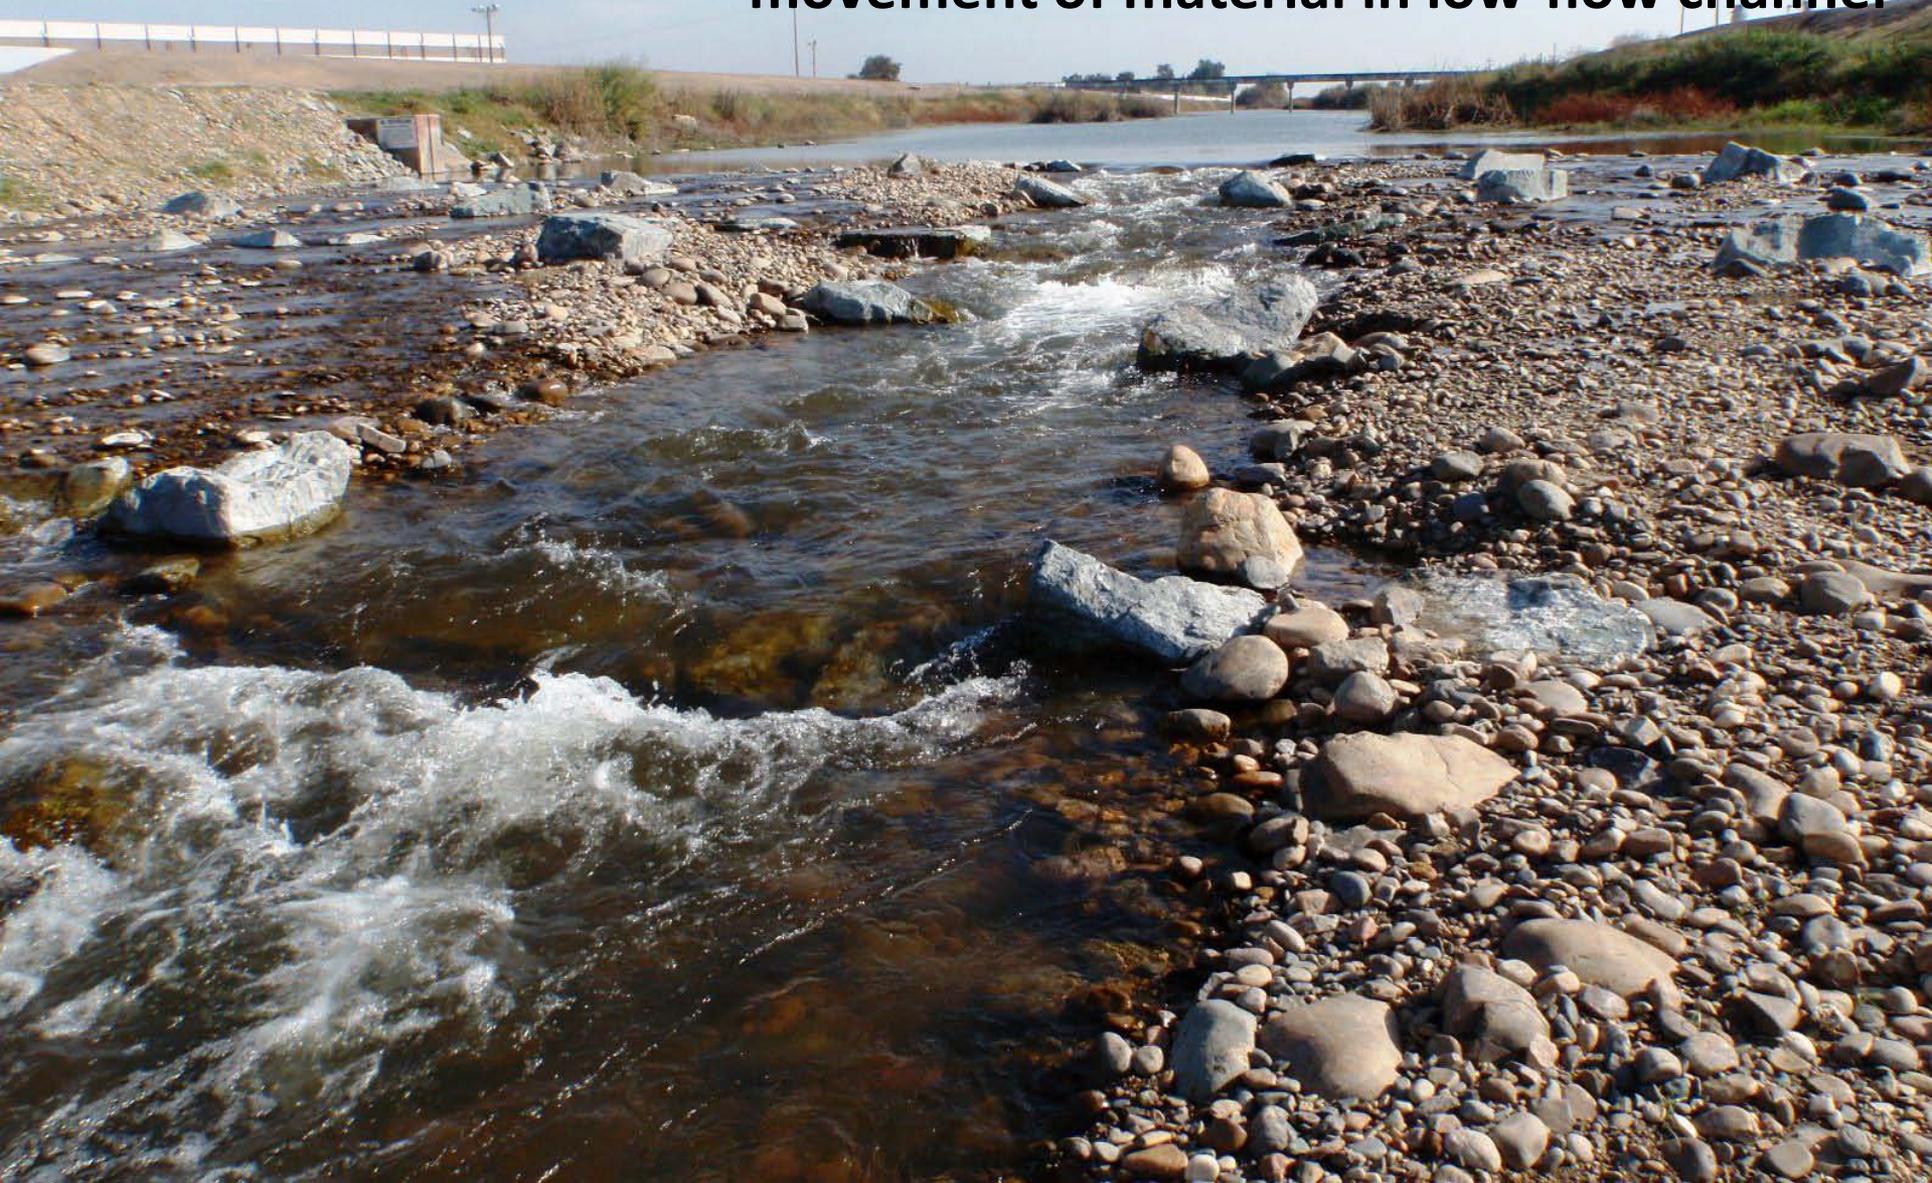
**November 15, 2011**

**After initial pulse flow**

- **no major changes outside low-flow channel**
- **movement of material in low-flow channel**

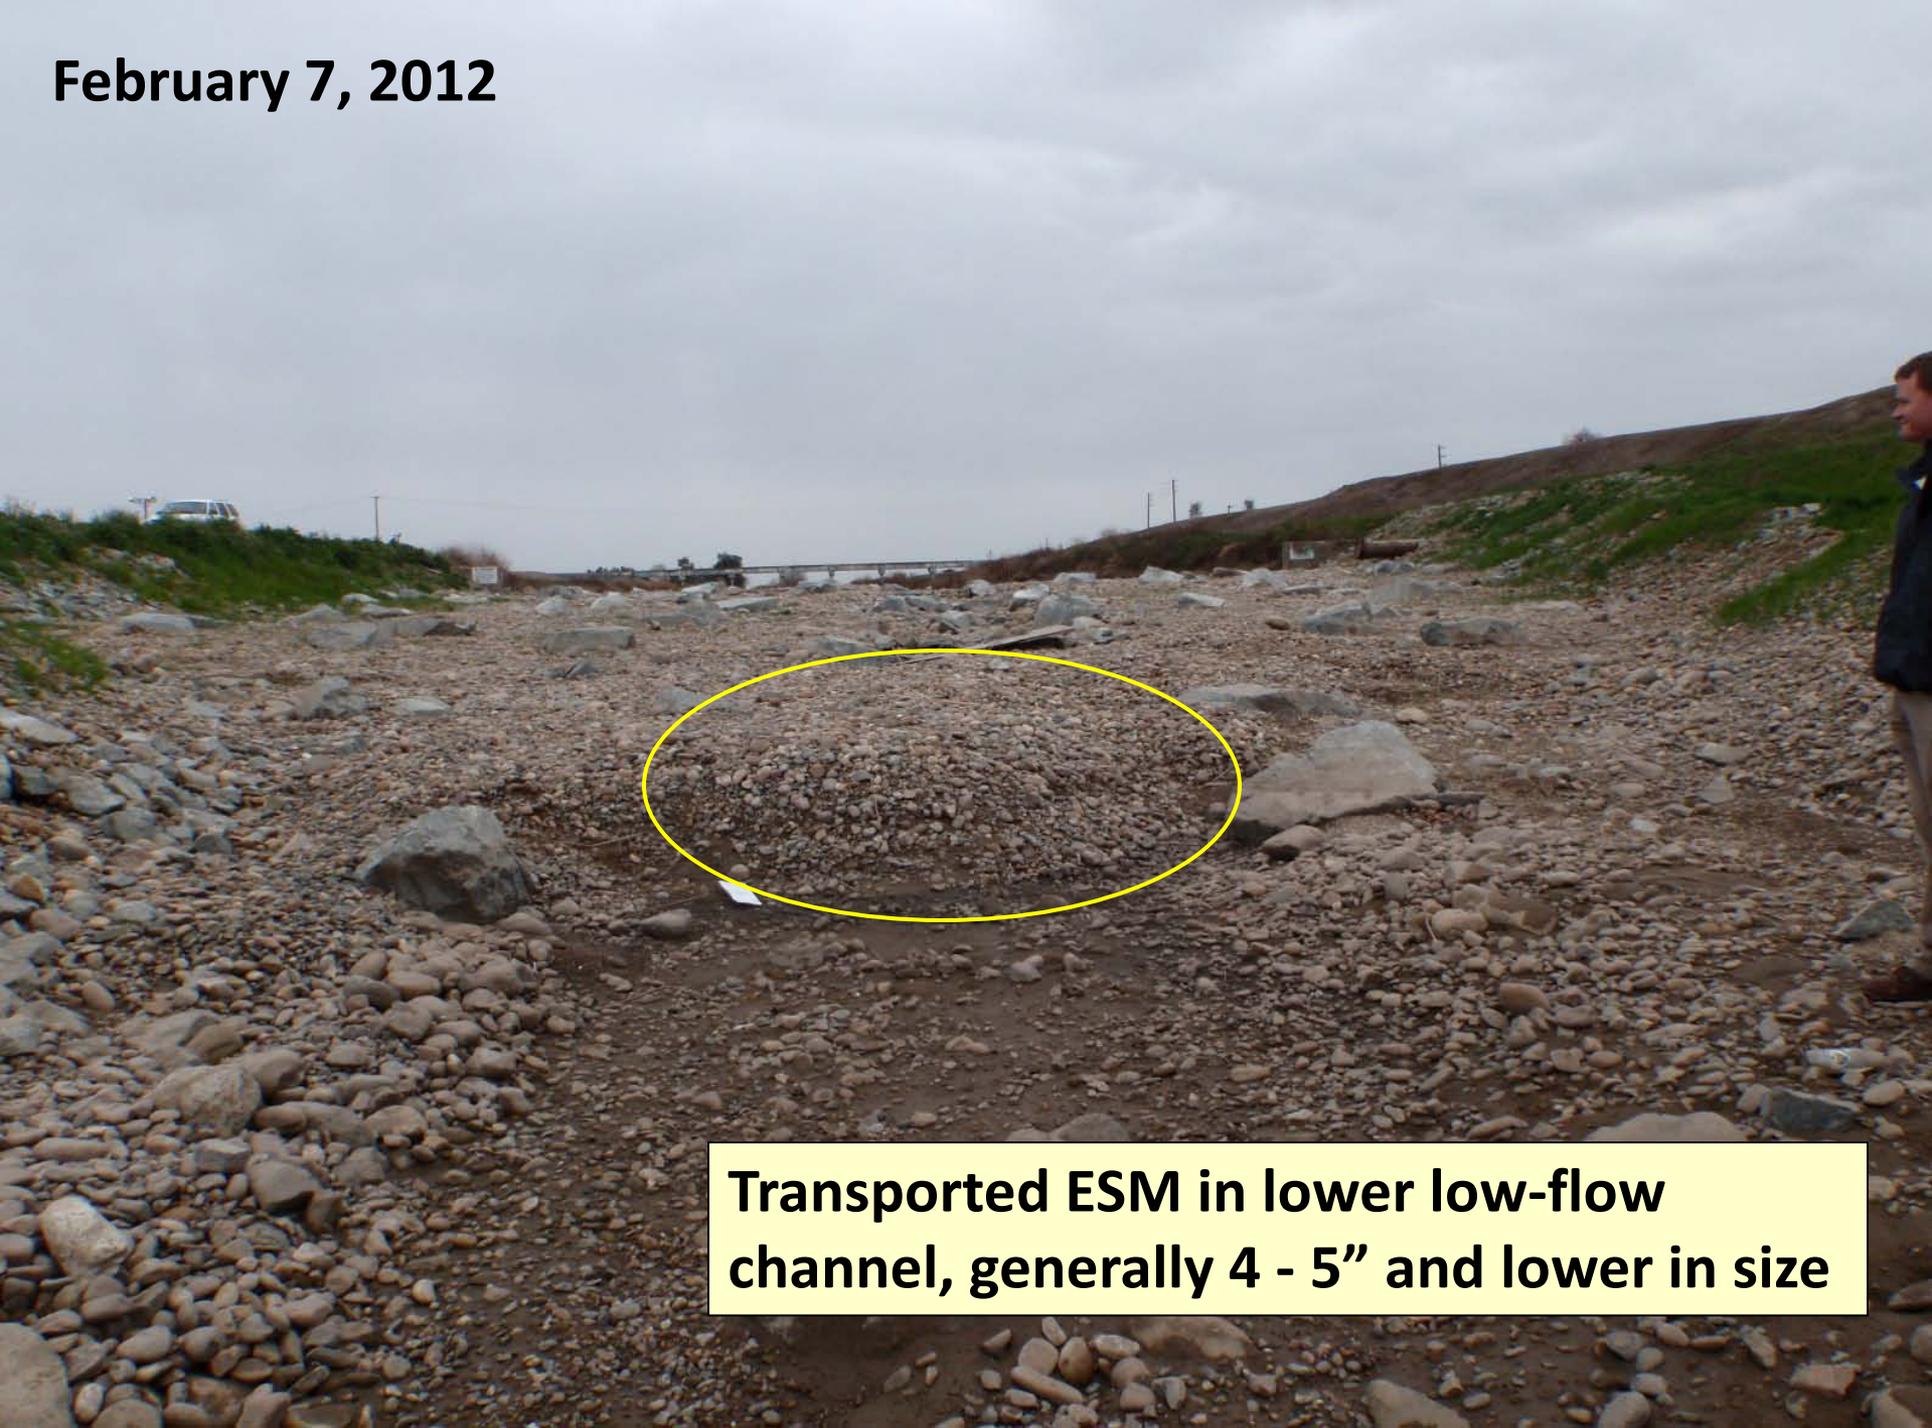
**February 7, 2012**

**Transported ESM in lower low-flow channel, generally 4 - 5" and lower in size**

- Look for ways to reduce the project footprint to reduce project costs and environmental impacts
- Rock Ramp Low-flow Channel
  - In adding flow complexity, smaller material can move if significant amounts of larger material are not present
  - Need to coarsen the low-flow channel by increasing the percentage of larger material
  - Need to increase size of individual boulders in the low-flow channel
  - Perhaps make the low-flow channel a step-pool design

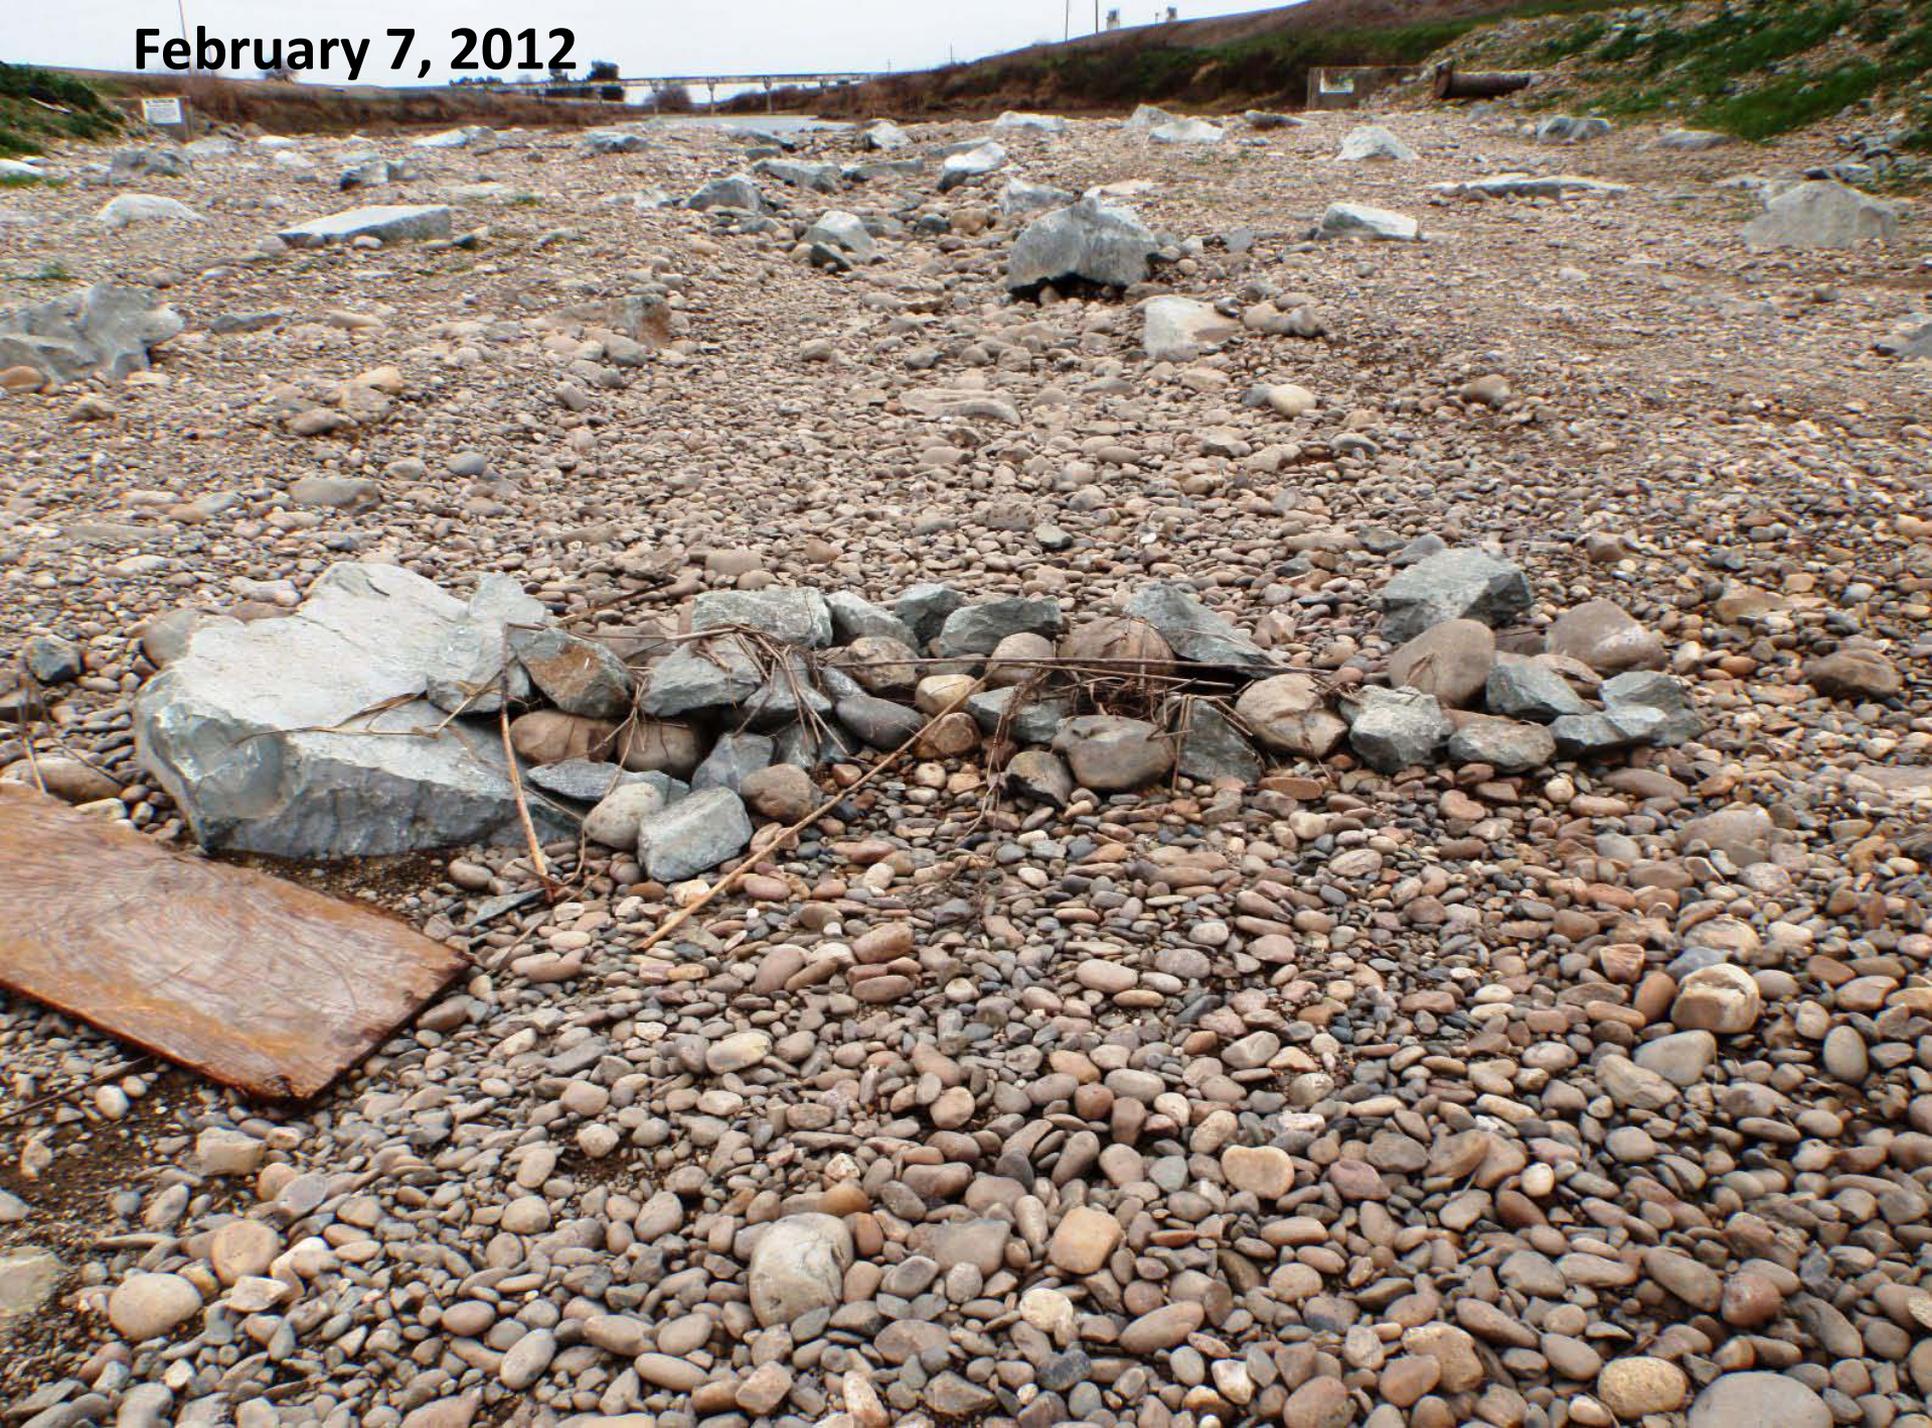
February 7, 2012

**Upper end of low-flow channel much coarser  
and boulders have been scoured**

- During design
  - our initial ESM calculations gave 9" as the largest particle size
  - we sized up to 12" since we used rounded material
  - shear stress calculations gave 6" as the largest particle that should move in the low-flow channel (we did account for an instantaneous maximums and a factor of safety) – Fischenich 2001
  - we thought that the larger material would help to hold the smaller material in place
- However,
  - while we expected some movement of ESM, the magnitude was greater than we anticipated
  - we believe that the individual boulders produced flow patterns that created significant scour areas
  - local residents created small dams to poach fish which caused localized increases in channel slope and subsequent scour
