**DRY CANYON CREEK RESTORATION PROJECT  
GRANT SUPPORT  
HEADWATER CORNERS FLOODPLAIN ANALYSIS**

**February 12, 2003**

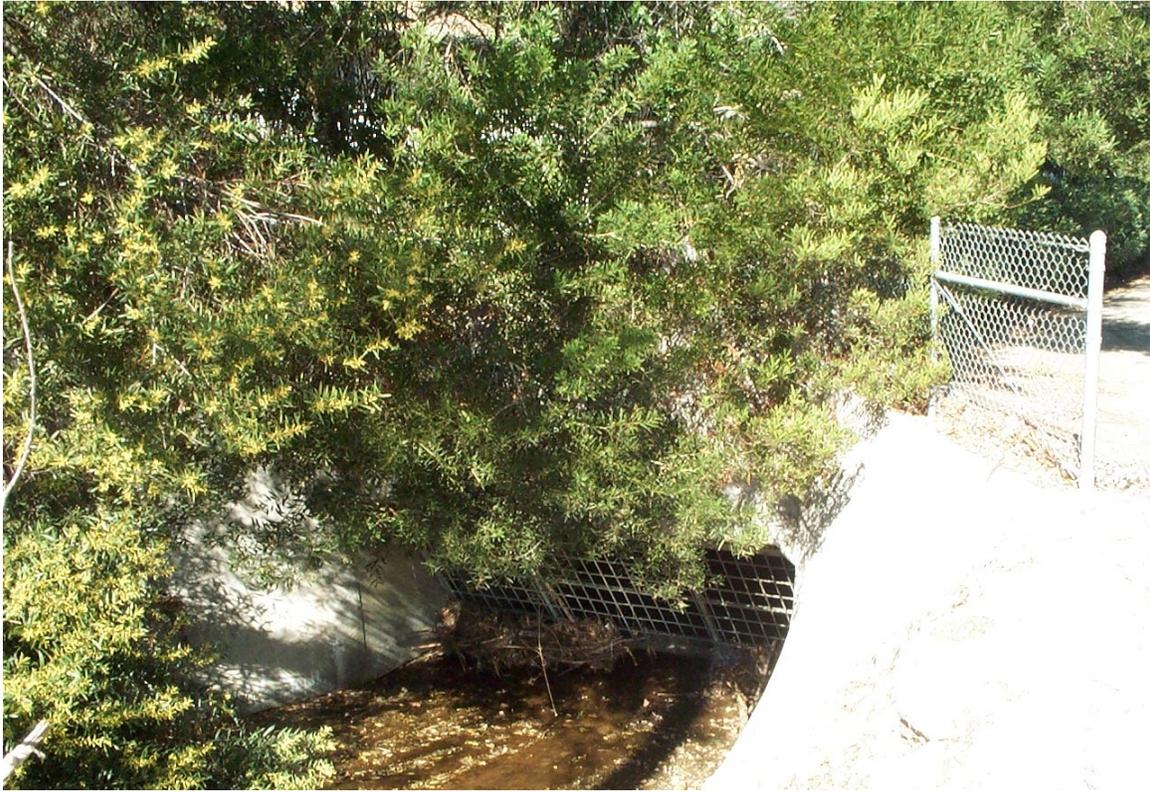
The Creek flows into a concrete box culvert at 3871 Topanga Canyon Road south of Palm Drive. The culvert is approximately 10~12 feet wide and 6~7 feet tall with a metal grid gate at the inlet. The top of the culvert is approximately 5 feet below the street level. The inlet was relatively clear at the time of survey. The length of the culvert could not be determined at the time of survey due to restricted access downstream of its location. The culvert is shown in Photograph 1.

**Photograph 1 Box Culvert under Properties South of Palm Drive**

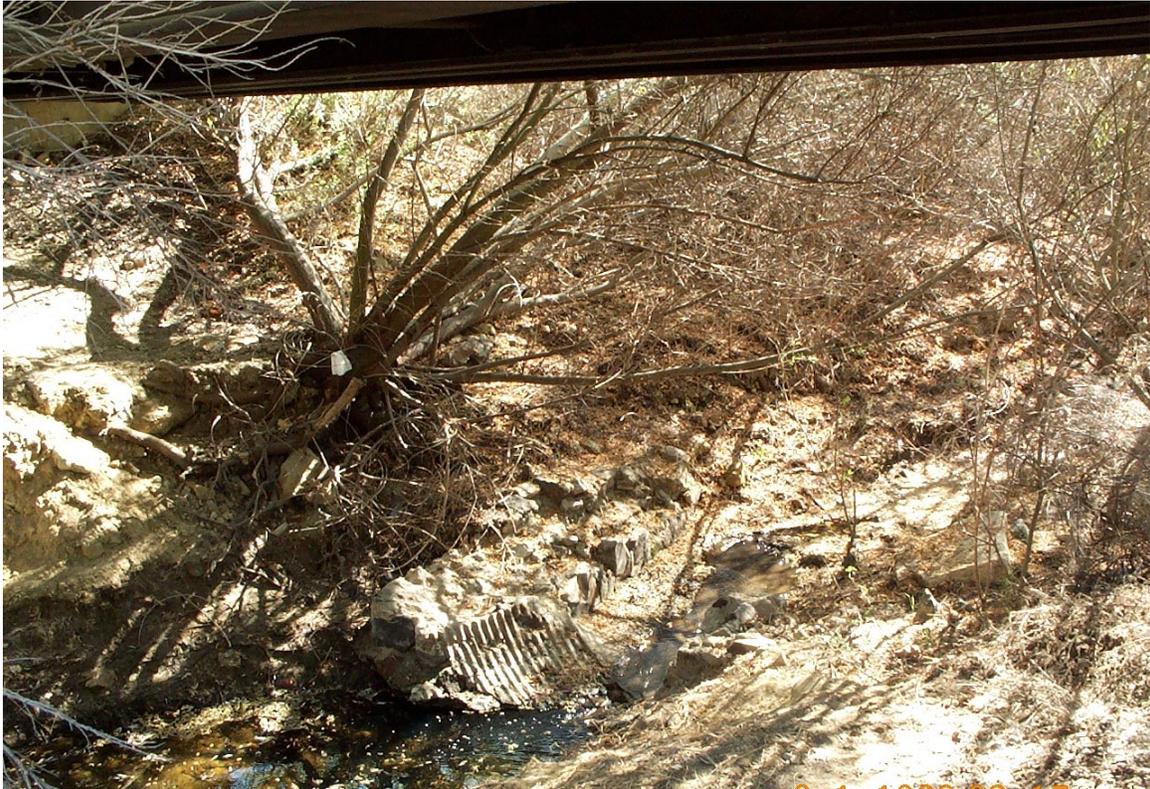
The Creek upstream of the box culvert consists typically of natural channel sections with variable depths of approximately 5~9 feet, bottom widths of approximately 5~10 feet and slopes of approximately 1:3 on average. A steel bridge crosses the Creek just upstream of the culvert. The bridge has a lowcord of approximately 10~12 feet from the bottom of the channel, a width of approximately 17 feet, and a span of approximately 60 feet. The channel under the steel bridge is shown in Photograph 2. The stream bed and banks are lined with cobbles, scattered boulders, tree stumps, exposed roots, thick layers of dead tree leaves and branches, and medium to dense leafless brushes. Trees and brushes at many locations have grown over the channel with dense groups of branches encroaching into the flow areas of the channel. The overgrown trees and brushes are shown in Photograph 3.

**Photograph 2 Channel under Steel Bridge Upstream of Box Culvert**

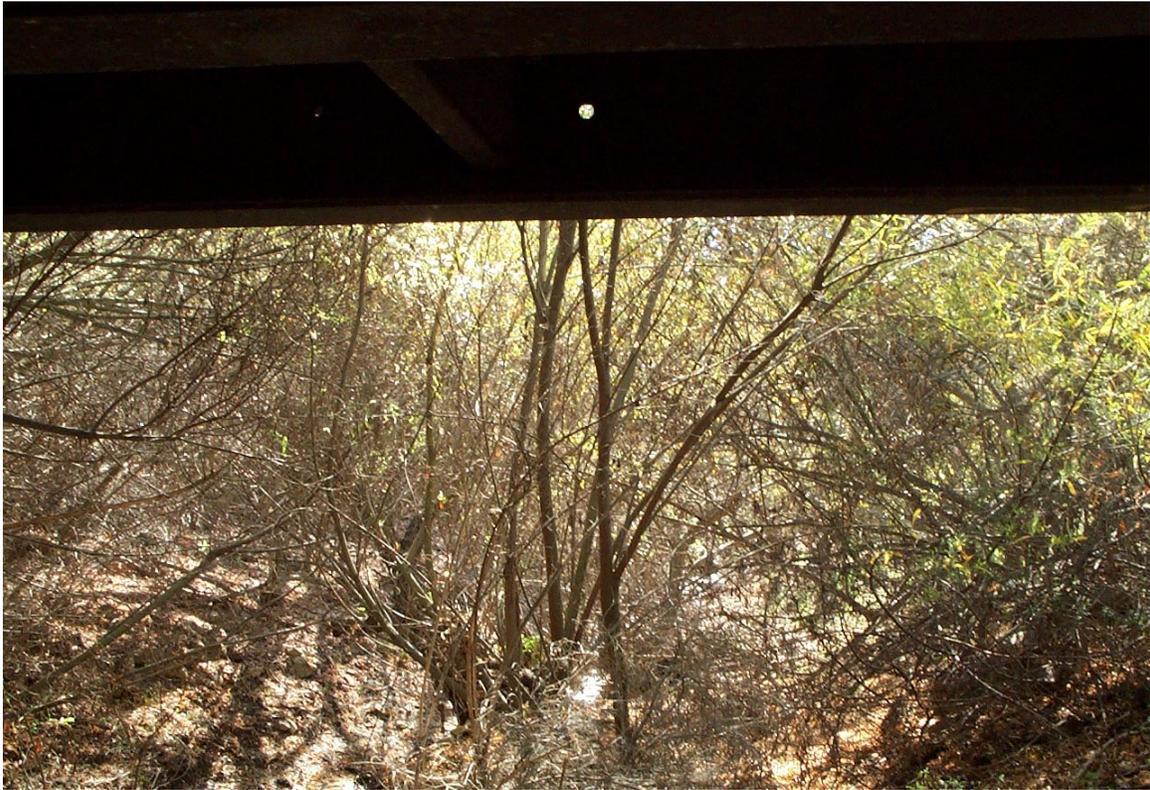
**Photograph 3 Overgrown Trees and Brushes in Channel**

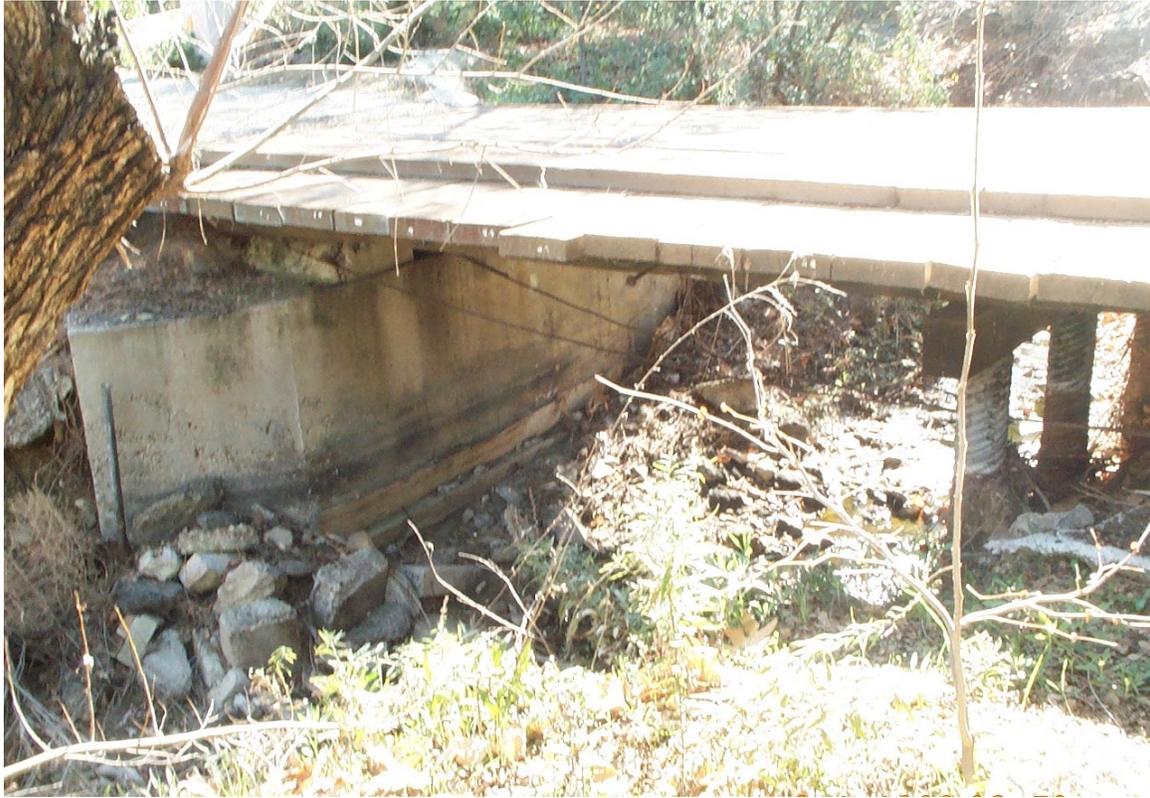
A wooden bridge crosses the Creek at 3815 Topanga Canyon Road (former Bartelles property) at the intersection of Topanga Canyon Road and Mulholland Highway. The bridge has a lowcord of approximately 7~9 feet from the bottom of the channel, a width of approximately 14 feet, and a span of approximately 13 feet. The wooden bridge is shown in Photograph 4.

**Photograph 4 Wooden Bridge at Bartelles Property**

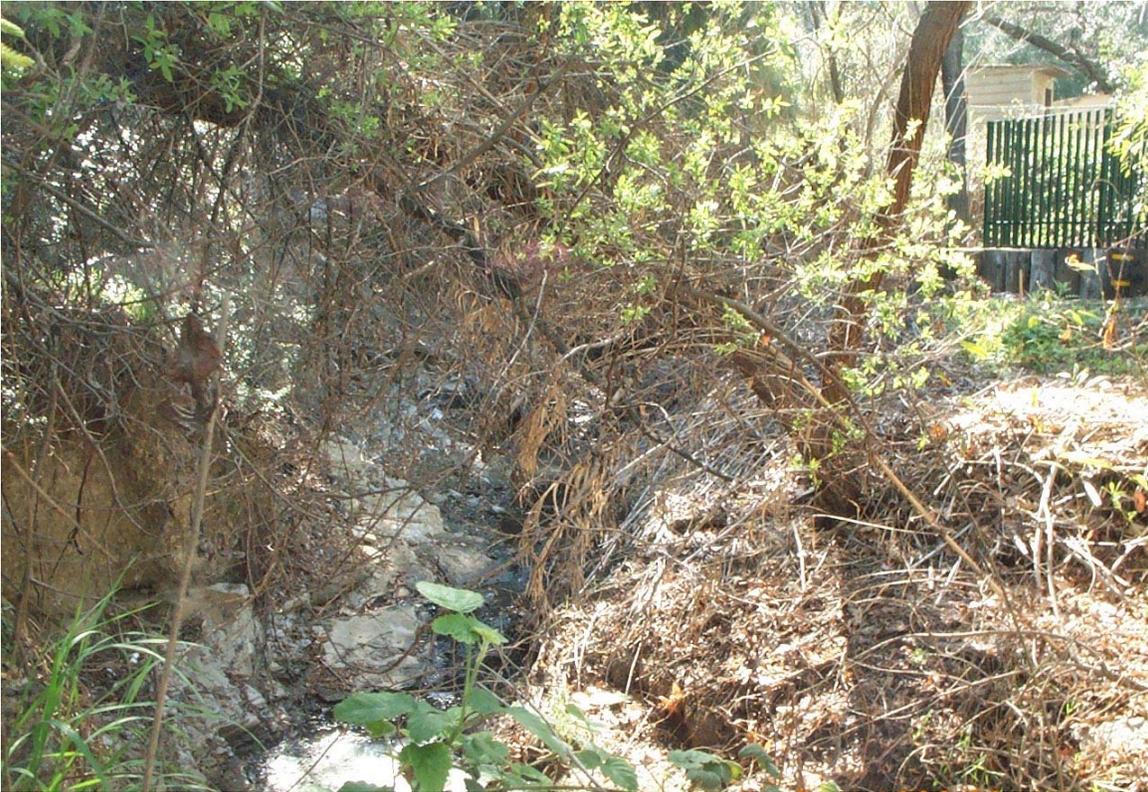
The Creek upstream of the wooden bridge typically consists of natural channel sections with steep side slopes of approximately 1:1~1:2 on average and narrow bottom widths. The stream bed and banks are lined with cobbles, scattered boulders, tree stumps, exposed roots, thick layers of dead tree leaves and branches, and medium to dense brushes. A typical channel section along this stretch of the Creek is shown in Photograph 5.

**Photograph 5 Channel Upstream of Wooden Bridge**

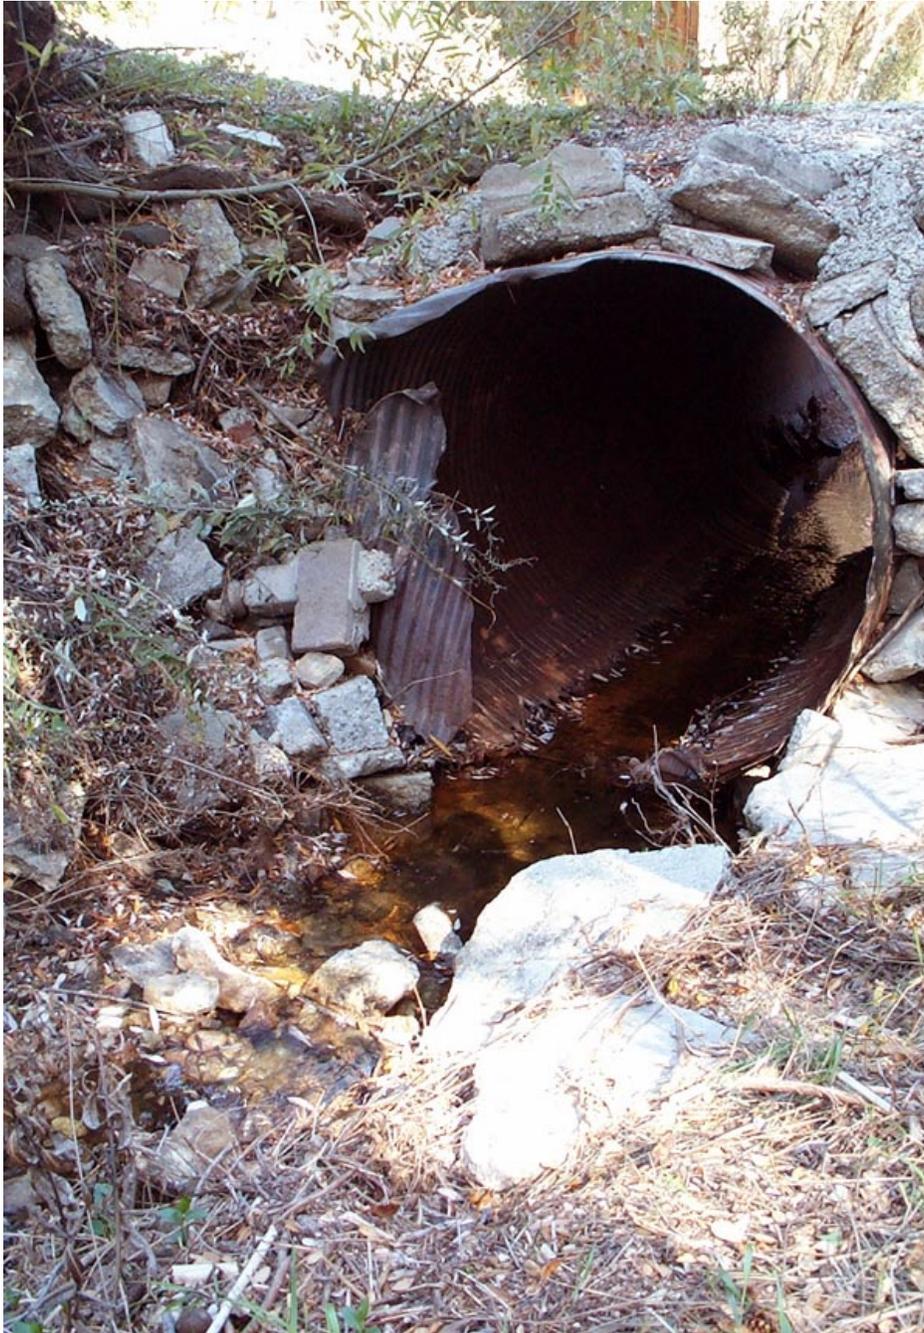
A corrugated metal circular culvert exists under an access road crossing the Creek at the boundary between the Bartelles property and the Miller property at 23075 Mulholland Highway near Dry Canyon Creek Park. The culvert measures approximately 25 feet in length and 6 feet in diameter with its top approximately 1 foot below the top of the road. The culvert is overall corroded and damaged at the inlet and outlet. The culvert is shown in Photograph 6.

**Photograph 6 Corrugated Metal Culvert at Miller-Bartelles Property Line**

The effect of the culvert on water surface profile was estimated analytically since the QUICK-2 model does not compute pressurized culvert flows. The capacity of the 6-foot culvert was calculated to be approximately 461 cfs, which corresponds to approximately 45~50 year flow based on values presented in Table 1. Given a 100-year flow of 1,340 cfs as determined previously, a balance of 879 cfs needs to be transferred downstream during a 100-year flood. This excess flow would overflow the road crossing approximately in the form of a weir flow, which in turn would cause a rise of water surface elevation upstream of the culvert.

The results indicate that both the Miller and Bartelles properties would be significantly flooded under 100-year flood conditions. The flooding on the Miller property would be caused primarily by the inadequacy of the culvert at the Miller-Bartelles property line. A portion of the water overflowing the road crossing would shed downgrade onto the Bartelles property in the form of a sheet flow and, combined with the higher-than-grade water levels in the Creek near the property, cause significant flooding on the property. This appears to be consistent with the local accounts and photographs documenting the 1980 storm that resulted in significant damage of the Bartelles property.

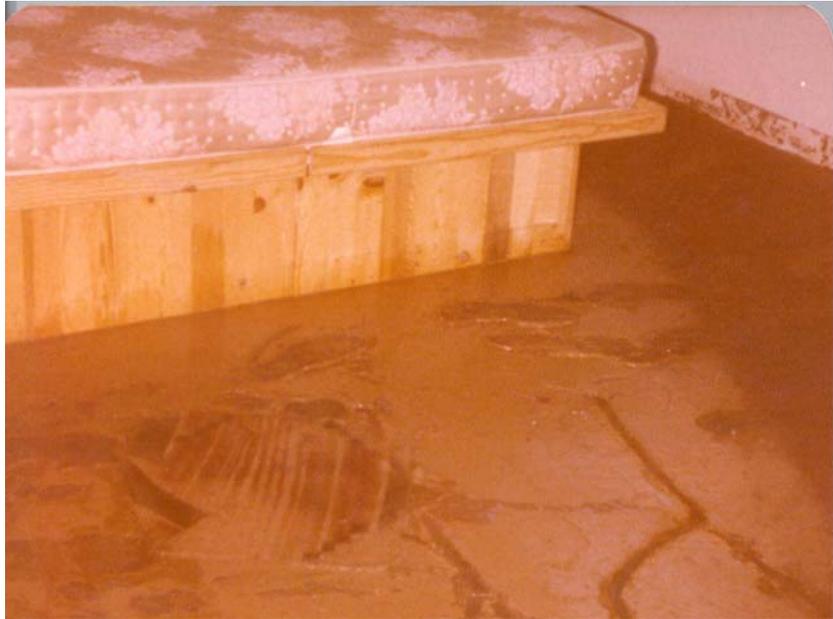
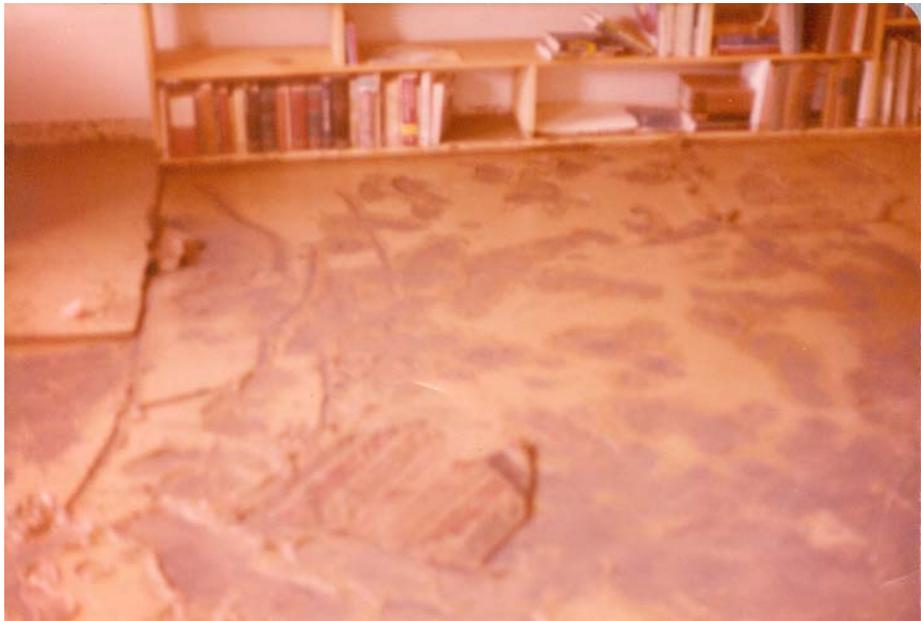
The study area was flooded historically during high-flow runoff events. One of the most significant events occurred in February, 1980, when the Bartelles property sustained significant flooding and resultant damages. The flows in the Creek during the storm exceeded the capacity of the corrugated metal culvert at the Miller-Bartelles property line, flowed over the road and the northern floodplain, and flooded the down-grade Bartelles property. Photograph 7 shows the flooding inside the Bartelles house (Bartelles, 1980). During the event, the Miller house on the southern bank of the Creek was not flooded. The flood water, however, came within a few feet of the house.

**Photograph 7 Flooding inside Bartelles House**
