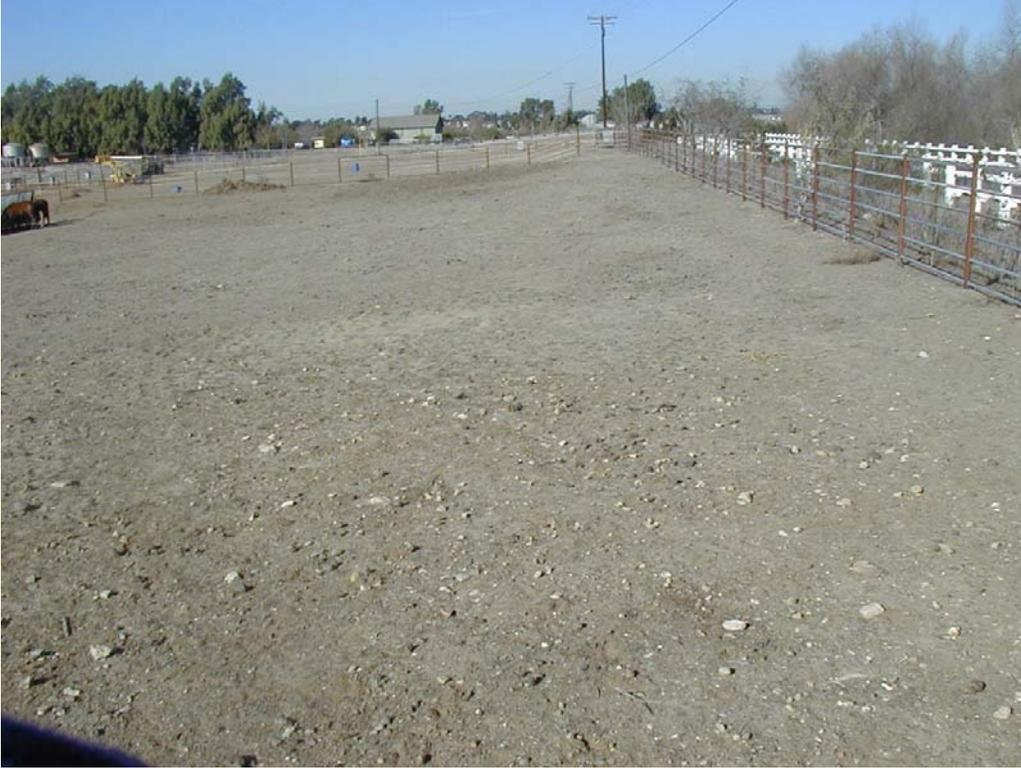
Photograph 1. View of unpermitted fill/berm on Brown property (looking north). Old Hollister Street Bridge at right.

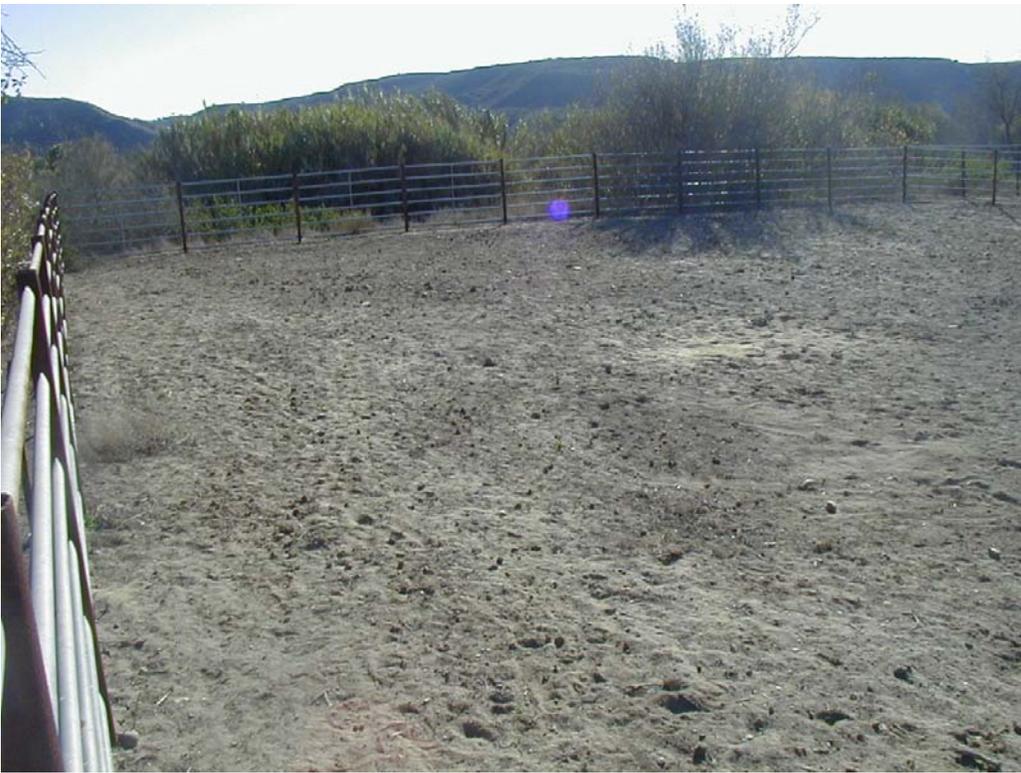
Photograph 2. View showing unpermitted fill/berm on property (looking south). Note *Arundo donax* in background, along existing river channel.

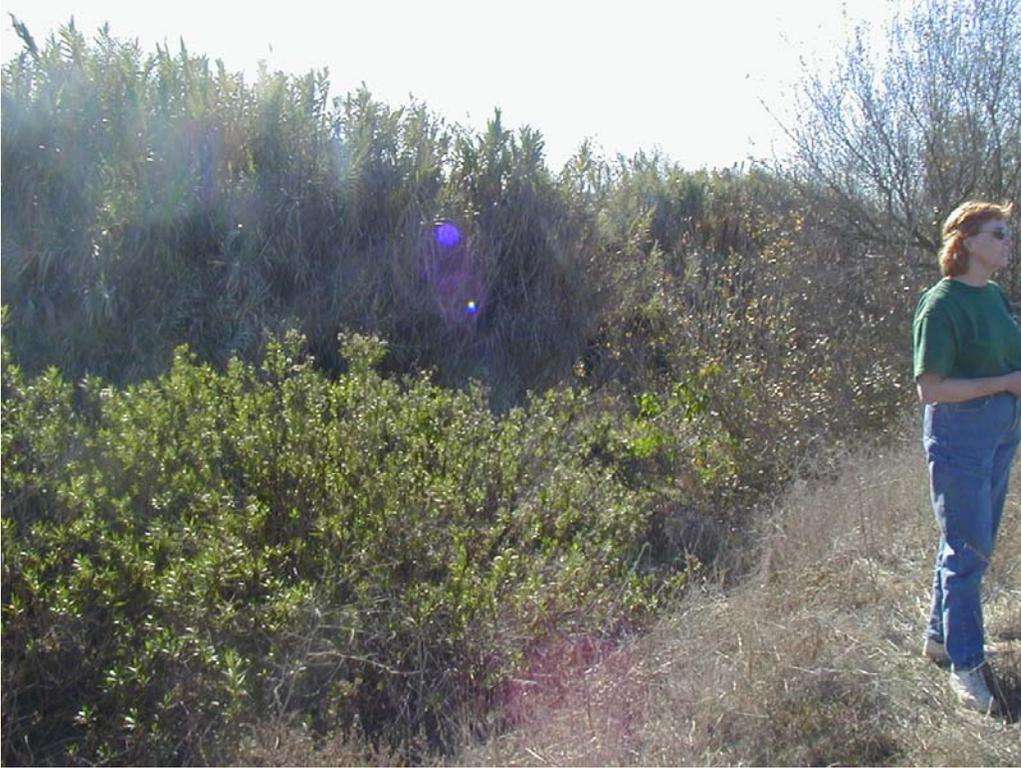
Photograph 3. View along unpermitted fill/berm (looking west). Tijuana River to left (south). *Arundo donax* infestation visible in background.

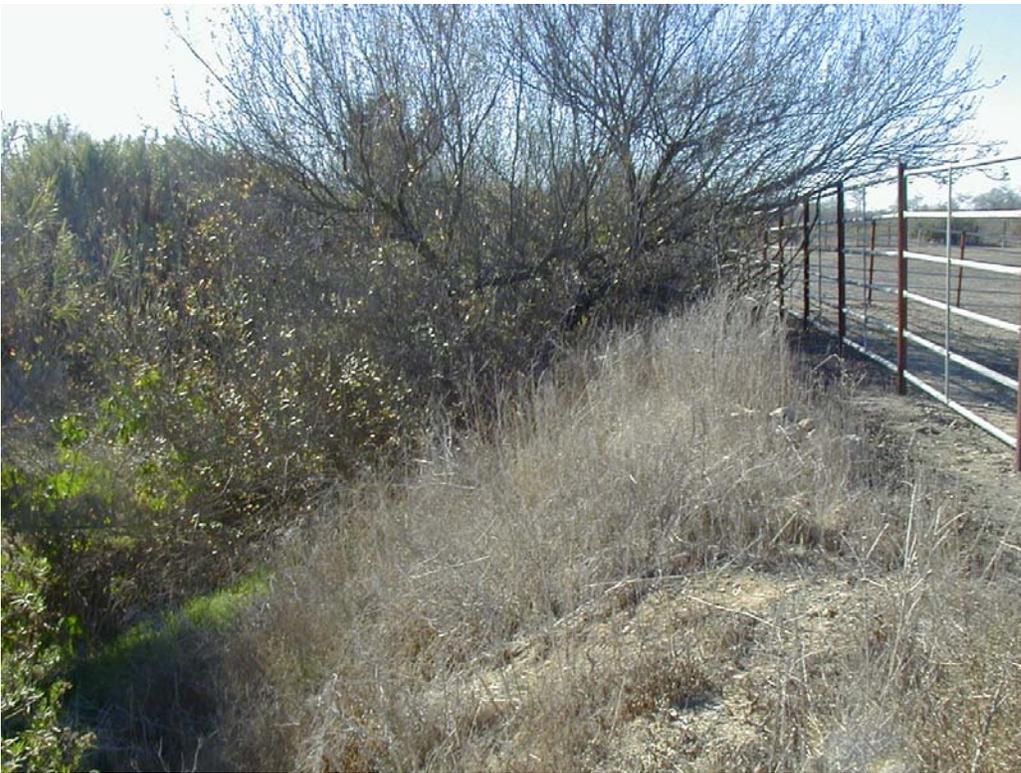
Photograph 4. View west along unpermitted fill/berm.

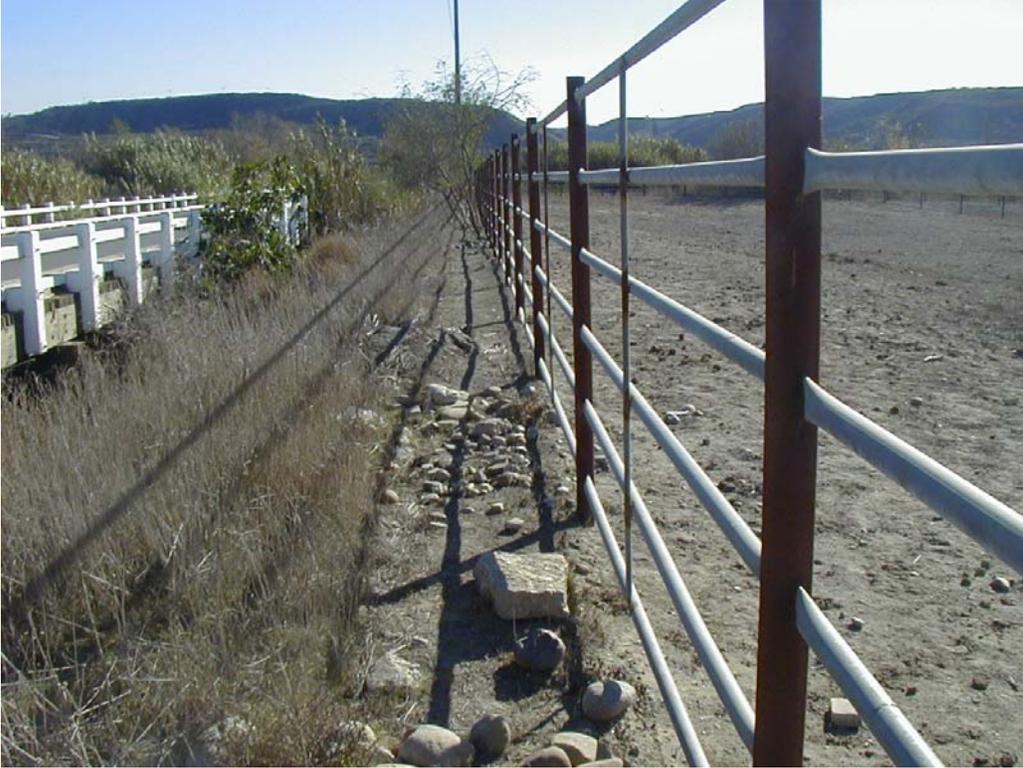
Photograph 5. Unpermitted fill/berm, looking south along Old Hollister Street Bridge.

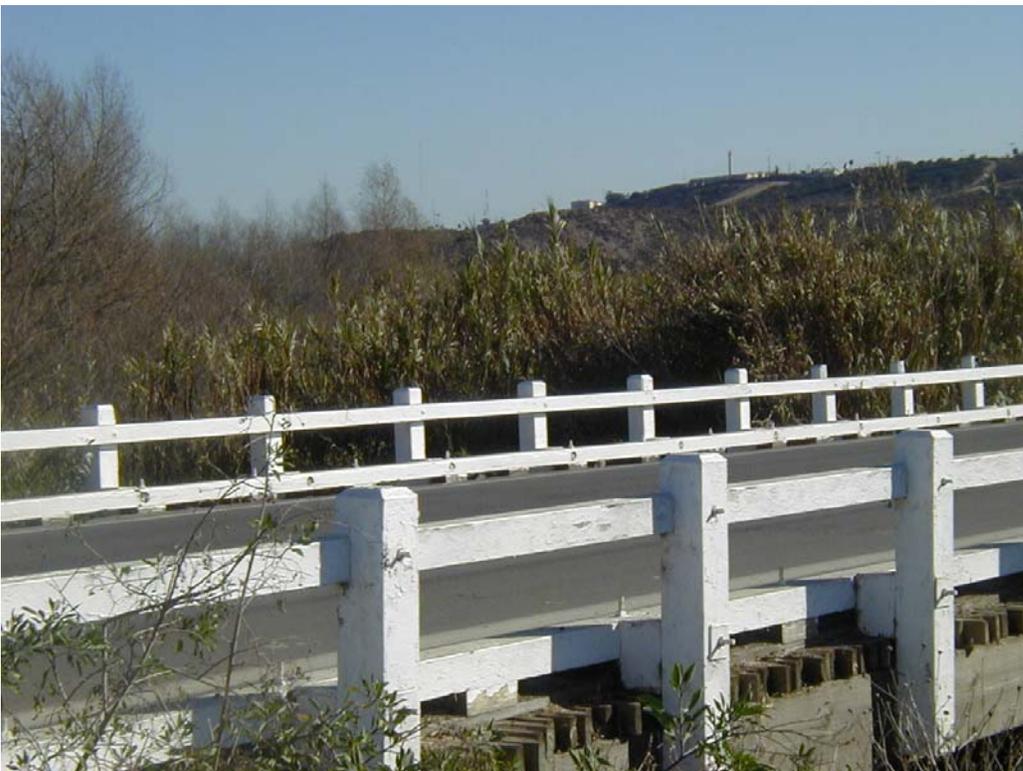
Photograph 6. Old Hollister Street Bridge (looking southeast) showing non-native vegetation (*Arundo donax*) in background.
