**Appendix 3.7: Underwater Inspection of the Chabot Reservoir Outlet  
Tower, DRS Marine, Inc., June 2011**

## WRITTEN REPORT FOR EAST BAY MUNICIPAL UTILITY DISTRICT

### UNDERWATER INSPECTION of the CHABOT RESERVOIR OUTLET TOWER

June 7, 2011

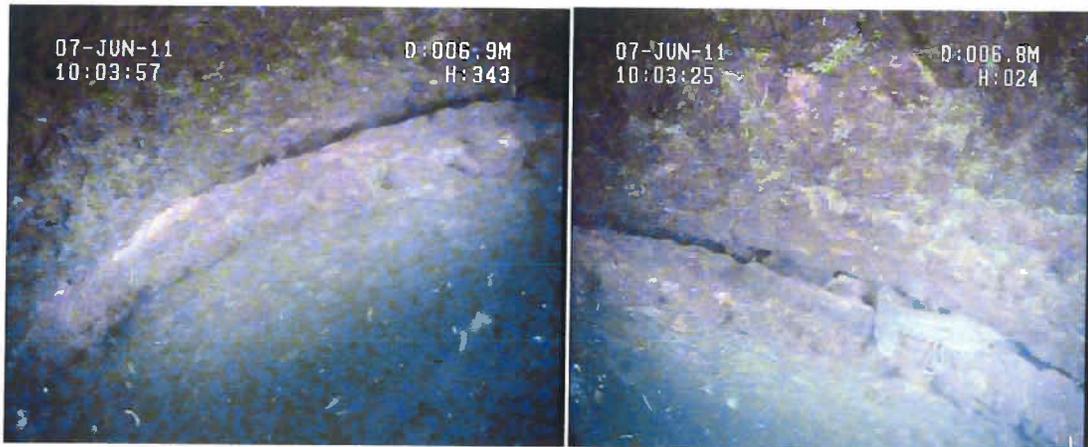
The ROV started the inspection on the 30" steel pipe (Elev. 197) to look for any major damage or anomalies. The 30" steel pipe is original riveted steel. From the access shaft the 30" steel pipe runs approx. 30 feet into the outlet tower. There are rust and corrosion pockets throughout the pipe line. Overall the 30" steel pipe is intact with no major deformities. A 30" sluice gate is attached the end of the 30" steel pipe inside the outlet tower. From the face of the 30" sluice gate to the opening of the 38 3/4" riveted steel pipe there is no "30 inch extra strong pipe" as referred to in drawing 9480-G-1 {Chabot Reservoir Outlet Tower Screen Replacement (Tunnel #2 Inlet Structure)}. The ROV continued offshore towards the lower inlet screen through the 38 3/4" riveted steel pipe. This pipe also has rust and corrosion pockets throughout. Approx. 55' from the access shaft a riveted joint appears to be separated. This separation travels around the perimeter of the pipe along the joint. Approx. 70' from the access shaft a riveted joint appears to be separated. This separation is mainly at the top crown of the pipe. Approx. 80' from the access shaft a riveted joint appears to be separated. At the end of the 38 3/4" riveted steel pipe is a stainless steel inlet screen structure. This is located approx. 100' from the access shaft.

SEPARATION IN 38 3/4" RIVETED STEEL PIPE

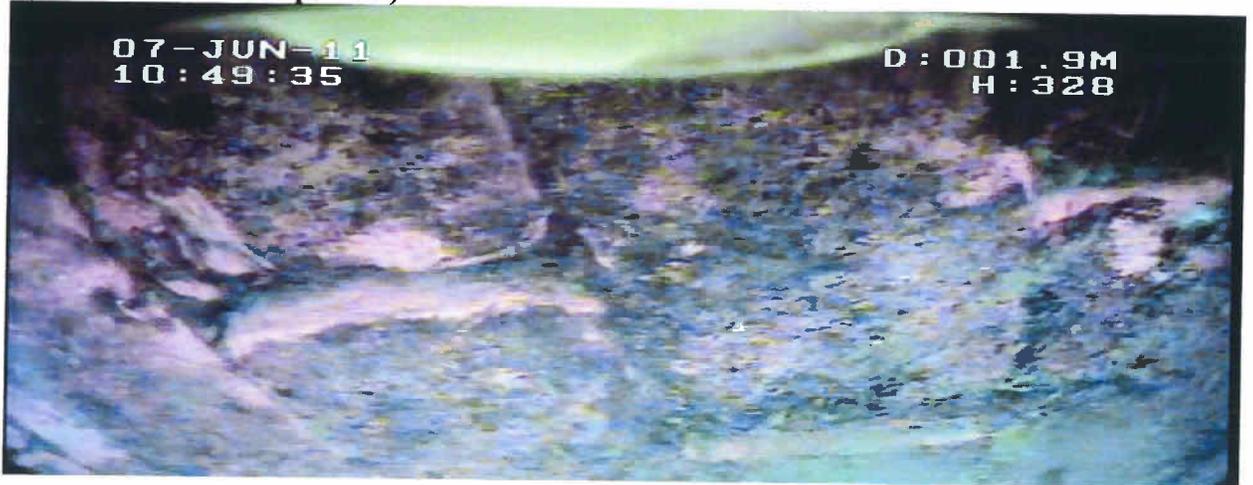
The 20" Sluiceway is located inside the access shaft approx. 10 feet below the waste tunnel. This tunnel appears to be a brick masonry tunnel. This tunnel is approx. 25' long. No major damage or deformities were found inside this tunnel. At the end of the 20" sluiceway a 20" sluice gate is attached inside the outlet tower.

BRICK MASONRY SLUICEWAY

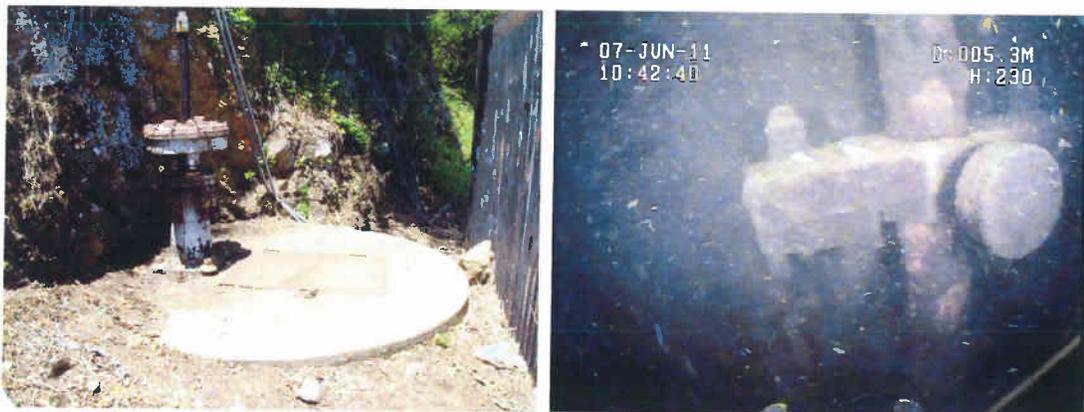
The 36" sluice gate is located inside the access shaft at elevation 197. This sluice gate is 100% open. The guides have rust and corrosion. Parts of the left guide appear to be broken and/or missing. The stem guides have rust pockets but appear to be intact. It is unknown if this sluice gate valve is operational.

36" OPERATOR / 36" STEM GUIDE

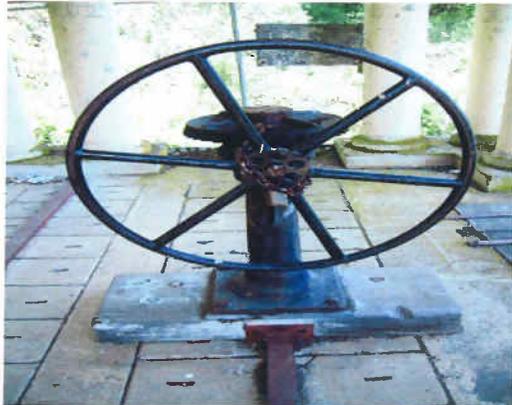
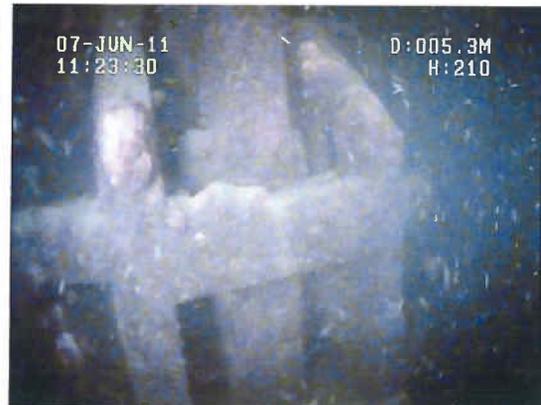
The 30" sluice gate is located inside the outlet tower at elevation 197. This sluice gate is 100% open. The guides for this gate are rusted and corroded. Parts of the gate frame and guides appear to be broken or missing. There are no stem guides underwater. It is unknown if this gate is operational.

30" OPERATOR / STEM CONNECTION ON 30" GATE

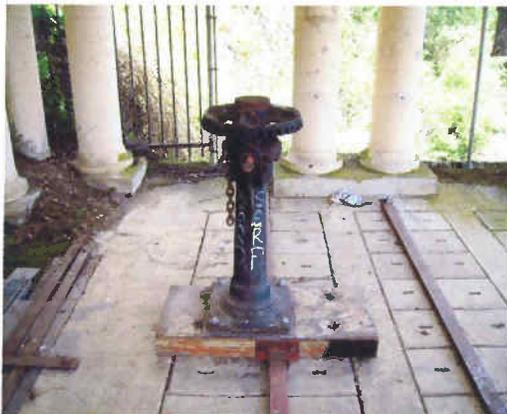
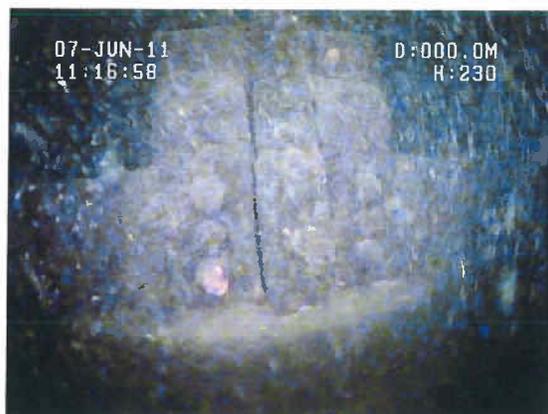
The 20" sluice gate is located inside the outlet tower at elevation 214. This sluice gate is 100% open. The guides for this gate are rusted and corroded. There are no stem guides underwater. The stem is intact with no bends. It is unknown if this gate is operational.

20" OPERATOR / STEM CONNECTION ON 20" GATE

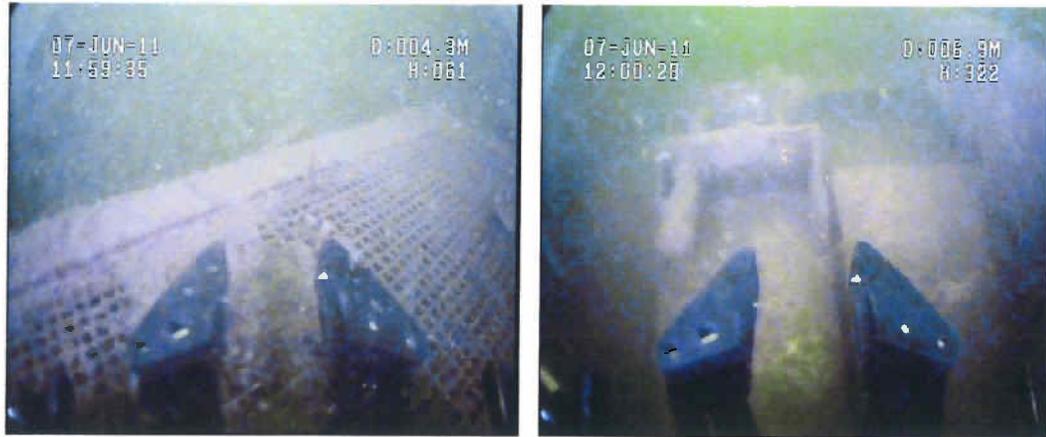
There is a trash rack structure located approx. 70' offshore from the Chabot outlet tower. The screen is made of a stainless steel frame and wire mesh. The screen is attached to the 38 3/4" riveted steel pipe with a squeeze clamp connection. This screen has minimal amount of debris on it and appears to be in good condition. The 38 3/4" riveted steel pipe is covered in mud and debris.

TRASH RACK SCREEN / SQUEEZE CLAMP CONNECTION

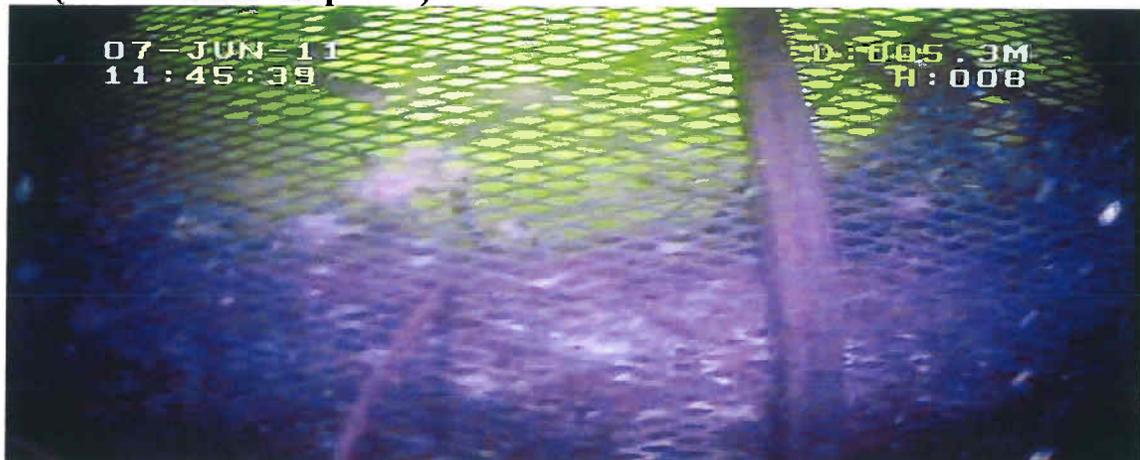
The Chabot outlet tower has 6 vertical screens attached to the tower. These screens appear to be intact and in good condition. The bottom screen has mud, sticks and debris in front of it, covering approx. 50%. There are two wires connected with shackles to the lower screen.

MUD, STICKS AND DEBRIS AGAINST TOWER SCREENS
