Tank Inspection Report

Lost Hills Utility District
Western Tank
Liquid Engineering Corporation 44412

Tank Name:	Western Tank	Tank Type:	On-Grade
City:	Lost Hills	Tank Capacity:	2,200,000 Gallon
State:	CA	Type of Construction:	Riveted Steel
Year Built:	Unknown

Inspected By:	LEC Maintenance Team 10 – Team Leader C. Fromm		
Inspection Date:	January 19, 2013

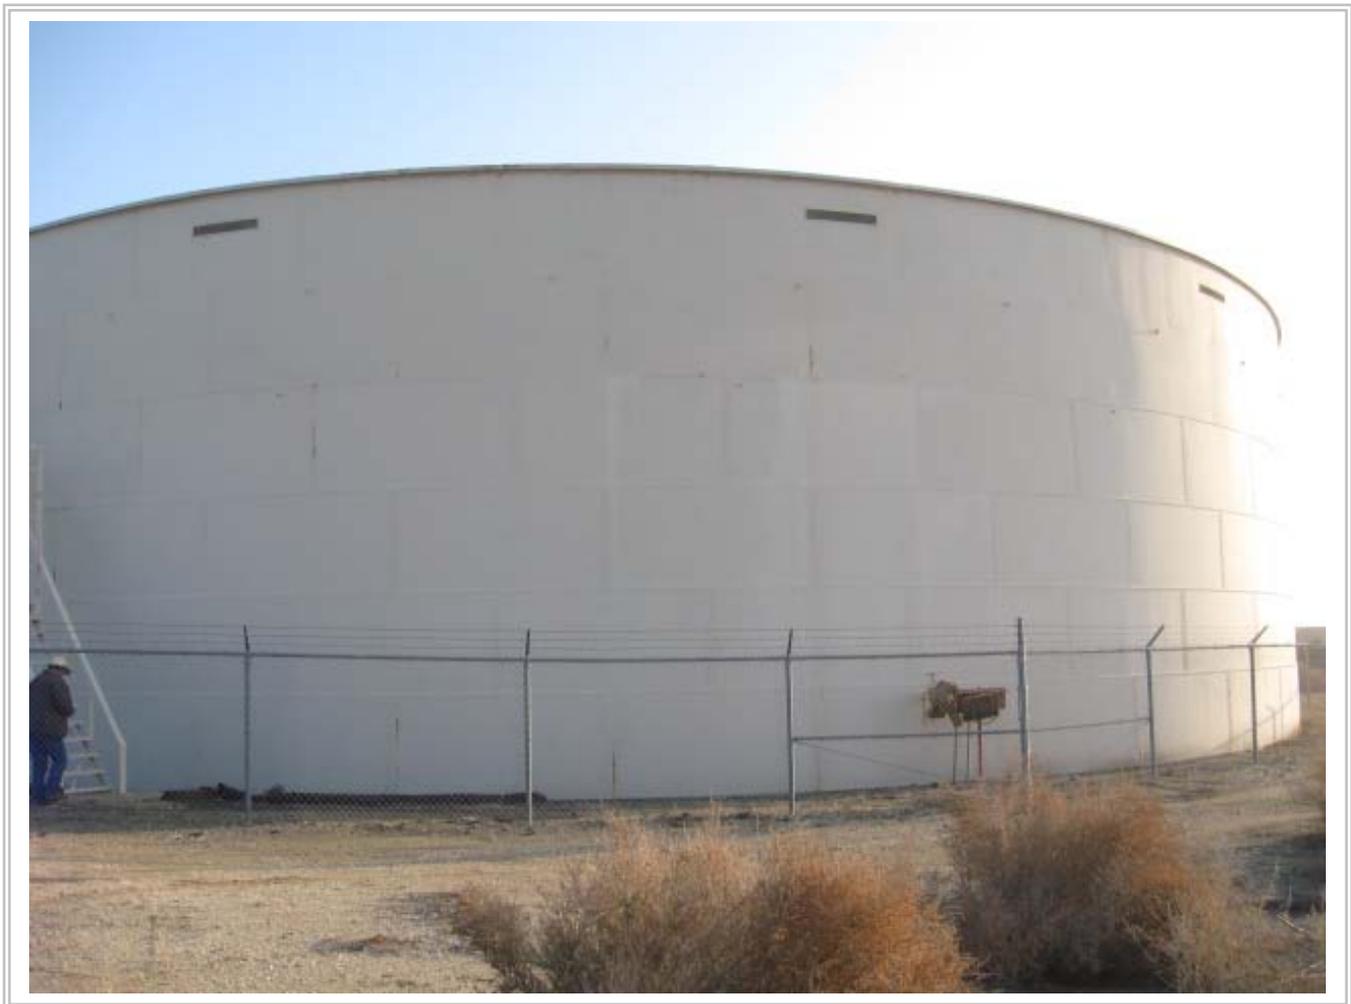
Photograph No. 1

This report is a supplement to the visual and video inspection undertaken for the Lost Hills Utility District, CA, by Liquid Engineering Corporation of Billings, MT. The Western Tank is an on-grade style, riveted steel water storage tank. (See Photo No.1). The tank has a 2,200,000-gallon capacity, with an approximate height of 30' and an overall diameter of approximately 115'.

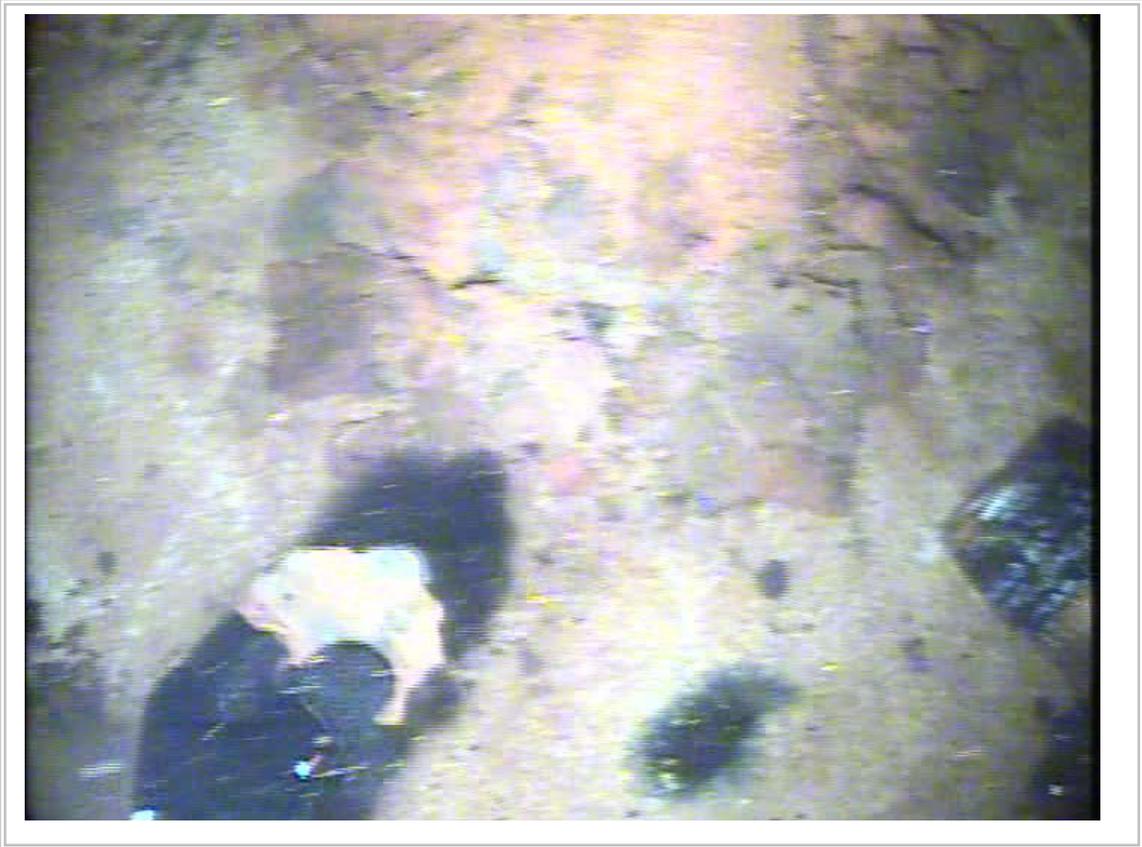
- **Wall to Roof Joint** – The joint appears to be fully sealed and there is no leaking or ambient light visible.
- **Ring Panels** – The interior wall panels are made from riveted steel. The walls are rated in Very Poor condition. All of the panels are rated a 0 on the SSPC legend, with 100% of the surface showing corrosion. Corrosion is present in the form of heavy rust noduling with pitting damage underneath, concentration cell corrosion, and uniform surface corrosion. Tested areas identify pitting damage at approximately ¼"+ deep. The middle and upper wall panels show a heavy amount of dealloying. There are layers of dealloyed steel falling off the walls, and much of this material was found lying throughout the floor of the tank.

Example of dealloyed steel from the wall panels, lying on the floor

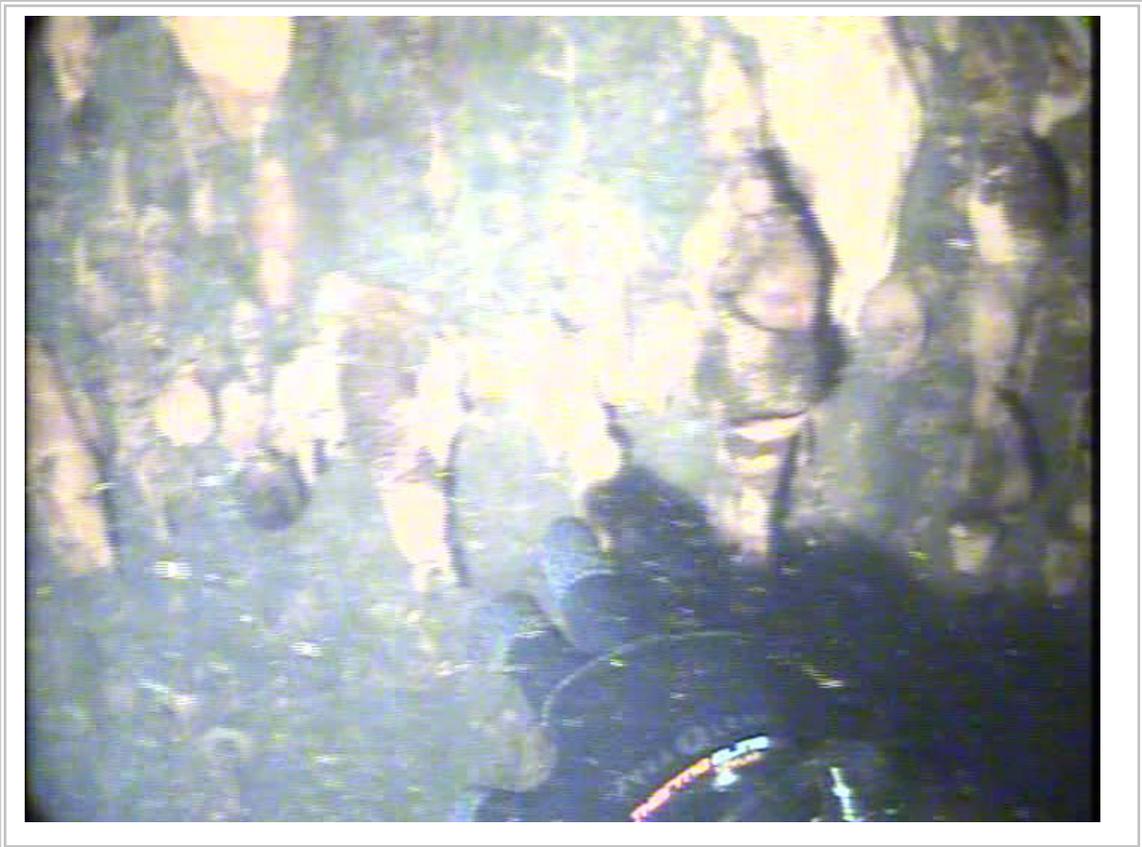
Example of heavy rust noduling on the interior wall

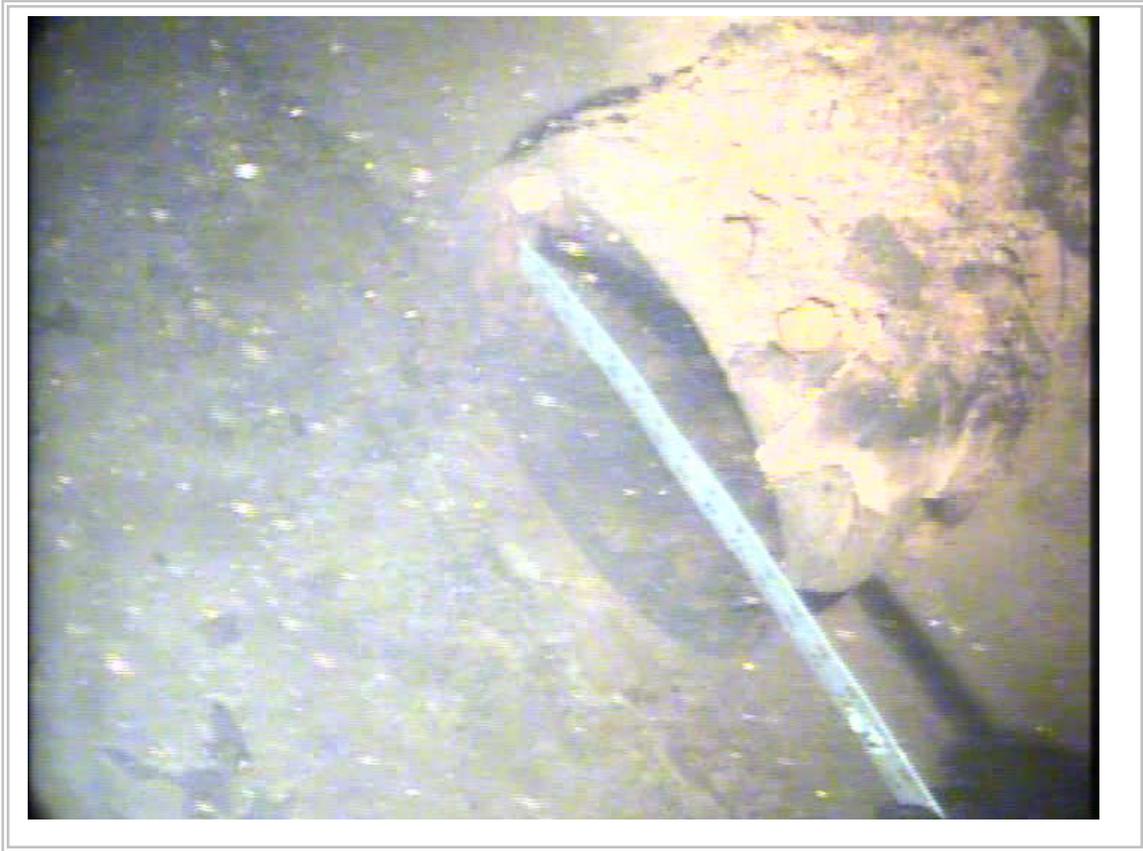
- **Plumbing** – The inlet and outlet plumbing penetration appears to be in Fair to Poor condition. There is corrosion on the visible interior surfaces. Due to the placement of the plumbing, the reservoir water does not appear to be mixing adequately for turnover. This may allow thermal stratification of the water, stagnant water from dead zones, disinfection byproducts to form, and there may be a loss of disinfectant residual in the upper layers of the water. An active mixing system should be installed to prevent stratification, and allow the disinfectant residual to mix thoroughly in the entire water column. Call Liquid Engineering Corp. for options and pricing.

Interior plumbing in lower wall (note heavy amount of corrosion)

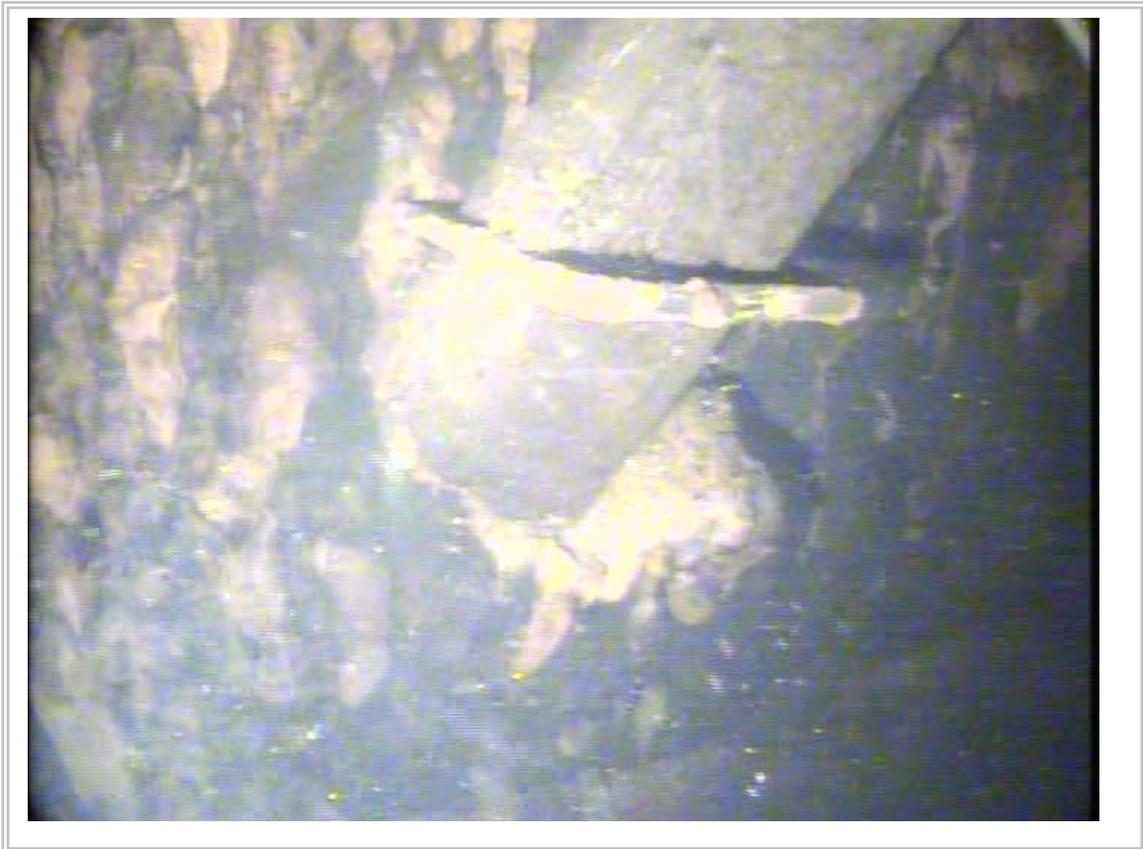
Example of a wall support, and the wooden beam that has detached

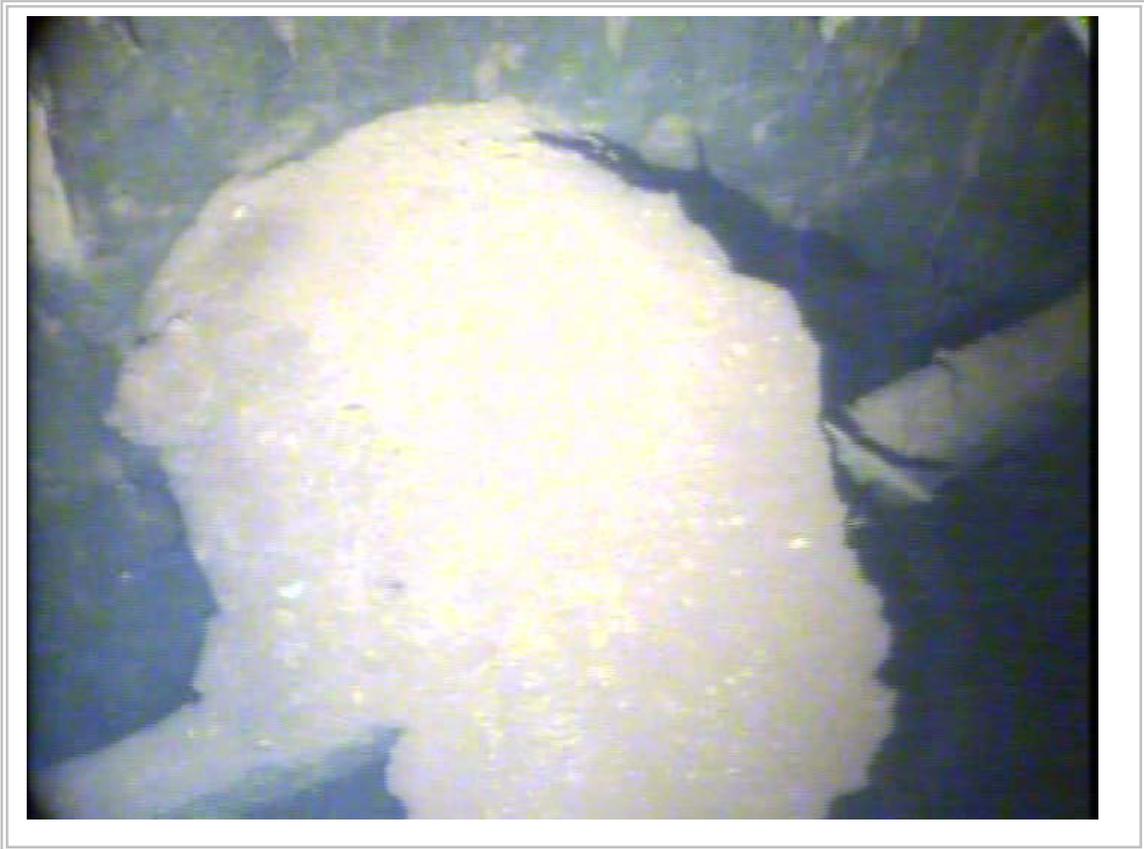
Example of a large piece of dealloyed steel fallen from the interior wall (approx. 2' x 1' piece)

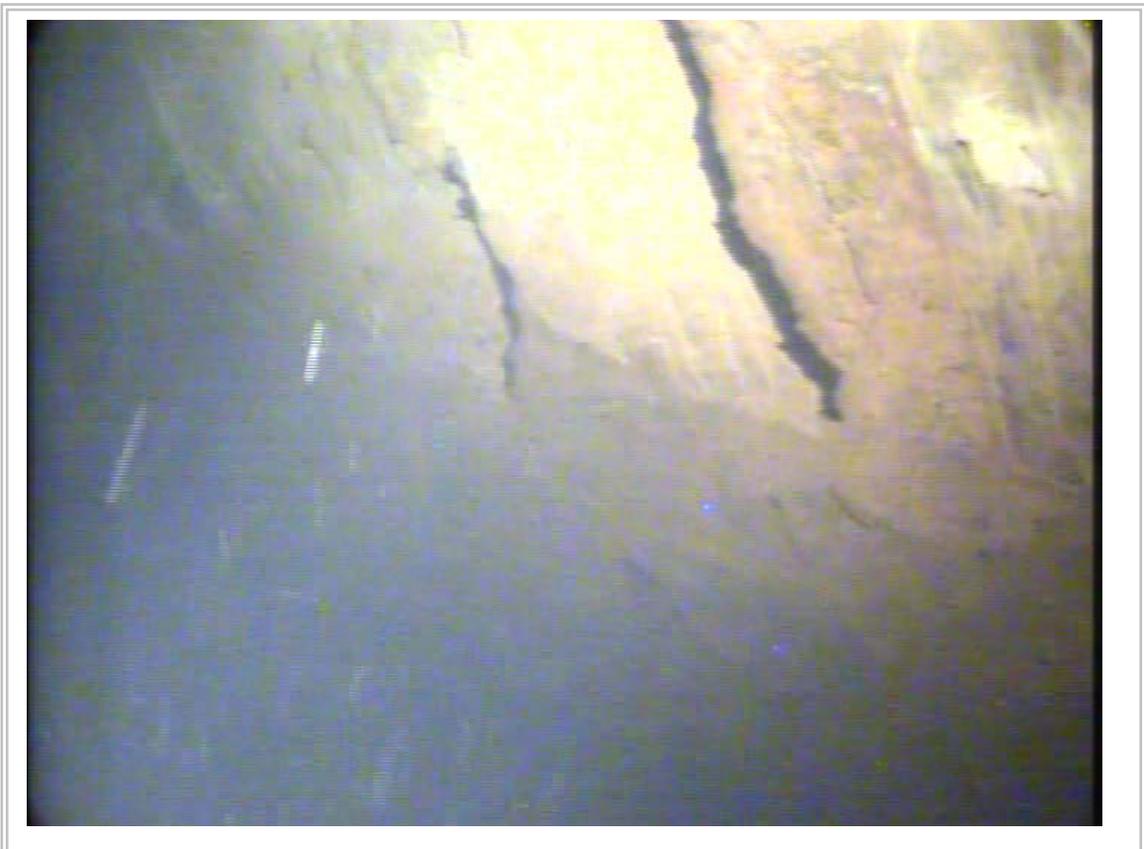
Example of heavy dealloying on the interior wall panels

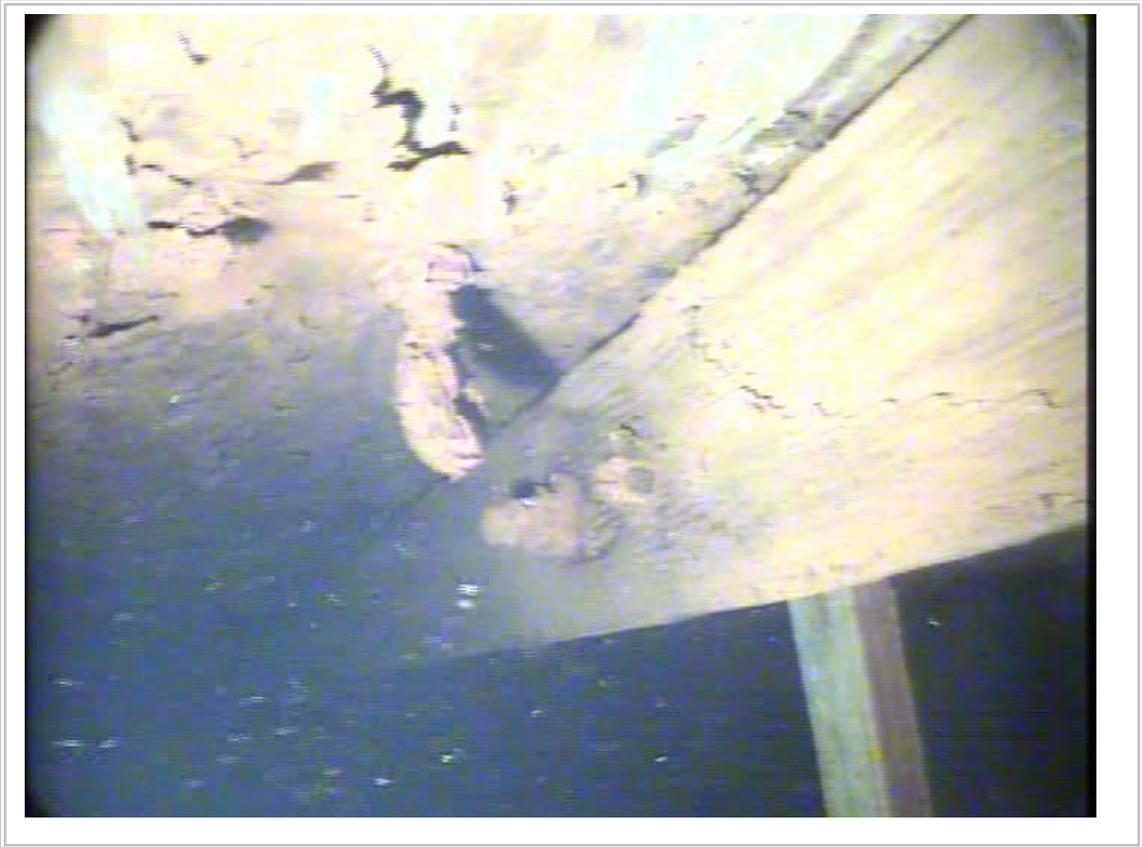
Example of corroded hardware and missing wood support on the interior wall column

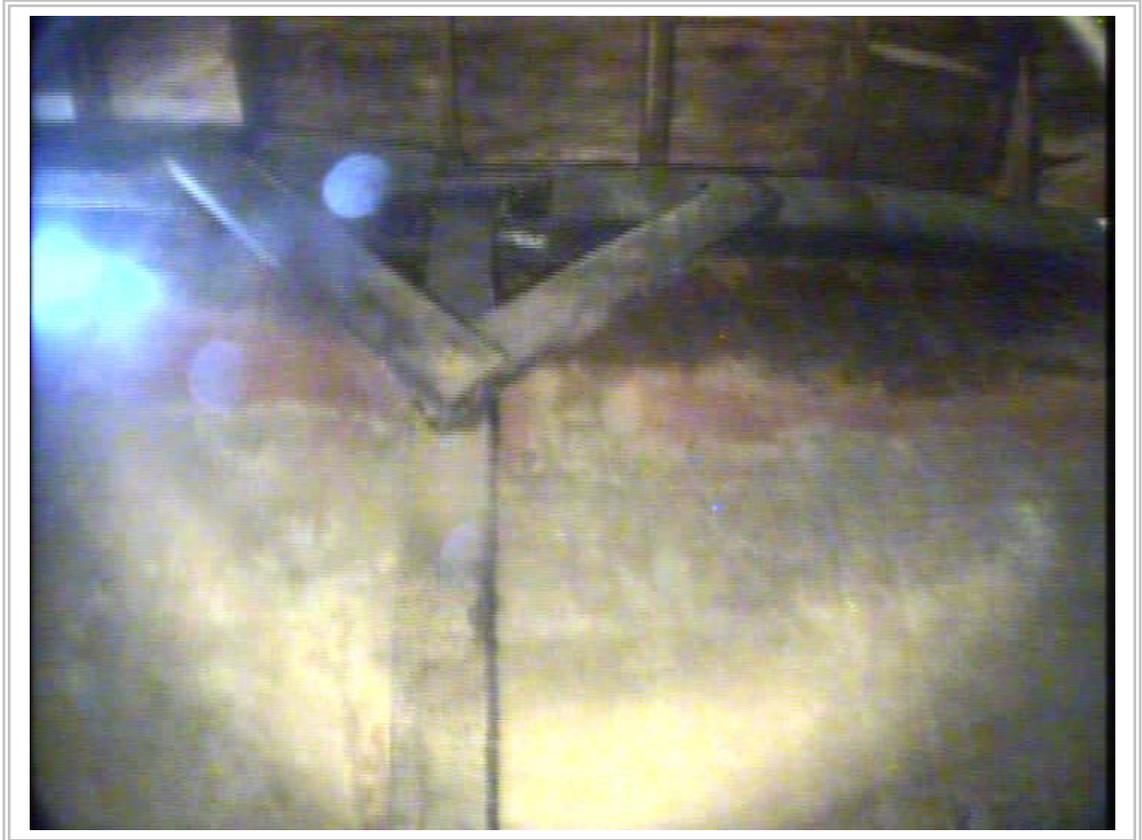
- **Column Structure(s)** – The interior columns are made of wood. The columns are rated in Poor/Critical condition. See supplemental video documentation of the interior. Many of the columns have completely failed, and are lying on the floor or suspended in the roof crossbeams. The wood shows many critical discrepancies, including cracking, splitting, separation, as well as biological/mold growth. All of the hardware connecting the supports show varying amounts of corrosion, some have completely failed. Due to the amount of column failure in this tank, the structure is not supporting the roof as designed. **Roof support structure is in critical condition.**

Interior wooden wall column (many pieces of broken wood have fallen from the structure)

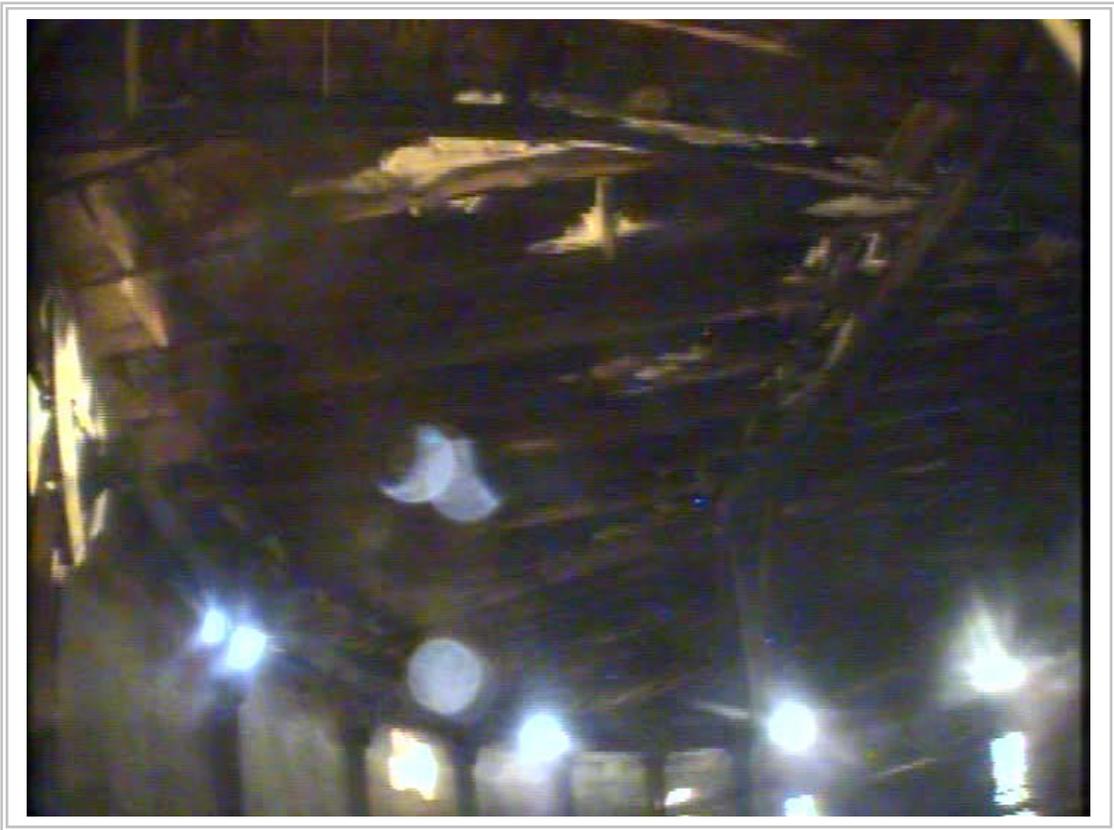
Interior wooden roof (many pieces of broken wood have fallen from the structure)

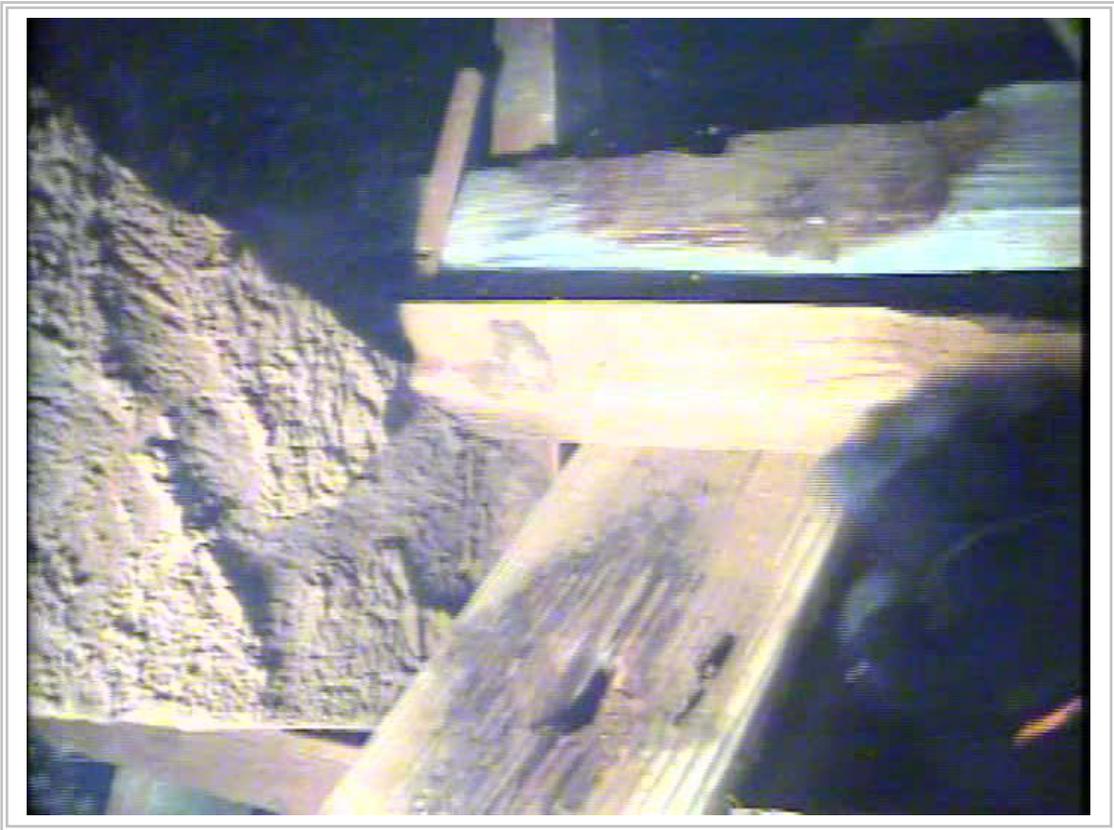
Example of an interior floor column with failed lateral wood supports

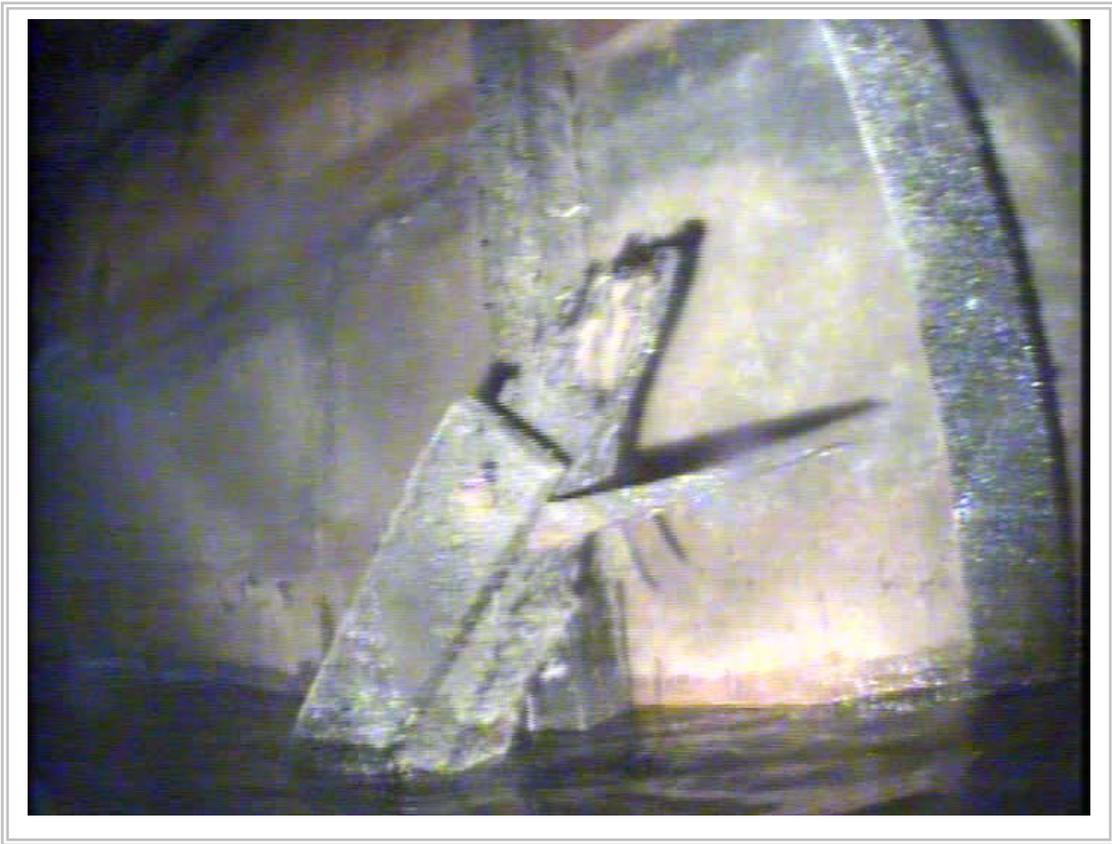
Example of a failed wooden support

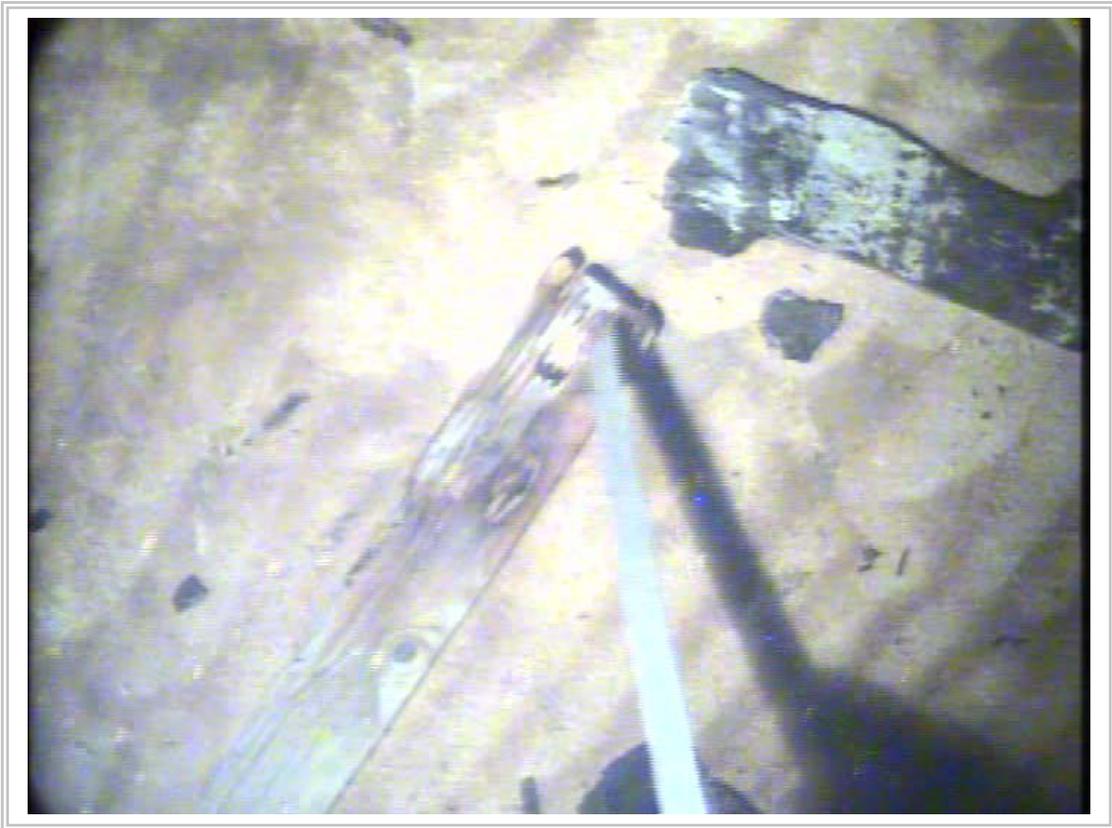
Fractured and failed supports lying on the tank floor

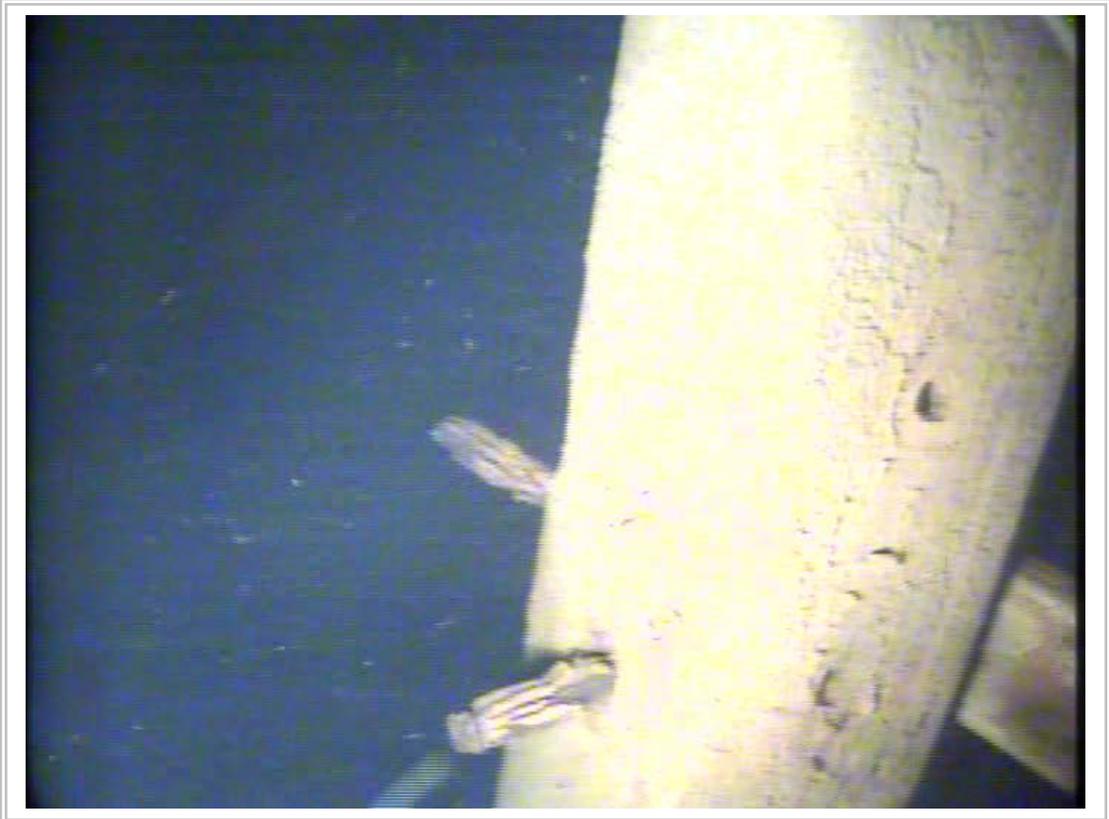
Example of corroded hardware and missing wood supports on a center support column

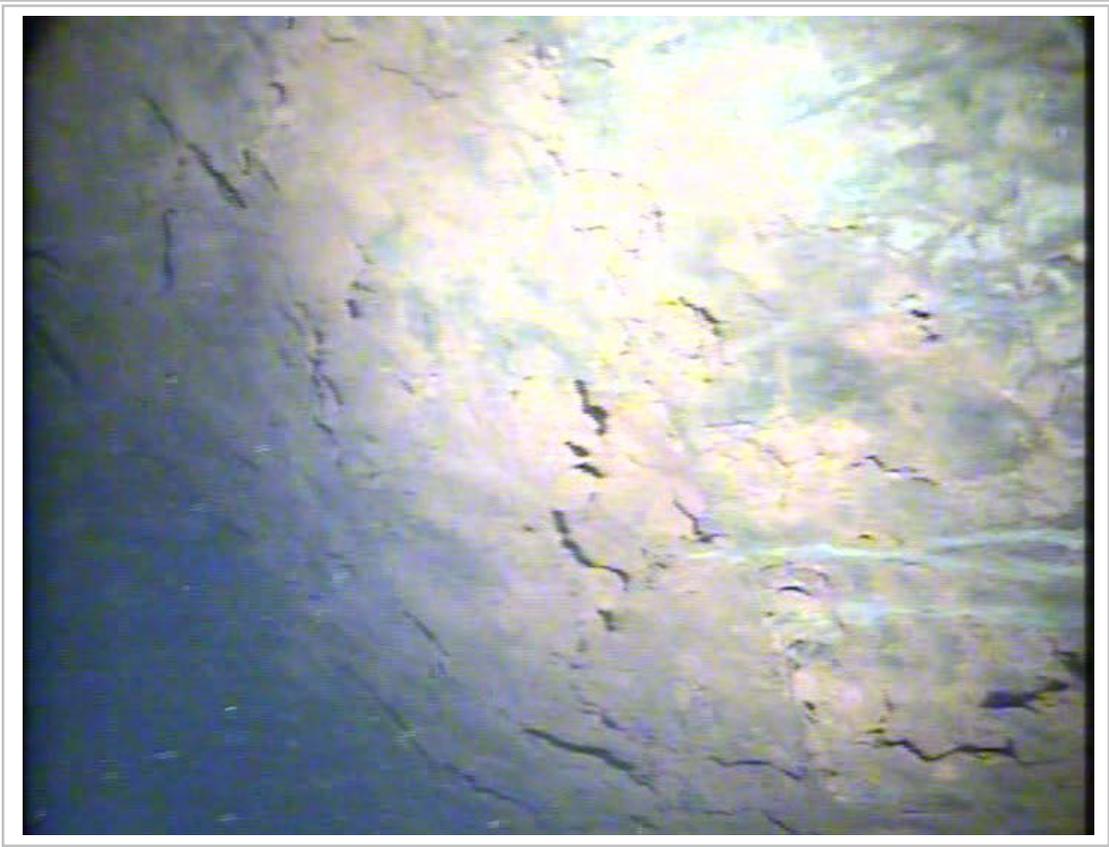
Example of heavy dealloying corrosion on the interior wall

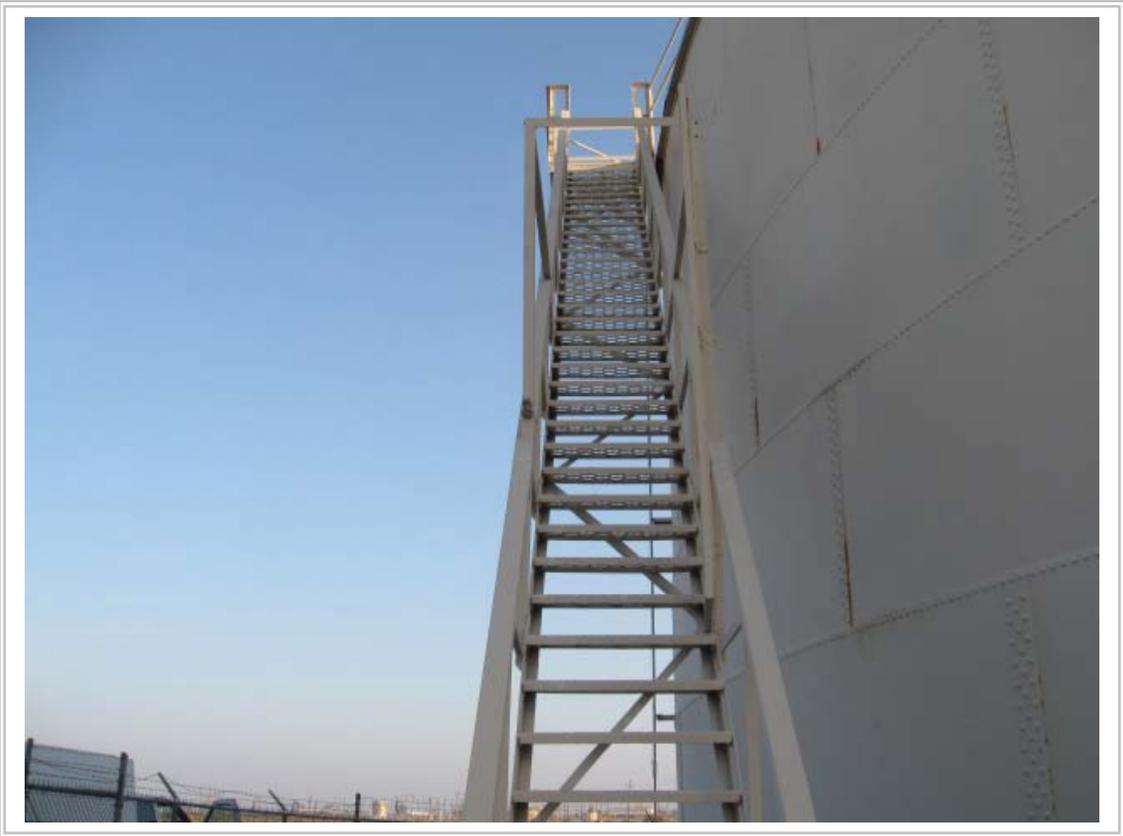
Exterior ladder

- **Wall to Roof Joint** – The roof to wall joint appears to be in Fair to Good condition and is properly sealed.
- **Ladder** – There is no ladder, but a full staircase is present to access the roof. The staircase appears to be in Good condition. All the attachments, standoffs, and bolt assemblies show no major discrepancy. There is NO locking Vandal Guard on the staircase to help prevent unauthorized access to the tank. Installation is recommended.

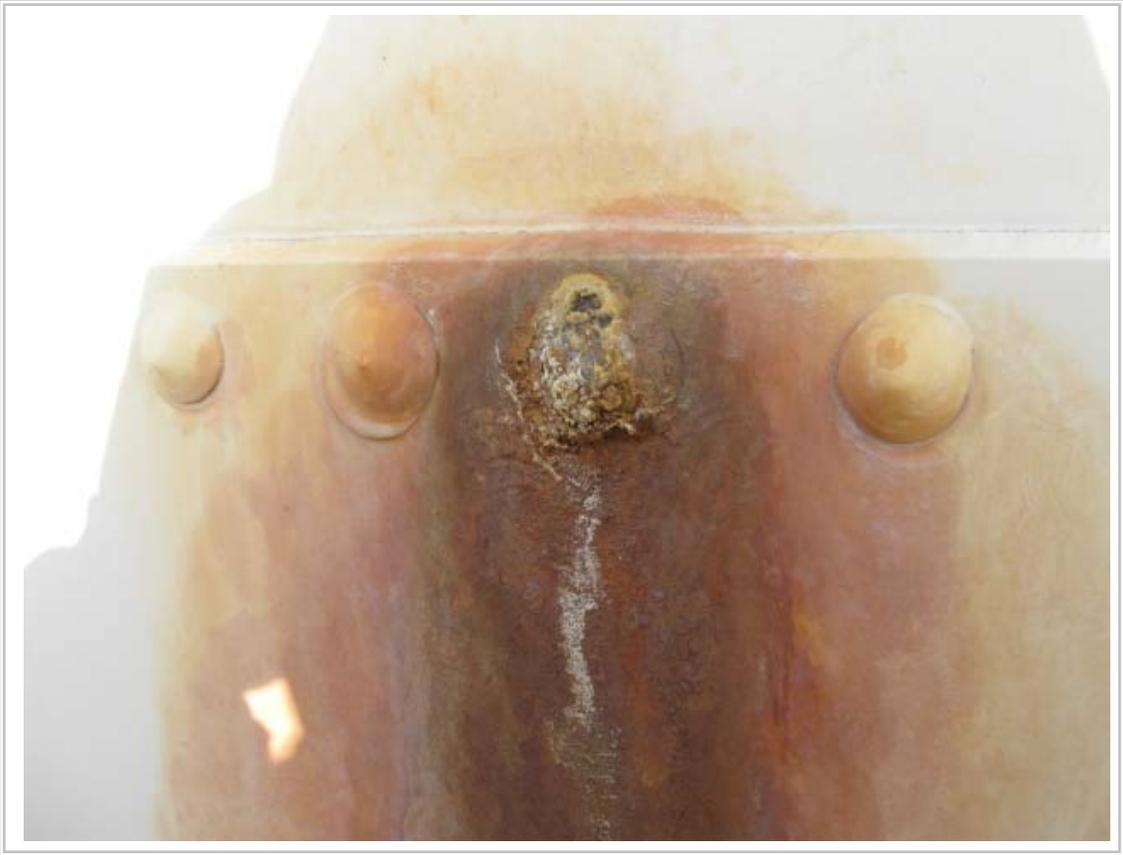
- **Ring Panels** – The exterior view of the wall panels show a Fair to Poor condition. There are isolated areas of severe penetrating corrosion damage with areas of complete coating failure.

Example of corrosion on the exterior wall rivet/panel with visible water penetration

- **Coating** – The exterior wall panel coating is in Fair/Good condition. The identified areas of corrosion from the coating discrepancies should be touched up to prevent further corrosion damage.

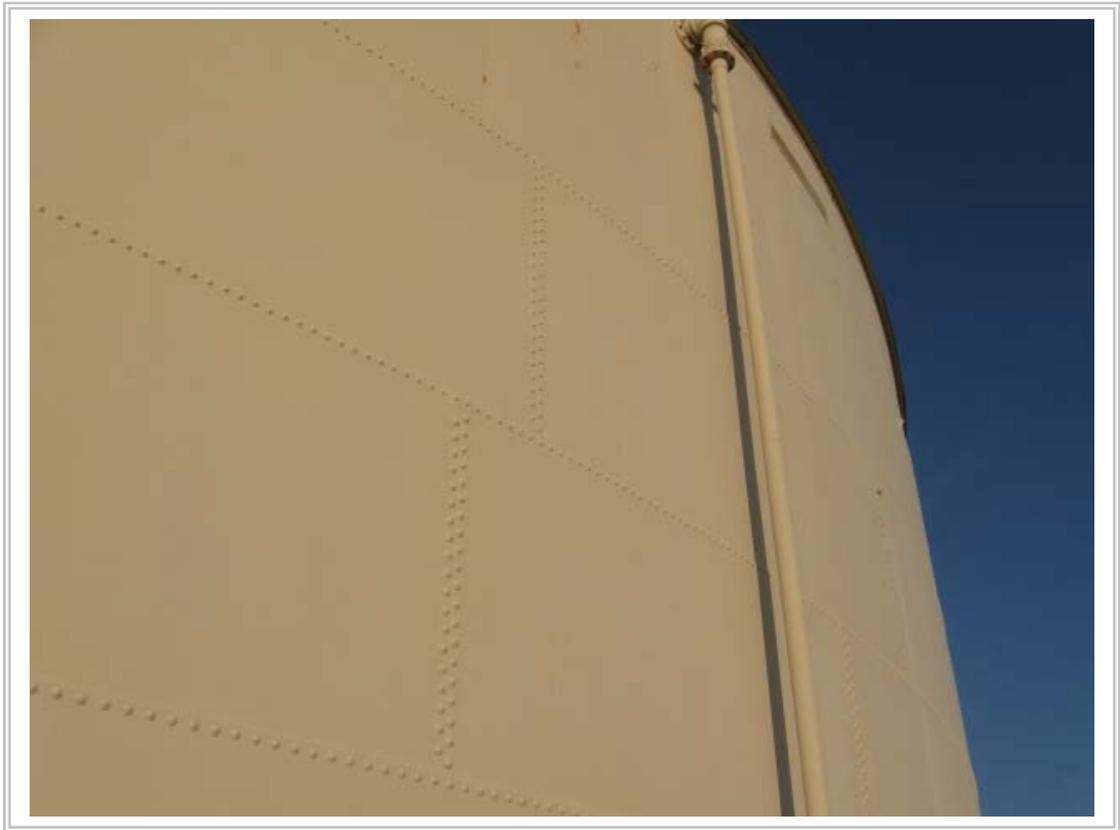
- **Overflow** – The overflow plumbing appears to be in Good condition. The overflow is not properly sealed with a flapper valve, gasket, or screen. Installation is recommended to prevent debris from entering the plumbing.

Exterior walls and overflow penetration

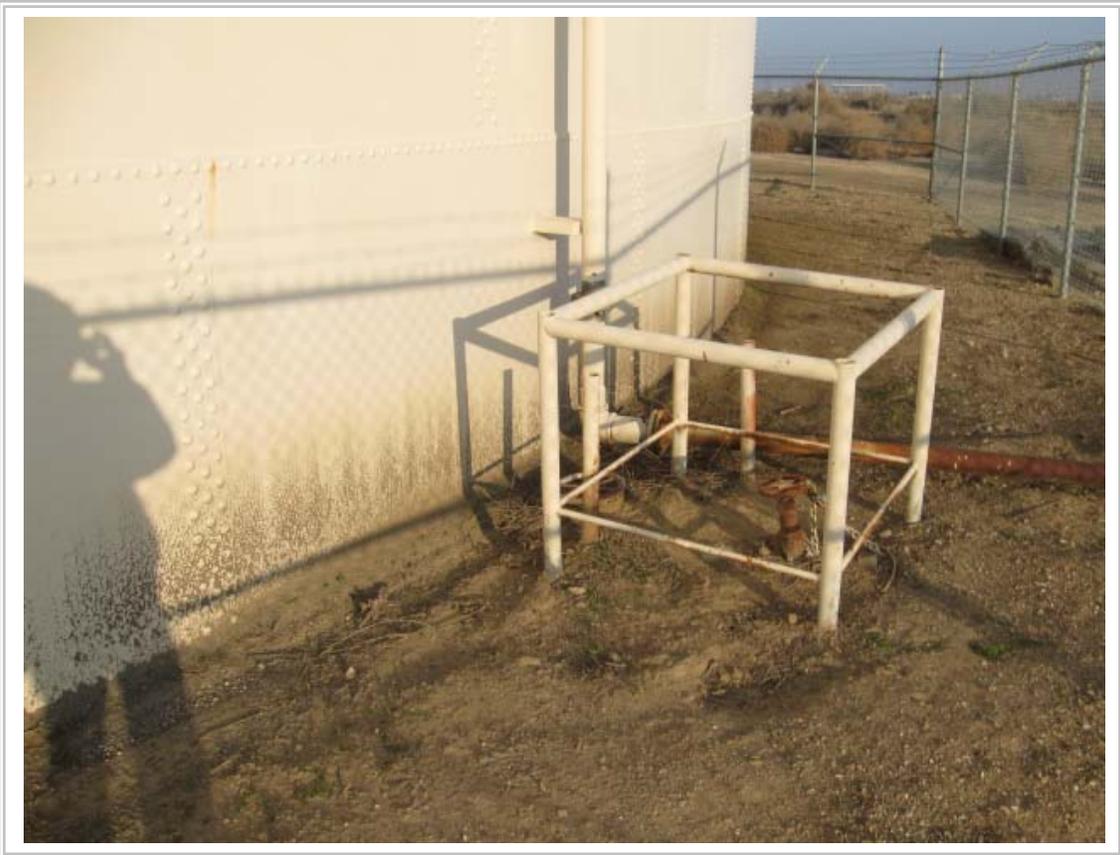
Lower walls and overflow plumbing

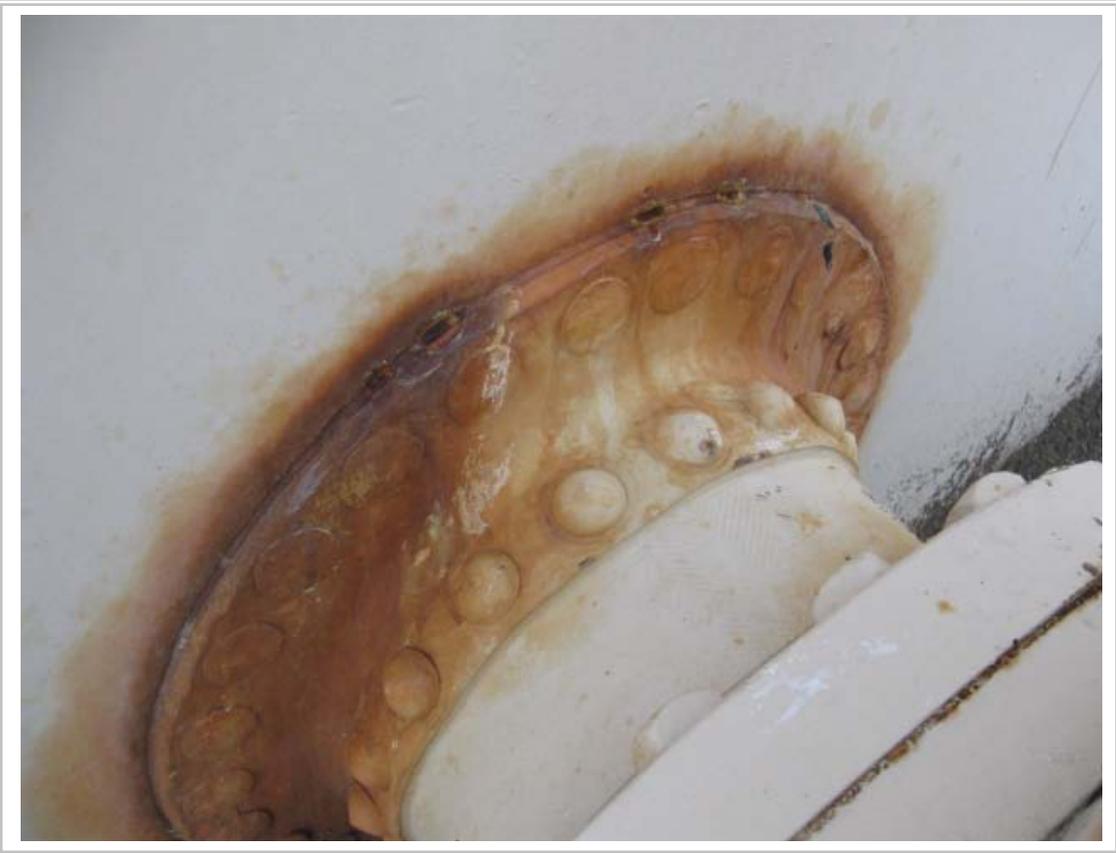
Exterior plumbing penetration into the lower wall (note advanced severe corrosion damage)

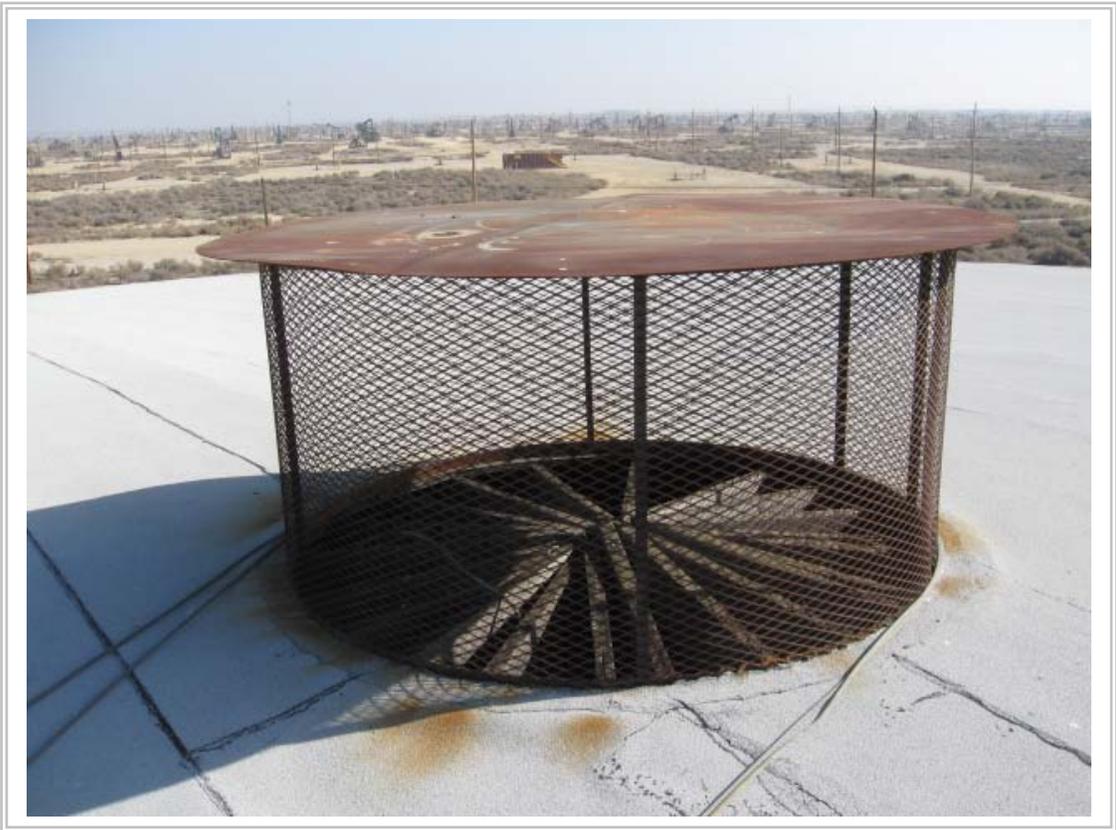
- **Vent(s)** – The roof vent is covered in uniform surface corrosion. The screen is very large mesh, and may be allowing contaminants to enter the reservoir. The screen should be cleaned or replaced periodically to maintain an adequate contamination protection and proper ventilation. An ARC³ Omega Security Vent should be installed for the best combination of ventilation and security.

Exterior center roof vent with severe corrosion

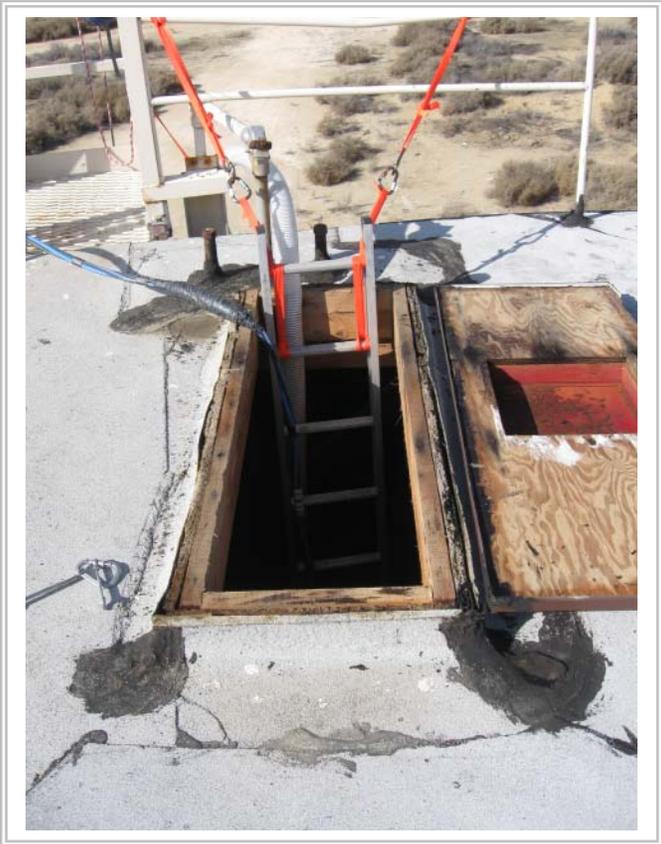
Exterior view of the roof hatch

- **Roof** – The exterior roof covering appears to be Good condition. The covering does not show any leaks.
- **Access Hatch** – The primary roof access hatch measures 60" x 18". There is severe advanced deterioration of the wooden structure, and this access point should be considered unsafe. A new steel hatch structure should be installed, with the current minimum dimensions recommended by the American Water Works Association and OSHA.
