Tank Inspection Report

Lost Hills Utility District
Western Tank
Liquid Engineering Corporation 44412

Tank Name:	Western Tank	Tank Type:	On-Grade
City:	Lost Hills	Tank Capacity:	2,200,000 Gallon
State:	CA	Type of Construction:	Riveted Steel
Year Built:	Unknown

Inspected By:	LEC Maintenance Team 10 – Team Leader C. Fromm		
Inspection Date:	January 19, 2013

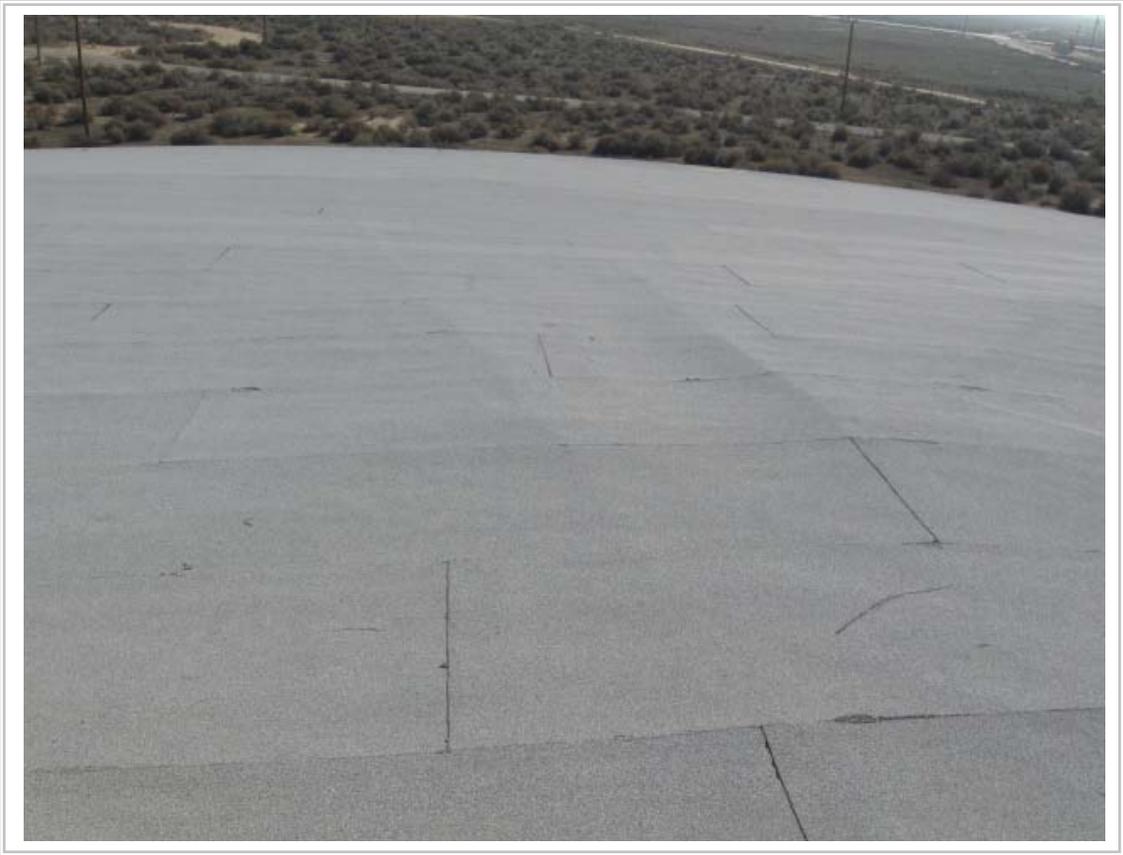
- **Roof Integrity** – There are no holes or standing water on the roof, but the roof is visibly sagging.
- **Wall Integrity** – There is extensive pitting damage to the interior side of the wall panels. A structural engineer should be hired to identify if the panels can be rehabilitated, or if the tank should be condemned.

Exterior view of the roof covering (Note sagging roof panels)
