Sacramento River, RM 55.2L

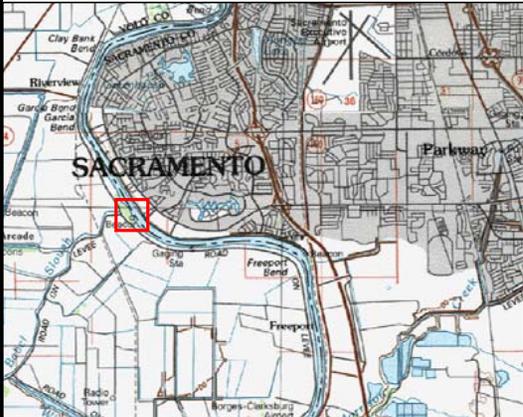
Sacramento River, RM 49.7L

Criteria	Score	Notes
Bank Slope	3	1.5:1 slope
Berm Width - Estimated	2	10 ft of berm
Soil Type	5	silts
Velocity	4	5.6 ft/s (UNET)
Economic Factor	20	Sacramento
Bank Stability	6	tree hazards, and slumping
Erosion Hazard	40

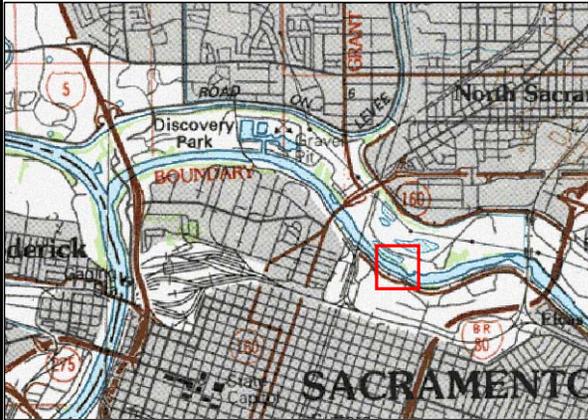
Lower American River, RM 2.8L

Criteria	Score	Notes
Bank Slope	4	1:1 slope
Berm Width - Estimated	2	10 to 20 ft
Soil Type	4	sands and silts
Velocity	3	3.4 ft/s
Economic Factor	20	Sacramento
Bank Stability	7	tree hazards, caves, and slumping
Erosion Hazard	40

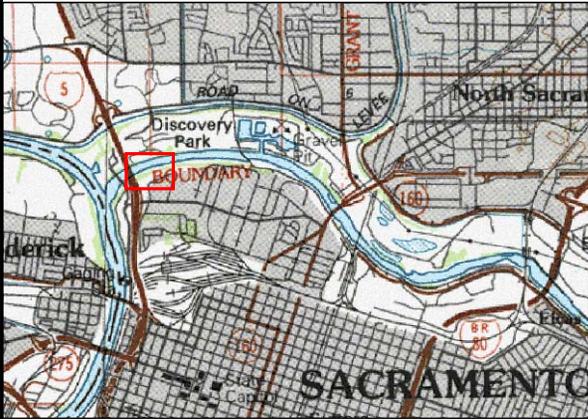
Lower American River, RM 0.3L

Criteria	Score	Notes
Bank Slope	3	1.5:1 slope
Berm Width - Estimated	3	6 to 30 ft
Soil Type	4	clays and silts
Velocity	4	5.2 ft/s
Economic Factor	20	Sacramento
Bank Stability	6	tree hazards, slumping
Erosion Hazard	40

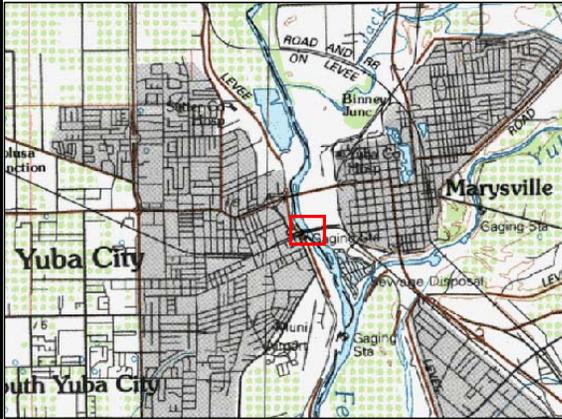
Feather River, RM 28.5R (LM 14.5 Sutter County LD 1 West)

Criteria	Score	Notes
Bank Slope	4	1:1 slope
Berm Width - Estimated	5	0 to 10 ft of berm
Soil Type	4	sands and silts
Velocity	3	4.0 ft/s
Economic Factor	17	Yuba City
Bank Stability	7	tree hazards, caves, and slumping
Erosion Hazard	40

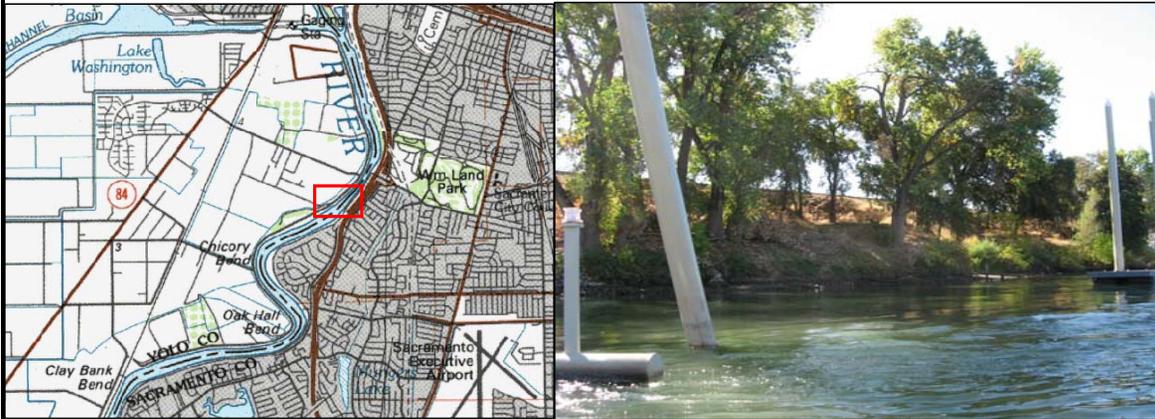
Sacramento River, RM 55.5L

Criteria	Score	Notes
Bank Slope	3	1.5:1 slope
Berm Width - Estimated	2	15 ft
Soil Type	4	sands and silts
Velocity	3	4.9 ft/s
Economic Factor	20	Sacramento
Bank Stability	6	tree hazards and slumping
Erosion Hazard	38

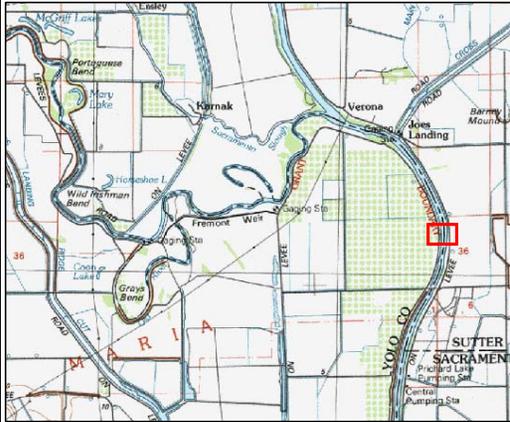
Sacramento River, RM 77.2L

Criteria	Score	Notes
Bank Slope	4	less than 1:1 slope
Berm Width - Estimated	0	30 ft
Soil Type	4	sands and silts
Velocity	4	5.0 ft/s
Economic Factor	18	Natomas
Bank Stability	7	tree hazards, caves, slumping, and seepage
Erosion Hazard	37

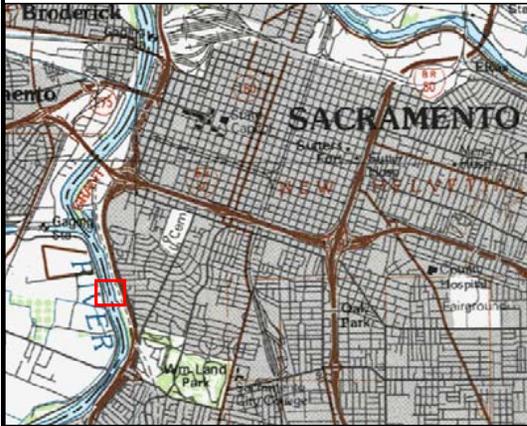
Sacramento River, RM 56.6L

Criteria	Score	Notes
Bank Slope	3	1.5:1 slope
Berm Width - Estimated	0	125 ft
Soil Type	4	sands and silts
Velocity	4	5.1 ft/s
Economic Factor	20	Sacramento
Bank Stability	6	tree hazards and slumping
Erosion Hazard	37

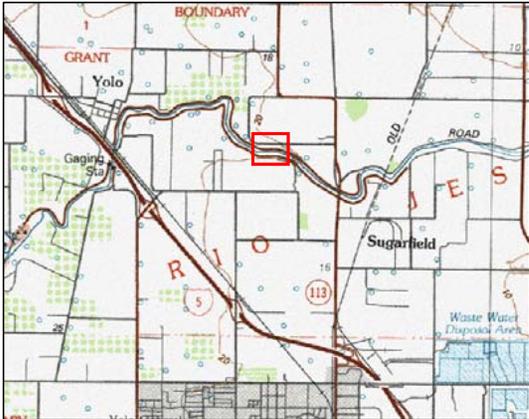
Cache Creek, LM 3.9L

Criteria	Score	Notes
Bank Slope	4	less than 1:1
Berm Width - Estimated	2	10 to 25 ft
Soil Type	4	sands and silts
Velocity	4	6 ft/s
Economic Factor	15	Yolo
Bank Stability	7	tree hazards, caves, tension cracks, and slumping
Erosion Hazard	36

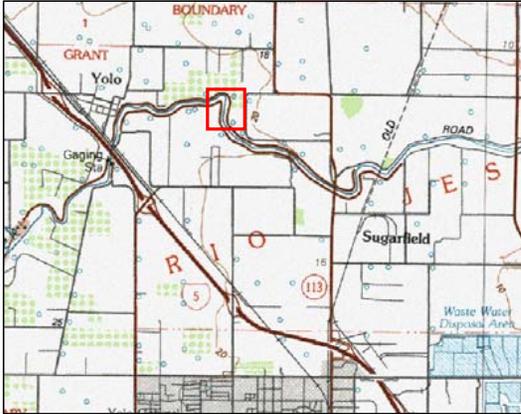
Cache Creek, LM 3.4L

Criteria	Score	Notes
Bank Slope	4	1:1 slope
Berm Width - Estimated	2	15 to 30 ft
Soil Type	4	sands and silts
Velocity	4	6.5 ft/s
Economic Factor	15	Yolo
Bank Stability	7	caves, tension cracks, and slumping
Erosion Hazard	36

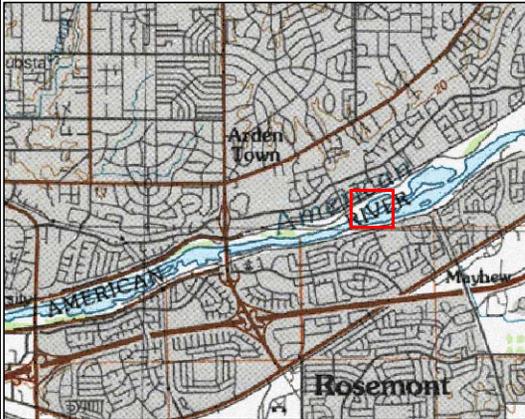
Lower American River, RM 10.6L

Criteria	Score	Notes
Bank Slope	5	near vertical slope
Berm Width - Estimated	2	15 to 20 ft
Soil Type	4	sands and silts
Velocity	3	3.9 ft/s
Economic Factor	20	Sacramento
Bank Stability	1	tree hazards
Erosion Hazard	35

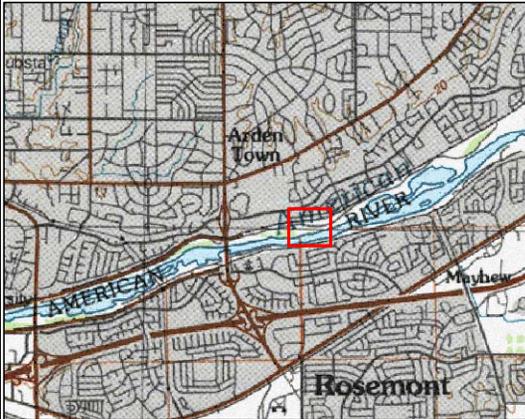
Lower American River, RM 10.0L

Criteria	Score	Notes
Bank Slope	3	1.5:1 slope
Berm Width - Estimated	2	10 to 15 ft
Soil Type	4	sands and silts
Velocity	5	8.7 ft/s
Economic Factor	20	Sacramento
Bank Stability	1	tree hazards
Erosion Hazard	35

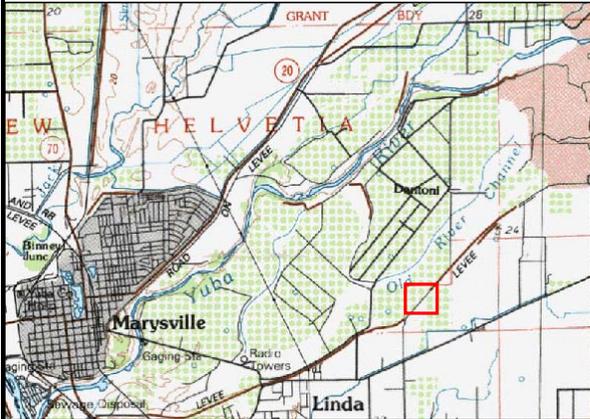
Yuba River, LM 2.3 (DWR MA 8 South)

Criteria	Score	Notes
Bank Slope	5	near vertical
Berm Width - Estimated	5	no berm
Soil Type	4	sands and silts
Velocity	0	water does not reach bank
Economic Factor	15	Plumis Lake
Bank Stability	6	animal burrows and slumping
Erosion Hazard	35

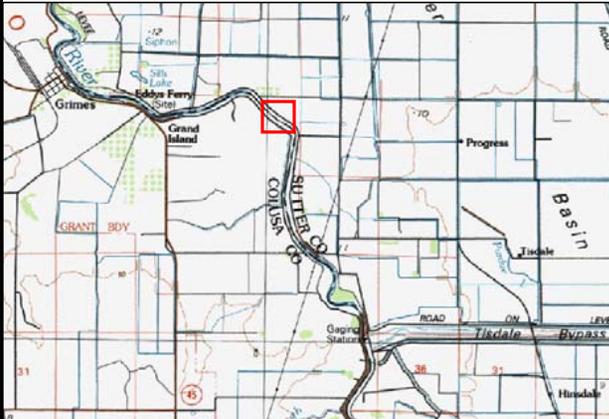
Sacramento River, RM 122.3R

Criteria	Score	Notes
Bank Slope	3	1.5:1 slope
Berm Width - Estimated	0	40 ft
Soil Type	2	clays and silts
Velocity	4	5.5 ft/s
Economic Factor	19	Colusa Basin
Bank Stability	6	tree hazards and slumping
Erosion Hazard	34

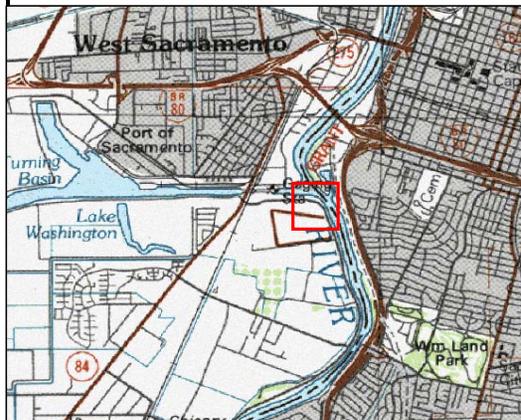
Sacramento River, RM 57.2R

Criteria	Score	Notes
Bank Slope	3	1.5:1 slope
Berm Width - Estimated	5	0 to 10 ft
Soil Type	4	sands and silts
Velocity	4	5.16 ft/s
Economic Factor	11	South West Sacramento
Bank Stability	7	tree hazards, caves, and slumping
Erosion Hazard	34

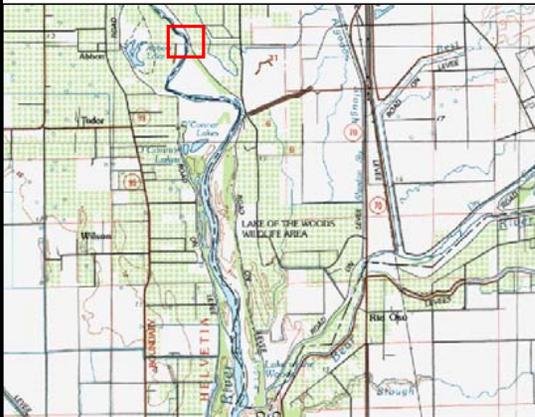
Feather River, RM 19.7L

Criteria	Score	Notes
Bank Slope	4	1:1 slope of less
Berm Width - Estimated	0	50 ft
Soil Type	4	sands and silts
Velocity	4	5.3 ft/s
Economic Factor	15	Plumis Lake
Bank Stability	7	tree hazards, caves, slumping, and seepage history
Erosion Hazard	34

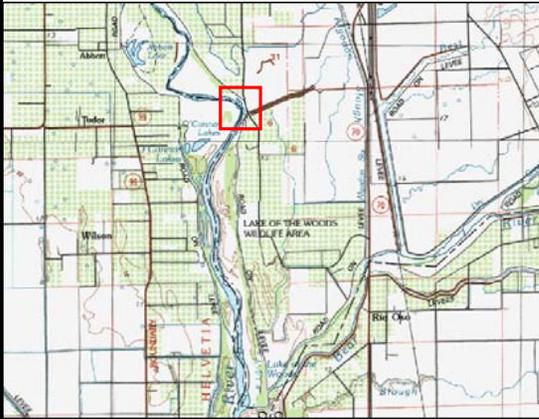
Feather River, RM 17.8L

Criteria	Score	Notes
Bank Slope	4	1:1 slope
Berm Width - Estimated	0	50 ft
Soil Type	4	sands and silts
Velocity	3	4.6 ft/s
Economic Factor	15	Plumis Lake
Bank Stability	7	tree hazards, slumping, and seepage
Erosion Hazard	33

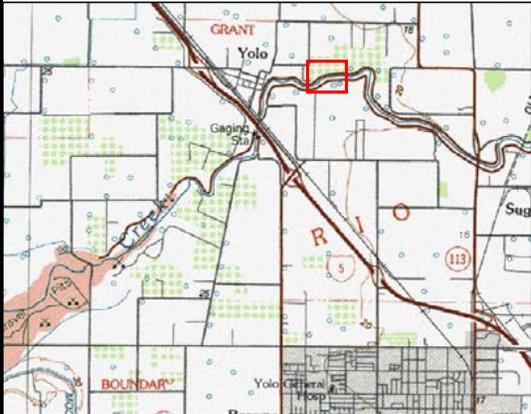
Cache Creek, LM 2.8L

Criteria	Score	Notes
Bank Slope	4	1:1 or less slope
Berm Width - Estimated	2	15 to 30 ft
Soil Type	4	sands and silts
Velocity	4	5.9 ft/s
Economic Factor	15	Yolo
Bank Stability	4	Slumping
Erosion Hazard	33

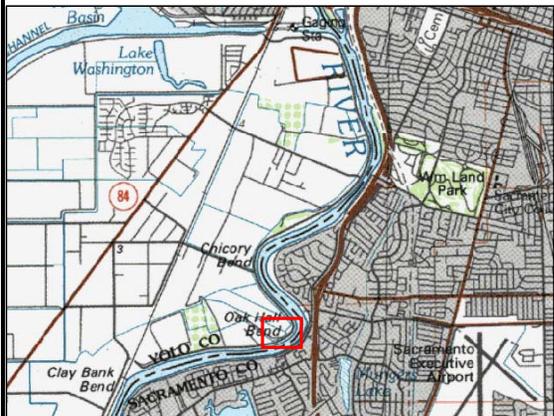
Sacramento River, RM 53.5R

Criteria	Score	Notes
Bank Slope	4	1:1 slope
Berm Width - Estimated	3	5 ft
Soil Type	4	sands and silts
Velocity	4	6.0 ft/s
Economic Factor	11	South West Sacramento
Bank Stability	6	tree hazards and slumping
Erosion Hazard	32

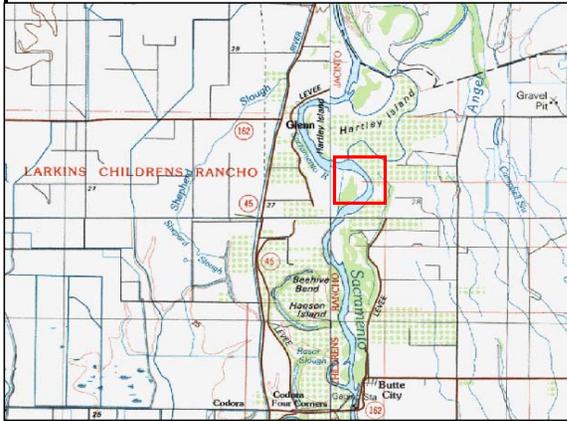
Sacramento River, RM 172.0L

Criteria	Score	Notes
Bank Slope	5	vertical banks
Berm Width - Estimated	0	30 ft
Soil Type	2	clays with some silts
Velocity	4	5.64 ft/s
Economic Factor	13	Butte Basin
Bank Stability	7	caves, slumping, and tension cracks
Erosion Hazard	31

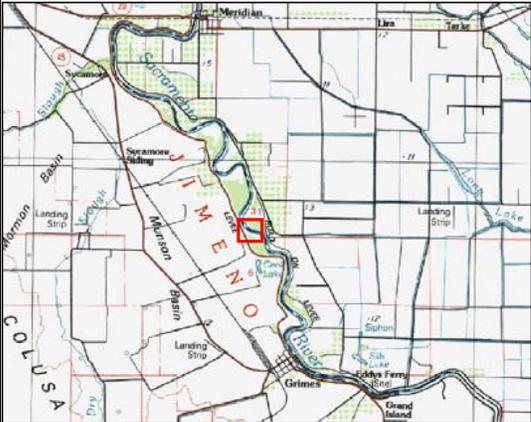
Sacramento River, RM127.9R

Criteria	Score	Notes
Bank Slope	2	2:1 slope
Berm Width - Estimated	0	35 ft
Soil Type	2	clays and silts
Velocity	2	2.9 ft/s
Economic Factor	19	Colusa Basin
Bank Stability	6	tree hazards and slumping
Erosion Hazard	31

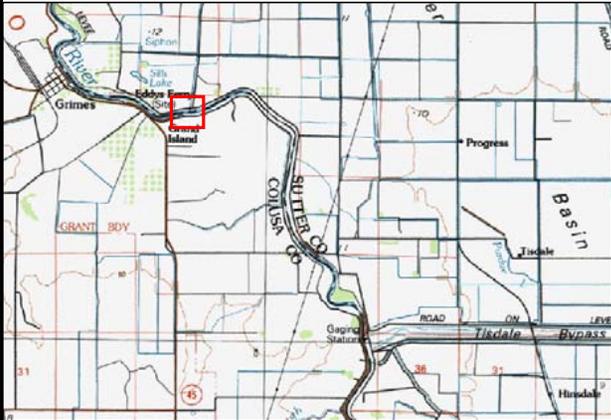
Sacramento River, RM 123.7R

Criteria	Score	Notes
Bank Slope	4	less than 1:1 slope
Berm Width - Estimated	2	15 ft
Soil Type	2	clays and silts
Velocity	4	5.3 ft/s
Economic Factor	19	Colusa Basin
Bank Stability	0	no stability issues
Erosion Hazard	31

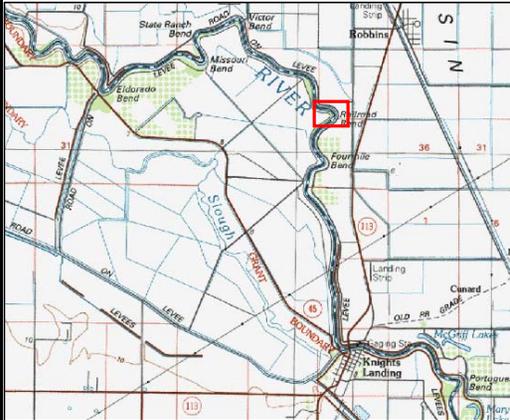
Sacramento River, RM 93.7L

Criteria	Score	Notes
Bank Slope	3	1.5:1 slope
Berm Width - Estimated	2	15 ft
Soil Type	4	sands and silts
Velocity	3	3.4 ft/s
Economic Factor	12	Sutter Basin
Bank Stability	6	tension cracks and slumping
Erosion Hazard	30

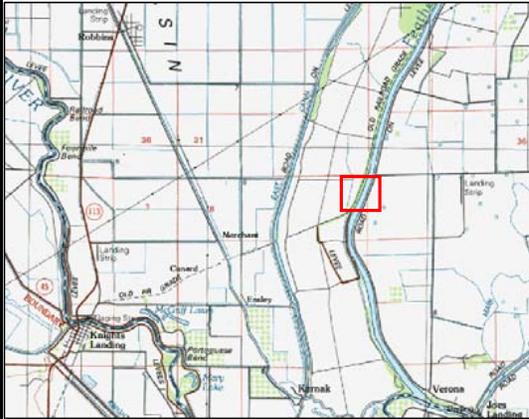
Feather River, RM 3.8L

Criteria	Score	Notes
Bank Slope	4	1:1 slope
Berm Width - Estimated	1	25 to 30 ft
Soil Type	4	sands and silts
Velocity	4	7.1 ft/s
Economic Factor	10	Verona
Bank Stability	7	tree hazards, caves, and seepage
Erosion Hazard	30

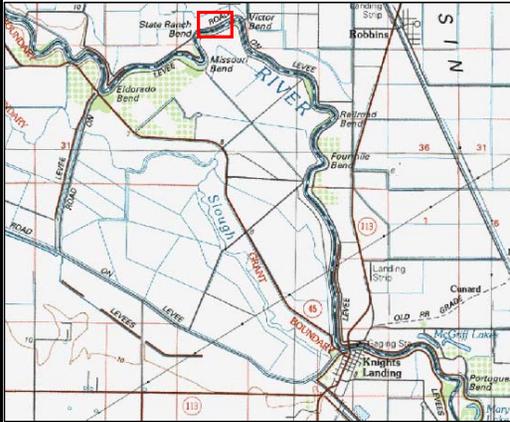
Sacramento River, RM 96.2L

Criteria	Score	Notes
Bank Slope	4	1:1 slope
Berm Width - Estimated	0	30 ft
Soil Type	4	sands and silts
Velocity	3	3.2 ft/s
Economic Factor	12	Sutter Basin
Bank Stability	6	caves and slumping
Erosion Hazard	29

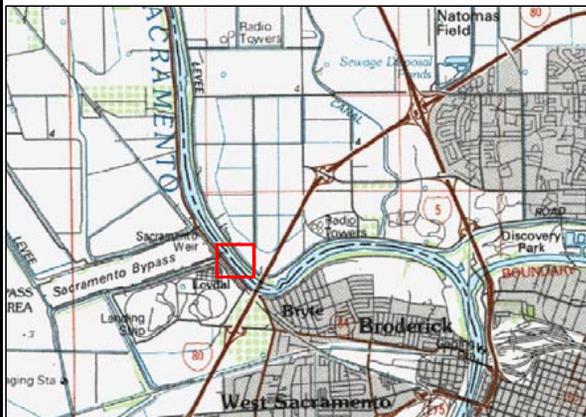
Sacramento River, RM 62.9R

Criteria	Score	Notes
Bank Slope	3	1.5:1 slope
Berm Width - Estimated	2	less than 20 ft
Soil Type	2	clays and silts
Velocity	3	3.1 ft/s
Economic Factor	13	West Sacramento
Bank Stability	6	tree hazards and slumping
Erosion Hazard	29

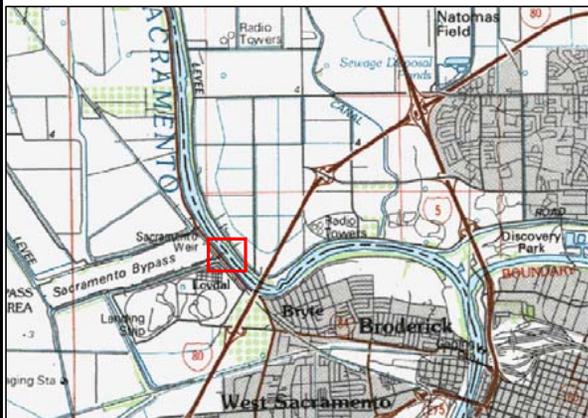
Sacramento River, RM 63.0R

Criteria	Score	Notes
Bank Slope	3	1.5:1 slope
Berm Width - Estimated	2	less than 20 ft
Soil Type	2	clays and silts
Velocity	2	2.9 ft/s
Economic Factor	13	West Sacramento
Bank Stability	6	tree hazards and slumping
Erosion Hazard	28

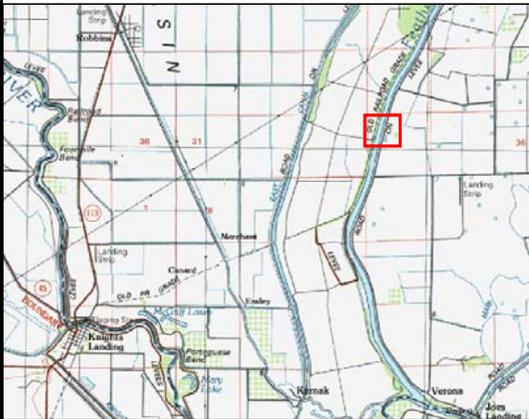
Feather River, RM 4.9L

Criteria	Score	Notes
Bank Slope	3	1.5:1 slope
Berm Width - Estimated	0	greater than 30 ft
Soil Type	4	sands and silts
Velocity	5	8.8 ft/s
Economic Factor	10	Verona
Bank Stability	6	tree hazards, and seepage
Erosion Hazard	28

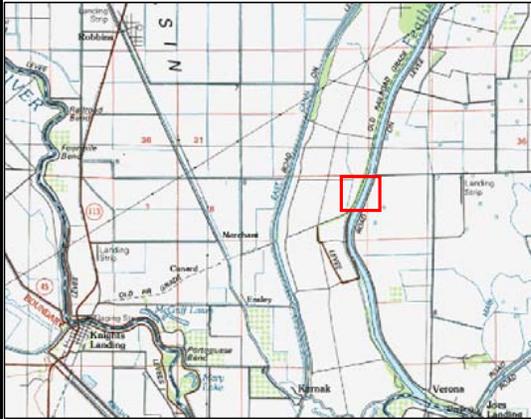
Feather River, RM 3.6L

Criteria	Score	Notes
Bank Slope	3	1.5:1 slope
Berm Width - Estimated	0	30 ft
Soil Type	4	sands and silts
Velocity	4	7.2 ft/s
Economic Factor	10	Verona
Bank Stability	7	tree hazards, caves, and seepage
Erosion Hazard	28

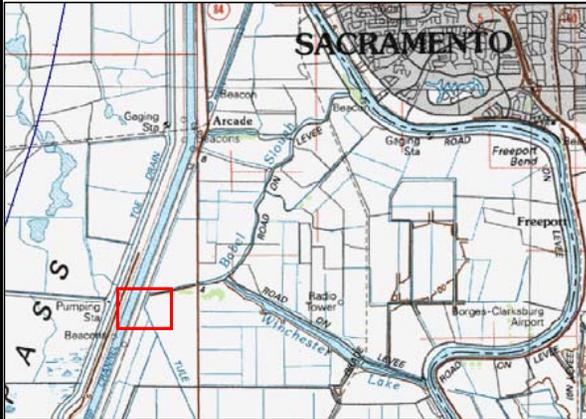
Deep Water Ship Channel, LM 5.01 (RD 999 Unit 1 East)

Criteria	Score	Notes
Bank Slope	2	2:1 slope
Berm Width - Estimated	5	no berm
Soil Type	2	clays and silts
Velocity	1	1.3 ft/s
Economic Factor	12	Clarksburg
Bank Stability	6	tension cracks and slumping
Erosion Hazard	28

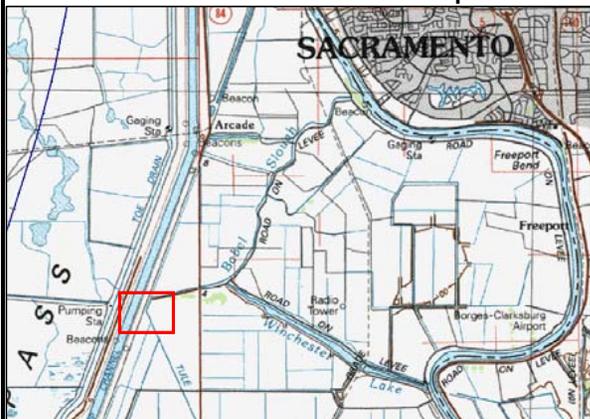
Deep Water Ship Channel, LM 5.0 (RD 999 Unit 1 East)

Criteria	Score	Notes
Bank Slope	2	2:1 slope
Berm Width - Estimated	5	no berm
Soil Type	2	clays and silts
Velocity	1	1.3 ft/s
Economic Factor	12	Clarksburg
Bank Stability	6	tension cracks and slumping
Erosion Hazard	28

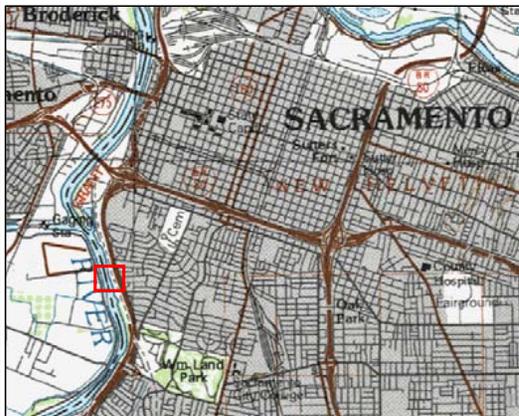
Sacramento River, RM 57.0R

Criteria	Score	Notes
Bank Slope	2	2:1 slope
Berm Width - Estimated	5	0 to 10 ft
Soil Type	4	sands and silts
Velocity	4	5.0 ft/s
Economic Factor	11	South West Sacramento
Bank Stability	1	tree hazards
Erosion Hazard	27

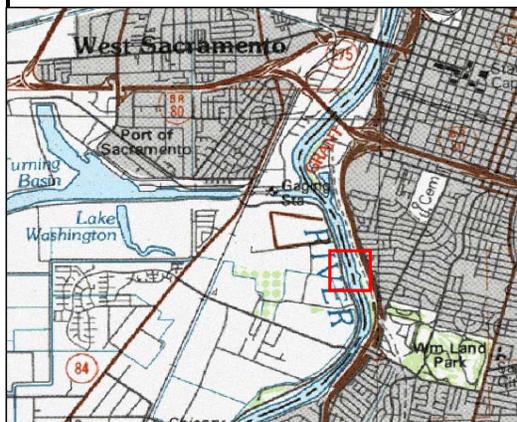
Sacramento River, RM 56.7R

Criteria	Score	Notes
Bank Slope	3	1.5:1 slope
Berm Width - Estimated	0	3 to 40 ft
Soil Type	4	sands and silts
Velocity	3	4.88 ft/s
Economic Factor	11	South West Sacramento
Bank Stability	6	tree hazards and slumping
Erosion Hazard	27

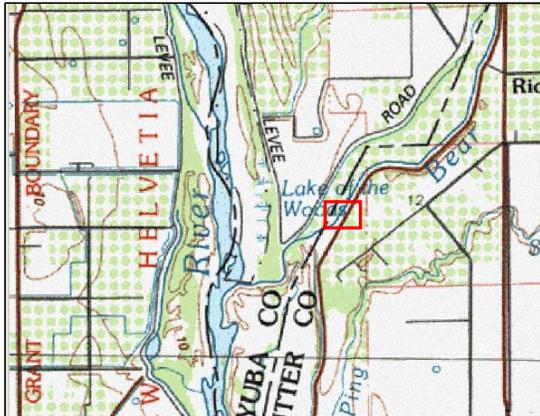
Bear River, RM 0.8L

Criteria	Score	Notes
Bank Slope	5	Some vertical sections
Berm Width - Estimated	2	15 to 30 ft
Soil Type	2	Clays and Silts
Velocity	2	2.8 ft/s
Economic Factor	10	Verona
Bank Stability	6	Seepage History and beaver holes
Erosion Hazard	27
