Sacramento River, RM 57.2R

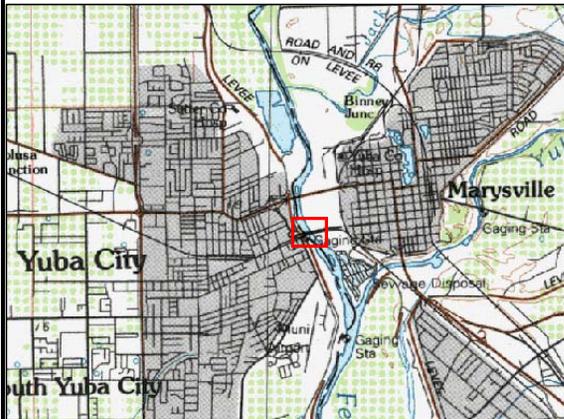
Feather River, RM 28.5R (LM 14.5 Sutter County LD 1 West)

Criteria	Score	Notes
Bank Slope	4	1:1 slope
Berm Width - Estimated	5	0 to 10 ft of berm
Soil Type	4	sands and silts
Velocity	3	4.0 ft/s
Bank Stability	7	tree hazards, caves, and slumping
Erosion Hazard	23

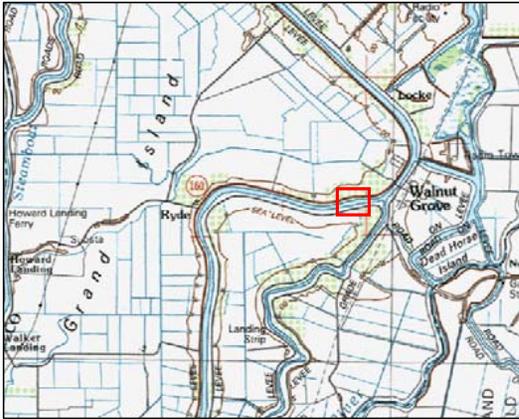
Sacramento River, RM 26.0L

Criteria	Score	Notes
Bank Slope	4	1:1 slope
Berm Width - Estimated	5	0 to 50 ft
Soil Type	2	clays and silts
Velocity	4	5.1 ft/s
Bank Stability	6	tree hazards and slumping
Erosion Hazard	21

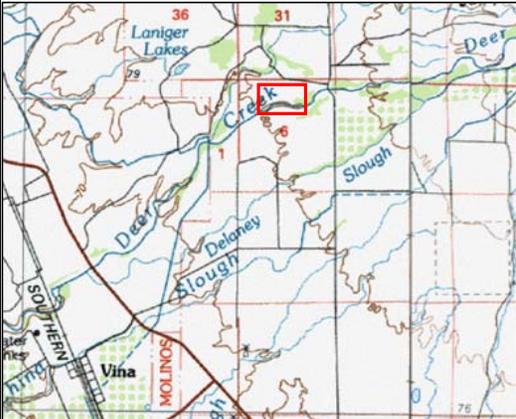
Deer Creek, LM 0.9 (Tehama Unit 1 North)

Criteria	Score	Notes
Bank Slope	5	near vertical
Berm Width - Estimated	2	10 to 15 ft
Soil Type	3	sands and cobbles
Velocity	4	5 ft/s
Bank Stability	7	tree hazards, animal holes, and slumping
Erosion Hazard	21

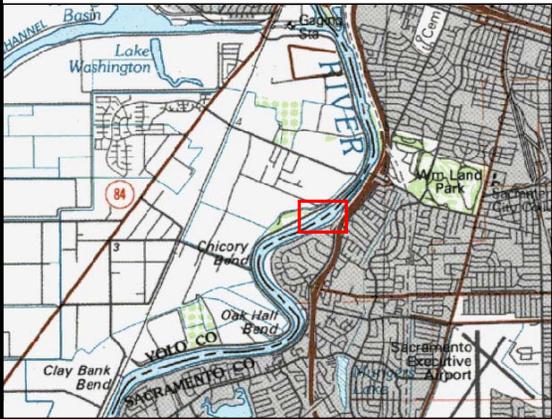
Sacramento River, RM 55.2L

Criteria	Score	Notes
Bank Slope	2	2:1 slope
Berm Width - Estimated	5	0 to 15 ft of berm
Soil Type	4	sands and silts
Velocity	3	4.8 ft/s
Bank Stability	6	tree hazards and slumping
Erosion Hazard	20

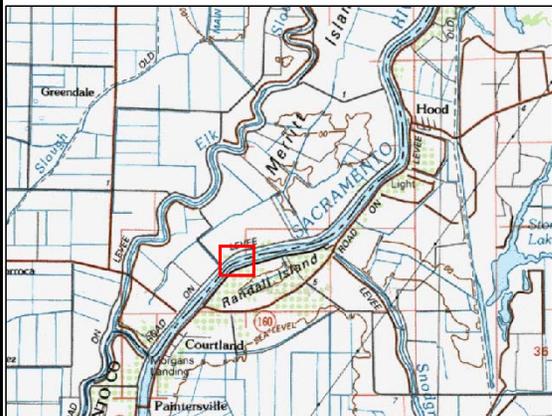
Sacramento River, RM 35.4R

Criteria	Score	Notes
Bank Slope	2	2:1 slopes
Berm Width - Estimated	5	no berm
Soil Type	4	sands and silts
Velocity	4	6.5 ft/s
Bank Stability	4	slumping
Erosion Hazard	19

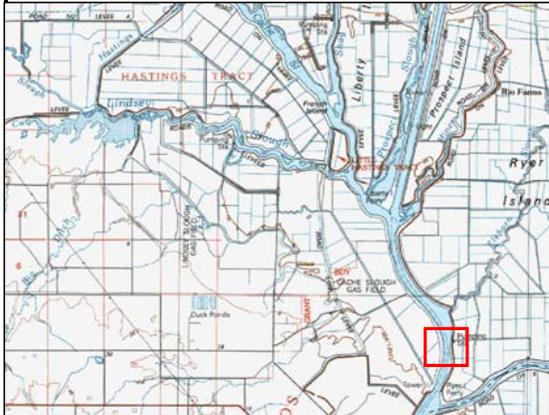
Cache Slough, RM 15.9L

Criteria	Score	Notes
Bank Slope	2	2:1 slope
Berm Width - Estimated	4	3 to 6 ft
Soil Type	2	clays and silts
Velocity	5	10.9 ft/s
Bank Stability	6	slumping, beaver holes
Erosion Hazard	19

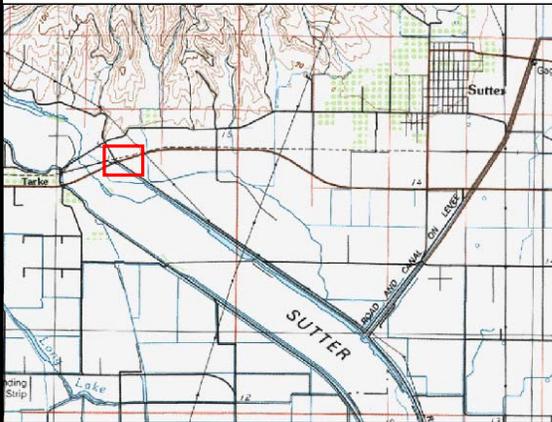
Sutter Bypass, LM 0.4 (DWR East)

Criteria	Score	Notes
Bank Slope	4	1:1 slope
Berm Width - Estimated	3	5 to 6 ft of berm
Soil Type	4	sands and silts
Velocity	2	3.0 ft/s
Bank Stability	6	vertical sections and slumping
Erosion Hazard	19

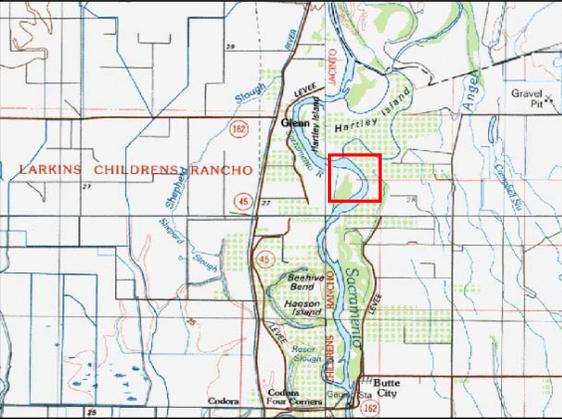
Sacramento River, RM 172.0L

Criteria	Score	Notes
Bank Slope	5	vertical banks
Berm Width - Estimated	0	30 ft
Soil Type	2	clays with some silts
Velocity	4	5.64 ft/s
Bank Stability	7	caves, slumping, and tension cracks
Erosion Hazard	18

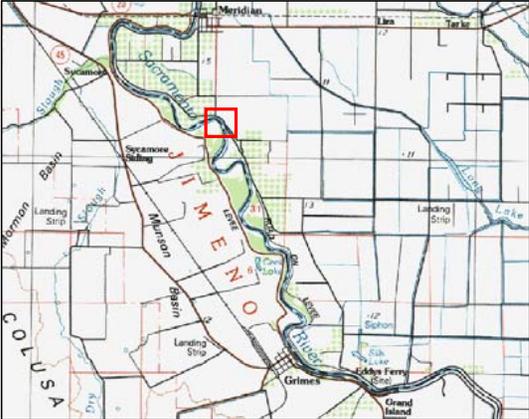
Sacramento River, RM 130.0L

Criteria	Score	Notes
Bank Slope	3	1.5:1 slope
Berm Width - Estimated	5	0 to 60 ft
Soil Type	2	clays and silts
Velocity	2	2.9 ft/s
Bank Stability	6	tree hazards and slumping
Erosion Hazard	18

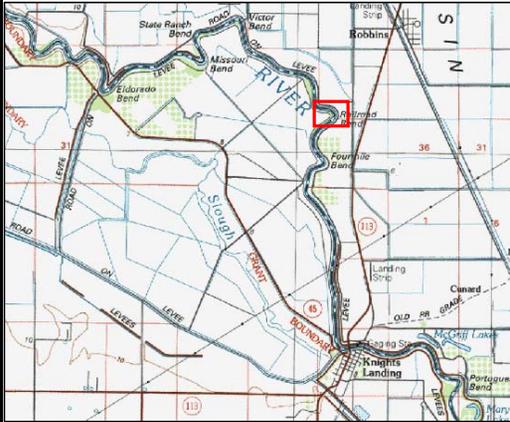
Sacramento River, RM 93.7L

Criteria	Score	Notes
Bank Slope	3	1.5:1 slope
Berm Width - Estimated	2	15 ft
Soil Type	4	sands and silts
Velocity	3	3.4 ft/s
Bank Stability	6	tension cracks and slumping
Erosion Hazard	18

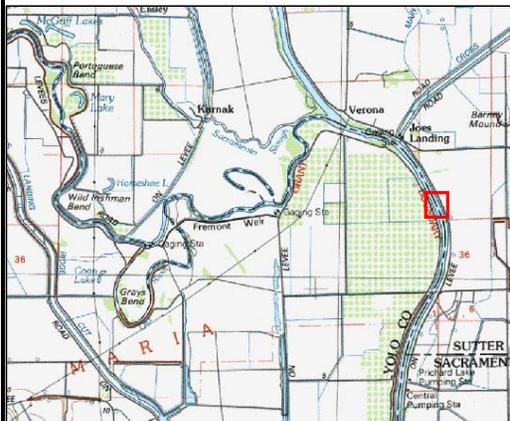
Sacramento River, RM 77.7R

Criteria	Score	Notes
Bank Slope	3	1.5:1 slope
Berm Width - Estimated	1	25 to 30 ft
Soil Type	2	clays and silts
Velocity	5	5.0 ft/s plus eddy from adjacent rock
Bank Stability	7	tree hazards, caves, and slumping
Erosion Hazard	18

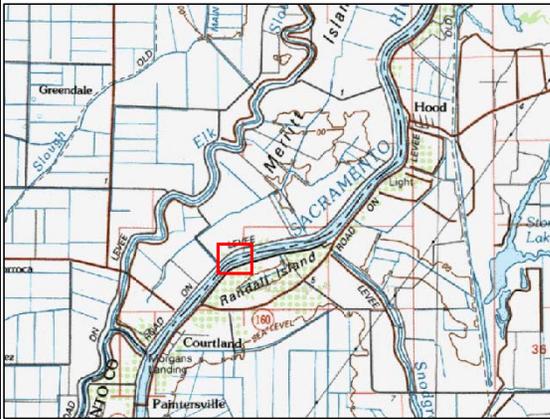
Sacramento River, RM 35.4L

Criteria	Score	Notes
Bank Slope	3	1.5:1 slopes
Berm Width - Estimated	5	no berm
Soil Type	4	sands and silts
Velocity	4	6.5 ft/s
Bank Stability	2	caves
Erosion Hazard	18

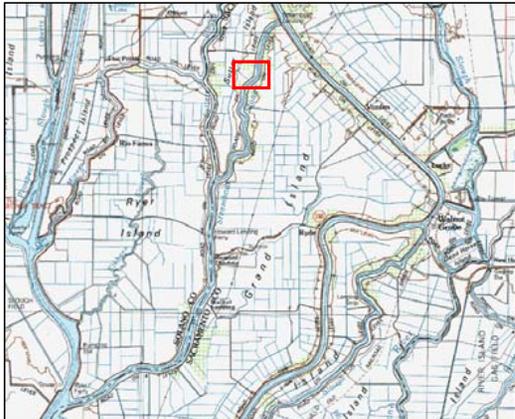
Steamboat Slough, RM 24.7R

Criteria	Score	Notes
Bank Slope	4	1:1 slope
Berm Width - Estimated	3	5 ft
Soil Type	2	clays and silts
Velocity	3	4.7 ft/s
Bank Stability	6	tree hazards and slumping
Erosion Hazard	18

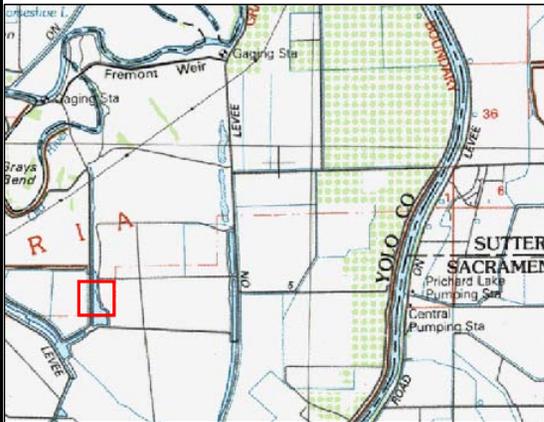
Yolo Bypass, LM 2.5 (DWR Unit 1 West)

Criteria	Score	Notes
Bank Slope	2	2:1 slope
Berm Width - Estimated	5	no berm
Soil Type	4	sands and silts
Velocity	1	1.5 ft/s
Bank Stability	6	tension cracks and slumping
Erosion Hazard	18

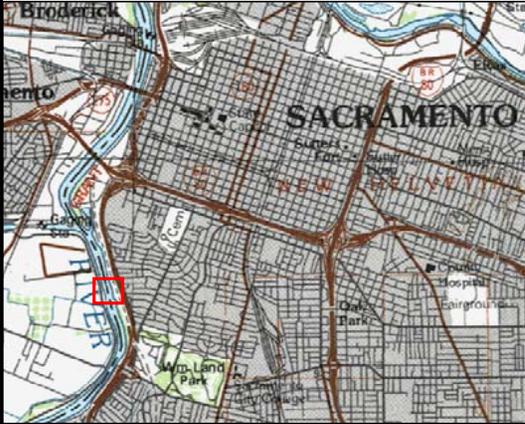
Sacramento River, RM 56.6L

Criteria	Score	Notes
Bank Slope	3	1.5:1 slope
Berm Width - Estimated	0	125 ft
Soil Type	4	sands and silts
Velocity	4	5.1 ft/s
Bank Stability	6	tree hazards and slumping
Erosion Hazard	17

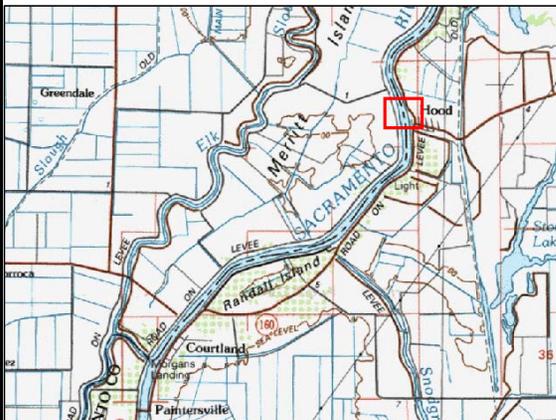
Sacramento River, RM 38.5R

Criteria	Score	Notes
Bank Slope	3	1.5:1 slope
Berm Width - Estimated	4	less than 5 ft
Soil Type	2	clays and silts
Velocity	4	5.5 ft/s
Bank Stability	4	slumping
Erosion Hazard	17

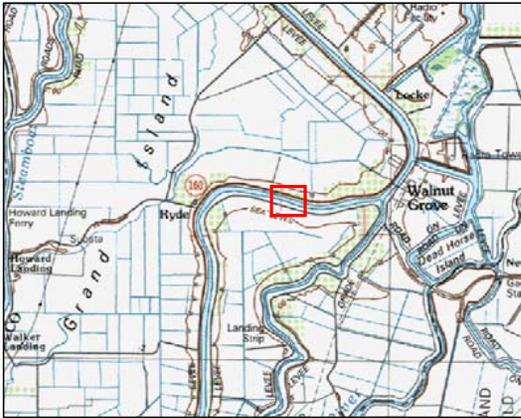
Sacramento River, RM 25.2L

Criteria	Score	Notes
Bank Slope	4	1:1 slope
Berm Width - Estimated	2	10 ft
Soil Type	2	clays and silts
Velocity	3	4.5 ft/s
Bank Stability	6	tree haszards and slumping
Erosion Hazard	17

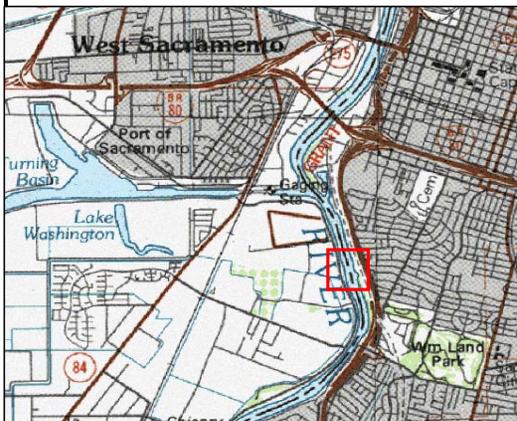
Sacramento River, RM 56.7R

Criteria	Score	Notes
Bank Slope	3	1.5:1 slope
Berm Width - Estimated	0	3 to 40 ft
Soil Type	4	sands and silts
Velocity	3	4.88 ft/s
Bank Stability	6	tree hazards and slumping
Erosion Hazard	16

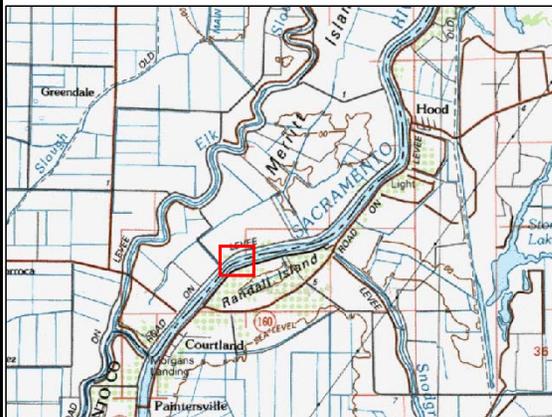
Sacramento River, RM 35.3R

Criteria	Score	Notes
Bank Slope	3	1.5:1 slopes
Berm Width - Estimated	5	no berm
Soil Type	4	sands and silts
Velocity	4	5.9 ft/s
Bank Stability	0	no stability issues
Erosion Hazard	16

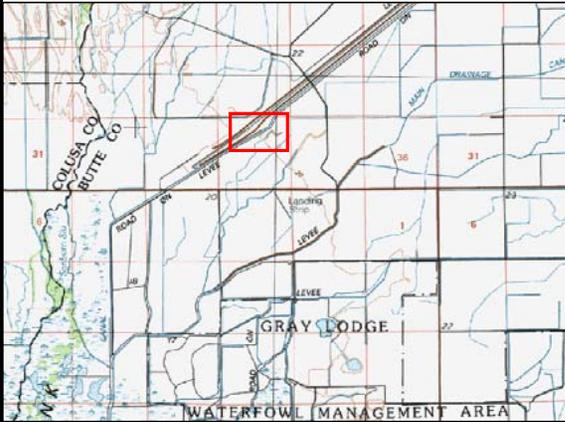
Cherokee Canal LM 21.9 (DWR MA 13 Unit 2 East)

Criteria	Score	Notes
Bank Slope	1	2.5:1 slope
Berm Width - Estimated	5	no berm
Soil Type	2	silts and clays
Velocity	4	6.0 ft/s
Bank Stability	4	slumping
Erosion Hazard	16
