# UNDERWATER INSPECTION AND VELOCITY SURVEY OF THE DOS AMIGOS PUMPING PLANT TRASHRACKS AND FOREBAY

February 21 and 22, 2007

U.S. Bureau of Reclamation  
March 2007

Subject: Underwater Inspection and Velocity Survey of the  
Dos Amigos Pumping Plant Trashracks and Forebay  
February 21 and 22, 2007

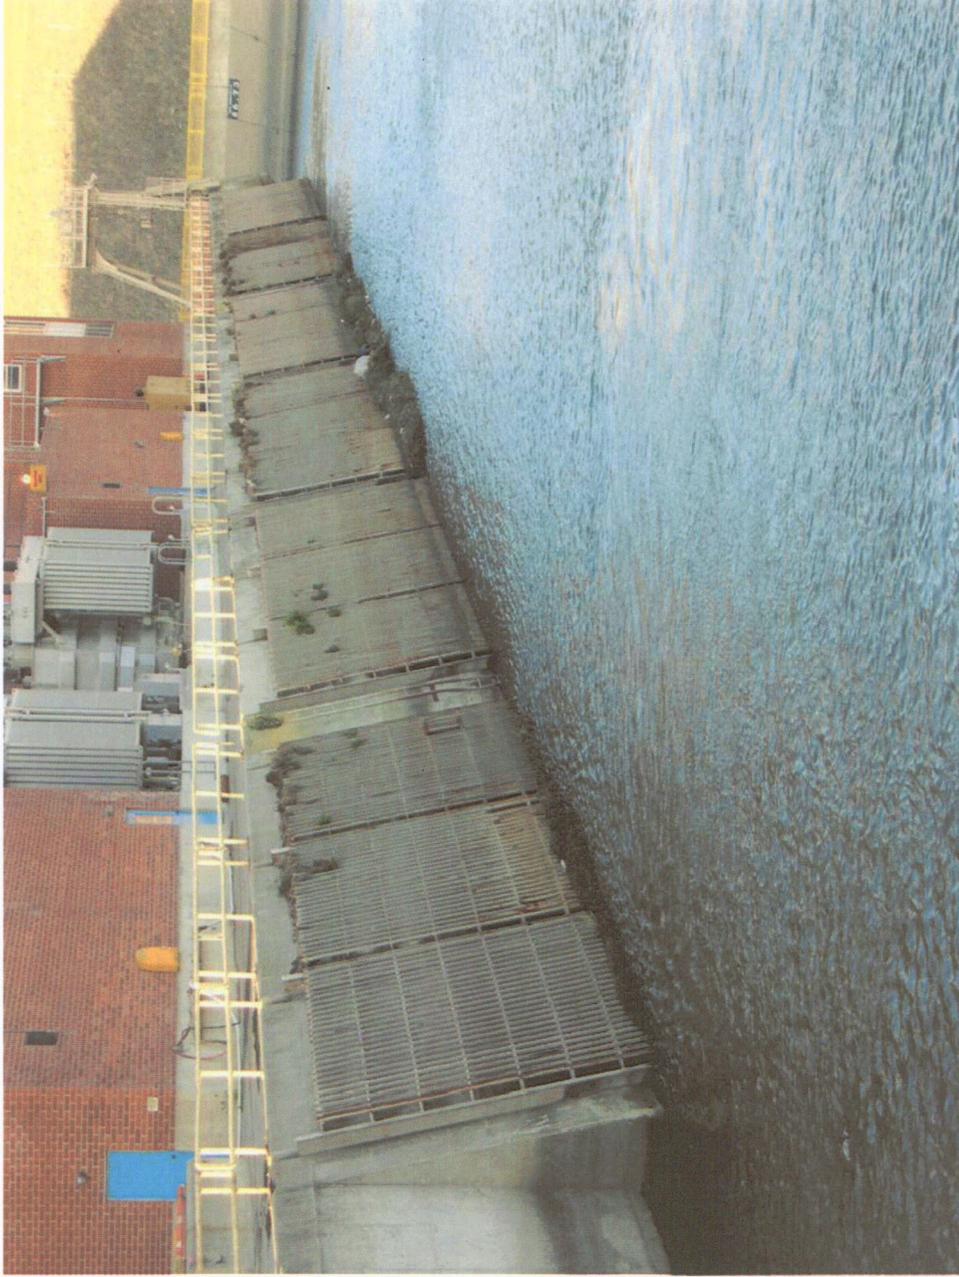
Photo 2

View of the trashracks looking toward canal right (west). Units are numbered 1 to 6 from left to right. Water weed and floating debris has accumulated on the Unit 1, 3 and 4 trashracks indicating that these three units are operating.

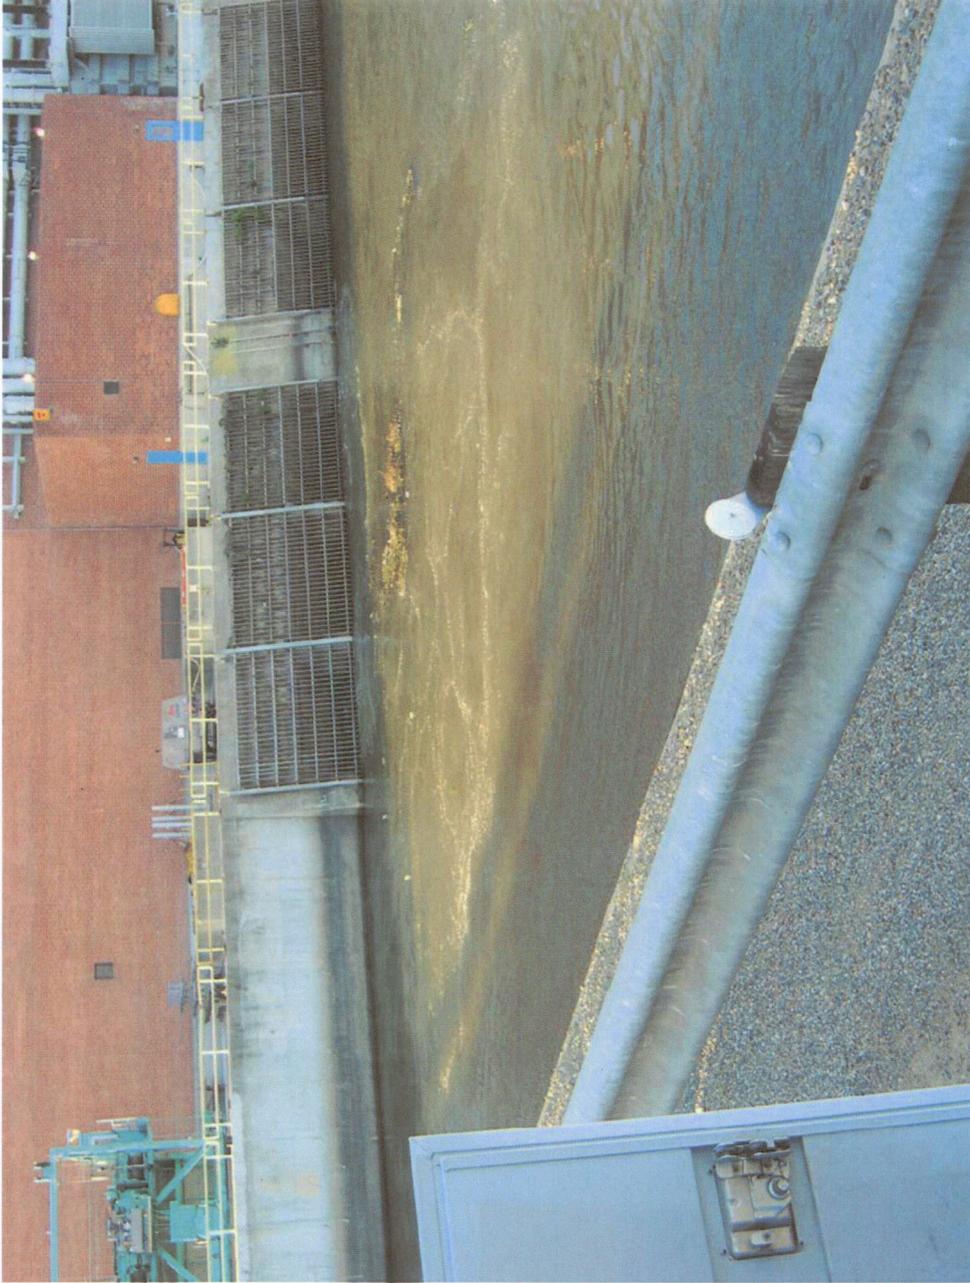
Photo 3

Return surge and clearing of water weed from the Unit 1 trashracks following shut down of the unit.  
February 21, 2007

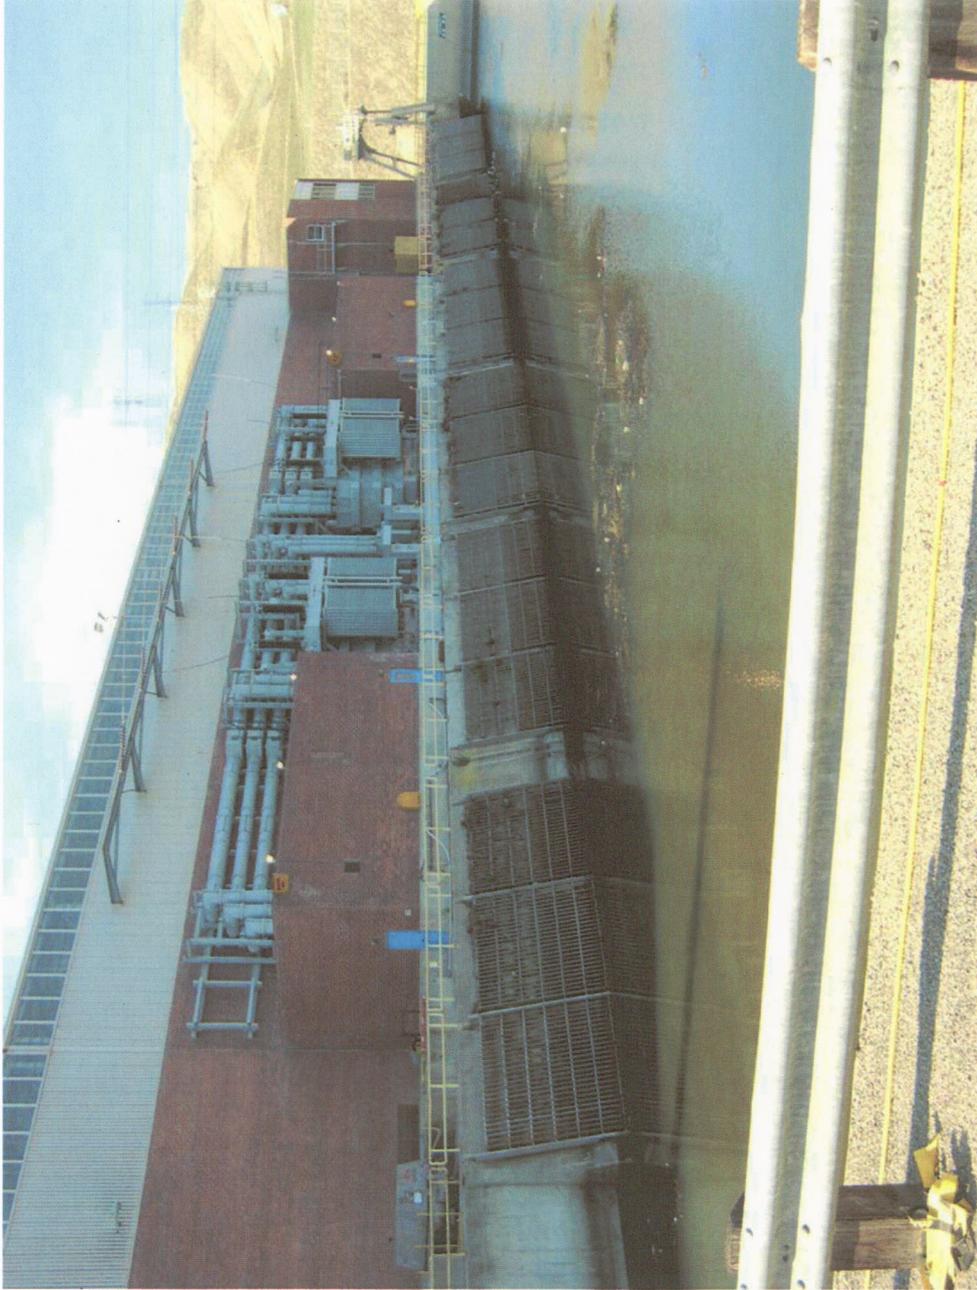
Photo 4

Floating water weed following shut down of Units 1, 3 and 4.

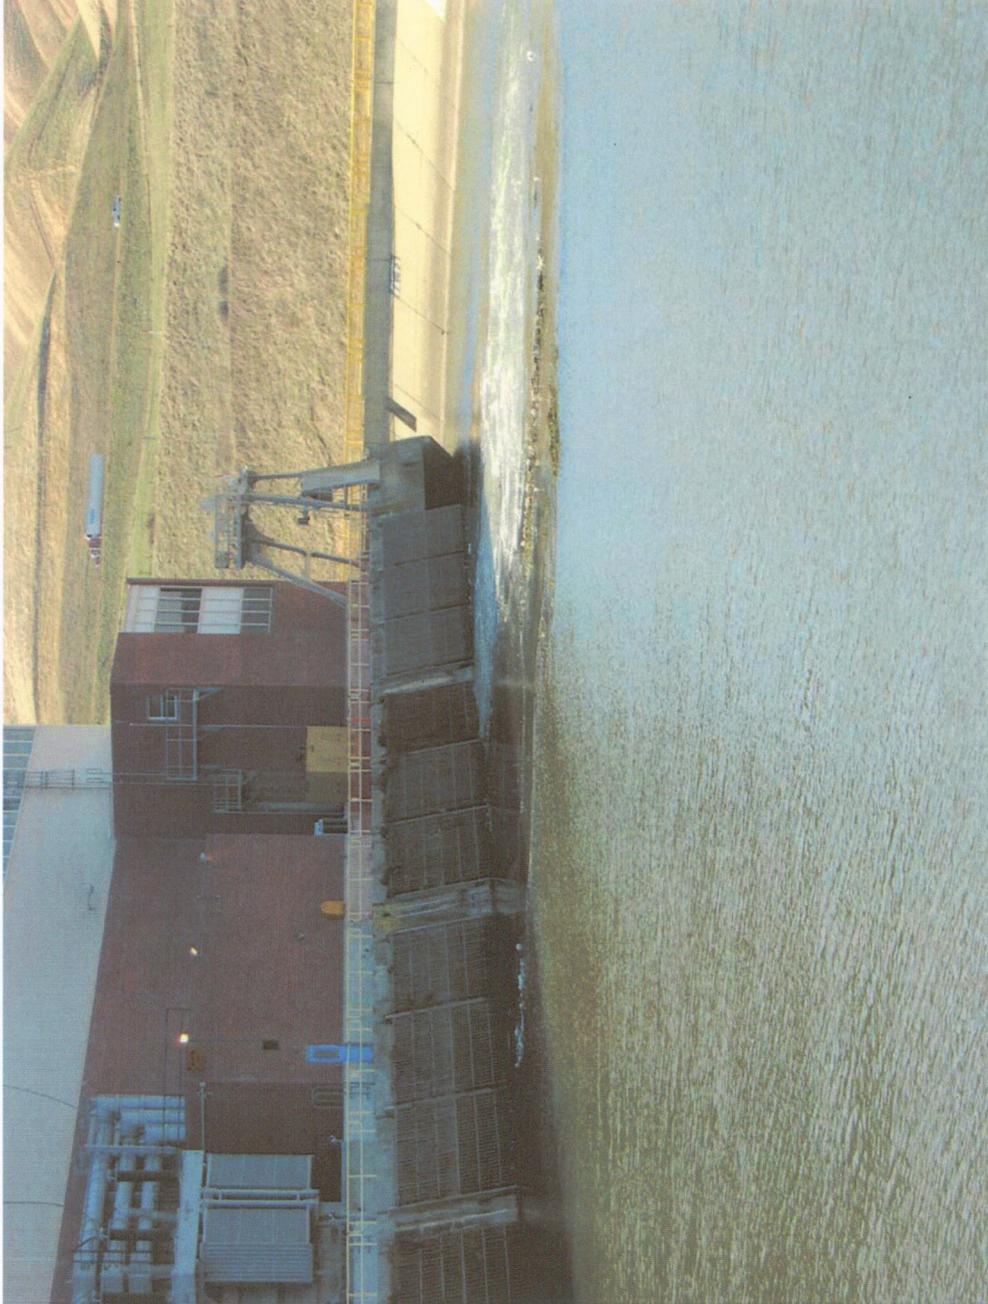
Photo 5

Return surge and clearing of water weed from the Unit 5 trashracks following shut down of the unit at 13:26 in order to free the ROV.  
J. Sturm  
February 21, 2007

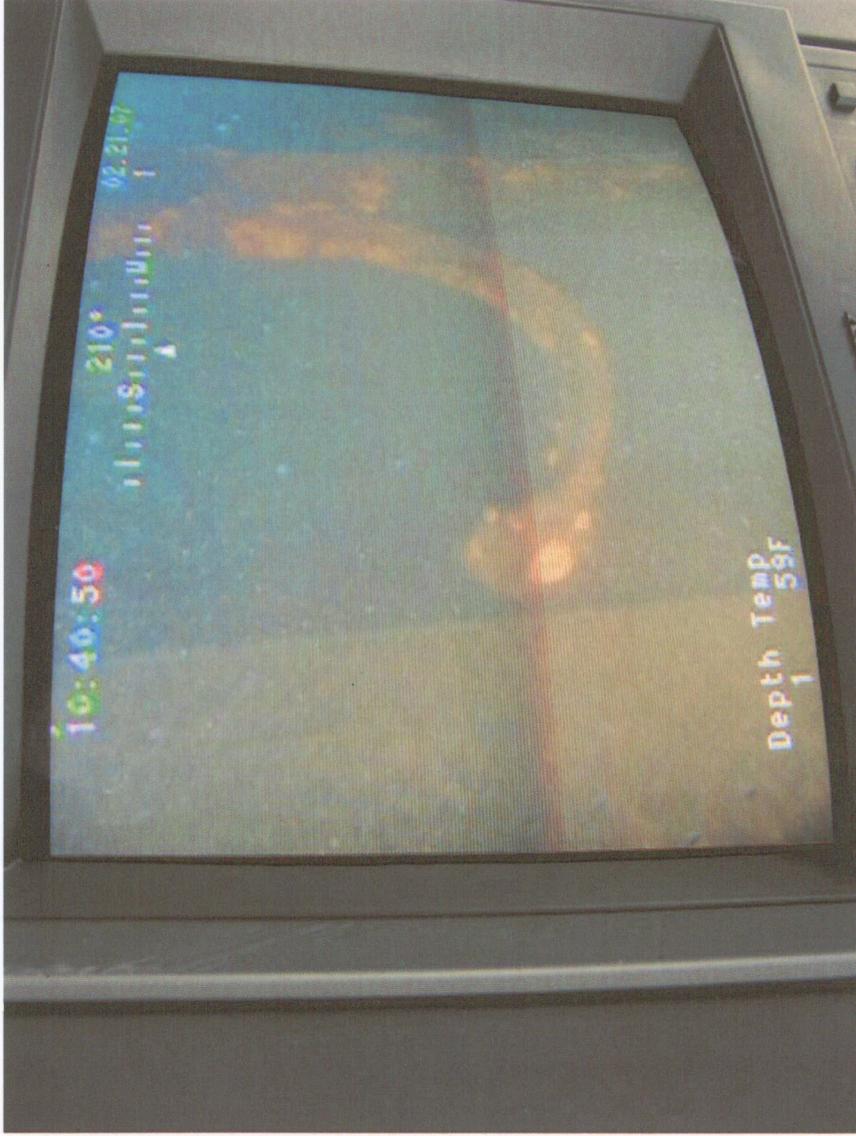
Photo 12.

Video image of minor damage to the Unit 2 trashrack bars at a depth of 1 foot. The bar was probably bent by the excavator used for trash removal.

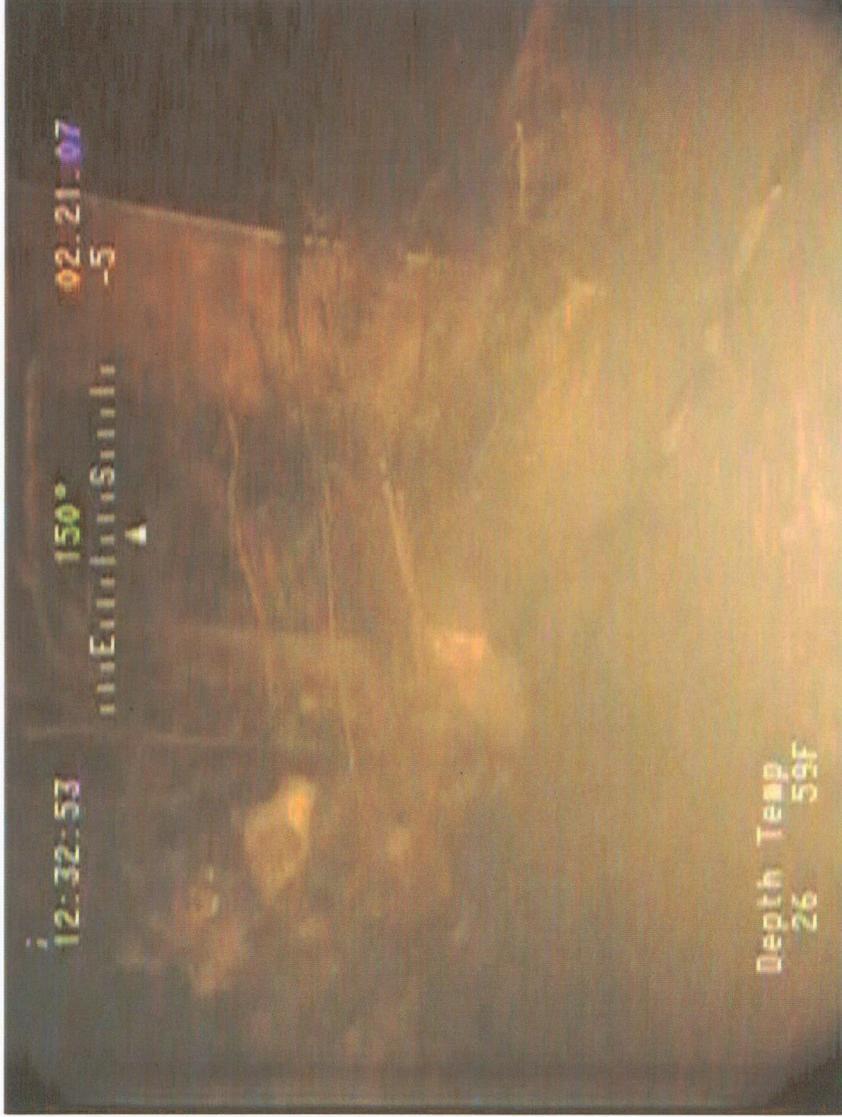
Photo V5.

Video image of the Unit 4 trashrack at a depth of 26 feet at the bottom right corner of trashrack panel C, next to the right trashrack guide (visible in photo) and the Unit 4/5 pier. A moderately strong sweeping current toward Unit 5, the only unit operating, was observed. The information on the screen includes: time (top left), heading (top center), date (top right), depth (feet of sea water, fsw) and water temperature (lower left).

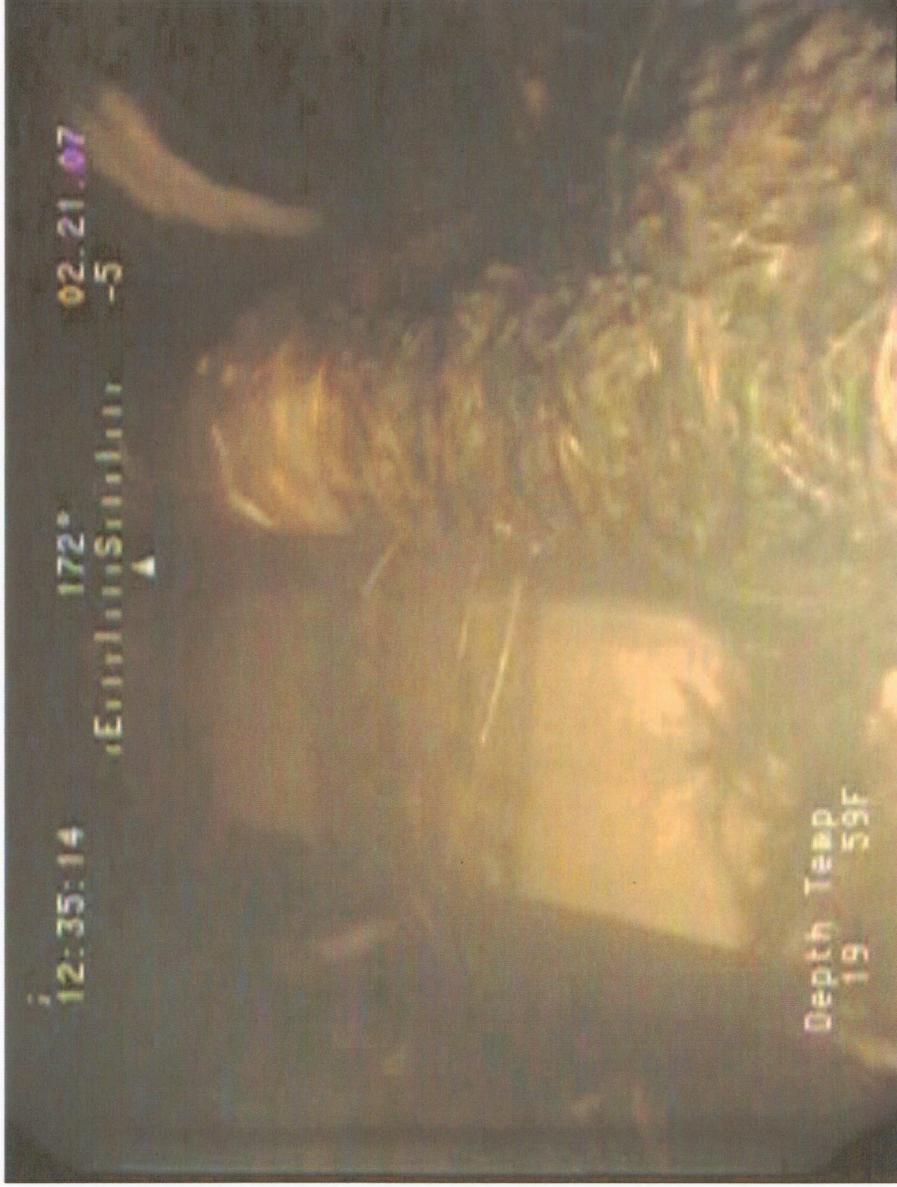
Photo V7.

Video image of the Unit 5 trashrack and guide at a depth of 19 feet. Very high velocity flow was observed at this location. The information on the screen includes: time (top left), heading (top center), date (top right), depth (feet of sea water, fsw) and water temperature (lower left).

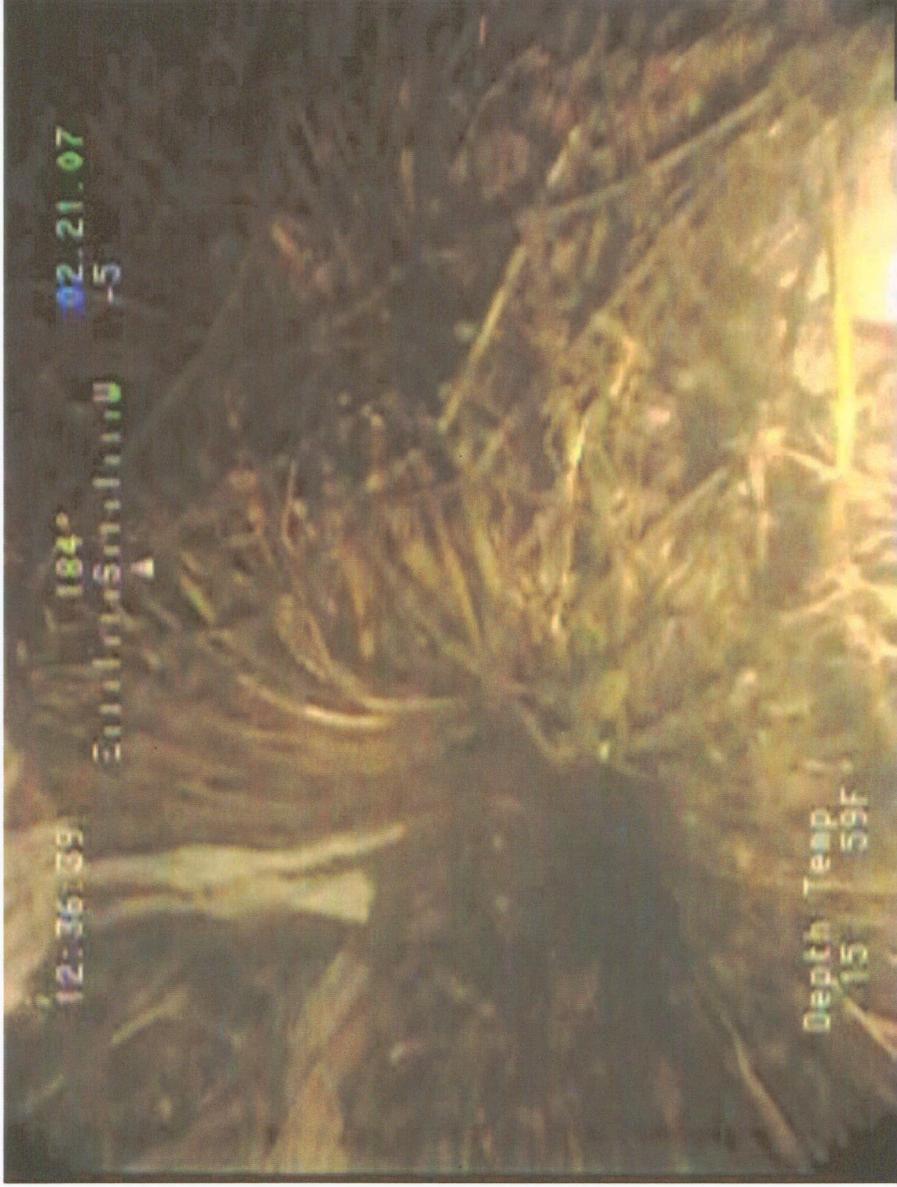
Photo V8.

Video image of the Unit 5 trashrack at a depth of 15 feet showing a "window" or hole through the dense water weed mat where very high velocity flow was observed. The information on the screen includes: time (top left), heading (top center), date (top right), depth (feet of sea water, fsw) and water temperature (lower left).

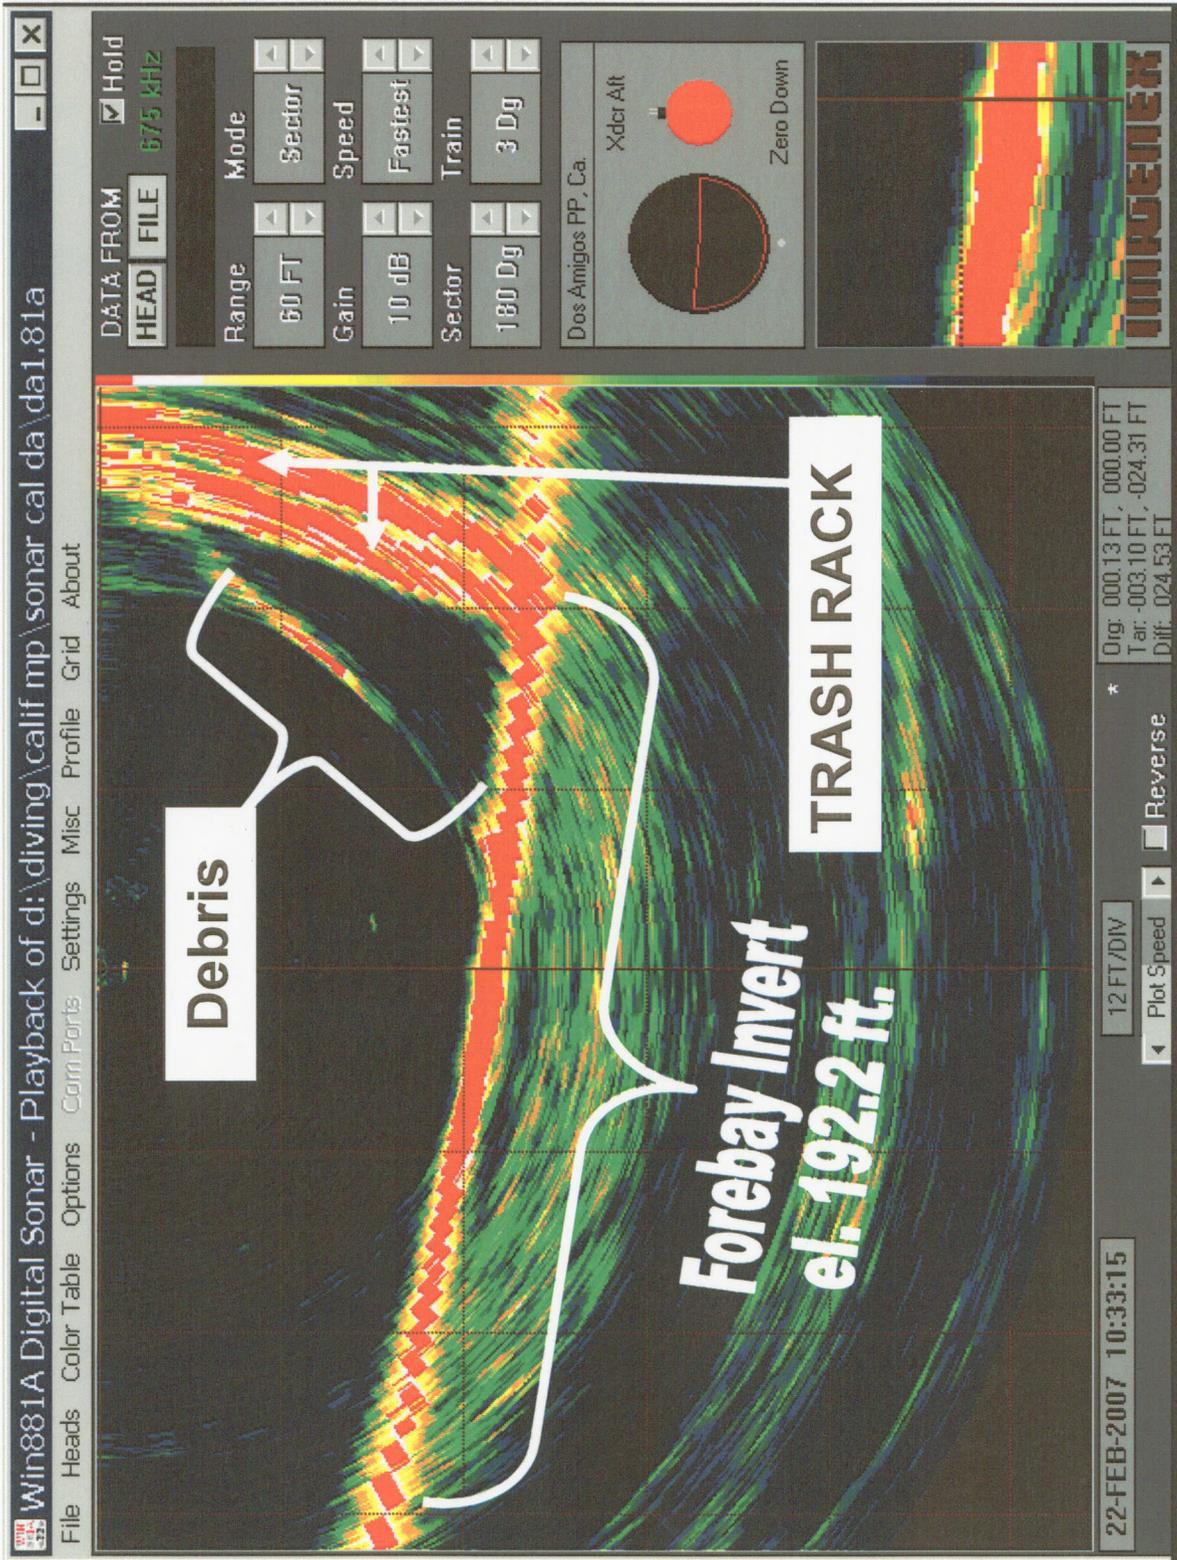
**FIGURE 1. Sonar Cross-Section of Trashracks and Forebay Invert**  
 Sonar image looking east at the trashracks and forebay invert upstream of a non-operating unit. The conditions shown are typical of all non-operating units. Debris is limited to a small "wedge" of water weed at the base of the trashracks. The forebay invert is horizontal. The apparent slope of the forebay invert is due to the angle of the sonar head on the ROV.

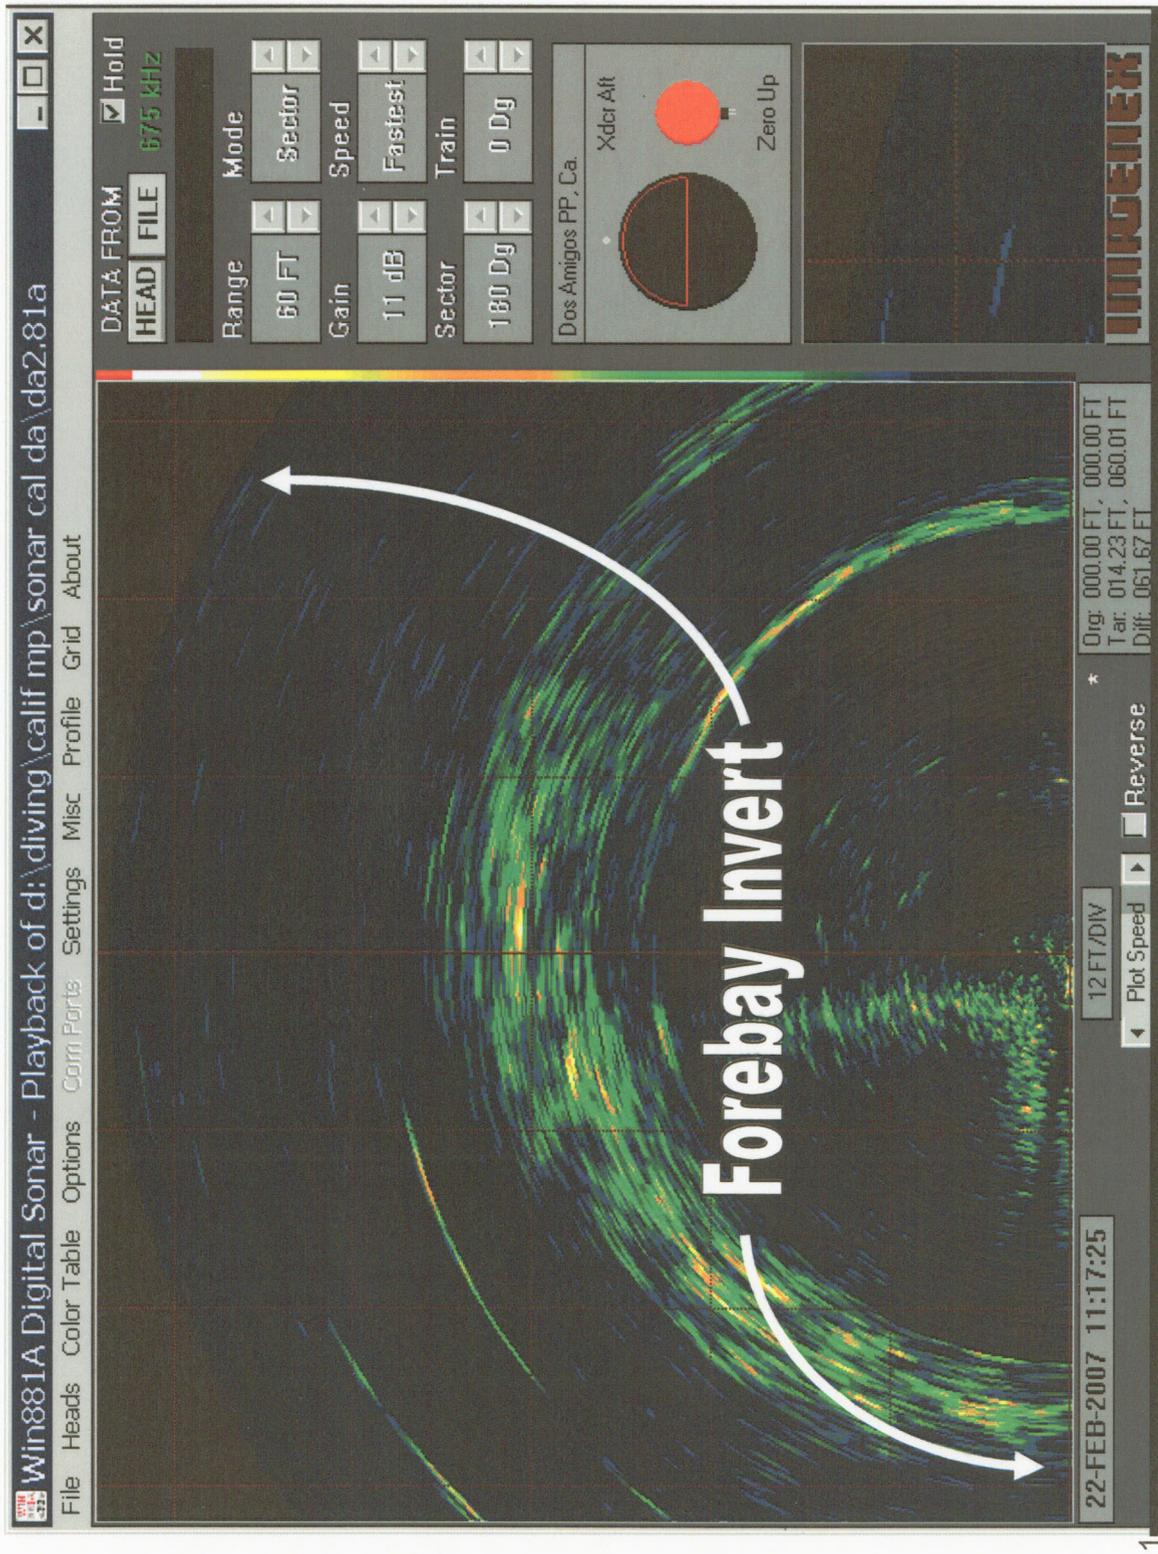
**FIGURE 2. Sonar Image of the Forebay Invert.**  
 Minor scattered debris or areas of rough concrete are evident as yellow, orange or red areas. No major debris is evident.

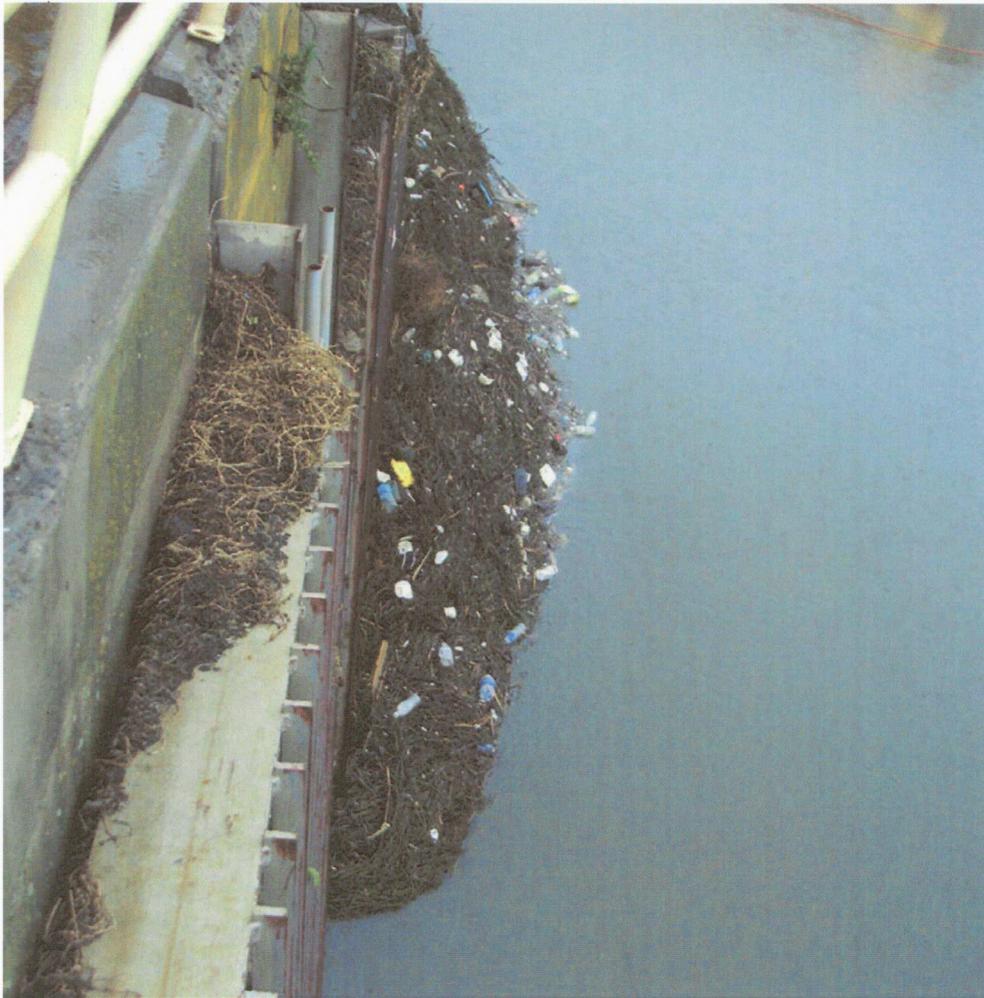
would then migrate toward the operating unit(s). The back flow appeared to effectively remove all surface debris that had accumulated. It usually took about one hour for most of the available aquatic debris to accumulate on the Unit 5 trash racks (figure 2).

Figure 2. View of aquatic debris and trash accumulated on the Unit 5 trash rack. This photograph was taken on February 22, 2007, at 10:00 a.m.

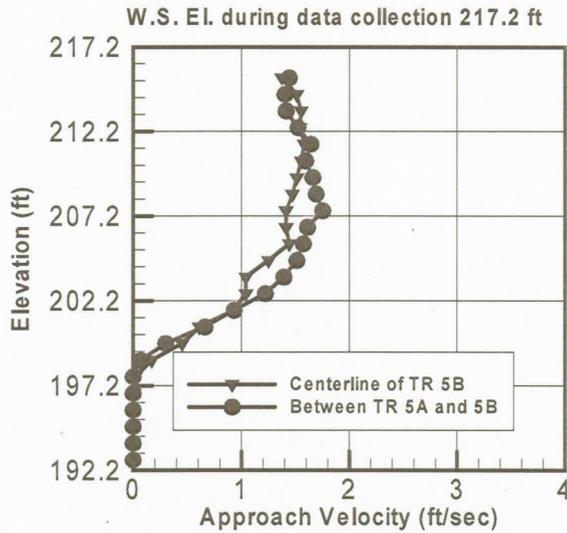
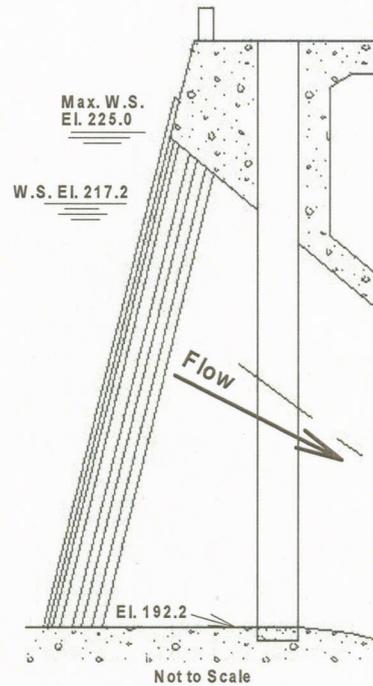
Figures 6 and 7 contain the approach velocity profiles that were measured at positions located 24, 14, 9, and 2 ft upstream from the base of the Unit 5 trash racks. Figure 6 shows two profiles collected along the centerline of rack 5B and between racks 5A and 5B. The two profiles agree very closely. The highest approach velocities occurred between depths of 5 and 10 ft. It was observed by the ROV that there were higher velocities along the vertical edges of the trash rack panels because there was less debris accumulation. This observation was the rationale for moving the Q-Liner from the centerline of rack 5B to the location between panels 5A and 5B. The slightly higher approach velocities for the location between 5A and 5B support this observation.

Figure 6. Approach velocity profiles collected by the Q-Liner 24 ft upstream from the base of trash rack 5B and between racks 5A and 5B. **prof24ftUS.wmf**

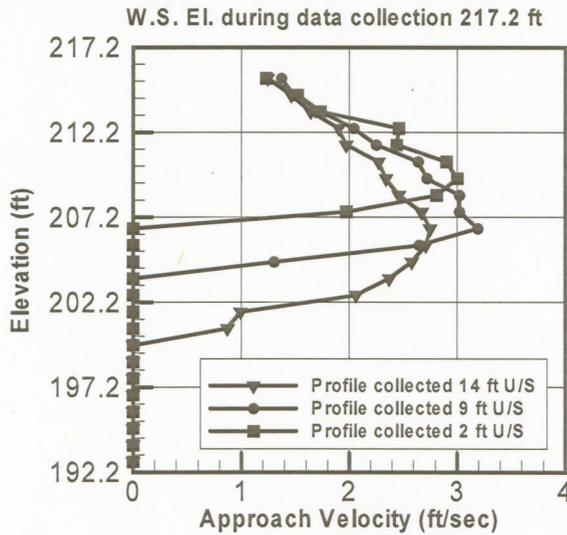
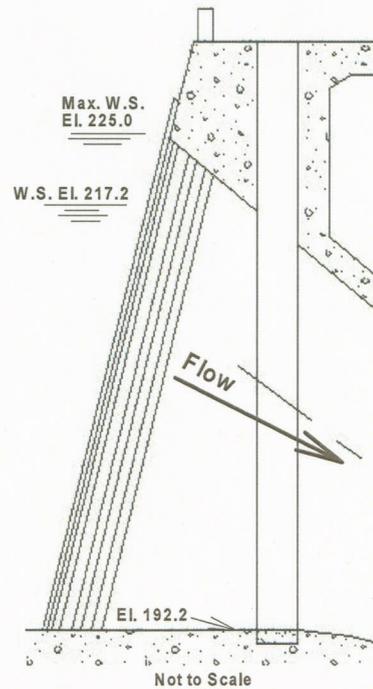
Note on figure 7 how the velocity profiles are truncated ( $V=0$ ) below where the aft acoustic beam hits a trash rack or concrete pier.

Figure 7. Approach velocity profiles collected by the Q-Liner at three distances upstream from pier between racks 5A and 5B. **ProfBtw5A&5B.wmf**
