## DWR Statement Regarding Independent Forensic Team Memo

# Memorandum

**To:** Mr. Paul Dunlap, California Department of Water Resources  
**From:** Oroville Dam Spillway Incident Independent Forensic Team  
**Date:** September 5, 2017  
**Re:** Interim Status Memorandum

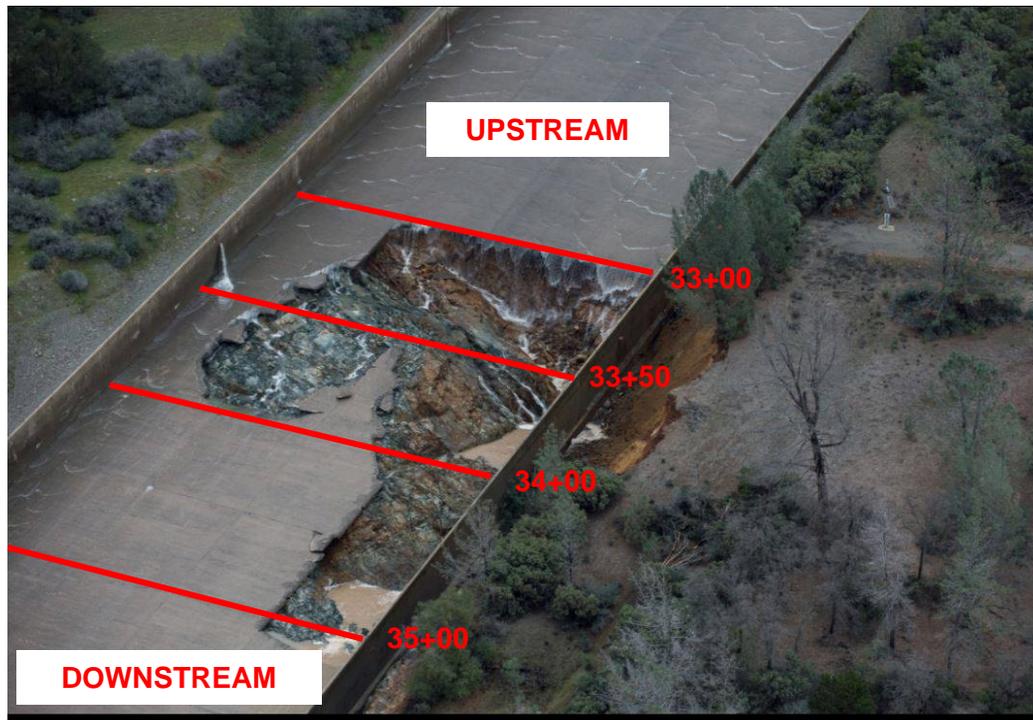
**Update on Initiating Event of Service Spillway Chute Failure** – The IFT believes that the service spillway chute failure most likely initiated by the uplift and removal of a section of the slab in the chute downstream of Station 33+50 at shortly after 10:00 am on February 7. Once the initial section of the chute slab was removed, the underlying moderately to highly weathered rock and soil-like material beneath the slab in this location was directly exposed to high-velocity spillway flow. The high-velocity flow rapidly eroded the foundation materials at this location, removed additional chute slab sections in both upstream and downstream directions, and quickly created the erosion hole that was observed by 12:30 pm on February 7, as flows diminished following spillway gate closure – see photo below. These findings are based on eyewitness accounts, and photo and video records.

Since all physical evidence at the point where the failure initiated was destroyed, it will never be possible to confirm exactly where the initiating event occurred. Others have suggested that the uplift initiated at Station 33+00 (see photo above). However, the IFT has concluded that, although there may have been water injection along the Station 33+00 joint, that was almost certainly not the location of the initial failure. Had the failure initiated along that joint, the concrete keys at the joint would have been damaged, and this was not observed when the spillway gates were closed, and the eroded hole was inspected on February 8 by a climb team engaged by DWR. The slab section downstream of the joint at that location could not have lifted without shearing the concrete key in the upstream slab section, and this condition was not observed in the photos and videos taken by the climb team, which were carefully reviewed by the IFT.
