State of California
THE RESOURCES AGENCY
Department of Water Resources

BULLETIN No. 116-5

THE ALASKAN EARTHQUAKE

OCTOBER 1965

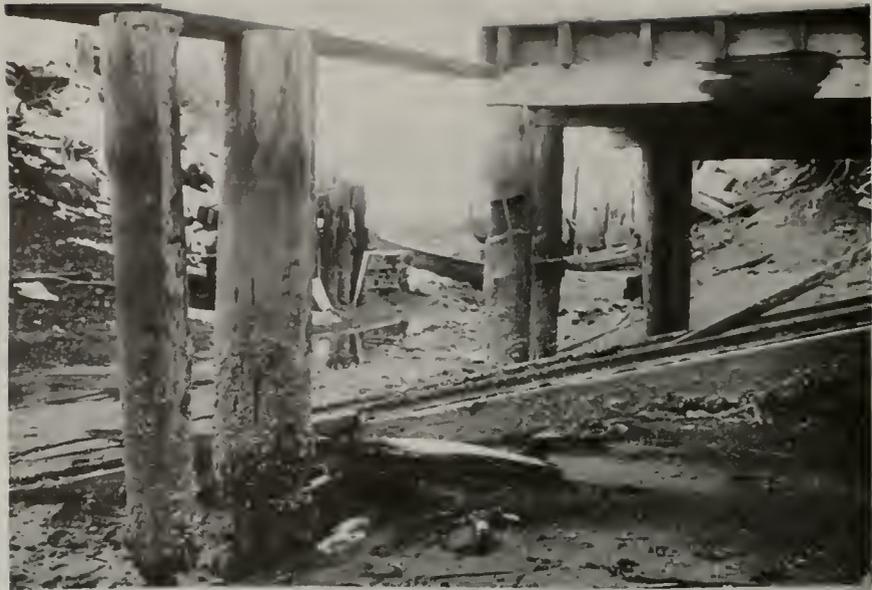
Illustration 1. Inlet to small boat harbor at Cordova. Picture was taken at high tide and shows result of tectonic uplift on coastal communities.

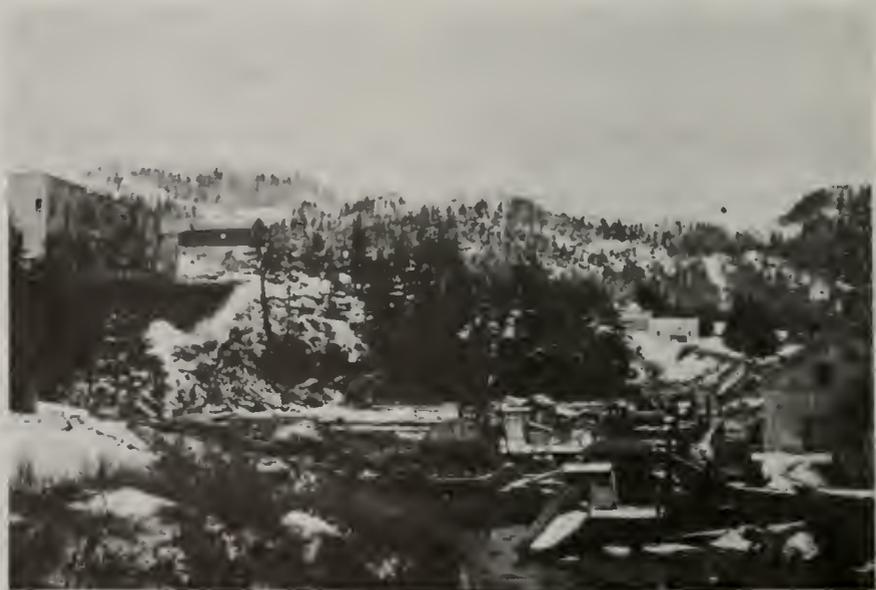
Illustration 2. Inner harbor at Cordova during high tide.

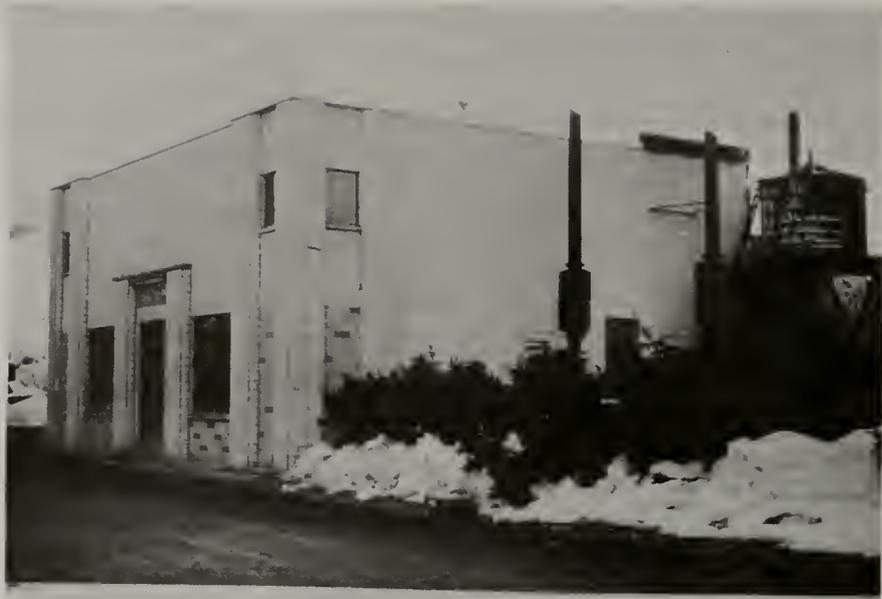
Illustration 3. Meals building in Valdez (power plant). No damage.

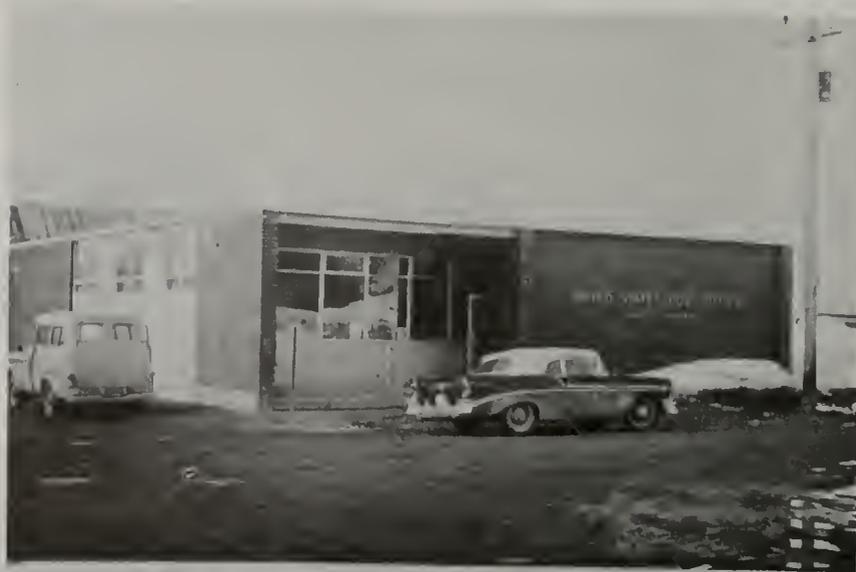
Illustration 4. Post Office in Valdez. No damage.

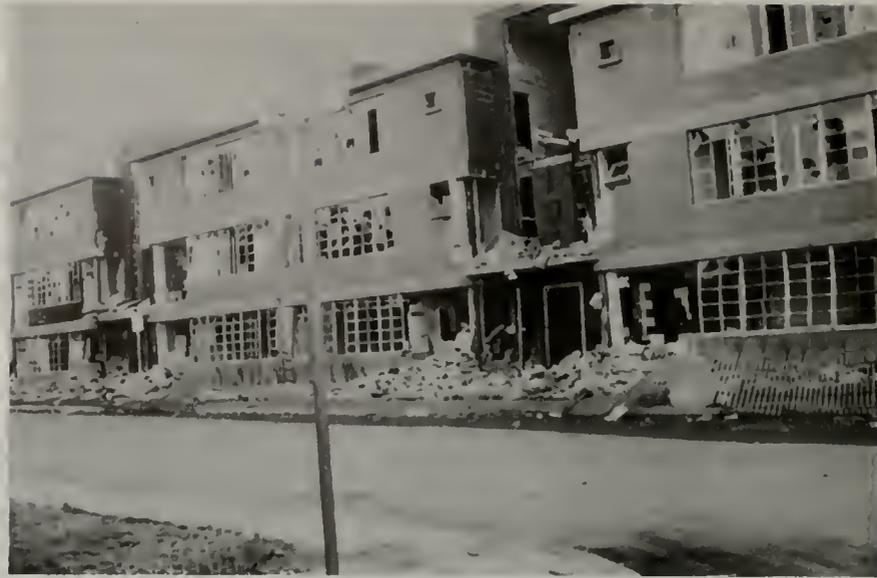
Hollow concrete block was a common building material used for commercial and industrial structures as well as apartment houses. Much earthquake damage occurred to structures using this type of construction material, because (1) as shown in Illustration 5, there was insufficient reinforcement, or no reinforcement at all to resist seismic forces, and (2) there was insufficient overlap of reinforcement steel to transfer stresses from one bar to another.

Illustration 5. An apartment building in Anchorage constructed mainly of hollow blocks. The damaged blocks showed apparent lack of reinforcement to resist lateral deflections.

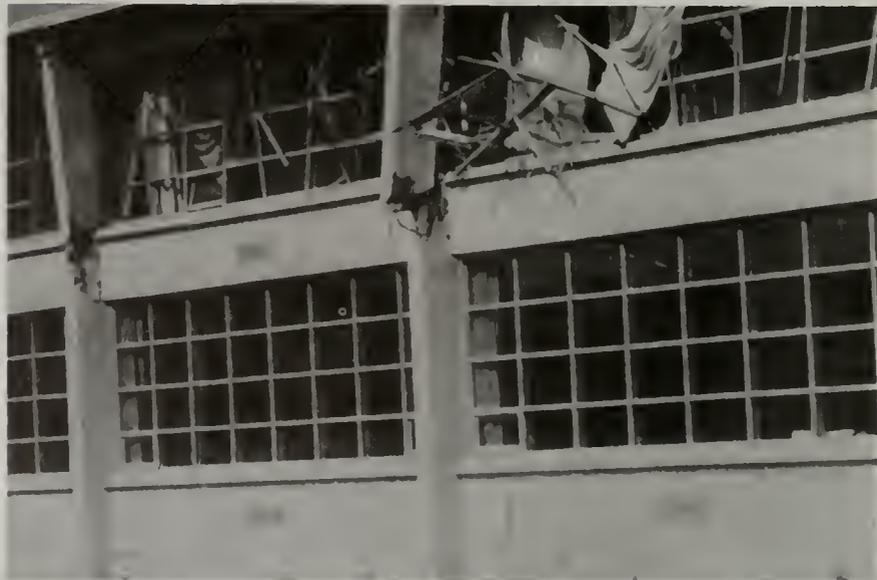
Illustration 6. Structural failures due to insufficient reinforcement steel and concrete area.

critical areas. Some column failures indicated columns were inadequately designed for compressive strength and had insufficient reinforcement or concrete area.

In other instances, lack of reinforcement and concrete area in column connections to floorings or roofs did not permit the columns to transfer the moments or shear structurally, resulting in fractured columns. This type of failure occurred at the West Anchorage High School. Illustration 6 shows failures resulting from insufficient reinforcement steel and concrete to resist the lateral shear forces.

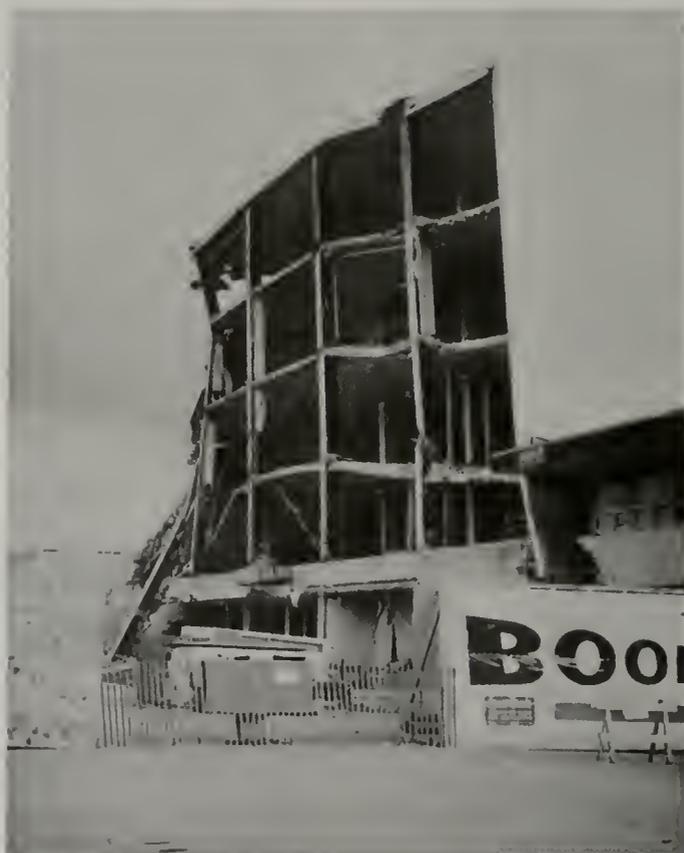
In the J. C. Penney Building, precast panels were connected to the steel frame as an exterior wall. During the earthquake, connections between these panels and the steel frame failed when they could no longer restrain the deflections of the frame. This failure was due to the difference in relative stiffness of the two elements and the error in designing the structure to act as a homogenous system to resist lateral forces dynamically. See Illustration 7.

Illustration 7. The J. C. Penney building
in Anchorage.

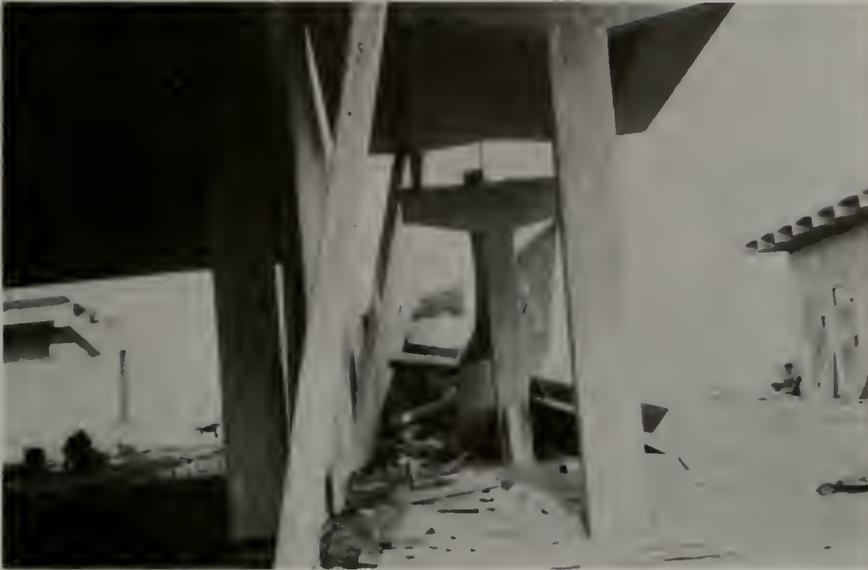
Another type of design failure resulted from inadequate connections between precast elements. A good example was the Alaska Sales and Service Building which was constructed of precast panel walls, and precast "T" beam roof resting on precast reinforced concrete bents. Interconnections between the precast elements were made by means of welded metal connections. After the earthquake, investigations showed that the connections failed causing the walls to collapse or tilt out of plumb. See Illustrations 8 and 9.

Illustration 8. Connection failure of precast members resulting in separation of wall from roof.

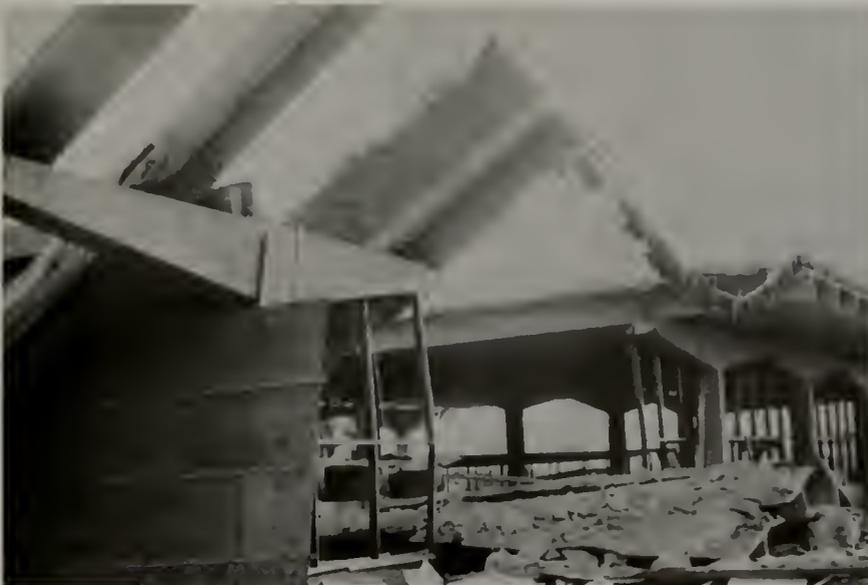
Illustration 9. The Alaska Sales and Service Building in Anchorage is a good example of damage resulting from defective connections in precast concrete construction.

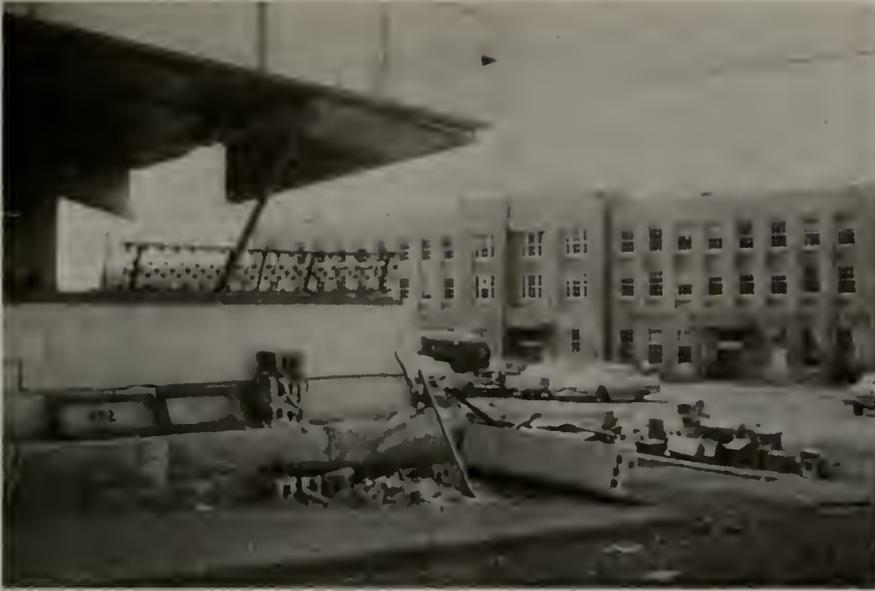
It is obvious that no matter how well a structure is designed by the engineer, his efforts will be wasted if the structure is not built according to his plans and specifications. Hollow concrete block construction, which was a common material used in structures in Anchorage, suffered greatly from failures that were attributed to faulty construction.

Illustration 10. Hollow concrete blocks showing lack of grout in cells.

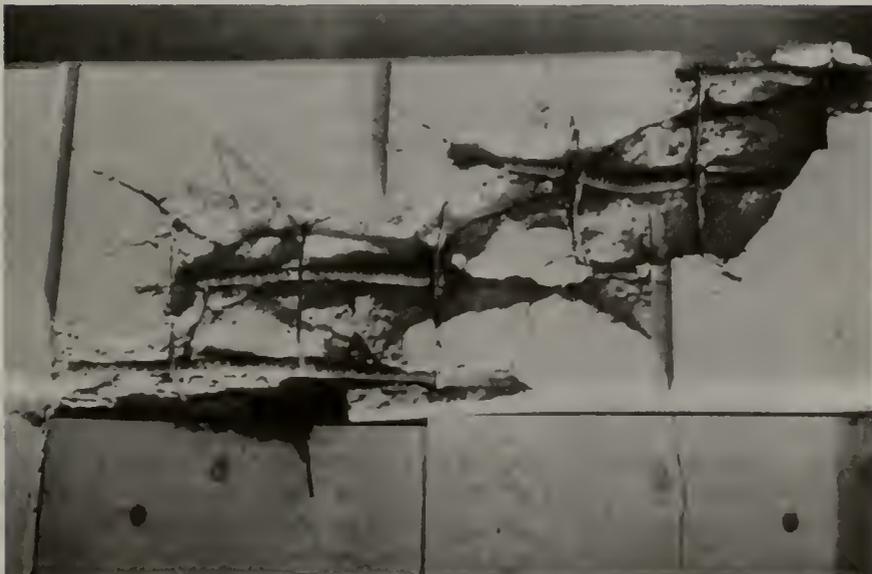
Improper concrete mix in some reinforced concrete structures resulted in the concrete possessing inadequate compressive strength. Failure occurred when the concrete could no longer withstand the loads resulting from the vibration and causing the concrete to bulge out or "mush out" in a manner similar to column failures resulting from insufficient ties. The plasticity of the concrete caused the tremendous load to be transferred to the reinforcement steel, resulting in a bending failure of reinforcement. An example (showing column buckling of reinforcement steel) is shown in Illustration 11.

Illustration 11. Compression failure due to inability of reinforcement to sustain transferred load resulting from plastic flow of concrete.

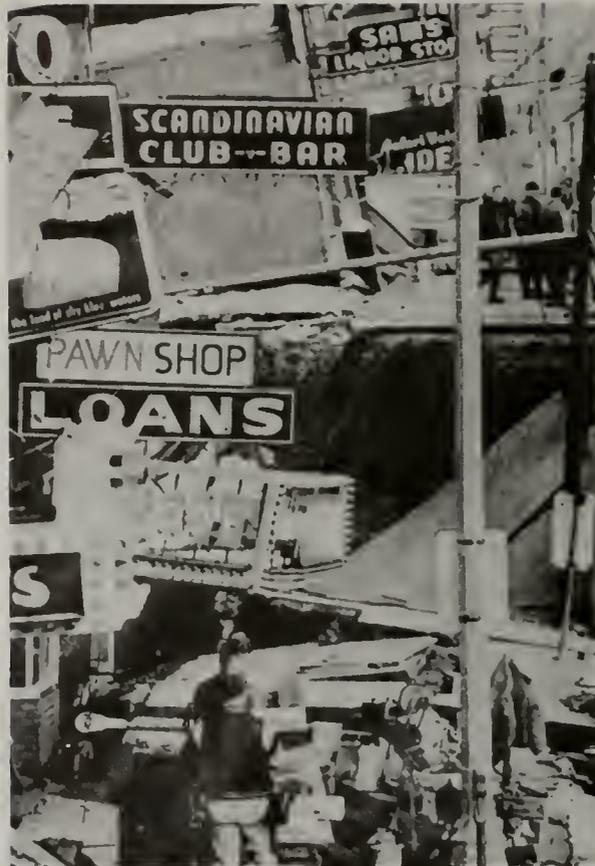
The city of Anchorage is on a plain comprised of glacial outwash material carried down from the high, rugged, Chugach Mountains. Under the city these outwash materials are called the Naptowne outwash, a series of dense sand and gravel deposits, which cover the underlying Bootlegger Cove formation comprised of clay, silt, and fine sand. Soil failures starting within the Bootlegger Cove formation caused most of the Anchorage slides.

Illustration 12. Fourth Avenue landslide in Anchorage.

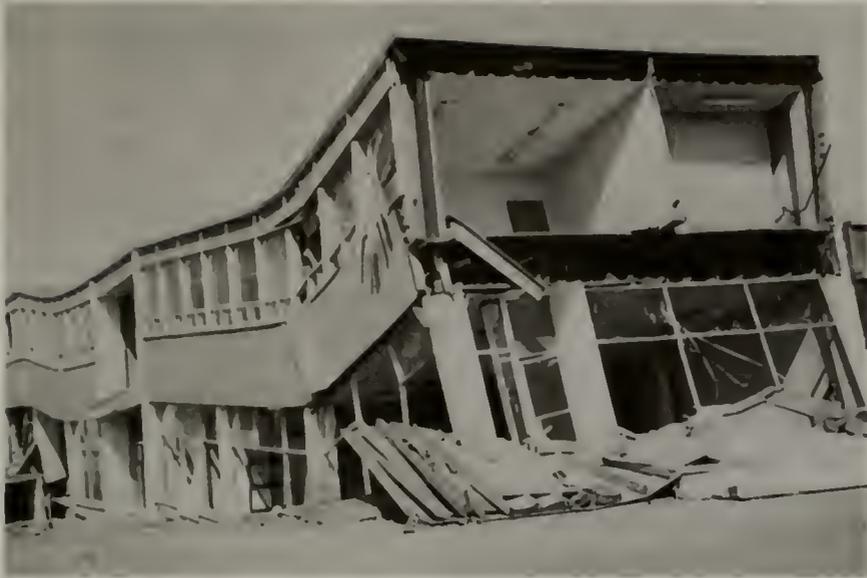
Illustration 13. Building damaged by movement of foundation.

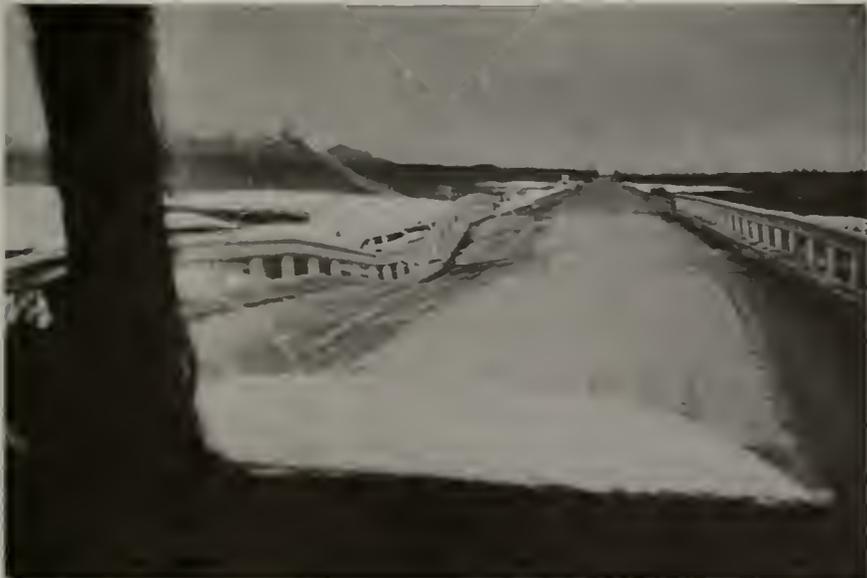
Illustration 14. Sag in highway fill near Cordova.

Damage from settlement of poorly consolidated glacial outwash and other types of alluvial materials were noted in a number of areas. The Copper River highway which traverses approximately 14 miles of bay mud and muskeg near the town of Cordova suffered much damage from settlement and lurching of highway fills on these poor foundation materials. Structures of the Eklutna Project were damaged by settlement of alluvial materials. Settlement of soil combined with tectonic subsidence lowered the seaport town of Homer Spit, causing inundation by the sea, and caused about 5 miles of the Alaskan Railroad to be inundated in the vicinity of Turnagain Arm.
