# Banks Organic Carbon

# Banks Pumping

### Gianelli Organic Carbon and Pumping/Generating:

## Jones organic carbon and pumping

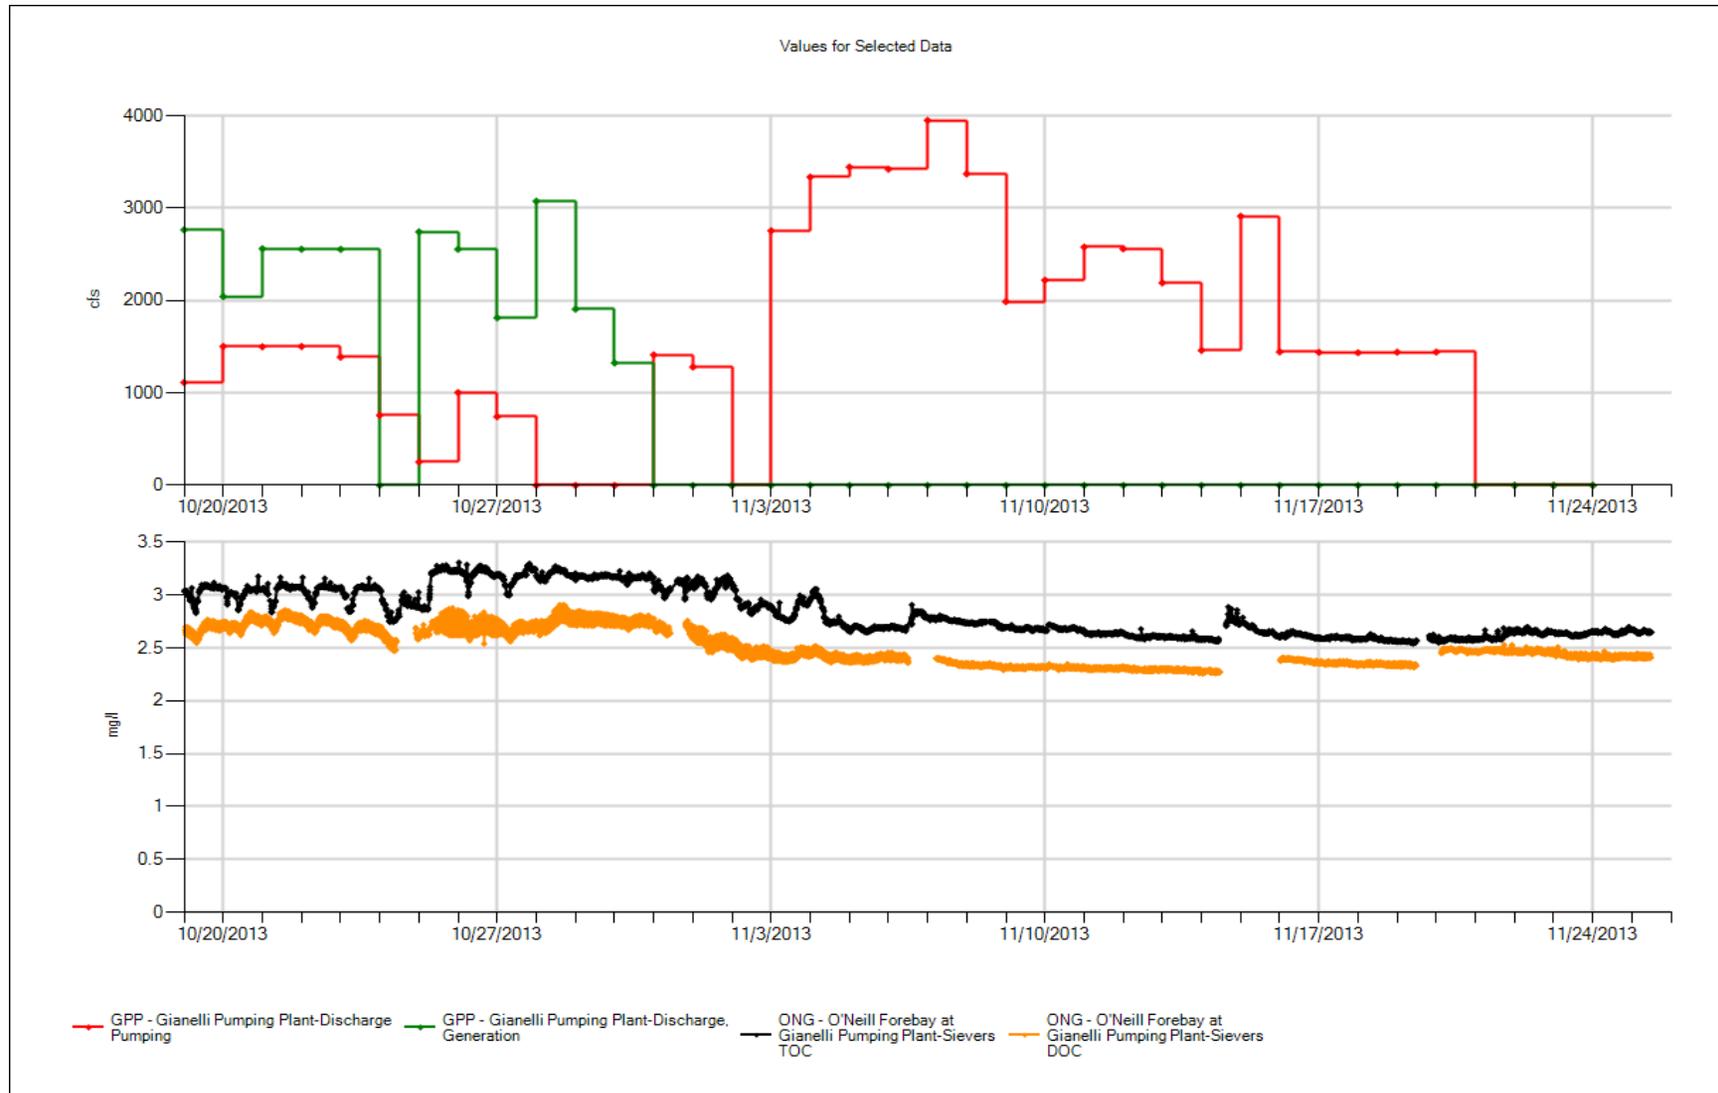
### Gianelli Significant Sievers Events: Oct 19, 2013 – Nov 25, 2013

- Cleaned the ICS degasser on 11/6 which helped clear up some of the variability in prior samples.

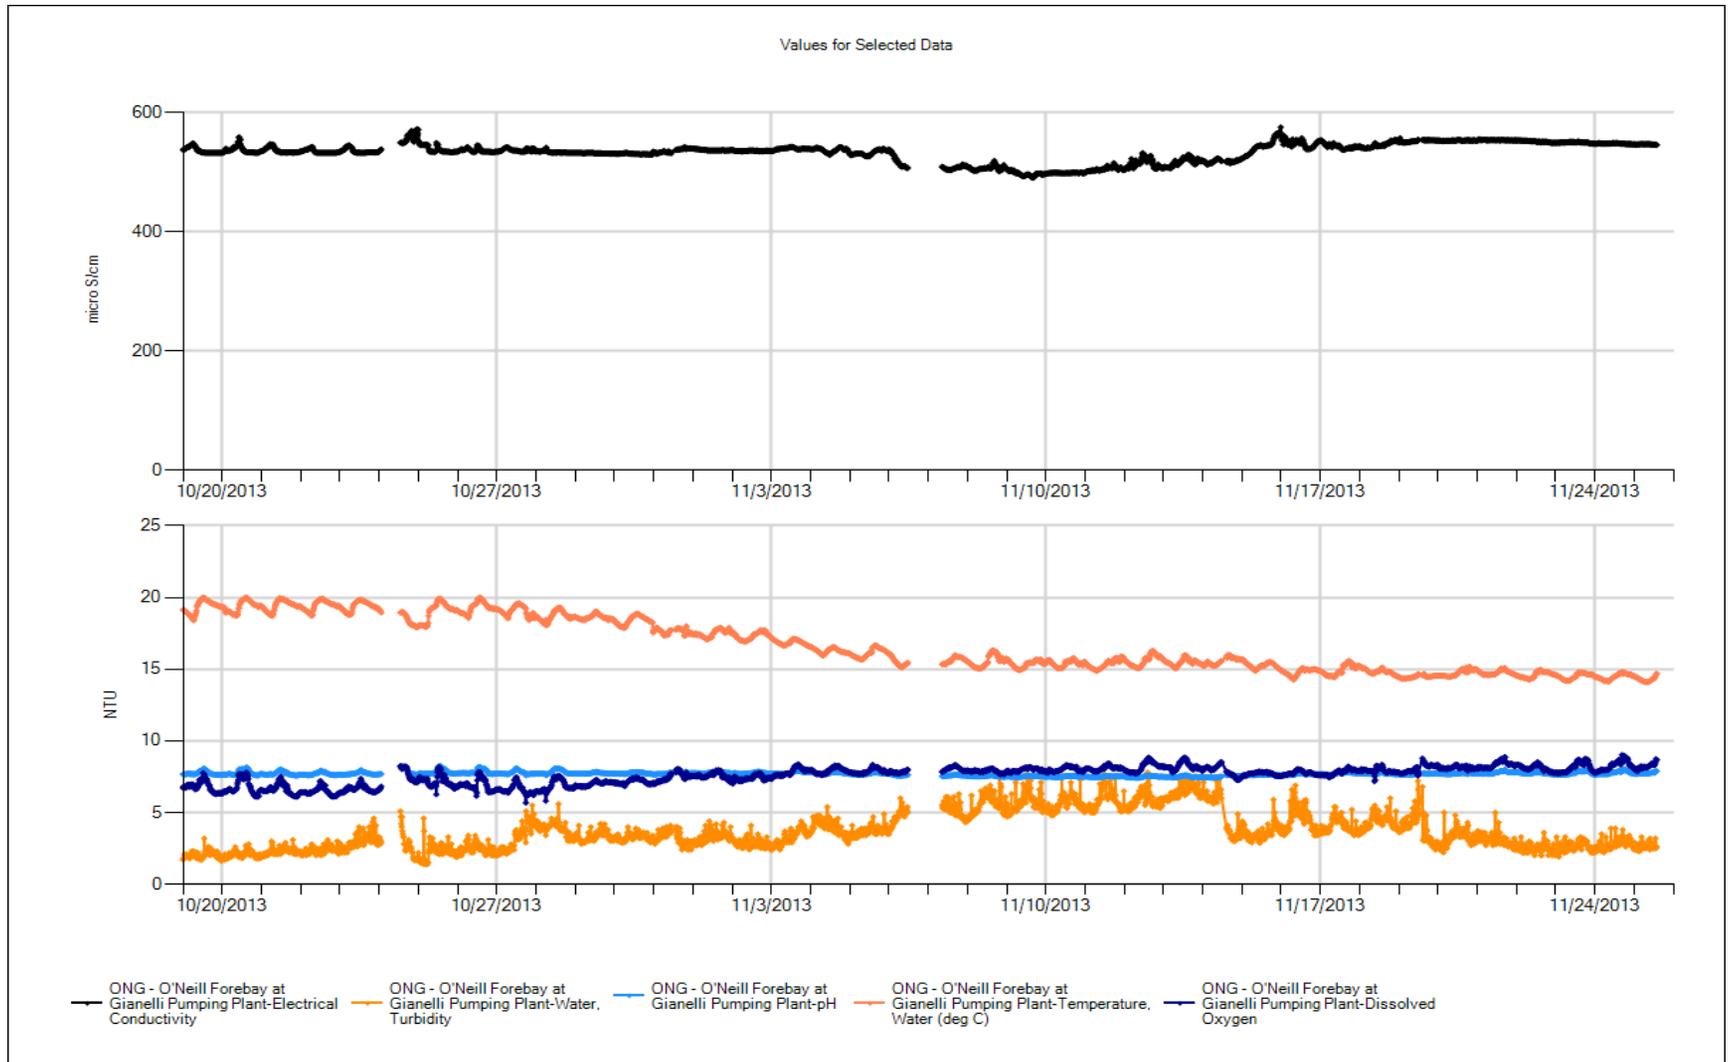
Gianelli Sonde (EC, DO, Temp, Turbidity, pH):

**Gianelli Significant Sonde Events: Oct 19, 2013 – Nov 25, 2013**

- Calibrated on 10/24.

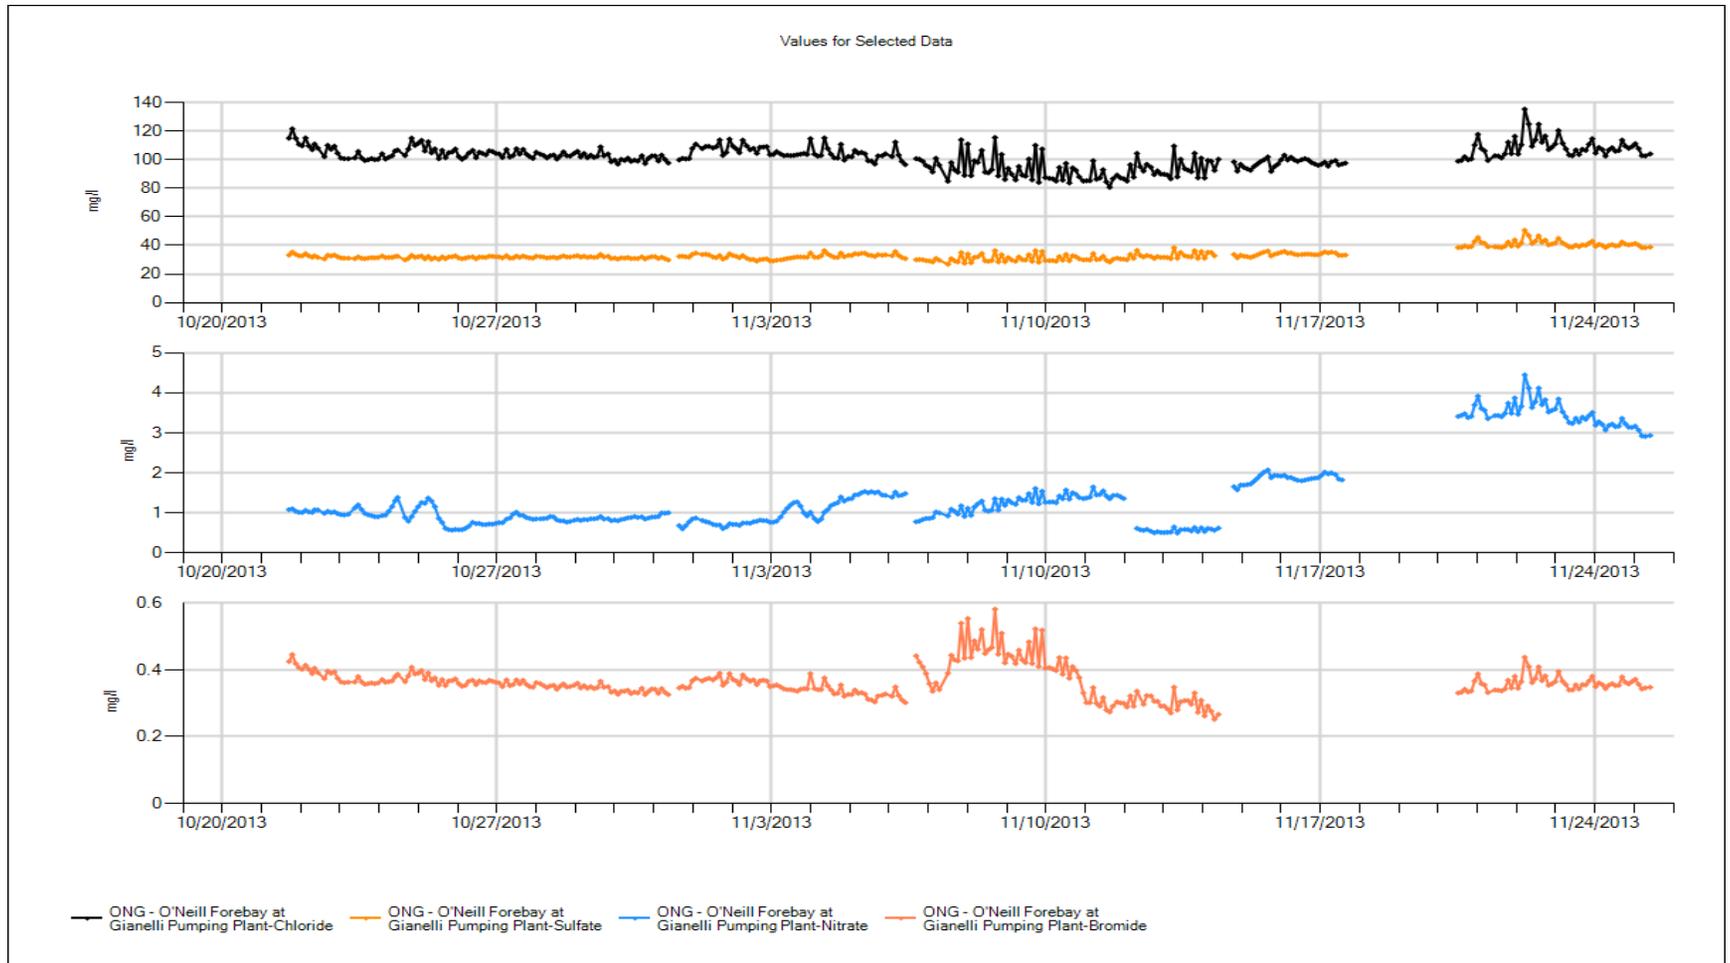
## Gianelli Anions (Chloride, Sulfate, Nitrate, & Bromide):

### ***Gianelli Significant Metrohm Events: Oct 19, 2013 – Nov 25, 2013***

- Installed a new guard and analytical columns and calibrated on **11/6**.
- The nitrate peak was being misread from **11/12 – 11/14** and the bromide peak was getting misread from **11/14 – 11/17**. Both are signs of bad columns.
- The system ran out of eluent on **11/17**, which shut off the analysis until **11/19** when both the eluent and guard column were replaced.

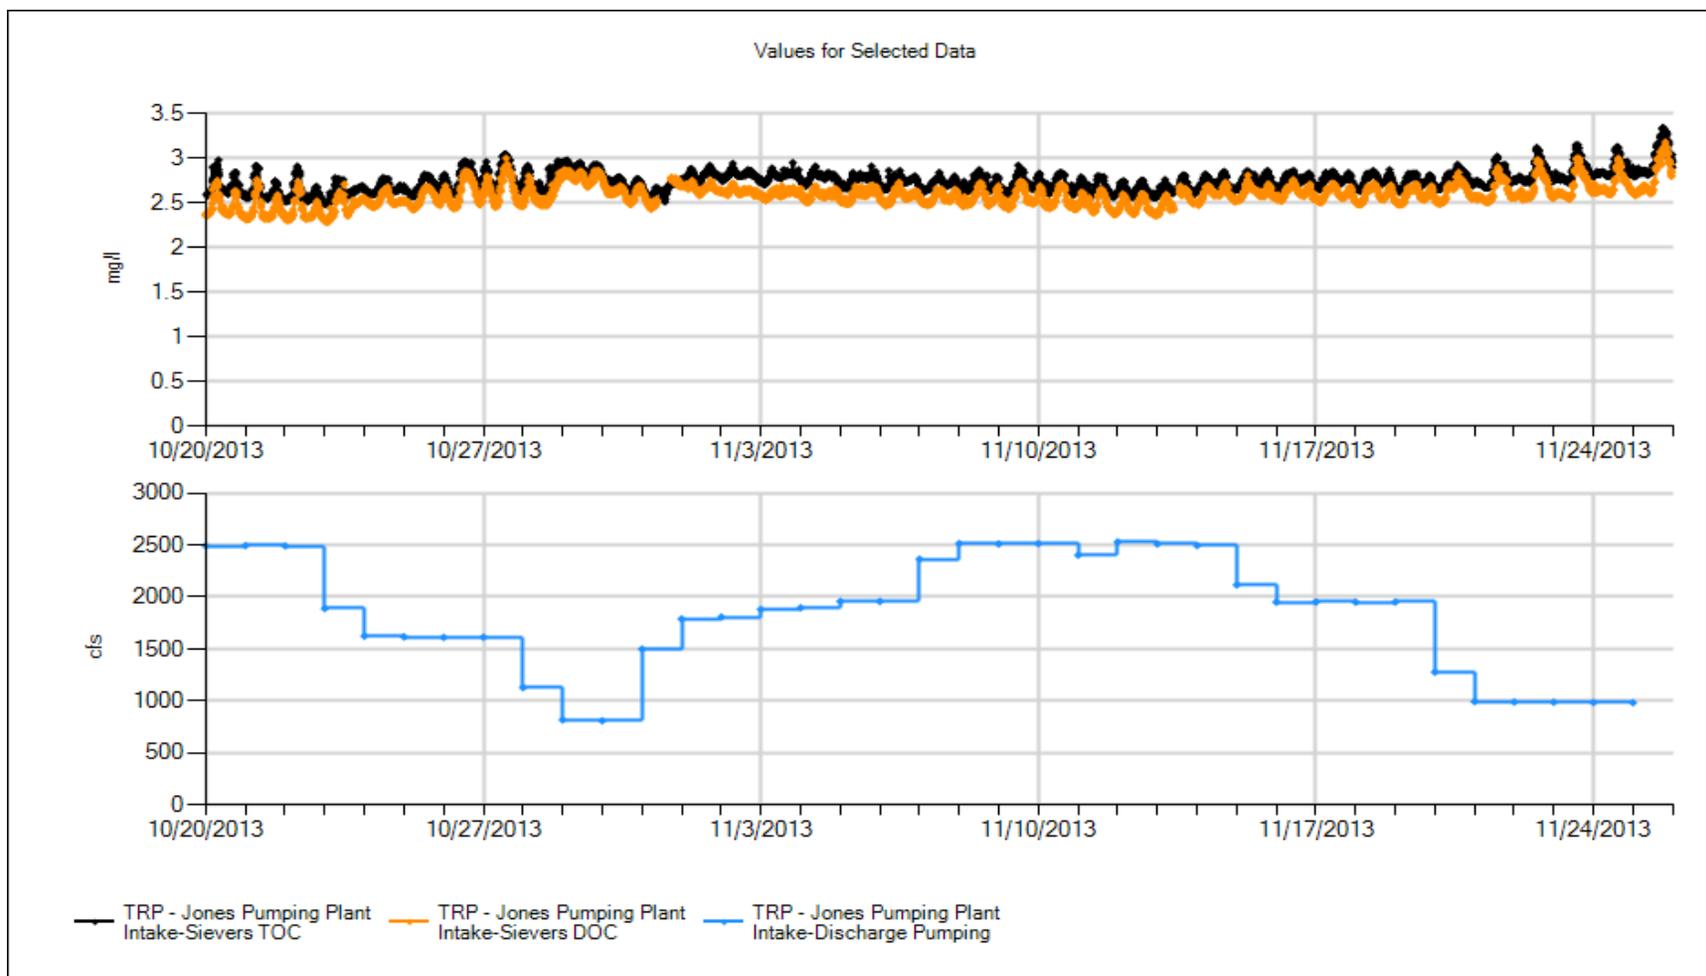
- 10/23 – filter change
- 10/31 – filter change. Cleaned IOS system because of increasing variability in TOC/DOC data.
- 11/13 - Filter change. Our 5KHP standard that we use for our QC checks came in very low, but I believe this is due to a bad batch and not with the instrument. Overall, the Sievers analyzer has been operating very well.

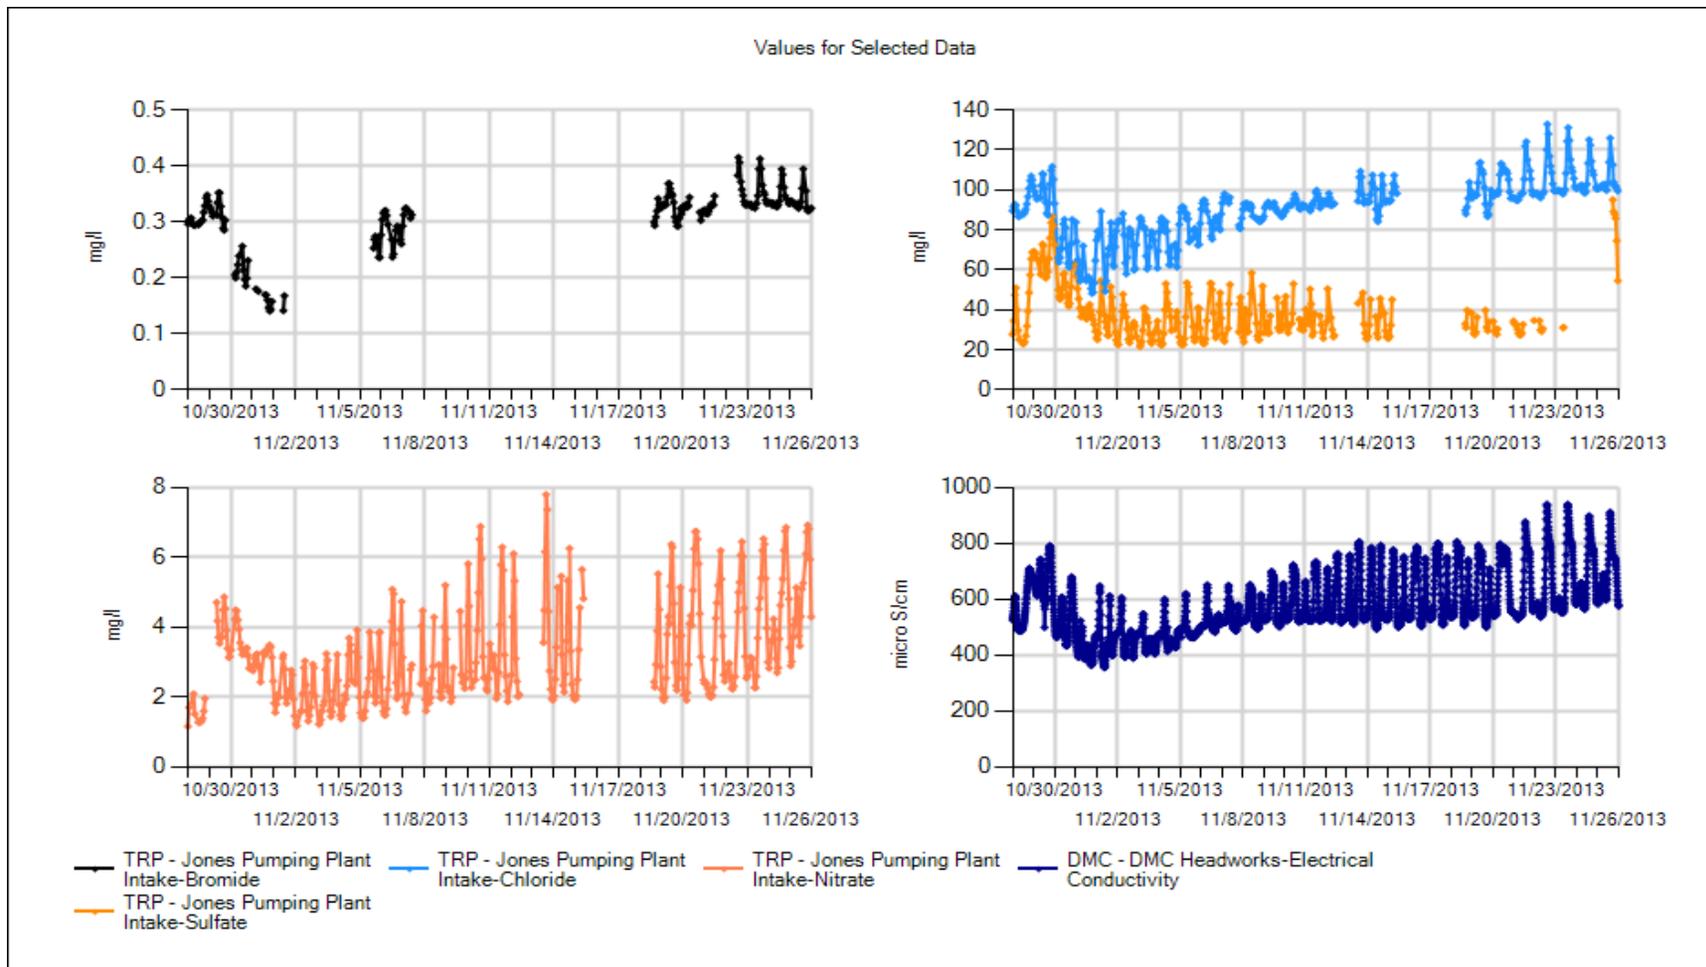
## Jones Anions and EC

- filter change dates are the same as on previous page
- 11/7 - Changed stock and check standard on Dionex. Ran a system calibration followed by “default” settings. Did not change filters.
- 11/5 – changed stock and check standard on Dionex. Previous batch of standards had inaccurate quantities of bromide, which explains the gap in data in bromide.
- 11/20 – Added double DI to the Dionex reservoir. Did not change filters in an attempt to let filters run for two weeks.

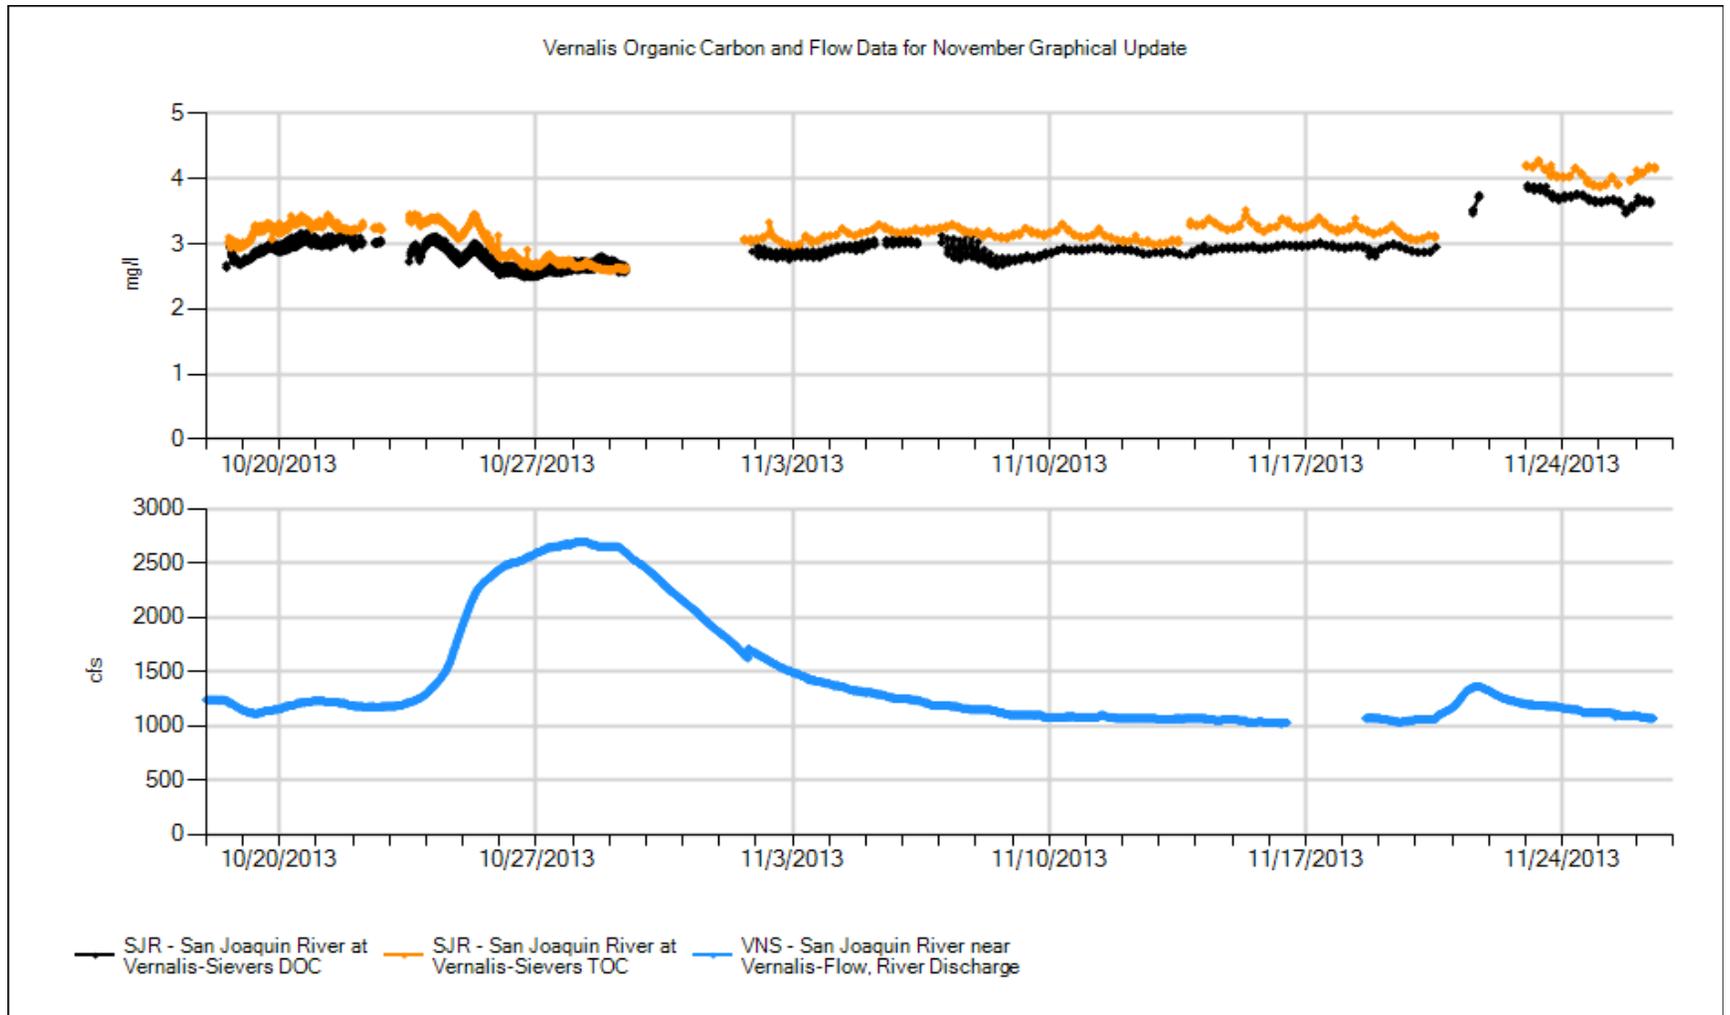
**Filter Changes:** 10/18 all filters, 10/23 prefilters only, 10/29 prefilters only, 11/6 all filters, 11/13 new 20" prefilters, and 10s", 11/20 prefilters only, 11/25 all filters. ("All filters" includes the 0.45 micron finishing filter, "prefilters only" means the 0.45 micron filter did not need to be changed.) **Significant events:** From 10/29 to 11/1 the "Stevens II" flow controller was installed, greatly increasing the filter life of the 0.45 micron cartridge. From 11/20 to 11/21 the Sievers was inadvertently left in the "IDLE" mode after station maintenance. Turned online 11/21.

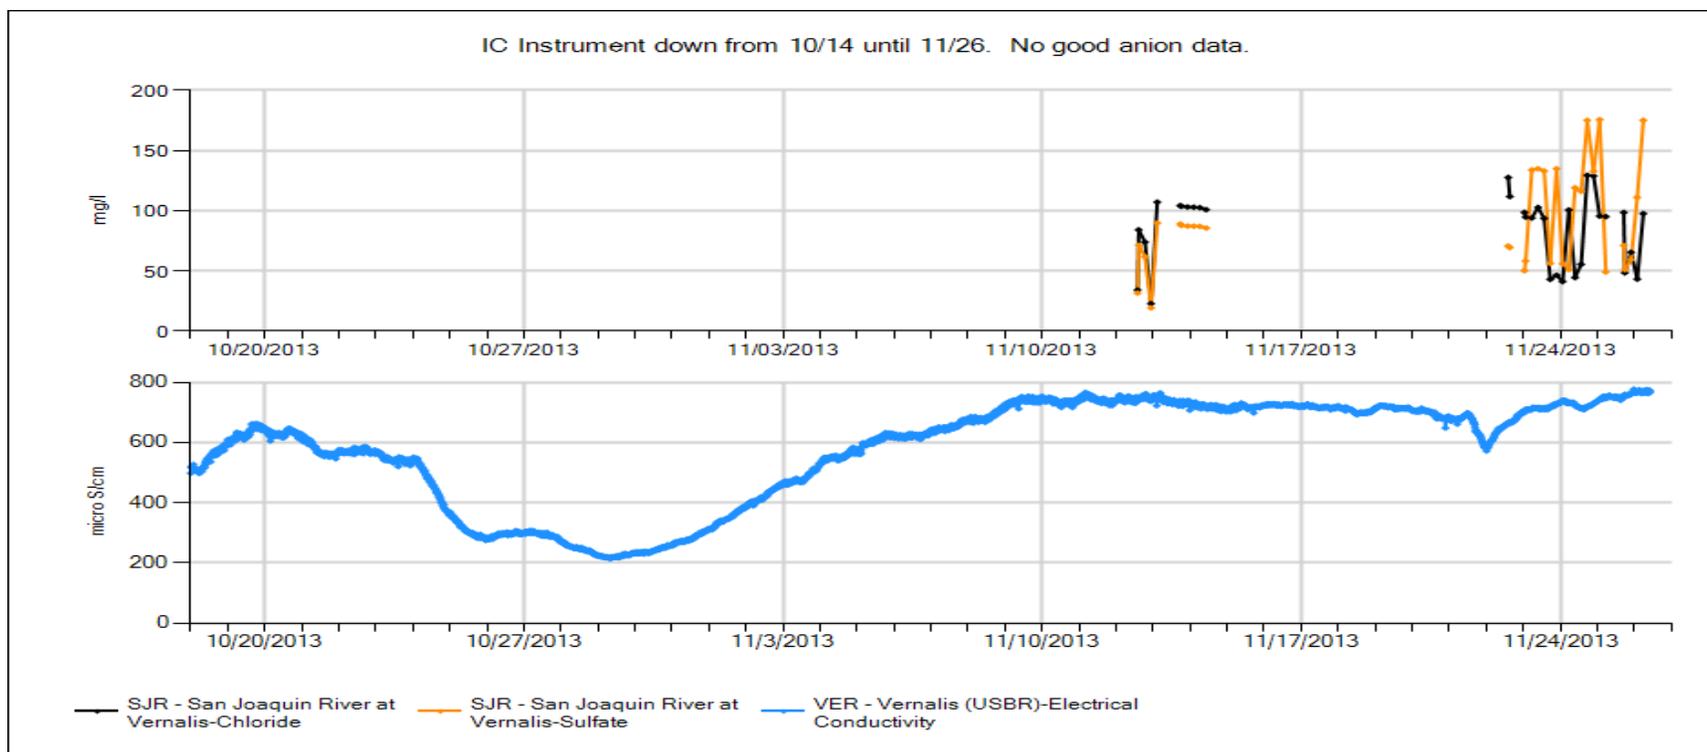
The Dionex has been non-operational since mid-October, from a series of events. On 10/13, the analytical and guard columns were changed, but the instrument would not finish the necessary calibration sequence because of an error in the software. The Thermo-Fisher/Dionex tech made a site visit on 10/31 to diagnose the previously unseen issue, but did not make much progress by the end of the day. In the meantime, Mark was able to trace the error to a Windows 7 printer update/Chromeleon software interface issue, and fixed the problem by disabling certain features of the software. On 11/13, the calibration showed a problem with the bromide concentration of the stock standards made for the Dionex. The standards were made using an older formula that only contained half of the necessary bromide. On 11/18, the new standards were installed but there were problems with one of the peristaltic pumps not delivering enough standard to the dilution vessel for calibration. The peristaltic tubing was worn-out and a new length was procured and installed on 11/21. The analyzer calibrated on Friday 11/22 and ran over the weekend. After a QA/QC site visit on Monday 11/25, the anion data was set to report the morning of 11/26.

IC Instrument down from 10/14 until 11/26. No good anion data.
