Clover Creek – Millville Diversion Fish Passage Project

Preliminary Engineering Technical Report

April 2013

Technical Information Record (TIR) – NRO-2013-01

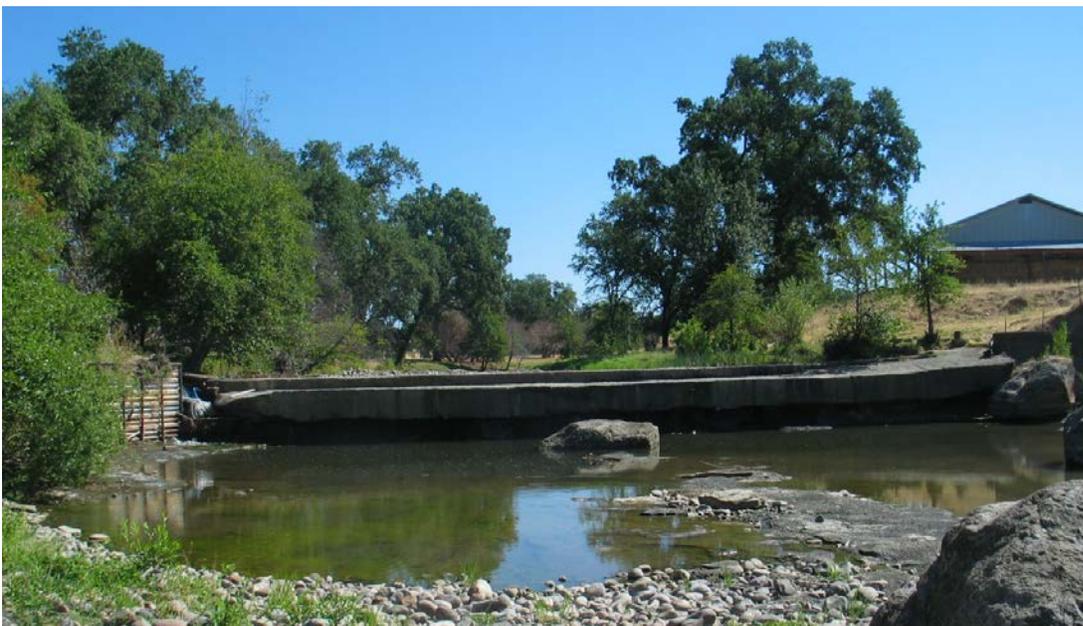
Since the dam and siphon have been constructed, major incision has occurred in the channel, creating a fish passage impediment at both structures. The 1959 photo shown in Figure 3 represents the dam's appearance prior to channel incision. Today, the dam sits atop exposed bedrock, making the total height from the top of the dam to the channel bottom closer to 10 feet (Figure 4).

Figure 4. Millville Diversion Dam (July 2007)

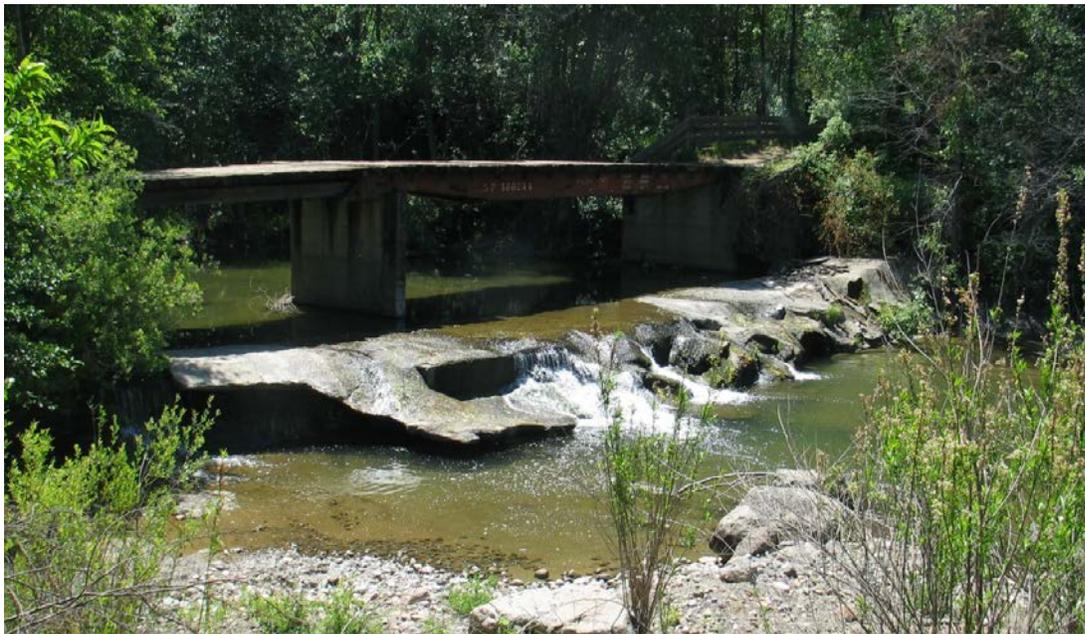
Over time, incision has also occurred where the siphon crosses the creek, exposing the downstream side of the siphon and bedrock (Figure 5). The total height from the top of the concrete apron to the channel bottom is about 6.5 feet. Gunite has been used over time to help maintain the structural integrity of the siphon. During low flows, water is sheeting across the concrete apron which impedes fish passage due to the shallow water depth as well as the 4-foot head differential caused by the siphon.

Figure 5. Siphon structure on Clover Creek (May 2007)

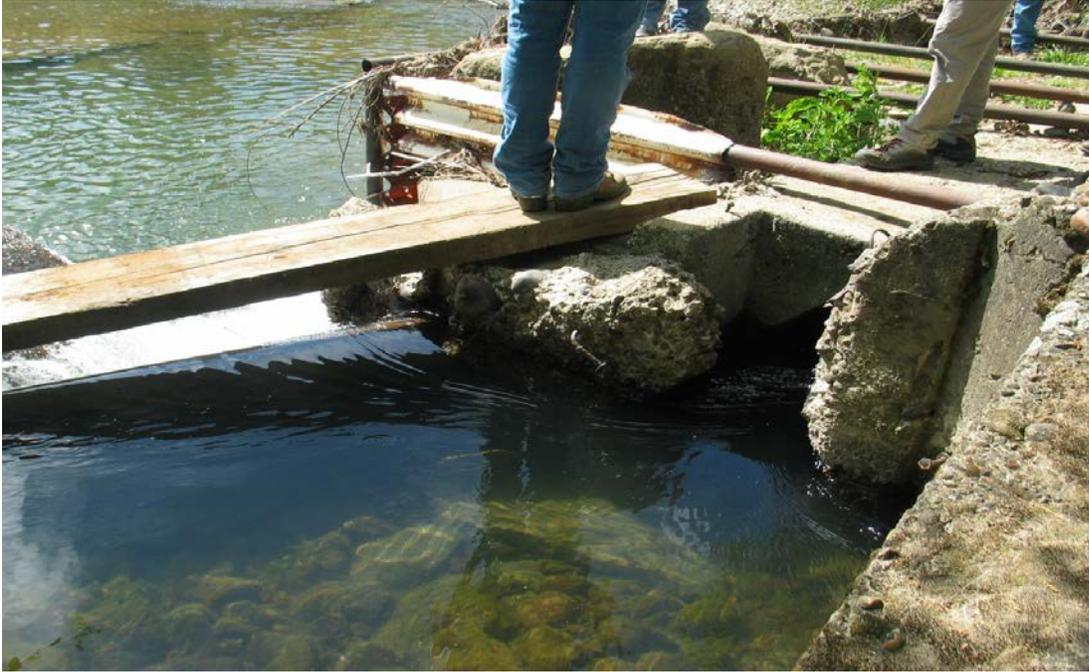
The diversion entrance is not screened as shown in Figure 6. During irrigation season, all instream flow is concentrated through a notch in the dam located near the diversion entrance. The concentrated flows through the notch creates a velocity barrier to fish. The notch is about 5 feet wide with an adjustable height (adjusted with boards). The height of the notch is adjusted to divert water into the ditch. The notch has rebar protruding upwards and other sharp metal objects that would cause major injury to fish trying to migrate upstream or downstream through the notch (Figure 7).

Figure 6. Unscreened diversion entrance (April 2007)

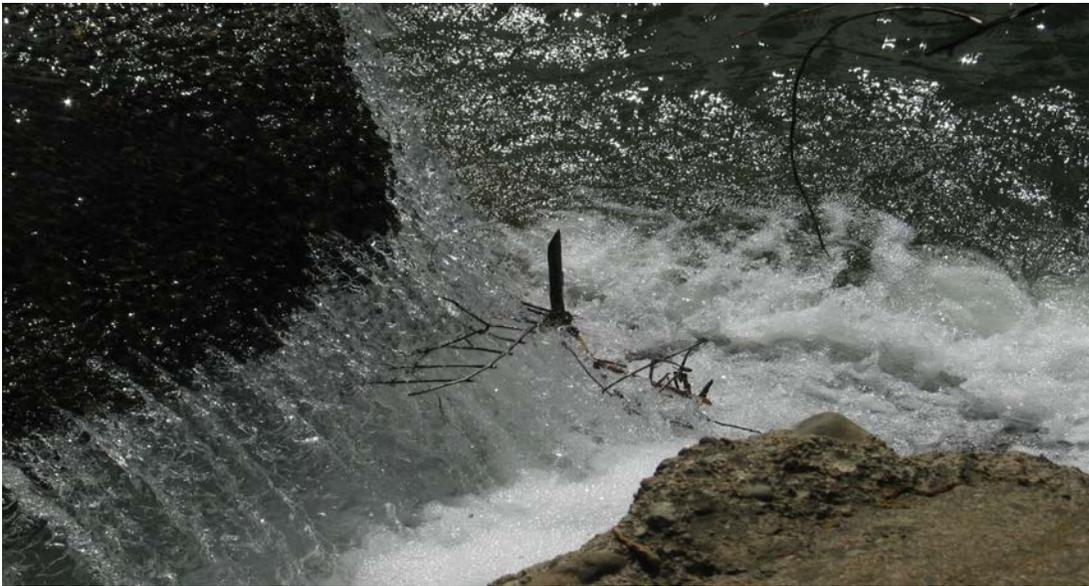
Figure 7. Concentrated Flow Through Notch in Dam (April 2007)

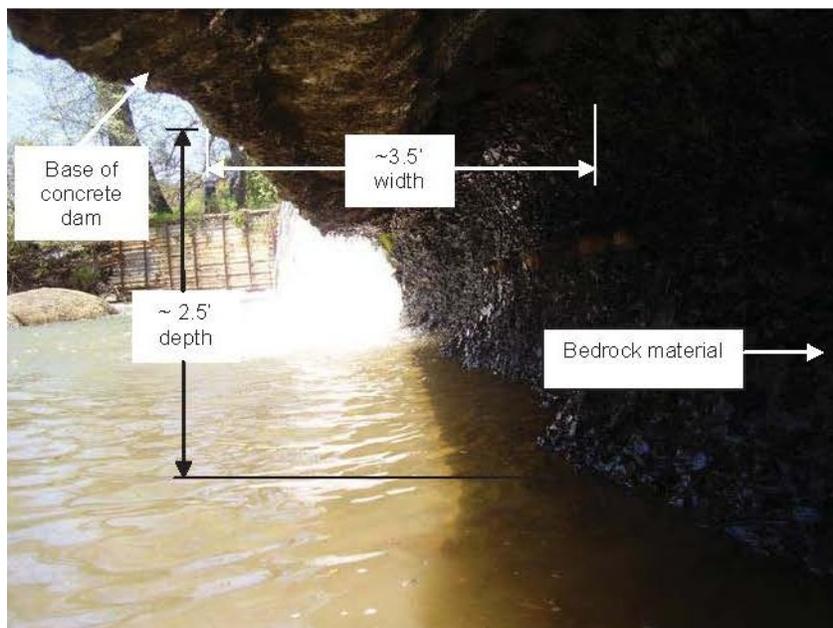
In 2007, DWR geologists conducted a geologic investigation on the potential impacts with removal of the dam (Appendix A). The dam structure is constructed on bedrock of the Cretaceous Chico Formation. This formation consists mainly of siltstone that is very friable and slakes when exposed to air and sunlight. The undercutting on the downstream side of the dam and the plunge pool that has developed is evidence of this (Figure 12).

Figure 12. Photo of Undercutting on Downstream Side of the Dam (May 2007)

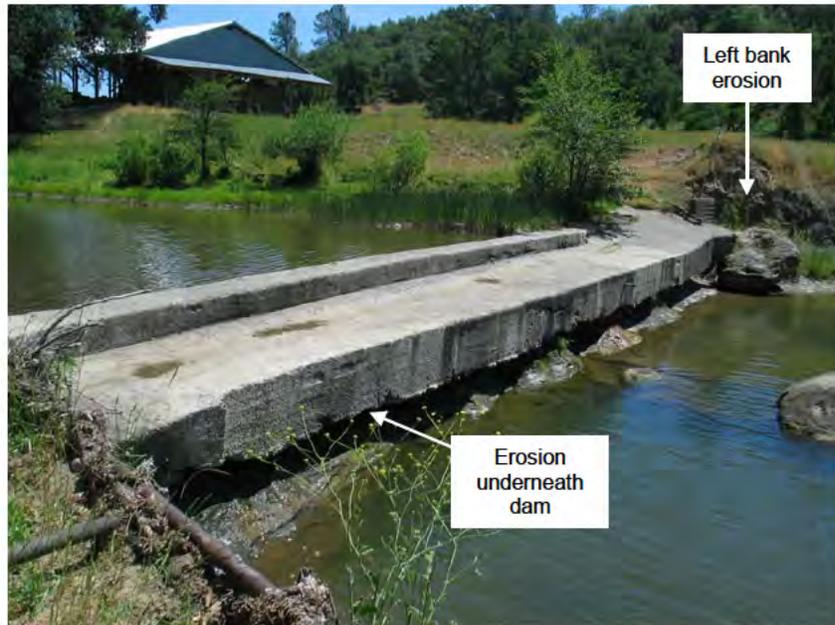
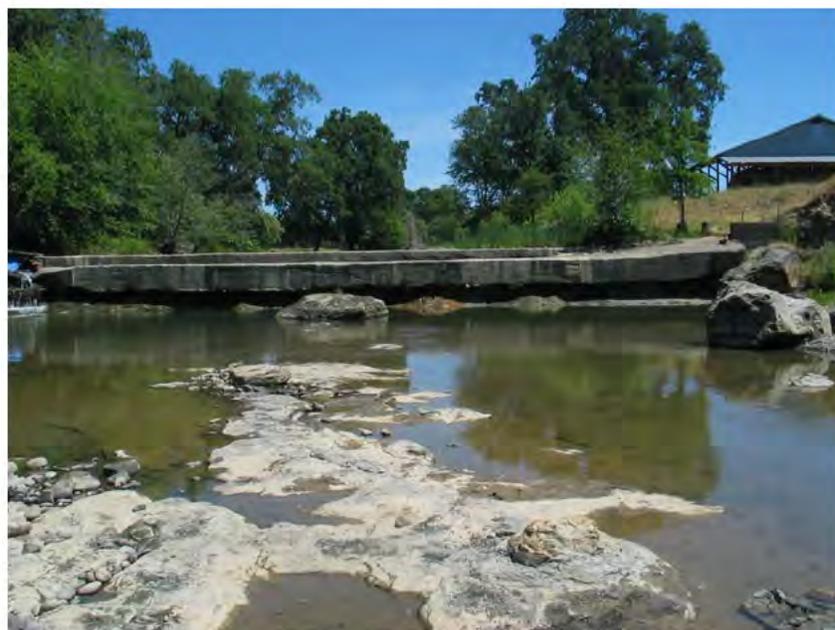
As shown in Photos 1 and 2, the bedrock underneath the dam has been eroded along the downstream side. The left embankment at the dam also shows evidence of erosion.

Photo 1 - Millville Diversion Dam, 2007 (Source: NRO)

Photo 2 - Millville Diversion Dam, looking upstream, 2007 (Source: NRO)

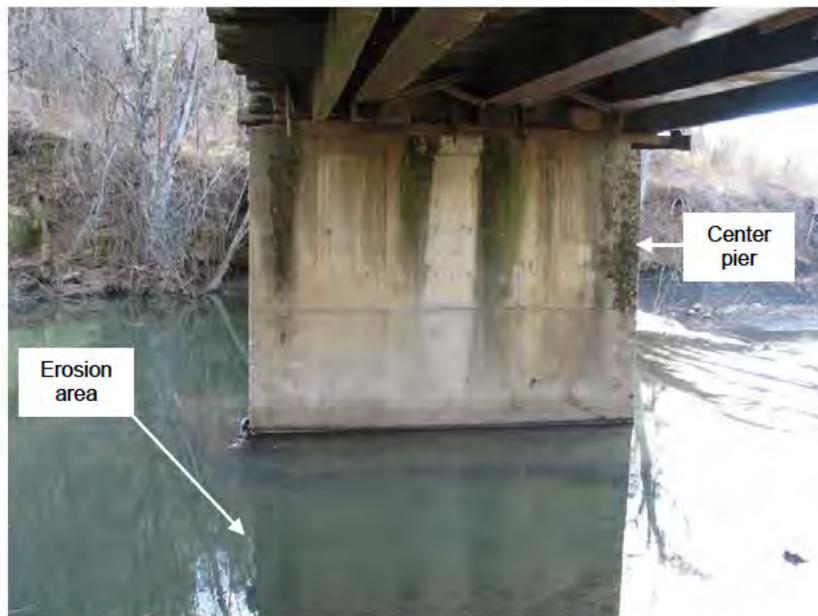
Located downstream of the dam are the bridge and siphon. The bridge superstructure has a wooden deck supported at two abutments and three piers. There is evidence of scour around the center pier, as shown in Photo 3.

Photo 3 - Millville Bridge Right Center Pier, 2012 (Source: NRO)

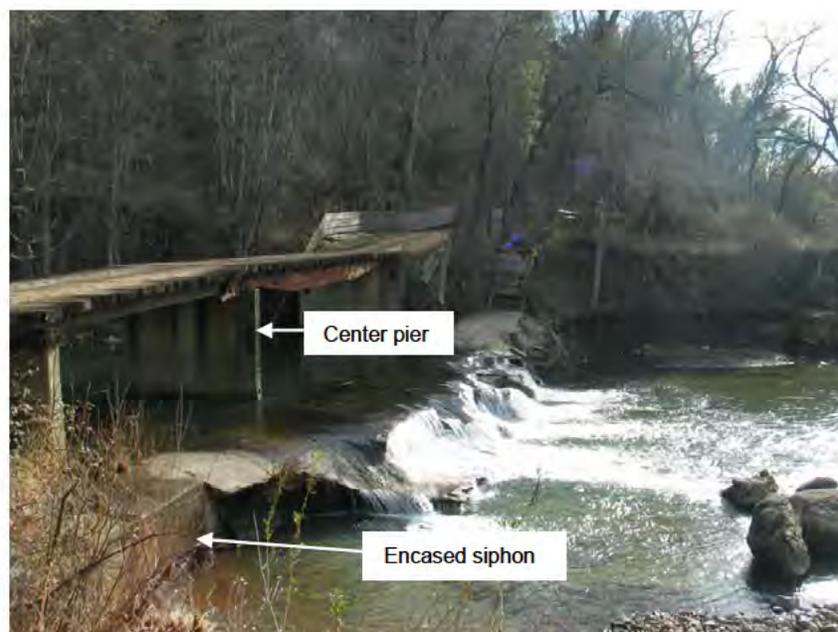
Located immediately downstream of the bridge is an inverted siphon encased in concrete. The siphon is a 30-inch-diameter corrugated metal pipe, and the concrete encasement is 130 feet long by 10 feet wide by 5 feet high. The encasement crossing was originally buried. Over time, erosion of the stream material has uncovered the encasement such that there is normally about a 5-foot drop between top of encasement and downstream water surface. The owner of the siphon and bridge has indicated that, over the years, concrete material has been placed over the original encasement as protection measures against erosion. See Photo 4 below.

Photo 4 - Millville Bridge and Inverted Siphon, 4/20/12

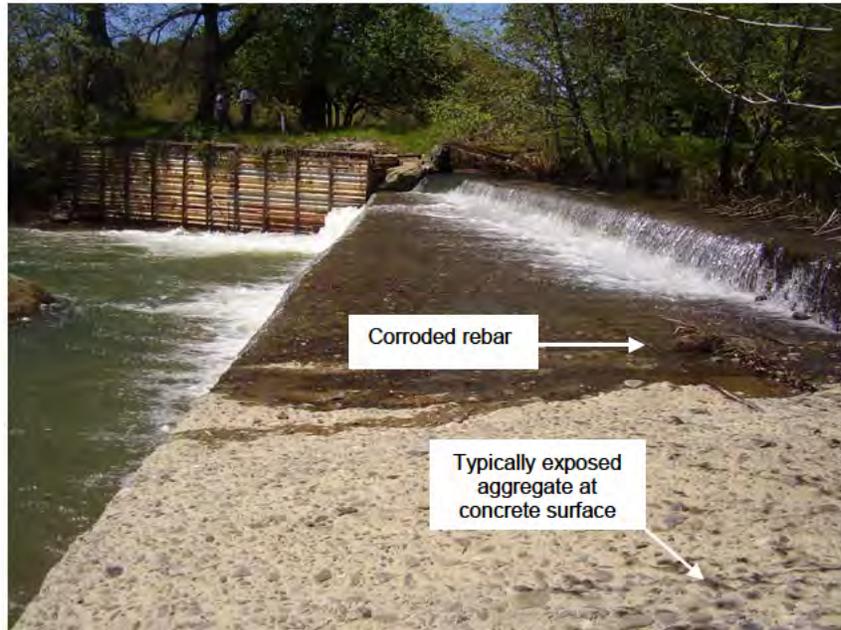
Photo 5 - Millville Diversion Dam, Delamination on Dam Surface, 4/20/12

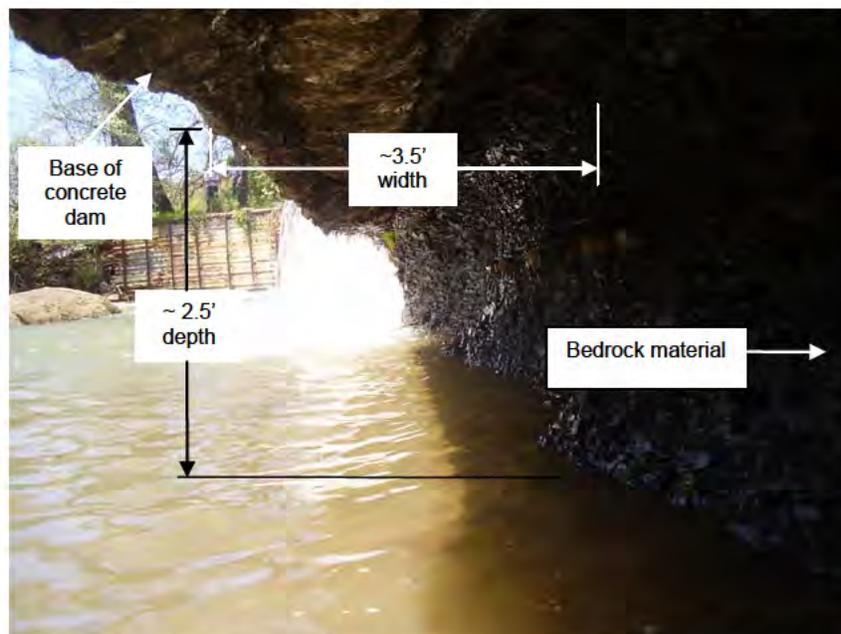
As shown in Photo 6, the width of scour underneath the dam near the left embankment was measured to be about 3.5 feet.

**Photo 6 - Millville Diversion Dam, Scour Underneath Downstream End of Dam, 4/20/12.
(Standing near left bank looking across base of dam)**
