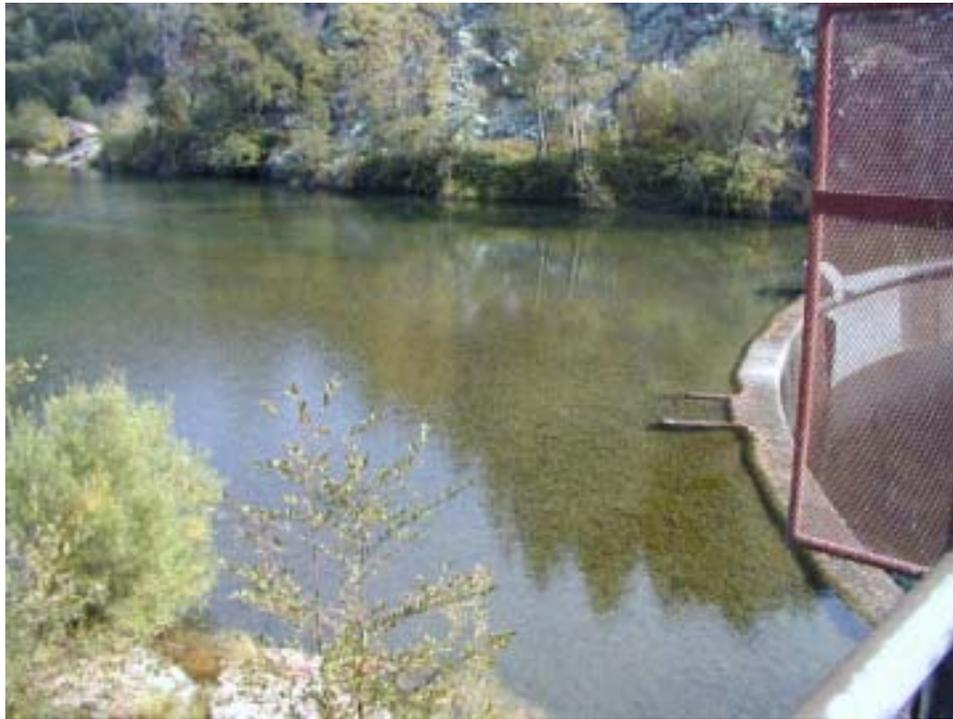
**Photo 5.1-1. Trapped sediments behind Miocene Dam.**

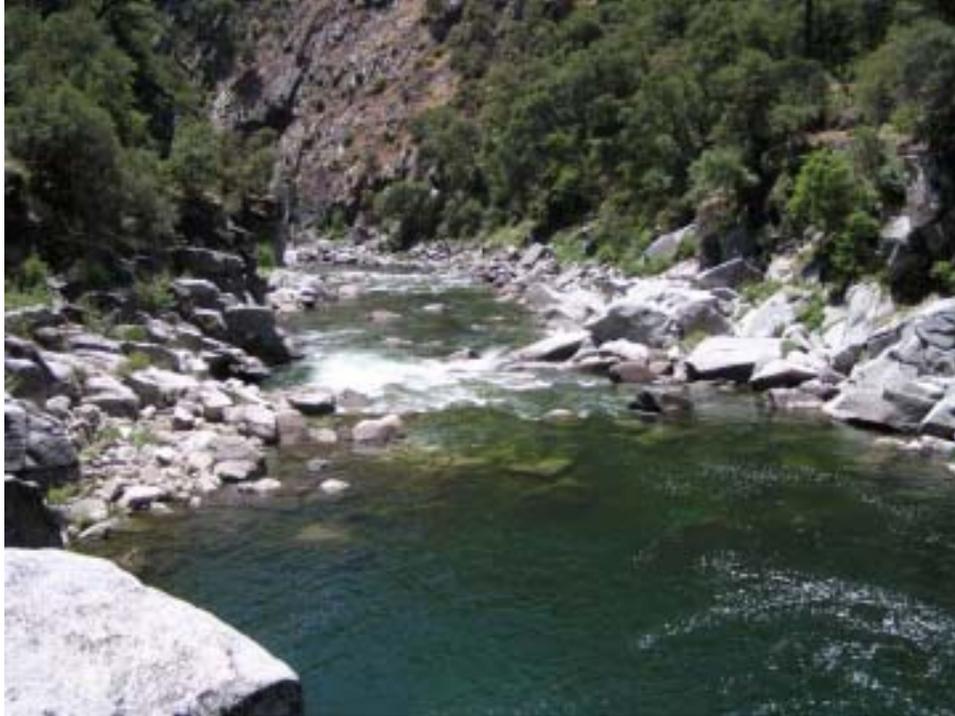
**Photo 5.1-6. Tail-out portion of pool on Middle Fork, showing notable lack of spawning gravel.**

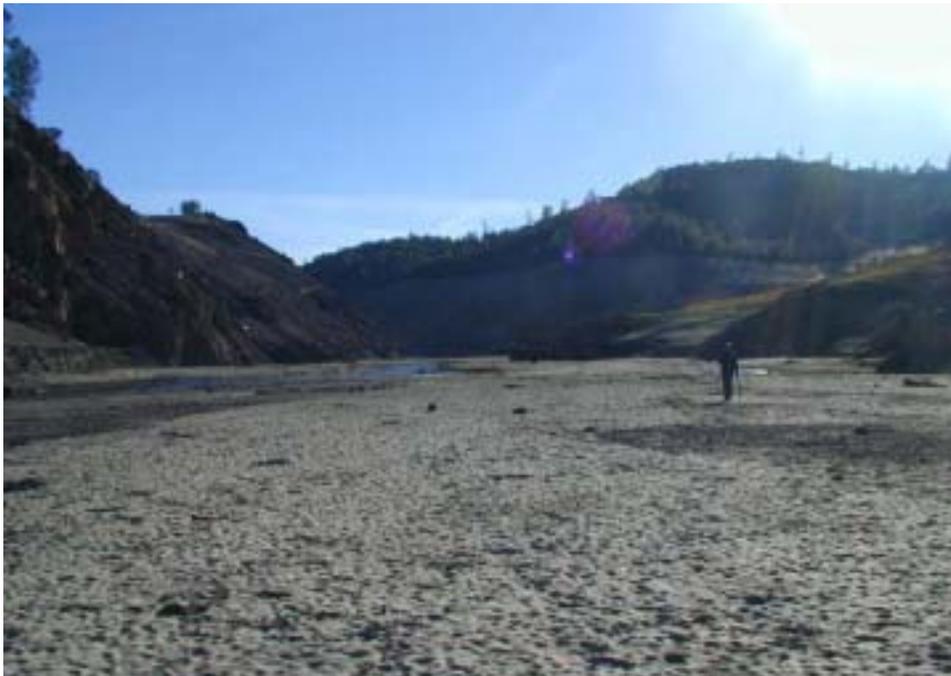
**Photo 5.2.2. Sediment wedge looking downstream; fine silt covers higher spot not reworked by river channel.**

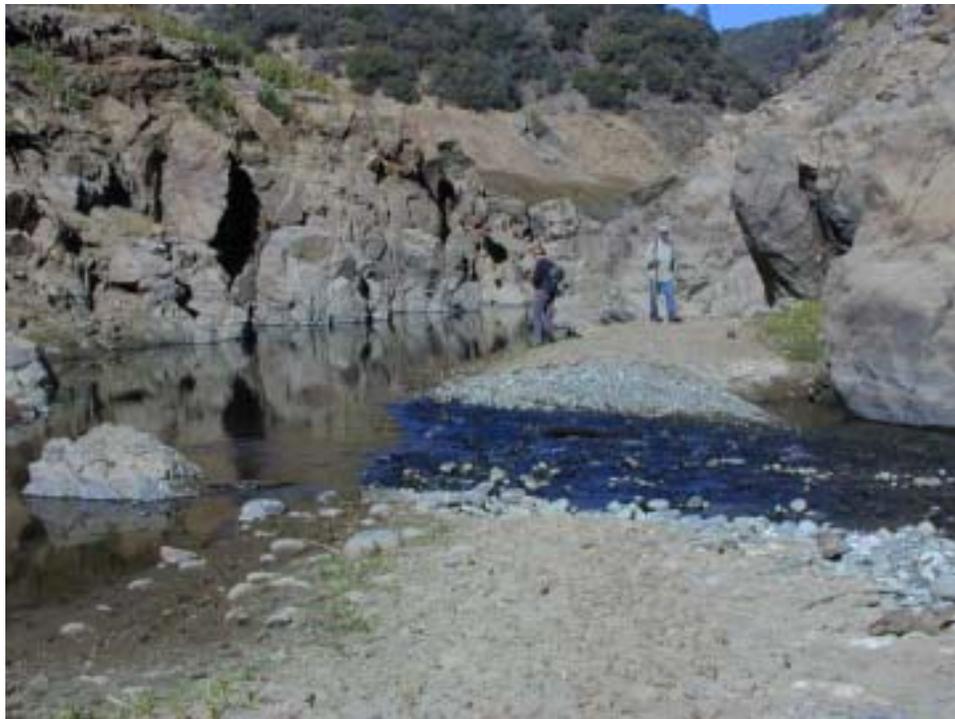
**Photo 5.2-6. Silt-laden gravel bar above Cape Horn, West Branch.**

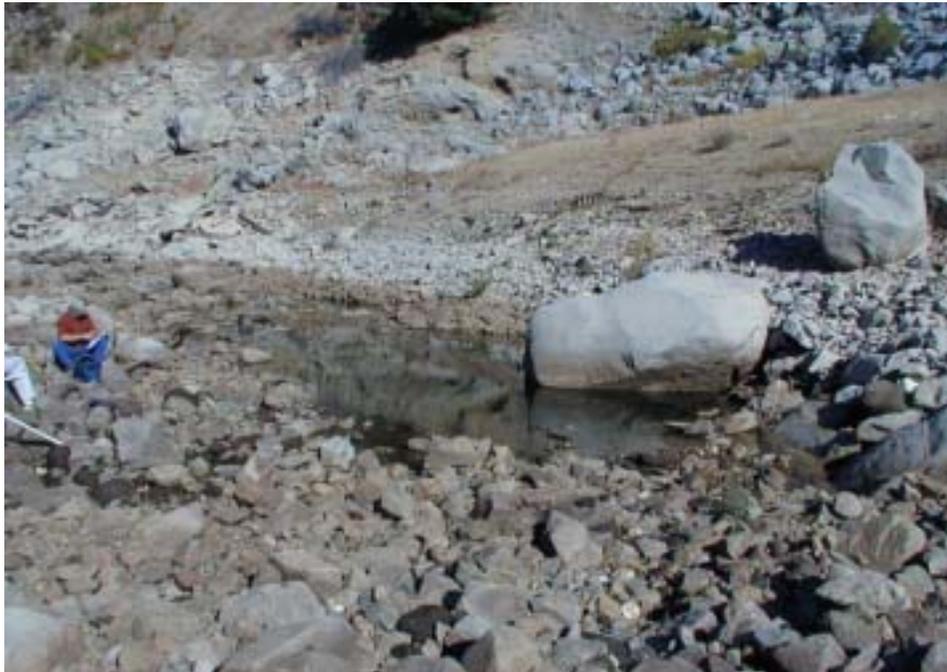
**Photo 5.2-16. Immediately below Ponderosa Dam on South Fork when dam is spilling about 5 cfs. Note water stain about two feet high.**

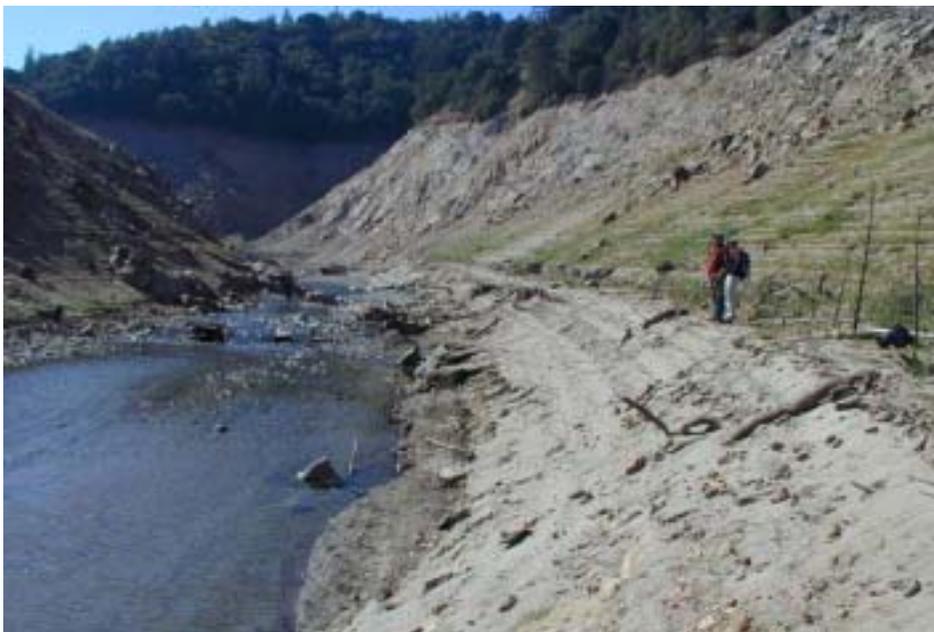
**Photo 5.2-20. Degraded habitat on South Fork due to erosion of remnant sediment wedge.**

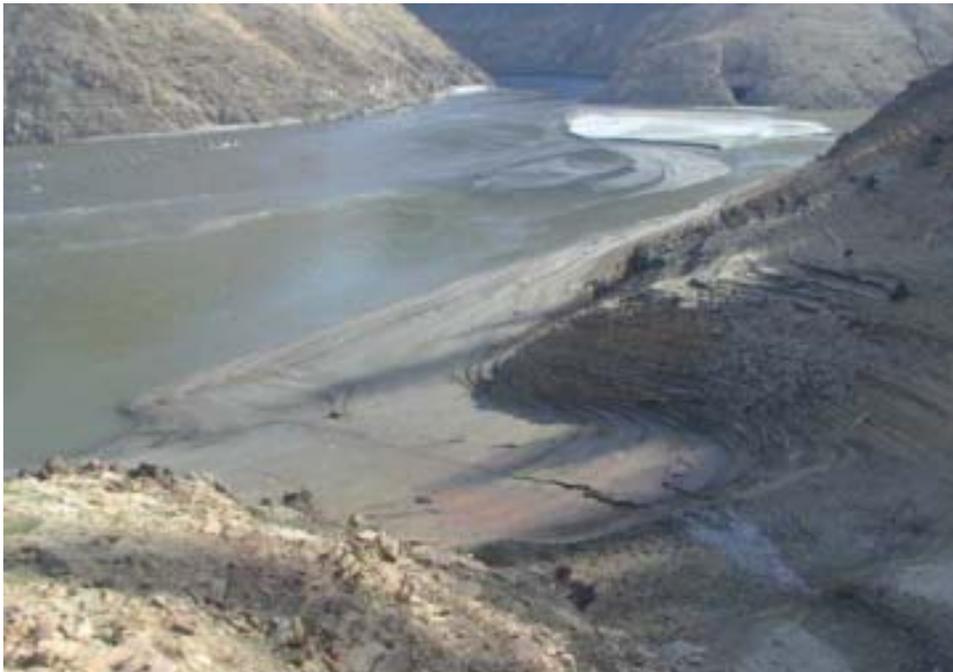
**Photo 6.1-2. Cross Section NF-7 showing exposed sediments when reservoir elevation was approximately 700 feet.**

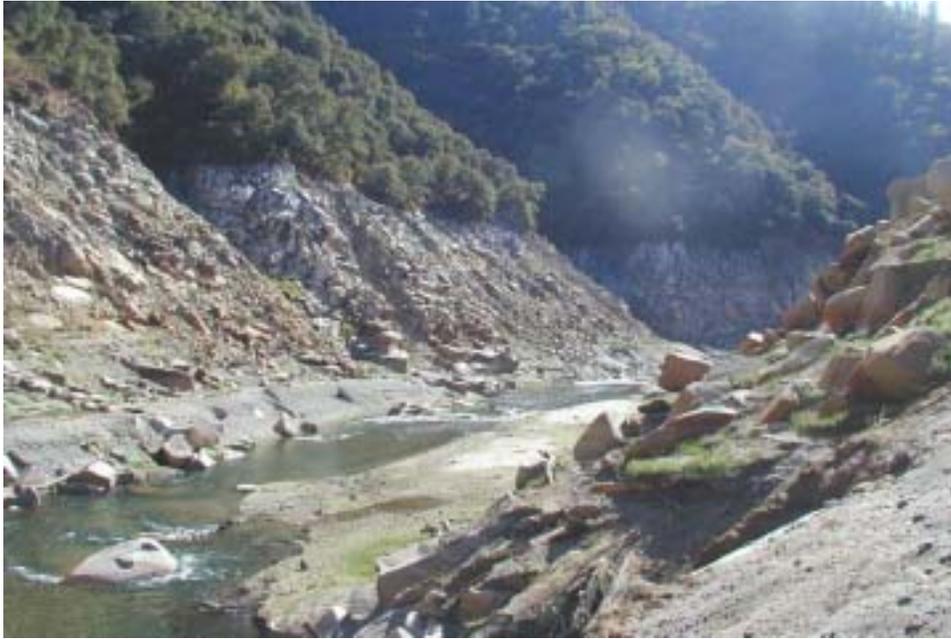
**Photo 6.1-5. Cross section MF-7 on October 2002 showing removal of sediment that was measured in July 2002.**

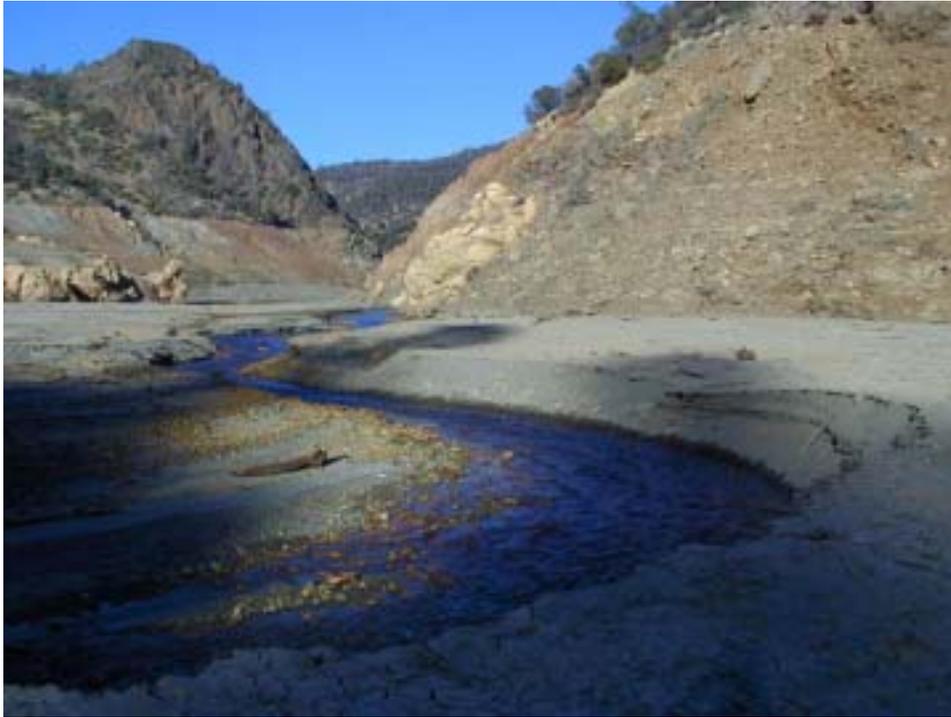
**Photo 6.2-3. Upper portion of West Branch sediment wedge showing channel entrenchment in wedge material.**

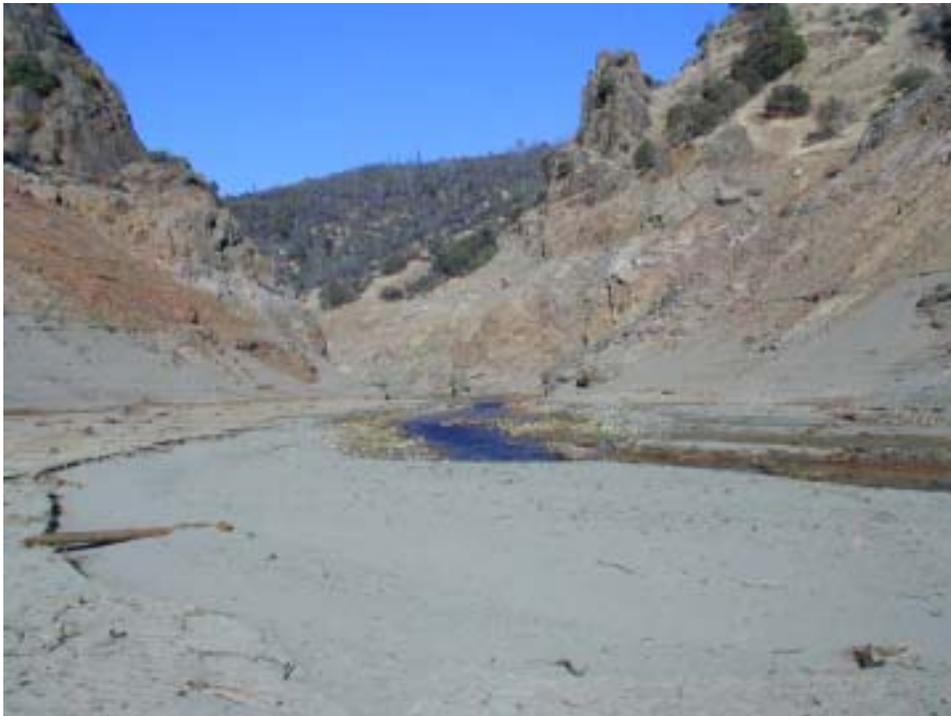
**Photo 6.2-4. Beginning of channel entrenchment near upstream end of West Branch sediment wedge.**

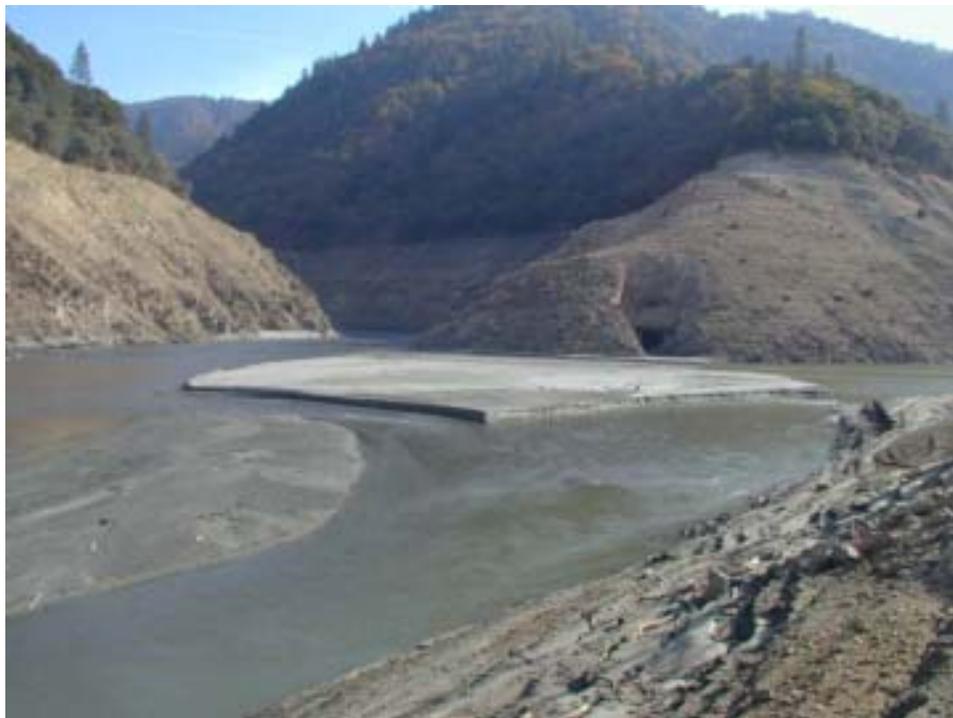
**Photo 6.2-6. Residual sediment wedge material not eroded away at channel widening near confluence of Berry Creek.**

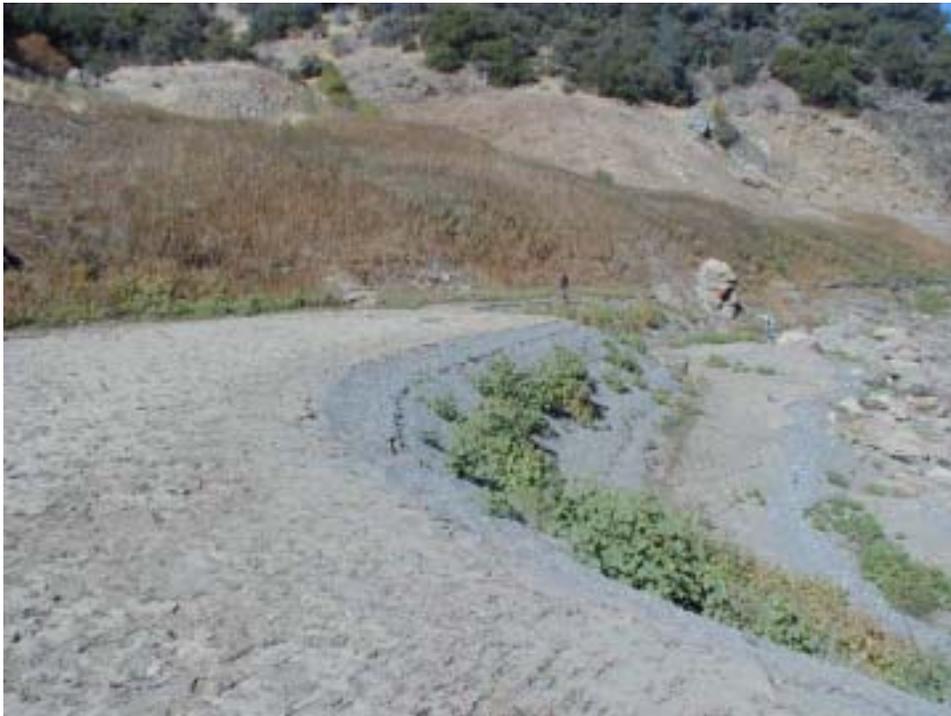
**Photo 6.2-14. Sediment lag deposits, West Branch, just upstream of Cape Horn.**

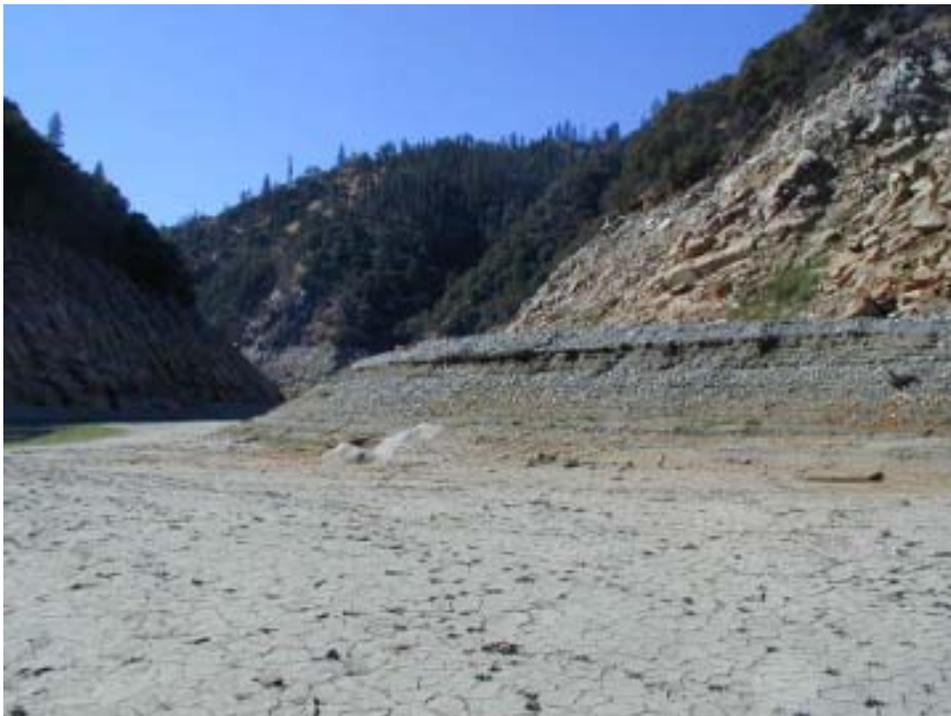
**Photo 6.2-15. Sediment lag deposits, Middle Fork, downstream of Cross-section MF-7.**

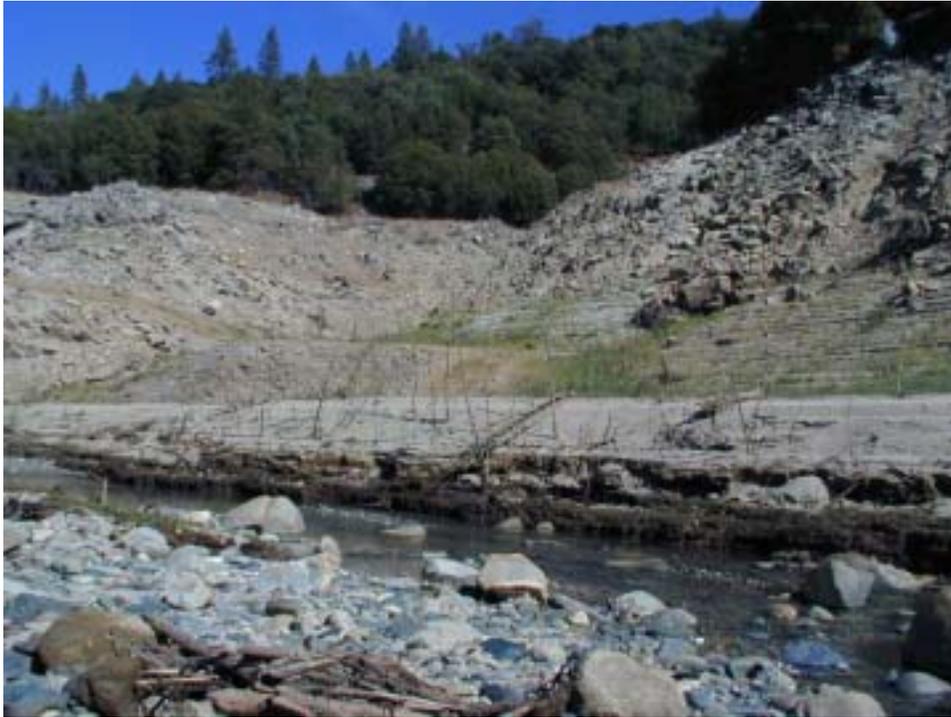
**Photo 6.2-16. Sediment lag deposits, South Fork, about 2 miles upstream of Enterprise Bridge.**

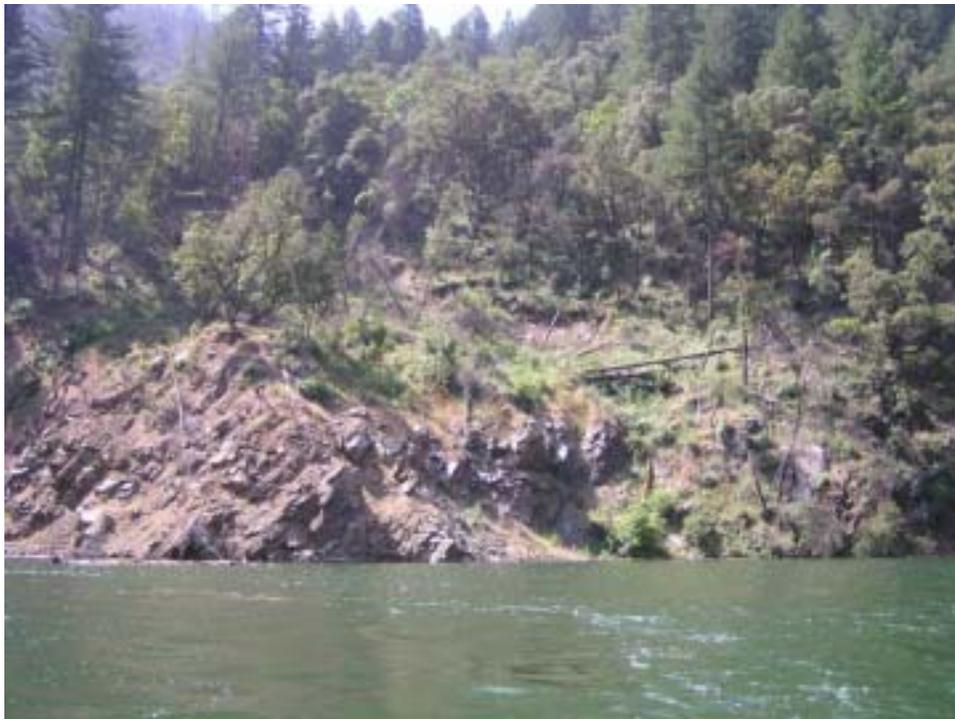
**Photo 6.3-2. Active landslide on upper North Fork showing typical features, such as jackstrawed trees.**

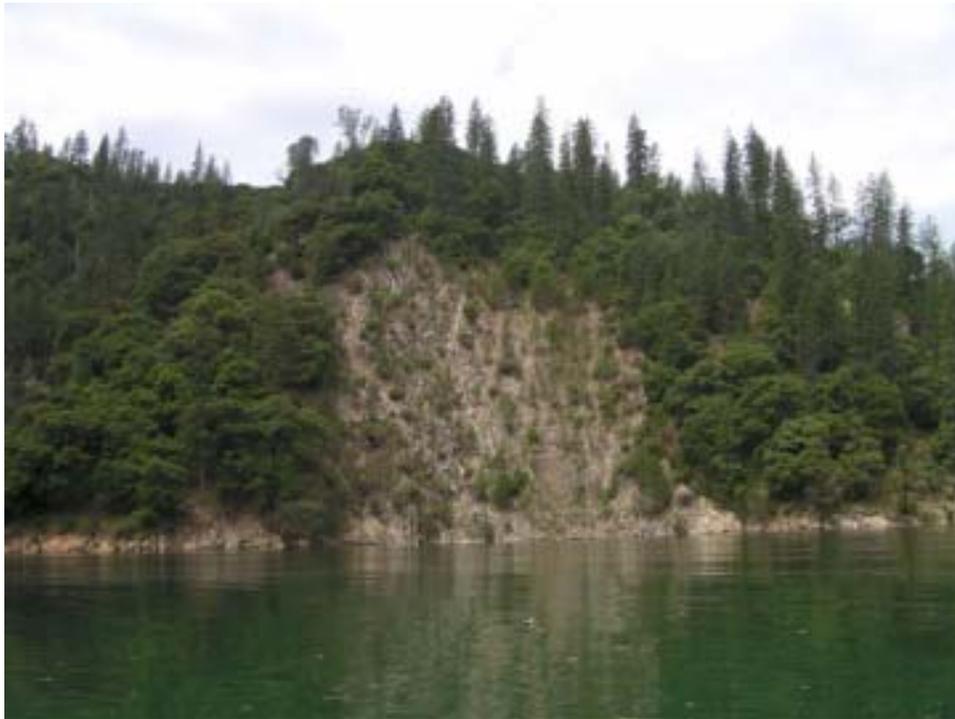
**Photo 6.3-3. Active debris slides on upper Middle Fork.**

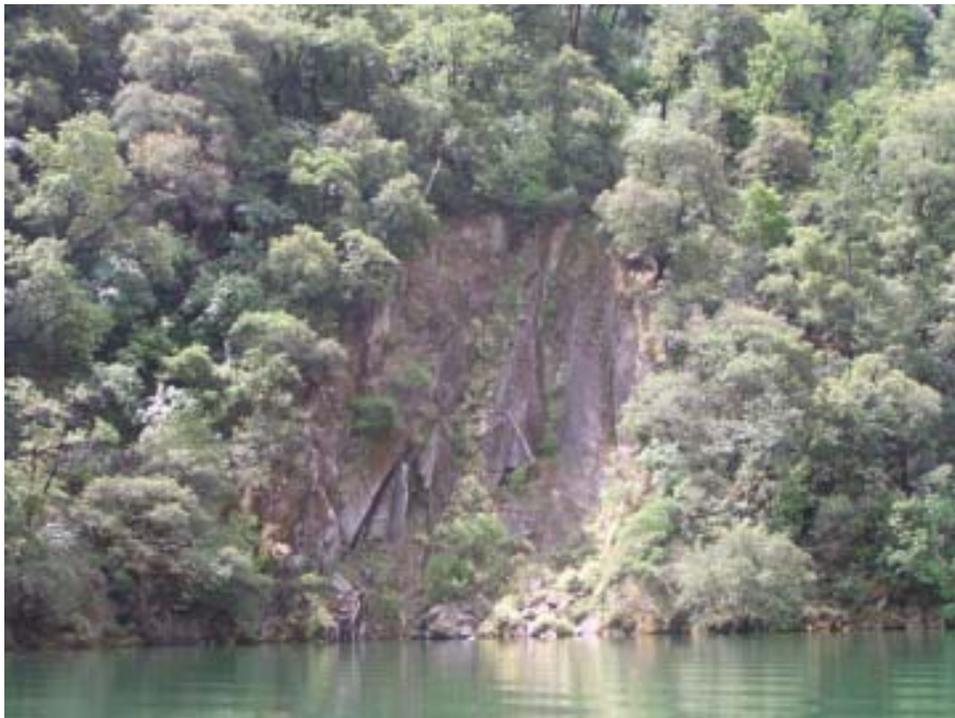
**Photo 6.3-4. Active slippage along joint planes on upper Middle Fork.**

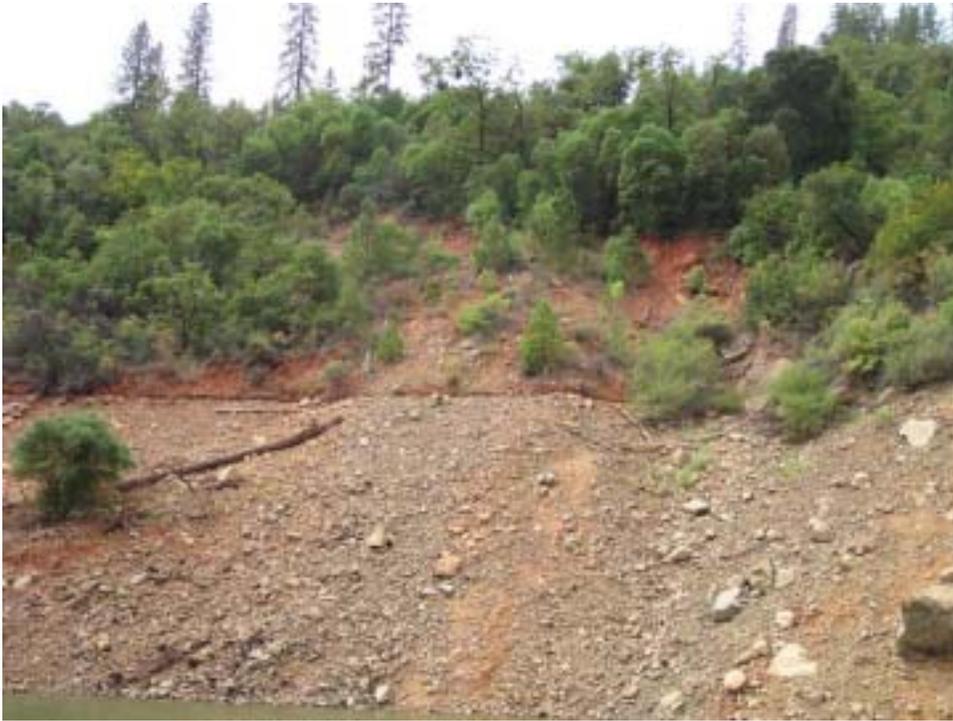
**Photo 6.3-5. Reactivation on ancient Bloomer Hill landslide, upper North Fork.**

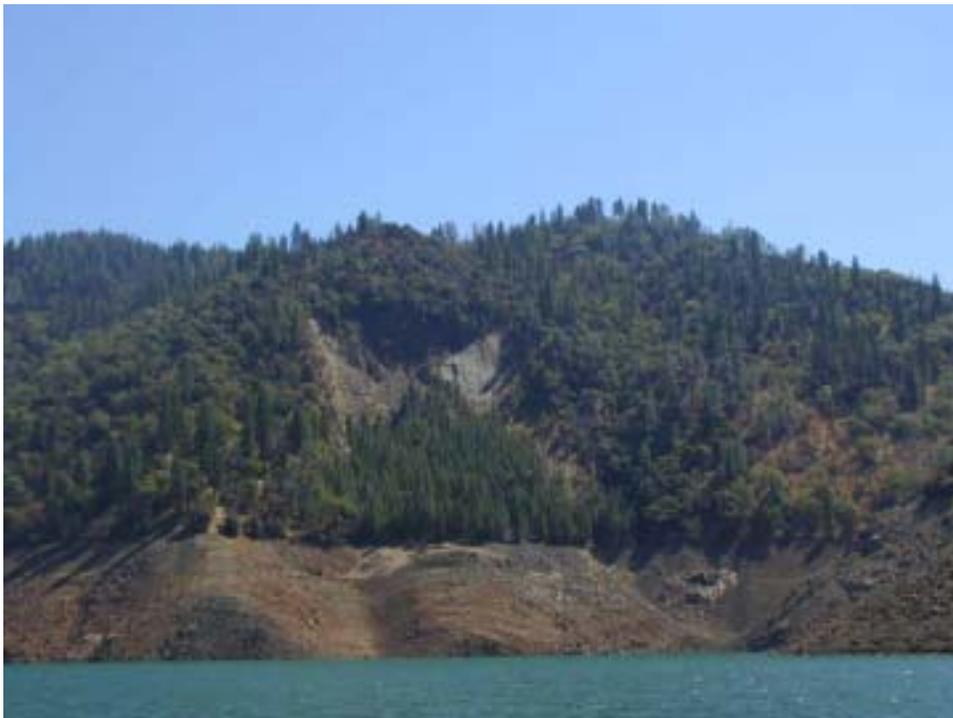
**Photo 6.3-6. Stringtown Mountain landslide, Middle Fork, showing reactivation of central portion.**

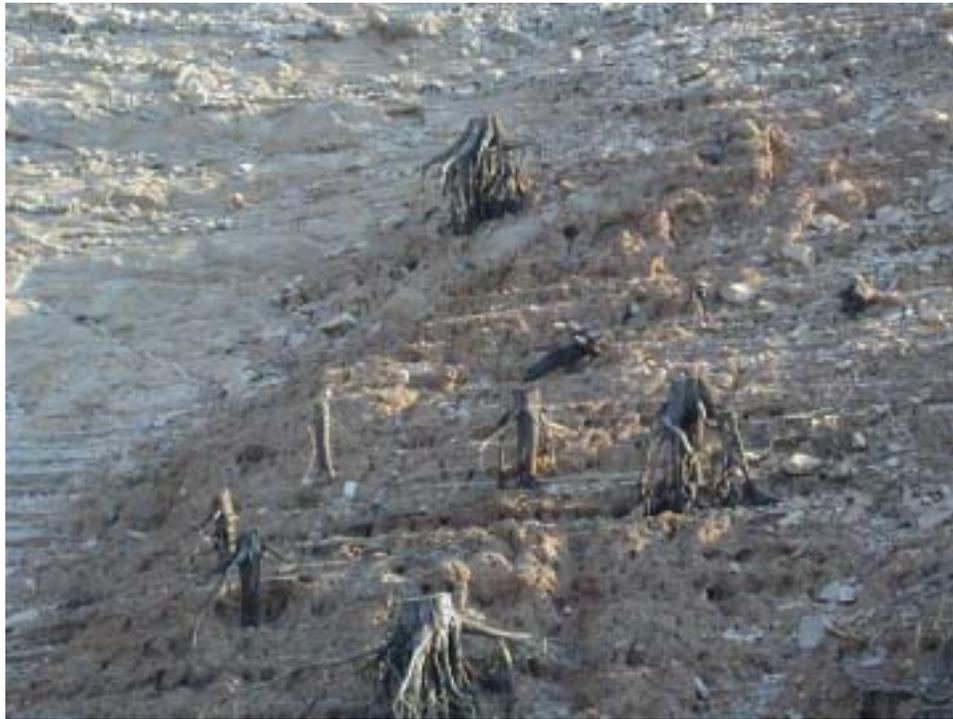
**Photo 6.4-1. Tree stumps, Middle Fork, showing 3 to 5 feet of soil erosion.**

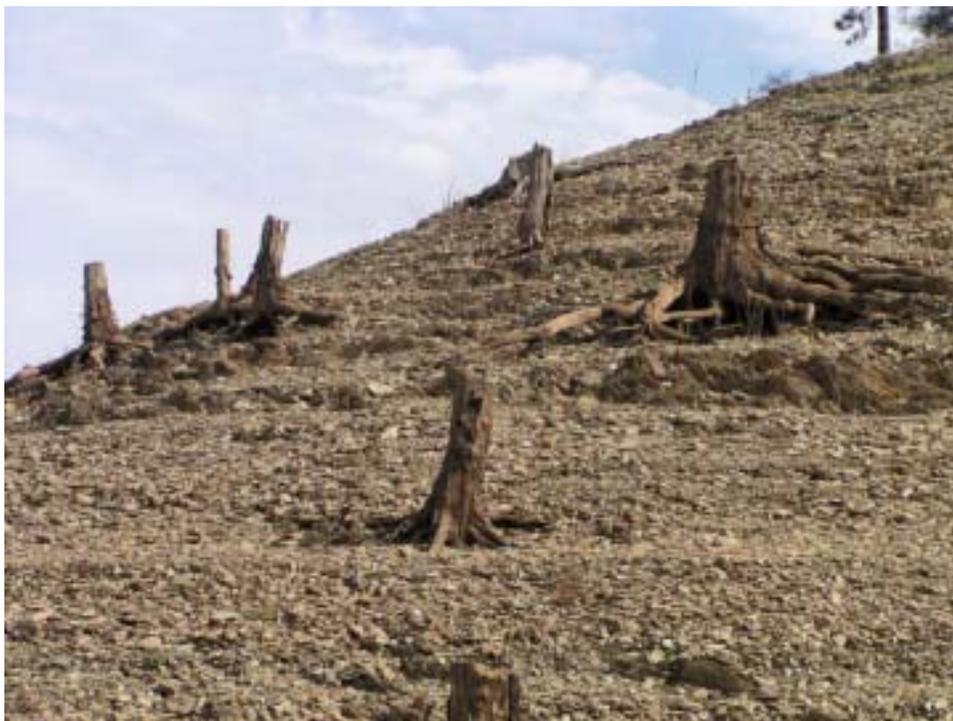
**Photo 6.4-2. Tree stumps, West Branch, Dark Canyon, showing 1 to 2 feet of soil erosion.**

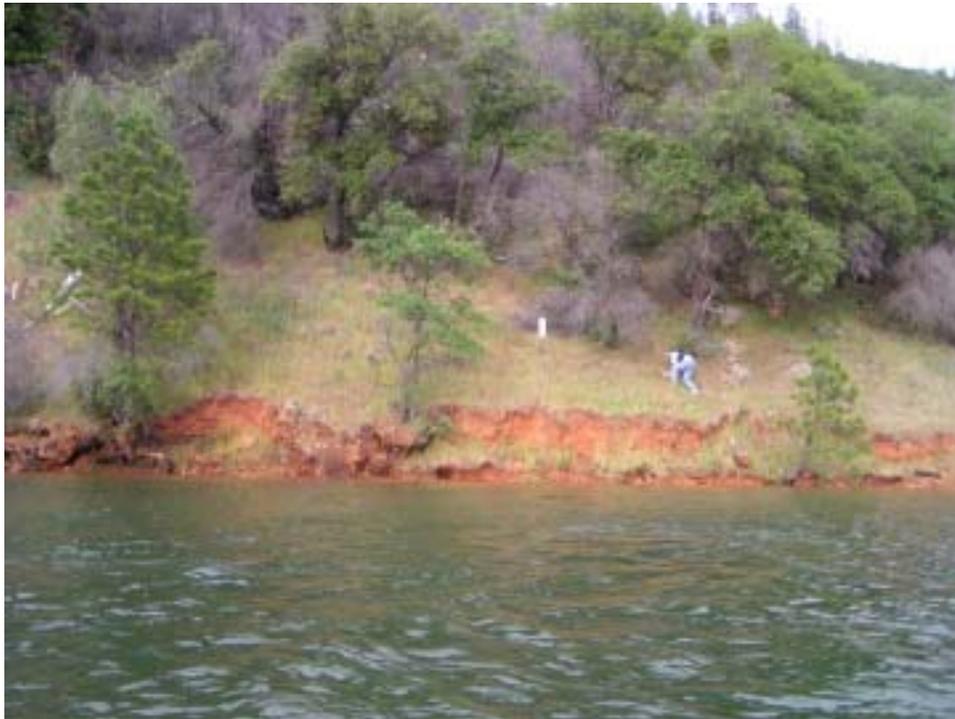
**Photo 6.4-3. Bank erosion at Cross-Section NF-4, showing approximately 5 feet of vertical bank erosion.**

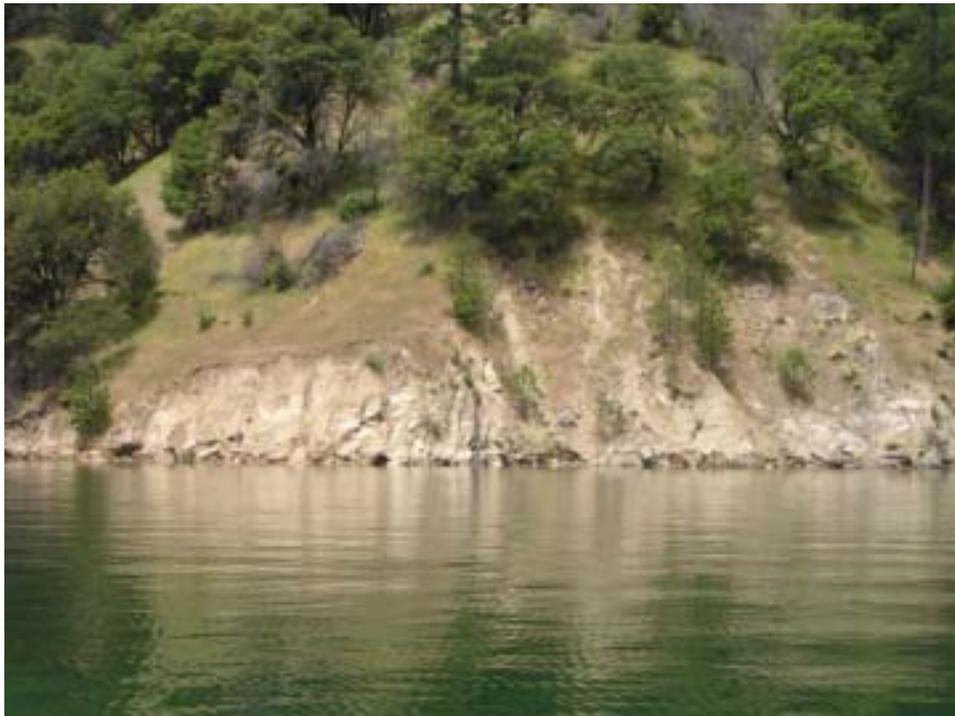
**Photo 6.4-4. High bank erosion merging into active debris slide, Middle Fork.**

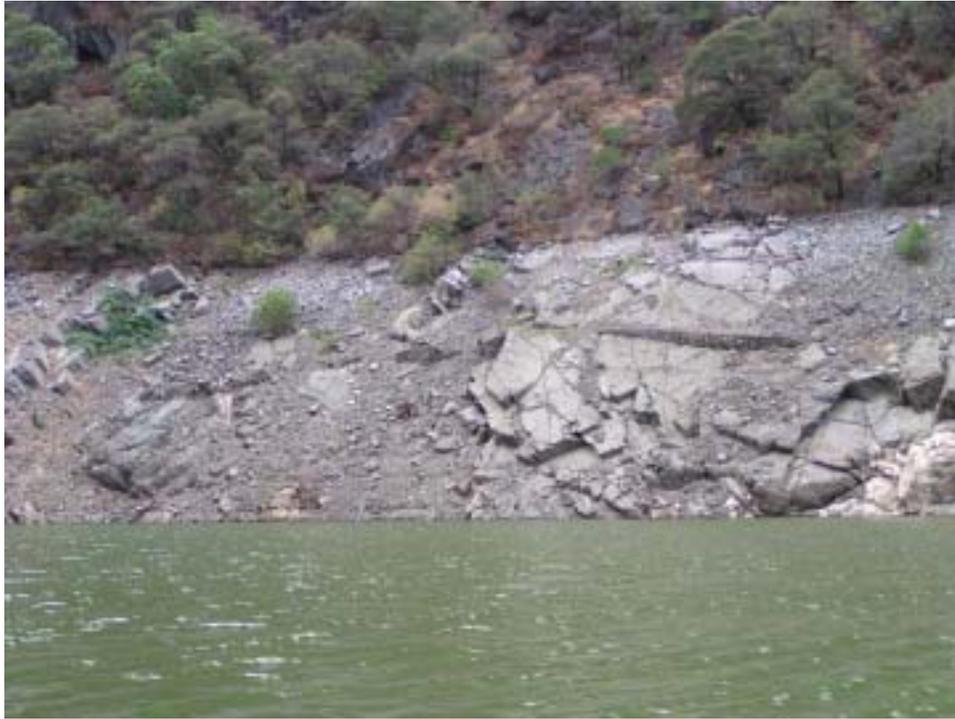
**Photo 6.4-5. Low bank erosion, upper North Fork. Note miner's trail from 1800's.**
