**Estimate of the Number of Spring-Run Chinook  
Salmon Supportable by River Rehabilitation in  
the Narrows Reach of the Lower Yuba River**

Prepared for:	Prepared by:
HEA Steering Committee	Dr. Gregory B. Pasternack
	39601 Lupine Court
	Davis, CA 95616

November 9, 2010

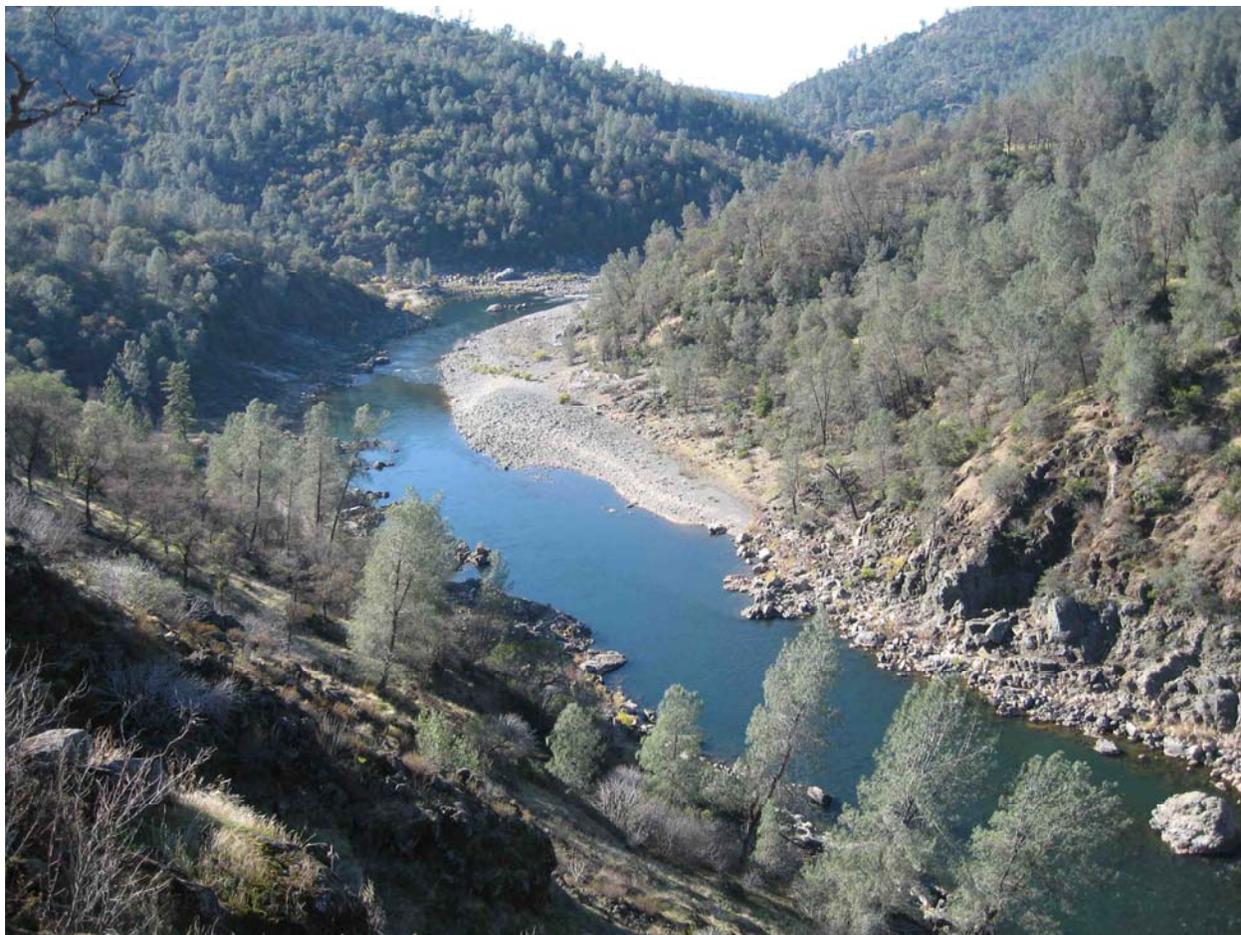
**Figure 3.1.** Oblique photo of the Sinoro Bar area proposed for river rehabilitation as part of the HEA. The proposed project would start at the house-sized boulder in the lower right of the photo and end at the top of the rapid barely visible at the farthest downstream location in the photo (top center).

Pasternack (2010) proposed river rehabilitation in the Sinoro Bar area of the EDR (Fig. 3.1). The goals would be to 1) undo the harm imposed by mechanized gold mining and overly coarse, angular rocks and 2) implement SRCS habitat enhancements to provide an array of sustainable, fish-preferred channel features at the hydraulic-unit and geomorphic-unit spatial scales. Such a project would entail excavating out the existing infill- estimated at a maximum of 128,940 m<sup>3</sup> (168,650 yds<sup>3</sup>)- and then installing roughly the same volume of a mixture of river-rounded gravel/cobble, but distributed according to a carefully vetted design able to yield the necessary array of physical habitat needed to support the different SRCS lifestage requirements. In terms of ecological benefits of such a project relative to HEA goals and specifically the HET, 20 different estimates of supported SRCS were calculated based on different assumptions about the project area, fish behavior, and available adult SRCS. The potential for the project to support SRCS that otherwise presently have no support in that area was most reasonably estimated to be in the range of **10,116-12,644** adult SRCS (full range of uncertainty was 6,136-33,504). When population constraints due to full lifecycle constraints were considered (e.g., ocean and estuarine conditions) as an additional constraint, the most reasonable range of likely supported fish (rather than potential for support) under current conditions was **1,977-5,246**. In other words, the project would create fantastic conditions capable of supporting a large number of SRCS, but in fact there are far fewer SRCS in the LYR currently; thus, in actuality the likely supported run under current conditions would be smaller than the full potential. One benefit of having such a large excess of high-quality physical habitat available is that it would enable both fall-run and spring-run Chinook salmon to utilize the same area without having the fall-run decimate SRCS redds. The potential habitat from a Sinoro Bar project is large enough to meet both runs' needs.

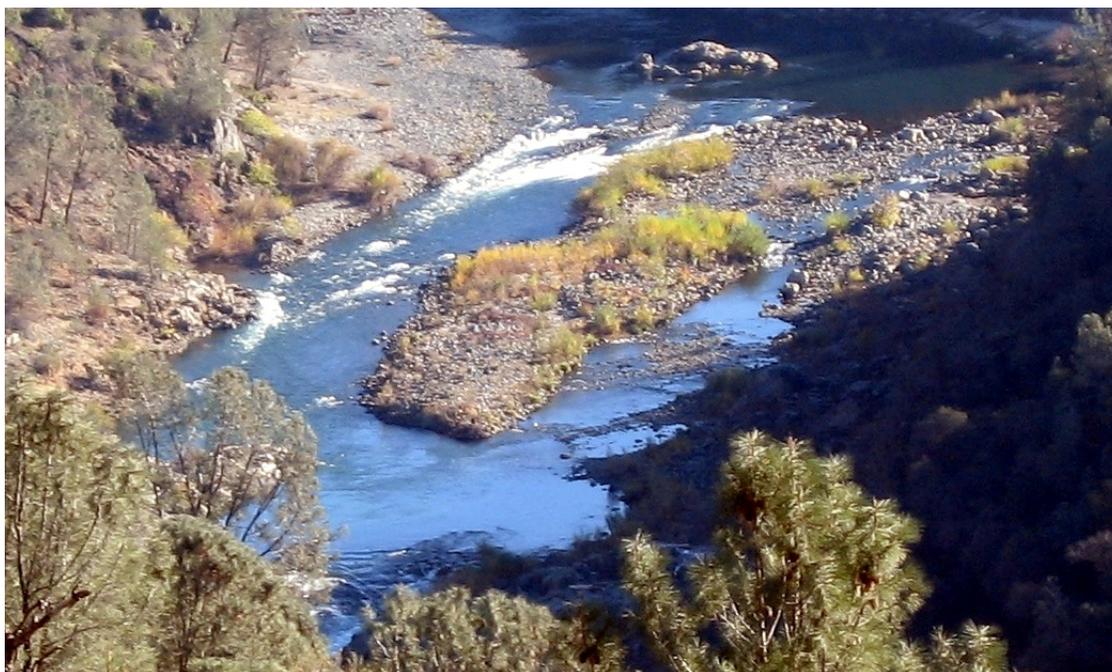
**Figure 4.3.** High oblique view of Narrows Gateway taken on 11/29/2006.

In terms of hydraulic-unit scale features in the Narrows Gateway, a site recon and aerial photo interpretation were used to visually estimate what was present (Fig. 4.2-4.3). The morphological unit classification of Pasternack (2008b) was used to define these units at the 0.1 to 1 W spatial scale. Given the steep slope of the channel here and the constricting role of the cobble bar, the features are primarily high-velocity units – rapids, chutes, and runs. The two pools are forced by bedrock outcrops and are deep. In the side channel there is riffle habitat, but the flow is regulated by Lake Wildwood on Deer Creek. Vegetation has grown onto much of the bar, indicating that it is not actively changing in recent years.

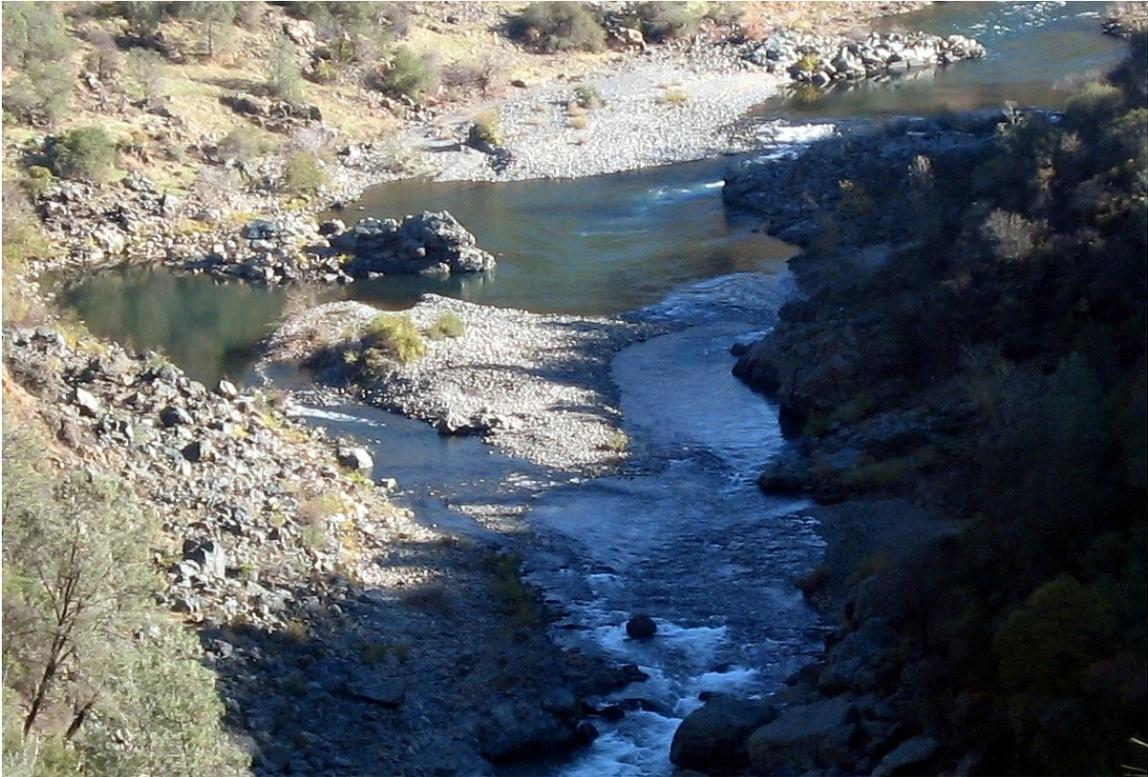
**Figure 4.5.** High oblique view of Narrows S-turn and the top of Skinny Escalator taken on 11/29/2006. This view highlights the width constriction causing the deposit of the medial bar and shows the relative incision of the main channel compared to the side channel.

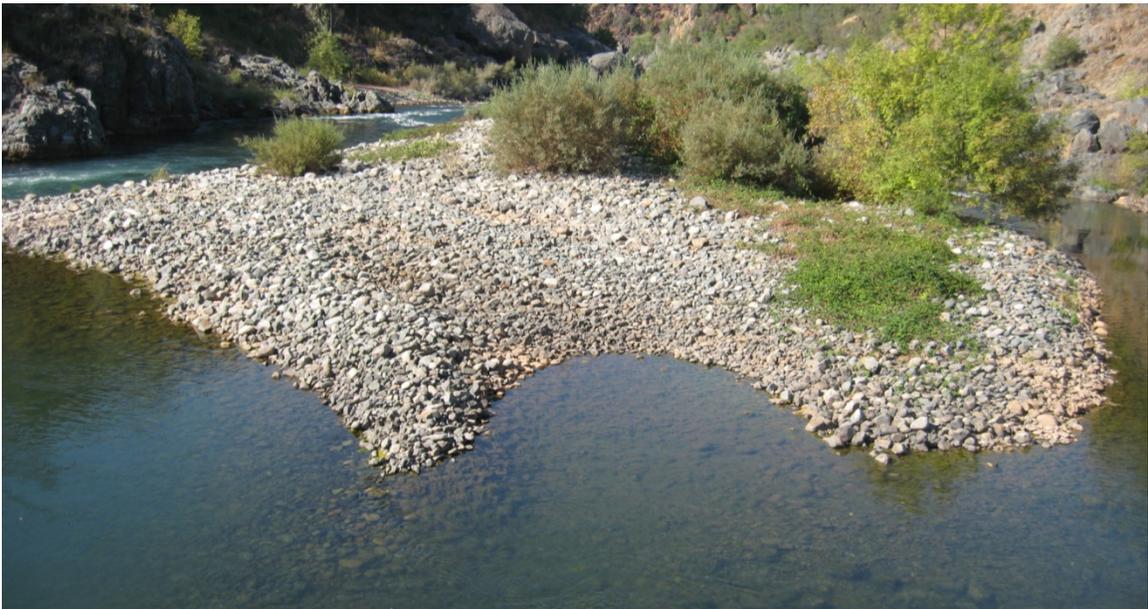
**Figure 4.6.** Medial cobble bar near the end of Narrows S-turn.

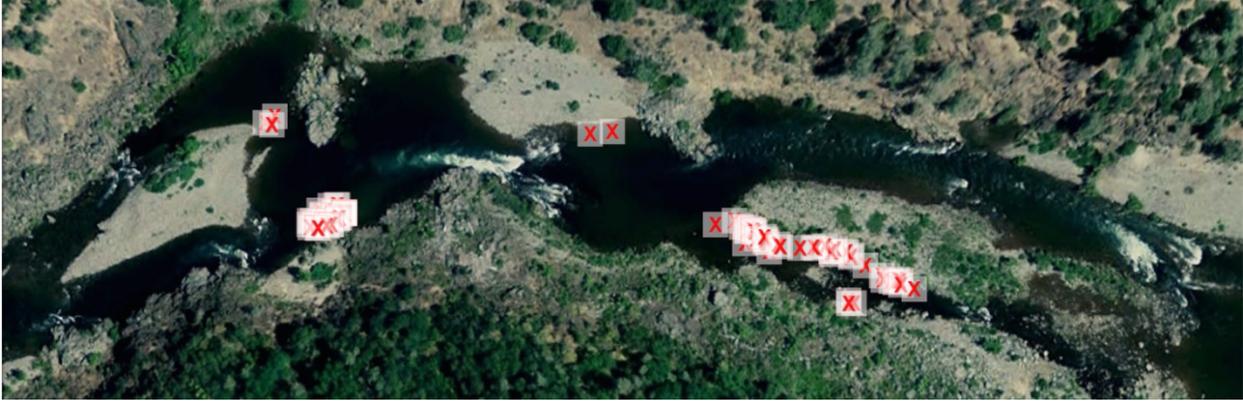
**Figure 4.7.** 2007 aerial photo of Narrows Gateway and S-turn showing the locations of redds in the September 2009 to March 2010 spawning period. No redds were observed in the other NR geomorphic units. (data courtesy the LYR Accord RMT)

The RMT has established a standard protocol for mapping all observed redds on the entire LYR in translucent water depths on a weekly basis. The protocol is available at <http://www.yubaaccordrmt.com>. Using this procedure, 84 redds were observed in the Narrows Reach between September 2009 and March 2010 (Fig. 4.7). The redds are concentrated in two primary and two secondary areas. One primary area was the side channel in Narrows Gateway. This is the area that receives a high outflow from Deer Creek during flushing operations in Lake Wildwood every October, which happens to be the peak of fall-run Chinook salmon spawning. Spawners were distributed all down the length of the side channel. The other primary area was the second rapid entrance in Narrows S-turn. At this site 2009 spawning was densely packed into a small area. This site was visited in 2010 during the period of phenotypic SRCS spawning and 25 adult spawners were directly observed (Fig. 4.8), with indications of many more present holding in the pool upstream of the site and in the other nearby pool to the north behind the large bedrock peninsula. In Figure 4.8 several fish are clearly discernable as well as a clean gravel substrate. Besides these primary spawning areas, there is a small amount of spawning on the large lateral bar on the north side of S-turn and at the top of the medial bar, where a submerged finger of the bar composed of gravel creates riffle-like habitat as water flows into the side channel. In the 2010 recon for this study, a large SRCS redd was observed at this location and several SRCS spawners were observed in this area and moving around nearby (Fig. 4.9). A movie was made of their activity. It appeared that the fish were all moving to the exact same spot with excellent microhabitat hydraulics, but that spot was devoid of suitably sized gravel, because it had all already been used in a large redd just downstream.

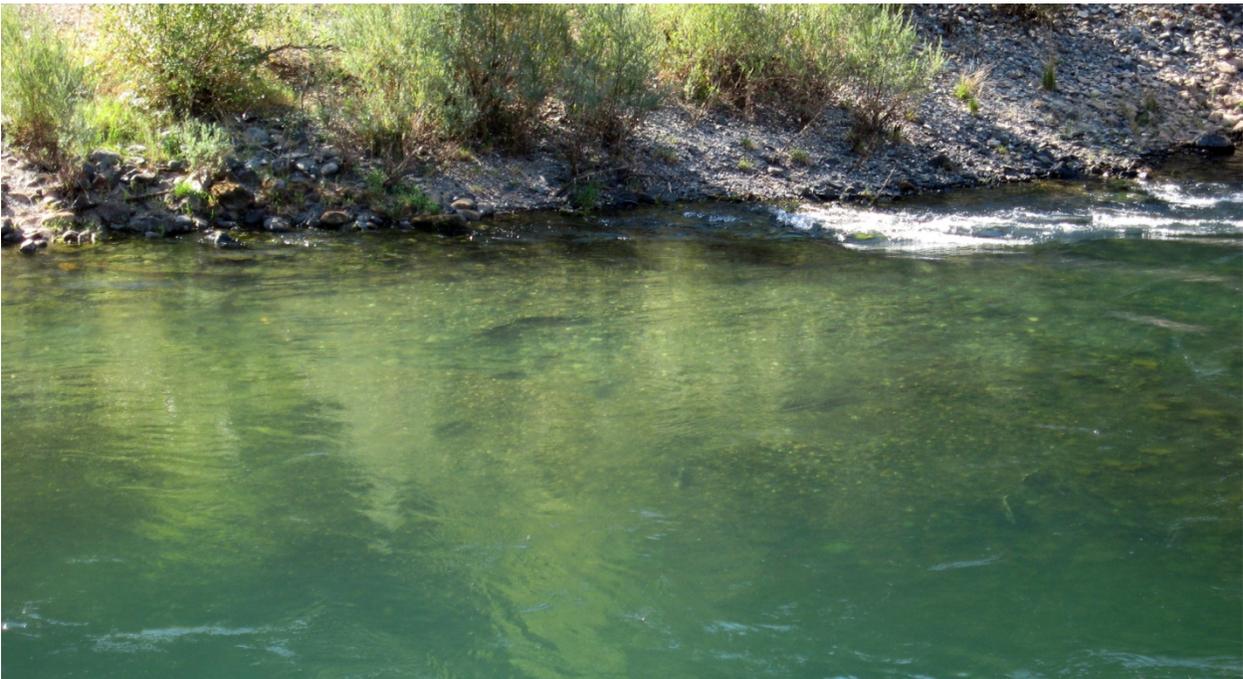
**Figure 4.8.** Photo of dense (phenotypic) SRCS spawning activity on 10/1/2010 at the second rapid entrance in the Narrows S-turn geomorphic unit.

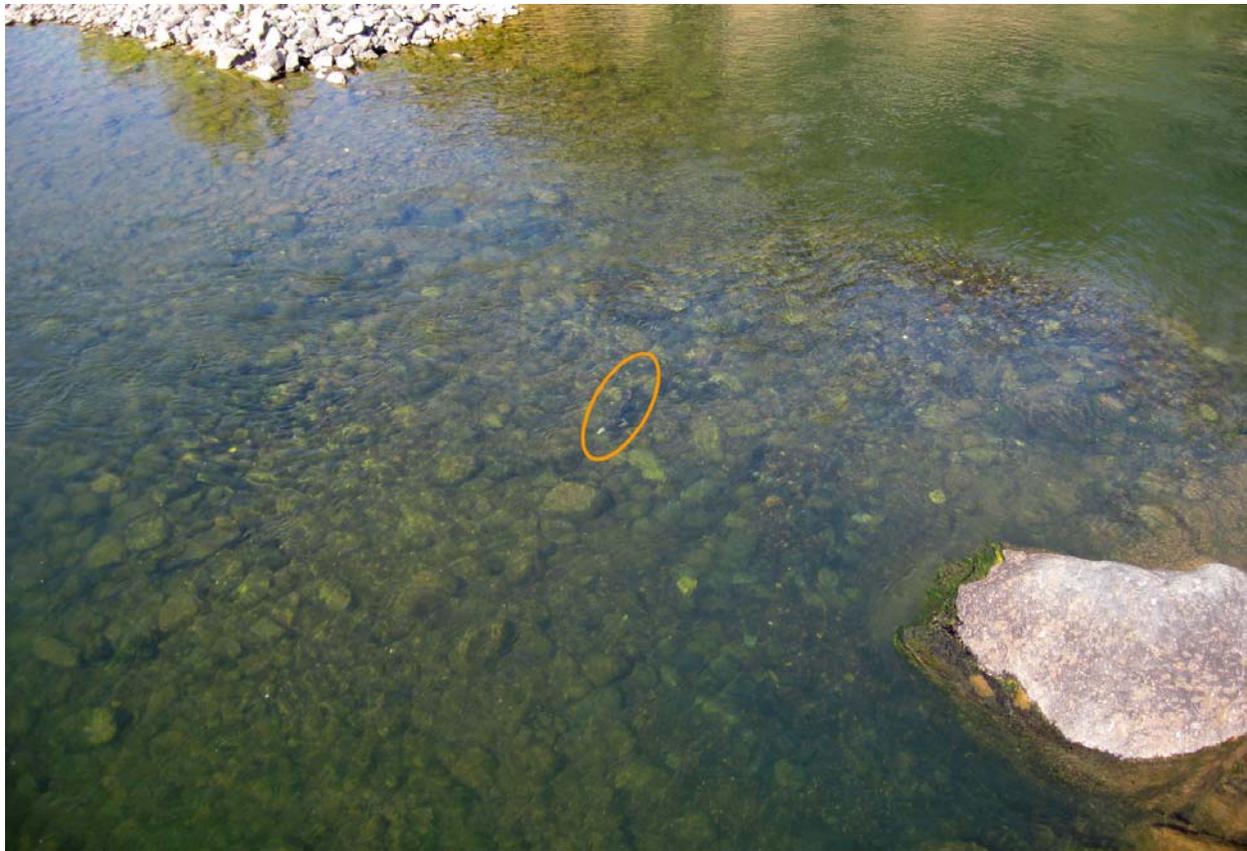
**Figure 4.9.** Photo of an adult SRCS (center of photo) hovering at the point of optimal microhabitat hydraulics where the substrate is on the coarse side for preferred spawning. A large redd composed of suitably sized gravel/cobble is present in the center right of the photo.

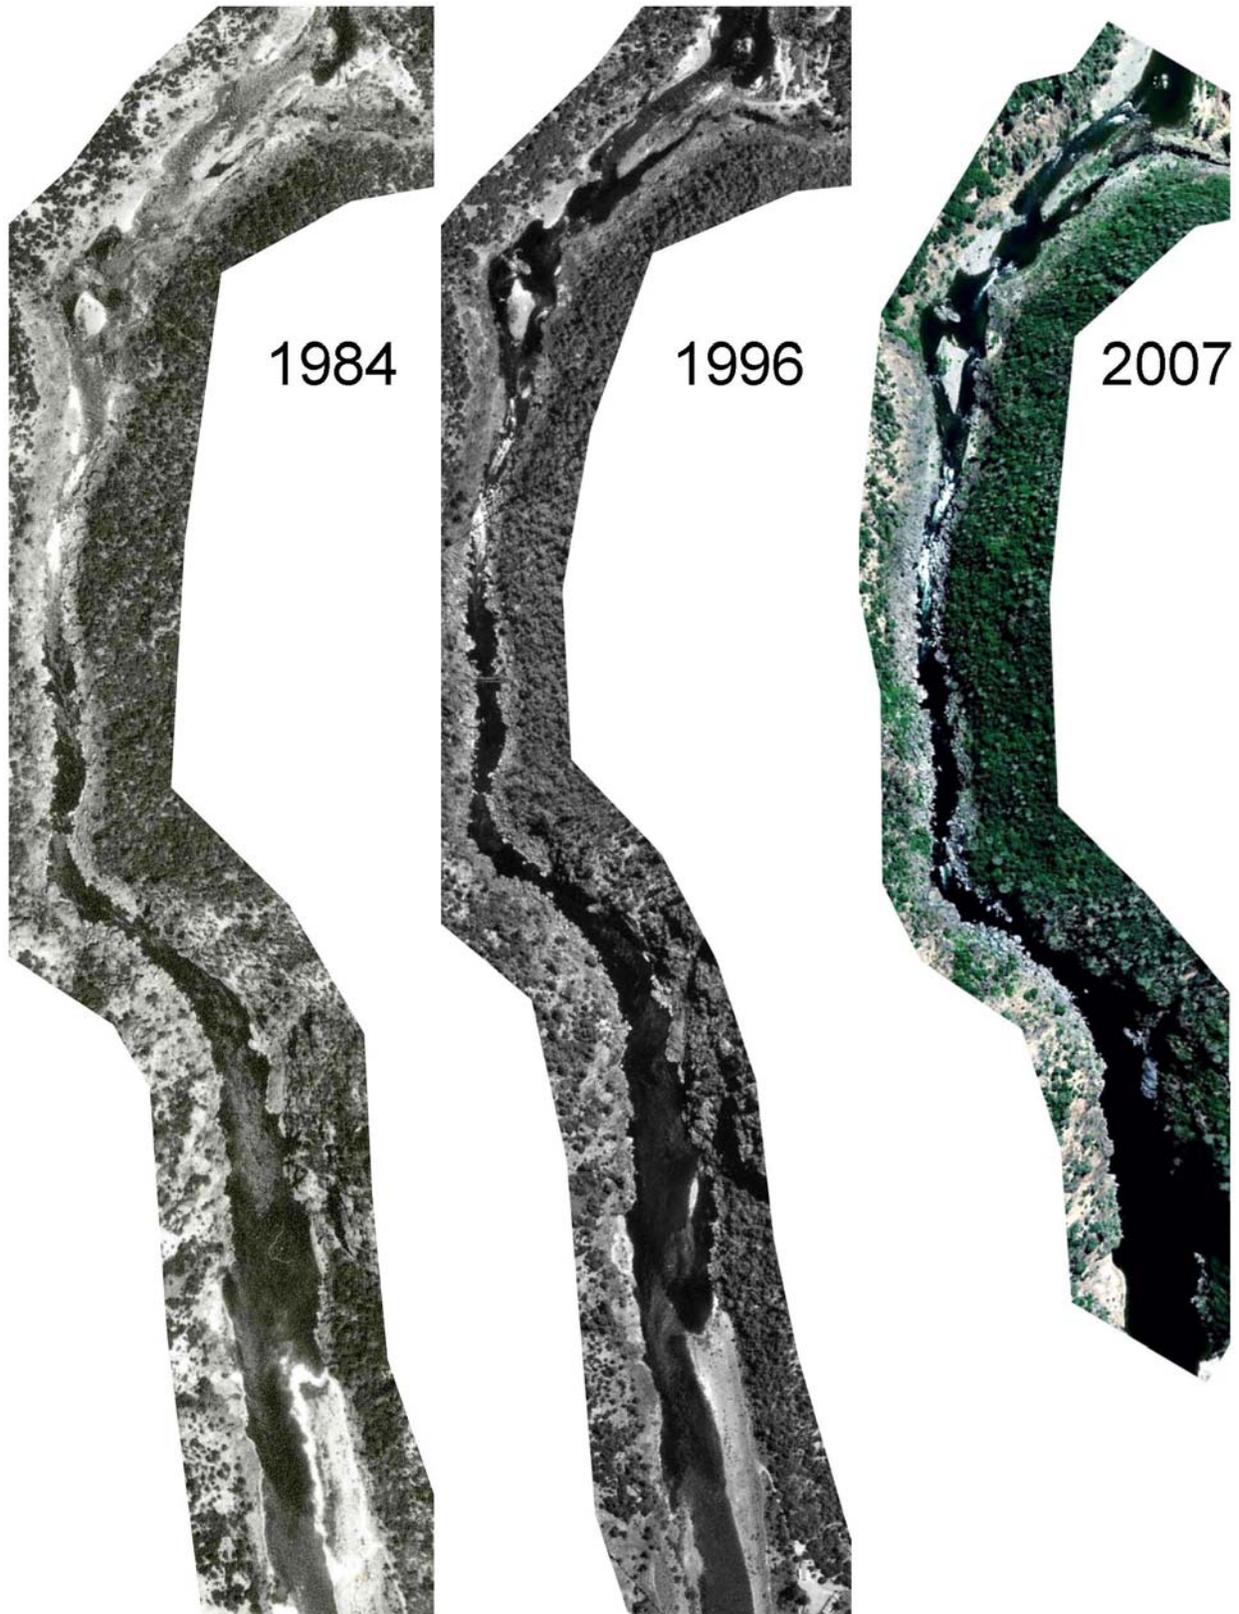
**Figure 5.2.** Comparison of selected NR aerial images 1984-2007.

After the 100,000 cfs flood of February 19, 1986 there was not much change (Fig. 5.2). No other large events occurred, so the 1991 and 1996 aerial photos look similar. An important indicator shared by the 1986, 1991, and 1996 photos is that there is strong visual evidence of an alluvial riffle midway down the Narrows Pool.

The next big flood was a rain-on-snow event on January 2, 1997. The next photo thereafter is from the Army Corps topographic survey in 1999 (Fig. 5.2). In that photo the pre-existing riffle midway down the Narrows Pool is gone and there is now a very deep scour pool instead. This has been the condition of the Narrows Pool ever since.
