California Levee Vegetation Research Program (CLVRP)

Informational Circular No. 2: Summary of Research Completed to Date

December 12, 2011

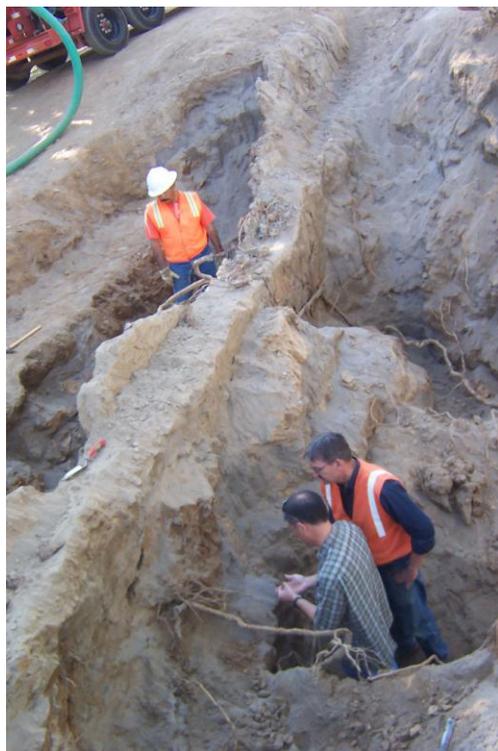
Exposed slurry wall (Pocket area levee)

Dr. Les Harder, a levee geotechnical engineer and researcher with HDR, Inc., has excavated trenches in a Sacramento-area levee to study tree root penetration into an 18-year-old soil-cement-bentonite (SCB) wall designed to cut off water seeping through the levee. Excavations in 2009 revealed that roots from a large black walnut tree growing at the top of levee had been encountered during the original construction of the wall and were cut or broken at the edge of the wall by construction equipment in 1991. However, over time, many of the cut roots had regenerated new branch roots which were

observed to grow laterally along the outside edge and within the outer few inches of the SCB wall – sometimes for distances of up to 10 feet. The 18-inch-thick SCB wall was also observed to have small, vertical cracks. In some cases cracks were exploited by small roots growing along the outside portion of the wall, at times penetrating through the SCB wall. In 2010, Dr. Harder undertook a follow-up slurry wall trenching investigation along the same SCB wall opposite valley oak and cottonwood trees. The trenches opposite valley oak trees showed no significant root penetration into the levee at a distance of 15 feet or more. A separate excavation in this area, however, revealed that cottonwood roots had penetrated the levee (both perpendicular and parallel to the levee) from trees as far away as 50 to 100 feet. Similar to observations in 2009, several cottonwood roots penetrated the wall through small vertical cracks. In 2010 ground squirrel burrows were also observed in the levee and in the SCB wall. The burrows were found approximately 4 to 5.5 feet below the levee crown, and approximately 15 - 20 feet horizontally into the levee slope.

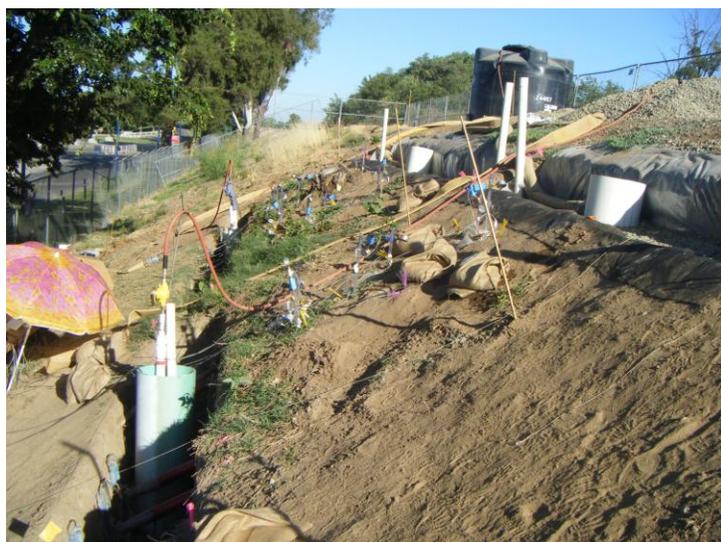
Decomposing stump field test site at Cal Expo

Between August and November of 2010, UC Berkeley researchers in the Department of Civil and Environmental Engineering conducted a field test to examine the effects of live and decaying root systems on seepage and slope stability on a levee bordering the American River near the California Exposition and State Fair (Cal Expo) grounds in Sacramento. The test consisted of constructing 45-foot-long parallel trenches on the landside slope above and below a decomposing eucalyptus stump. The trenches extended into a control area away from the stump and decomposing root system. The upper trench (2 feet wide by 3 feet deep) was filled with water and held at constant head to simulate and induce a slope-parallel wetting front through the levee. The lower trench was left open to view the effect on the progression of seepage caused by tree roots and other anomalies found in the trench walls. Piezometers and tensiometers installed across the test section of levee were used to describe the

wetting and flow patterns as they evolved within the levee during the test. Based on observations made during the flow test, wetting front and water flow patterns appeared to be dominated by flow through a network of shallow small mammal burrows. Though intermittent gaps associated with decomposing roots were observed, the gaps did not result in preferential water flow between the upper and lower trenches. Advancement of the wetting front appeared to be delayed in the area of the stump. Instrument data and preliminary computer simulations support the basic patterns observed in the field test.

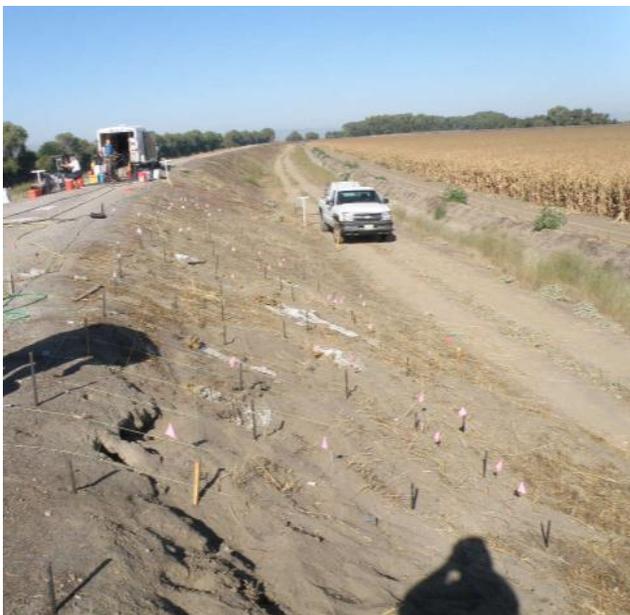
Levee site pre excavation

UC Berkeley recently completed field work for a burrow grouting study to ascertain the extent of mammal burrows on a Sacramento River levee segment near Kirkville, CA with no woody vegetation. The objectives of the test were twofold: to assess the extent and architecture of the mammal burrow networks in a previously un-grouted sandy levee; and to study the efficacy of current California Department of Water Resources (DWR) grouting techniques. Two methods of grouting were used: first, DWR performed their regular grouting procedure by injecting a standard gray cement-bentonite grout into the largest burrows that were visible on the levee surface. Subsequently, a urethane-based chemical grout, colored with pink dye, was injected in perforated stand pipes arranged in a 1.2 m x 1.2 m grid pattern to fill burrows potentially not fully grouted in the first round and other holes with no

Preliminary observations of the test exposed a complex system of burrows that seemed to be highly dependent on soil stratigraphy. The excavations on the waterside slope exposed a single large burrow near the toe, and the excavations on the landside slope exposed a series of interconnected squirrel burrows that extended both horizontally and vertically for several tens of feet in the direction parallel to the levee alignment. No tunnels were found that extended through the levee from landside to waterside.

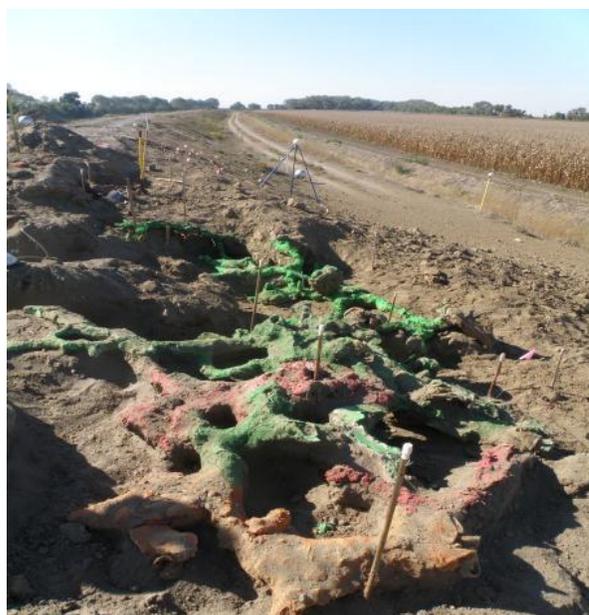
Post excavation - site with grouted excavated burrows

visible surface expression. As the levee was excavated burrows grouted with standard grout were painted green to distinguish them prior to T-LiDAR imagery taken by USGS. The data collected will be used to estimate the volume of voids created by burrowing mammals within the embankment, differentiating between the two types of grout (pictures next page).
