4.2 Watershed Characterization

4.2.1 Watershed Boundaries

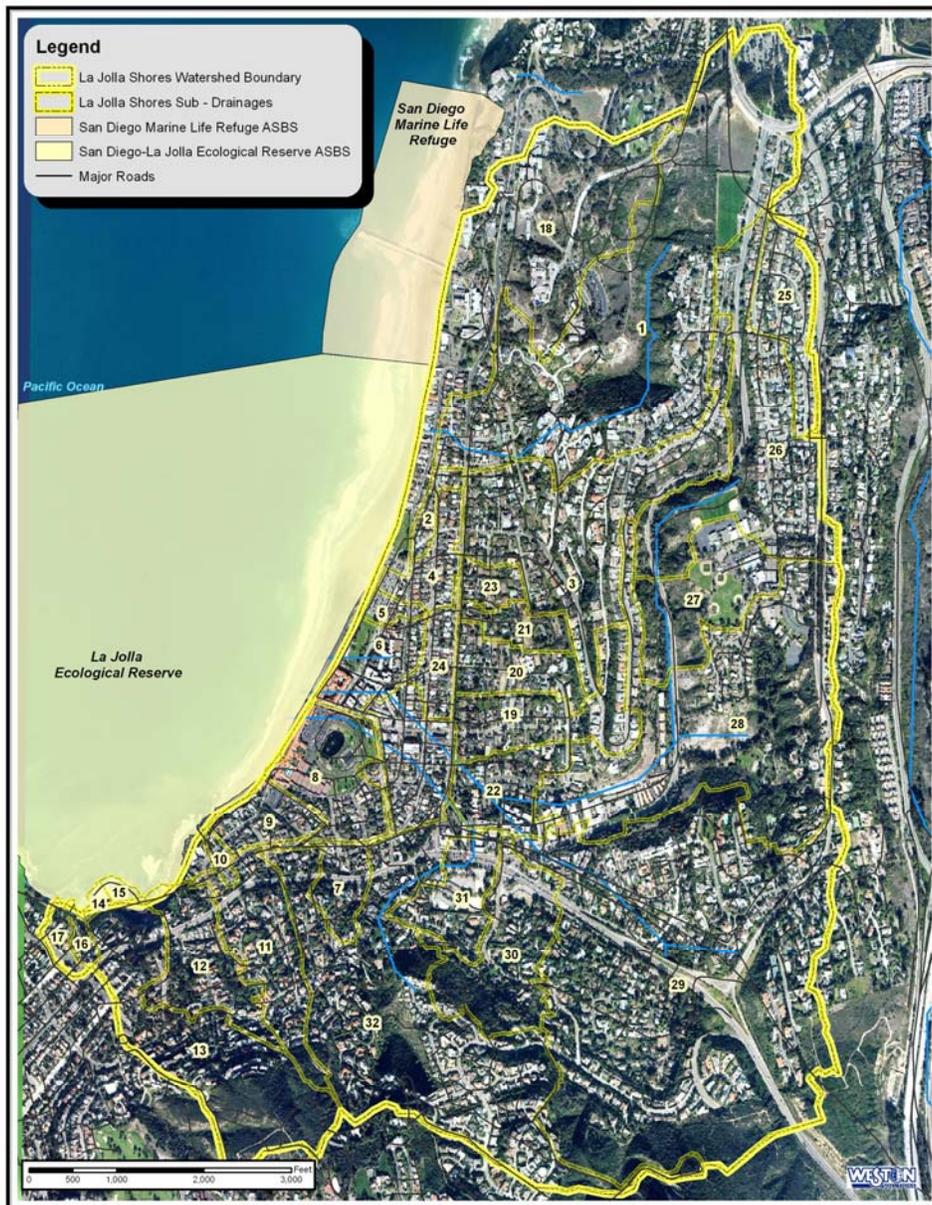
Figure 4-3. Sub-drainages within the La Jolla Shores Coastal Watershed.

The La Jolla Shores Coastal Watershed is located in La Jolla, California, within the limits of the City of San Diego. The watershed is 1,614 square acres and is roughly bounded by the Pacific Ocean shoreline to the west and La Jolla Scenic Drive to the east. The intersection of La Jolla Shores Drive and Torrey Pines Road marks the farthest northern point of the watershed and South Via Casa Alta the most southern point. The slope of the land rises from the coast up to about 800 feet at Mt. Soledad. Within the watershed boundaries there are 32 distinct sub-drainage areas (Figure 4-3).

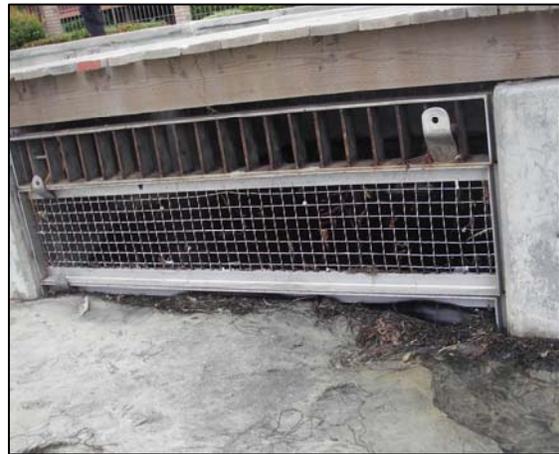
Figure 4-4. A storm water catchment basin located on the beach at Avenida de la Playa. Direct discharge to beach visible in lower left corner.

Much of the central portion of the La Jolla Coastal Shores Watershed generally drains to a storm drain catch basin located directly on the beach at Avenida de la Playa, which then discharges runoff directly to the ASBS (Figure 4-4).
