Appendix F.
Hazardous Materials Background Information

**PHASE I ENVIRONMENTAL SITE
ASSESSMENT
ARROYO GRANDE CREEK
ARROYO GRANDE, CALIFORNIA**

Kleinfelder Job No: 96612

REGIONAL GEOLOGIC MAP
Arroyo Grande Creek
Waterways Management Plan
San Luis Obispo County, California

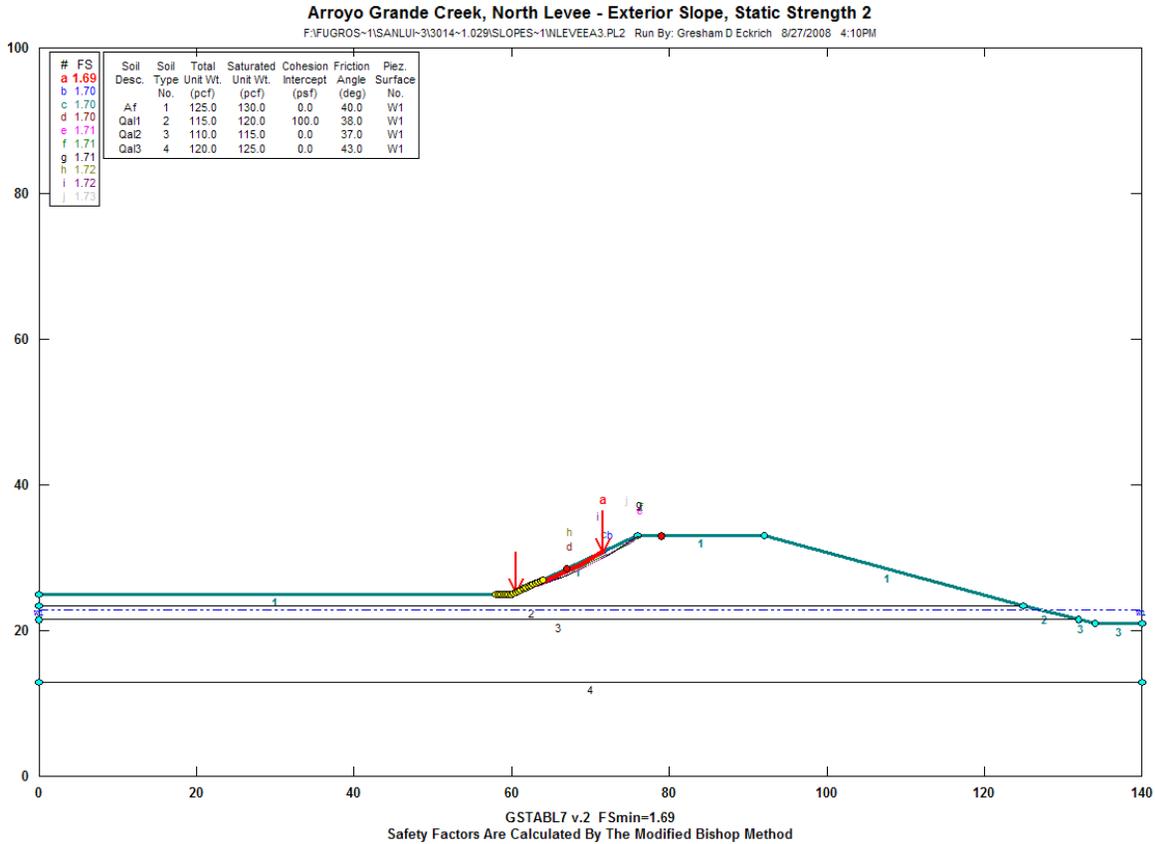
SLOPE STABILITY PLOT FOR NORTH LEVEE EMBANKMENT
 Arroyo Grande Creek Waterways Management Plan
 San Luis Obispo County, California

ESTIMATED FACTORS OF SAFETY

Static Loading Condition: 1.7
Pseudostatic Loading Condition: 1.2
Pseudostatic Coefficient: 0.15
Condition: Existing Exterior Slope, Static Loading

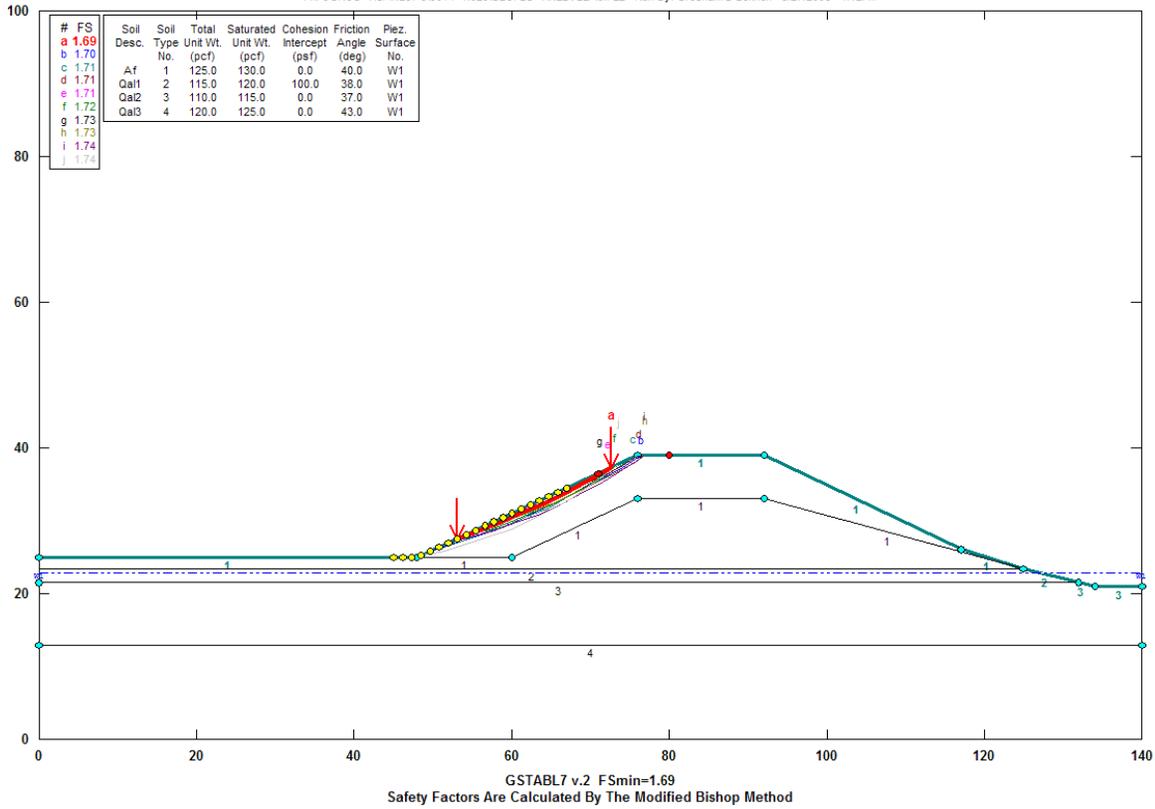
SLOPE STABILITY PLOT FOR NORTH LEVEE EMBANKMENT
 Arroyo Grande Creek Waterways Management Plan
 San Luis Obispo County, California

ESTIMATED FACTORS OF SAFETY

Static Loading Condition: 1.7
Pseudostatic Loading Condition: 1.2
Pseudostatic Coefficient: 0.15
Condition: Proposed Exterior Slope 1, Static Loading

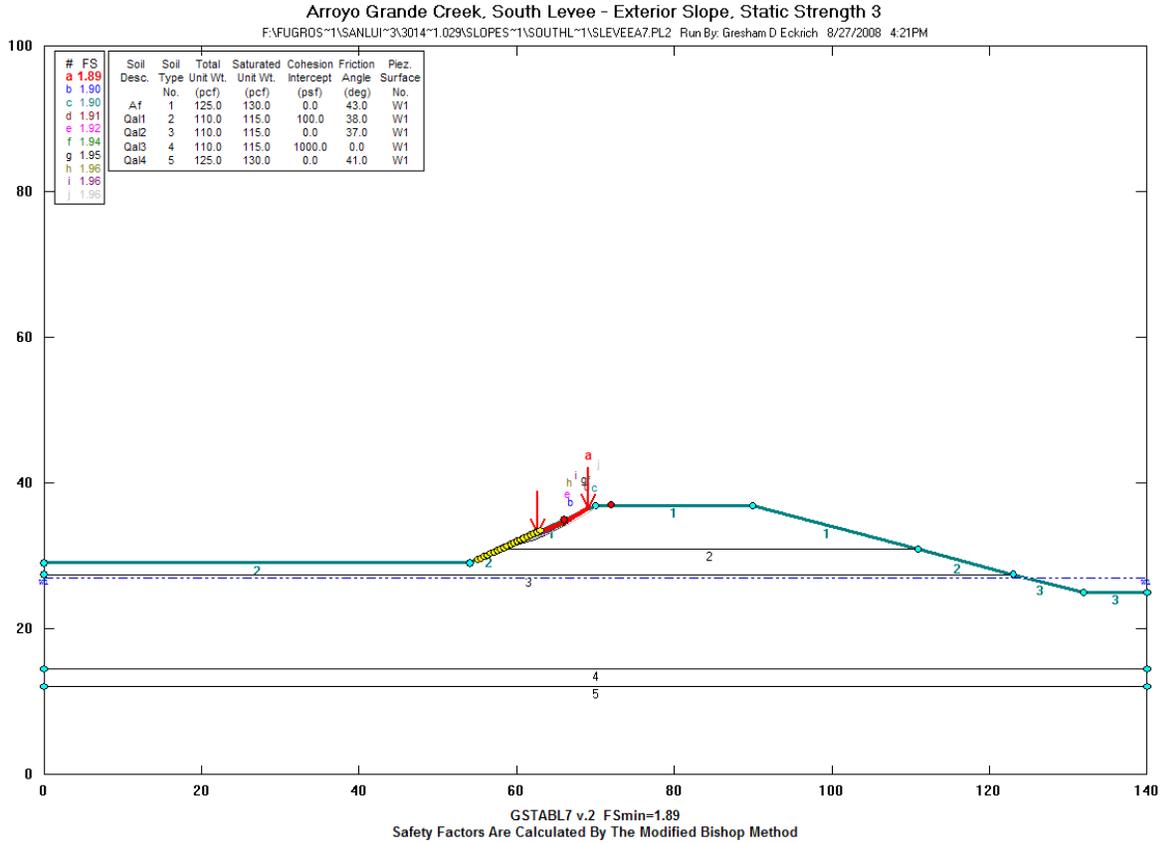
SLOPE STABILITY PLOT FOR SOUTH LEVEE EMBANKMENT
 Arroyo Grande Creek Waterways Management Plan
 San Luis Obispo County, California

ESTIMATED FACTORS OF SAFETY

Static Loading Condition: 1.9
Pseudostatic Loading Condition: 1.3
Pseudostatic Coefficient: 0.15
Condition: Existing Exterior Slope, Static Loading

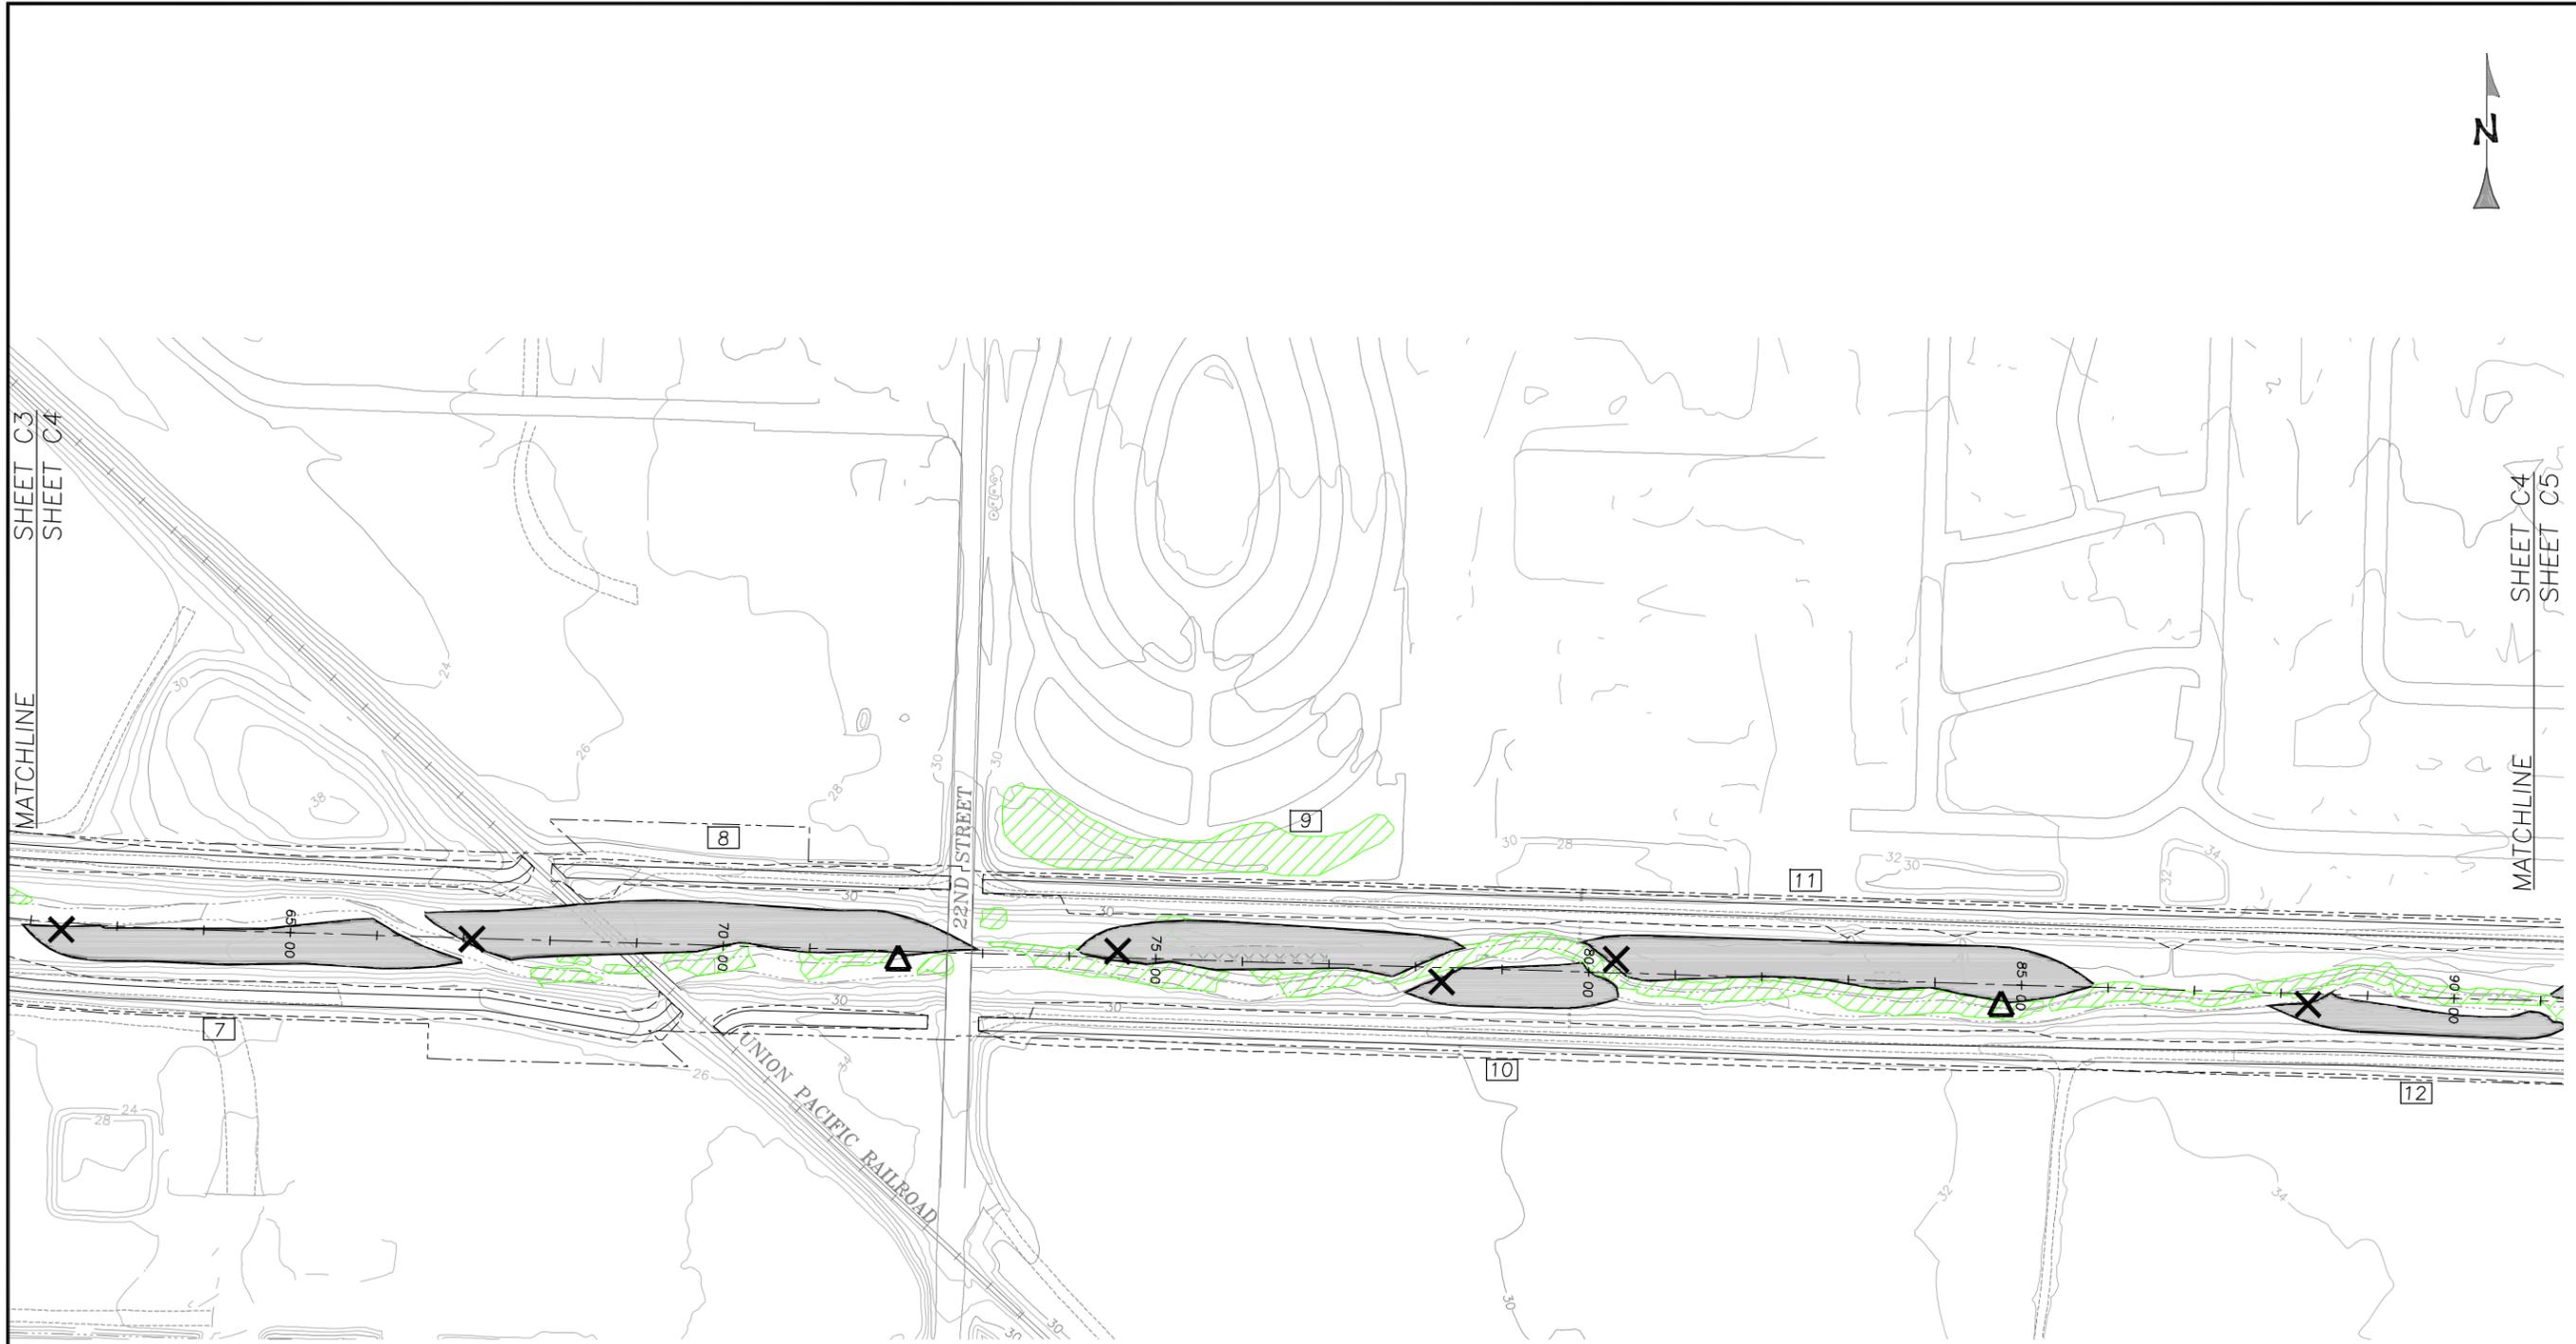
SITE PLAN
SCALE: 1"=100'

SITE	GRADING SITE FINISHED GRADE EL.	EXCAVATION VOLUME (CY)	LENGTH APPROX (FT)	AVG. DEPTH (FT)
7	21 TO 22	193	450	0.3
8	22 TO 24	1,121	560	1.1
9	24.5 TO 25.8	738	400	1.0
10	25.8 TO 26.1	498	210	1.4
11	26.2 TO 28.5	1,262	530	1.3
12	29 TO 29.2	243	300	0.6

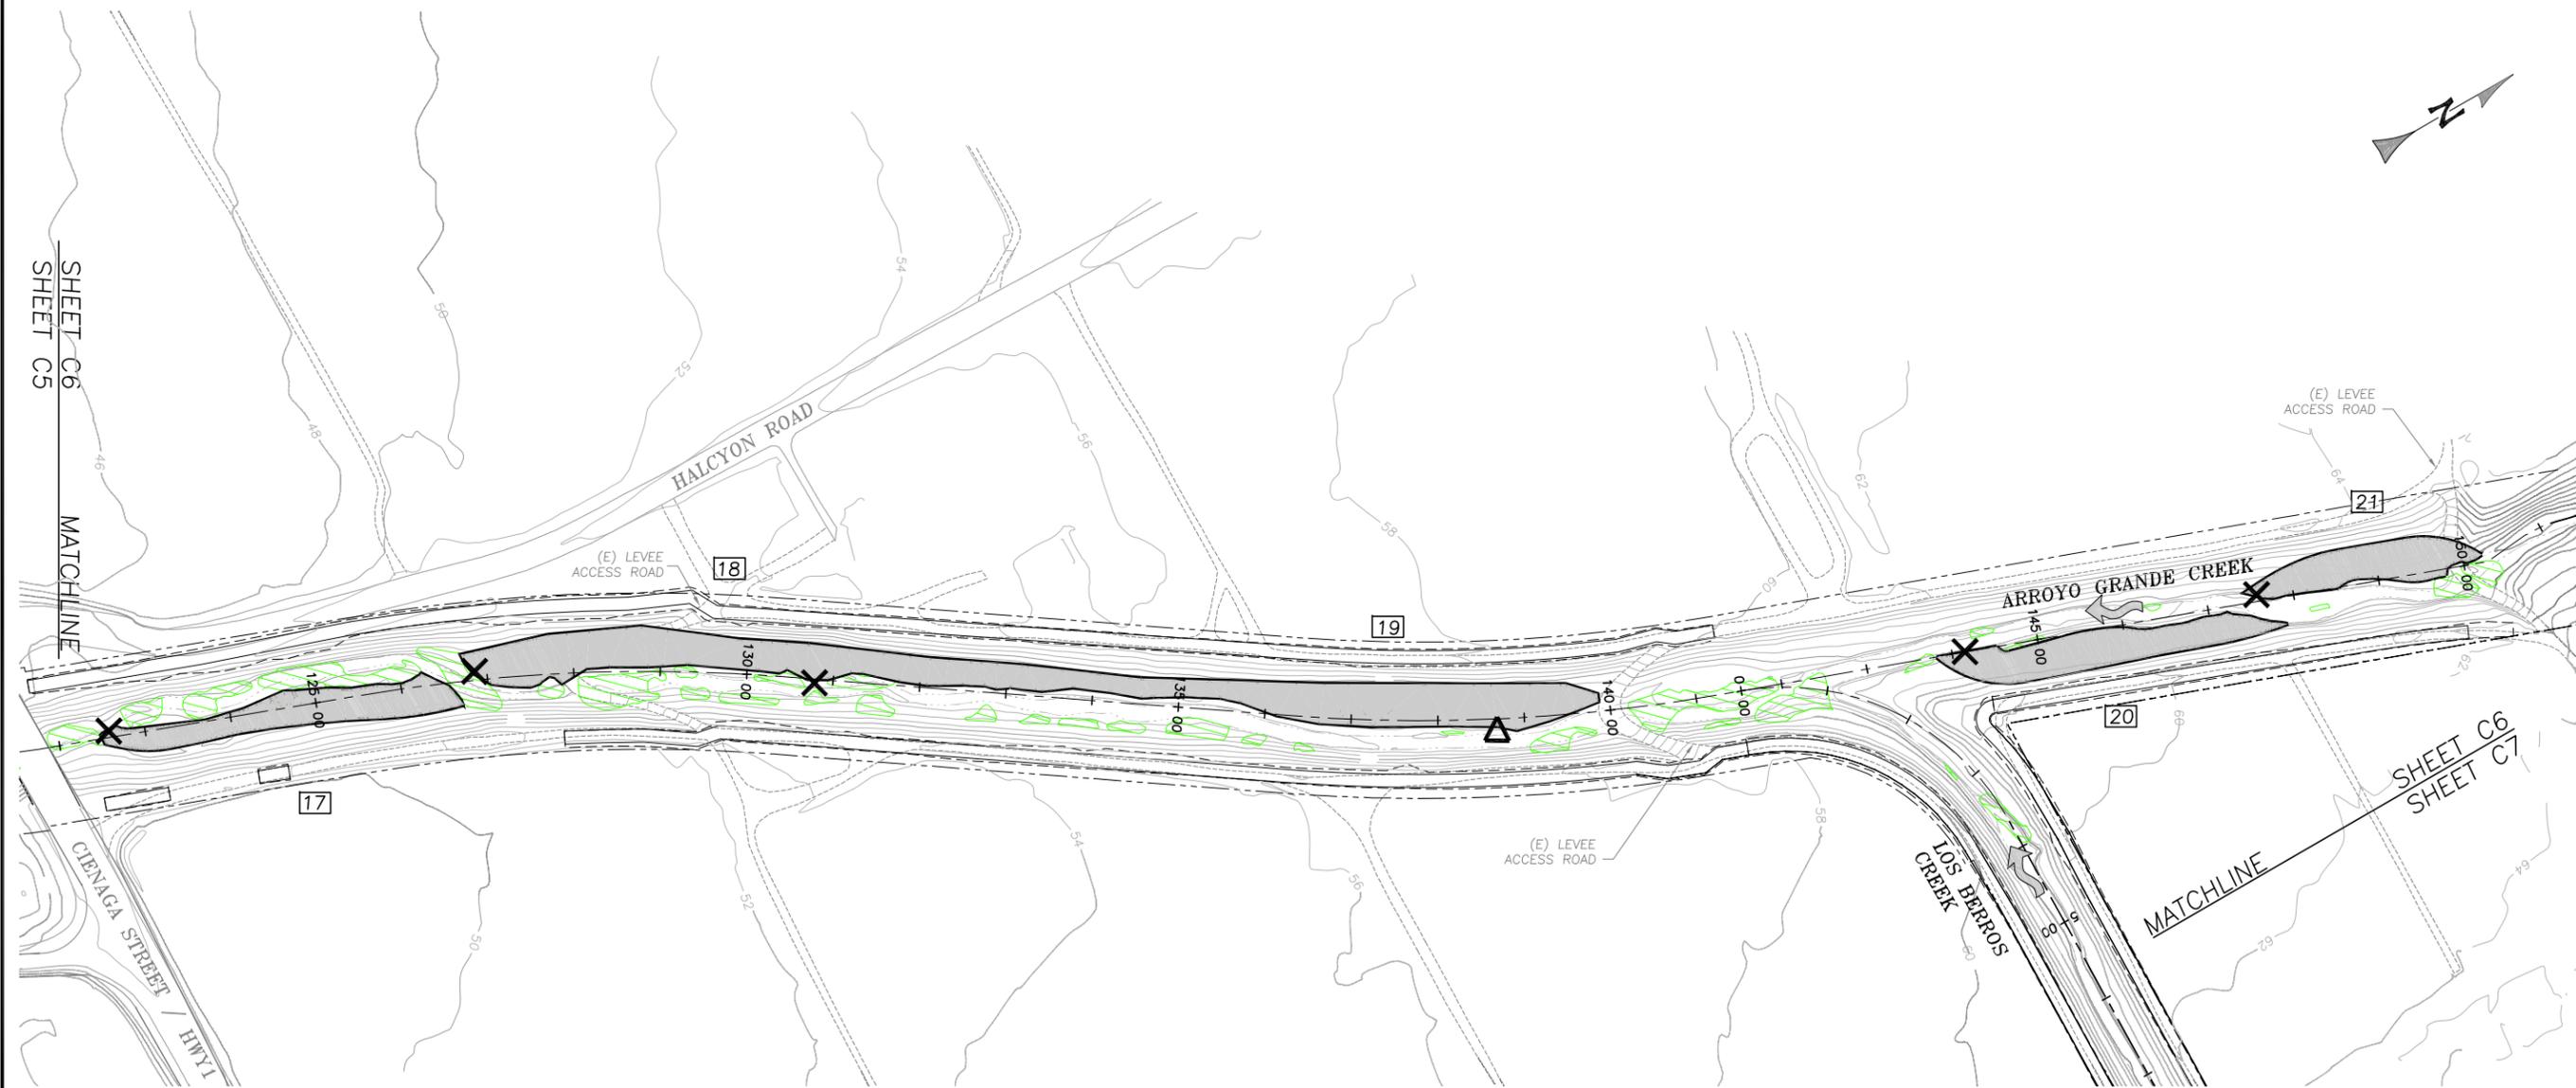
SITE PLAN
SCALE: 1"=100'

SITE	GRADING SITE FINISHED GRADE EL.	EXCAVATION VOLUME (CY)	LENGTH APPROX (FT)	AVG. DEPTH (FT)
17	38.5 TO 40.5	605	400	1.2
18	40.5 TO 44	615	490	0.8
19	44 TO 46	504	800	0.5
20	47 TO 48	767	350	1.3
21	48.5 TO 49	532	250	1.3
