Conceptual Mitigation Monitoring Plan
for the
Lower Berryessa Creek Program Elements:
Lower Berryessa Creek and Lower Calera Creek

December, 2012

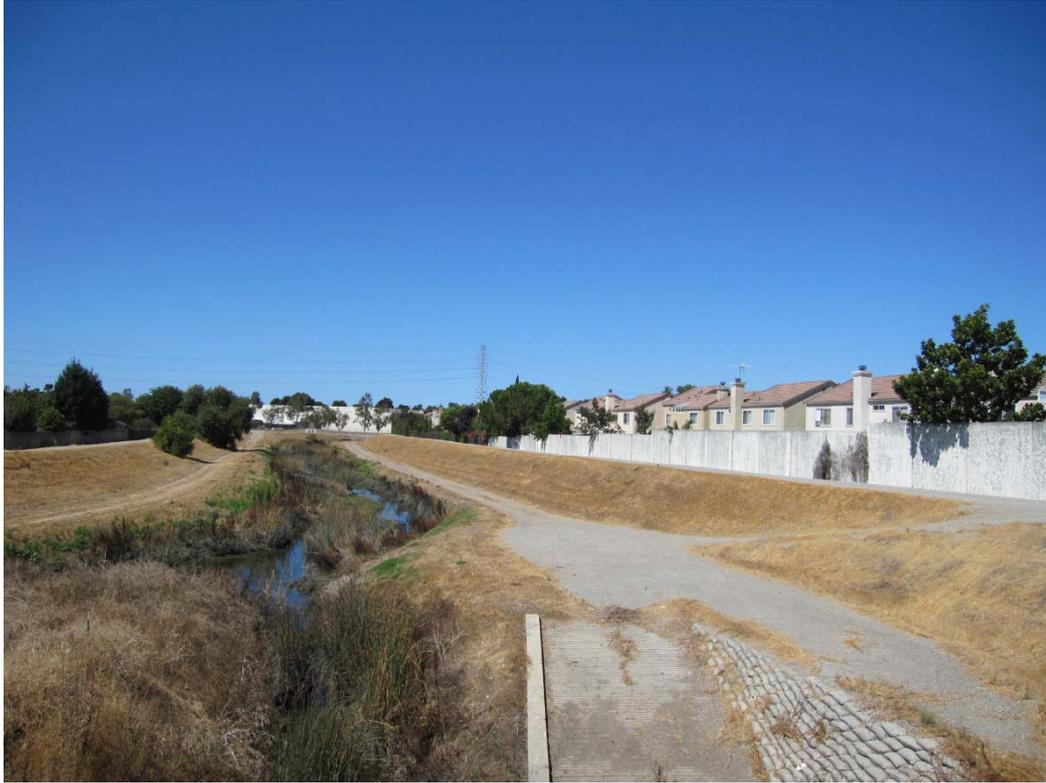
Figure 4. West view of Lower Berryessa Creek (Reach A), looking downstream toward the Lower Penitencia Creek confluence.

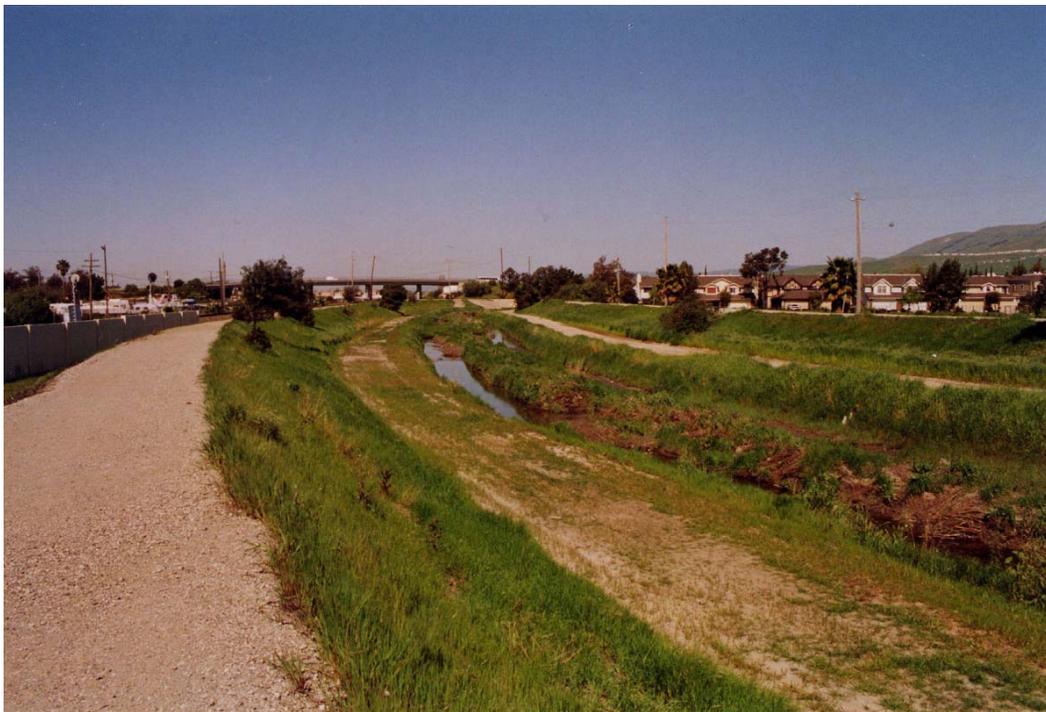
Figure 5. Northwest view of Lower Berryessa Creek (Reach D) with the Abel Street Bridge in the background.

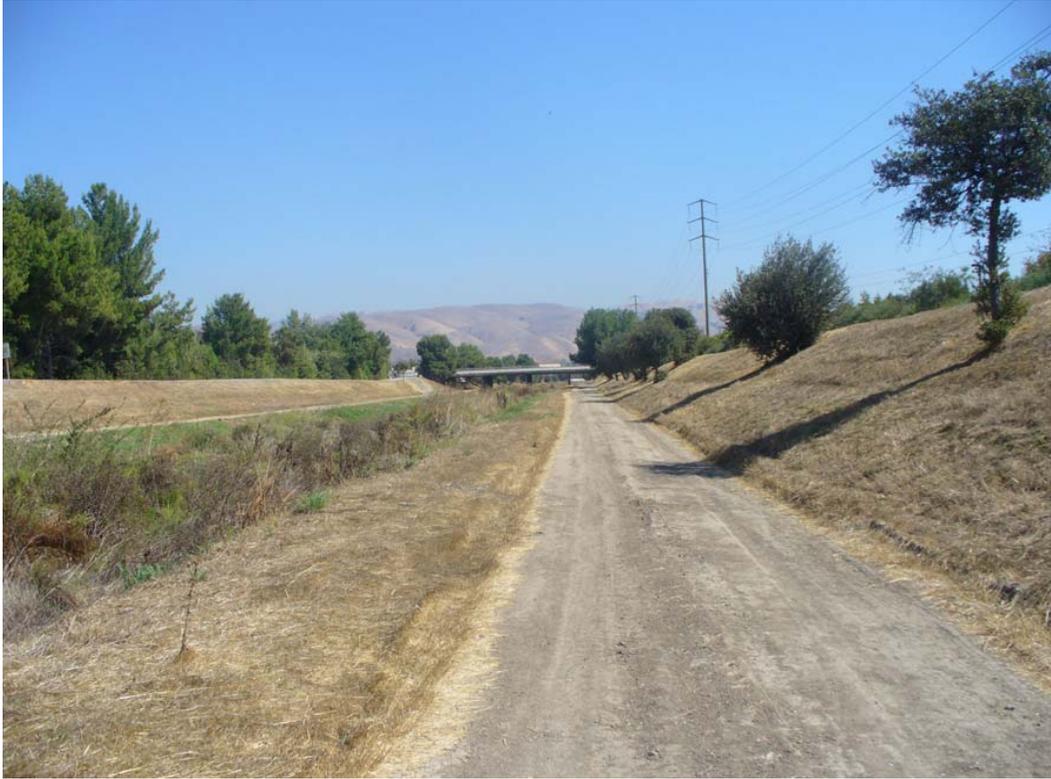
Figure 6. East-southeast view of Lower Berryessa Creek (Reach E), looking upstream, with N. Milpitas Drive in the background.

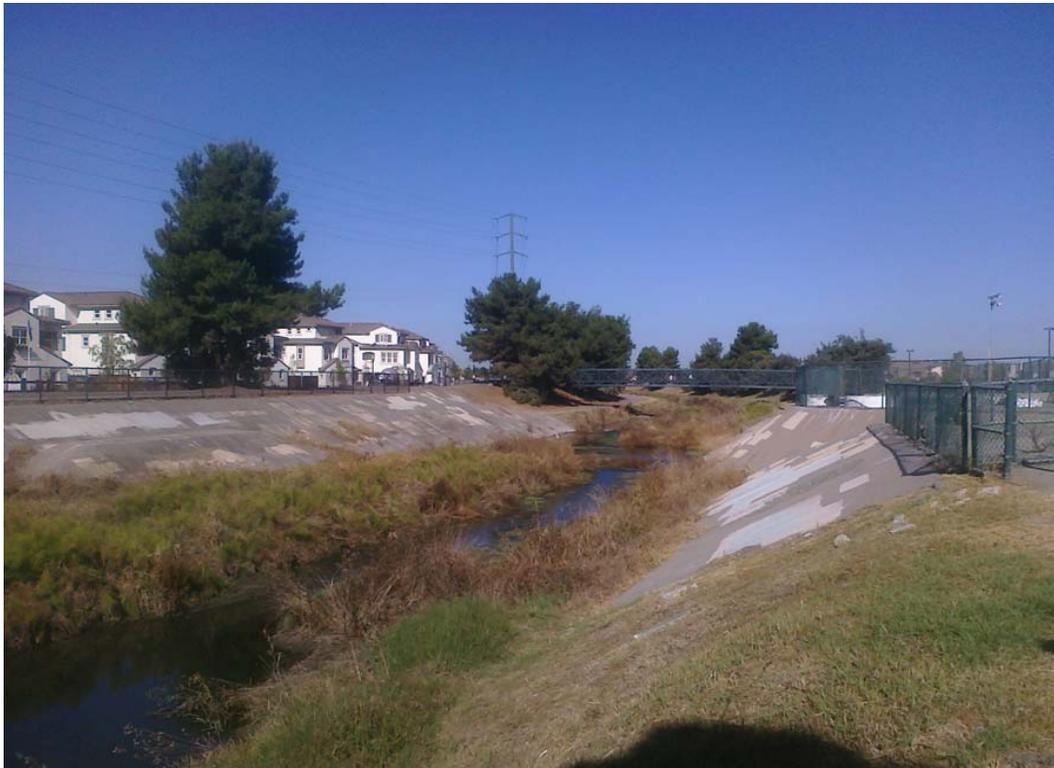
Figure 7. Northwest view of Lower Berryessa Creek (Reach F), looking downstream near Paseo Refugio.

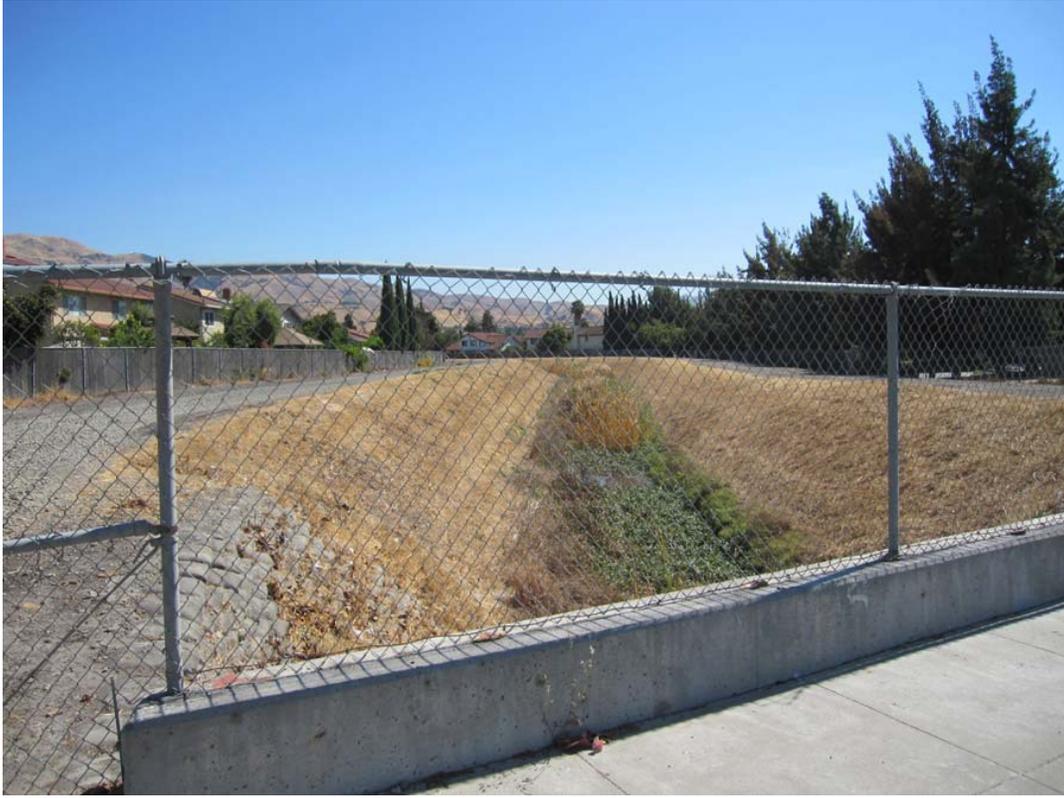
Figure 8. East view of Lower Calera Creek (Reach A), looking upstream from sidewalk on N. Milpitas Blvd.

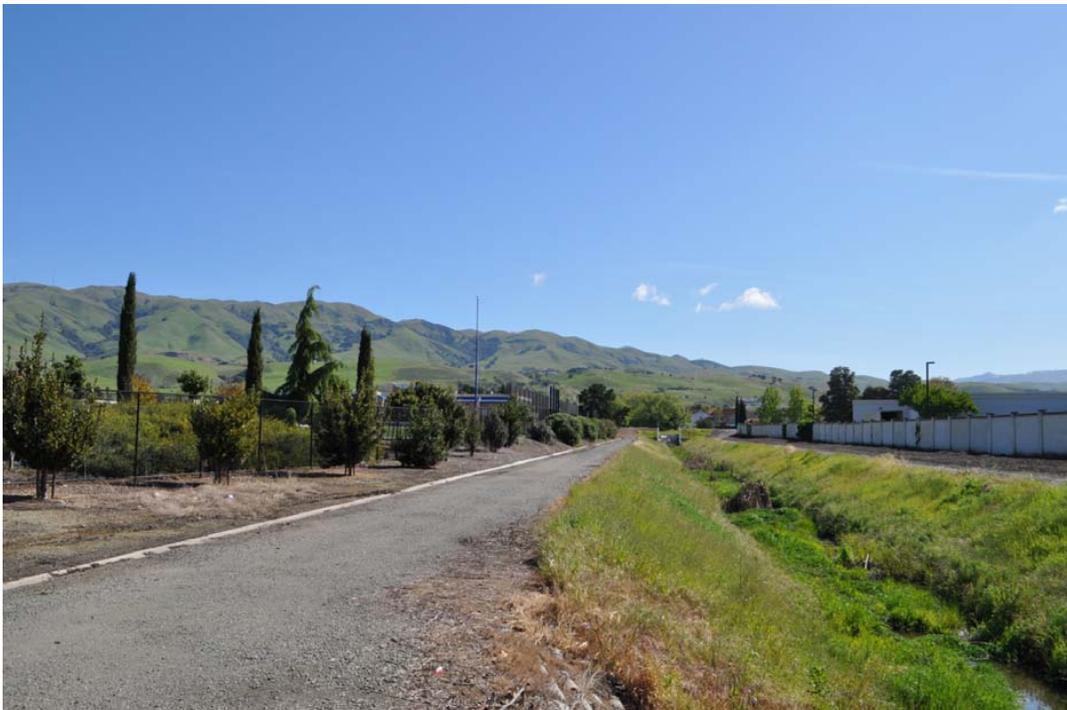
Figure 9. East view of Lower Calera Creek (Reach B), looking upstream from Arizona Ave.
