Work under way to restore native plants in Aliso Creek

This geomorphic assessment of Aliso Creek was conducted to provide a basis for interpreting the hydraulic engineering work associated with the comparison of alternative environmental restoration plans, and specifically to provide a rational basis for prediction of future geomorphic conditions associated with the no-action plan. This assessment builds on numerous earlier hydrologic, hydraulic, geotechnical, and geologic studies and investigations conducted in the Aliso Creek watershed.

ALISO CREEK F4 GEOMORPHIC ASSESSMENT
ORANGE COUNTY, CALIFORNIA

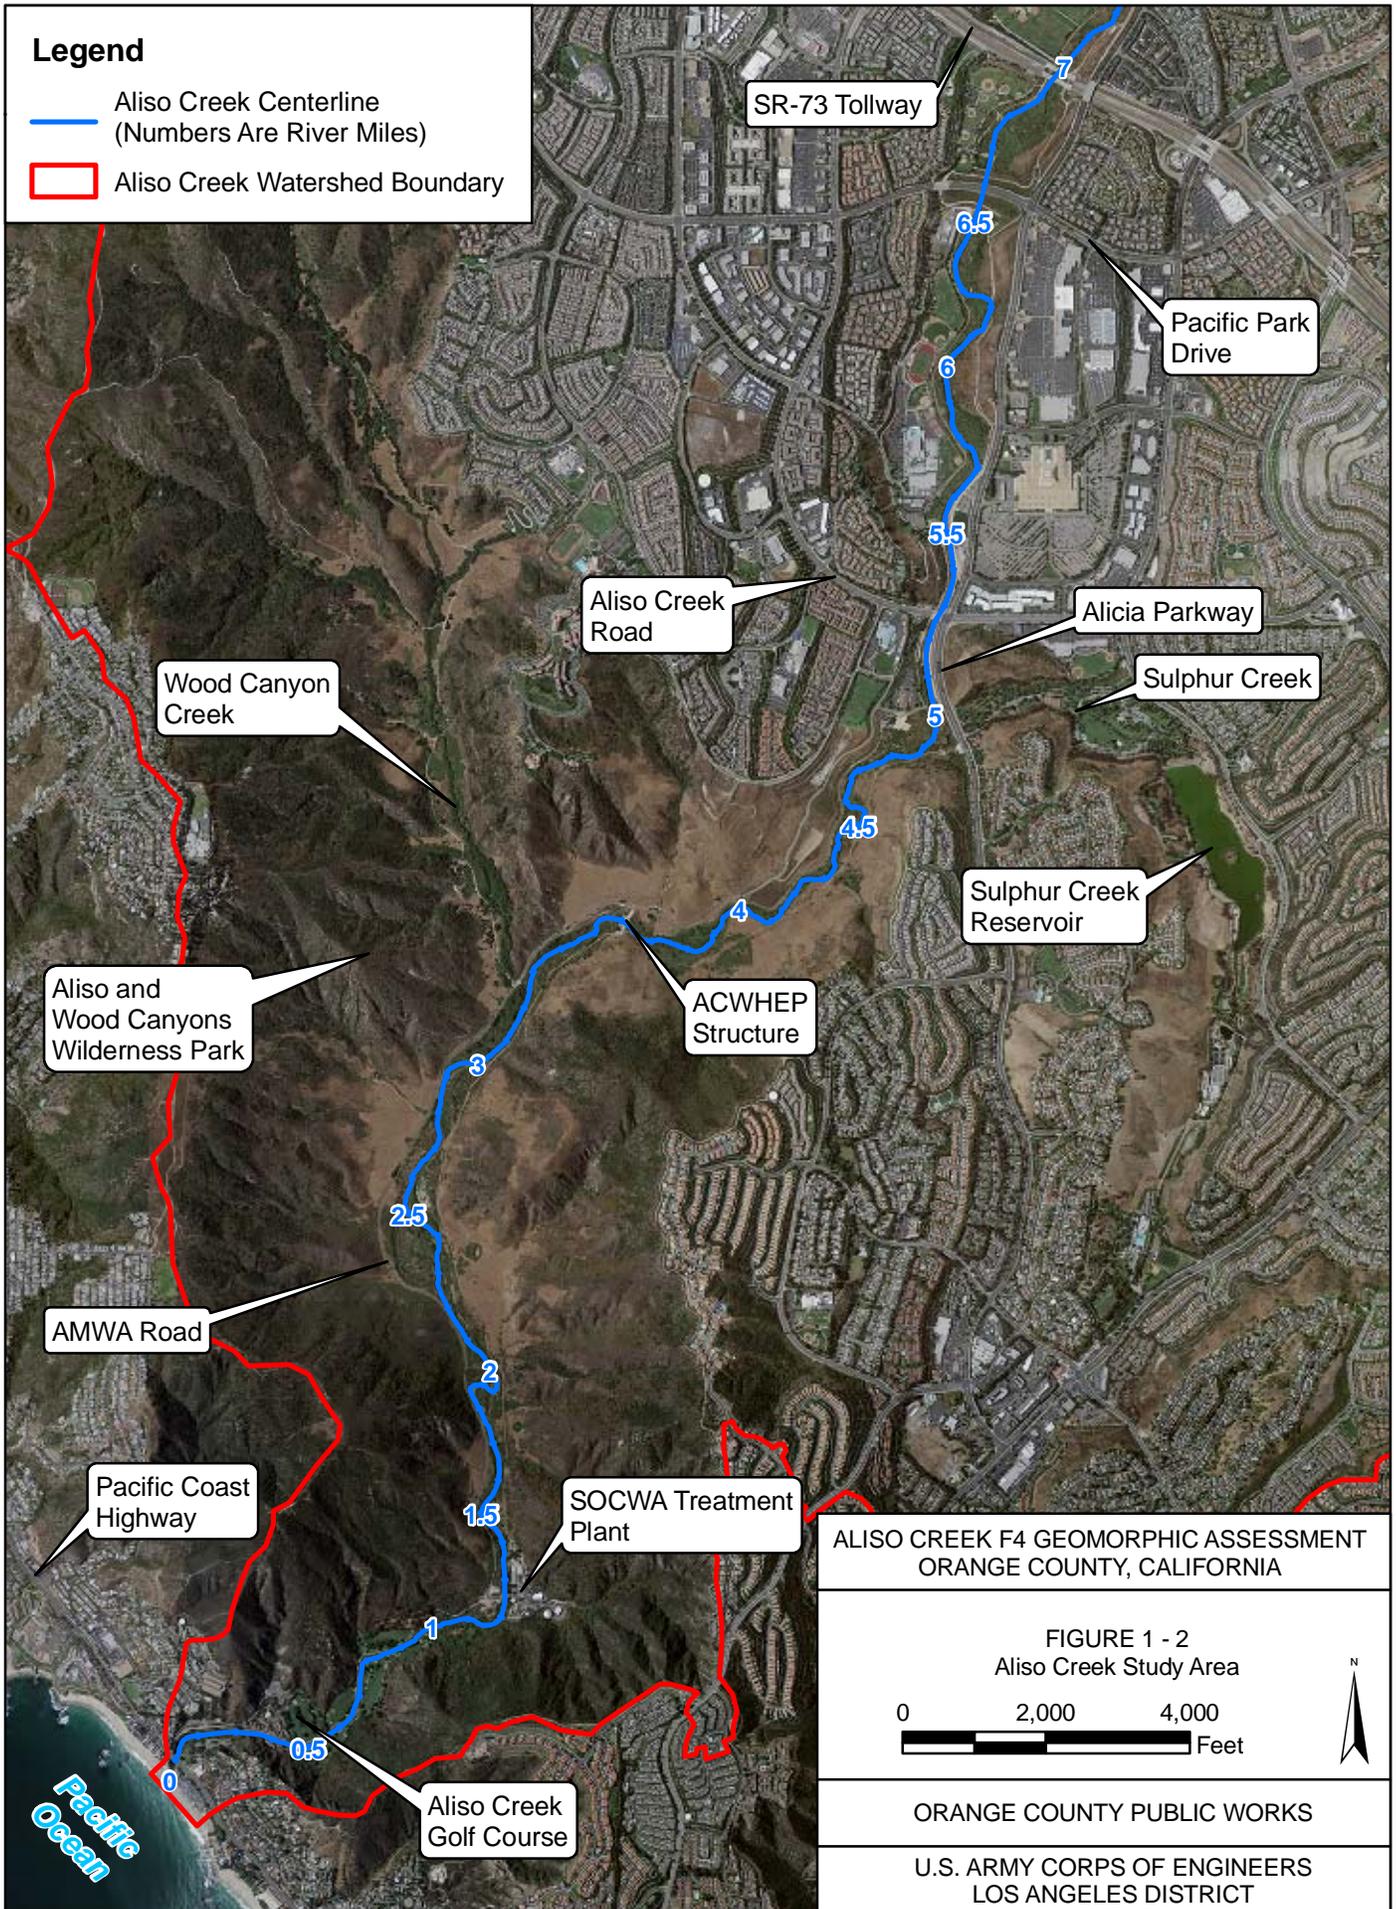
FIGURE 1 - 2
Aliso Creek Study Area

The study area (Figure 1-2) focuses on the lower reach of Aliso Creek (a distance of approximately 8 miles), specifically the reach from Pacific Park Drive downstream to the Pacific Ocean.

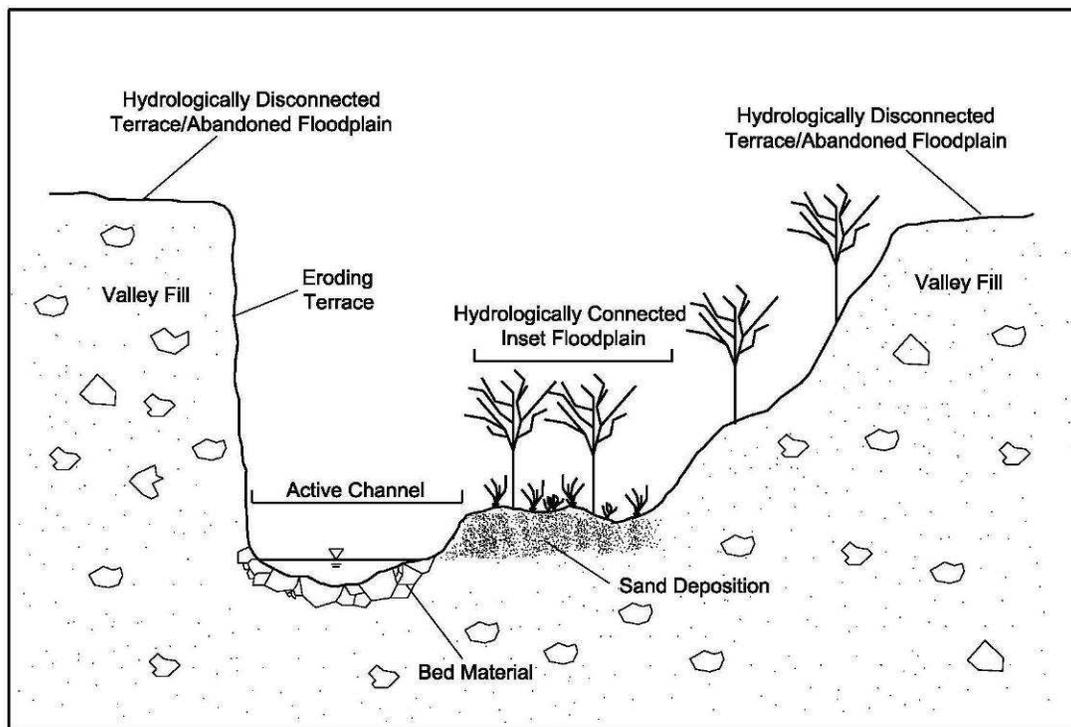
Figure 3-1. Schematic of an incised alluvial channel

A five-class ICEM was developed by Schumm et al. (1984) and modified to a six-class ICEM that included a channelized class by Harvey and Watson (1986) to explain the evolution of incised channels from a state of disequilibrium characterized by system-wide vertical and lateral instability to a new state of dynamic equilibrium characterized by system-wide vertical and lateral stability. The new channel is bounded by a functional floodplain that is inset below the former floodplain that has become a hydrologically-disconnected terrace. Figure 3-1 illustrates the spatial relation of these morphological features that are represented in the ICEM.

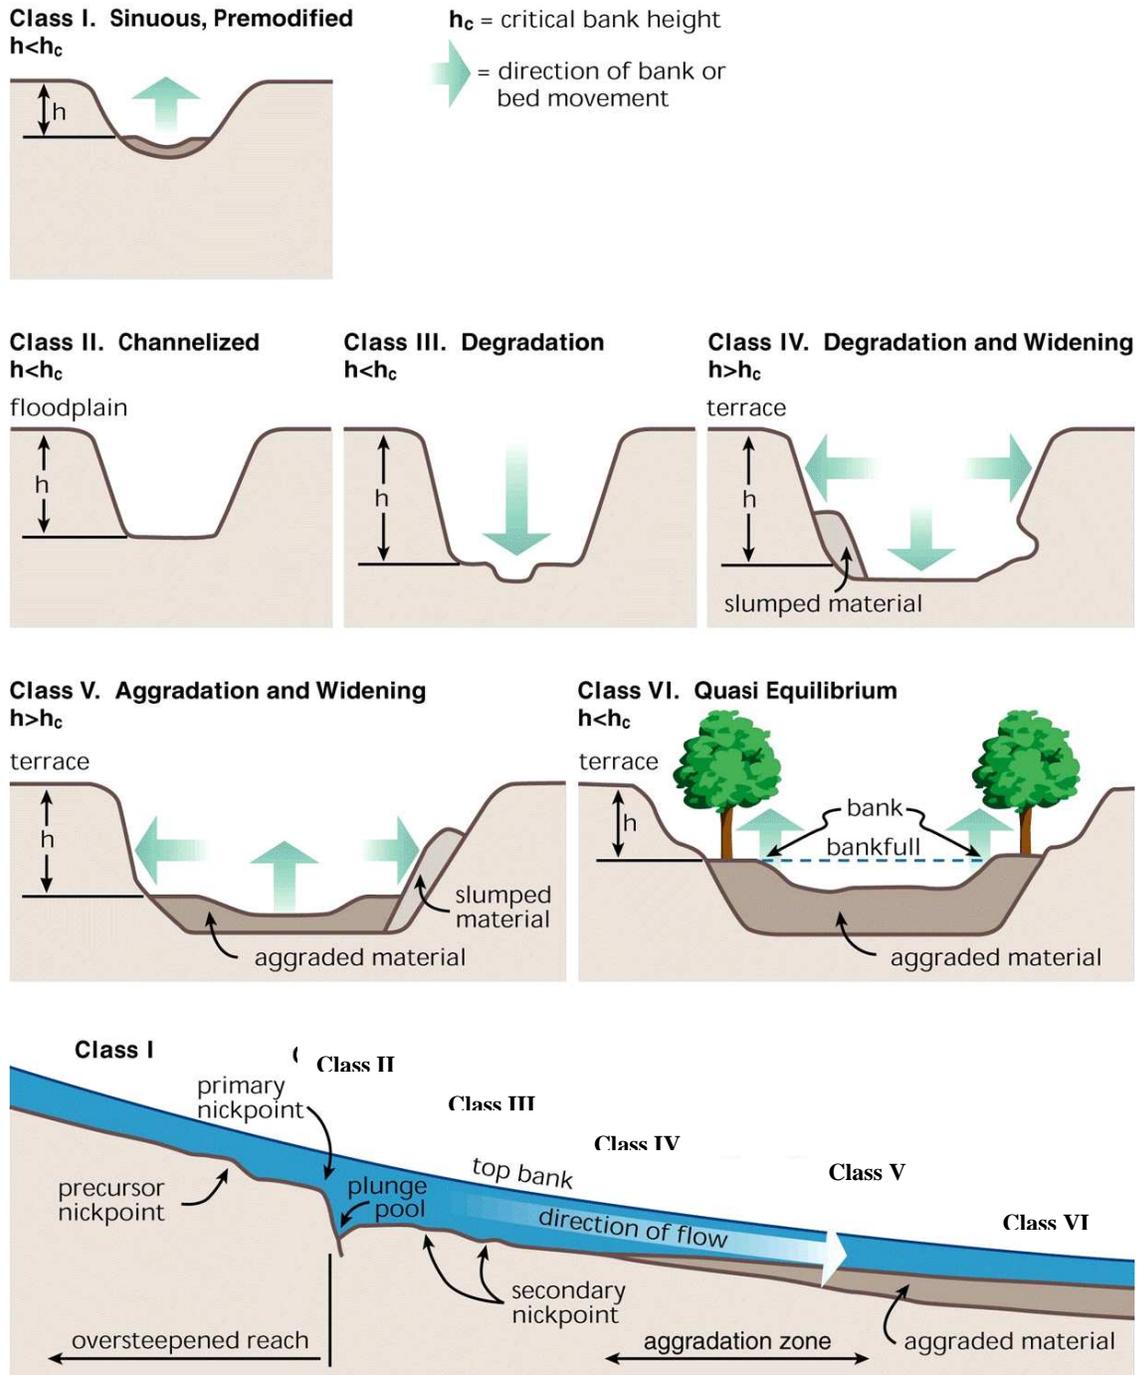
Figure 3-2. Incised Channel Evolution Model (ICEM) (after Schumm et al. 1984)

The six-class model describes the systematic evolution of a channelized stream from a state of human-induced disequilibrium (Class II) to a new state of dynamic equilibrium (Class VI) (Figure 3-2). The six classes represent a continuum of morphological changes with gradational boundaries between the

individual classes. The model identifies, quantifies, and integrates four important components of channel evolution: bank stability, the dominant/effective discharge, the hydraulic energy and sediment transport capacity of the dominant/effective discharge, and the morphological adjustments of the channel through time and space (Harvey and Watson 1986; Watson et al. 1988). Following human-induced disequilibrium (Class II), the channel incises (Classes III and IV), widens as a result of failure of the excessive bank heights (Classes IV and V), and ultimately aggrades (Class VI), at which point an equilibrium channel reflecting a dynamic balance between sediment supply and transport capacity has formed within the overwidened channel incised in the valley floor. Mass bank failure occurs when the bank height exceeds the critical bank height (Little et al. 1981; Watson et al. 1988). When the banks are steep, slab or wedge failures predominate (Class IV) and as the bank angle is subsequently reduced, deeper seated slump failures predominate (Class V) (Lohnes and Handy 1968; Harvey and Watson 1986; Thorne 1988; Thorne 1999; Simon and Darby 1999). System-wide, as opposed to local, channel widening as a consequence of bank failure will continue as long as the failed bank materials are removed by flows. Conversely, retention of the failed bank materials will promote bank stability and prevent further channel widening (Carson and Kirkby 1972; Thorne 1982, 1991).

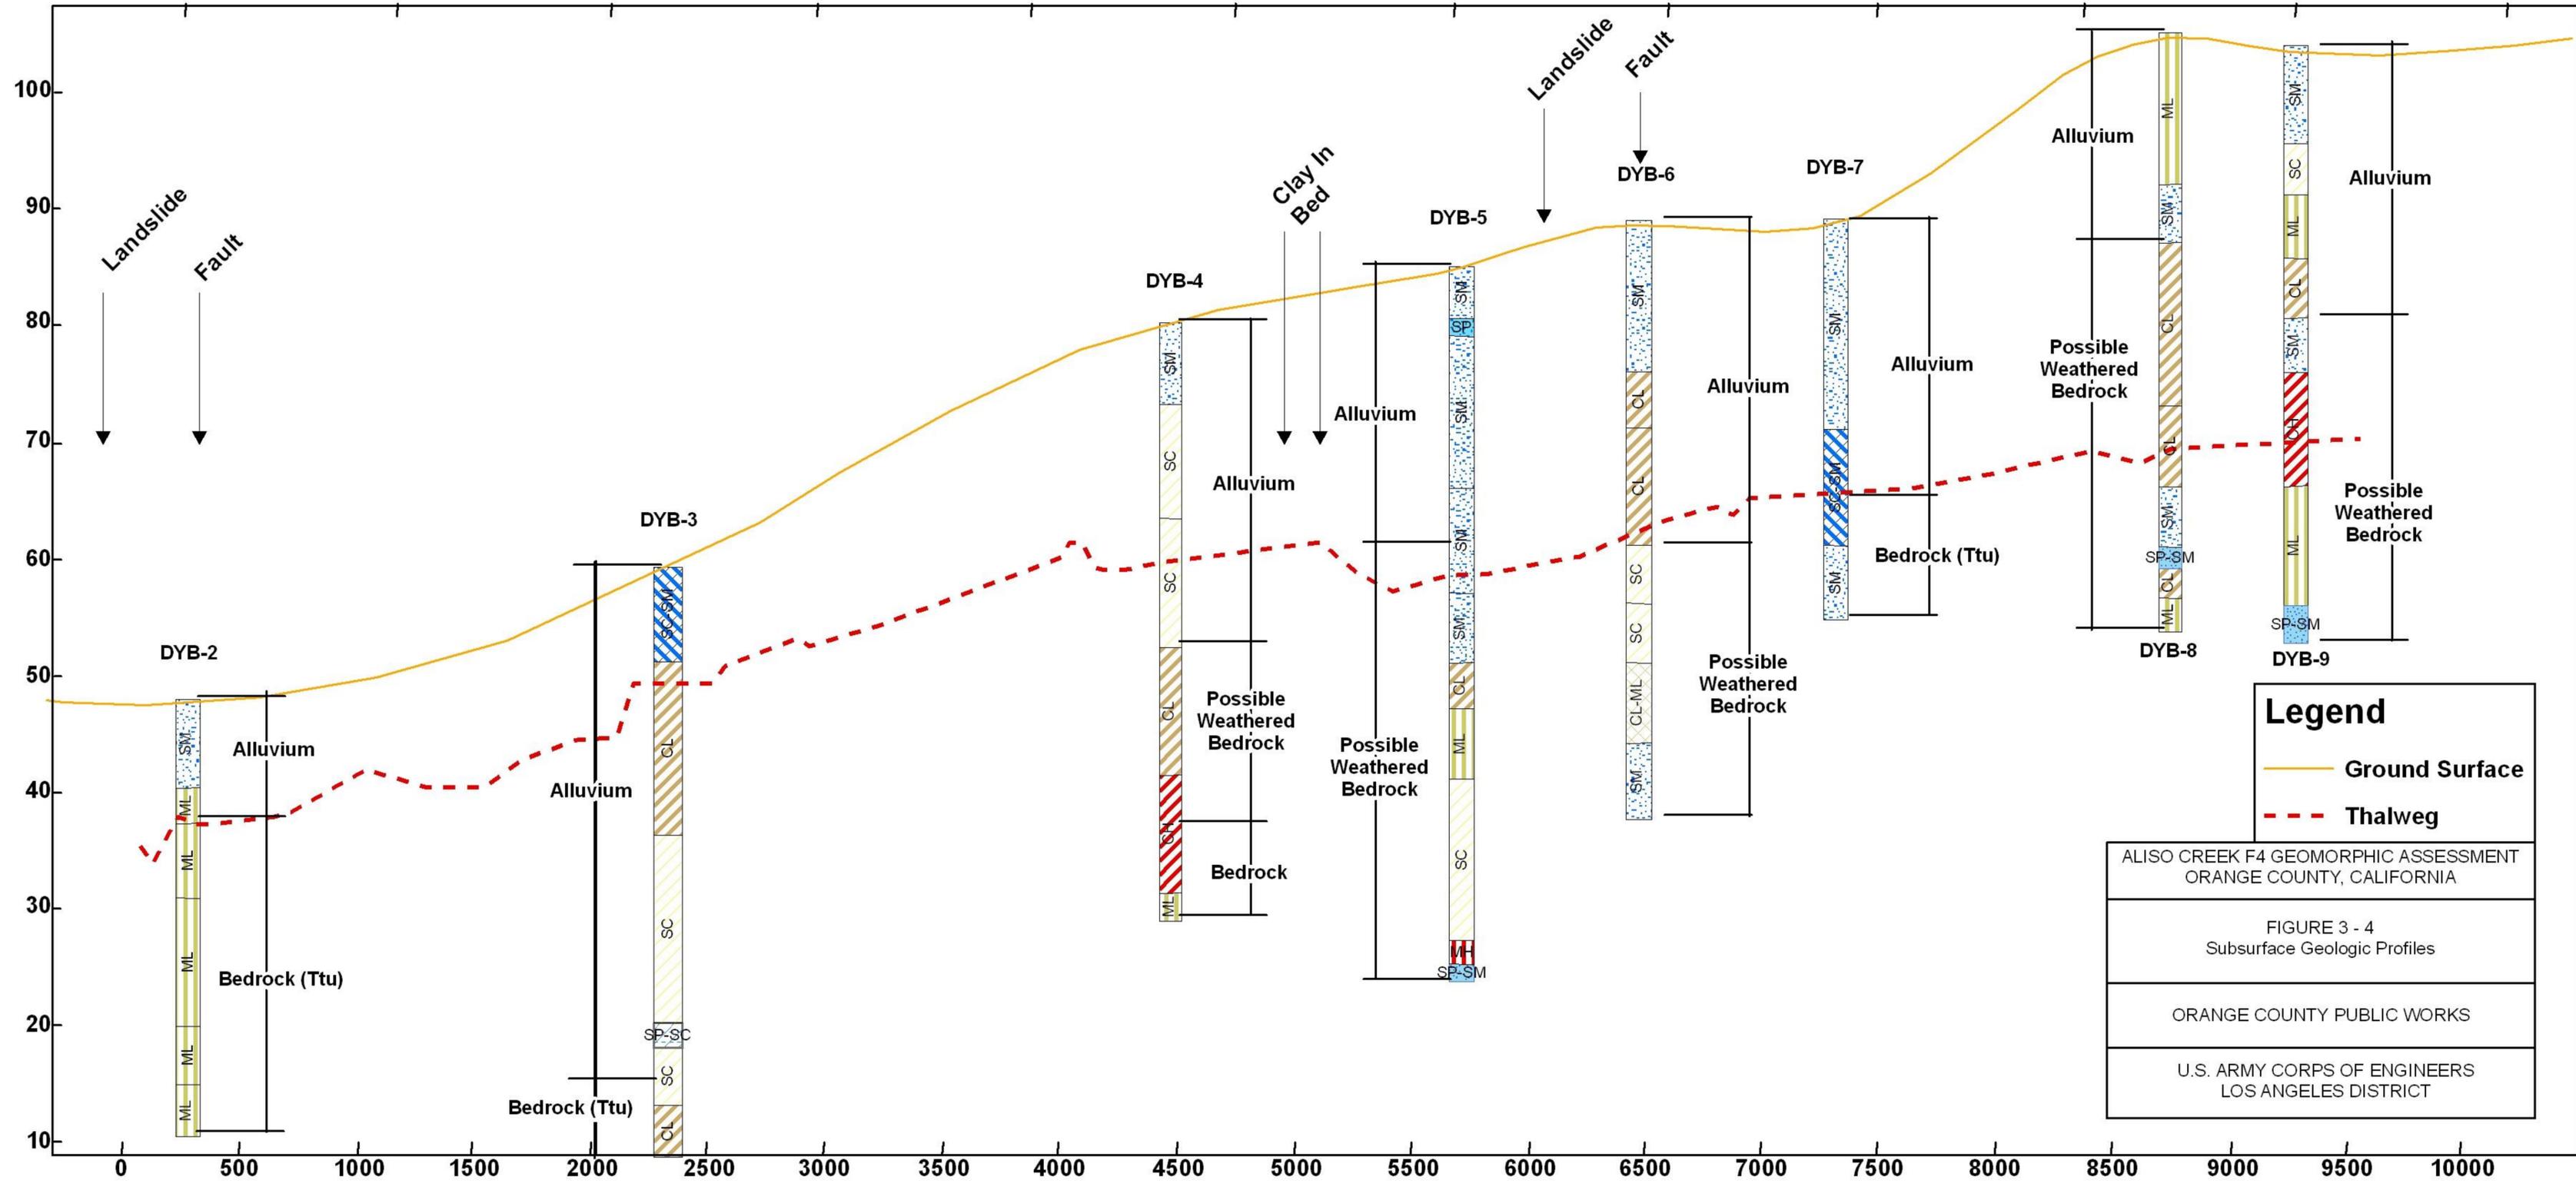
Re-plotting of the boring logs developed by Diaz, Yourman and Associates (DYA 2009) into a single longitudinal profile of Aliso Creek from just upstream of the SOCWA plant to the ACHWEP structure, and addition of the 2009 surveyed thalweg profile and the locations of major landslides and faults helps to explain the spatial distribution of valley fill units and bedrock exposures that control the vertical stability of Aliso Creek (Figure 3-4). A large landslide located between RM 1 and RM 1.5 (Figure 3-3a) probably blocked the channel of Aliso Creek and very likely formed an upstream lake that historically in-filled with fine-grained sediments. The uppermost elevations of the CL units in borings DYB-3, DYB-4 and DYB-5 are very similar, suggesting a lacustrine origin. Clay outcrops observed in the bed of the channel at RM 2.4, 2.6, and 2.7 are composed of this depositional unit. A large landslide between RM 2.5 and RM 3 (Figure 3-3b) may have also blocked the channel and formed an impoundment that resulted in deposition of the CL unit in DYB-6, and similarly, this could have occurred as a result of a landslide at RM 3.5 in DYB-8 and DYB-9.

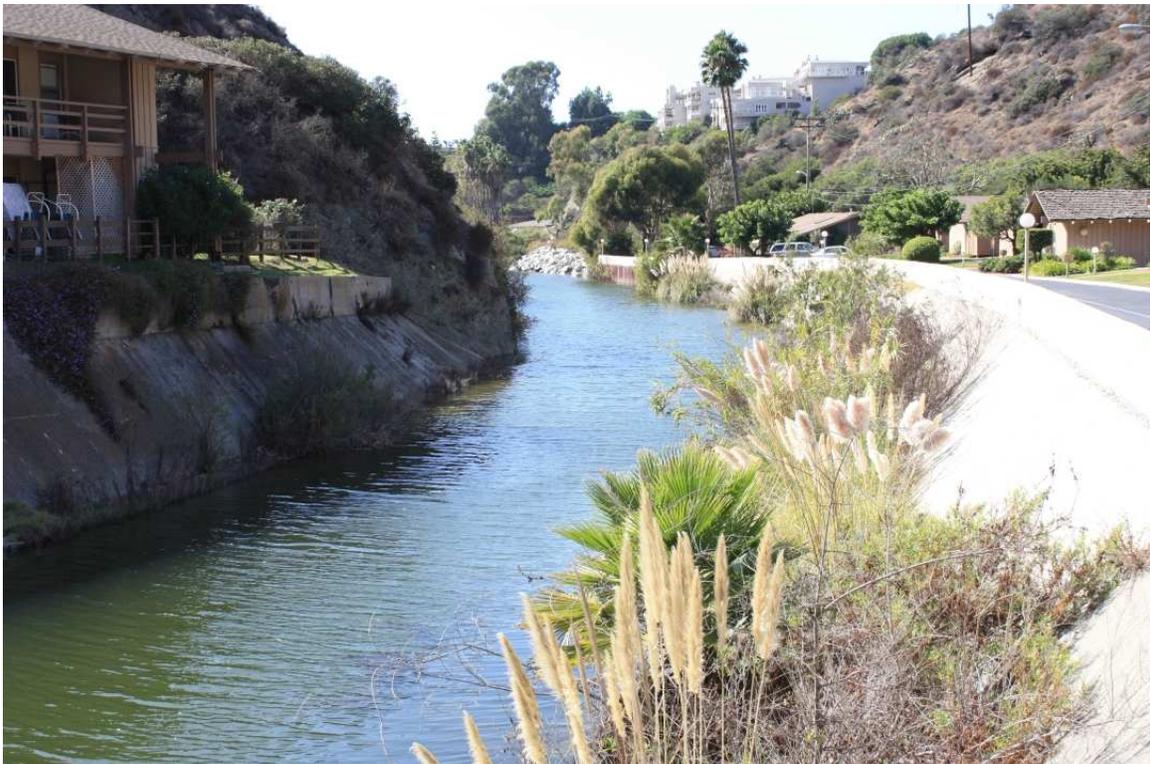
Figure 3-26. Downstream-facing view of Aliso Creek through the Aliso Creek Inn

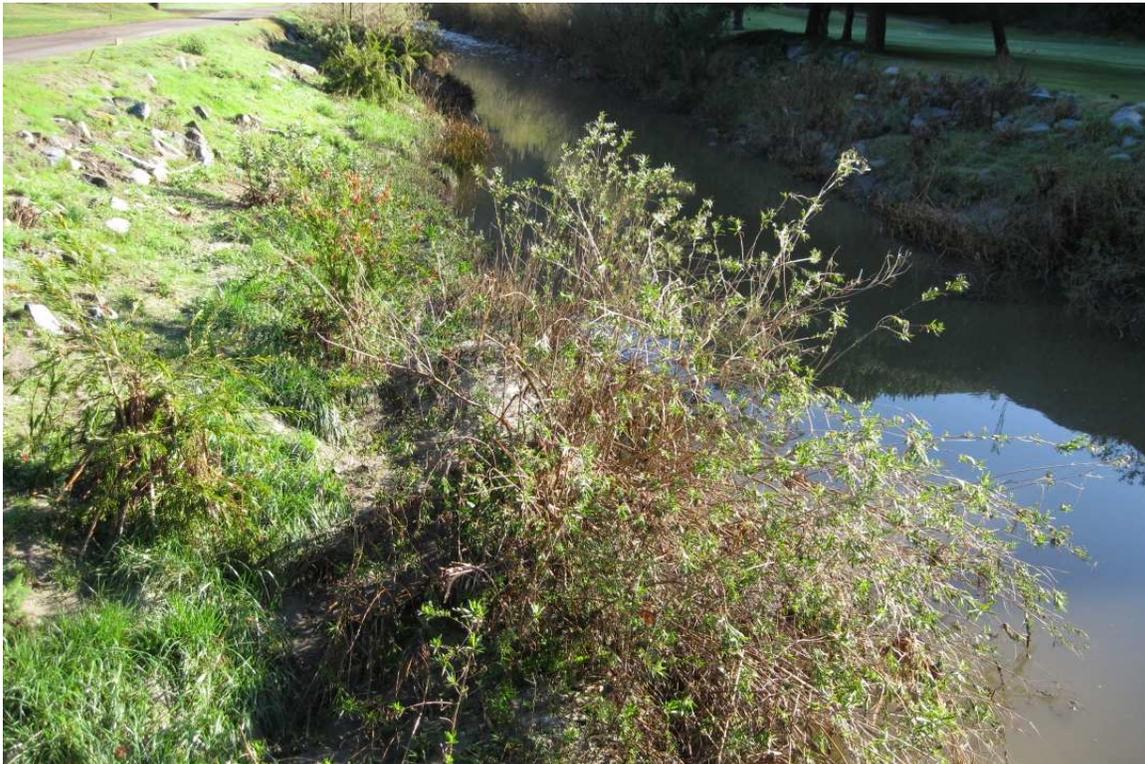
Figure 3-27. Aliso Creek through the Aliso Creek Golf Course

Reach 2 - The Aliso Creek Golf Course is contained entirely within Reach 2, from the exposed San Onofre Breccia outcrop at the downstream end to the transition to the natural area at the upstream end. The 2,620 feet of channel through the golf course is maintained: for example, riprap lines some of the banks and the vegetation is trimmed in places (Figure 3-27). The overbank areas contain the managed turf for the golf course. One bridge for the Aliso Creek Inn is located in this reach as are four pedestrian bridges for the golf course. Few signs of instability were noted during the field investigations. As with Reach 1, the bank heights in Reach 2 range from 10 to 15 feet. Gravel bars were observed in the bed through Reach 2. The bed slope is 0.35 percent. Bottom widths range from 10 to 50 feet, with an average of 25 feet. This reach is channelized and the banks are lined with riprap, and therefore the channel morphology could be represented as the early stages of Class II in the ICEM; however, the riprap inhibits the ability of the channel to self-adjust, so the ICEM is not applicable.

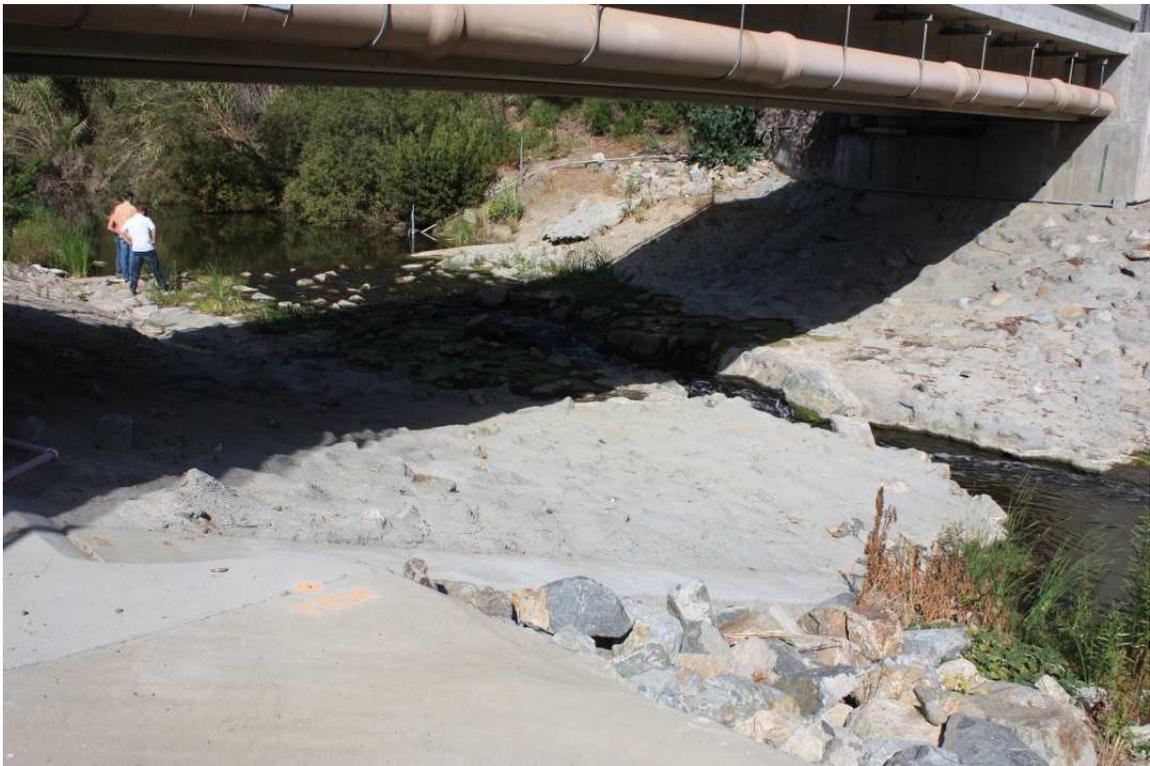
Figure 3-29. SOCWA bridge grade control and concrete sill

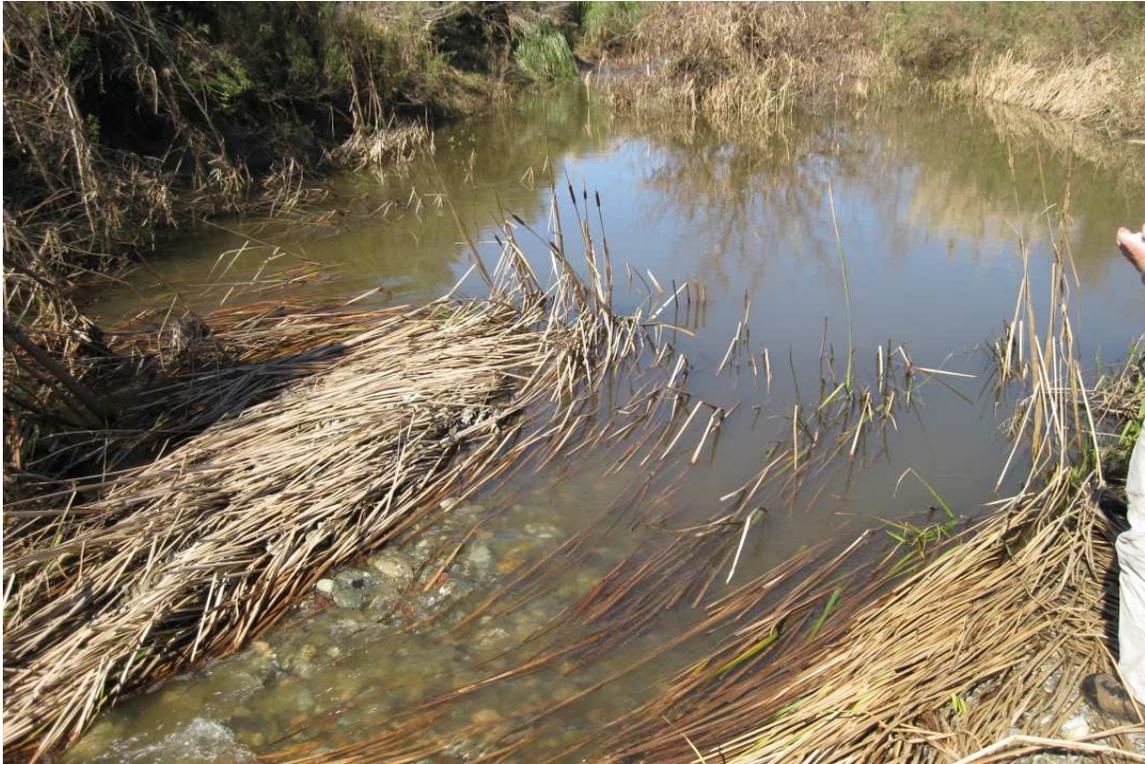
Figure 3-30. Example of pool located upstream of coarse gravel plug in Reach 4A

Reach 4A - This 2,720-foot long reach extends from the SOCWA bridge to the gravel plug at the downstream end of the S-bend. Older riprap bank protection was observed along this reach to protect the AMWA Road along the right overbank and sanitary sewer pipes in the left overbank. A few natural grade controls were observed in this reach (e.g., coarse gravel and cobble plugs/riffles and an outcrop of bedrock). Sandy bed material was noted within this reach, primarily in the pools upstream of the coarse gravel and cobble plugs (Figure 3-30). Bank heights in Reach 4A range from 8 to 20 feet (Figure 3-31). The average bed slope in Reach 4A is 0.30 percent. The average bottom width is 22 feet, ranging between 8 and 46 feet. This reach is in Class V of the ICEM where the channel is vertically stable but some additional localized erosion and slumping of geotechnically unstable banks can be expected.

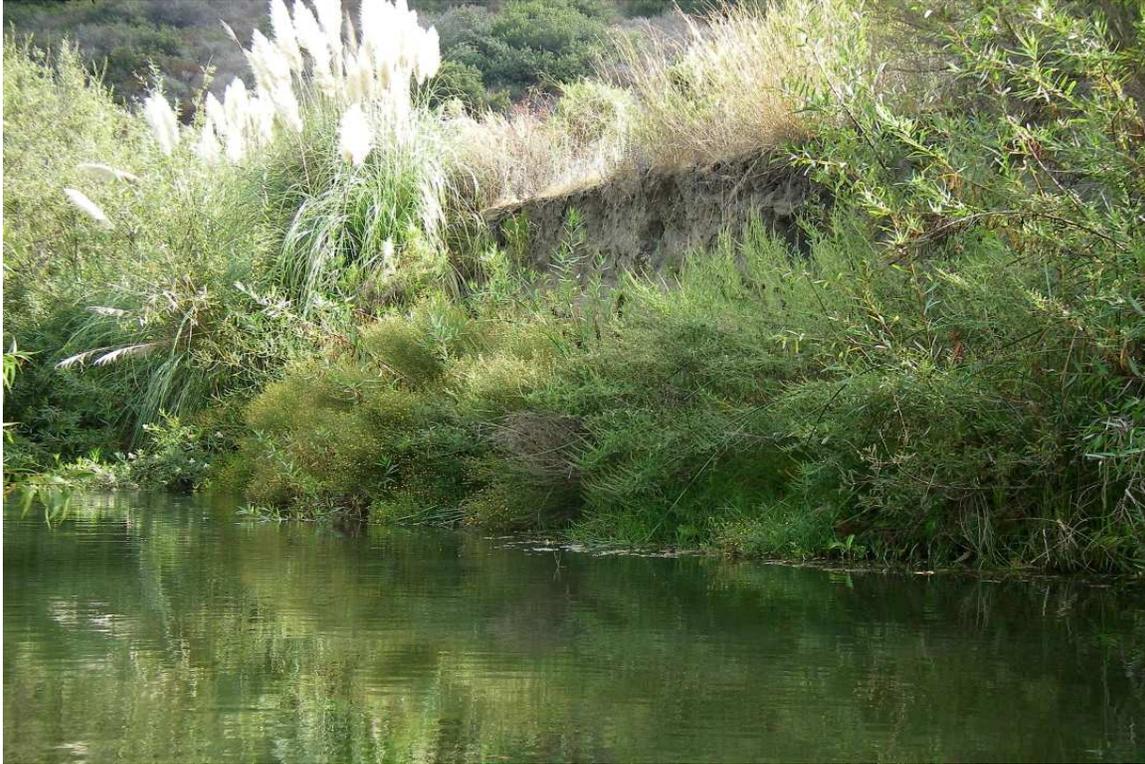
Figure 3-31. Left bank within Reach 4A

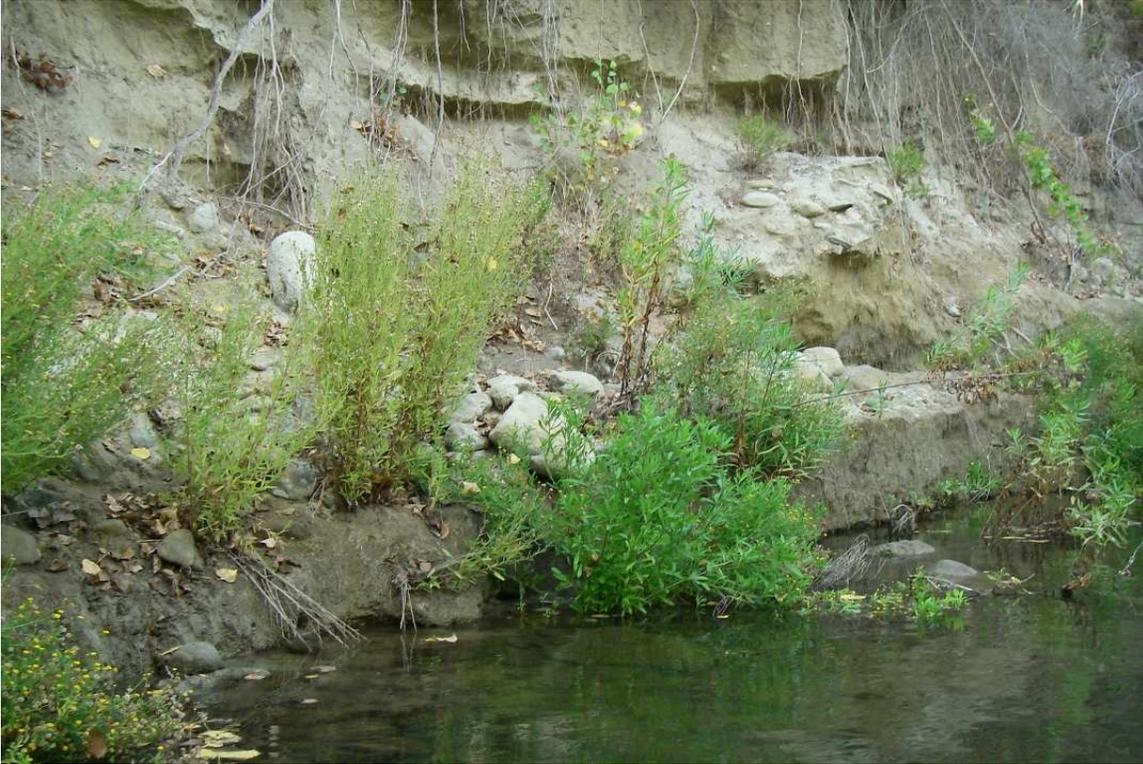
Figure 3-34. Cobbles excavated from the valley fill due to bank erosion

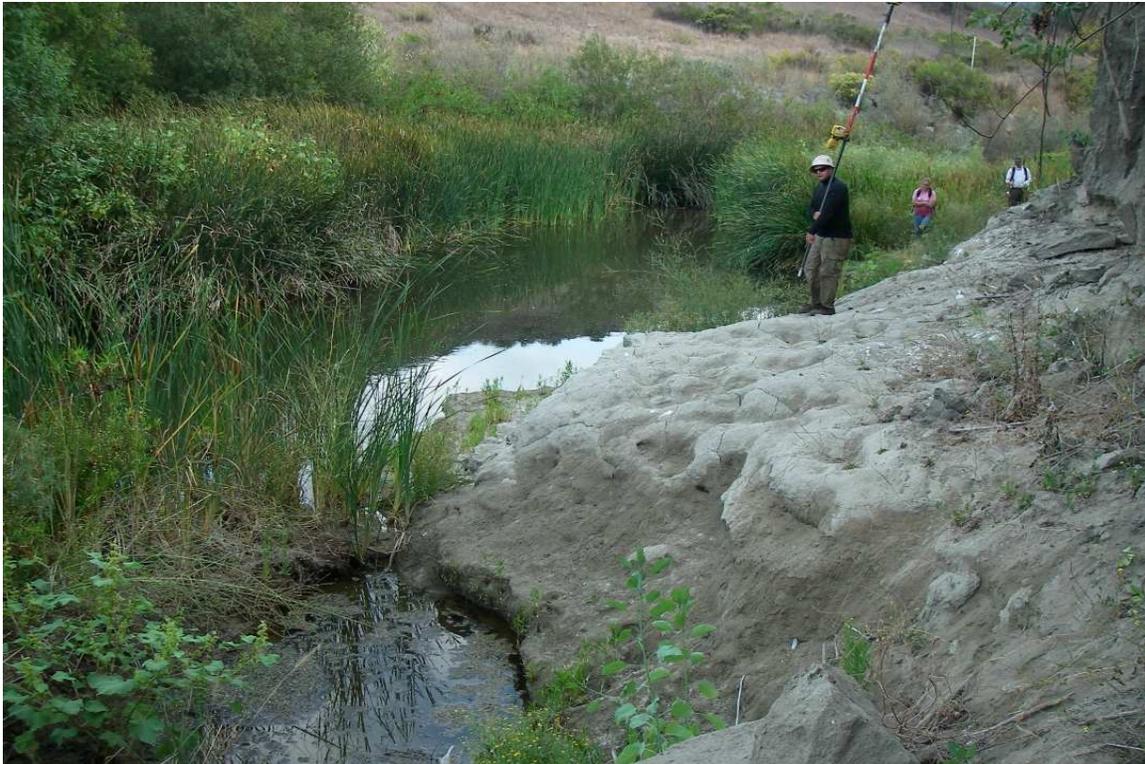
Figure 3-35. Major clay outcrop marking the upstream extent of Reach 5A

Reach 5A - Approximately 1,480 feet upstream of the weathered sandstone at the upper extent of Reach 4B, a major clay outcrop was observed in the bed and lower banks of Aliso Creek (Figure 3-35). This clay outcrop marks the upstream end of the newly-delineated Reach 5A. Since the clay was also observed in the lower few feet of the banks, it indicates that incision into the clay is ongoing. While the clay is more erosion resistant than non-cohesive materials, it is still susceptible to erosive forces. The bank heights in this reach are typically between 20 and 25 feet. A buried soil overlain by 3 to 4 feet of post-settlement alluvium was observed in the right bank (Figure 3-36). As with Reach 4B, the bank materials were composed of valley fill. The bed material through this reach was dominated by coarse gravels and cobbles, although just downstream from the clay outcrop at the upper end of the reach, a wedge of sand had filled in part of the coarse bedded pool (Figure 3-37). The average bed slope in Reach 4B is 0.30 percent. The bottom width ranges from 11 to 45 feet, with an average of 34 feet. This reach is in Class IV approaching Class V of the ICEM where there could be some further degradation into the clay-rich material in the bed and there is likely to be on-going channel widening.

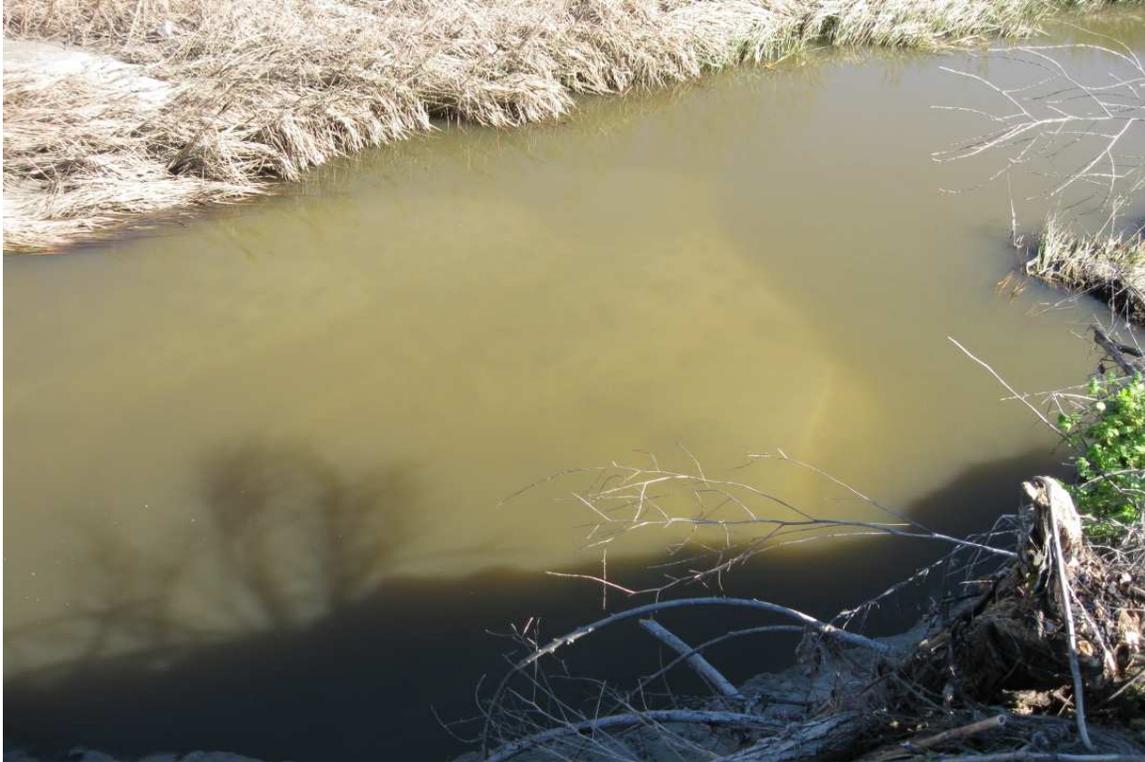
Figure 3-37. Sand wedge migrating into a pool at the upper end of Reach 5A

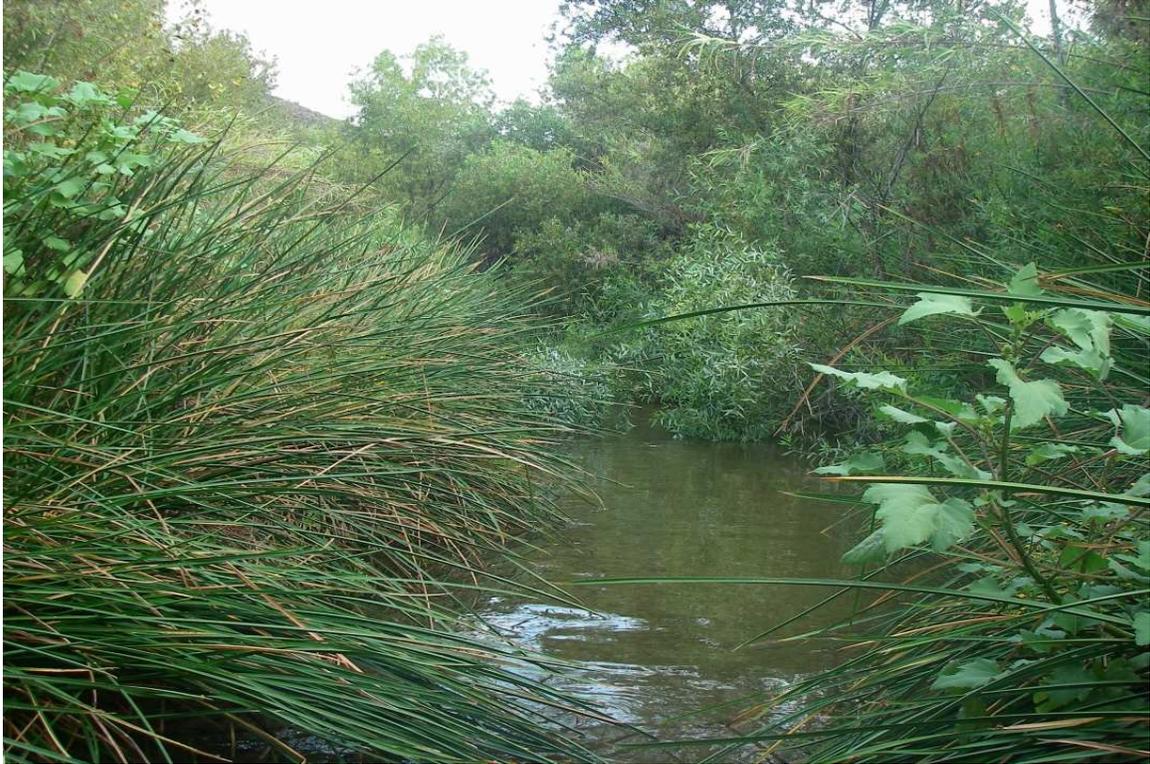
Figure 3-38. Upstream view of dense vegetation in reach 5B

Reach 5B - This reach extends for approximately 1,810 feet upstream from the clay outcrop at the upper end of Reach 5A. This reach is incised, and other than a moderate bend in the middle of the reach, it is fairly straight and densely vegetated (Figure 3-38). Riprap has been placed on the banks in places to protect AMWA Road and the buried infrastructure, specifically along the previously noted bend. A large debris jam was observed in the bend, and the jam was formed primarily of small woody debris, arundo, and trash. A few coarse gravel, cobble, and boulder plugs/riffles were encountered; the most upstream plug marks the upper extent of Reach 5B. This is also approximately the location where the bedrock mapped in boring DYB-7 is at the elevation of the existing thalweg (DYA 2009). The bedrock is a geologic grade control that provides a stable transition from Reach 5B to Reach 5C. The bank heights in this reach are typically 20 to 25 feet. As with Reach 4B, the bank materials were composed of valley fill. Figure 3-39 shows the downstream extent of the reach as seen from the top of the right bank. The bed material in this reach was dominated by sands and fine gravels, with the grade of the reach being maintained by the regularly-spaced plugs/riffles. The average bed slope in Reach 4B is 0.46 percent. The bottom width ranges from 8 to 60 feet, with an average of 23 feet. This reach is in Class V to VI of the ICEM where the bed is vertically stable, the channel width has reached a new dynamic equilibrium, but some further localized slumping and failures of geotechnically unstable banks, particularly where the active channel impinges on the toe of the terrace, can be expected.

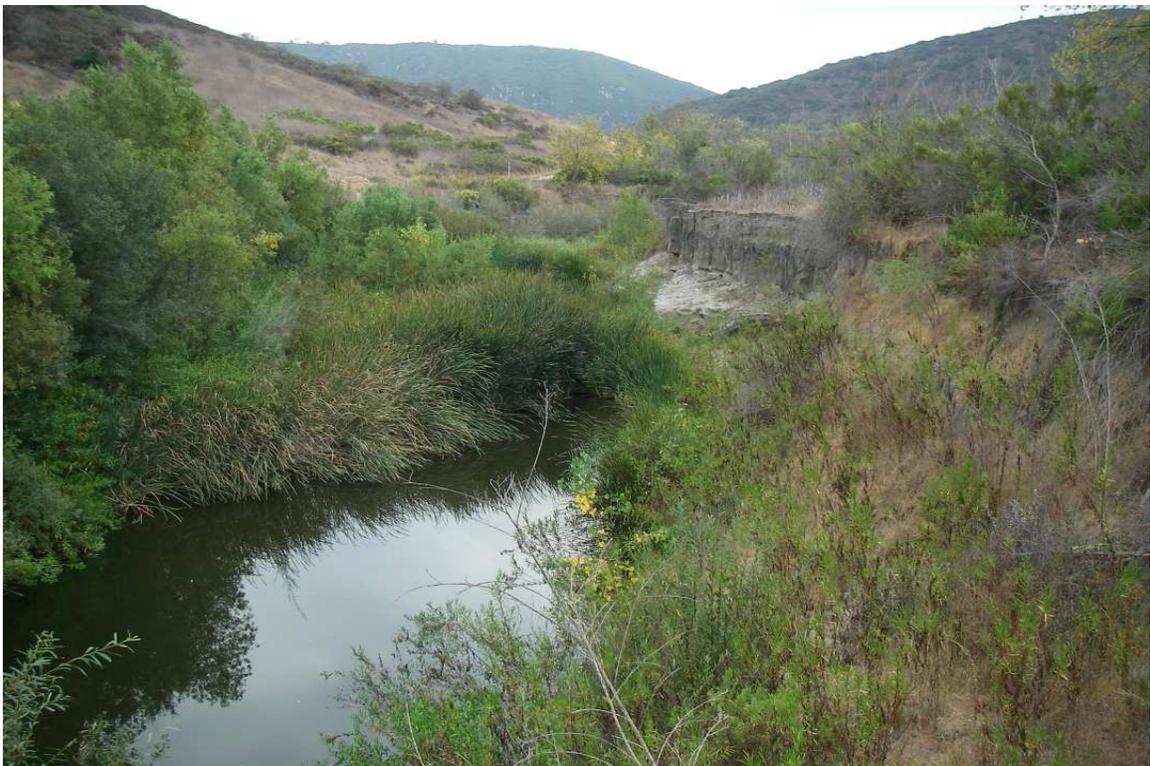
Figure 3-39. Downstream extent of Reach 5B as seen from the right top of bank

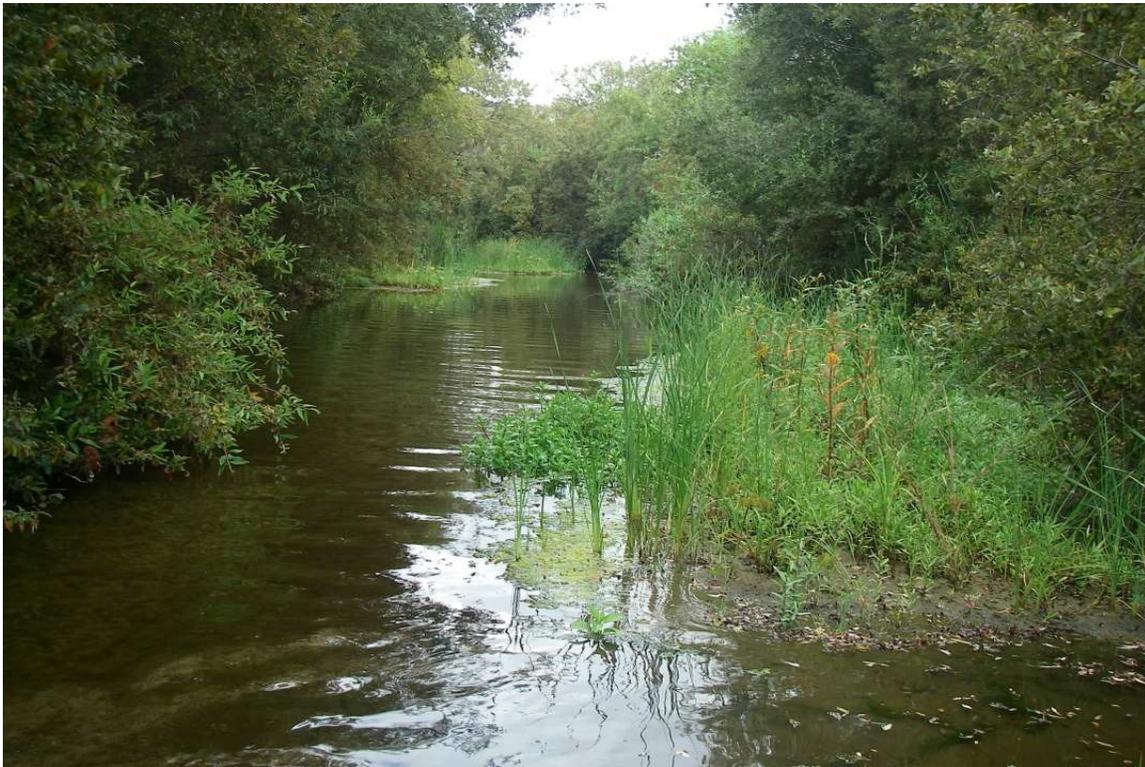
Figure 3-40. Alternate sand bars observed in Reach 5C

Reach 5C - The most notable feature of reach 5C is the abundance of sand stored in the bed of the channel. Alternate bars were observed throughout the reach (Figure 3-40), and probes were inserted in the sand to a depth of approximately five feet. This reach is approximately 1,080 feet long. The coarse plug at the downstream end overlies bedrock mapped at the elevation of the thalweg. These features control the grade of the reach, causing the observed deposition of sand. It is notable that the confluence with Wood Canyon Creek occurs in this reach. The average bed slope is 0.04 percent – the flattest within the study reach. The bank heights in this reach are typically 25 feet. As with Reach 4B, the bank materials are composed of valley fill. Despite the bank heights, the bank angles were less steep than downstream reaches, and more mature woody vegetation was established across the full floodplain (Figure 3-41). The bed material in this reach was dominated by sands and fine gravels (Figure 3-42). The bottom width ranges from 17 to 37 feet, with an average of 27 feet. This reach is in Class VI of the ICEM where the bed is vertically stable and further systematic channel widening is not expected. However, where the active channel impinges directly on the toe of the terrace, localized bank erosion can be expected to continue.

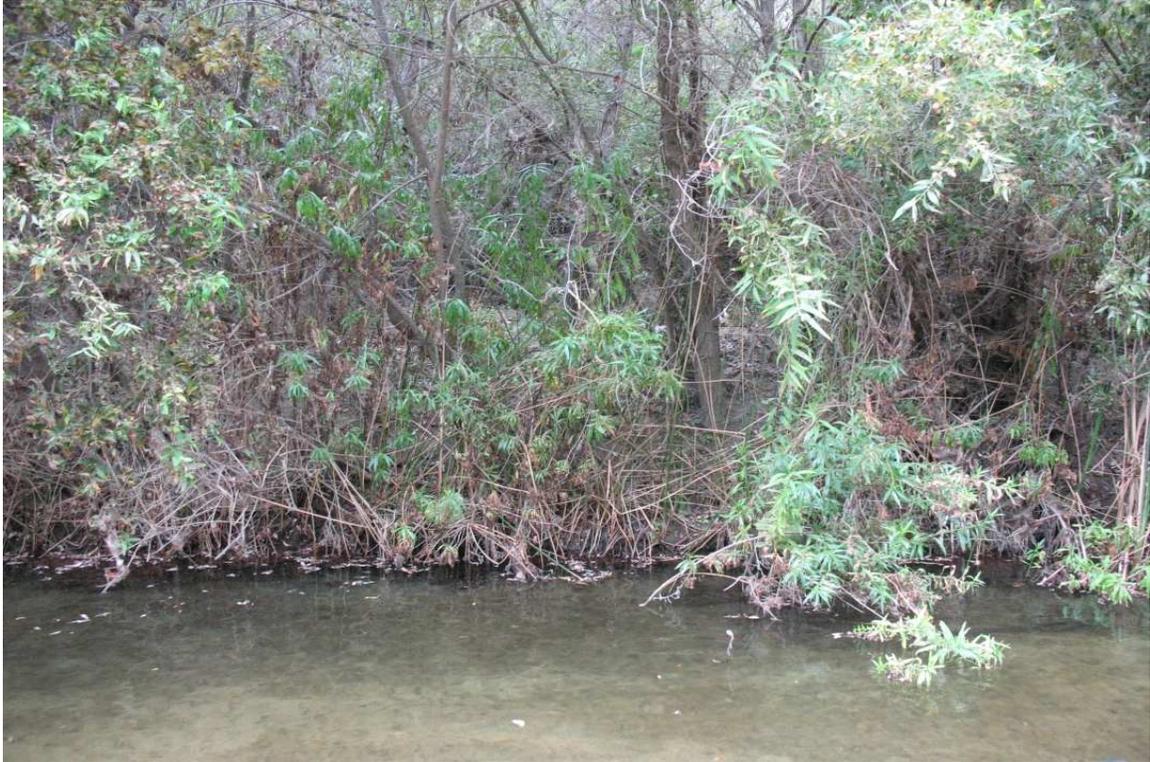
Figure 3-41. Woody vegetation established on left bank of Reach 5C
