Work under way to restore native plants in Aliso Creek

This geomorphic assessment of Aliso Creek was conducted to provide a basis for interpreting the hydraulic engineering work associated with the comparison of alternative environmental restoration plans, and specifically to provide a rational basis for prediction of future geomorphic conditions associated with the no-action plan. This assessment builds on numerous earlier hydrologic, hydraulic, geotechnical, and geologic studies and investigations conducted in the Aliso Creek watershed.

ALISO CREEK F4 GEOMORPHIC ASSESSMENT
ORANGE COUNTY, CALIFORNIA

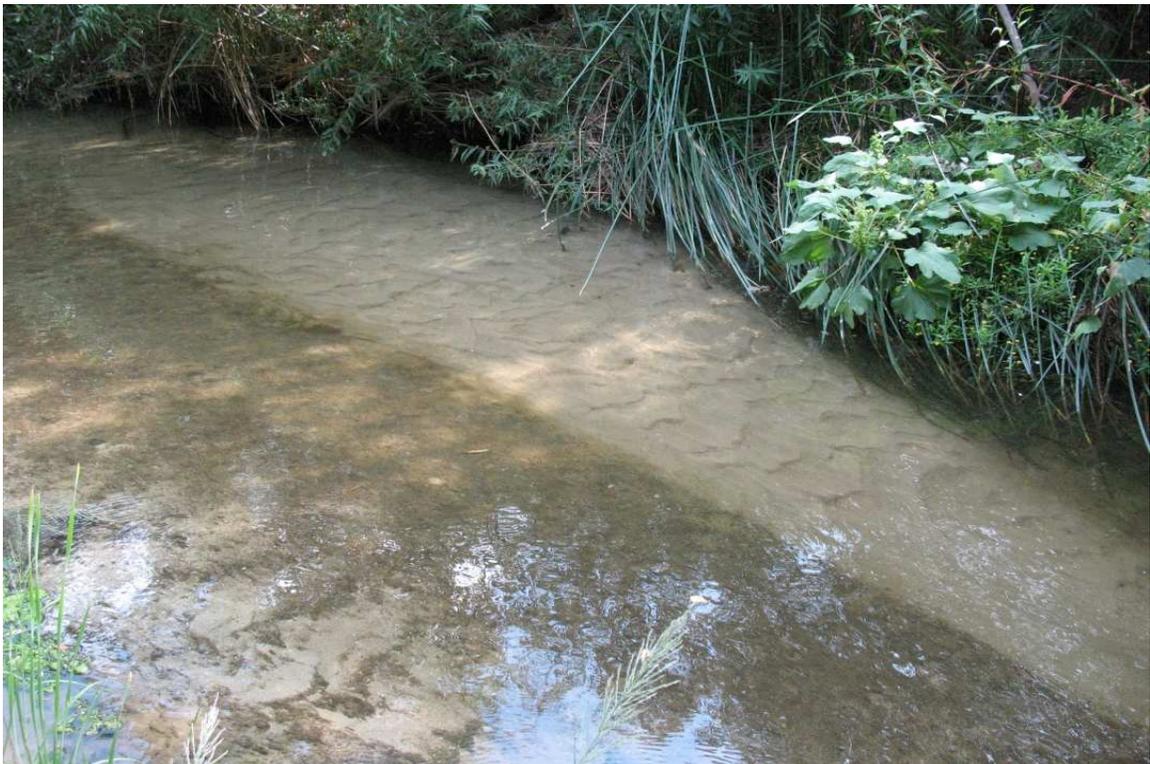
Figure 3-42. Ripples on the sand stored in the bed of Reach 5C

Reach 5C - The most notable feature of reach 5C is the abundance of sand stored in the bed of the channel. Alternate bars were observed throughout the reach (Figure 3-40), and probes were inserted in the sand to a depth of approximately five feet. This reach is approximately 1,080 feet long. The coarse plug at the downstream end overlies bedrock mapped at the elevation of the thalweg. These features control the grade of the reach, causing the observed deposition of sand. It is notable that the confluence with Wood Canyon Creek occurs in this reach. The average bed slope is 0.04 percent – the flattest within the study reach. The bank heights in this reach are typically 25 feet. As with Reach 4B, the bank materials are composed of valley fill. Despite the bank heights, the bank angles were less steep than downstream reaches, and more mature woody vegetation was established across the full floodplain (Figure 3-41). The bed material in this reach was dominated by sands and fine gravels (Figure 3-42). The bottom width ranges from 17 to 37 feet, with an average of 27 feet. This reach is in Class VI of the ICEM where the bed is vertically stable and further systematic channel widening is not expected. However, where the active channel impinges directly on the toe of the terrace, localized bank erosion can be expected to continue.

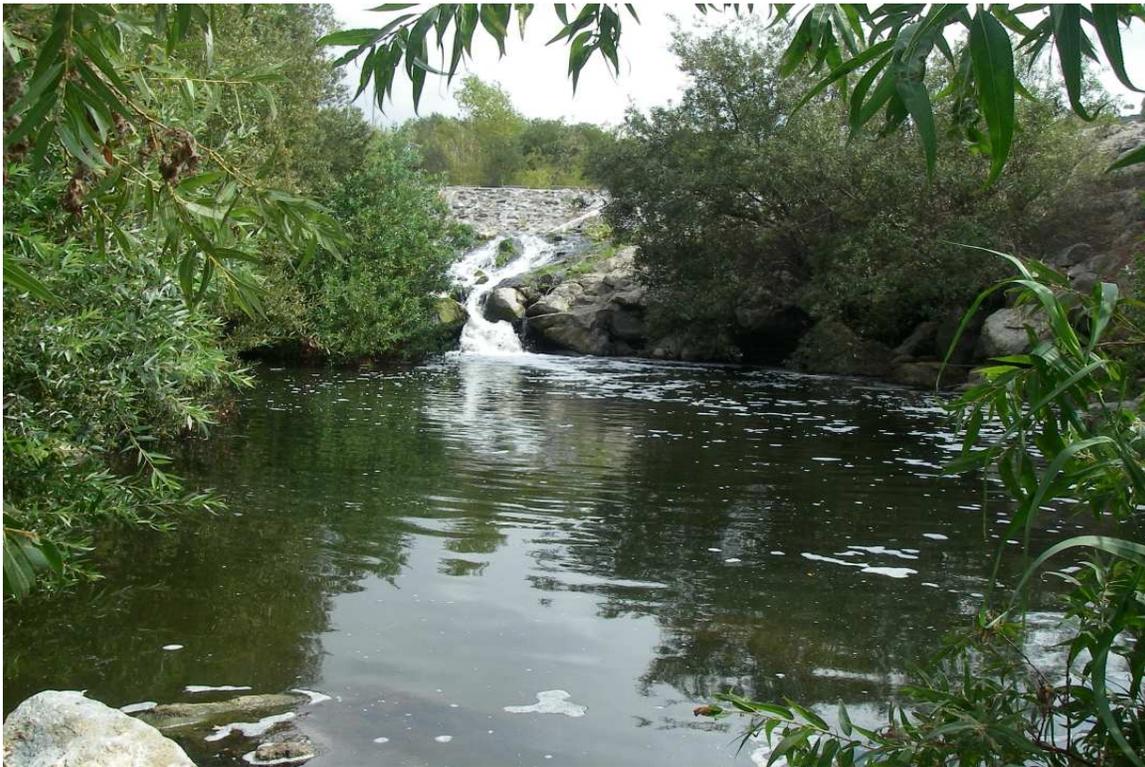
Figure 3-43. Upstream view of the ACWHEP structure at the upstream end of Reach 6

Reach 6 - This reach includes 1,300 feet between the upstream end of the sand storage area in Reach 5C and the toe of the ACWHEP structure. The ACWHEP structure is approximately 25 feet high and made of grouted riprap (Figure 3-43); originally it was constructed as a small diversion structure to divert flow for irrigation of floodplain vegetation. Multiple cobble-boulder riffles were seen in this reach, and riprap, likely displaced from the ACWHEP structure, was observed at various locations in the bed (Figure 3-44). The average bed slope of 0.55 percent is the highest downstream of the ACWHEP structure. The bank heights in this reach are between 25 and 30 feet. Valley fill is the primary component of the bank materials. In places the banks were nearly vertical (Figure 3-45), and some riprap was observed on the left bank to protect the sewer pipelines. The grade of the bed was checked by coarse riffles, so despite the presence of sands and fine gravels in the bed, the slope of the channel is controlled by the cobbles and boulders. The bottom width ranges from 16 to 26 feet, with an average of 23 feet. It is notable that the scoured area downstream of the structure is approximately 175 feet wide. This reach is in Class V of the ICEM where the bed elevation is controlled by coarse materials introduced to the channel at the ACWHEP diversion structure. The banks are generally vegetated and appear to have stabilized except in the immediate vicinity of the drop structure, where flood flows are directed at the geotechnically unstable banks.

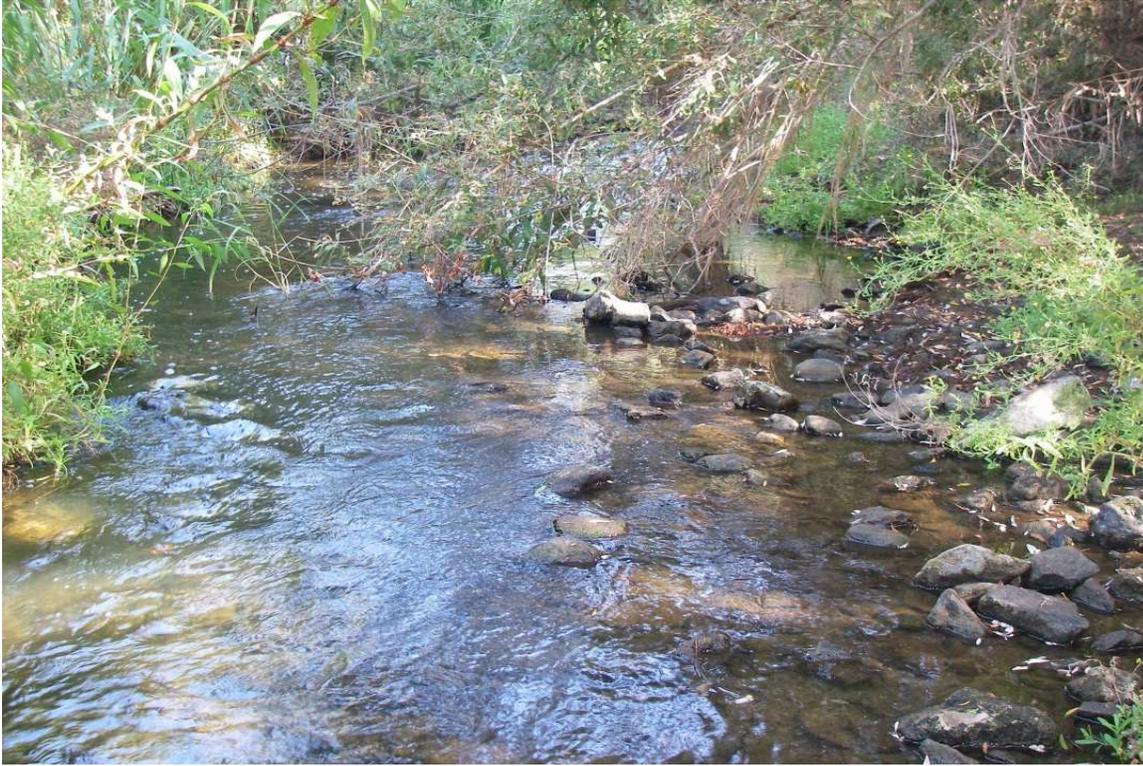
Figure 3-49. Cobble riffle observed in Reach 7

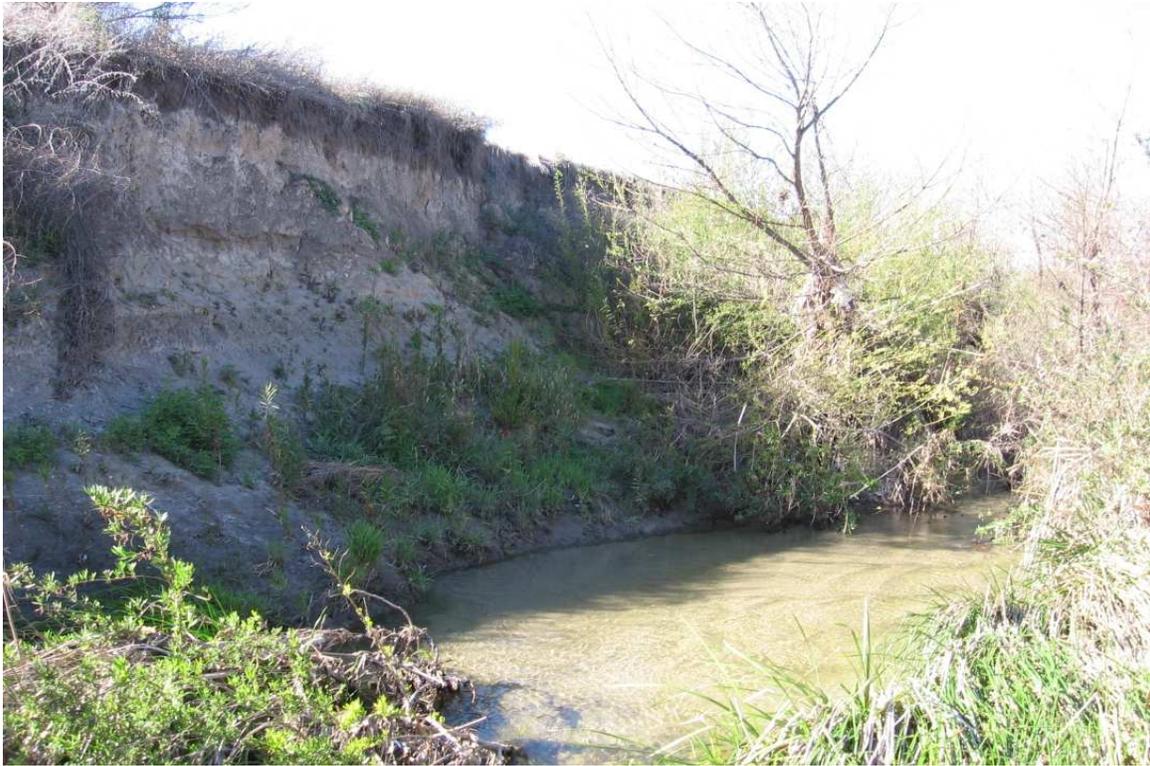
Figure 3-50. Typical 15-foot bank height at the downstream end of Reach 8

Reach 8 - The confluence of Sulphur Creek marks the upstream extent of Reach 8. This 3,110-foot long reach is similar to Reach 7, except that the bank heights are noticeably greater. At the downstream end of the reach, the bank height is approximately 15 feet (Figure 3-50), increasing to over 30 feet at the upstream end (Figure 3-51). The bank materials are composed of valley fill, and in the immediate vicinity of Sulphur Creek, the bank materials reflect the incision through the historical alluvial fan at the mouth of the creek. A thick clay layer was noted in the toe of the banks near the Sulphur Creek confluence (Figure 3-52). A large sand and gravel bar exists at, and downstream of, the confluence of the two creeks. The bed morphology of Reach 8 reflects the regular series of coarse gravel and cobble plugs between long sand storage reaches. The bed material switches between gravels and cobbles in the plugs and sands and fine gravels in the intervening pools. The average bed slope through Reach 8 is 0.27 percent, nearly matching the average slope of Reach 7. Reach 8 exhibits some sinuosity – the value of 1.3 is the greatest in the studied reaches. The bottom width ranges from 10 to 28 feet, with an average of 19 feet. This reach is in Class V of the ICEM where the channel is vertically stable but further channel widening can be expected as a result of both systematic and local factors.

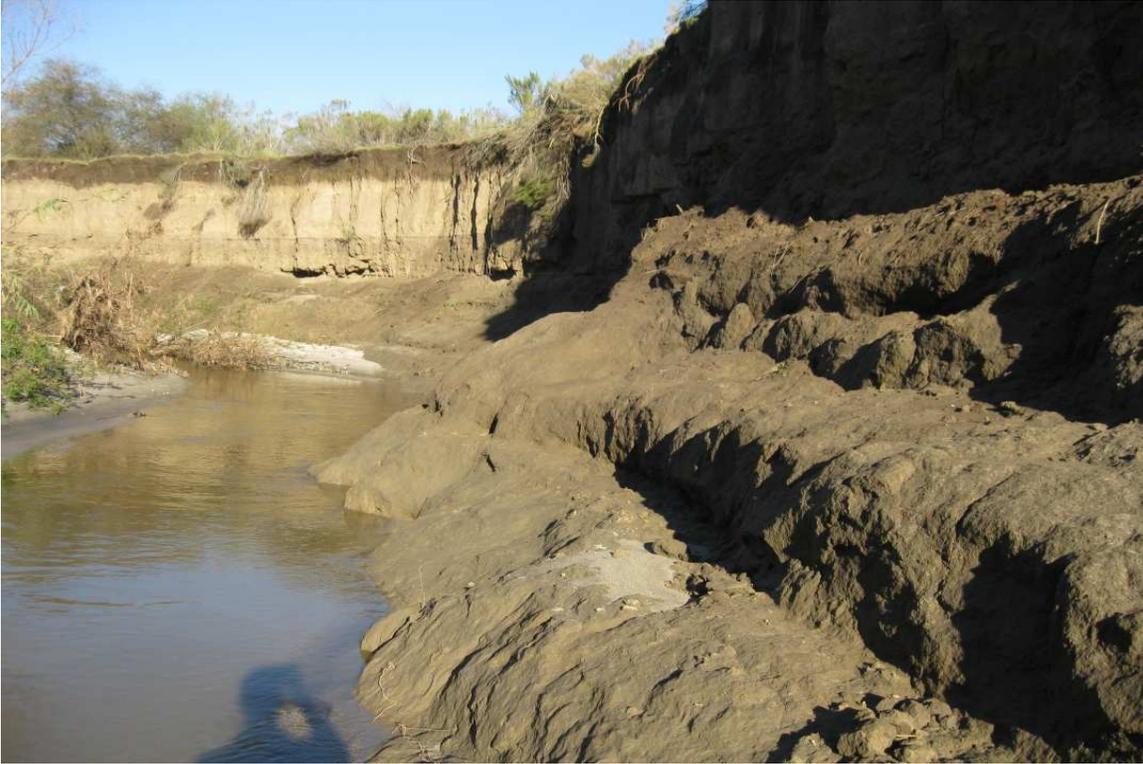
Figure 3-52. Clay layer observed in the toe of the bank near the Sulphur Creek confluence

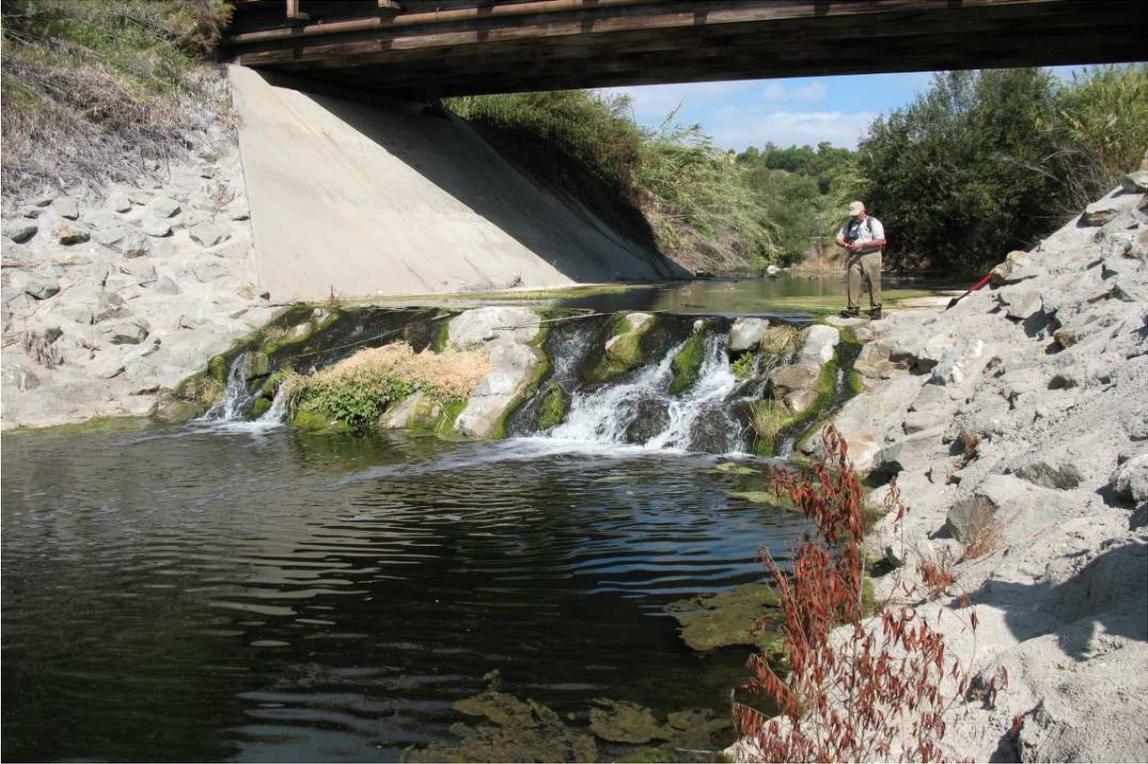
Figure 3-53. AMWA Road grade control at upstream end of Reach 9

Reach 9 - The 360-foot length of Reach 9 is the shortest of the geomorphic reaches because it represents the transition from the confluence with Sulphur Creek to the downstream end of the engineered channel that terminates at the AMWA Road bridge crossing (Figure 3-53). Due to the location of Sulphur Creek, flows in Reach 9 differ appreciably from flows in Reach 8, and the morphology of the channel is very different from the engineered shape typical of Reach 10. The average bed slope in Reach 9 is 1.0 percent, and the bottom widths range from 8 to 18 feet, for an average of 12 feet. Despite the similar bank heights (i.e., 25 to 30 feet) and bank material compared to Reach 8, the greater slope and narrower bottom width of Reach 9 produce a coarser bed comprised primarily of gravels and cobbles (Figure 3-54). This reach is in Class V of the ICEM where the bed is vertically stable but further channel widening can be expected.

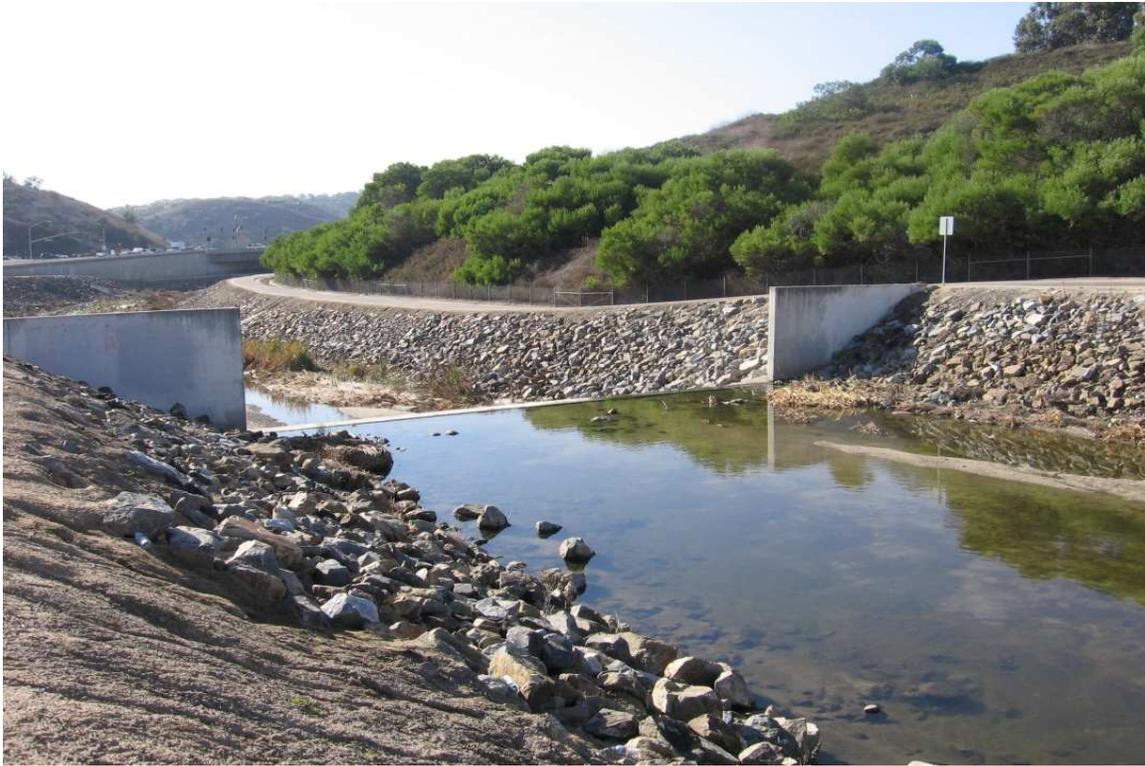
Figure 3-56. Engineered channel and riprap-protected banks typical of Reach 10

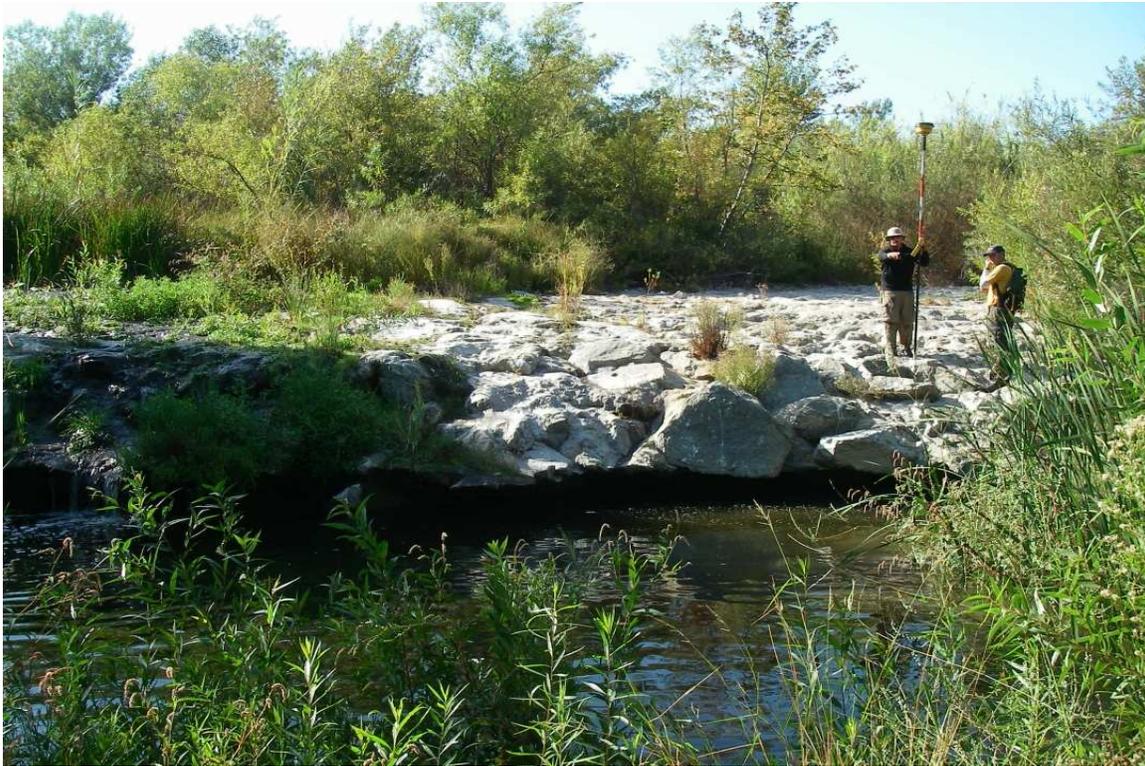
Figure 3-57. Grouted riprap grade control at crossing of water supply pipelines

Reach 11 - This reach of Aliso Creek covers a distance of 2,670 feet between the upstream end of the engineered channel (Reach 10) and a grouted riprap grade-control structure where the Joint Regional Water Supply System pipelines cross the creek (Figure 3-57). Reach 11 is east of the Aliso Niguel High School, and a bike path runs along the top of the east bank. Riprap was observed at various places along the bank (Figure 3-58), and in a more extreme case, a steel sheet pile wall was supporting the bank near the high school football stadium (Figure 3-59). Bank heights along the reach range from 10 to 20 feet. Outcrops of clay were observed in the bed and in the toe of the banks through this reach (Figure 3-60). A few knickpoints were observed with heights of one to two feet where the channel was incising through the clay layers in the bed of the channel. Coarse gravel plugs were also spaced along the reach, and sandy deposition was observed in the pools between plugs (Figure 3-61). The average bed slope is 0.38 percent. Reach 11 exhibits sinuosity of 1.2, making it one of the more sinuous reaches in the study area. This reach is in Class IV of the ICEM where further vertical incision and associated channel widening can be expected.

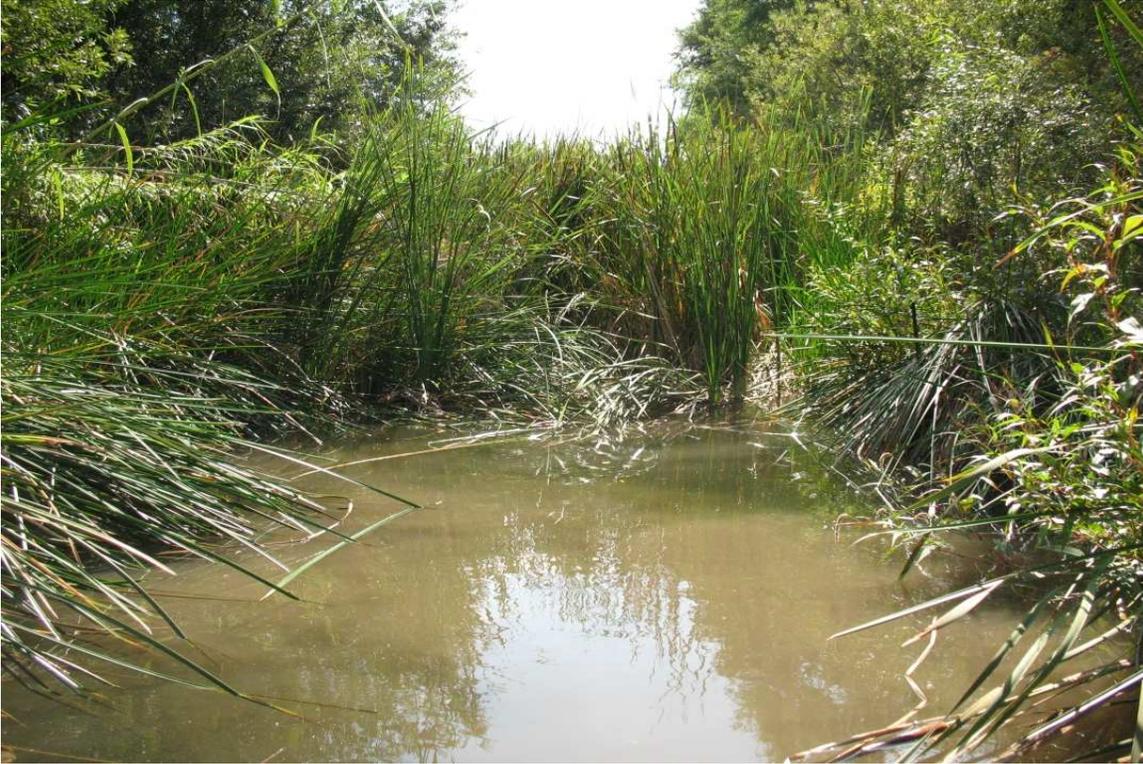
Figure 3-61. Downstream view of sand-bottom pool and cattail covered gravel plug

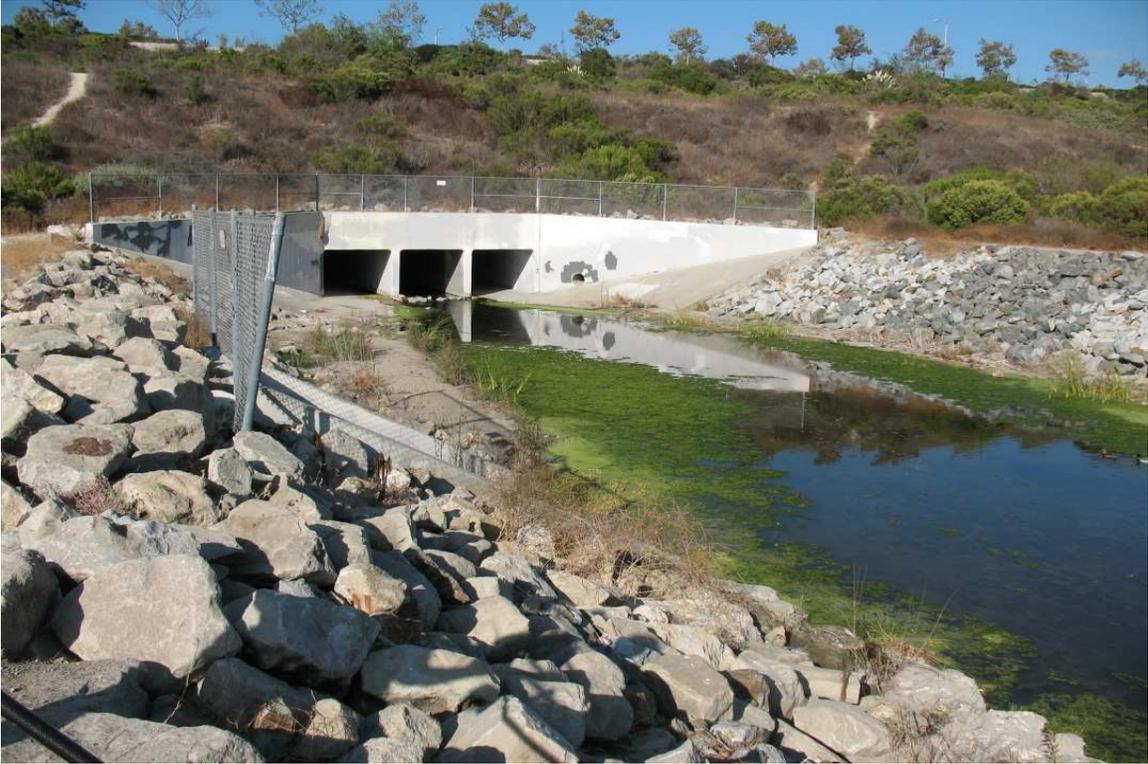
Figure 3-62. Upstream view of three 8-ft x 8-ft concrete box culverts under Pacific Park Drive

Reach 12 - The most upstream reach in the study area extends for a distance of 1,270 feet from the water supply pipeline crossing to the three 8-foot by 8-foot concrete box culverts under Pacific Park Drive (Figure 3-62). As with Reach 11, a bike path runs along the top of the right bank, and riprap has been placed at selected locations along the bank to protect the path; although, in places without riprap, scalloping was observed (Figure 3-63). Approximately 250 feet of the channel immediately below the culvert outlets have been engineered and the banks lined with riprap. Bank heights in this reach are no greater than 10 feet, and the bank materials are composed of valley fill. More coarse gravel plugs were observed in this reach, and a channel spanning gravel bar was observed at the transition from the engineered channel below the culvert outlets to the natural channel (Figure 3-64). Sands and fine gravels were observed in the bed between the coarser controls. The average bed slope in Reach 12 is 0.51 percent. Bottom widths range between 27 and 55 feet. This reach is in Class VI of the ICEM where both the bed and banks are stable.

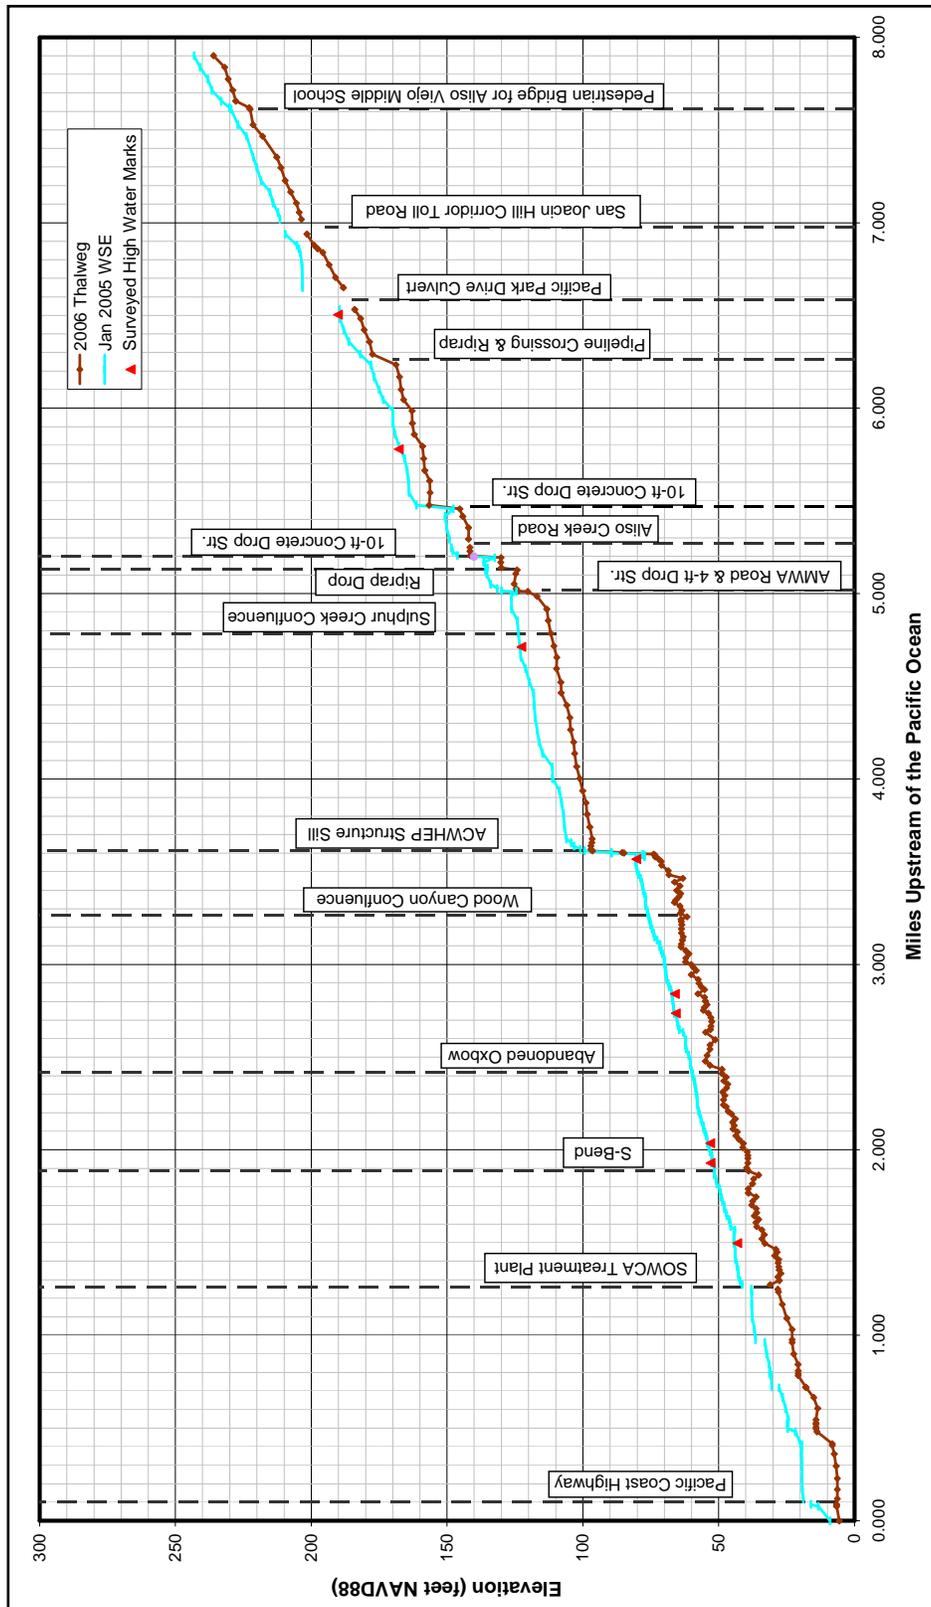
Figure 4-1. Comparison of surveyed high water marks to modeled Jan. 2005 water surface profile

marks. Review of the modeled water-surface elevations indicates that they were not consistently biased high or low relative to the surveyed high-water mark elevations. Comparisons of the surveyed high-water mark elevations with the modeled water-surface profiles are provided in Figures 4-1 and 4-2.

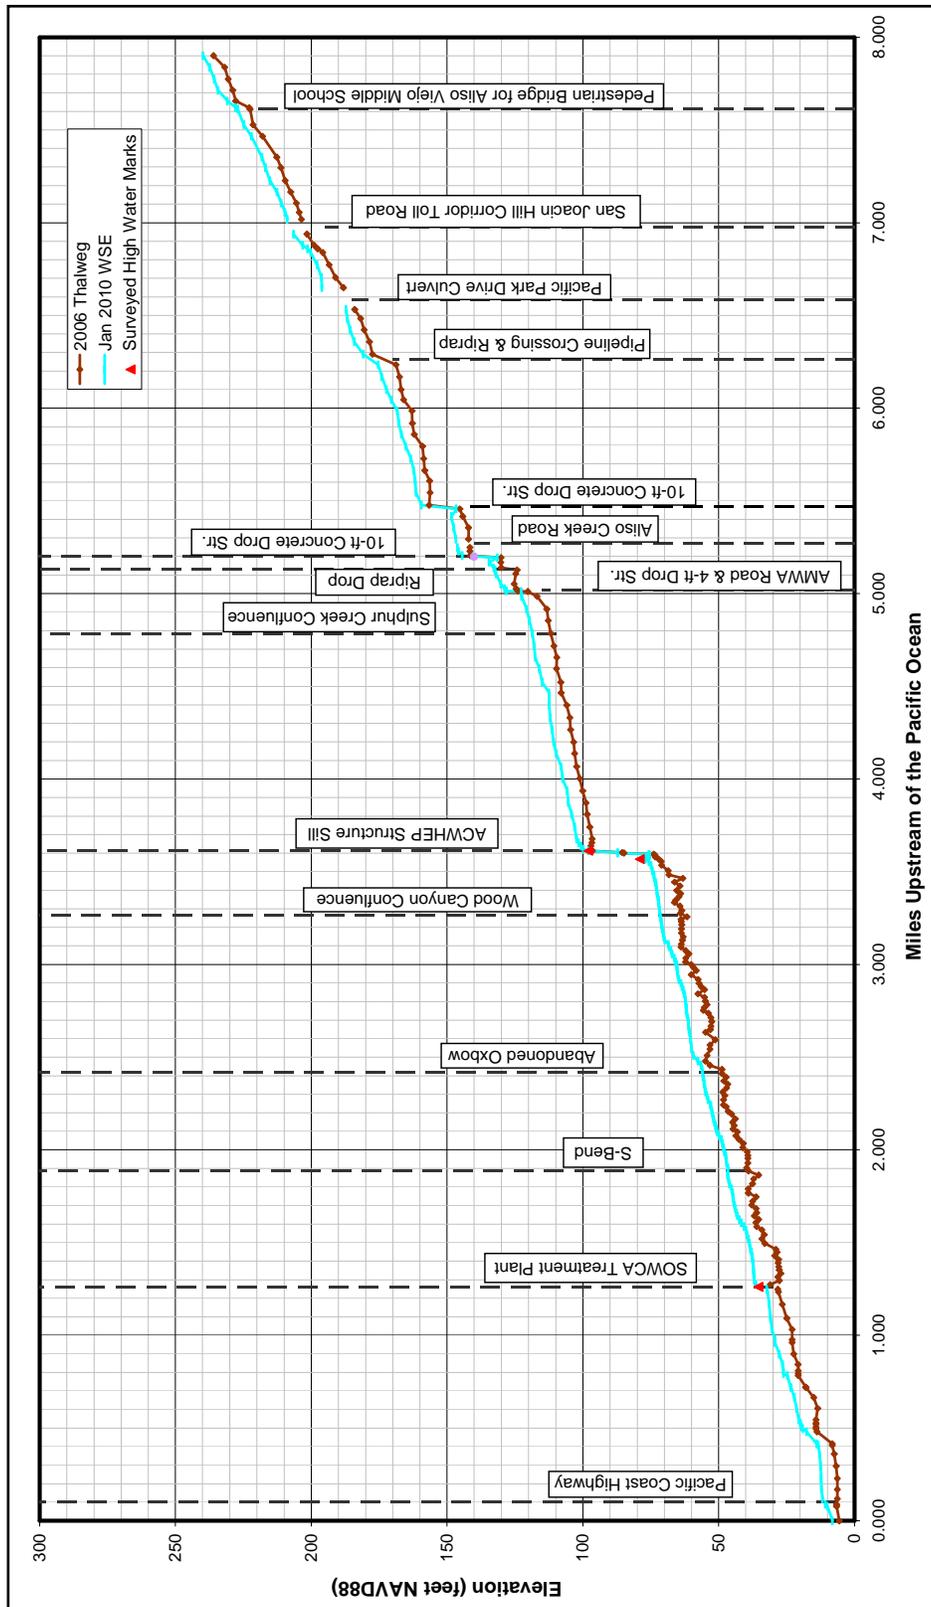
Figure 4-2. Comparison of surveyed high water marks to modeled Jan. 2010 water surface profile

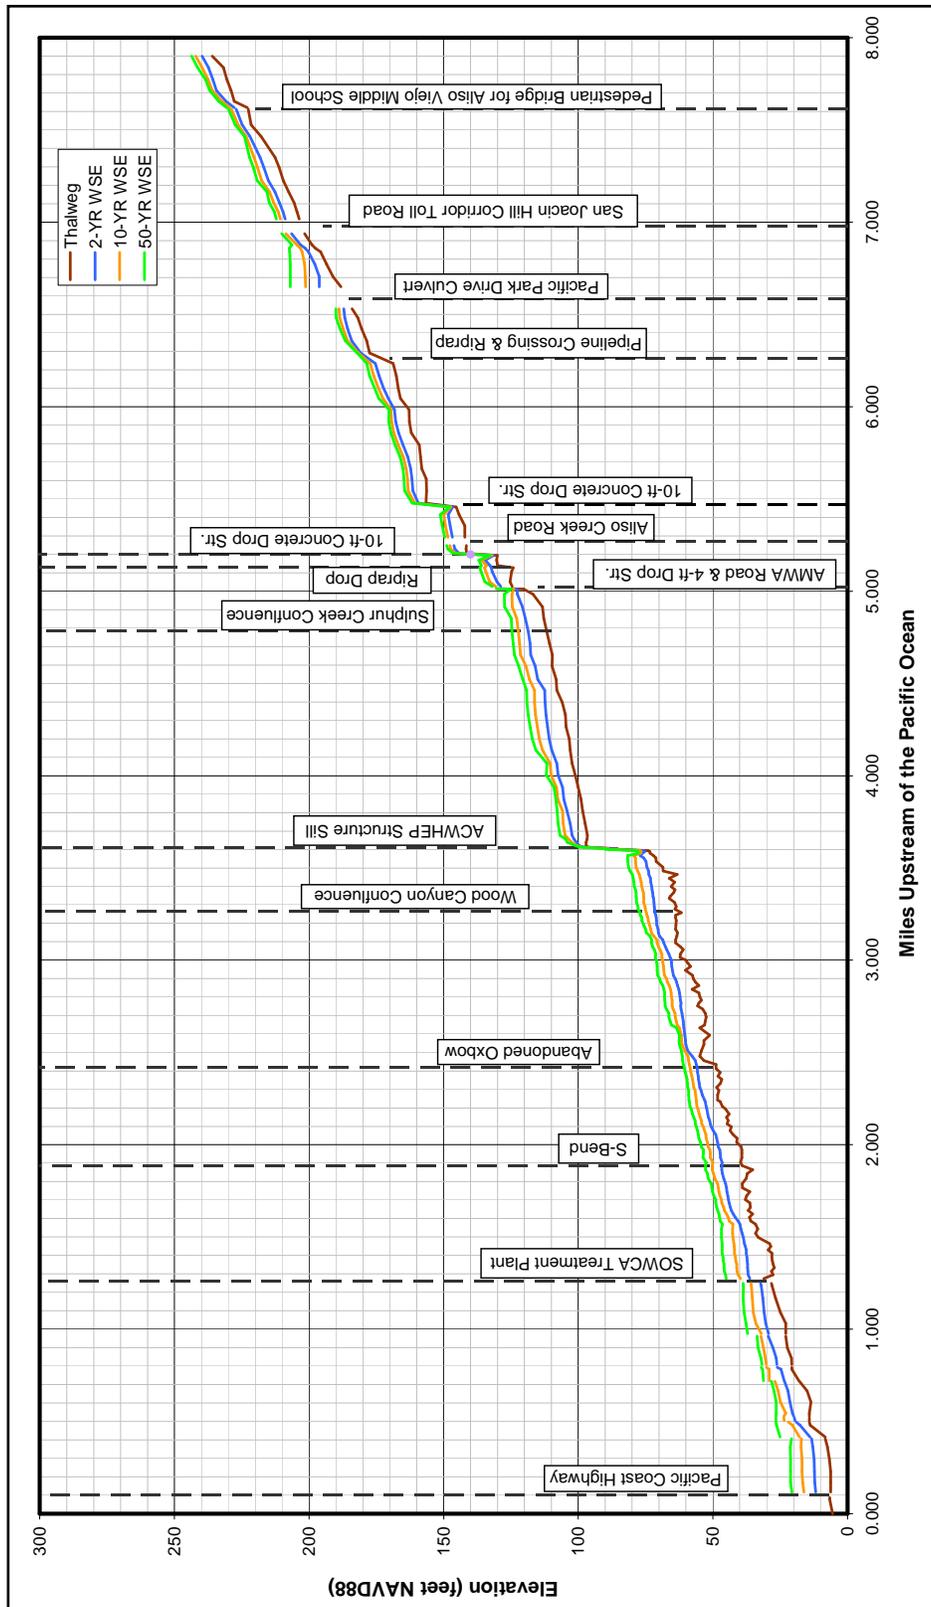
Figure 4-3. Calculated water surface profiles for the 2-yr, 10-yr, and 50-yr flood

To provide further detail regarding the calculated hydraulics, selected indicators for different flows were plotted along the longitudinal profile of Aliso Creek. The selected parameters include the water surface profile (Figures 4-3 and 4-4), top width of the active channel (Figures 4-5 and 4-6), hydraulic depth (Figures 4-7 and 4-8), channel velocity (Figures 4-9 and 4-10), and total channel shear stress (Figures 4-11 and 4-12). These indicators were plotted for the 2-, 5-, 10-, 25-, 50-, and 100-year recurrence interval floods.

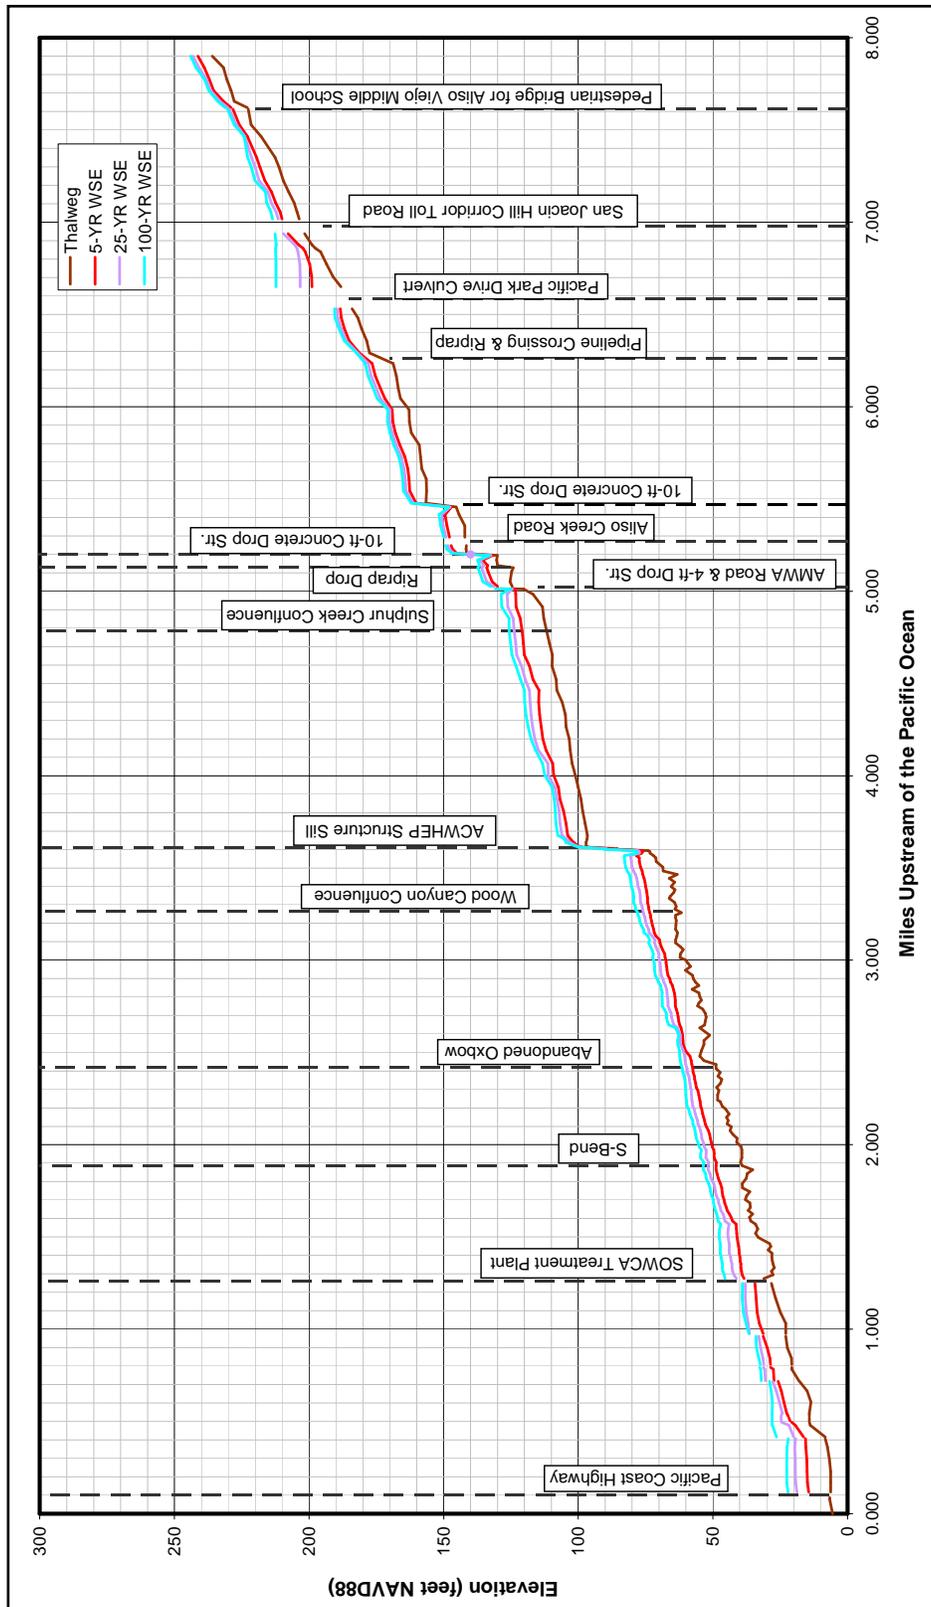
Figure 4-4. Calculated water surface profiles for the 5-yr, 25-yr, and 100-yr floods

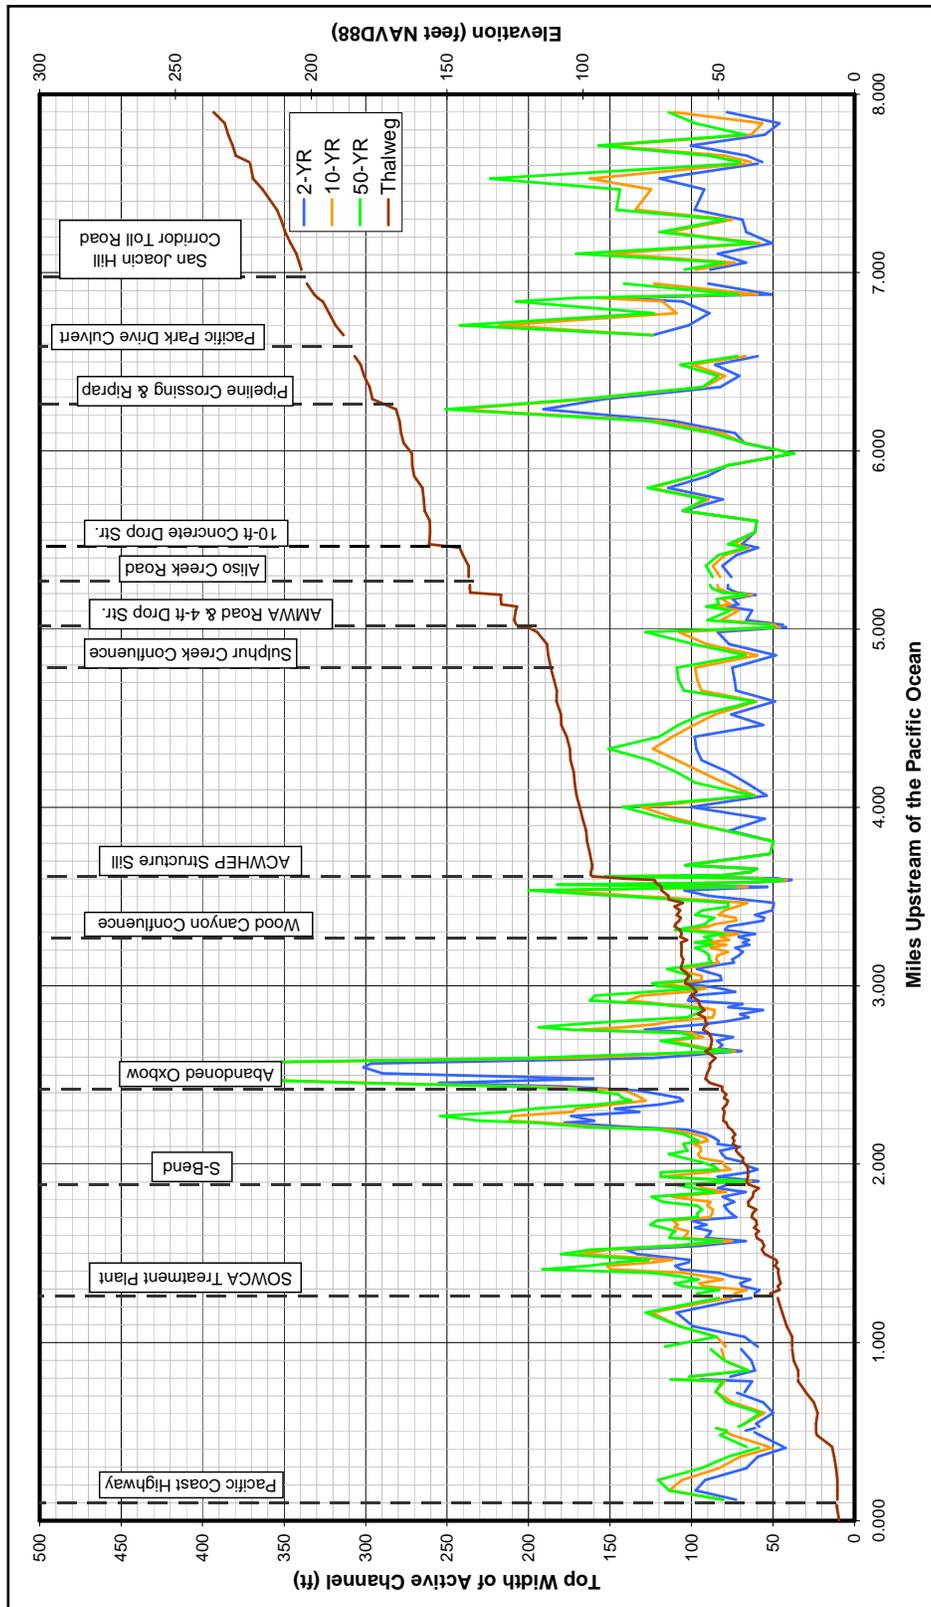
Figure 4-5. Calculated top width for the 2-yr, 10-yr, and 50-yr floods

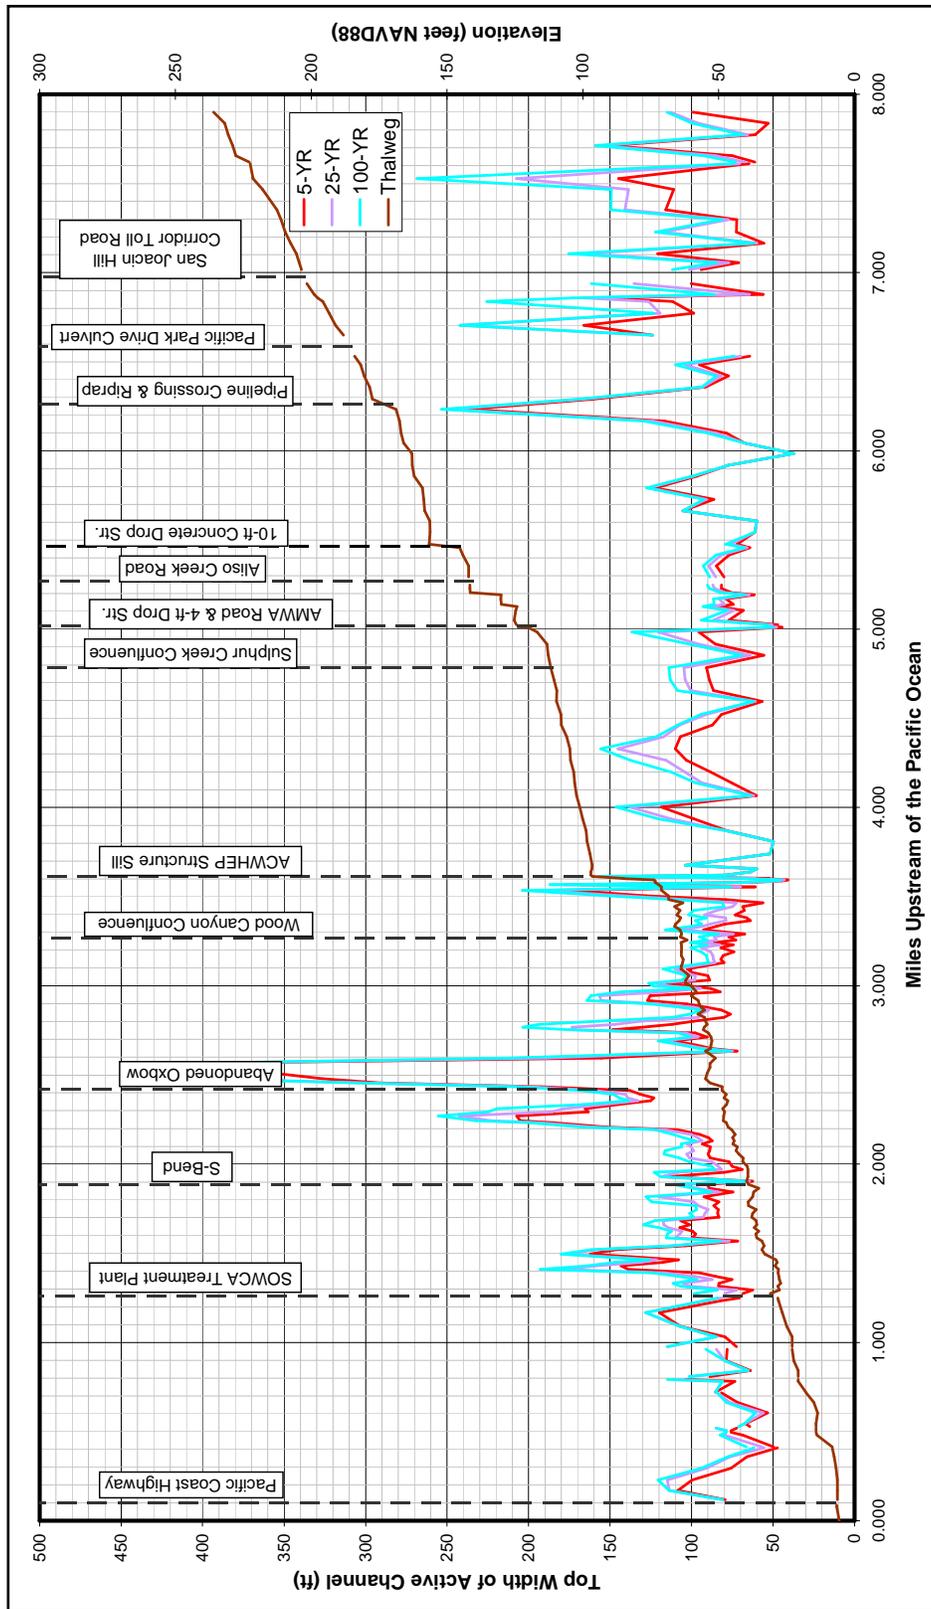
Figure 4-6. Calculated top width for the 5-yr, 25-yr, and 100-yr floods

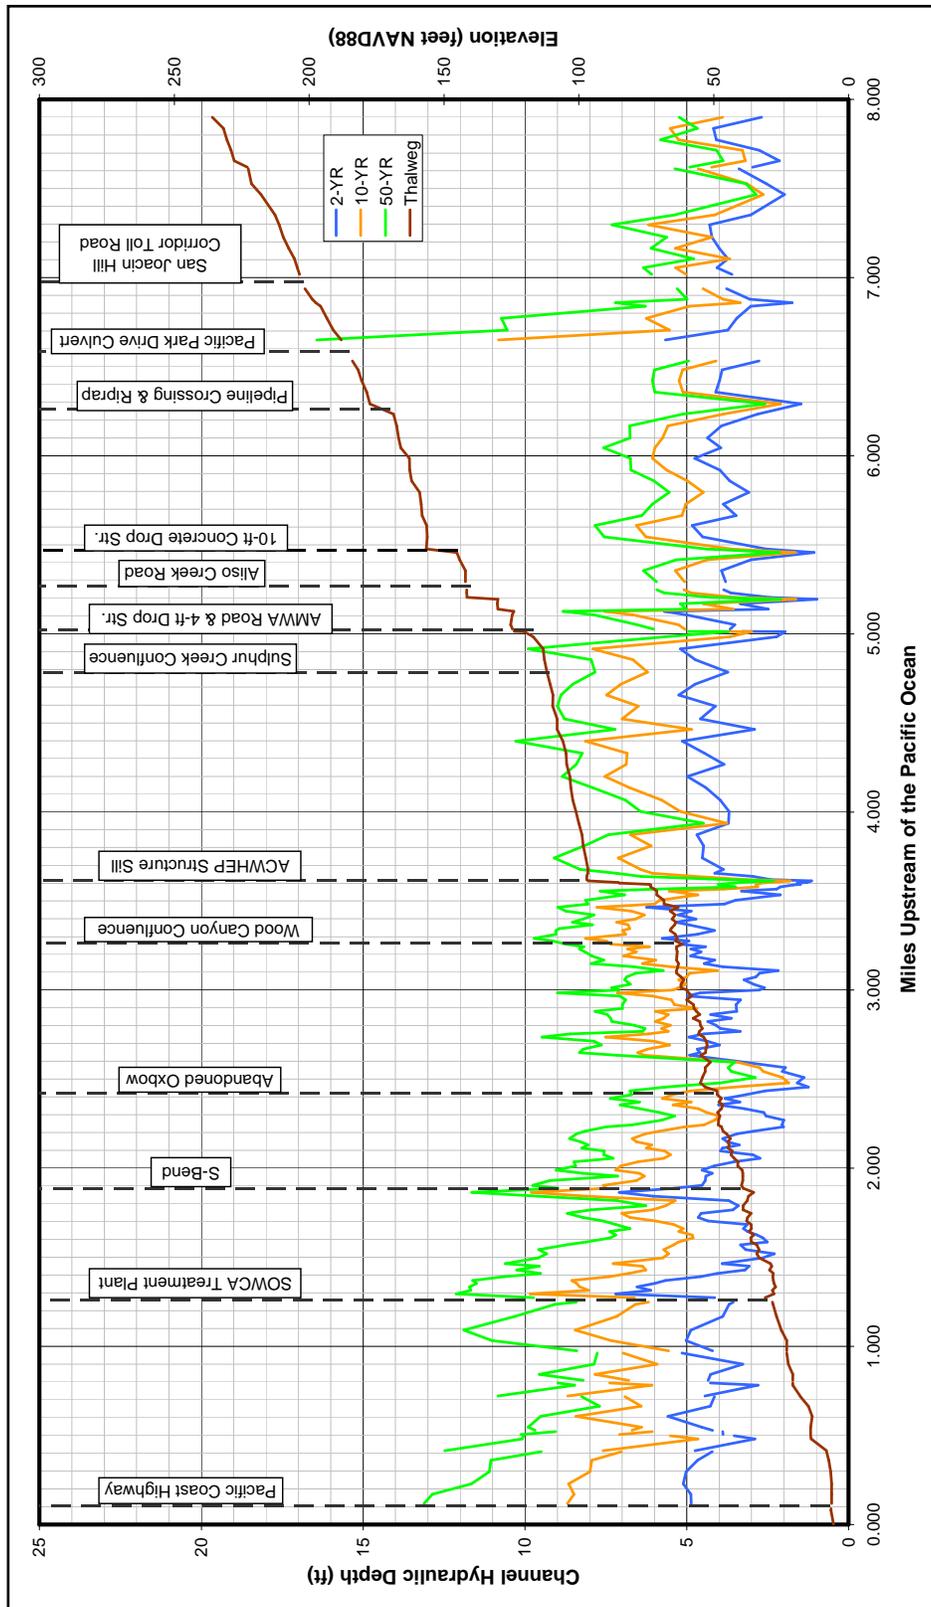
Figure 4-7. Calculated hydraulic depth for the 2-yr, 10-yr, and 50-yr floods
