Work under way to restore native plants in Aliso Creek

This geomorphic assessment of Aliso Creek was conducted to provide a basis for interpreting the hydraulic engineering work associated with the comparison of alternative environmental restoration plans, and specifically to provide a rational basis for prediction of future geomorphic conditions associated with the no-action plan. This assessment builds on numerous earlier hydrologic, hydraulic, geotechnical, and geologic studies and investigations conducted in the Aliso Creek watershed.

ALISO CREEK F4 GEOMORPHIC ASSESSMENT
ORANGE COUNTY, CALIFORNIA

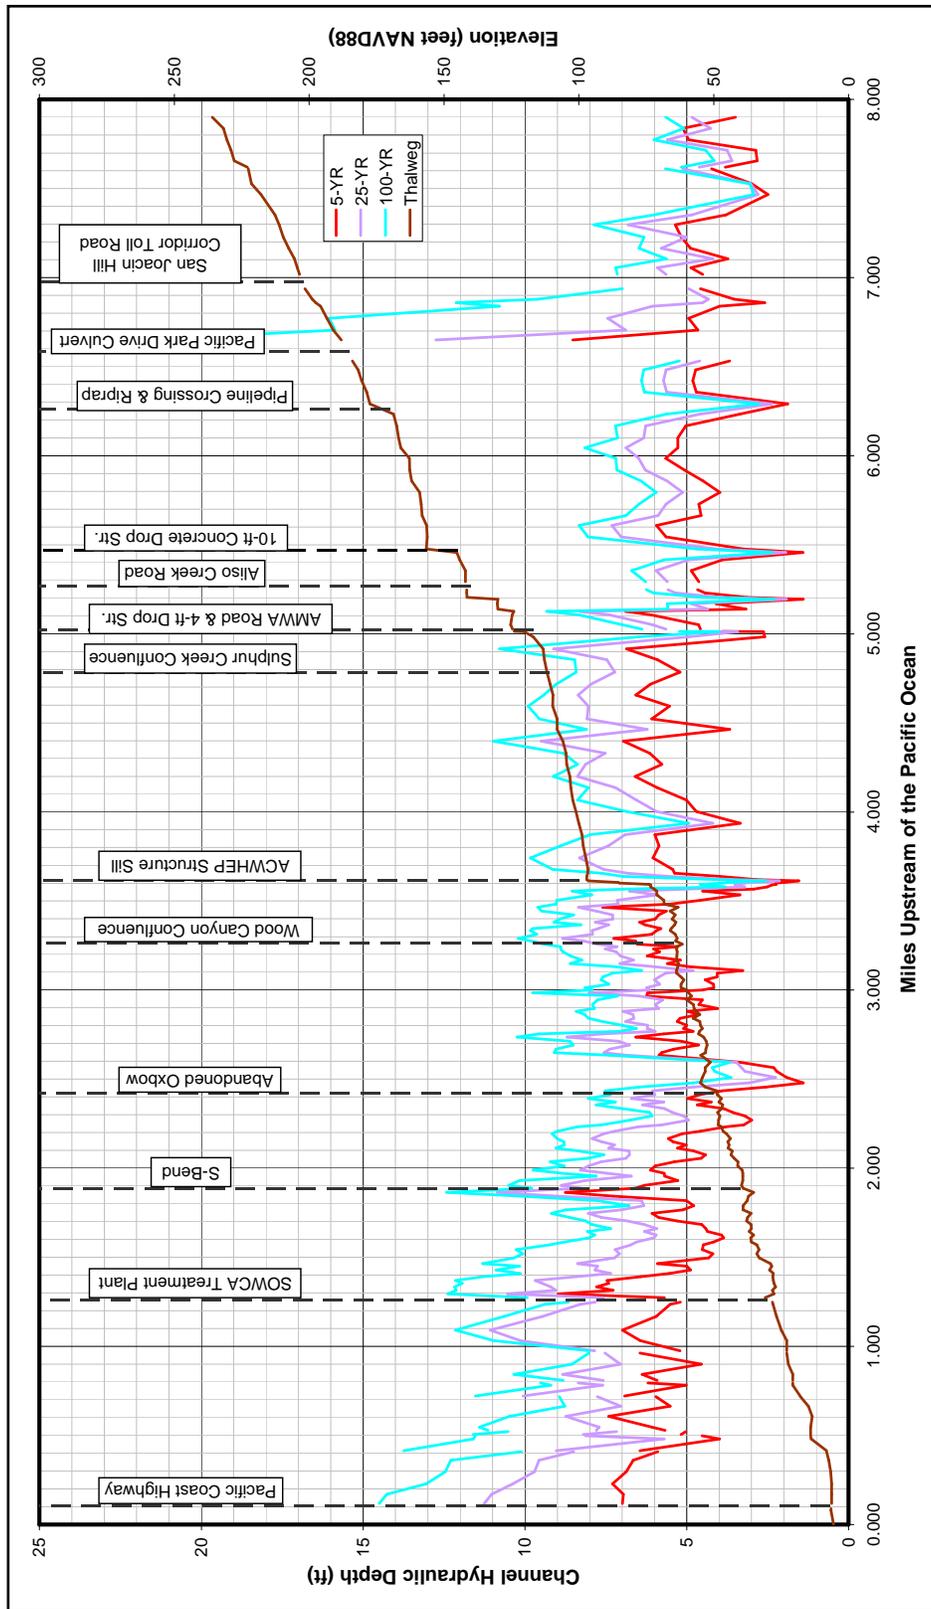
Figure 4-8. Calculated hydraulic depth for the 5-yr, 25-yr, and 100-yr floods

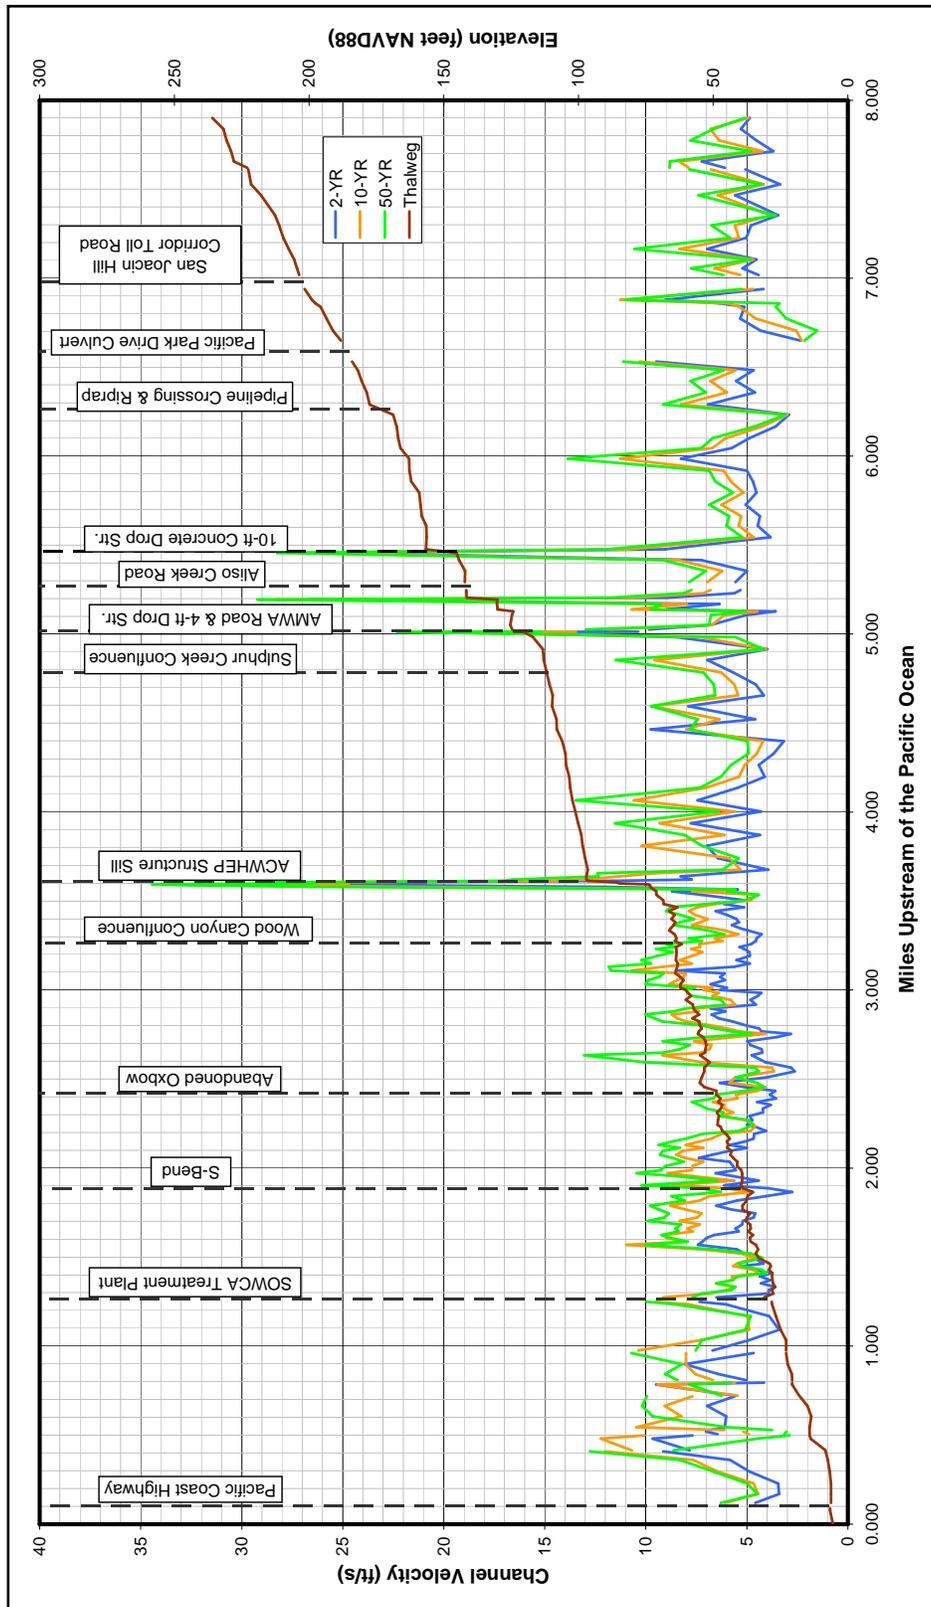
Figure 4-9. Calculated channel velocity for the 2-yr, 10-yr, and 50-yr floods

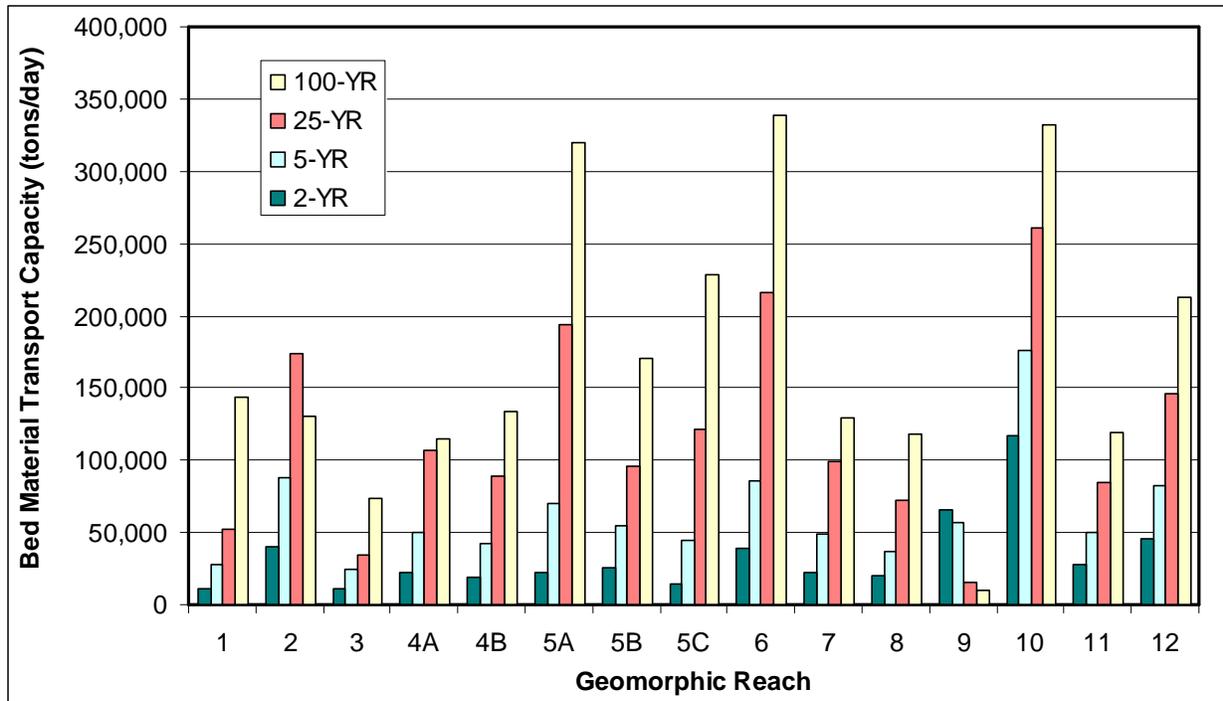
Figure 5-10. Bed material transport capacity for selected peak flood flows

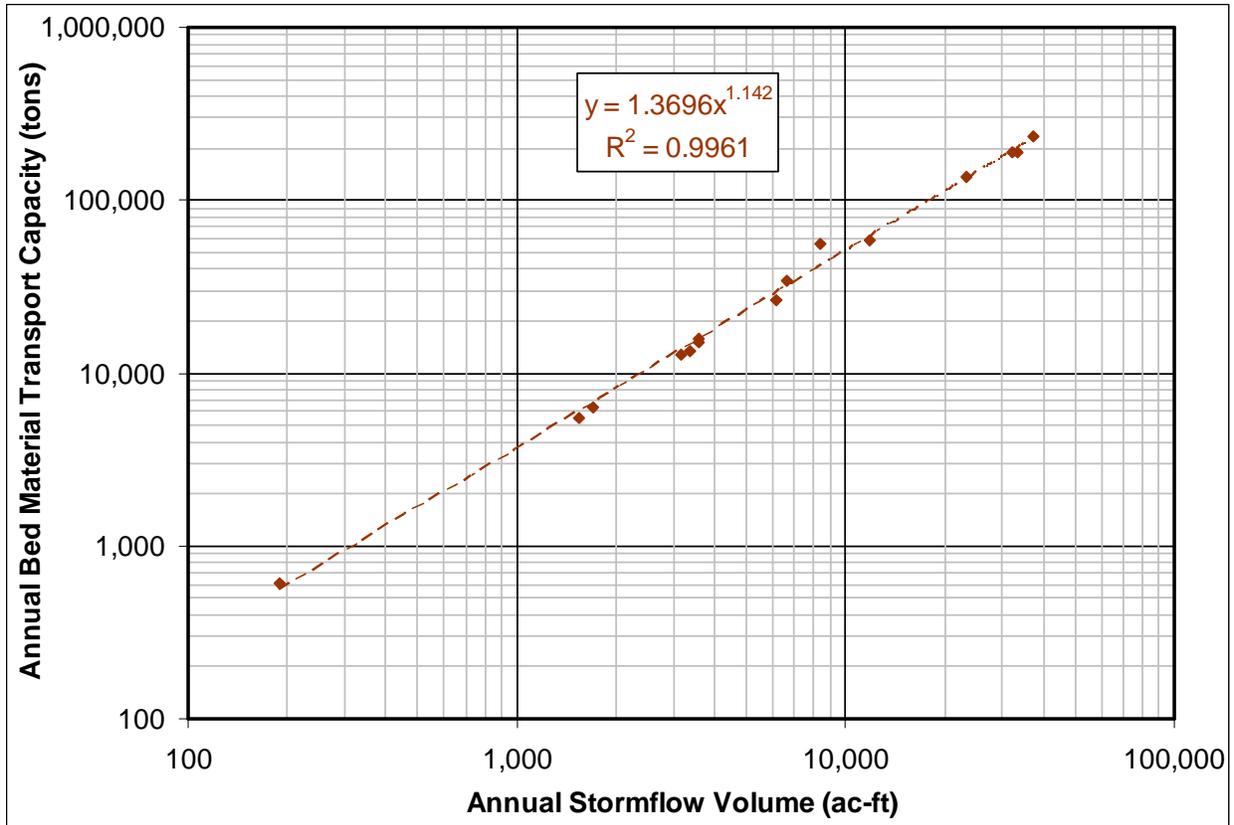
Figure 5-11. Aliso Creek Reach 7 relationship between annual stormflow bed material transport capacity and annual stormflow volume

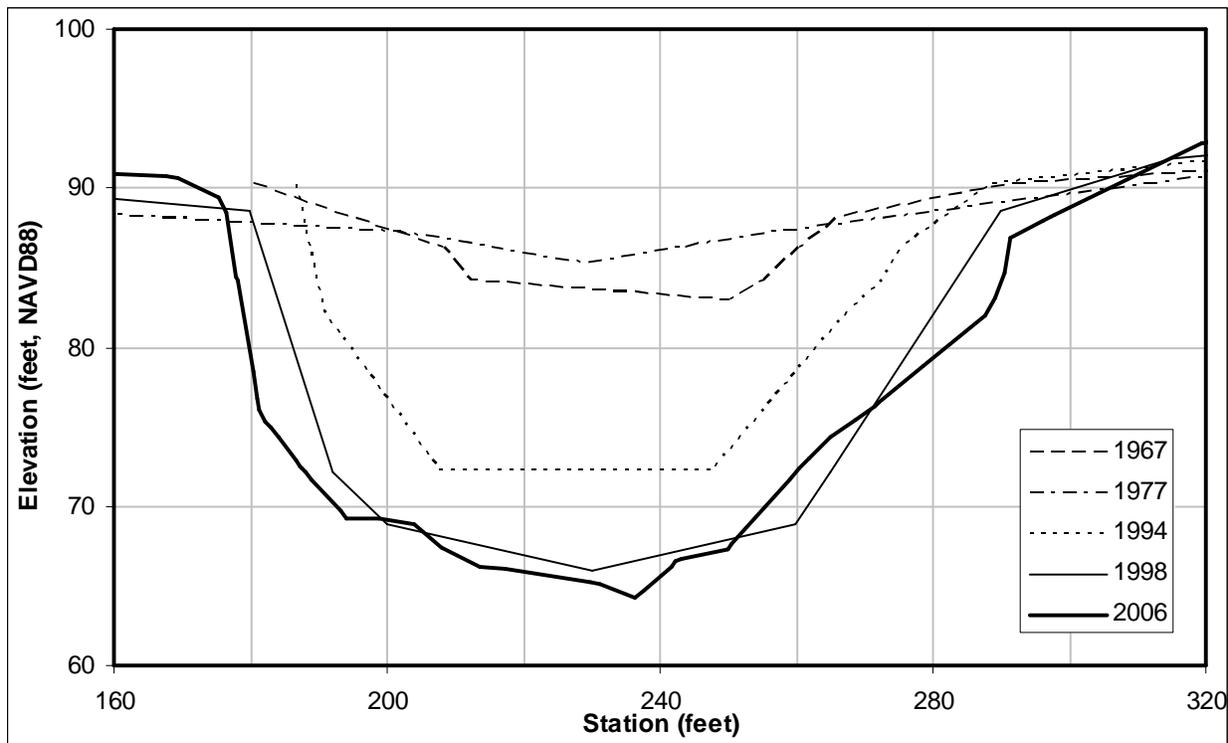
Figure 6-1. Aliso Creek channel geometry 300 feet upstream of the Wood Canyon Creek confluence

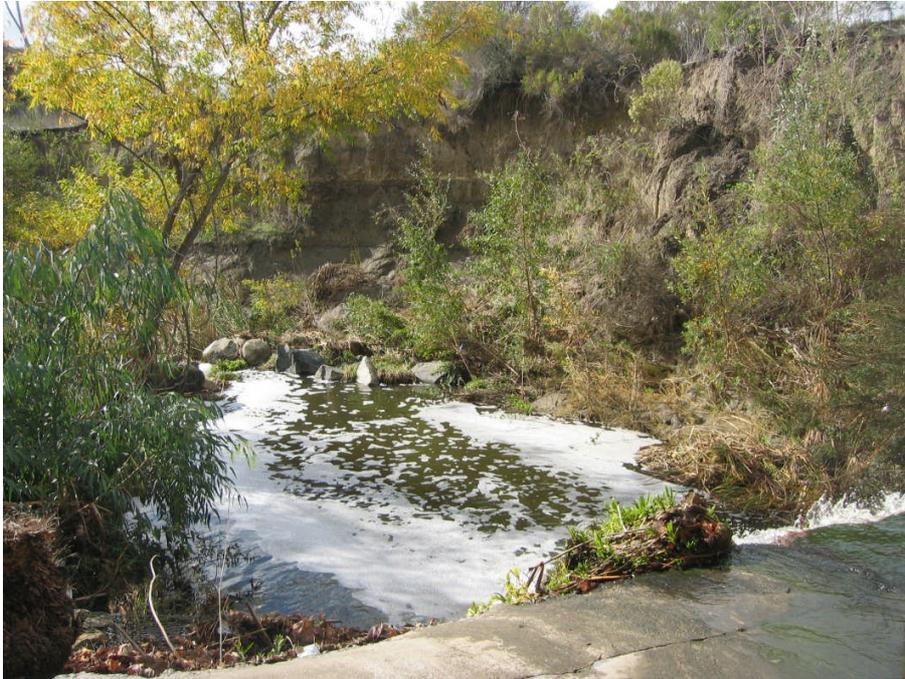
Figure 1.3 – Typical Bank Erosion

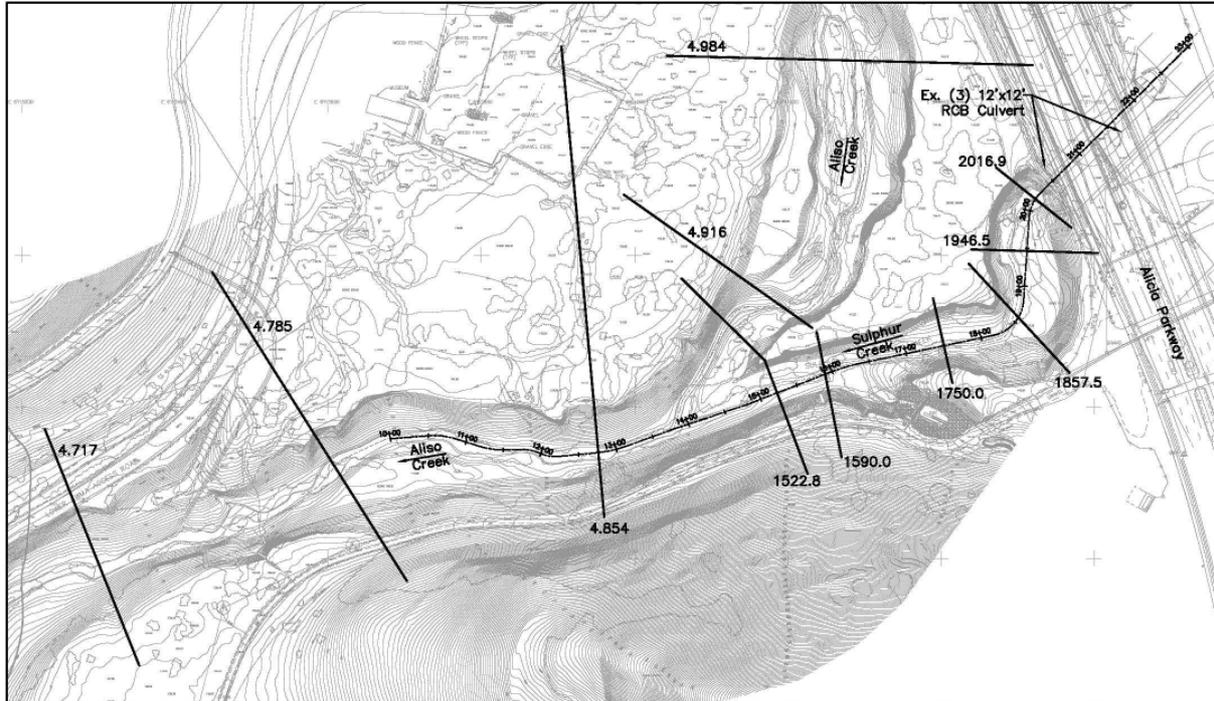
Figure 2.1 – HEC-RAS Cross Section Locations (Existing Conditions)

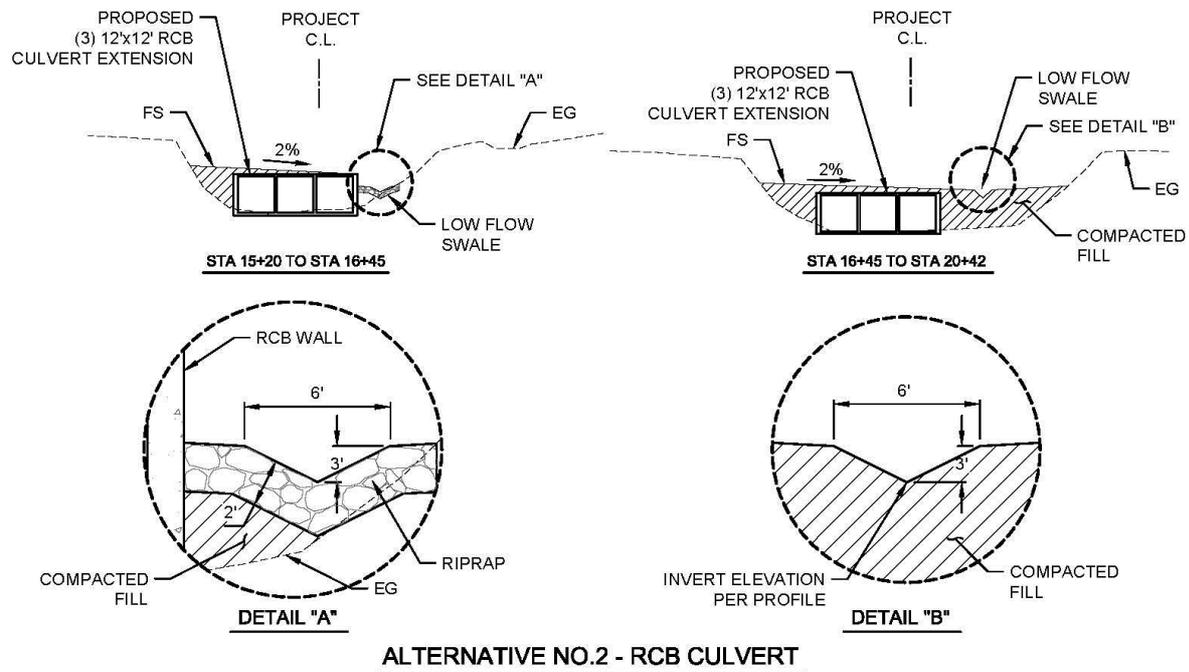
Figure 3.2 – Typical Section of RCB Culvert Extension (Alternative 2)

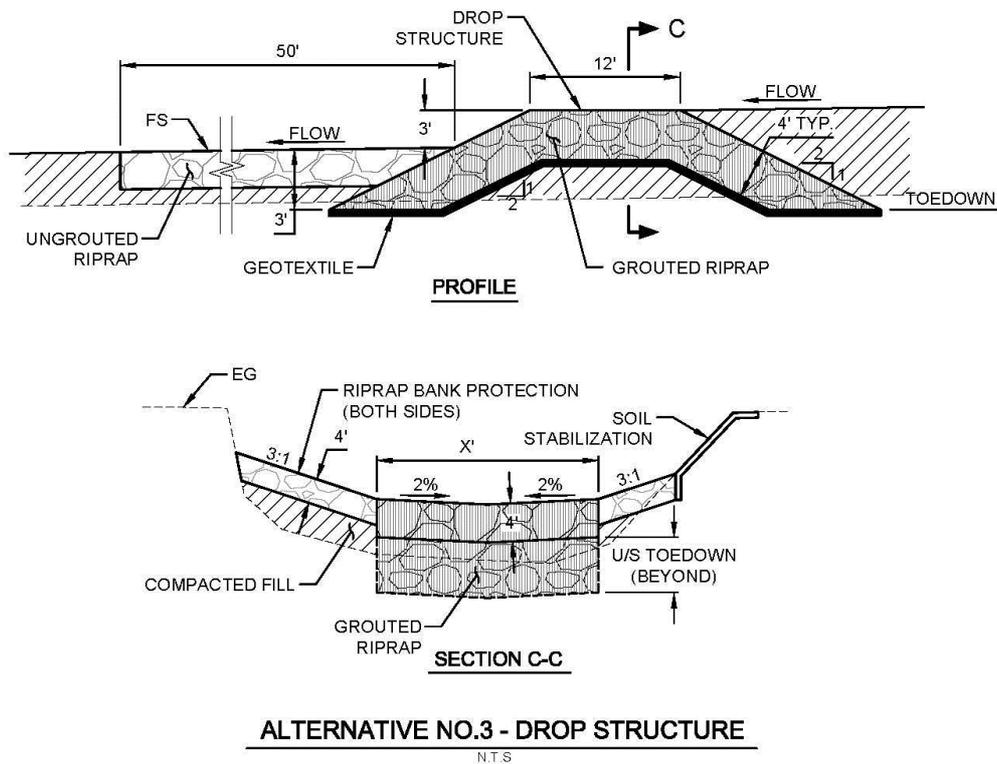
Figure 3.4 – Typical Section of Drop Structures (Alternative 3)
