**U.S. Army Corps
of Engineers**
Los Angeles District

Aliso Creek F4 Geomorphic Assessment

County of Orange, California

Draft Report

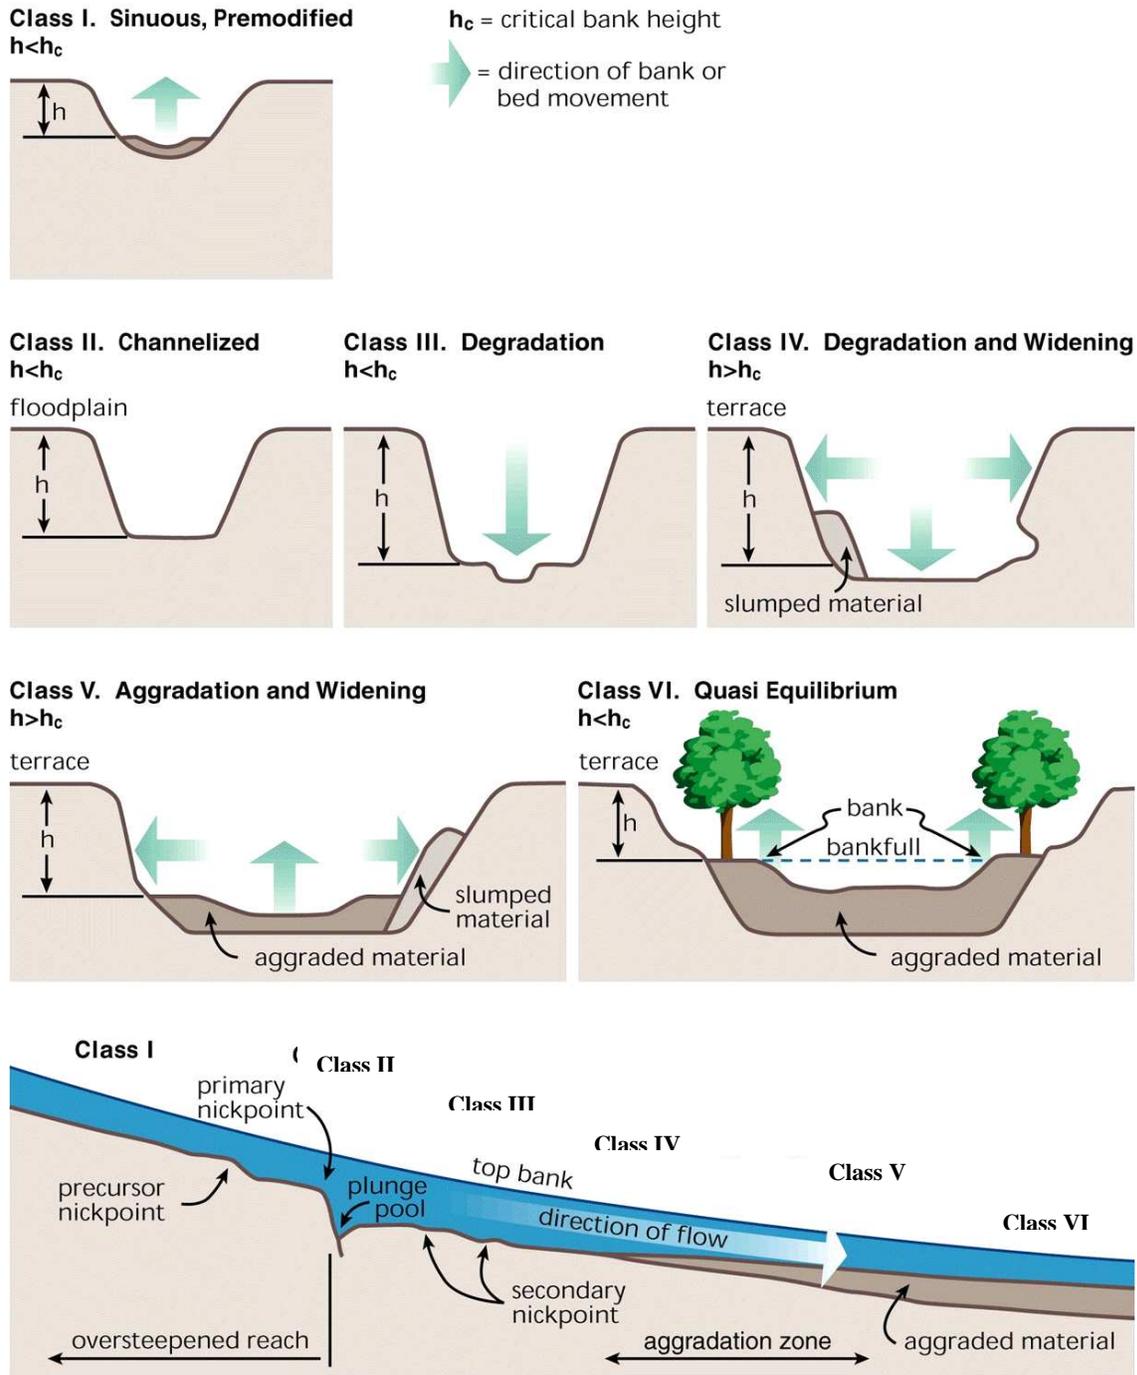
Figure 3-2. Incised Channel Evolution Model (ICEM) (after Schumm et al. 1984)

The six-class model describes the systematic evolution of a channelized stream from a state of human-induced disequilibrium (Class II) to a new state of dynamic equilibrium (Class VI) (Figure 3-2). The six classes represent a continuum of morphological changes with gradational boundaries between the

individual classes. The model identifies, quantifies, and integrates four important components of channel evolution: bank stability, the dominant/effective discharge, the hydraulic energy and sediment transport capacity of the dominant/effective discharge, and the morphological adjustments of the channel through time and space (Harvey and Watson 1986; Watson et al. 1988). Following human-induced disequilibrium (Class II), the channel incises (Classes III and IV), widens as a result of failure of the excessive bank heights (Classes IV and V), and ultimately aggrades (Class VI), at which point an equilibrium channel reflecting a dynamic balance between sediment supply and transport capacity has formed within the overwidened channel incised in the valley floor. Mass bank failure occurs when the bank height exceeds the critical bank height (Little et al. 1981; Watson et al. 1988). When the banks are steep, slab or wedge failures predominate (Class IV) and as the bank angle is subsequently reduced, deeper seated slump failures predominate (Class V) (Lohnes and Handy 1968; Harvey and Watson 1986; Thorne 1988; Thorne 1999; Simon and Darby 1999). System-wide, as opposed to local, channel widening as a consequence of bank failure will continue as long as the failed bank materials are removed by flows. Conversely, retention of the failed bank materials will promote bank stability and prevent further channel widening (Carson and Kirkby 1972; Thorne 1982, 1991).

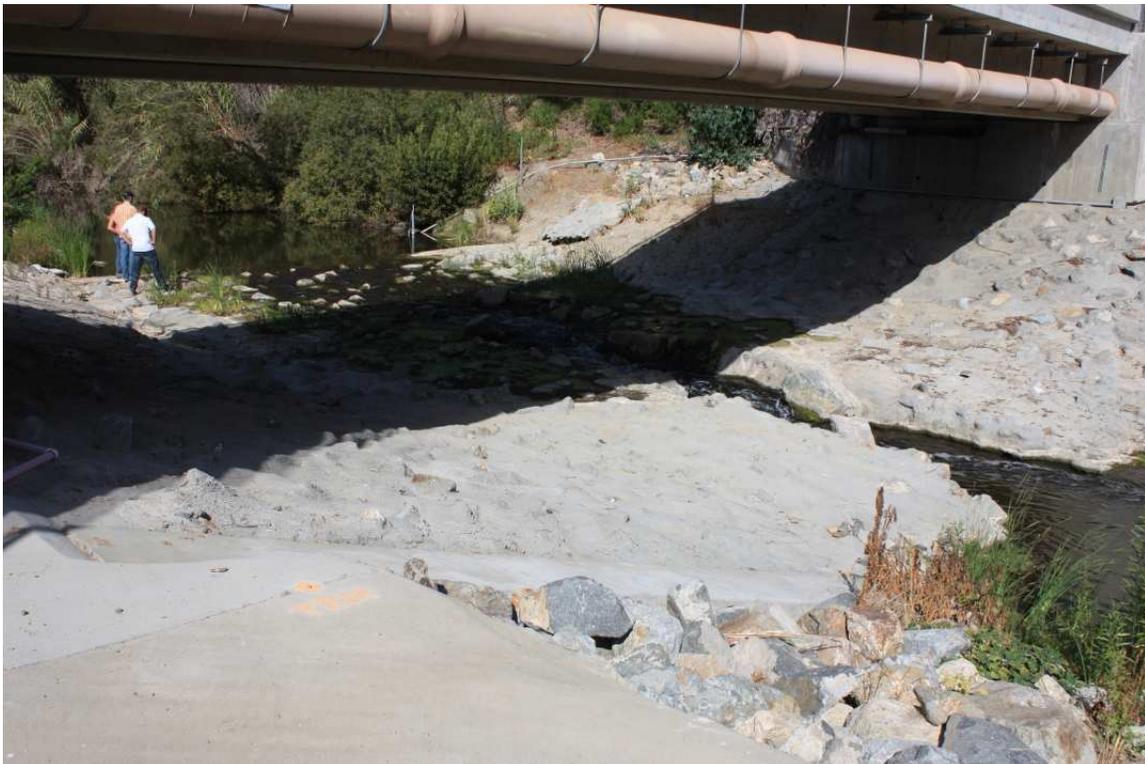
Figure 3-29. SOCWA bridge grade control and concrete sill

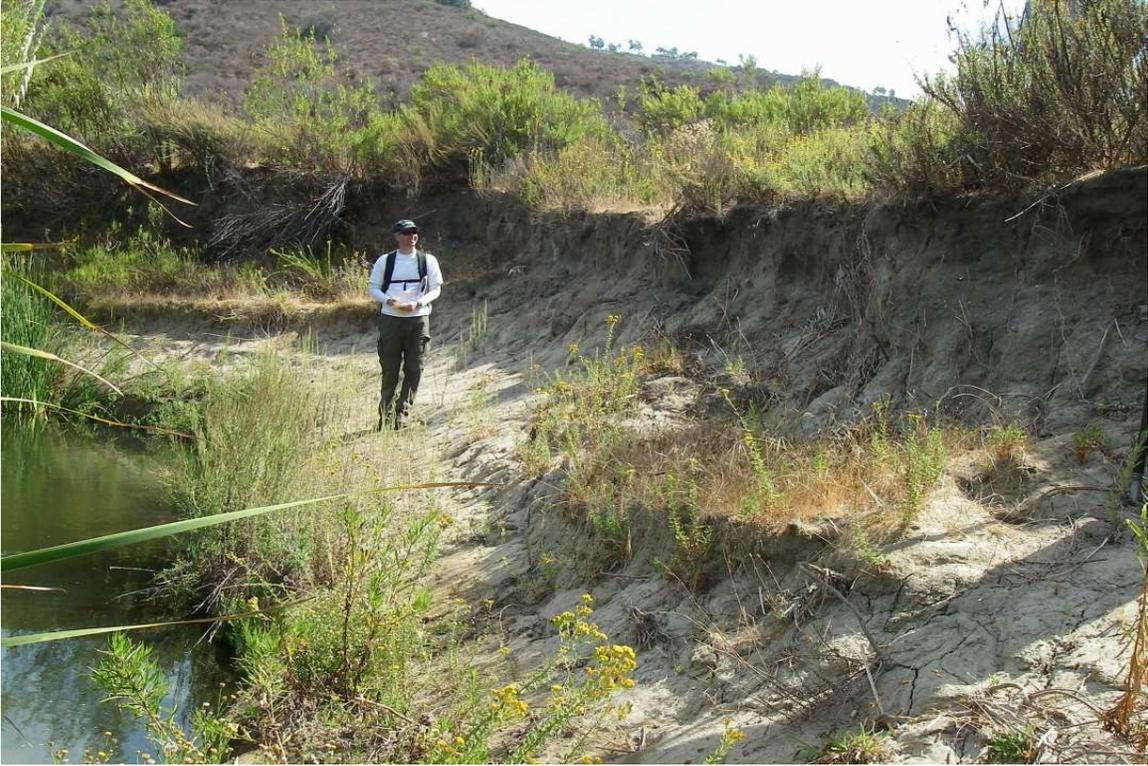
Figure 3-32. Upstream view of clay in left bank of S-bend

Reach 4B - The 3,260 feet of Aliso Creek between the downstream end of the S-bend (Figure 3-32) and the weathered sandstone and clay outcrop near the upstream end of the abandoned oxbow (Figure 3-33) make up Reach 4B. Two notable geomorphic features include the S-bend and the abandoned oxbow. Due to the influence of historical landslides and associated deposition of clays, the degradation of the channel through this reach has exposed numerous coarse gravel and cobble plugs as well as clay and sandstone outcrops. The presence of these relatively erosion resistant materials has allowed for the persistence of the S-bend and the currently abandoned oxbow. While sandy bed deposits were observed in this reach, coarser gravels and cobbles along with clay outcrops control the bed profile. Bank heights in Reach 4B are around 15 feet up to the downstream end of the abandoned oxbow, where a noticeable increase to approximately 20 feet occurs. Bank materials are composed of valley fill, and ample supplies of gravels and cobble were observed in the fill material (Figure 3-34). The average bed slope in Reach 4B is 0.35 percent. The average bottom width is 17 feet, ranging between 5 and 40 feet. This reach is in Class V of the ICEM where the bed is vertically stable but some additional localized erosion and slumping of geotechnically unstable banks can be expected.

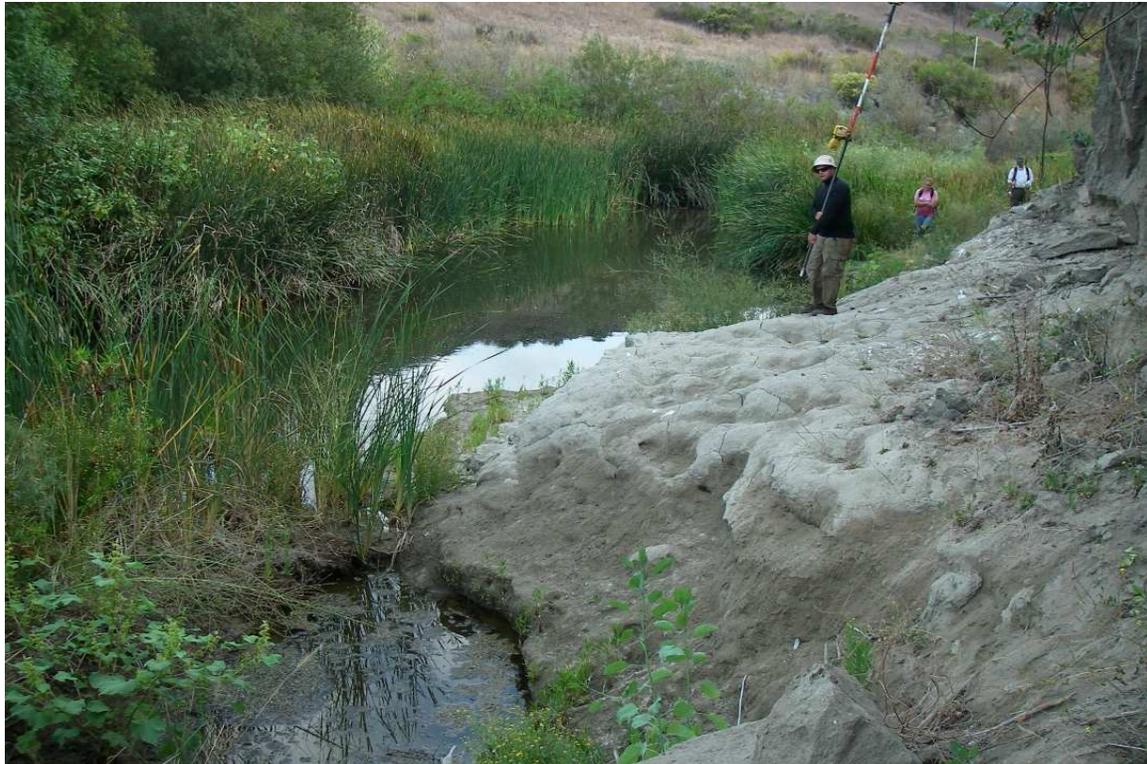
Figure 3-35. Major clay outcrop marking the upstream extent of Reach 5A

Reach 5A - Approximately 1,480 feet upstream of the weathered sandstone at the upper extent of Reach 4B, a major clay outcrop was observed in the bed and lower banks of Aliso Creek (Figure 3-35). This clay outcrop marks the upstream end of the newly-delineated Reach 5A. Since the clay was also observed in the lower few feet of the banks, it indicates that incision into the clay is ongoing. While the clay is more erosion resistant than non-cohesive materials, it is still susceptible to erosive forces. The bank heights in this reach are typically between 20 and 25 feet. A buried soil overlain by 3 to 4 feet of post-settlement alluvium was observed in the right bank (Figure 3-36). As with Reach 4B, the bank materials were composed of valley fill. The bed material through this reach was dominated by coarse gravels and cobbles, although just downstream from the clay outcrop at the upper end of the reach, a wedge of sand had filled in part of the coarse bedded pool (Figure 3-37). The average bed slope in Reach 4B is 0.30 percent. The bottom width ranges from 11 to 45 feet, with an average of 34 feet. This reach is in Class IV approaching Class V of the ICEM where there could be some further degradation into the clay-rich material in the bed and there is likely to be on-going channel widening.

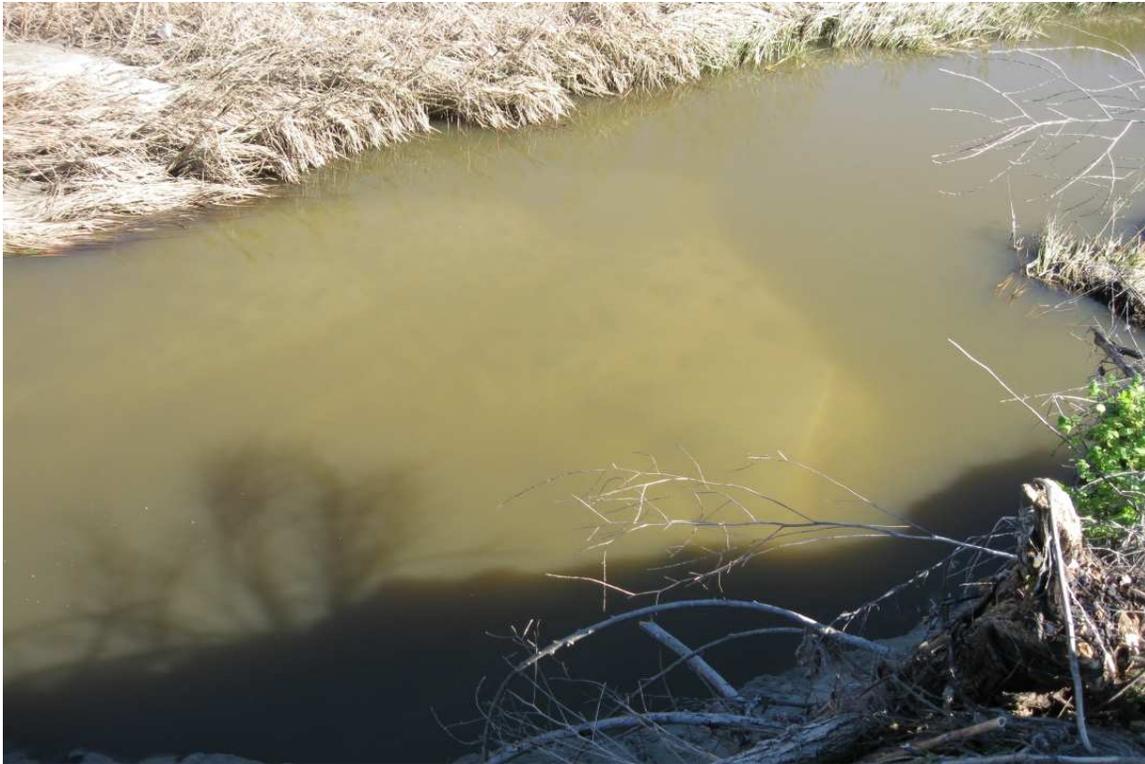
Figure 3-37. Sand wedge migrating into a pool at the upper end of Reach 5A

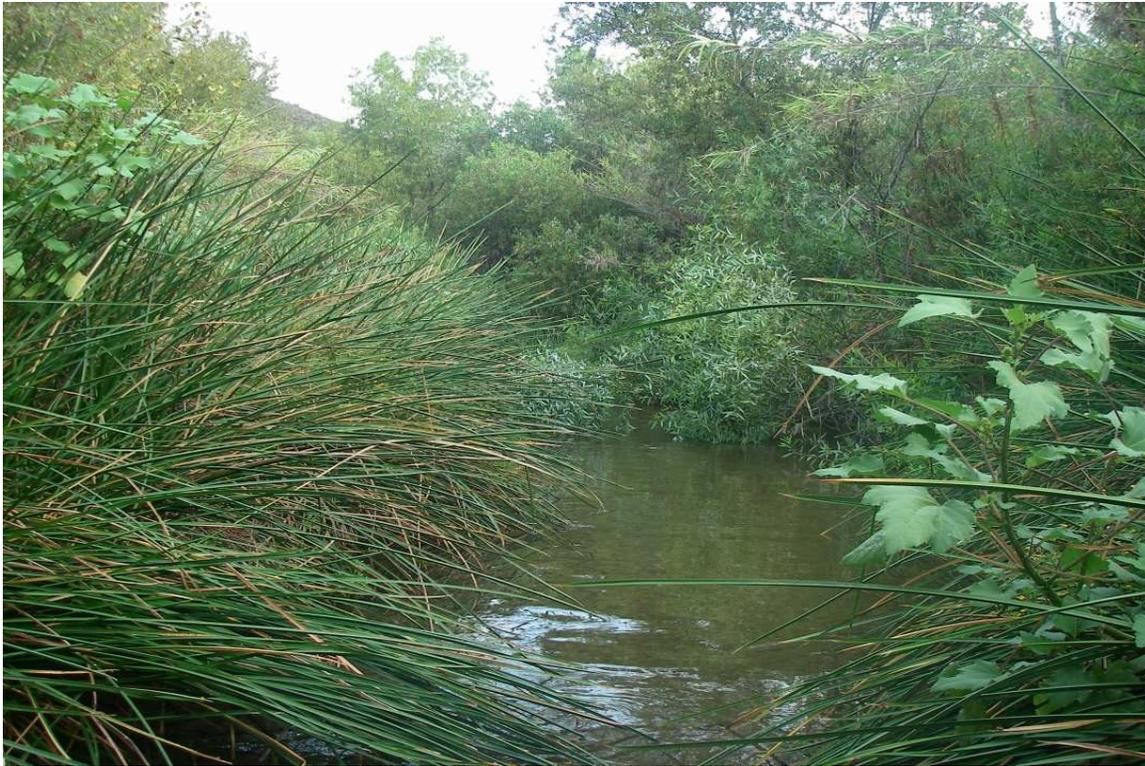
Figure 3-38. Upstream view of dense vegetation in reach 5B

Reach 5B - This reach extends for approximately 1,810 feet upstream from the clay outcrop at the upper end of Reach 5A. This reach is incised, and other than a moderate bend in the middle of the reach, it is fairly straight and densely vegetated (Figure 3-38). Riprap has been placed on the banks in places to protect AMWA Road and the buried infrastructure, specifically along the previously noted bend. A large debris jam was observed in the bend, and the jam was formed primarily of small woody debris, arundo, and trash. A few coarse gravel, cobble, and boulder plugs/riffles were encountered; the most upstream plug marks the upper extent of Reach 5B. This is also approximately the location where the bedrock mapped in boring DYB-7 is at the elevation of the existing thalweg (DYA 2009). The bedrock is a geologic grade control that provides a stable transition from Reach 5B to Reach 5C. The bank heights in this reach are typically 20 to 25 feet. As with Reach 4B, the bank materials were composed of valley fill. Figure 3-39 shows the downstream extent of the reach as seen from the top of the right bank. The bed material in this reach was dominated by sands and fine gravels, with the grade of the reach being maintained by the regularly-spaced plugs/riffles. The average bed slope in Reach 4B is 0.46 percent. The bottom width ranges from 8 to 60 feet, with an average of 23 feet. This reach is in Class V to VI of the ICEM where the bed is vertically stable, the channel width has reached a new dynamic equilibrium, but some further localized slumping and failures of geotechnically unstable banks, particularly where the active channel impinges on the toe of the terrace, can be expected.

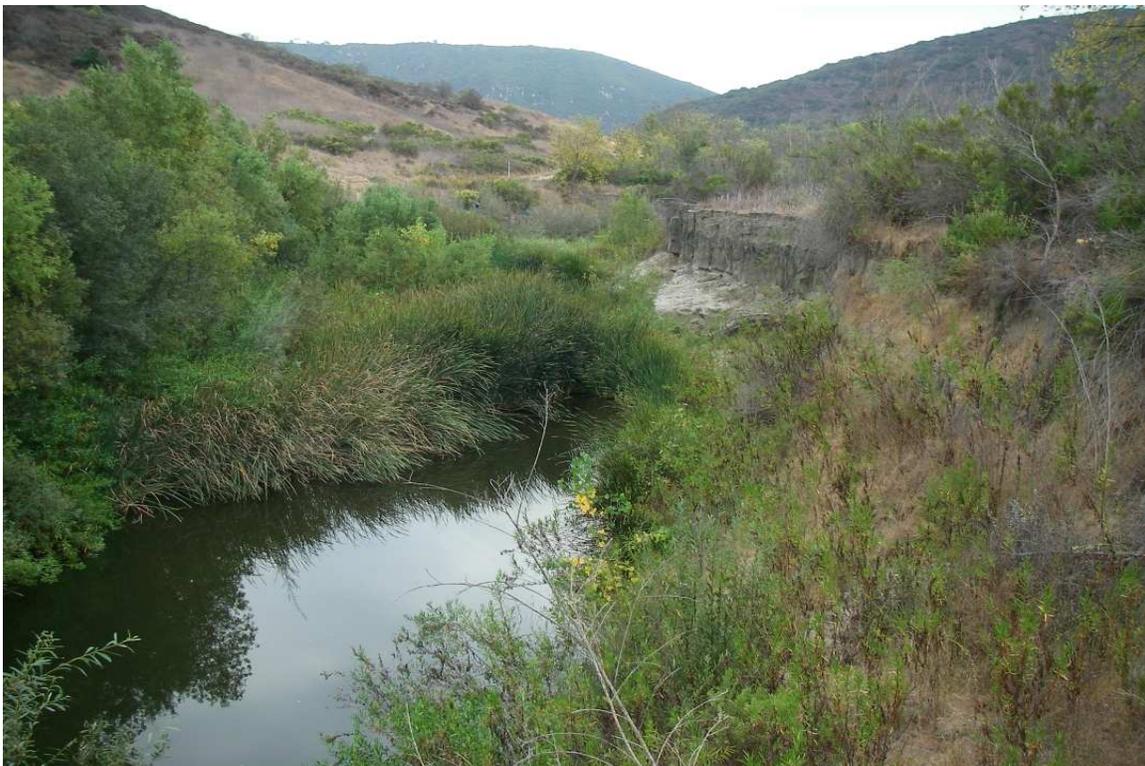
Figure 3-39. Downstream extent of Reach 5B as seen from the right top of bank

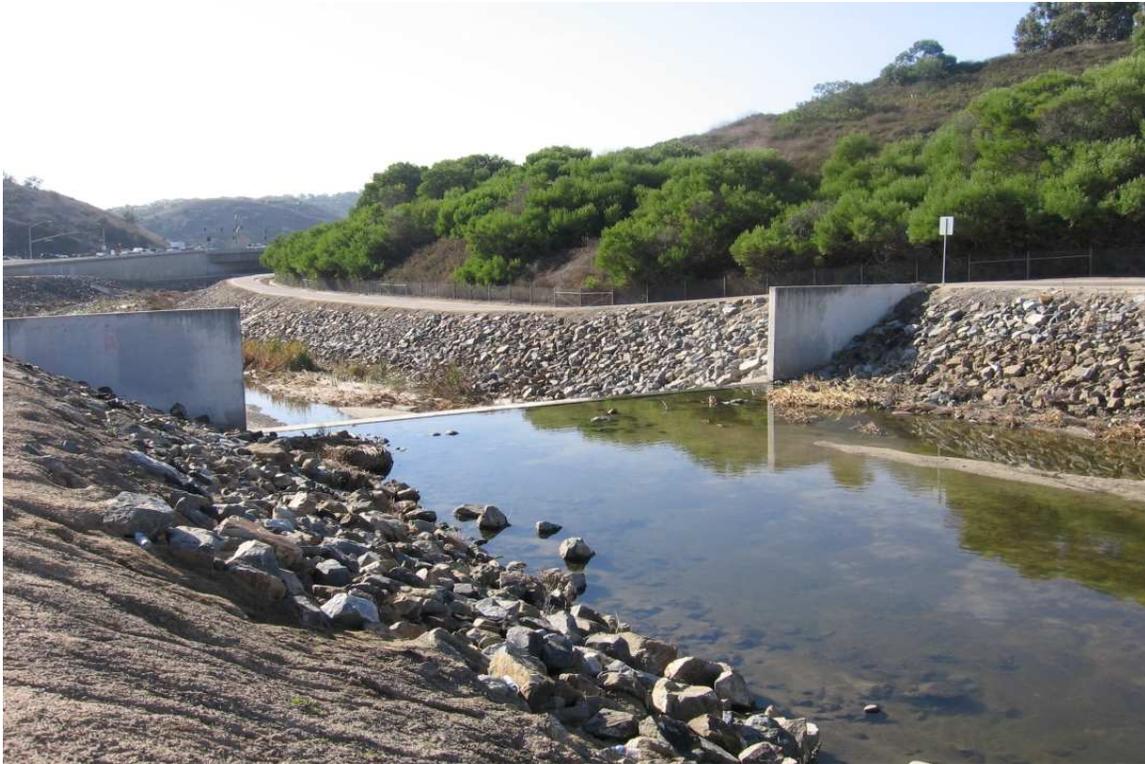
Figure 3-56. Engineered channel and riprap-protected banks typical of Reach 10

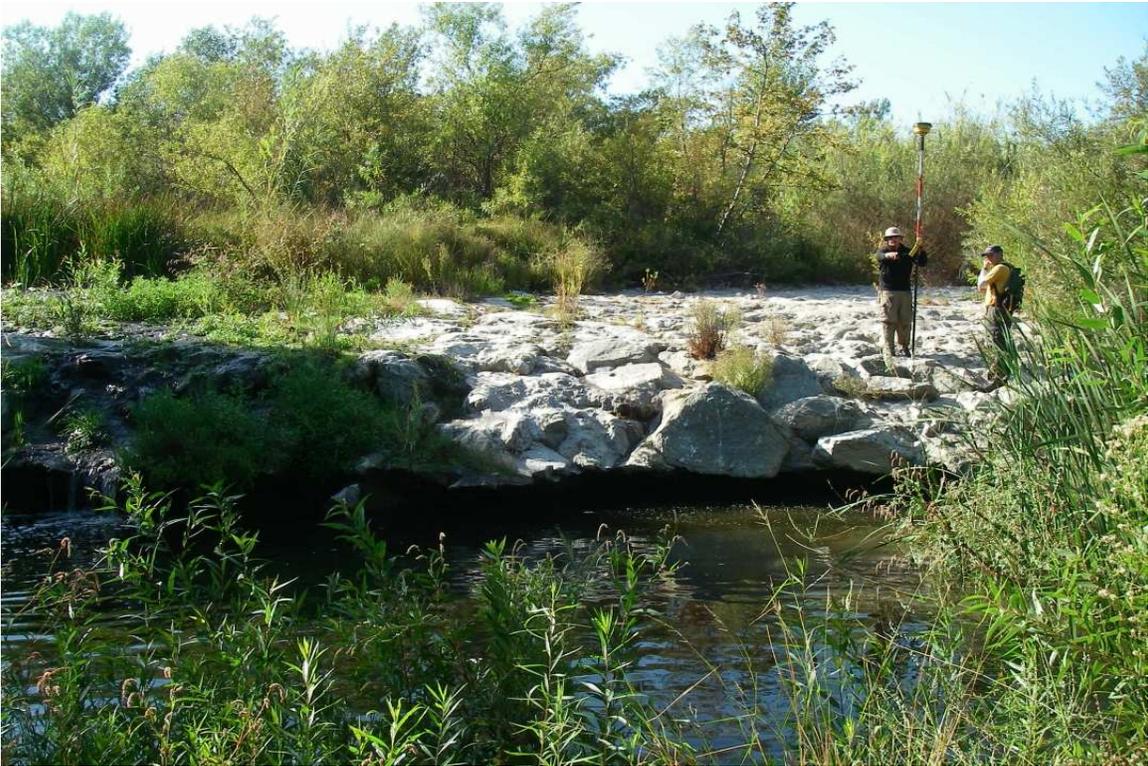
Figure 3-57. Grouted riprap grade control at crossing of water supply pipelines

Reach 11 - This reach of Aliso Creek covers a distance of 2,670 feet between the upstream end of the engineered channel (Reach 10) and a grouted riprap grade-control structure where the Joint Regional Water Supply System pipelines cross the creek (Figure 3-57). Reach 11 is east of the Aliso Niguel High School, and a bike path runs along the top of the east bank. Riprap was observed at various places along the bank (Figure 3-58), and in a more extreme case, a steel sheet pile wall was supporting the bank near the high school football stadium (Figure 3-59). Bank heights along the reach range from 10 to 20 feet. Outcrops of clay were observed in the bed and in the toe of the banks through this reach (Figure 3-60). A few knickpoints were observed with heights of one to two feet where the channel was incising through the clay layers in the bed of the channel. Coarse gravel plugs were also spaced along the reach, and sandy deposition was observed in the pools between plugs (Figure 3-61). The average bed slope is 0.38 percent. Reach 11 exhibits sinuosity of 1.2, making it one of the more sinuous reaches in the study area. This reach is in Class IV of the ICEM where further vertical incision and associated channel widening can be expected.

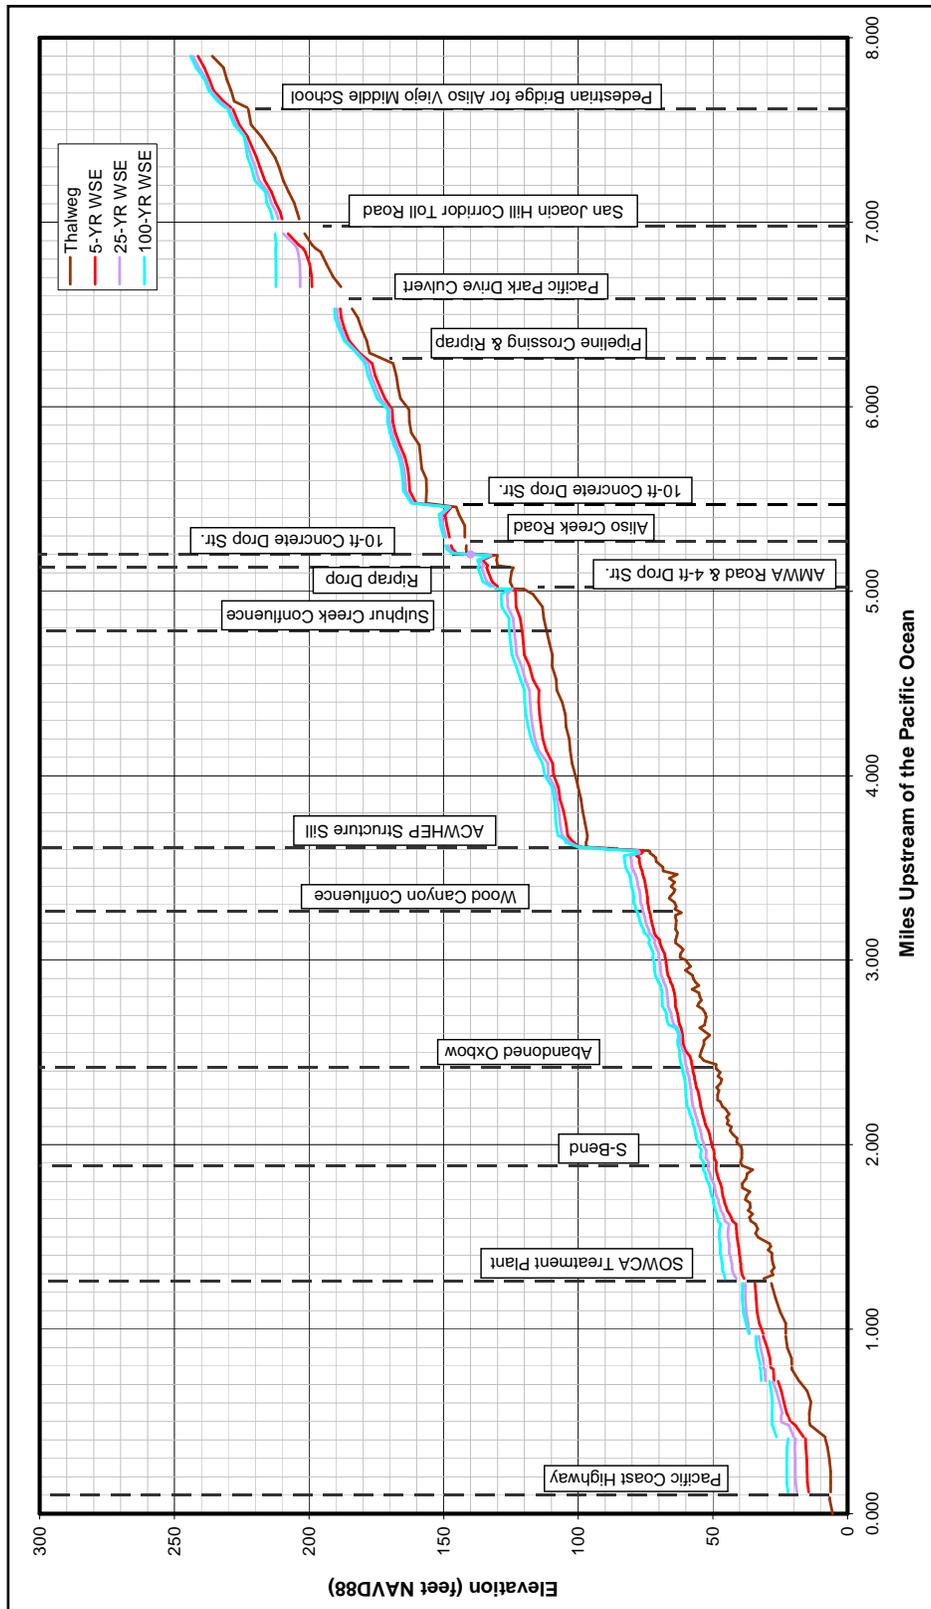
Figure 4-4. Calculated water surface profiles for the 5-yr, 25-yr, and 100-yr floods

To provide further detail regarding the calculated hydraulics, selected indicators for different flows were plotted along the longitudinal profile of Aliso Creek. The selected parameters include the water surface profile (Figures 4-3 and 4-4), top width of the active channel (Figures 4-5 and 4-6), hydraulic depth (Figures 4-7 and 4-8), channel velocity (Figures 4-9 and 4-10), and total channel shear stress (Figures 4-11 and 4-12). These indicators were plotted for the 2-, 5-, 10-, 25-, 50-, and 100-year recurrence interval floods.

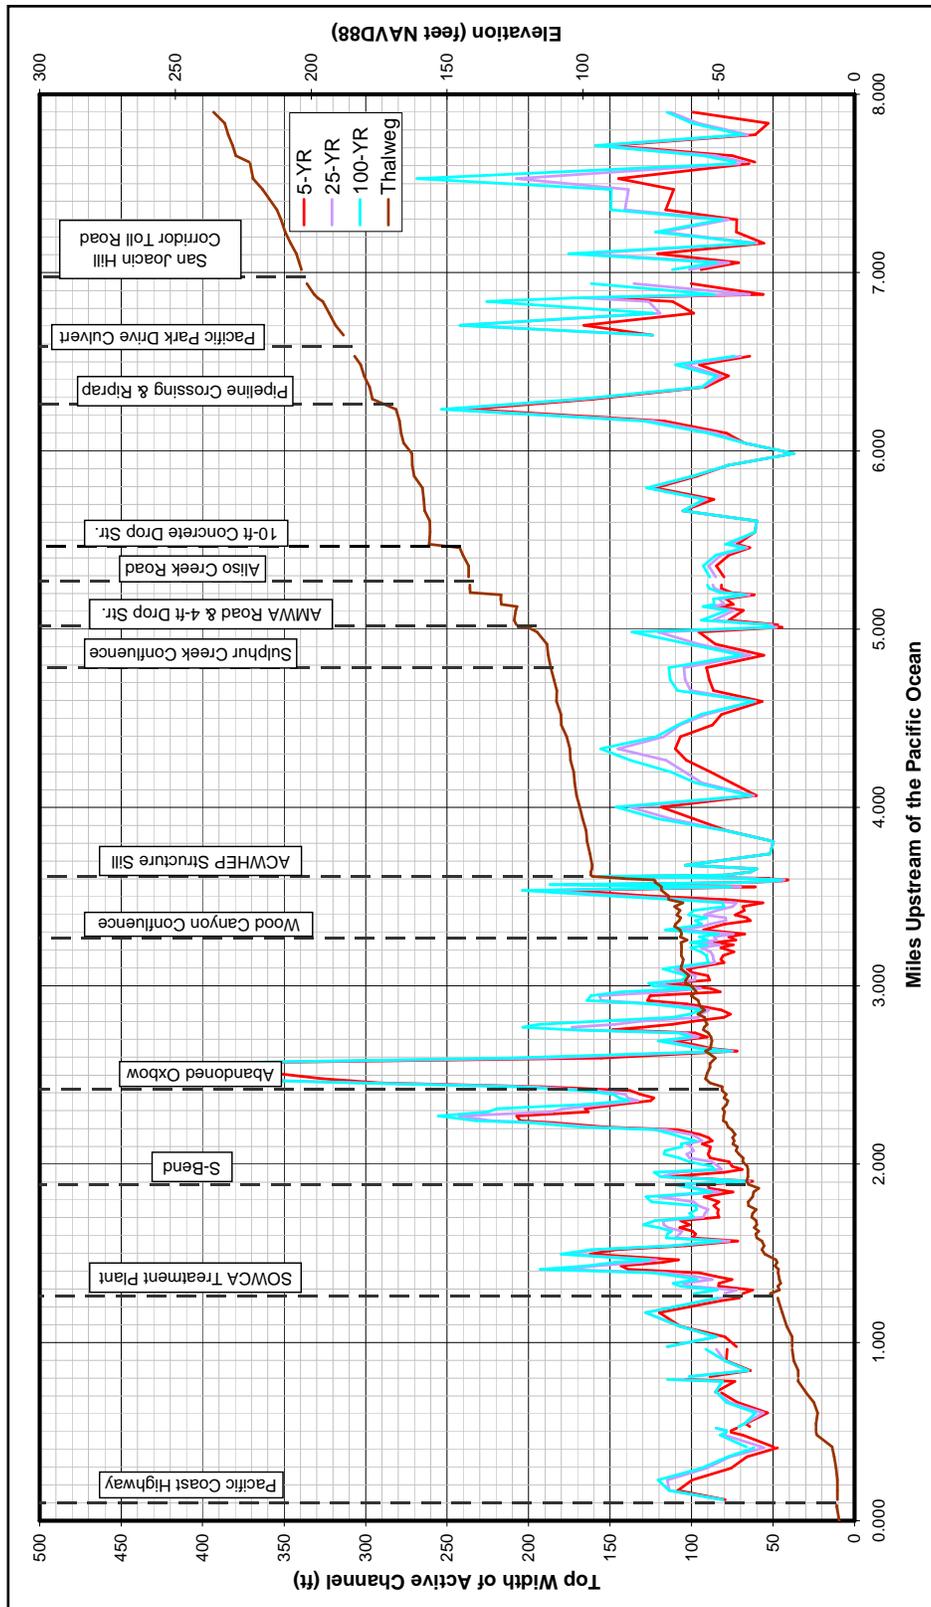
Figure 4-6. Calculated top width for the 5-yr, 25-yr, and 100-yr floods

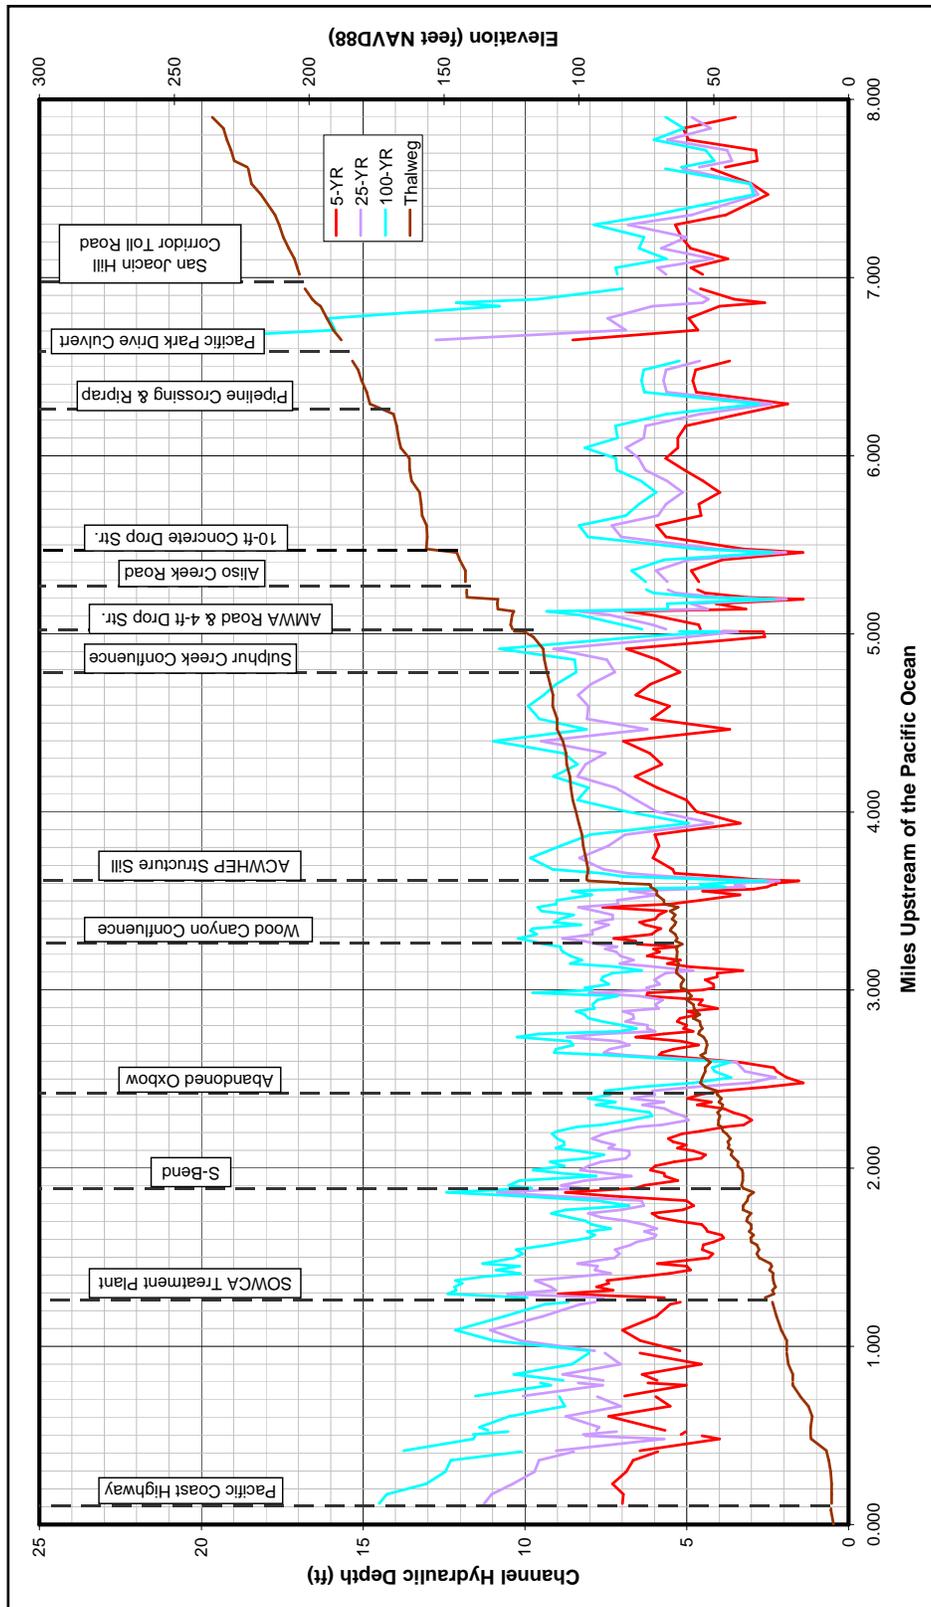
Figure 4-8. Calculated hydraulic depth for the 5-yr, 25-yr, and 100-yr floods

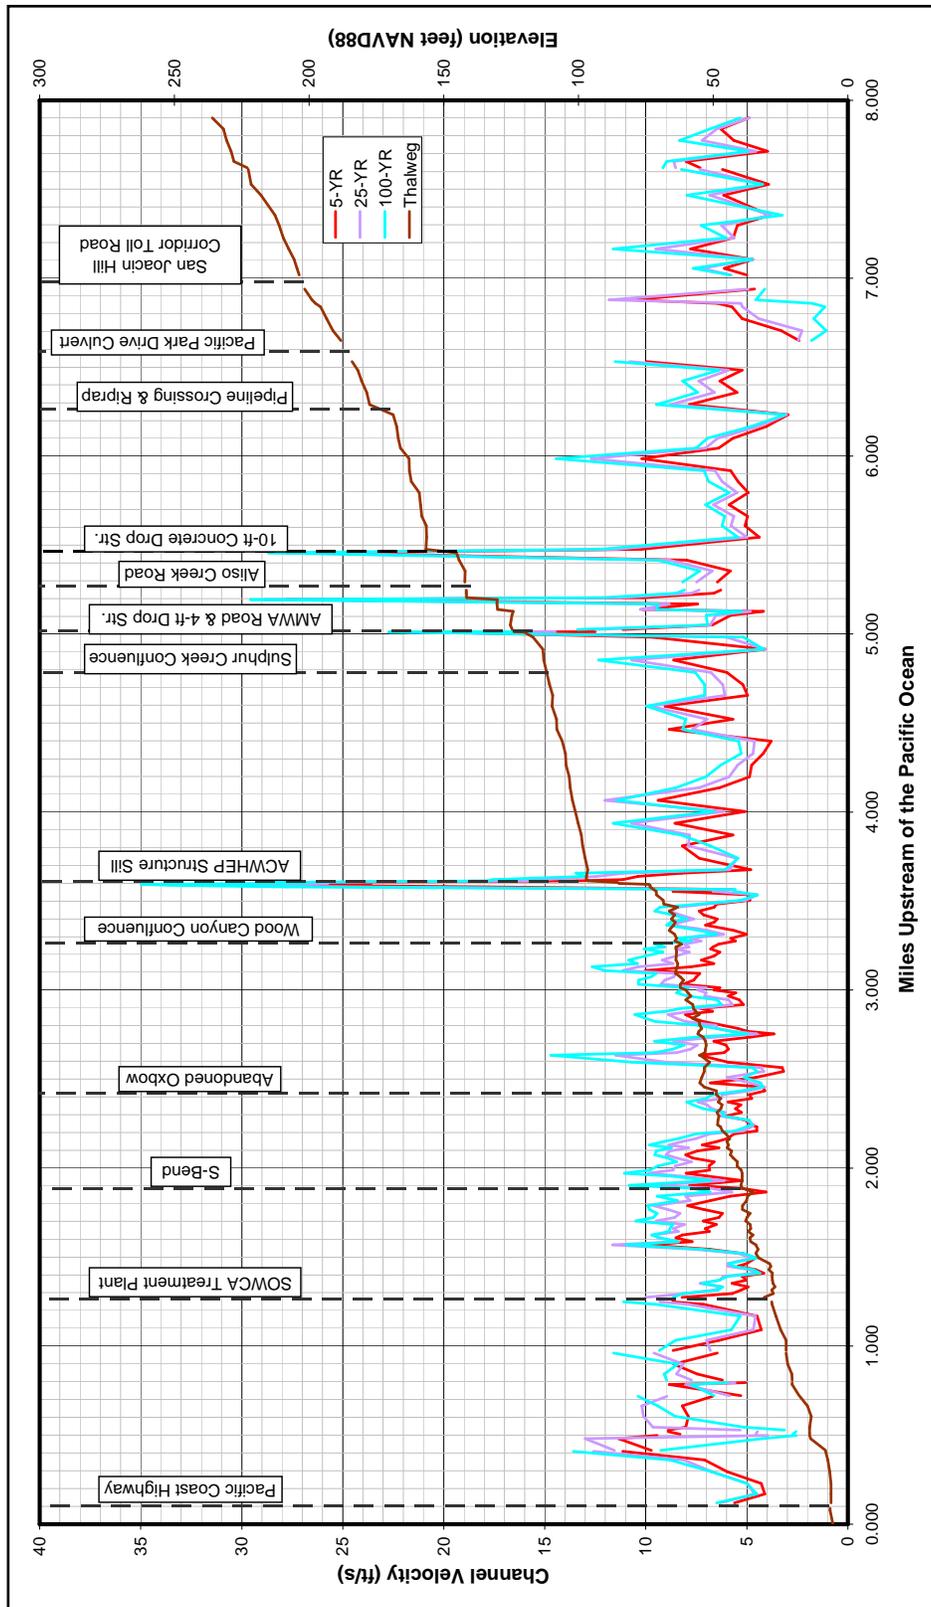
Figure 4-10. Calculated channel velocity for the 5-yr, 25-yr, and 100-yr floods

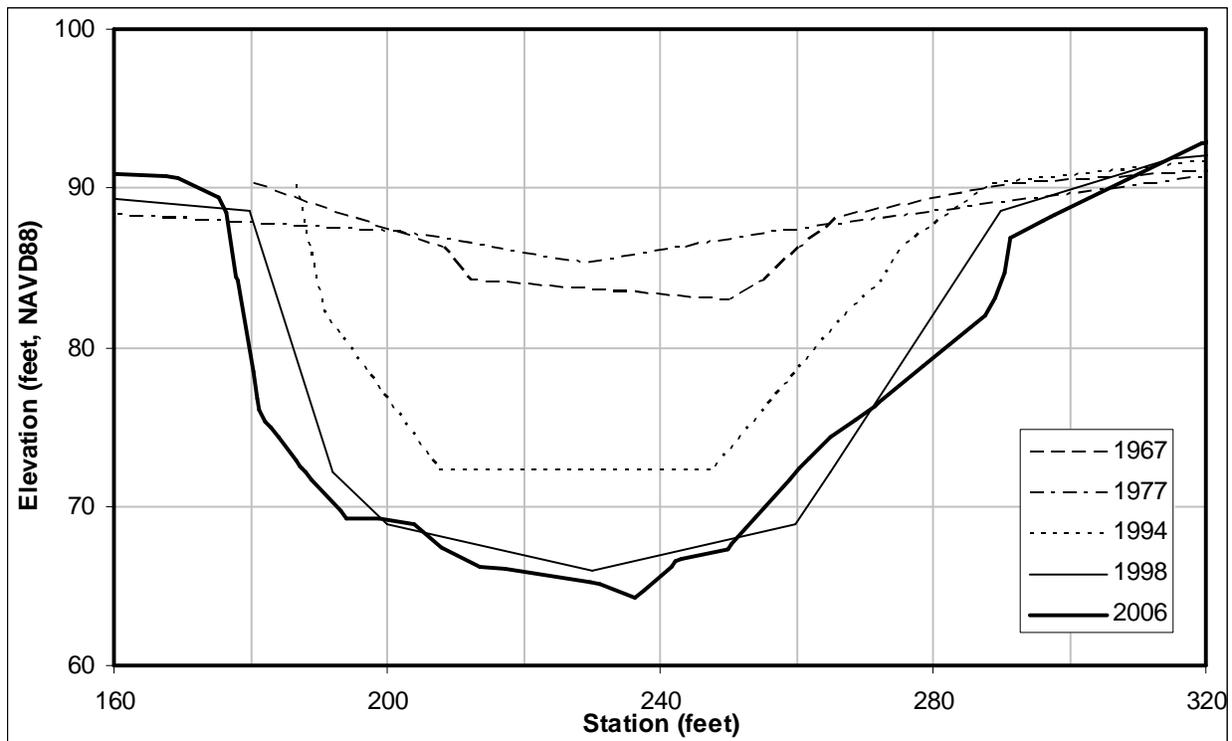
Figure 6-1. Aliso Creek channel geometry 300 feet upstream of the Wood Canyon Creek confluence

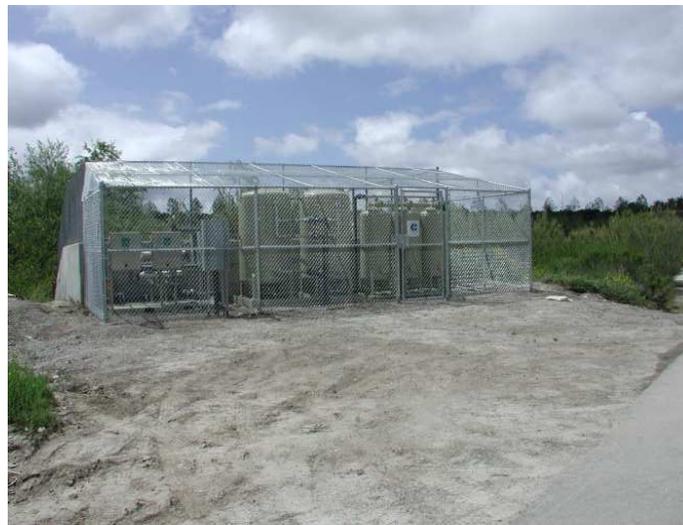
Figure 1. Clear Creek System, Inc. package plant treatment system installation at the Springdale Storm Drain outlet.
