Coachella Valley Water Systems Assessments

Executive Summary ❖ March 2010

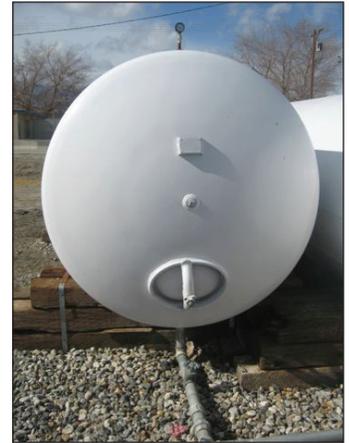
Most of the assessed drinking water systems used hydro-pneumatic tanks to maintain the water distribution system's pressure. The tanks that were in use were operating properly during the time of the assessment. One of the common problems associated with these tanks was the lack of level indication. Hydro-pneumatic tanks are usually supplied with a sight tube that lets the operator know the water and air levels within some of the tanks. Additionally, most of the tanks did not have pressure relief valves. These valves protect pressurized tanks by allowing air to escape when the pressure in the tank gets too high. There are other means of keeping the water to air ratio correct. Two simple methods include:

1. Pouring warm water on the tank and feeling the side of the tank to determine the air/water interface. If there is too much water, then add more air.
2. Pay attention to over cycling of the pump. If the air cushion is low or the tank is water logged the pump will cycle on and off frequently to compensate for pressure drops in the system. If this occurs more air is required.

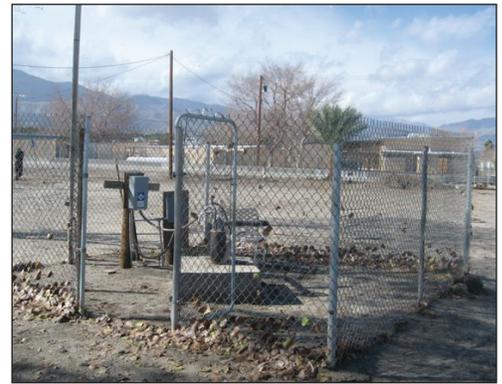
The well site is properly fenced, protecting the well site from vandalism. The well casing extends 18 inches above the ground level and is equipped with a concrete pad around the well casing, protecting the well from flooding that can contaminate the drinking water. There were no visual signs of chemicals, open dump sites, or abandoned vehicles that could pose a threat of potential sources of pollution. The well casing is properly sealed and vents properly screened to protect the well from outside contamination.

The well site is properly fenced.
The concrete pad is above flood level.

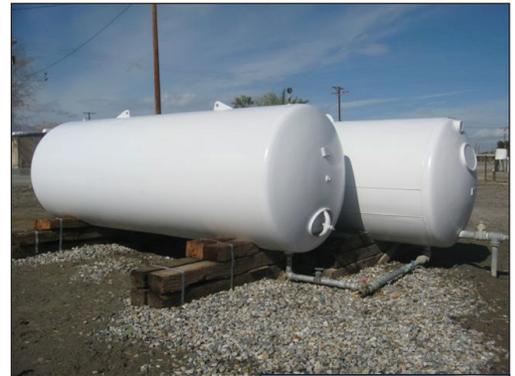
The tanks also do not have pressure relief valves. Pressure relief valves provide system protection against high pressure conditions. The tanks are equipped with drain valves, and were last drained and cleaned in 2008.

Hydro-pneumatic tanks and pressure gauge at 26 psi

- The hydro-pneumatic system would be damaged if the pressure in the system reaches a level that is too high for the system to contain. This may lead to equipment damage.

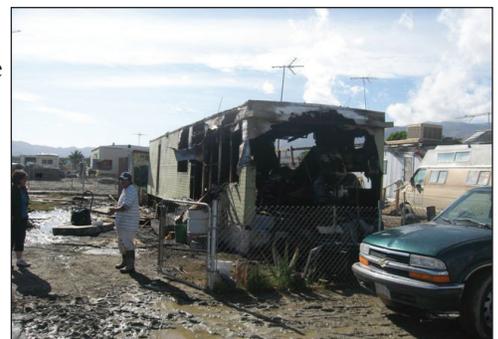
The D&D Oasis Mobile Home Park Water System is not equipped with fire hydrants, and is not able to install fire hydrants due to the inadequate size of the distribution system piping.

At the time of this inspection, one customer’s home was destroyed by fire due to the lack of capacity to fight fires.

- Install fire hydrants at strategic locations throughout the distribution system to best meet the needs of a flushing program and fire protection program.
 - It is also recommended that a flushing program and a fire protection program are implemented.

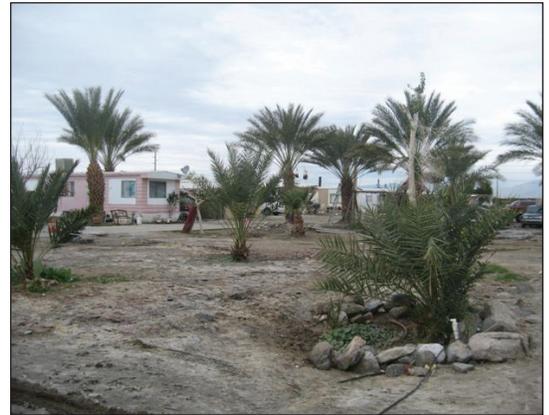
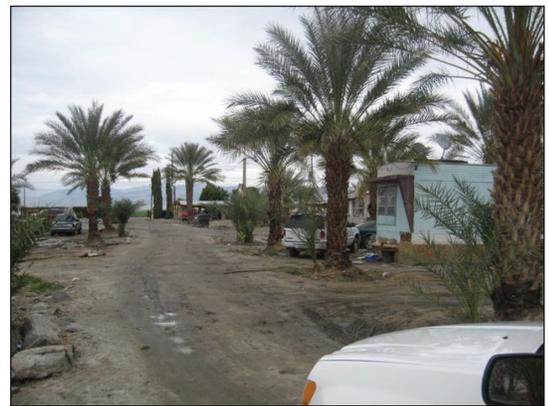
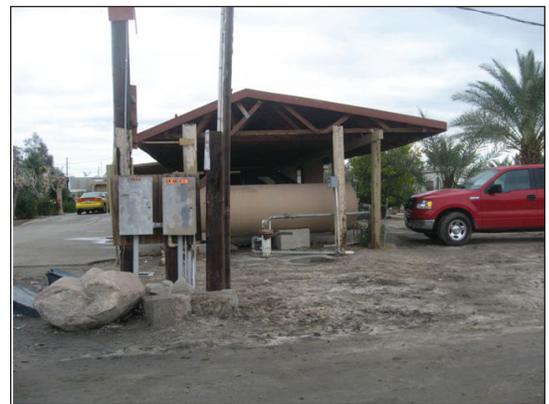
The well site is not fenced and is vulnerable to damage (vandalism) from passing vehicles from the nearby driveway. The well casing extends approximately 12 inches above the ground level and is equipped with a concrete pad. However, the concrete pad had visible cracks and was at the same elevation as the ground level, making it vulnerable to flooding or standing water.

Well site is not fenced and is vulnerable to damage.

- The well and its equipment are not fenced in properly, leaving it vulnerable to damage. The well equipment could be damaged or adjusted without warning, threatening the community's water supply.

- Have the barrier placed around the well and its equipment to protect it from vandalism and damage. This would better protect the community's water supply from being tampered with.

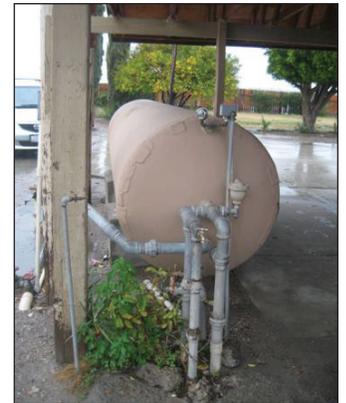
The Rancho Garcia water system uses one steel hydro-pneumatic pressure tank installed in 1990's to provide adequate pressure to the distribution system. The total volume of water contained in the pressure tanks is approximately 1,500 gallons and is in fair condition. The pressure is maintained between 30 and 50 pounds per square inch (psi), and requires the operator to bring in an air compressor to recharge vessel pressure. The pressure tanks are not equipped with level indicators. The tanks are equipped with drain valves and were last drained and cleaned in 2008 during well pump replacement.

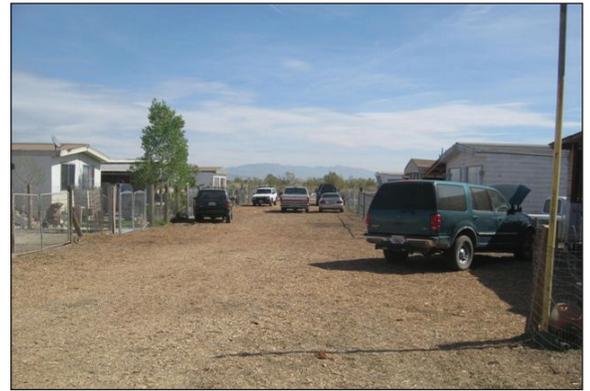
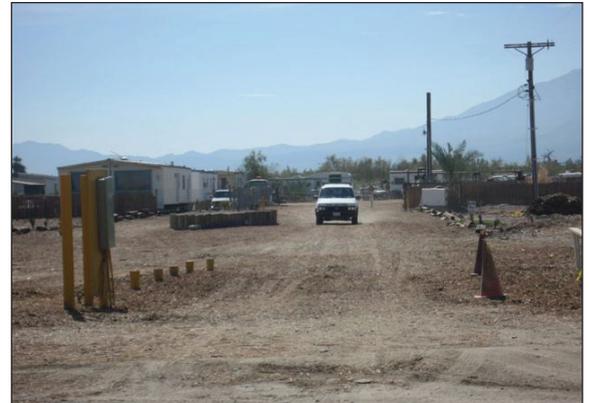
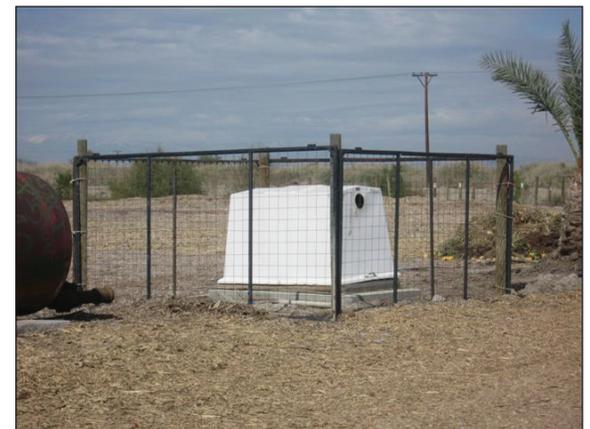
The well site is fenced, but not locked, and is vulnerable to damage (vandalism).

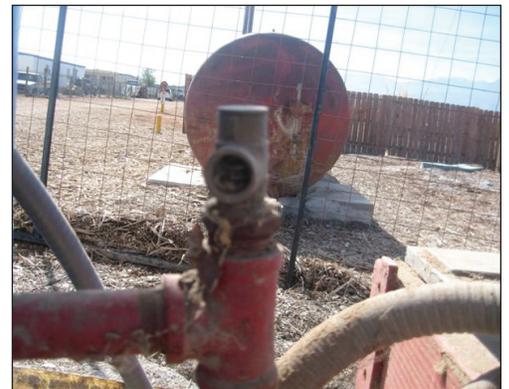
The Santillanes Mobile Home Park Water System uses one steel hydro-pneumatic pressure tank, installed in 2005, to provide adequate pressure to the distribution system. The total volume of water contained in the pressure tank is approximately 50 gallons and in good condition. The pressure is maintained between 20 and 60 pounds per square inch (psi), and requires the operator to bring in an air compressor to recharge vessel pressure. The pressure tank is not equipped with level indicators. The tank is equipped with drain valves but has not been drained since the initial installation date to 2005.

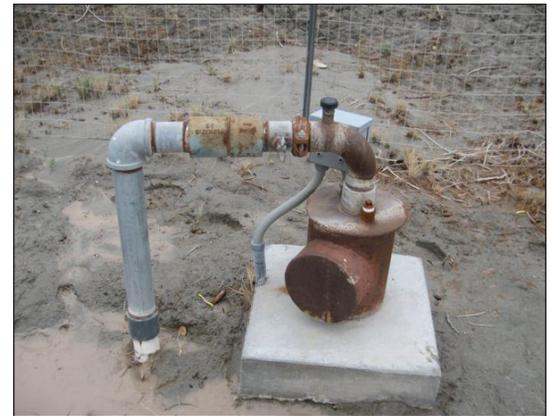
The well site is poorly fenced and is vulnerable to vandalism.

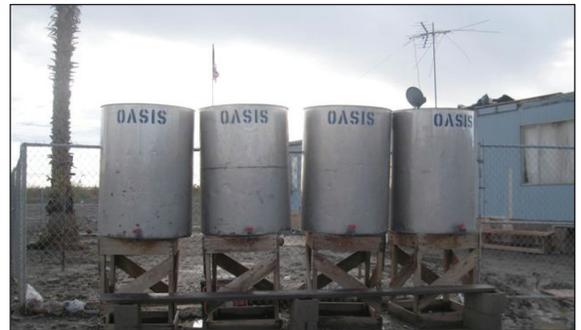
There currently is no defined maintenance program for maintaining sanitary conditions of the centralized drinking water tanks. The tanks are cleaned periodically and filled approximately every couple of days. There are no procedures for disinfection or sampling for bacteriological contamination of the tanks.

There are no procedures for disinfection or sampling for bacteriological contamination of the drinking water tanks.

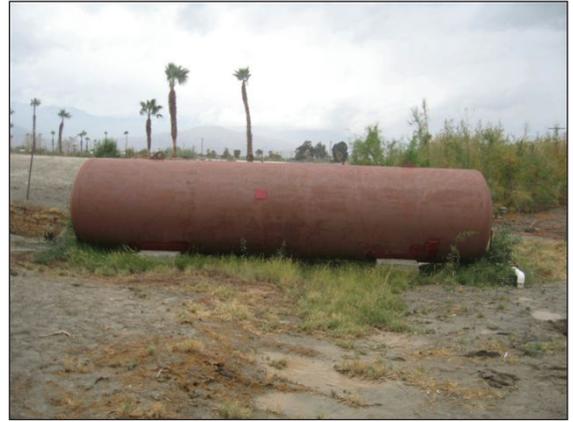
The St. Anthony water system uses one steel hydro-pneumatic pressure tank. The installation date is unknown. The hydro-pneumatic tank is designed to provide adequate pressure to the distribution system without causing the pump to cycle continuously. The total volume of the pressure tank is approximately 3,000 gallons and is old, but in fair condition. The pressure is maintained between 40 to 60 psi. The system requires the operator to bring in an air compressor to recharge tank pressure. The tank does not have a level indicator to indicate the amount water/air ratio. The tank is equipped with a pressure relief valve. This valve protects the water distribution system from damage due to high pressure situations. The tank is also equipped with a drain valve which allows the tank to be drained for maintenance or repairs. The last date of tank maintenance or cleaning is unknown.
