## NORTH COAST INTEGRATED REGIONAL WATER MANAGEMENT PLAN

### **North Coast Integrated Regional Water Management Plan Proposition 84 Round 1 Implementation Grant**

### **Priority Project Technical Documents: Plans and Specifications**

#### **402 - Ackerman Creek Habitat Restoration, Pinoleville Pomo Nation**

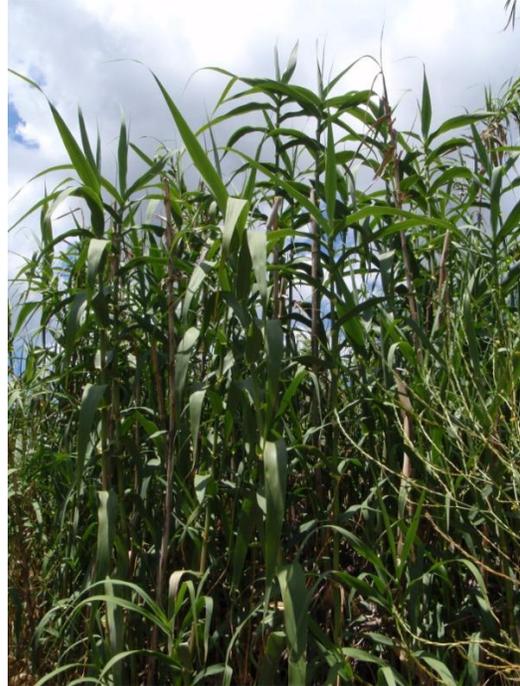
## What is *Arundo* and how do you identify it?

*Arundo donax* is a thick-stemmed plant in the grass family, resembling bamboo, that grows up to 30 feet tall. It forms many-stemmed clumps, spreading from thick, knobby roots called rhizomes (RYE-zomes) that grow horizontally, not downward. The root masses can spread over several acres, quickly forming large colonies that displace other plants. The stems of *Arundo* are tough and hollow, divided by nodes like bamboo. The pale green or blue-green leaves clasp the stem with a heart-shaped base. They are up to 1 foot long and arranged alternately along the stem (not opposite each other), each leaf pointing 180 degrees from the next one. In many areas, *Arundo* produces a tall plume-like flower-head at the top of its stems. Its stems often fade to brown during winter or drought. *Arundo* can be confused with bamboos and corn, and young stems can resemble some large grasses such as ryegrass and common reed (*Phragmites*). *Arundo* typically grows in riparian areas and floodplains. It can be found on wet streambanks, gravel bars, or dry banks far from permanent water. It prefers gently sloping streams over steeper, smaller, creek channels. Scattered colonies can be found in other moist sites such as springs, upper areas of coastal watersheds, drainage ditches, along rice field levees, and residential landscaping.

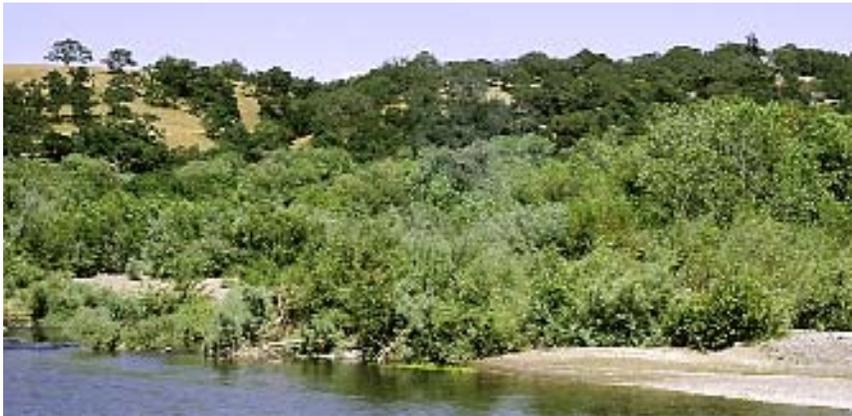
*Different age classes and species of riparian habitat at different elevations*

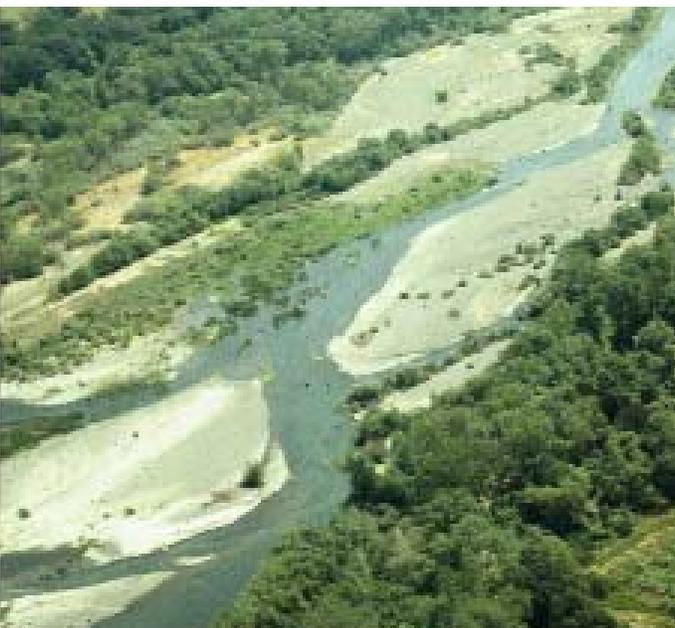
*Russian River meander corridor*

Streams and their tributaries often cut through broad alluvial valleys. In these alluvial zones, where the substrate is dominated by sand, gravel and silt, the stream freely moves (meanders) back and forth over time, creating and removing riparian habitat naturally. The ability of the stream to move through this meander corridor is what allows the development of diverse riparian forests. Streams

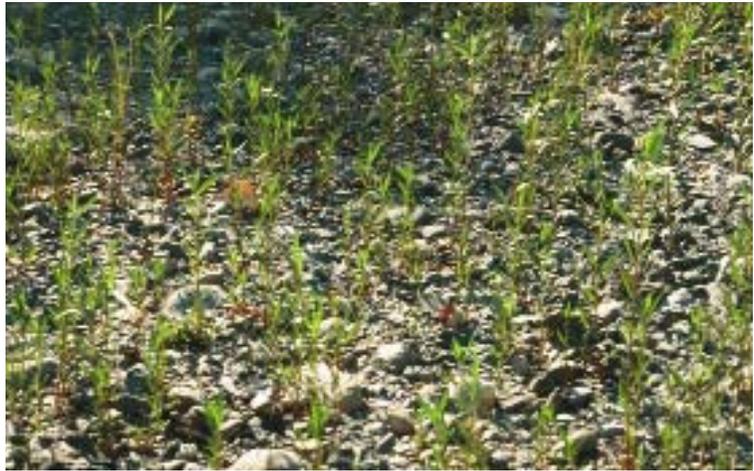
*Bankfull channel with small seedlings of pioneer species*

The seeds of cottonwood and willow float through the air in the spring just as the water level is beginning to recede. Millions of seeds land on moist gravel bars and germinate there. As the summer progresses, the roots of these tiny seedlings follow the receding water table. Those plants that cannot stay connected to the water table face certain death on the desert-like gravel bar. Those plants that survive the summer drought and winter flood cycle will grow at incredible rates, up to 15 feet per year. As they grow, these pioneer species may begin to trap sediments, and can influence the movement of the stream.

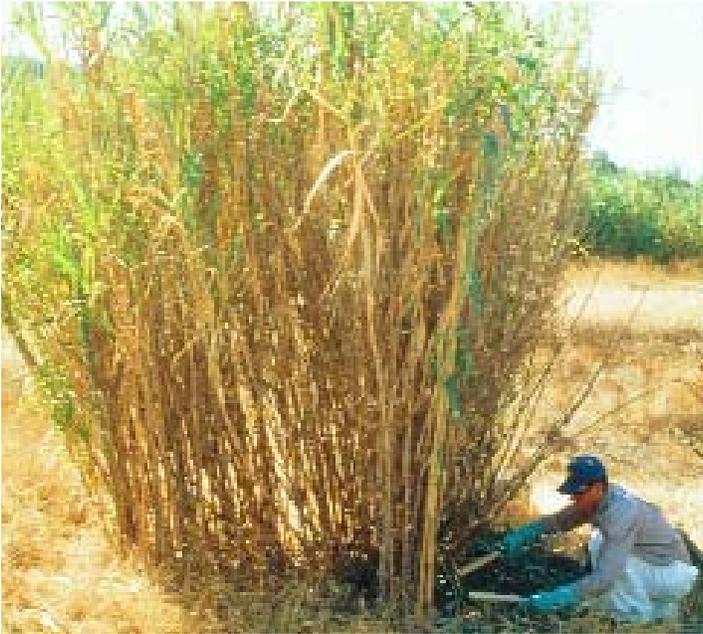
*Manual cutting of giant reed biomass*

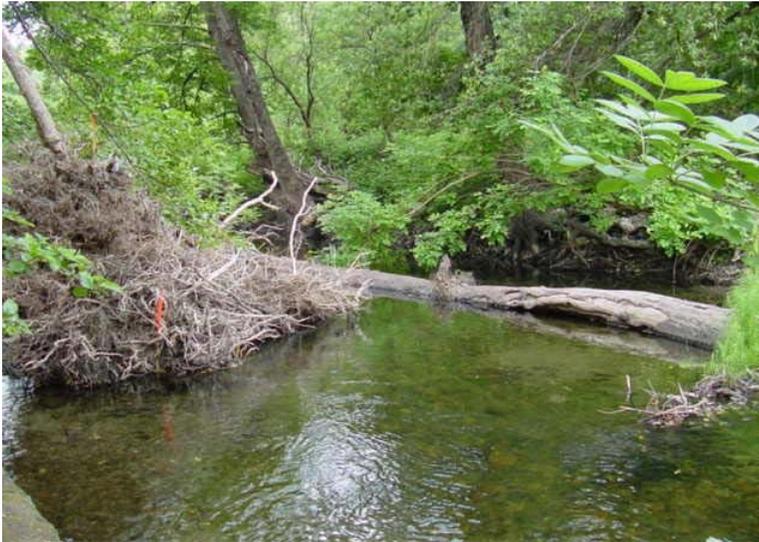
*Large woody debris creates pool habitat*

Riparian trees that fall into the stream play an important role in the aquatic system. They provide structure to the stream environment, helping to form pools as well as habitat for a variety of organisms. Large woody debris is an important factor in the recovery of salmonid populations. It is, therefore, desirable to retain a wide riparian corridor with large trees that may be recruited into the stream.

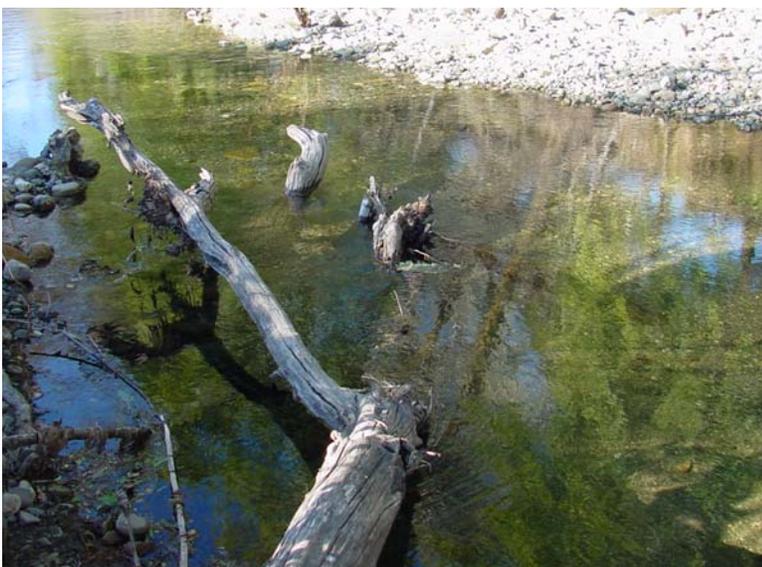
*Large woody debris provides structure to the stream environment*

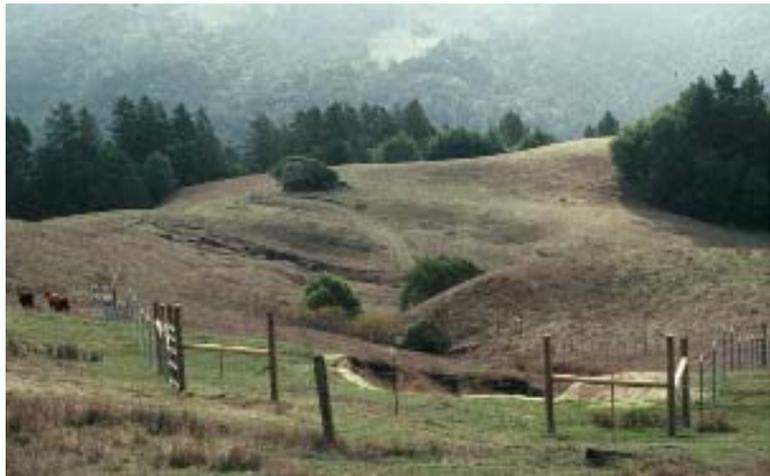
*Exclusionary fencing along stream headwaters*

If fencing is used to allow for the regeneration of riparian habitat, it should be set back far enough to allow the stream to meander and create a diversity of habitat. Fences placed too close to the stream corridor may be damaged during high flows, wasting time and money.

Fencing design, including type of wire, gauge and spacing must be specific to the types of animals you are attempting to exclude. Many fencing supply stores have this information and can help you with construction specifics. Alternative water sources for livestock should be developed to keep them out of the stream channel. If conditions require that livestock access the stream for pasturing or crossing between pastures, use specialized floating fences (which span the channel) to limit such access. When funding restoration projects, the Department of Fish and Game requires a riparian management plan to be developed and signed by the landowner. For more detailed information on exclusionary fencing, see Part VII.

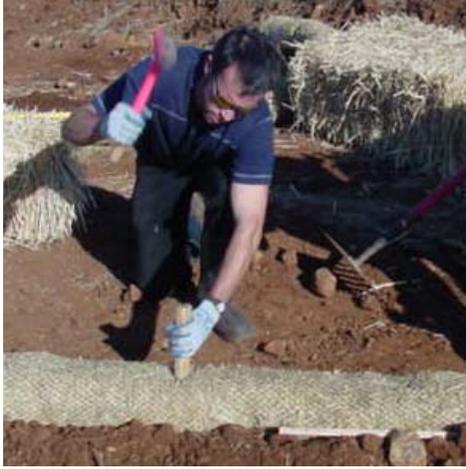
*Installation of erosion control*

reducing erosion such as bioengineering is preferable to a structural approach such as riprap. Structural approaches to stream bank erosion such as riprap tend to fix the stream in one place, exclude riparian vegetation, and prevent the natural movement that creates diverse habitats. Structural approaches are often more expensive, require permits, and may damage neighboring properties. Over the long term, structural approaches tend to fail or require excessive maintenance. If a structural approach is unavoidable, native vegetation should be incorporated into the structure. Bioengineering will increase the effectiveness of the erosion control method and provide some habitat value as well. See Part VII for descriptions of bioengineering.

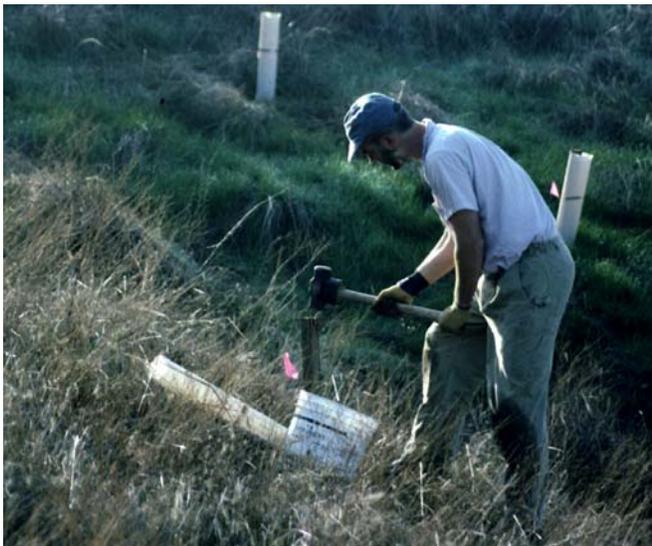
*Tree shelter installation*

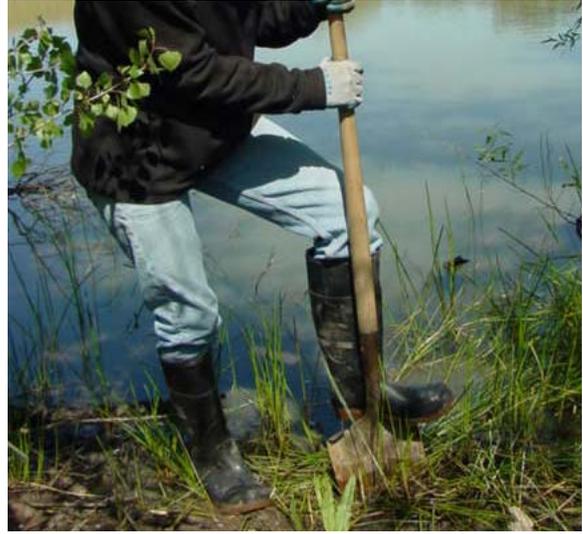
*Collecting emergent vegetation*

- In the winter or early spring, carefully harvest rhizomes and the above-ground portions of the plant with a mattox, sharp trowel or shovel. Make sure one to several intact rhizomes remain for each transplant.
- Store the collected plant in a cool moist location until time for transplanting. Ideally, plants should be stored in moist soil, and should be transplanted as soon as feasible after collection.
- Dig a hole for the transplant that is large enough to accommodate the extended rhizome without bending or breaking it. Place dirt around the rhizome, pack it down, and water it in thoroughly to close any air holes around the rhizome.
- Trim back the above ground portions of the plant in order to stimulate rhizome growth.

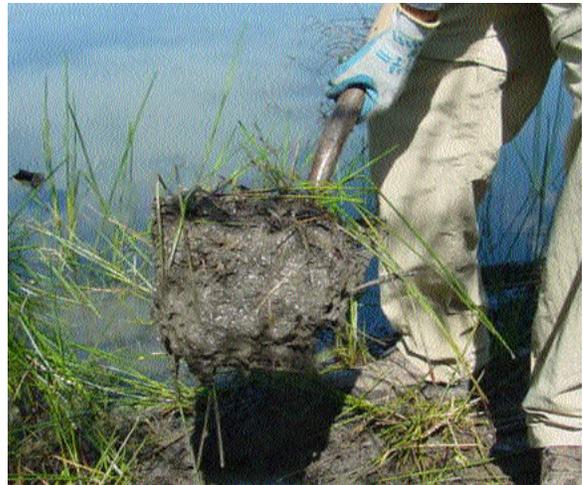
*Emergent vegetation, rhizomes exposed*

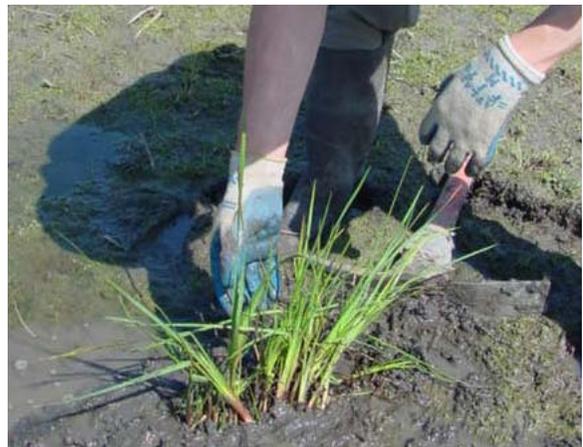
*Installation of emergent vegetation*

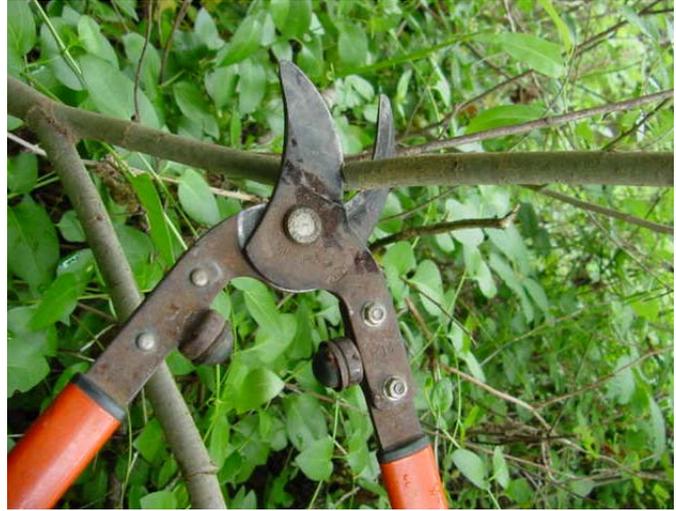
*Sharp, clean loppers produce high quality sprigs and cuttings*

- Harvest cuttings during the winter months when plants are dormant (usually December-January). Although willows and cottonwoods will grow from cuttings at other times of the year, dormant cuttings are more resistant to disease, have higher survival rates, and do not require irrigation if planted in the appropriate location. Sprigs may be harvested using sharp, clean loppers, hand shears, or a chainsaw. The cuttings

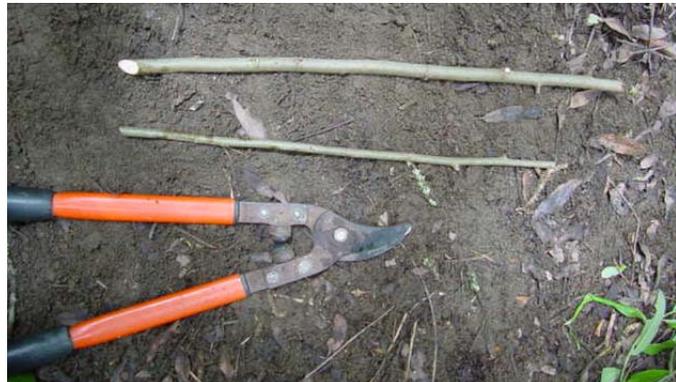
*Typical dimensions for willow and cottonwood sprigs*

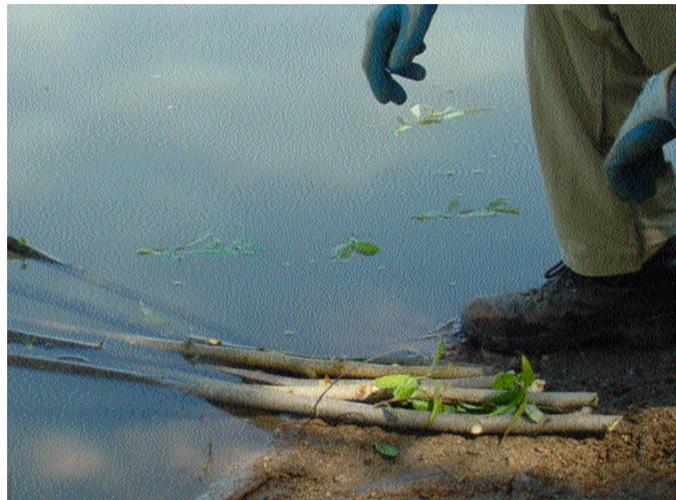
*Store cuttings in a moist environment*

- Cuttings may be used immediately, stored on-site in the stream, or stored off-site in a bucket of cool water. Ideally, material should be harvested and installed the same day.
- Sprigs should be installed with buds pointing up, with approximately  $\frac{3}{4}$  of the cutting in the soil, and  $\frac{1}{4}$  exposed. Holes may be dug with a pick, with a piece of rebar, with an auger, or a backhoe (for large material). In areas with soft soil, you may avoid digging a hole by cutting the bottom at an angle and pounding it into the ground with a small sledge hammer. If the top is damaged by the hammer, cut off the top of the sprig to allow for clean healing or place a driving shield over the top to drive in the sprig.

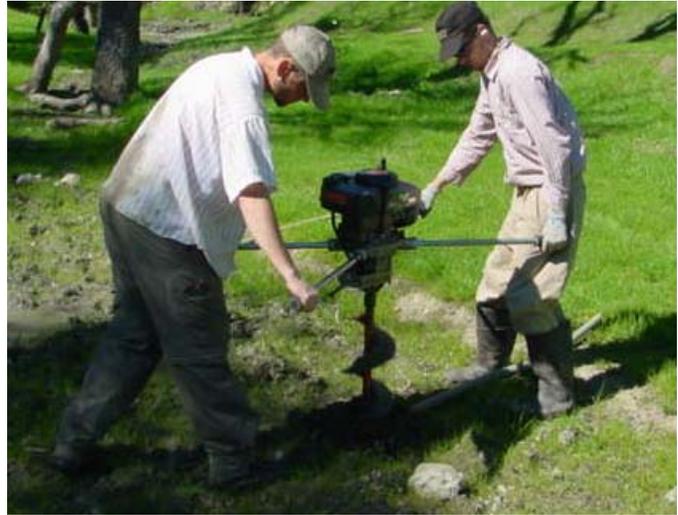
*Auger used for planting holes*

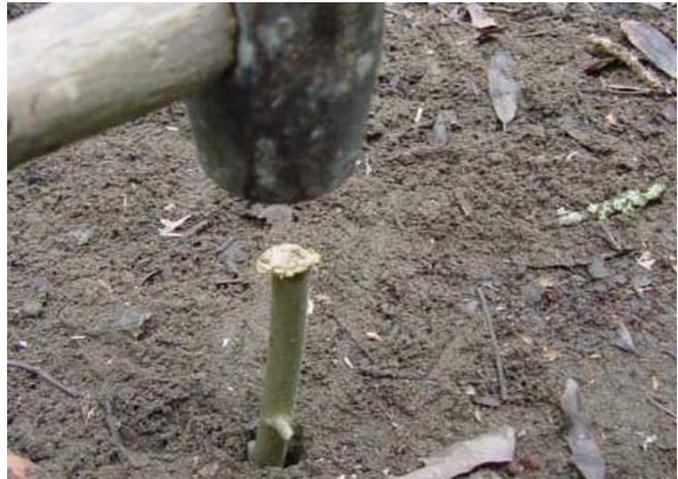
*Small sledge hammer for installing sprig*

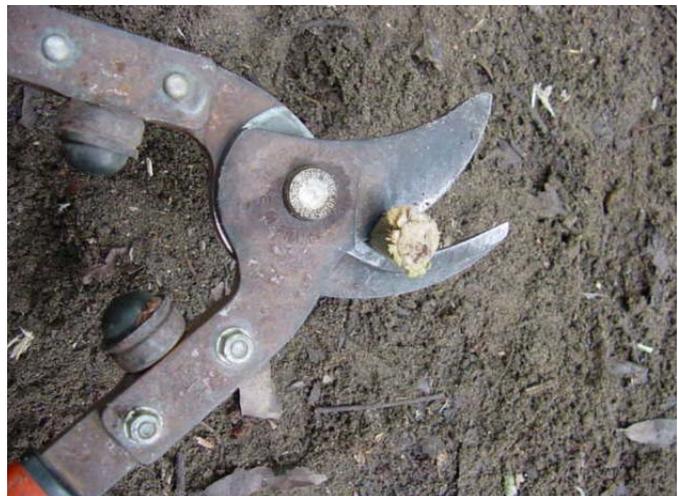
*Clean, sharp loppers cut off damaged top of sprig*

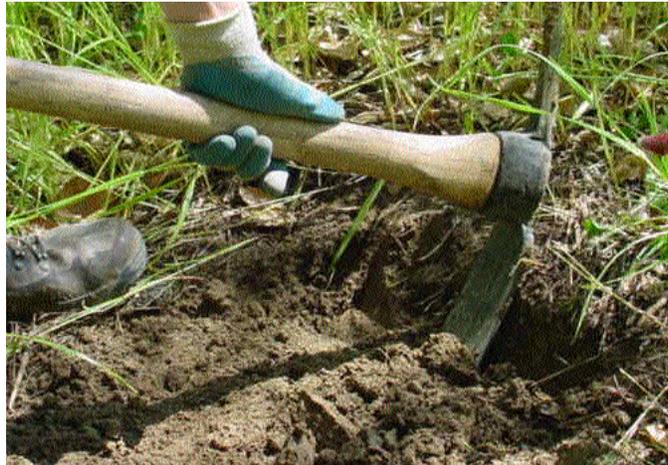
*Remove weeds from the planting area*

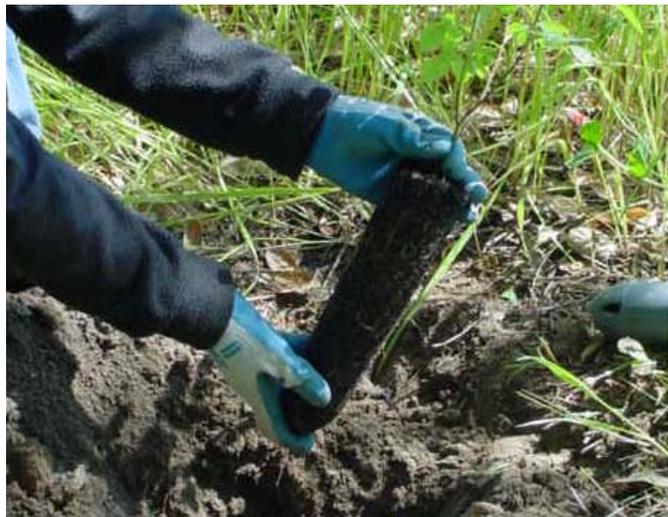
*Dig the planting hole twice the depth of the root ball*

- When installing plants, dig holes to twice the depth of the root-ball of the plant to be installed, crumbling any large soil clumps. Partially refill the hole, firmly tamping the soil to create a firm base for the new plant. Place the plant so the top of the root-ball is slightly above finish grade, to allow for future settling. Fill the hole and tamp firmly to remove any air pockets. Irrigate immediately, ensuring the water soaks deeply, unless the ground is already saturated.

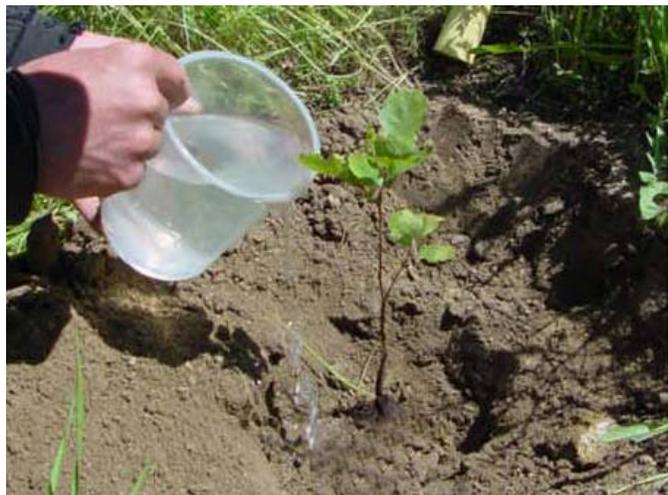
*Water the plant immediately, ensuring that the water soaks deeply. If planting in low moisture conditions, plants should be watered during the planting process and thereafter until rains begin.*

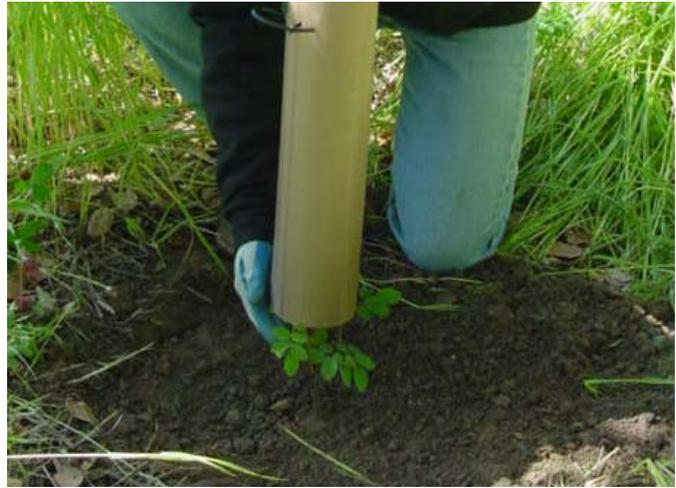
*Installation of supertube on newly planted native seedling*

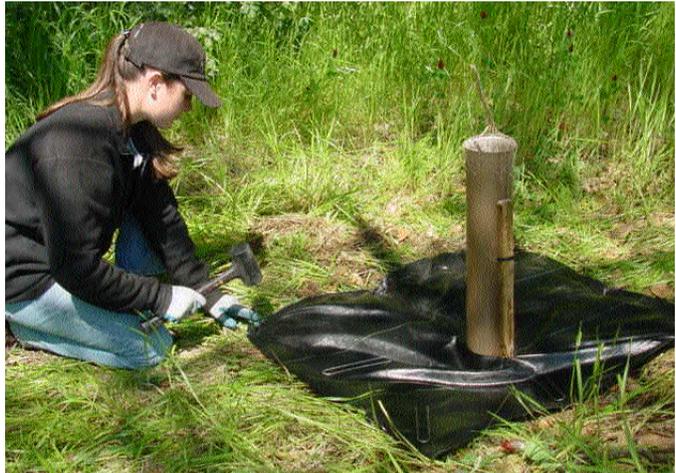
*Installation of weed mat*

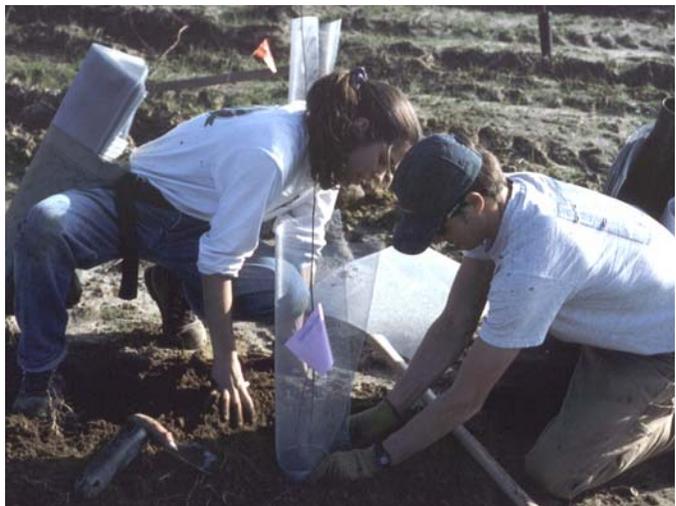
*Installation of screen and collar protective hardware*

- Where damage from domestic animals and wildlife is a concern, consider protecting plants with shelters (except those that will be in flood-scoured areas). Shelters should be firmly staked and tied so they will remain upright. There are a variety of shelters available, ranging from chicken wire enclosures (screen and collar, shown in photo at bottom) to plastic tubes (a.k.a., *supertubes*, shown in photo at right). All of these methods have proven successful, if they are maintained and weeds are controlled. Shelters should be removed as soon as the plants begin to outgrow them (3-5 years is typical for riparian plants).

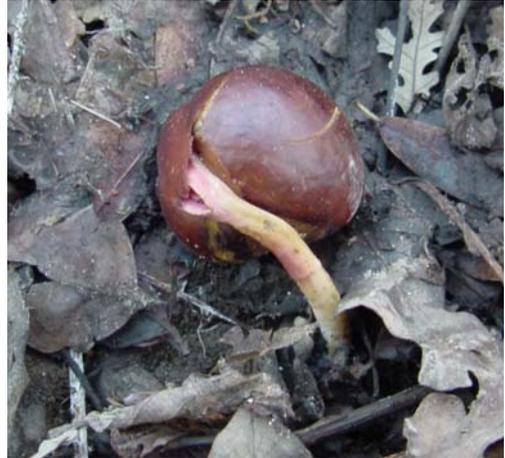
*Buckeye seed with developing root*

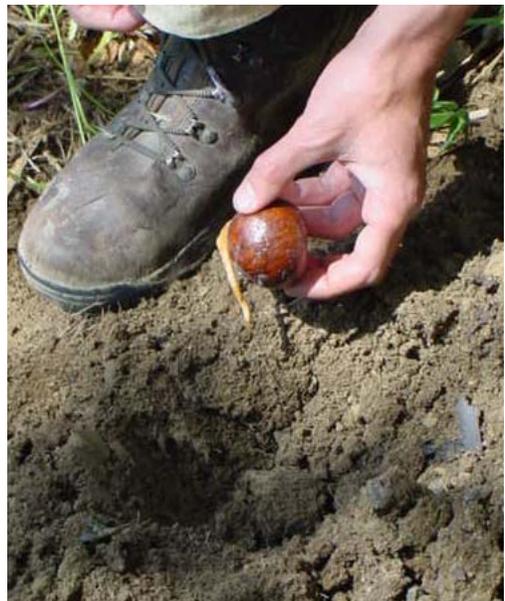
*Careful placement of buckeye seed*

- Plant seeds in the winter, when soil moisture has reached a depth of 10 inches or more. Dig a shallow hole at each planting location, and cover seeds with one to two inches of soil. If seeds have begun to germinate, care should be taken to protect the tender new root. For buckeye, only one seed should be required, whereas for the other species you will want to install three to five seeds per planting spot. Once they have germinated, you can select the strongest seedling and clip the others with shears.

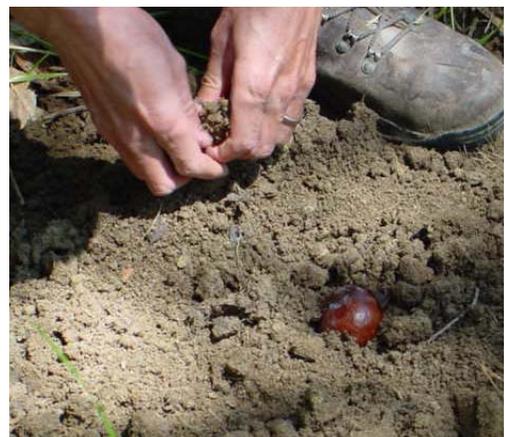
*Cover seed with 1-2 inches of soil*

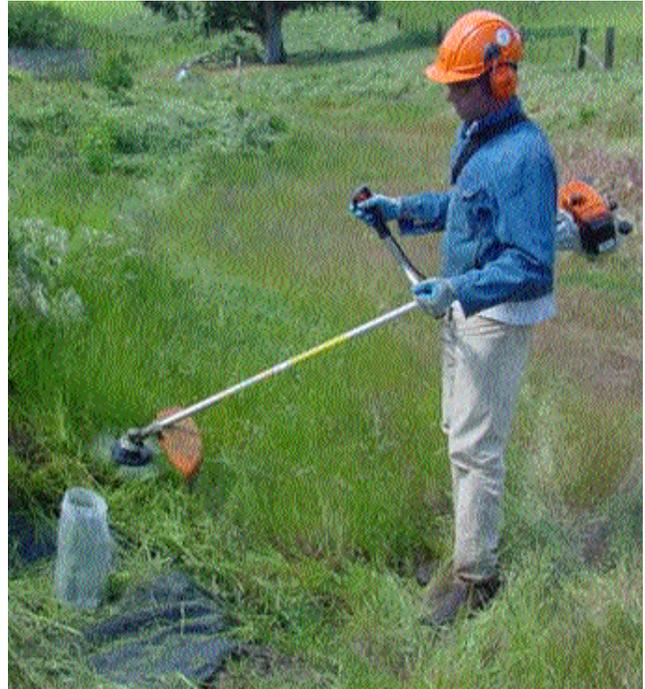
*Mechanical weeding of project site*

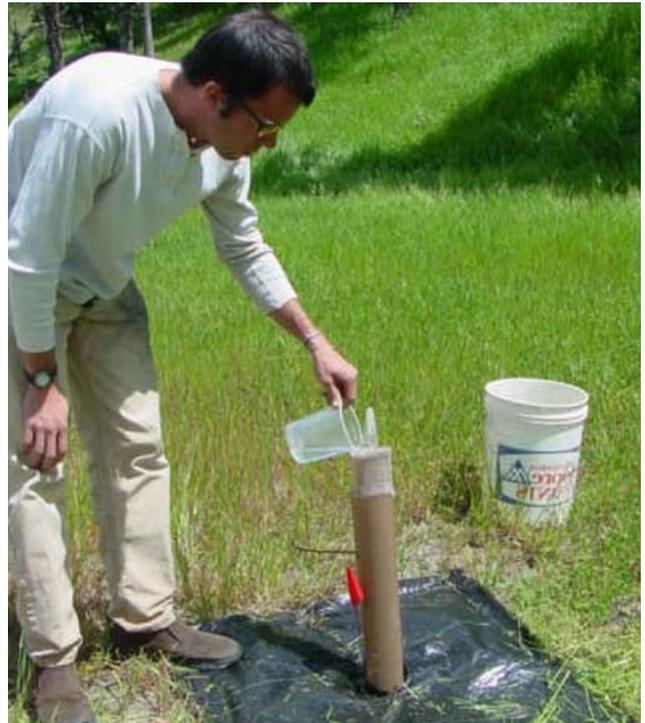
*Hand watering of individual plant*

- Soil moisture should be checked on a regular basis during the first two to three growing seasons and plants evaluated for drought stress. The watering regime (whether hand irrigation or a drip system) should be scheduled according to plant needs, rather than an arbitrary schedule. Irrigation should include the minimum amount necessary to keep the plants healthy so they do not become dependent upon additional water. If the plants are appropriate to the location, and installed correctly at the right time of year, they should not require irrigation past year three. Watering should taper off as the plants mature.

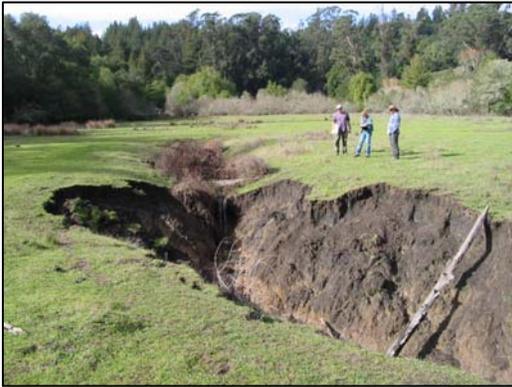
**Figure 5-2.** Number of sites inventoried in each category by potential sediment yield. Sediment production for each category are: Low yields = 0-100 yds<sup>3</sup>, Medium yields = 100-1,000 yds<sup>3</sup>, and High yields = >1,000 yds<sup>3</sup>. Unusual climatic conditions or changes to a site could lead to accelerated erosion processes and increase the estimated yield.

Two important considerations in determining the severity of erosion sites are the potential sediment yield (Figure 5-2) and the erosion activity (Figure 5-3). Potential sediment yields were ranked into three categories (high, medium, and low) based on the volume of sediment they are likely to mobilize and transport to the stream system. Erosion activity was also ranked similarly, and is based on evidence of recent soil loss and feature movement (e.g. headcut moving upstream, bank sloughing).

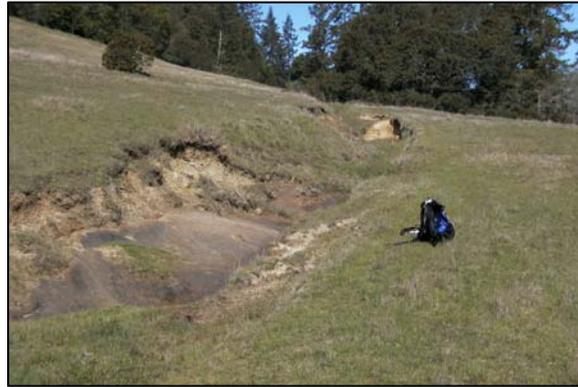
**Figure 5-3.** Number of sediment sources ranked by erosion activity and type. Highly active sites appear to have recently lost material, are devoid of vegetation, and are unstable. At the other end, low activity sites do not show signs of recent movement and are stabilizing through vegetation establishment or changes in erosive forces.

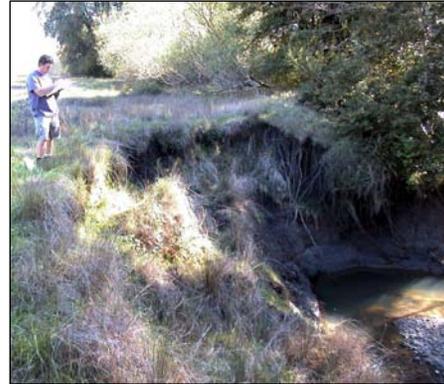
**Figure 5-4.** Distribution of repair priorities by sediment source type. Gullies and headcuts are the highest priority because of their higher sediment yields. Gullies also irreparably damage productive grassland and forests. Instream knickpoints that will lead to additional headcuts and gullying were also chosen as high priority sites. Landslides are also high priorities because of the fine sediment they produce though it is unlikely that they can be repaired.

Overall the erosion activity of each source type is ranked higher than the yield or repair priority (Figure 5-4). This is especially true of streambank failures. Eroding banks often

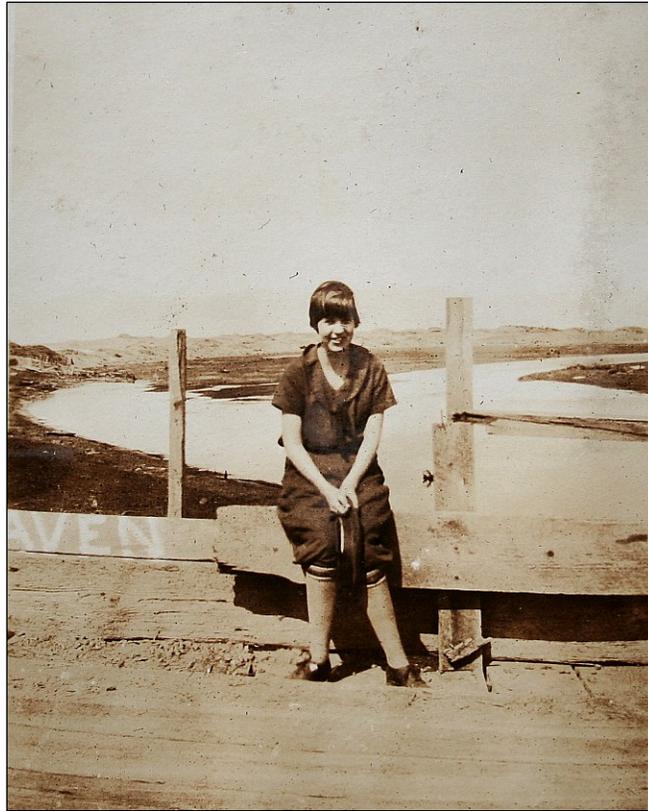
*Figure 3.1.2* 1920s photo taken from the first Highway 1 Bridge looking downstream at the lower estuary. Note the extensive tidal wetlands (dark area) covering much of the area in front of the high dunes. This diverse, productive habitat was quickly disappearing by the 1940s and completely gone from the system by the 1960s. (Photo provided by Charles Beck)

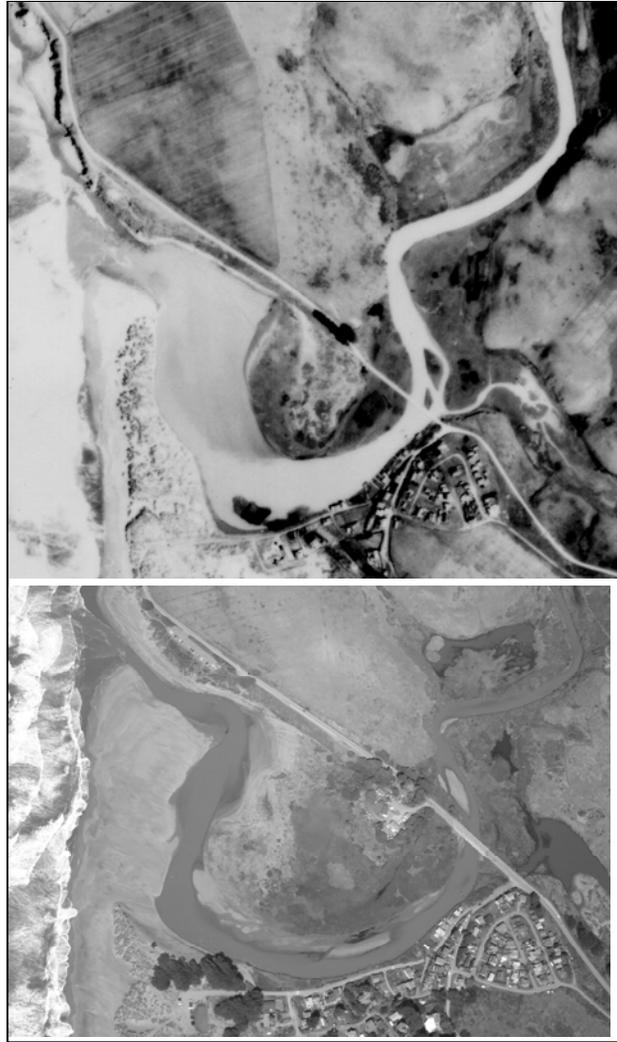
*Figure 3.1.3 Comparative photos of the lower and middle estuary from April 1941 (upper) and March 2006. In 1941 several vegetated islands were upstream of the bridge and a tidal channel network was formed in the southern tributary valley. This area was disconnected from the main channel by the new bridge construction in the late 1940s.*

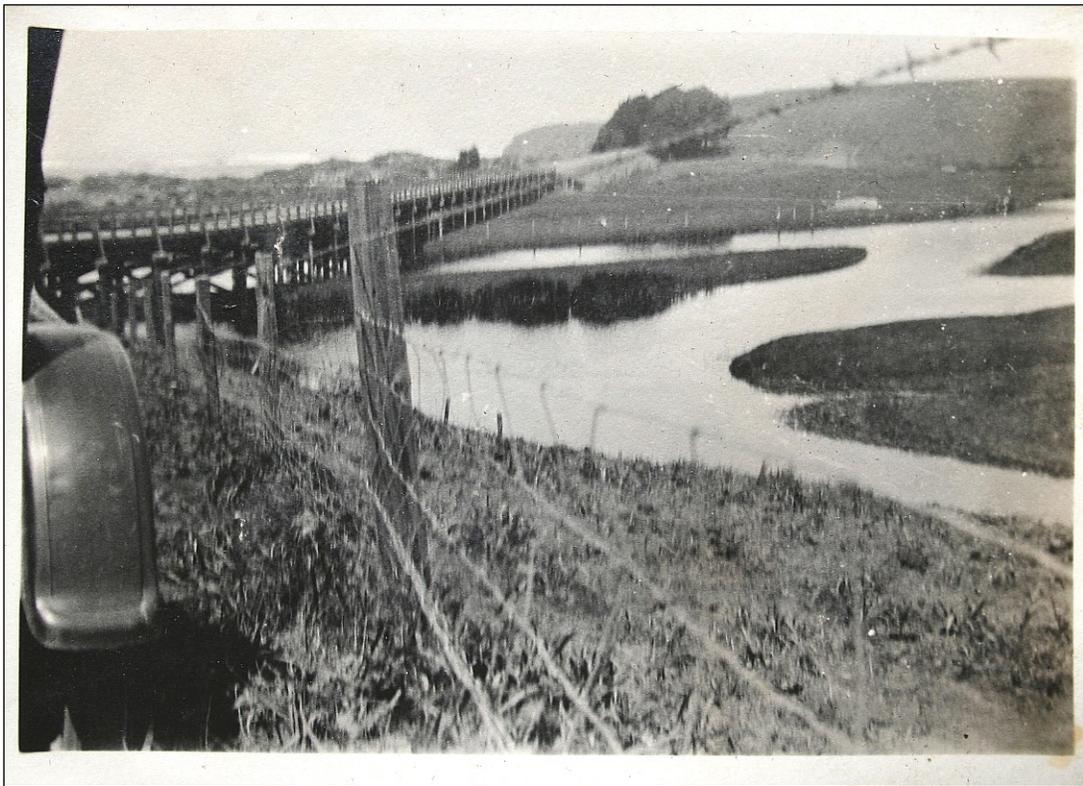
*Figure 3.1.5* 1920s photo taken from Highway 1 looking south across the estuary. Note the vegetated islands, side channels, and bank elevations that are at the water surface elevation. All of these features provide complex habitat that supports a healthy ecosystem and strong salmonid population. (Photo provided by Charles Beck)

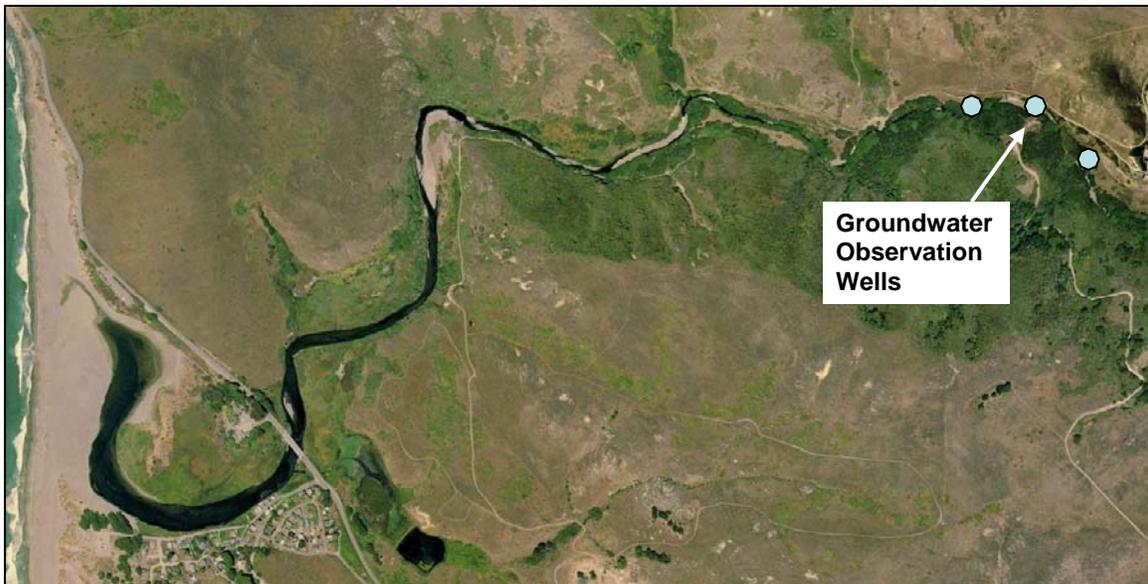
*Figure 3.2.1 Location of observation wells in relationship to the Salmon Creek estuary.*

Initial plans to document streamflows entering the estuary and the effect of well pumping on those streamflows involved monitoring of surface flows at multiple sites in the vicinity of the Bodega Bay Public Utility District (PUD) groundwater wells. By mid July 2004 it became apparent that streamflow was going to drop below easily measurable levels. An alternative method was devised. Water table monitoring wells were installed at four locations within a 1000 foot reach of channel adjacent to the PUD wells (Figure 3.2.1). Perforated PVC pipe was installed to a depth of 8 feet in the gravel bars and pressure transducers were dropped down the observation well. The water surface level loggers recorded water depths at 30 minute intervals. In 2004 the level loggers were installed on July 30<sup>th</sup> and removed on October 29<sup>th</sup>. The wells were sealed for the winter. Three loggers were reinstalled in July of 2005 and ran from July 13<sup>th</sup> through November 2<sup>nd</sup>. Topography of the study reach was surveyed, and included elevations of the wells in relation to important channel features.

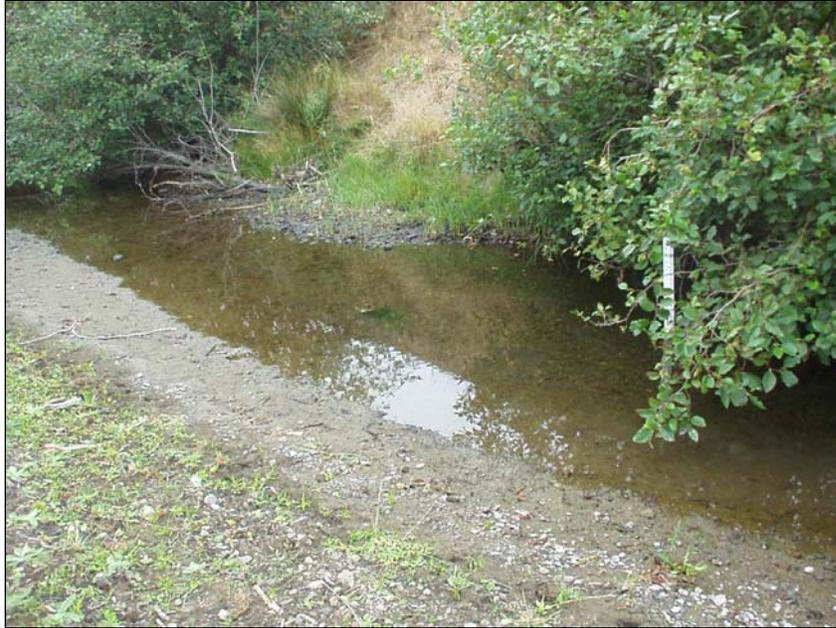
*Figure 3.4.3* Unit 10 near well site, 12 August 2004 – considerable dewatering had already occurred since 2 July survey.

General characteristics of the habitat units surveyed on three dates in summer 2004 in the study reach near the well site are provided in Table 3.4.7. The initial habitat survey was conducted on 4 June 2004, prior to dewatering of the reach. Additional habitat surveys were conducted on 12 August and 31 August, by which time most of the units were dry or reduced to shallow puddles, as shown in two photographs of Unit 10 (Figures 3.4.3 & 3.4.4), which lies directly across the channel from the well site. Detailed analyses of hydrological events accompanying the visible dewatering of the stream during this period are presented in the main report.

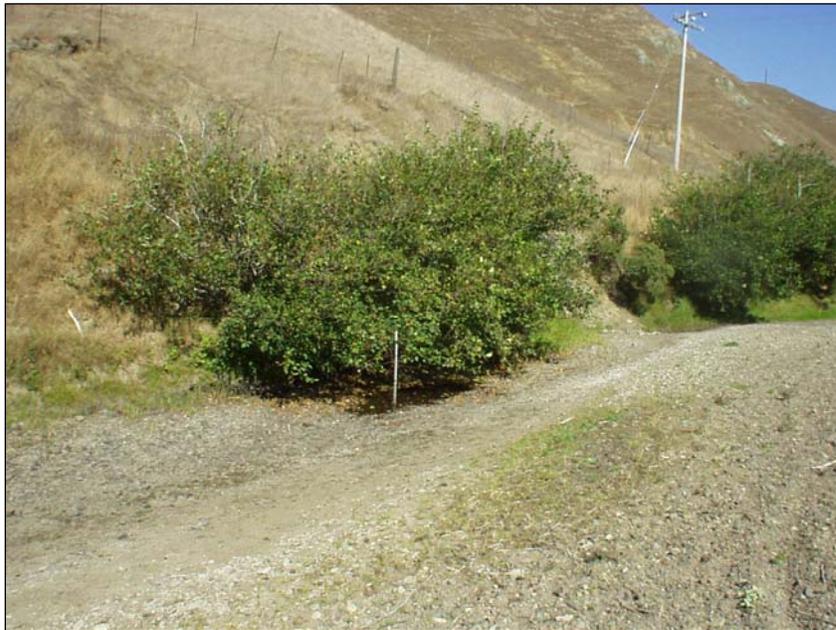
*Figure 3.4.4* Unit 10 near well site, 31 Aug 04 – remaining pool only 4.4 cm. deep, no vertebrates left in the pool.
