635 - Salyer Mutual Water Company, Distribution System and Hydrants

ENGINEERING REPORT FOR PLANNING STUDY AND SCOPE OF WORK

Riverview Acres Water System

Riverview Acres (PWS# 5304501) **February 28, 2011**

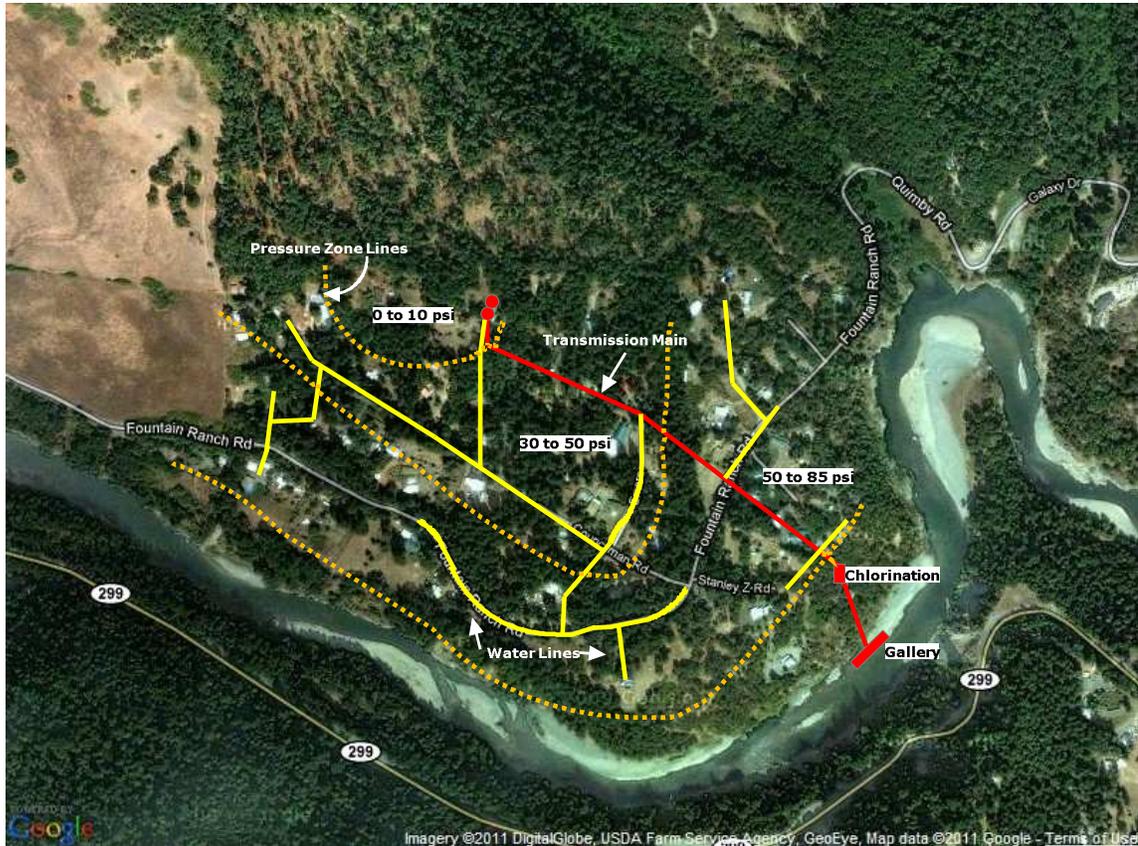
Figure 2 RA Water System Layout.

RA is located one mile east of Salyer, CA along California highway 299 in Trinity County, California. Figure 1 is a vicinity map showing the location. The primary drinking water source is a gallery located in the Trinity River. The GPS coordinates for the water system are N40°53.583 / W123°33.923. RA is a development with 56 connections which are zoned residential. However, 5 to 10 of those connections supply private agricultural businesses.

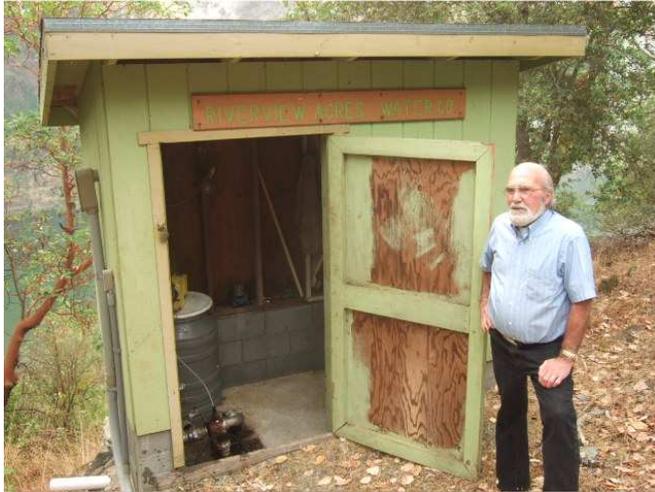
The chlorination shed is located 50 feet above the river gallery in this building.

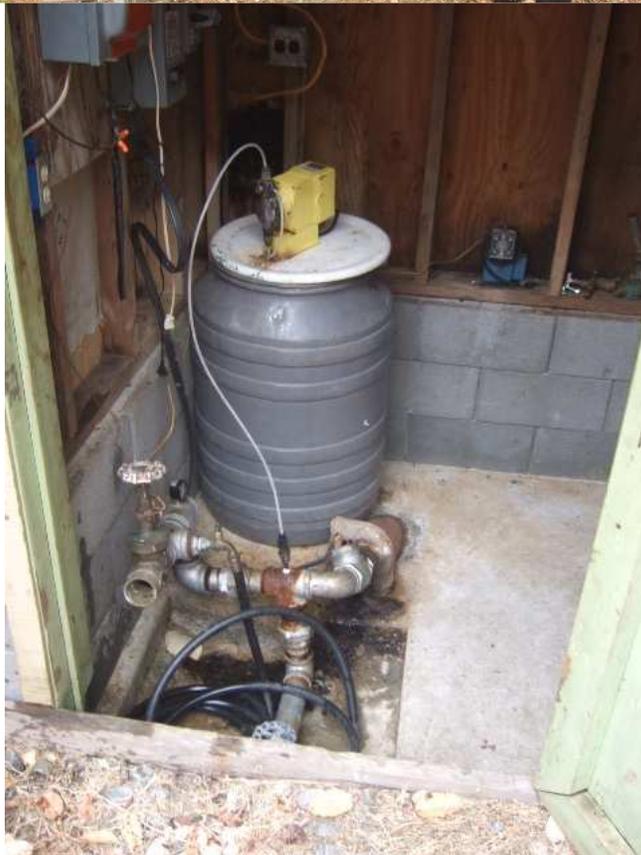
The chlorination equipment is of standard design and includes a 20 gallon storage tank and positive displacement pump. The system should be equipped with a means of calibrating the pump flow.

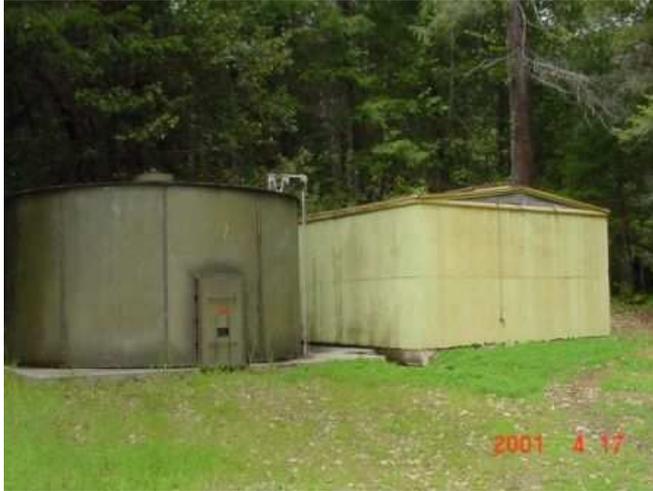
The two storage tanks have a combined storage of roughly 24,000 gallons which is inadequate to meet maximum day demand.

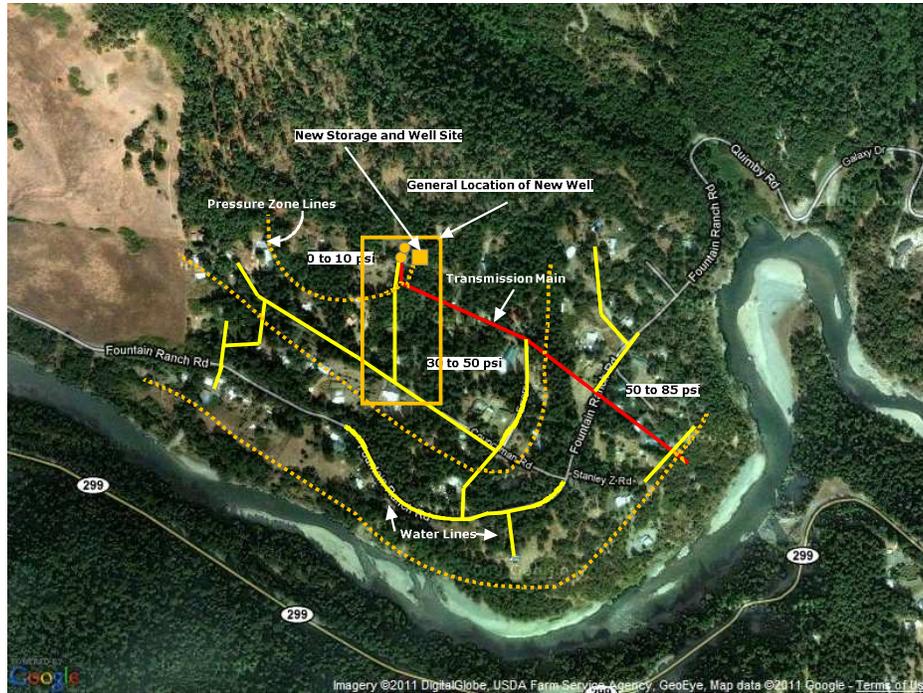
Figure 3 New Groundwater Source

This alternative is shown in Figure 3 which shows the new proposed facilities. Comparison with Figure 2 shows the differences between the existing and new facilities.

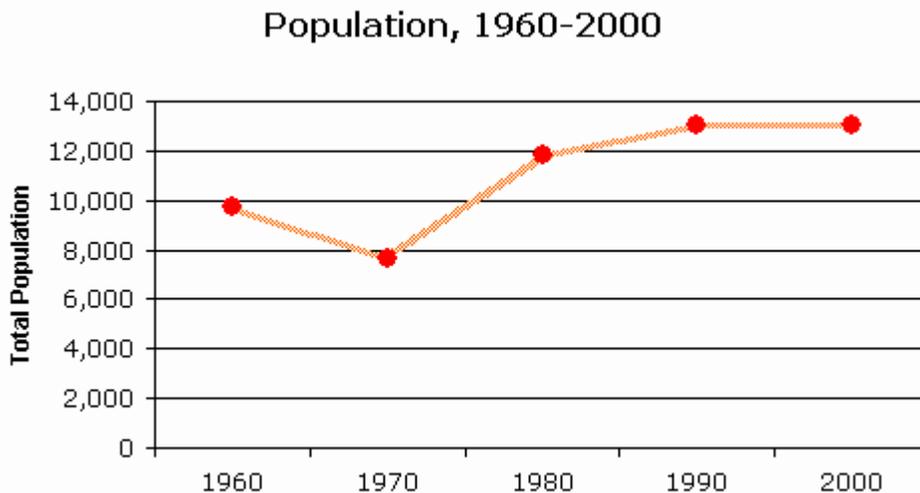
Figure 2-3 Trinity County Population Growth
(U.S. Census Bureau)

RA water system is located in Trinity County which has had a very stable population since the mid 1980's. The last census in year 2000 showed a negative 0.31 percent growth. The largest community close to RA is the community of Willow Creek which has a population of 2,500. Figure 2-3 shows the U.S. Census Bureau statistics for Trinity County.

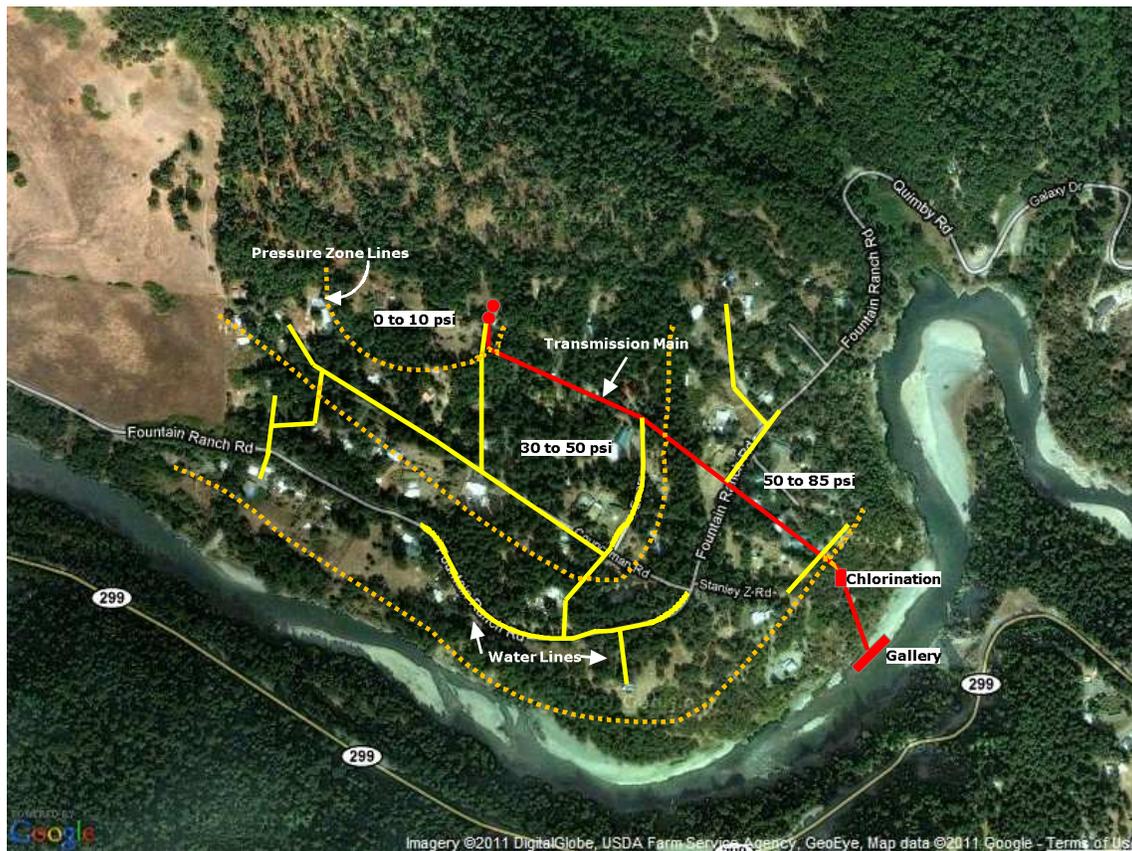
Figure 3-1 RA Water System Layout.

The RA water system is a river gallery subject to direct influence of surface water and has no filtration other than 18 inches of cover. The system includes two 20,000 gallon storage tanks, chlorination, and distribution. Water distribution is by three zones on a hillside with 320 foot elevation between the river and the storage at the upper zone. The zones are indicated in Figure 3-1 which is a layout of the water system for RA. There is currently a limited high demand protection system. The water system demand is estimated at 46 gpm for maximum day demand, 56 service connections, and some agriculture (approximately 10 acres). The water main from the river to the tanks is 4-inch PVC. Distribution piping is 2-inch or less.

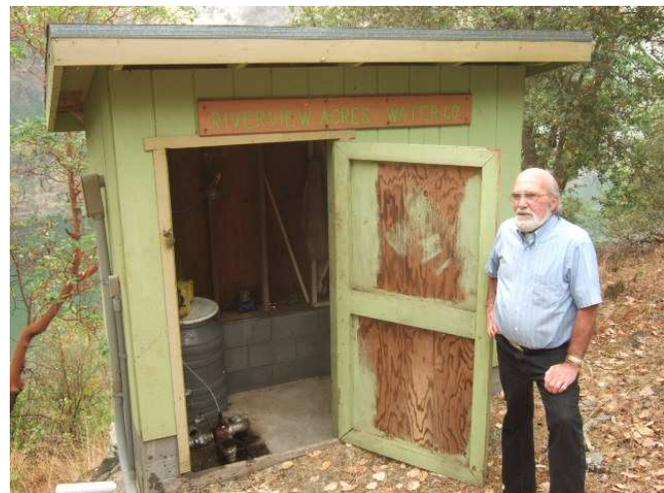
The chlorination shed is located 50 feet above the river gallery in this building.

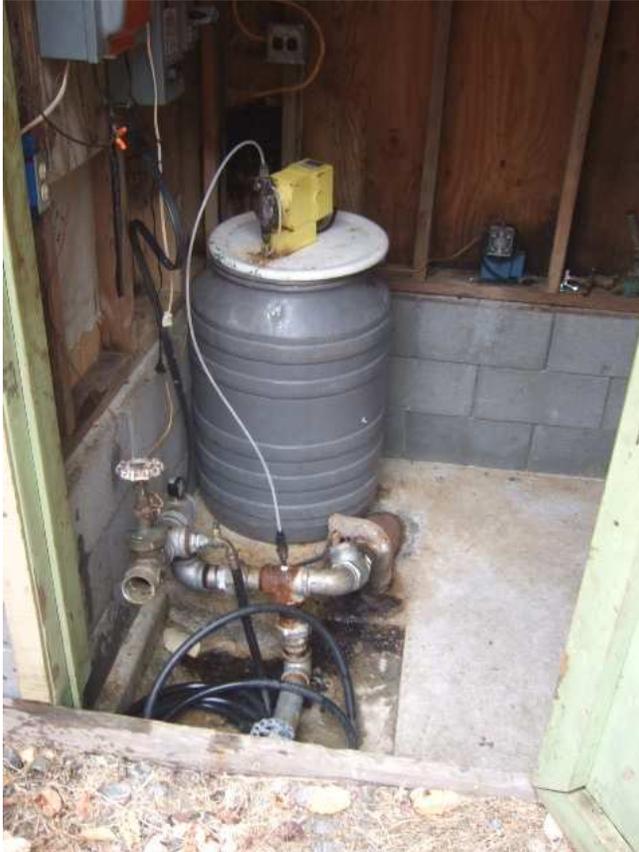
The chlorination equipment is of standard design and includes a 20 gallon storage tank and positive displacement pump. The system should be equipped with a means of calibrating the pump flow.

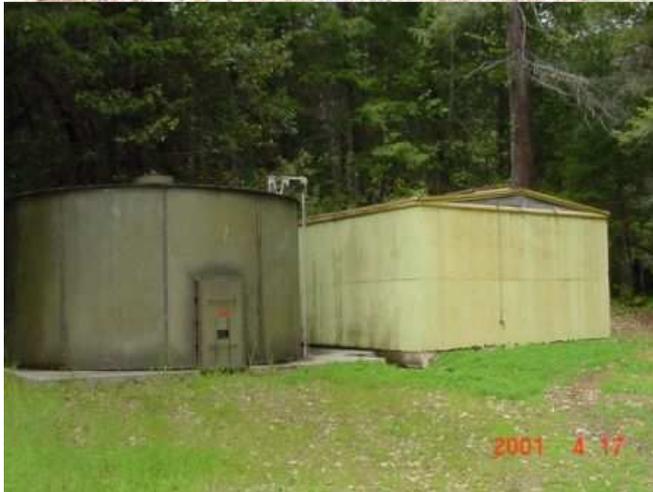
The two storage tanks have a combined storage of roughly 24,000 gallons which is inadequate to meet maximum day demand.

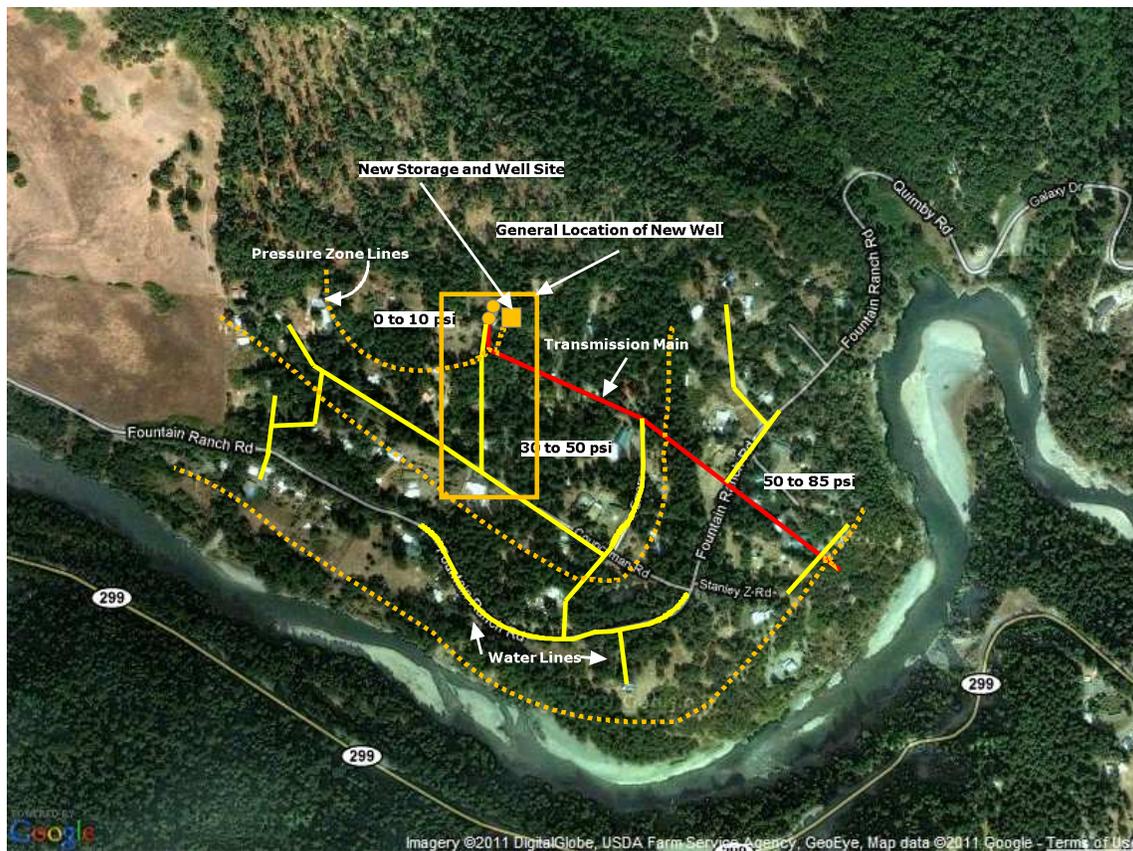
Figure 6-1 New Groundwater Source Alternative

This alternative is shown in Figure 6-1 which shows the new proposed facilities. Comparison with Figure 3-1 shows the differences between the existing and new facilities.

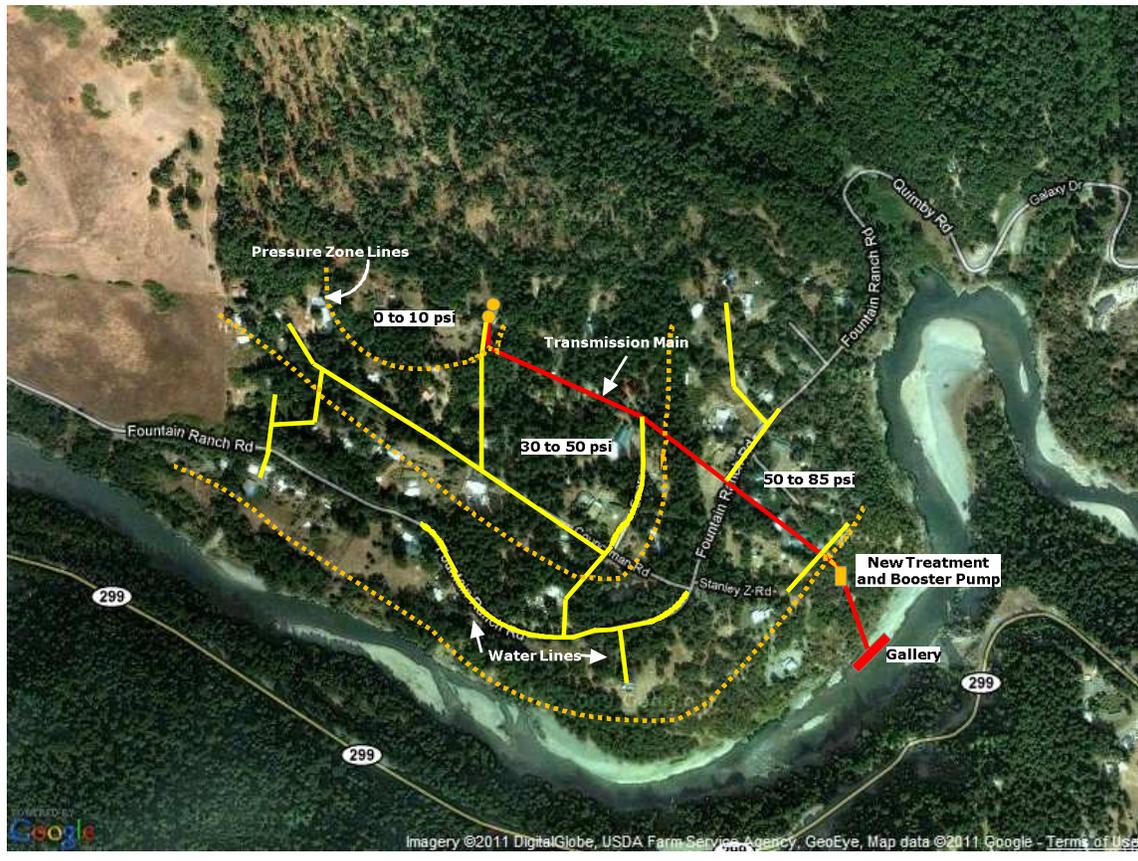
Figure 7-1 New Treatment Facility

This alternative is shown in Figure 7-1 which shows the new proposed facilities. Comparison with Figure 3-1 shows the differences between the existing and new facilities.

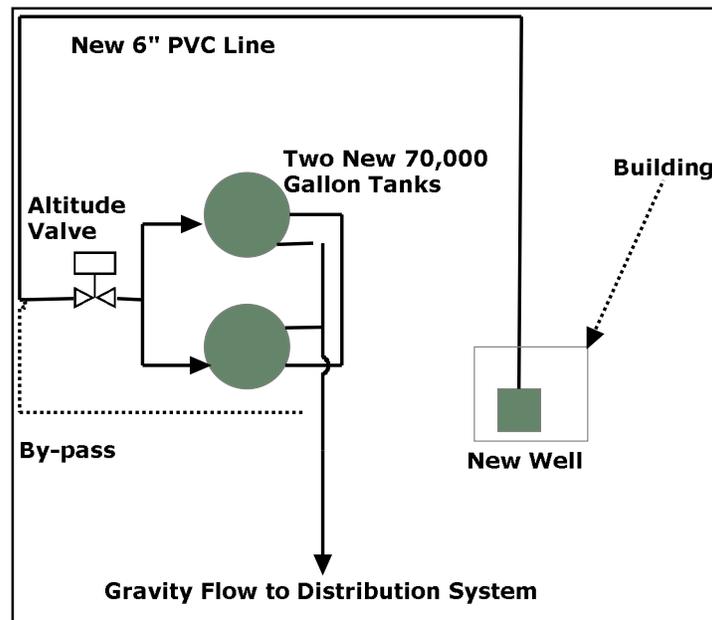
Figure 9-1 Well and Storage System Design

A more detailed site layout was prepared for the new well alternative and is shown in Figure 9-1.

All below grade piping is C-900 and above grade is coated steel with restrained joints. The reservoirs will be anchored for seismic activity with flexible couplings at the tank tie in points. The production capacity of the well should be 50 gpm for maximum day demand. The facility will be bordered by a chain link security fence with razor wire. Gate entry will be alarmed with an audible alarm system and red flashing light. Night time lighting will be provided for facility entry and inspection during non-daylight hours. The lighting will have an automatic on and off switch sensitive to ambient lighting. The well design will be to a depth necessary to find water. Figure 9-2 shows a schematic of the proposed well design.
