## **HISTORICAL ECOLOGY of the lower Santa Clara River, Ventura River, and Oxnard Plain: an analysis of terrestrial, riverine, and coastal habitats**

HISTORICAL ECOLOGY PROGRAM  
CONTRIBUTION NO. 641 • AUGUST 2011

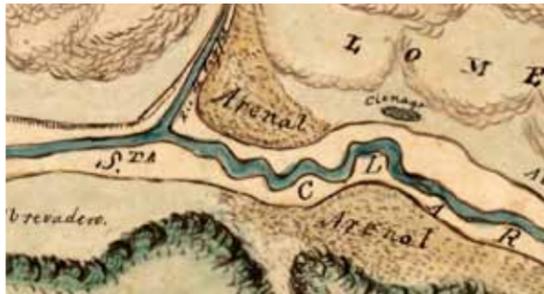
**Mexican land grant sketches (1840s-1850s).** As the Mission system disintegrated, influential Mexican citizens submitted claims to the government for land grants. A *diseño*, or rough sketch of the solicited property, was included with each claim. *Diseños* often show notable physical landmarks which would have served as boundaries or natural resources, such as creeks, wetlands, springs, and forests. While *diseños* are not as spatially accurate as subsequent surveys, they provide extremely early glimpses of former landscape features and patterns. (U.S. District Court ca. 1840d, courtesy of The Bancroft Library, UC Berkeley)

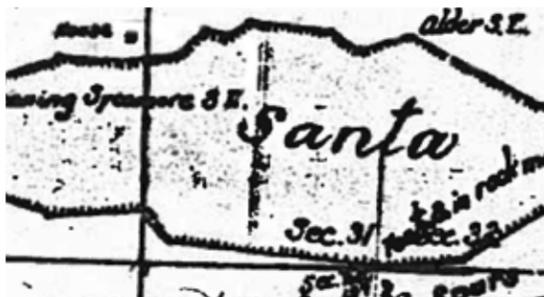
**General Land Office Public Land Surveys (1853-1900).** In areas not claimed through the land grant system, the U.S. Public Land Survey imposed a grid of straight lines on the landscape, dividing property into six-mile square townships. Each township was further subdivided into 36 one-mile sections, each section containing 640 acres. Surveyors methodically surveyed section lines along these transects, noting cultural and natural features they encountered along the way. Survey notes and plat maps from these surveys are useful for their ecological information. (Hoffman 1868d, courtesy of the Bureau of Land Management)

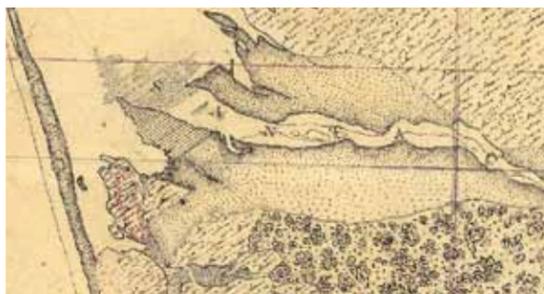
**U.S. Coast and Geodetic Survey maps (1855-1934).** The U.S. Coast and Geodetic Survey was established in 1807 by Thomas Jefferson to create navigation maps. Though the maps only cover the coastline and immediately adjacent areas, they are a highly valuable source because of their impressive detail and accuracy, scientific rigor, and relatively early survey dates. (Johnson 1855c, courtesy of the National Oceanographic and Atmospheric Administration)

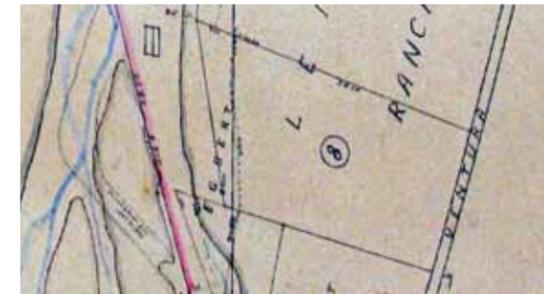
**City and county surveys (1860-1930).** Local surveyors produced abundant maps, including many surveys of individual parcels. These maps, often surveyed at a large scale, contain details not included in other regional mapping efforts such as sloughs and side channels, smaller ponds and wetlands, or clusters of trees. Though coverage is inconsistent, these maps are invaluable in constructing an understanding of local ecosystem dynamics. (Barry 1894, courtesy of the Ventura County Surveyor's Office)

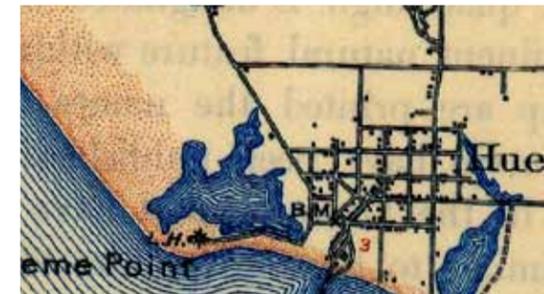
**U.S. Geological Survey topographic maps (1903-1943).** Shortly after 1900, the USGS (established in 1879) began producing topographic quadrangles at 1:62,500 for the Ventura County region. Though the maps are relatively coarse, they provide some of the earliest consistent, comprehensive coverage for the entire region. (USGS 1904, courtesy of the CSU Northridge Geography Map Library)

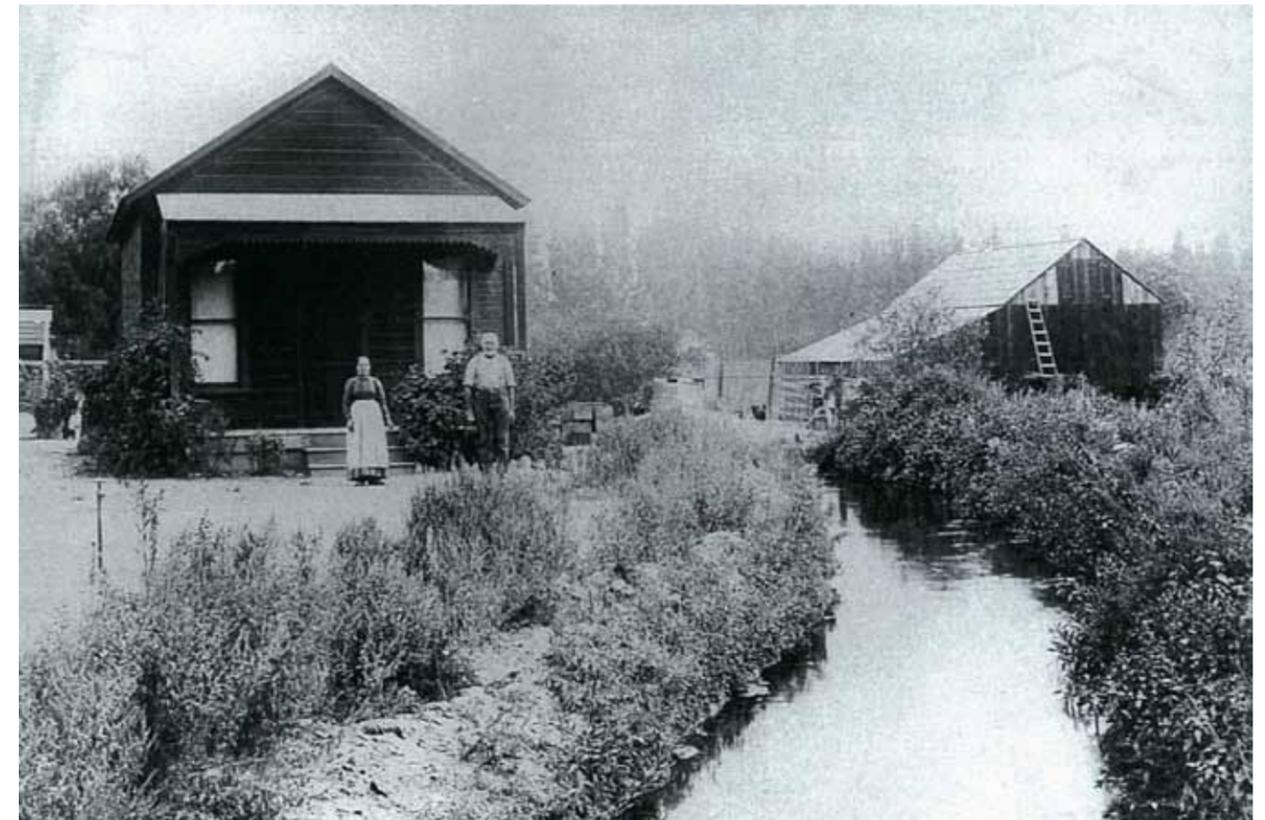
**Fig. 2.8. Diversion ditch from Santa Paula Creek, ca. 1900.** Surface diversions, such as this ditch taking water from Santa Paula Creek downvalley, brought water from areas with abundant surface flow to drier portions of the valley. (Unknown ca. 1900a, courtesy of the Santa Paula Historical Society)

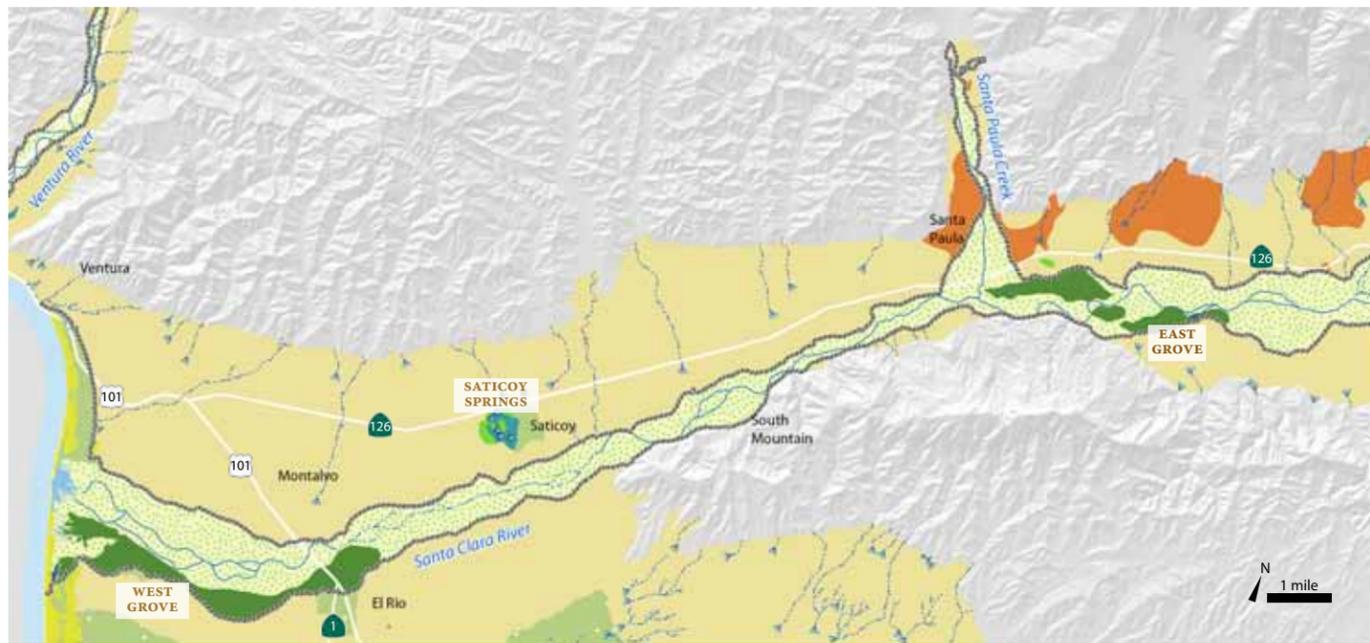
**Fig. 3.2. Historical habitats of the Santa Clara River and valley, early 1800s.** The Santa Clara River valley was dominated by broad, mostly treeless expanses of grassland and scrub. Trees, such as live oaks and sycamores, occurred on several alluvial fans north of the river and along many of the valley’s tributaries, most of which sank into valley soils before reaching the Santa Clara River. A large wetland complex at Saticoy included willow groves, freshwater marsh, springs, and alkali meadow, and was the only significant wetland complex documented on the plain in the valley. Within the outer river banks, however, large areas of willow-cottonwood forest and freshwater wetlands marked areas of perennial flow and rising groundwater east of Camulos, at Fillmore (near the present-day fish hatchery), Santa Paula, and below the Highway 101 bridge.

This chapter explores the historical characteristics of the Santa Clara River and valley prior to major urban and agricultural modifications (fig. 3.2). In particular, we focus on the pre-modification hydrology, morphology, and ecology of the Santa Clara River, describing each historical attribute at a reach scale.

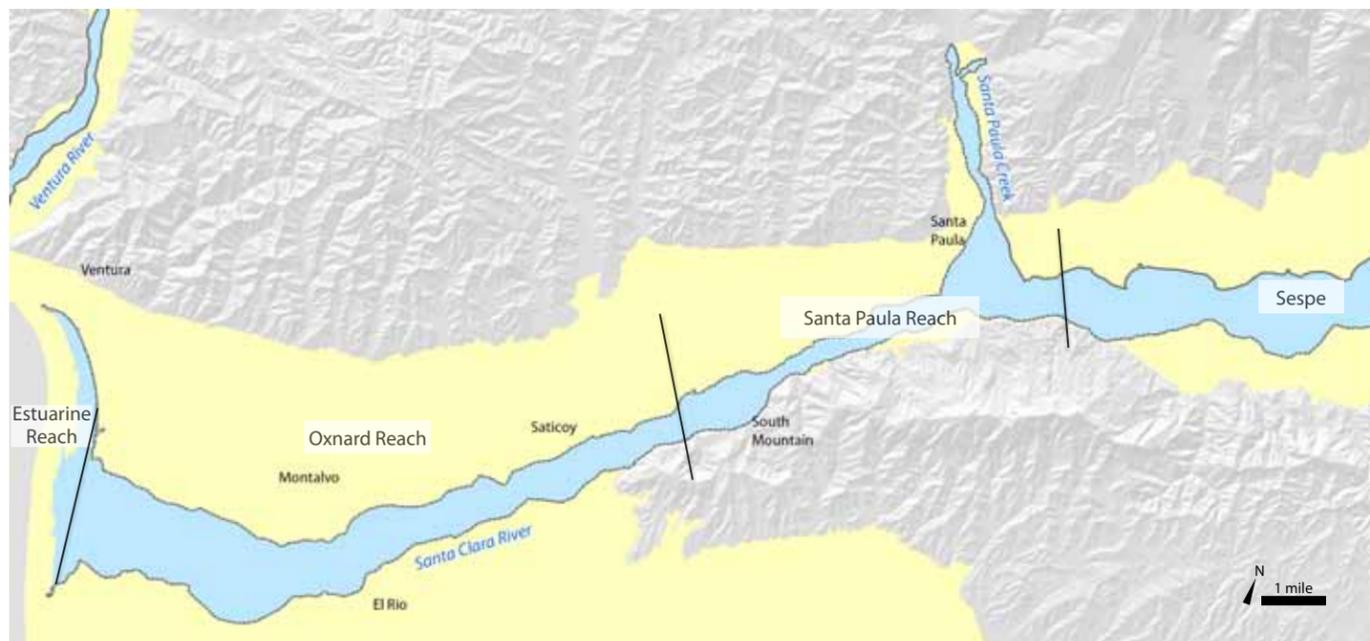
**Fig. 3.3. Reaches of the Santa Clara River.**

We designated six reaches of the lower Santa Clara River as units of analysis for the following chapter. These reaches are aggregations of Stillwater Sciences’ (2007b) more detailed reach designations for the river, with a few modifications to reflect historical conditions.

From the coast upstream to Interstate 5, the six reaches of the river are designated as the Estuarine reach, the Oxnard reach, the Santa Paula reach, the Sespe reach, the Piru reach, and the Del Valle reach. Through this report, we will refer to these reaches, and use them as a practical scale at which to examine and analyze historical riverine processes and dynamics.

For purposes of comparison, we identified six reaches of the lower Santa Clara River (fig. 3.3). These reaches were broadly defined based on physical characteristics of the system such as topography, flow dynamics, tributary inputs, and geology (Bisson et al. 2006). They are designed to provide meaningful units of analysis for reach-level investigations of channel dynamics and morphology.

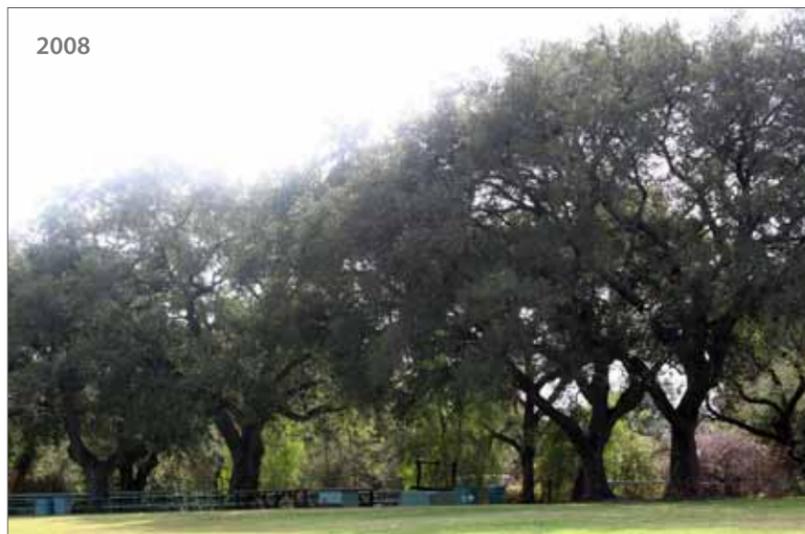
**Fig. 3.7. Sycamores and oaks between Santa Paula and Sespe creeks.** Scattered oaks and sycamores, documented by GLO, historical soils surveys, and early aerial photography, occupied coarse alluvial fans north of the Santa Clara River.

In addition to these isolated trees and groves, there were a few areas of denser tree cover on the valley floor. These timbered areas were documented exclusively on alluvial fans north of the Santa Clara River between Santa Paula and Sespe canyons (fig. 3.7). Using both GLO survey notes and historical aerial photography, we found that the gravelly fine sandy loam with stones (Yg) soil type from the historical soil survey (Nelson et al. 1917), prevalent on these alluvial fans, was well correlated with the documentation of historical oaks and sycamores. We subsequently used this soil type to delineate probable timbered areas (see page 15). GLO field notes for these areas describe “oak timber,” “scattering oak timber,” and “scattering live oak and sycamore with undergrowth sage brush” (Hoffman 1868c, Orcutt 1900).

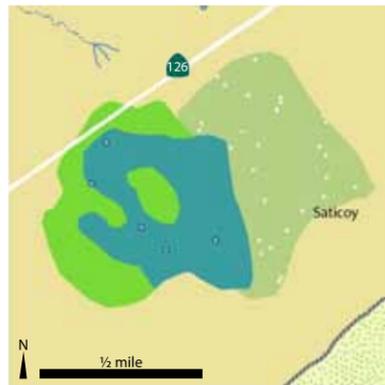
**Fig. 3.10 Detail of Saticoy Springs, early 1800s.** This 330 acre wetland complex was composed of springs, seasonal alkali meadows, and extensive willow groves and freshwater marsh.

**SATICOY SPRINGS** In contrast to the Oxnard Plain on the southern side of the Santa Clara River, the lowlands just to the north, on the opposite side of the river, contained few wetlands. This area was naturally steeper and more well drained than the south side of the river, as a result of alluvial fans emanating from the mouths of the series of canyons to the north. However, one distinctive wetland complex was found on the plain on the north side of lower Santa Clara River: Saticoy Springs. Groundwater emerged in an array of springs here, associated with a fault trace of the Country Club fault (Mann 1958), creating a series of springs, wetlands, willow thickets, and alkali meadows that were a noted source of water and wood through much of Ventura history (fig. 3.10).

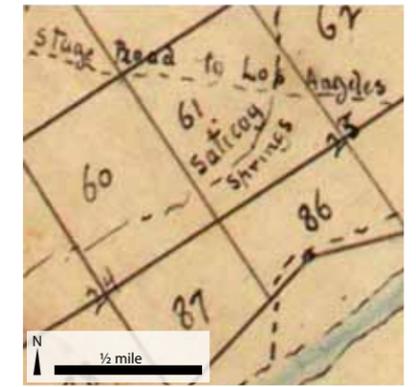
**Fig. 3.11. Detail of an early map** showing Saticoy Springs at the crossroads of two thoroughfares. (Norway 1867, courtesy of the Ventura County Surveyor’s Office)

The springs were recognized widely as a major landmark and water source for later settlers in the area (fig. 3.11). Their importance was so great that the Santa Clara River was sometimes called the “Saticoy River” even into the 20th century (Hittell 1874; Bancroft 1883; *Ventura Daily Democrat* 1902, in Browne 1974; Harrington 1913e). The Saticoy Springs area served as additional pasture for Mission animals when areas closer to the Mission were no longer available: “When the pasture there is exhausted or dried up, the cattle go in search of more plentiful or better grazing elsewhere... The animals furthest from the beach make their way to a place called Saticoy” (Señan and Santa María 1804). Modern American settlement in the area began when Jefferson Crane began to farm in the area in 1861 (Triem 1985, Gudde and Bright 1998). The springs were noted as a valuable aspect of the Saticoy area, described as “magnificent springs of pure water... said to be the finest in Ventura county” (*Ventura Signal* 1872).

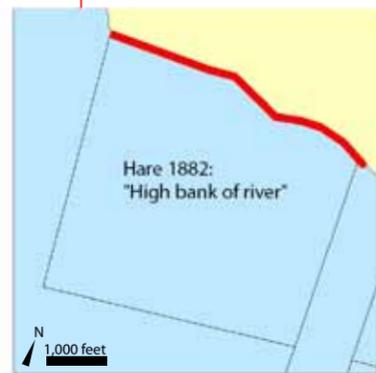
**Fig. 3.14. Location of the Santa Clara River corridor by earliest available source, 1853-1938.** We mapped the historical position of the outer bank, using the earliest data found for each stretch of the river. We found that while large flood events caused locally significant adjustments in outer bank position and total river corridor width, these changes were relatively small at a regional scale. Pull-out quotes provide examples of the types of sources used to map the historical river corridor.

The river corridor polygon included in our historical mapping represents the earliest reliable source available for each length of stream (fig. 3.14). For the lower Santa Clara River, previous mapping of high, medium, and low disturbance areas from 1938 aerial imagery (Stillwater Sciences 2007b) was used as a starting point. This layer was then compared to earlier historical sources where available. Where earlier sources confirmed 1938 mapping, bank position was left unchanged. Where they showed a substantial change (greater than 150 feet) in bank position, the 1938 layer was modified to reflect the earlier source. In places where Stillwater Sciences was missing 1938 aerial coverage (and in Los Angeles County), we extended their mapping of the active channel. We also mapped the outer banks of the Ventura River and major tributaries of the Santa Clara River from historical aerials and other spatially accurate historical sources.

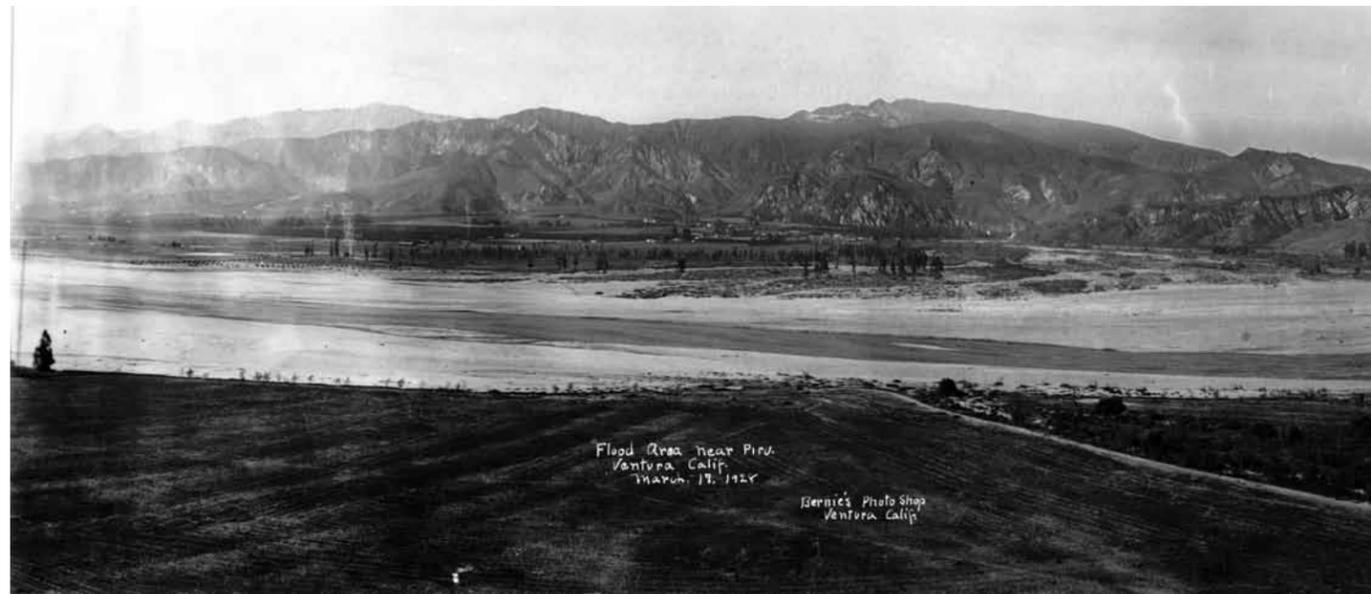
**Fig. 3.15. Santa Clara River after the St. Francis dam break, 1928.** This photograph was taken near Piru only five days after the failure of the St. Francis dam. (Isensee 1928a, courtesy of the Museum of Ventura County)

Even the St. Francis Dam break appears to have had minimal long-term impact on the river's overall plan form configuration (fig. 3.15), despite noteworthy scour and extensive deposition at various locations along the river valley and the possibility that the gradient of the channel between the county line and Sespe Creek has been recovering ever since (Stillwater Sciences 2007b). Many riparian features persisted, as did the general width and appearance of the channel.

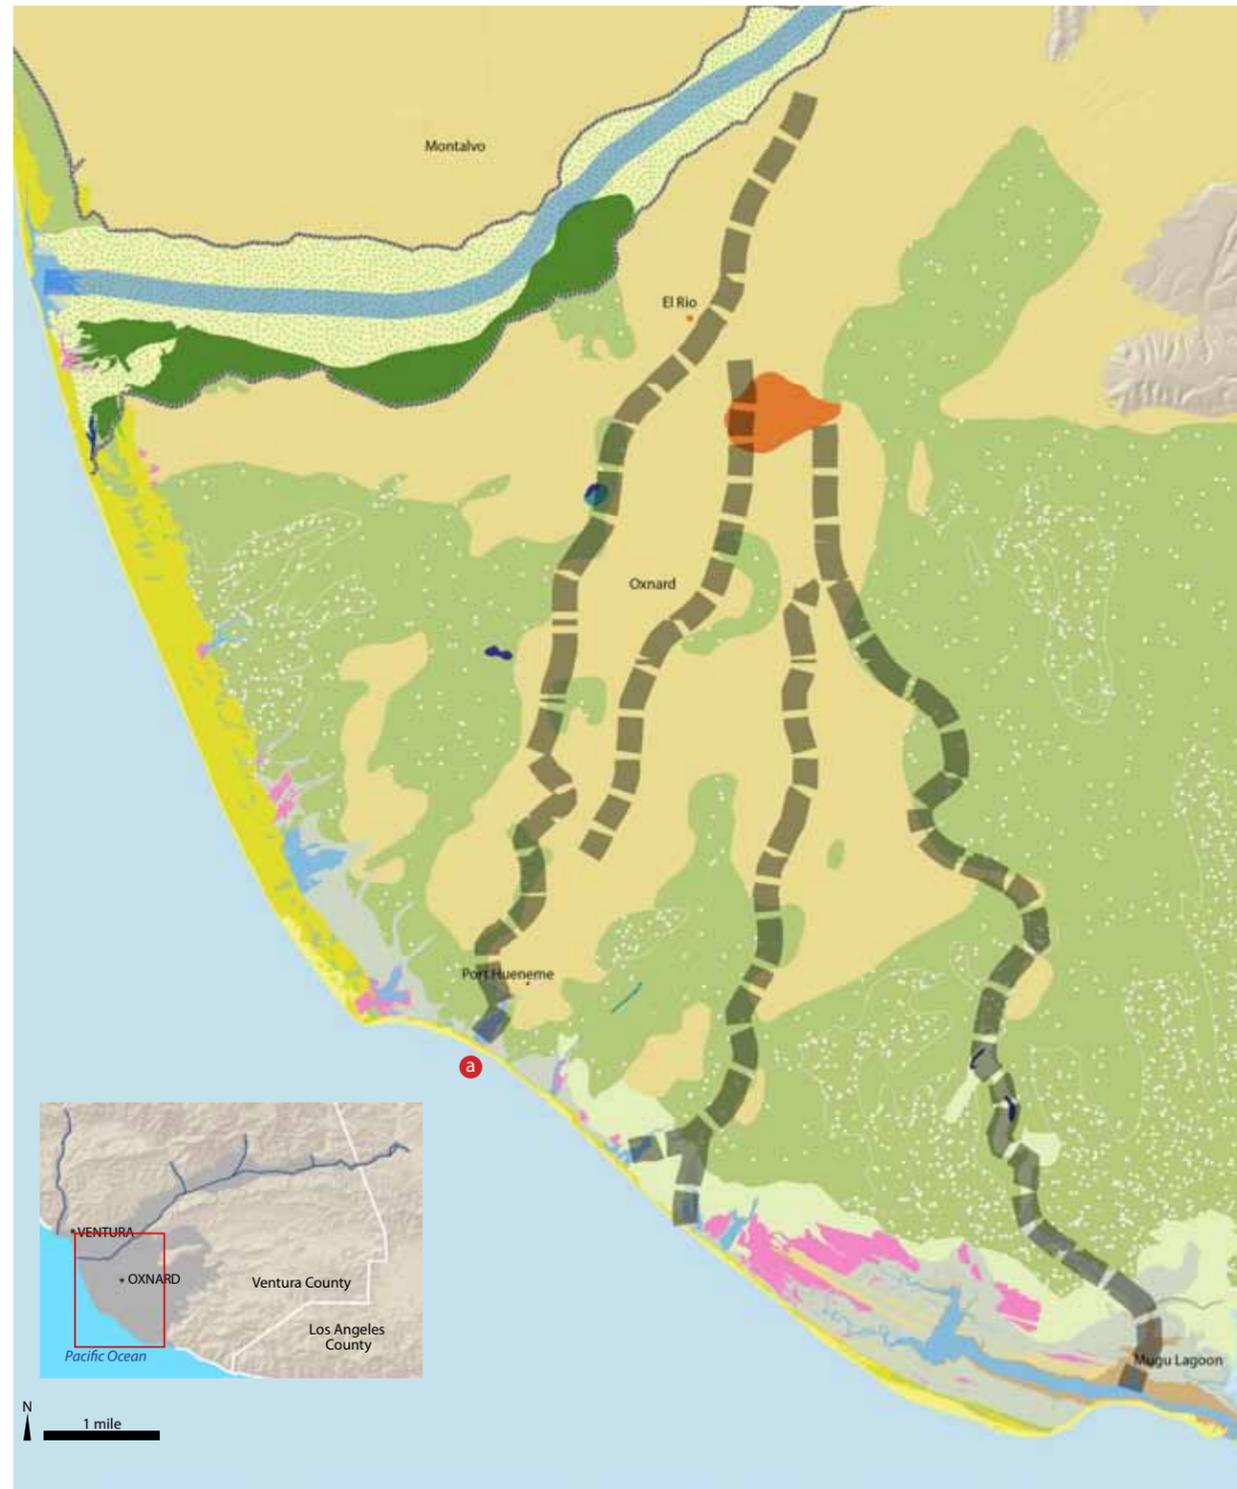
**Fig. 3.21. Large-scale changes in the lower Santa Clara River course on the Oxnard Plain.** Geologic, archaeological, historical, and edaphic data all support the migration of the Santa Clara River over the Oxnard Plain over geologic time. Extreme floods coupled with sediment deposition triggered channel migration on the Santa Clara River delta (Oxnard Plain) and subsequent large-scale changes in river corridor location. The dashed black lines represent paleochannels; the most recently occupied former course of the river (Saviers paleochannel, labeled **a**) may have been active as recently as 1812. It can also be seen here how ecological patterns of the Oxnard Plain are dictated by the channel migration history, with grassland/sage scrub on higher surfaces marking natural levees along more recently occupied routes of the river. (Nelson et al. 1917, Fairchild Aerial Surveys 1927, Clahan 2003, Parsons 2004)

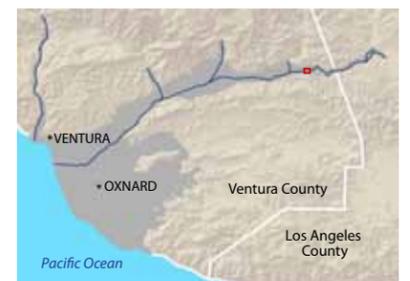
**Fig. 3.24. An early *diseño* (top) shows the Santa Clara River**—which it calls the "Arroyo de la Soledad"—stopping abruptly before reaching Piru Creek (labeled on the *diseño* as "Q-R"). This corresponds to the well documented location of the loss of summer surface flow in this reach, near Camulos (which is labeled with a small hut and "O" on the *diseño*). A historical USGS quad (bottom) shows the loss of flow in the same location, around sixty years later. (Unknown ca. 1843, courtesy of John Johnson and Santa Clarita Valley History; USGS 1903b, courtesy of the CSU Northridge Map Library)

USGS topographic quad from 1903 [Santa Susana], which shows a solid blue line in the sandy bed of the Santa Clara River (the conventional USGS symbol for a permanent stream) from west of Saugus to ½ mile east of Camulos, where a forked distributary represents the stream sinking into its sandy bed (fig. 3.24).

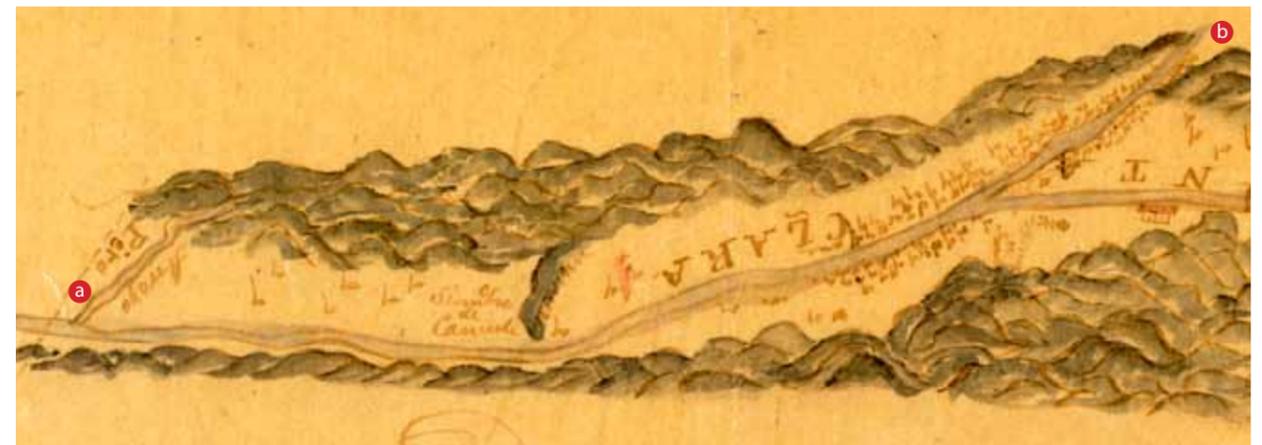
**Fig. 3.27. This diseño captures a similar pattern of discontinuous riparian forest** (shown here as closely spaced, small, circular trees) east of Piru Creek at **a**. Though the location of this transition is highly generalized, it is shown here east of Camulos and extending up what is likely Castaic Creek **b** in Los Angeles County. (U.S. District Court ca. 1840c, courtesy of The Bancroft Library, UC Berkeley)

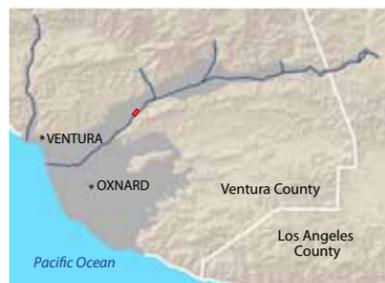
**Figure 3.28.** This 1897 map shows the variety of habitats found within the clearly delineated banks of the Santa Clara River, including a slough, “brush sand and waste land” with scattered willows, and a sand bar. Adams Barranca can be seen joining the river at left. (Orcutt 1897, courtesy of the Ventura County Surveyor’s Office)

A variety of habitats were found within the active channel and bottomlands of the Santa Clara River, including willow scrub, alluvial scrub, herbaceous cover, freshwater wetlands, side channels, and sloughs (fig. 3.28). (Large persistent wetland riparian areas are discussed separately in the subsequent section; see page 94.) With the exception of the persistent wetland riparian

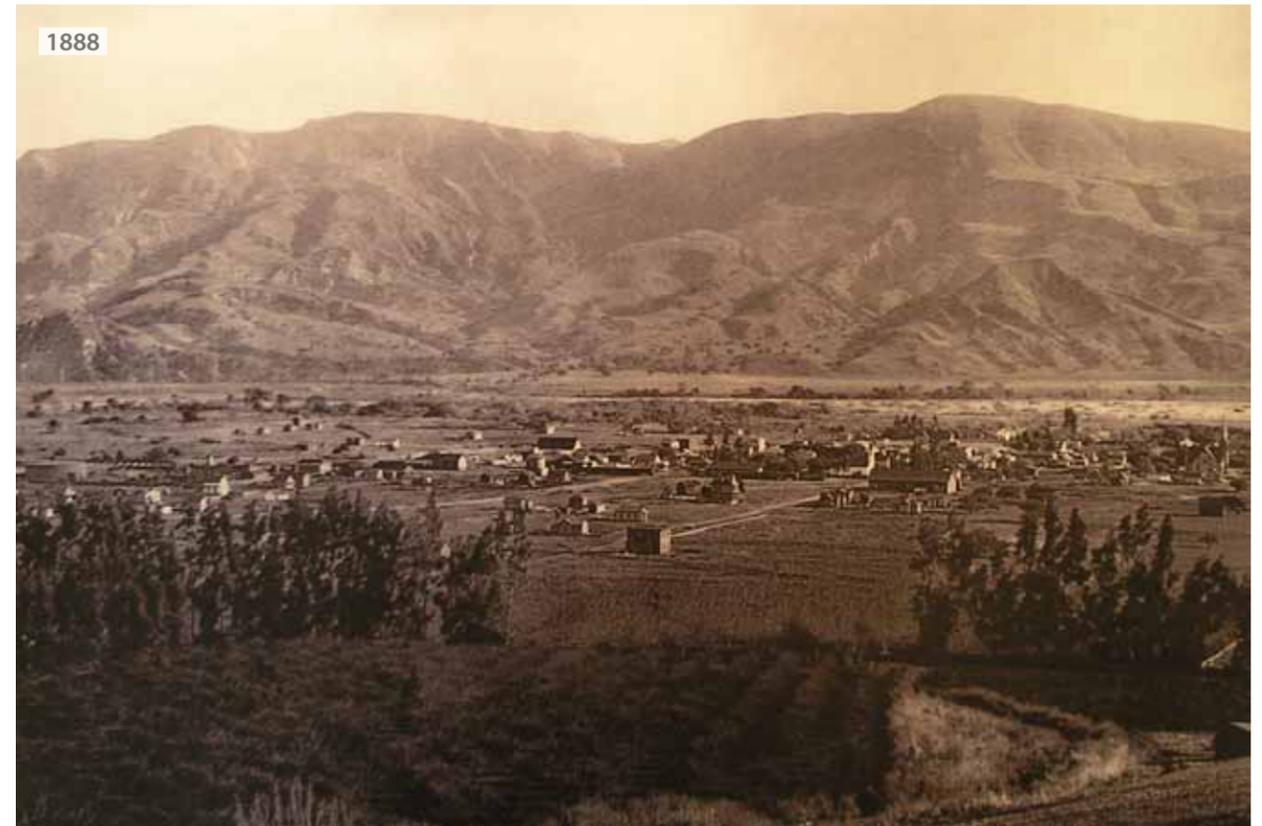
**Fig. 3.29.** A view of the river corridor south of Santa Paula (top) looking south toward South Mountain, 1888. The sparsely vegetated active channel can be seen behind the town of Santa Paula, with strips of dense riparian vegetation on bottomlands along both sides of the river. (Unknown 1888; courtesy of the Santa Paula Historical Society)

Features in the active channel included the low-flow channel, as well as side channels and sloughs which carried water during floods. The channel itself is consistently described as being sandy riverwash, and almost completely unvegetated or covered in herbaceous vegetation, depending on the season (fig. 3.29). The 1917 soil survey describes the active channel of the river as composed of “sand and fine sand” (Nelson et al. 1920), and GLO quotes repeatedly characterize the river as “sandy bed” (e.g., Hoffman 1868b, Barry 1892a). One surveyor traveling through the Cienega area noted “leave swamp for sandy plain” as he entered the active channel, emphasizing the abrupt shift between moist bottomland and the active channel (Norris 1853). Near Camulos (upper Piru reach), explorer Crespi noted that the bed of the river has “piles of drift and large banks of sand” (though he also notes “large bottomlands of very good soil”; Crespi and Brown 2001). In some places, this riverwash occupied all or nearly all of the area between the outer banks, with no other recorded major habitats present in the active channel or on bottomland surfaces. Near Camulos, the soil survey shows nearly the entire width of the Santa Clara River dominated by riverwash, a swath about ½ mile wide which would likely have been treeless and vegetated with only herbaceous cover, with minimal or no bottomlands (fig. 3.30). The presence of extensive areas of riverwash and herbaceous cover clearly predates many human-induced disturbances to the river, including the St. Francis dam break.

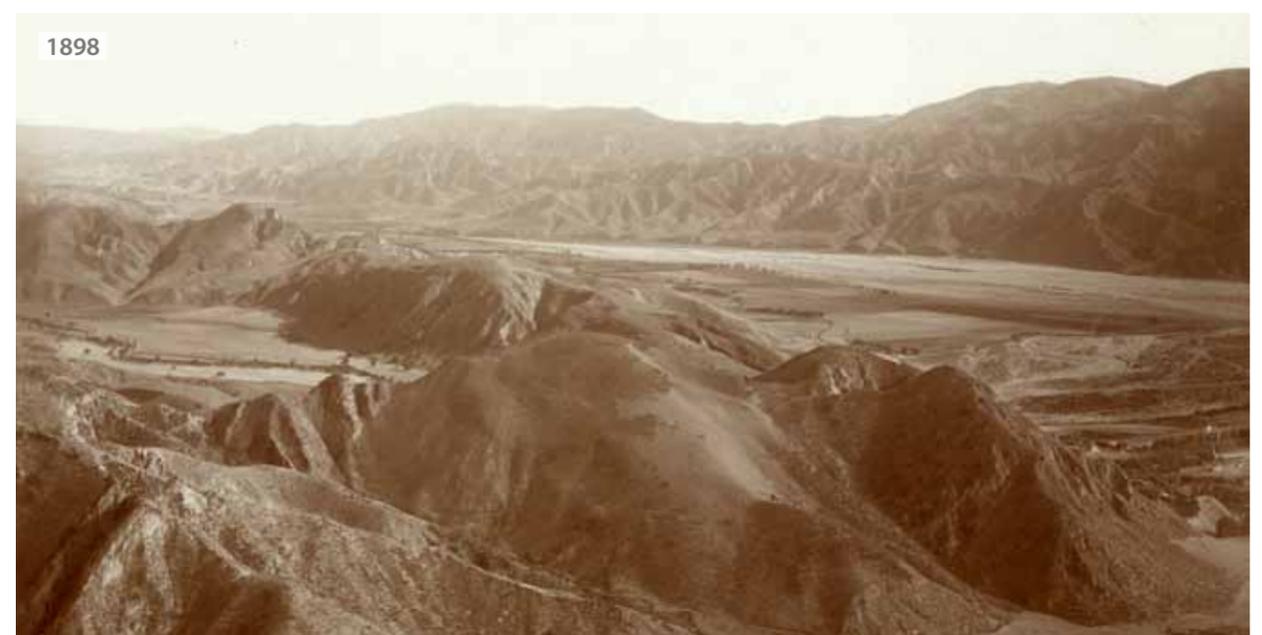
**Fig. 3.30.** Santa Clara River east of Piru Creek, 1898 (bottom). This view of the Santa Clara River, captured during the State Mineralogist’s 1898 field work, shows the broad expanses of sparsely vegetated riverwash characteristic of the Piru reach. The view is looking south east; Piru Creek can be seen coming into the Santa Clara River from the left. (Watts 1898, courtesy of the California State Archives)

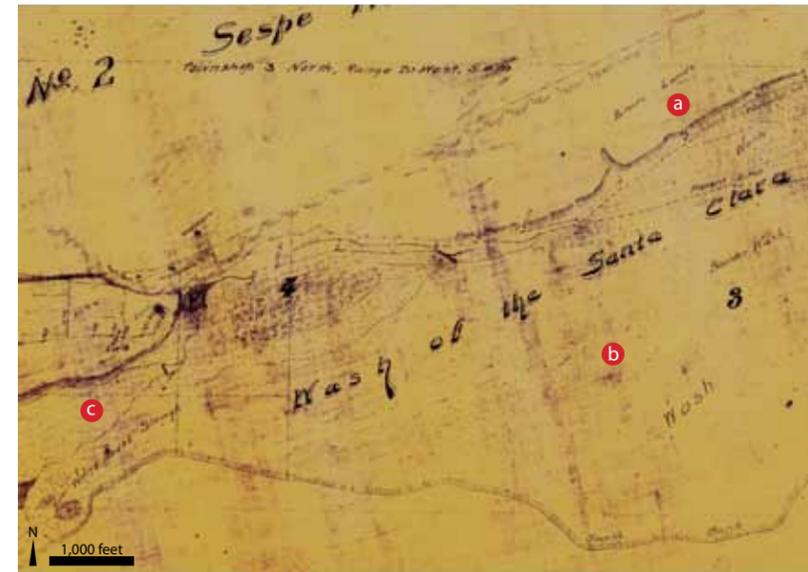
**Fig. 3.31.** This portion of a map showing the river immediately downstream of the confluence with the Sespe shows “Bottom Lands” **a** sitting above a break in slope, at a higher elevation than the “Wash” of the Santa Clara River **b**. Ponds and a slough (the upstream end of East Grove, **c**) and willows are also noted. (Stocker 1894, courtesy of the Museum of Ventura County)

In other areas, the bottomland would have been clearly differentiated from the active channel, both by its position and its vegetation. While this was most evident in the persistent wetland riparian areas, bottomlands also supported an array of other habitats, including willow scrub, alluvial scrub, herbaceous cover, and wetlands and sloughs (fig. 3.31).

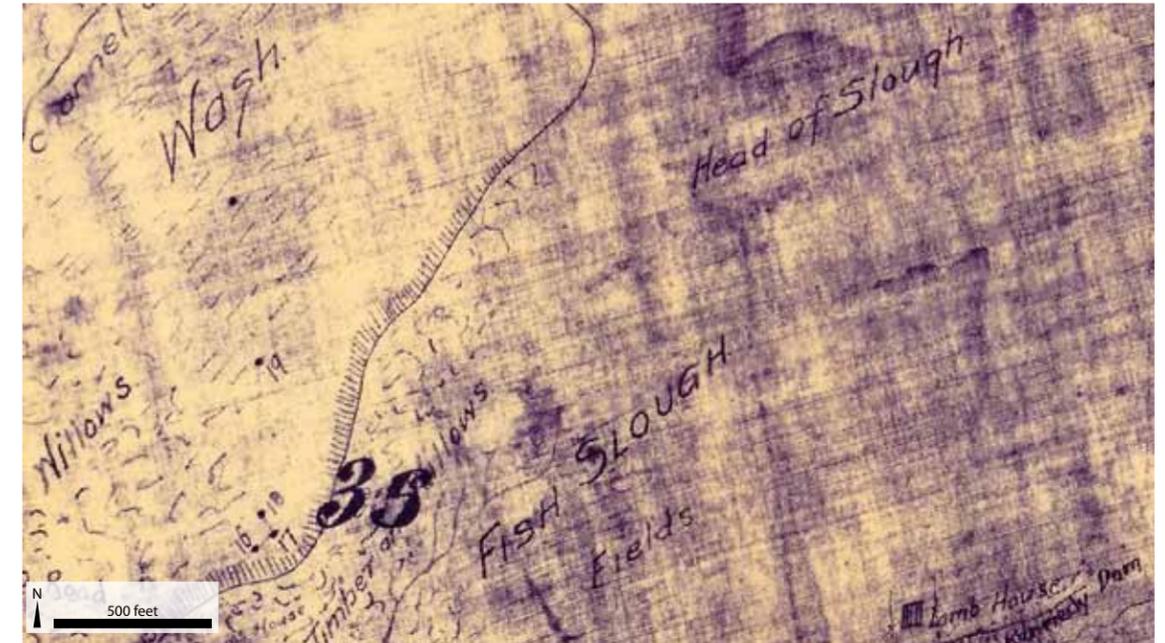
**Fig. 3.33. Fish Slough complex, 1894.** This map of the Santa Clara River-Sespe confluence shows the whole length of Fish Slough, extending about half a mile upstream on Sespe Creek. (Stocker 1894, courtesy of the Museum of Ventura County)

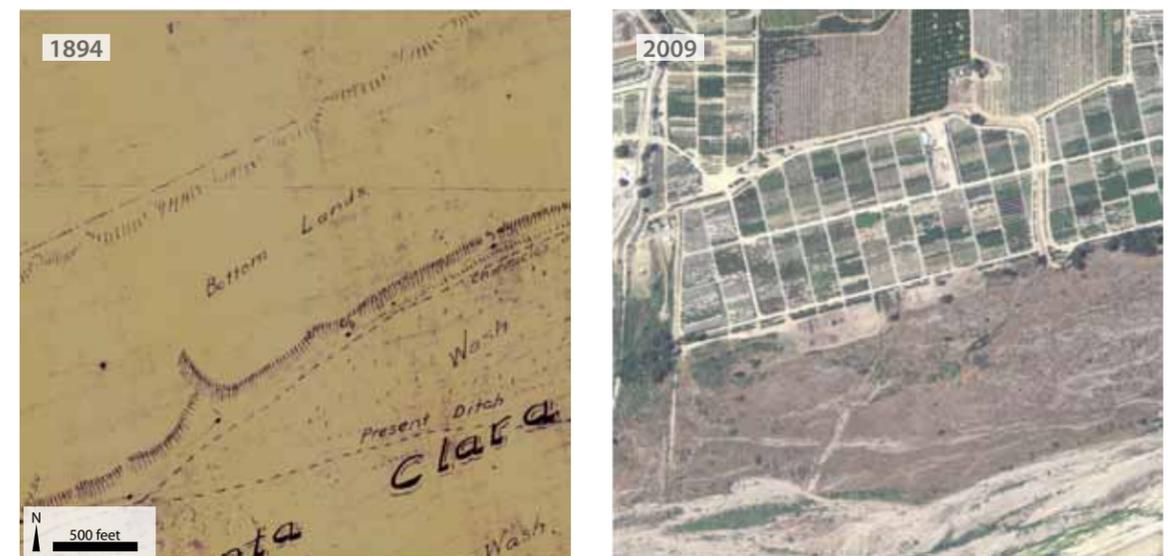
**Fig. 3.36.** This bottomland surface west of the Sespe Creek confluence remained uncultivated in the late 19th century, as shown here in this 1894 map (left). By 1938, the surface had been converted to mostly walnut, orange, and lemon orchards. The area is still farmed today (right). (Stocker 1894, courtesy of the Museum of Ventura County; USDA 2009)

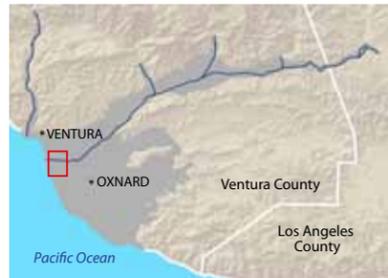
**Fig. 3.38. Santa Clara River mouth, 1855.** This early USCS survey shows the westernmost end of West Grove as it stood in 1855. Dense stands of trees surround an open area (including an “old corral”). Auxiliary sources describe the grove as a mix of willows, cottonwoods, and sycamores. (Johnson 1855c, courtesy of the National Oceanographic and Atmospheric Administration)

Mapping of West Grove (see page 48) was based on a few detailed sources which depicted the location and width of parts of the grove with spatial accuracy. A USCS T-sheet (Johnson 1855c; fig. 3.38) shows dense thickets approximately 3,700 feet wide at the mouth of the river, and GLO surveyors

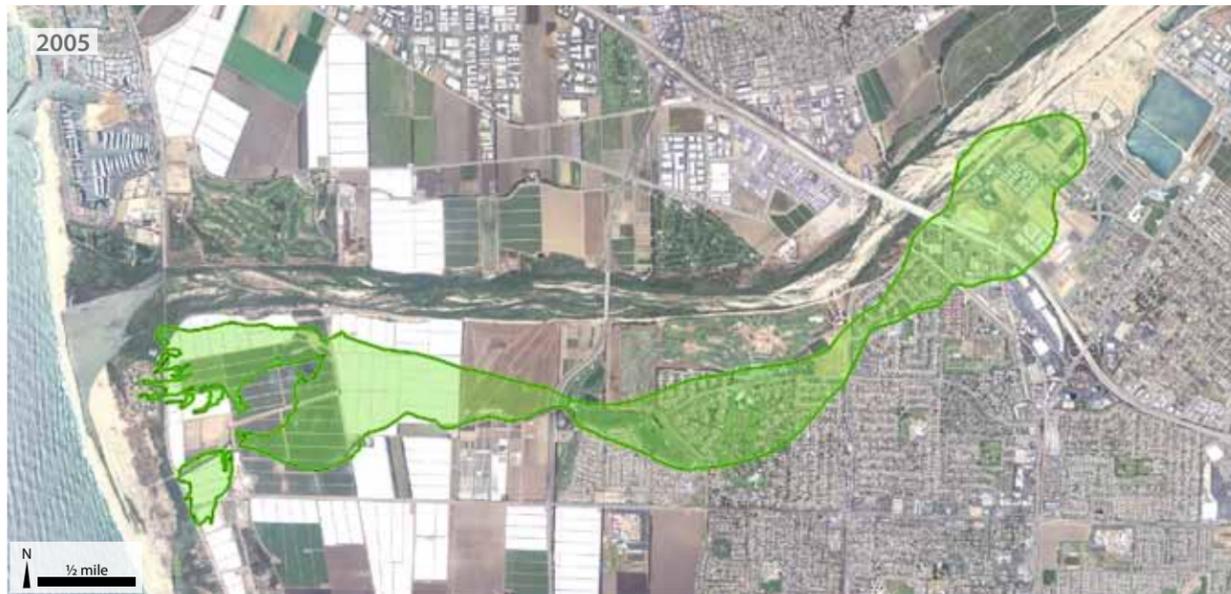
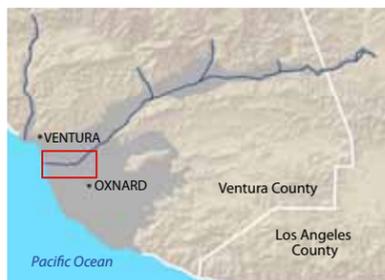
West Grove, historical extent

**Fig. 3.41. Lower Santa Clara river, 1927 (top) and 2005 (bottom).** By the 20th century, the majority of the original 1,200 acres of forest along the southern side of the Santa Clara River had disappeared. (Fairchild Aerial Surveys 1927, courtesy of Whittier College; USDA 2005)

While the forest had mostly disappeared by 1927, the outline of the low-disturbance bottomland is still visible on an aerial image. By 2005, nearly all traces of the forested area had disappeared into farmland, housing, a landfill, and golf course, and the area had been largely cut off from the river by a levee built by the Army Corps of Engineers in 1961 (Stillwater Sciences 2007b; see fig. 3.41).

The loss of vegetation is evident in a comparison of past and present willow-cottonwood forest below Highway 101 (near the river mouth), in the area formerly known as West Grove. This reach has been highly altered by floodplain development and constricted by levee construction, resulting in the near-complete loss of the most extensive historical grove of willow-cottonwood forest (approximately 1,200 acres; fig. 3.41). Near Fillmore, most of the 340 acre Cienega has also been converted to agriculture, though it clearly still experiences high groundwater levels (fig. 3.42). The riparian corridor is further threatened by the introduction of non-native plants, with the greatest threat currently posed by the extensive invasion of *Arundo* throughout the lower river.

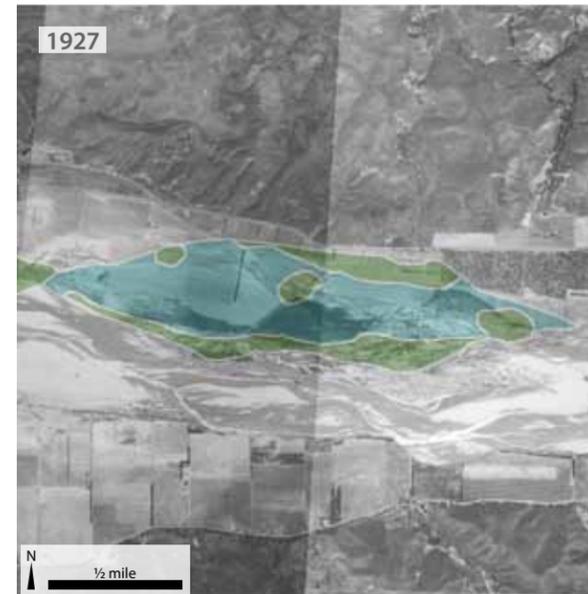
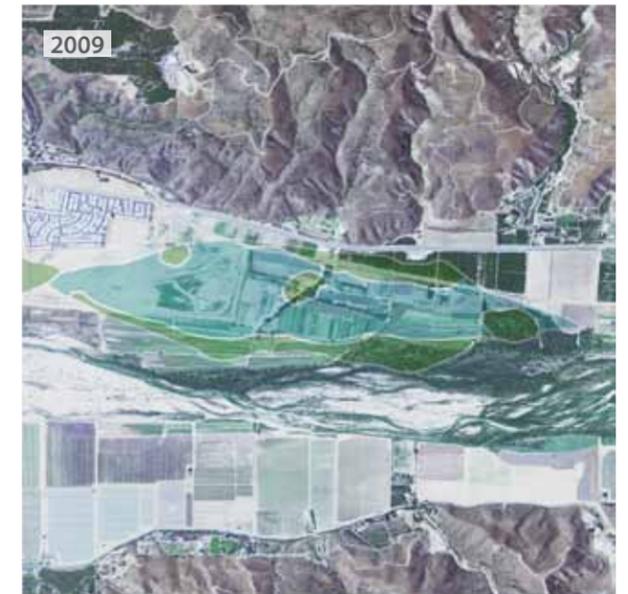
**Fig. 3.42. Cienega, 1927 (left) and 2009 (right).** As early as 1927, most of the original extent of the Cienega had been cleared. The former Cienega site is now the location of the Fillmore Fish Hatchery and crops tolerant of high groundwater conditions (e.g., watercress). Very little of the original Cienega extent remains, though substantial forest is found in the river corridor to the south. (Fairchild Aerial Surveys 1927, courtesy of Whittier College; USDA 2009)

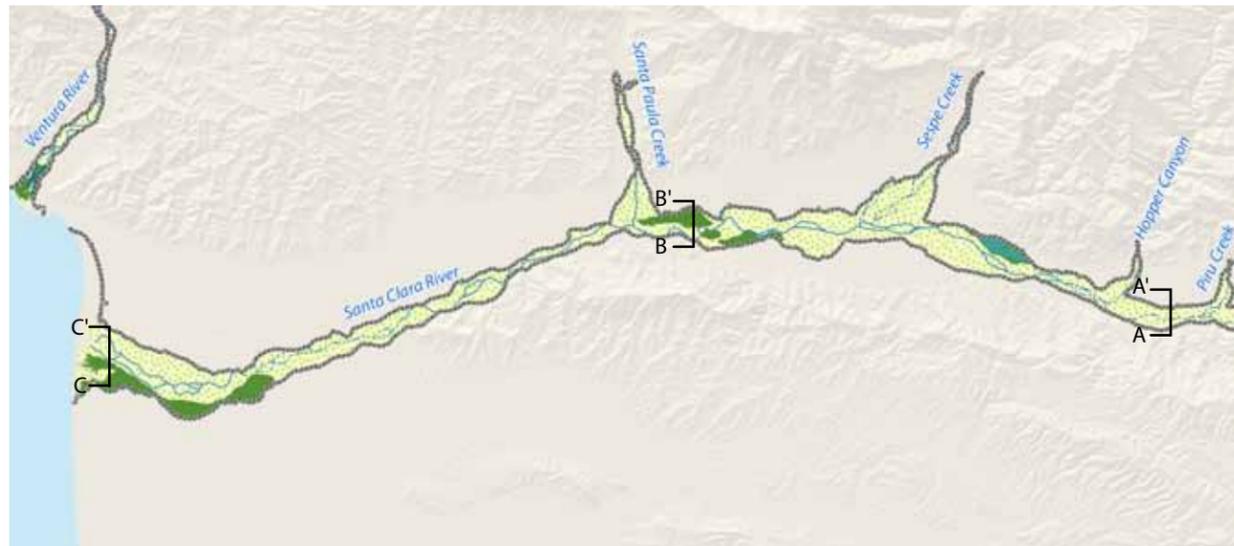
**Fig. 3.44. Locations of illustrated cross sections on Santa Clara River.** The easternmost reach is just downstream of the Piru confluence, and is characterized by intermittent flow and sparse, scrubby vegetation. The middle reach is just upstream of the town of Santa Paula, an area of rising groundwater historically characterized by multiple channels and marshes bounded by willow-cottonwood forests. The westernmost cross-section depicts the mouth of the river. This area has changed from a broad deltaic formation with seasonal lagoons surrounded by grasses and willow-cottonwood forest to a narrow single-thread channel with levees protecting a golf course on the north bank and agricultural operations on the south.

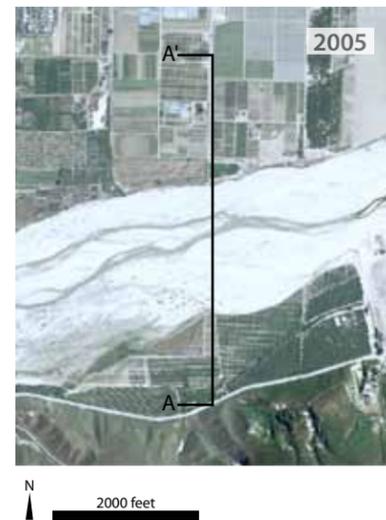
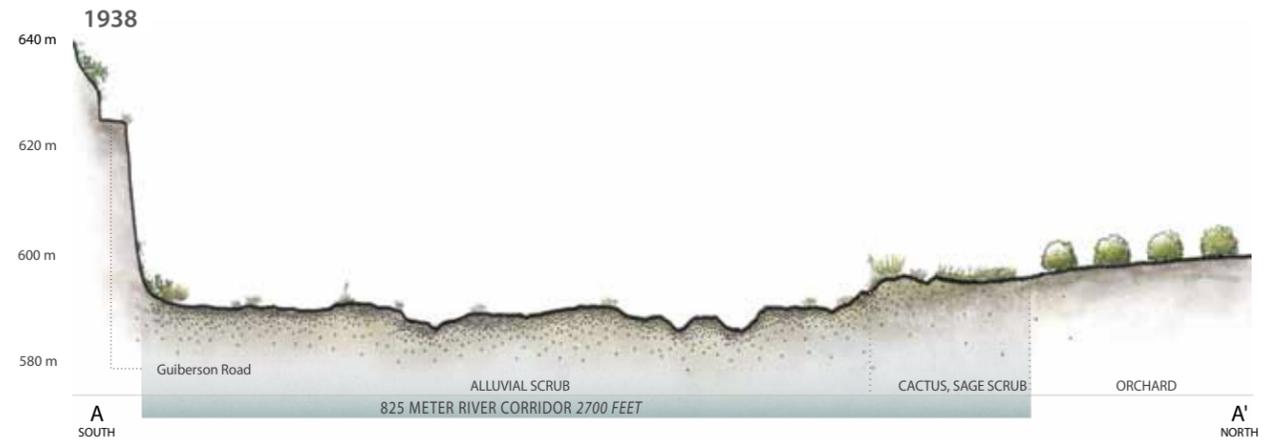
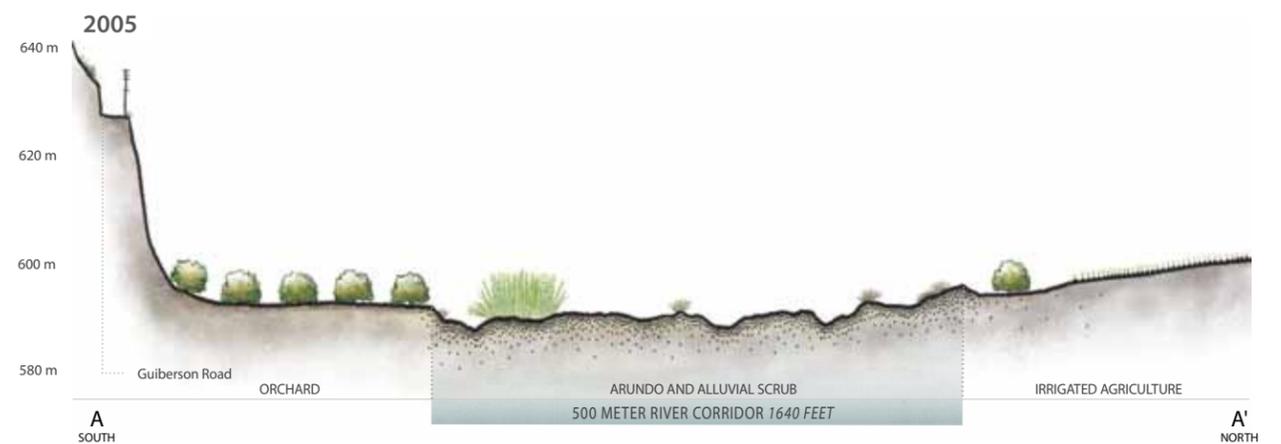
**Fig. 3.45. Historical cross-sections at Piru, 1874-2005.** This series shows the Santa Clara River west of Piru, between Piru Creek and Hopper Canyon. This intermittent reach was characterized by a broad active channel dominated by sand and scrub vegetation. Similar hydrology and vegetation persist today, though *Arundo* is now present and the river corridor has narrowed due to agricultural development on the floodplain. Cross-sections are drawn with 5x vertical exaggeration. (Craven 1874f; USDA 1938, courtesy of Ventura County; USDA 2005; Stillwater Sciences and URS Corporation 2007. Cross-sections produced by Jen Natali)

Though the river corridor maintained most of its width between 1874 and 1938, aerial photography reveals several distinct changes. Most notably, the scrub recorded in Craven’s 19th century survey notes had been cleared and replaced by orchard plantings, though limited xeric vegetation remained and washy arcuate patterns in the aerial image indicate that the plot was either recently ploughed or recently flooded.

Similar hydrology and vegetation persist today, though invasive giant reed (*Arundo donax* or *Arundo*) is now present and the river corridor has narrowed due to agricultural development on the floodplain. Between 1938 and 2005, the most drastic change was the addition of orchards on the south bank between Guiberson Road and the active channel, resulting in the constriction of river corridor width by 43% from 1874. The riverbed remains sandy and actively scoured, with some alluvial scrub and *Arundo* in 2005. Orchards and nurseries continue to occupy the right side of the river.
