## **HISTORICAL ECOLOGY of the lower Santa Clara River, Ventura River, and Oxnard Plain: an analysis of terrestrial, riverine, and coastal habitats**

HISTORICAL ECOLOGY PROGRAM  
CONTRIBUTION NO. 641 • AUGUST 2011

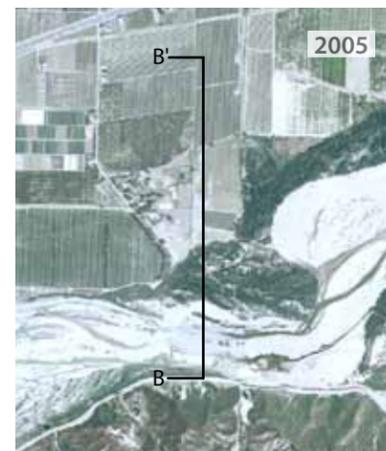
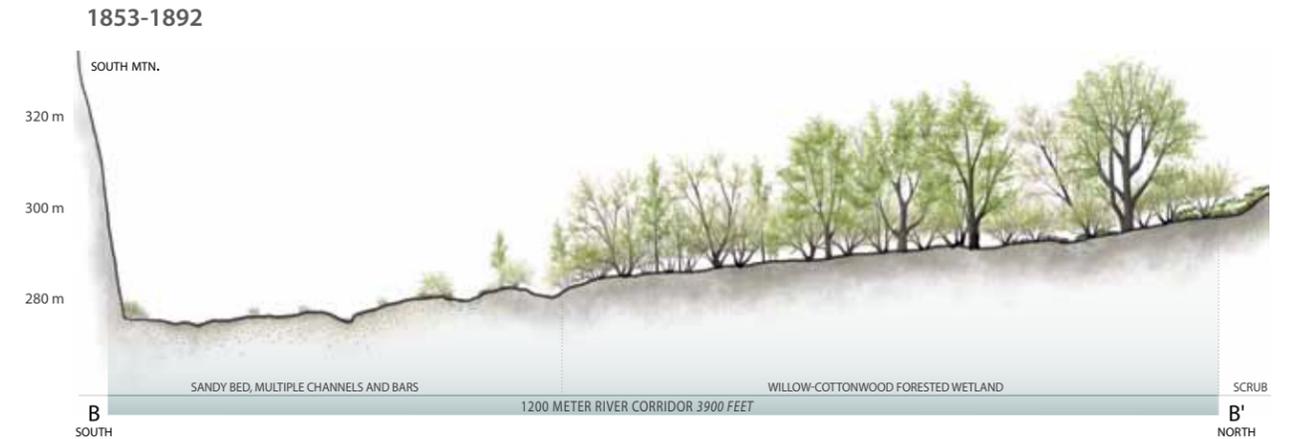
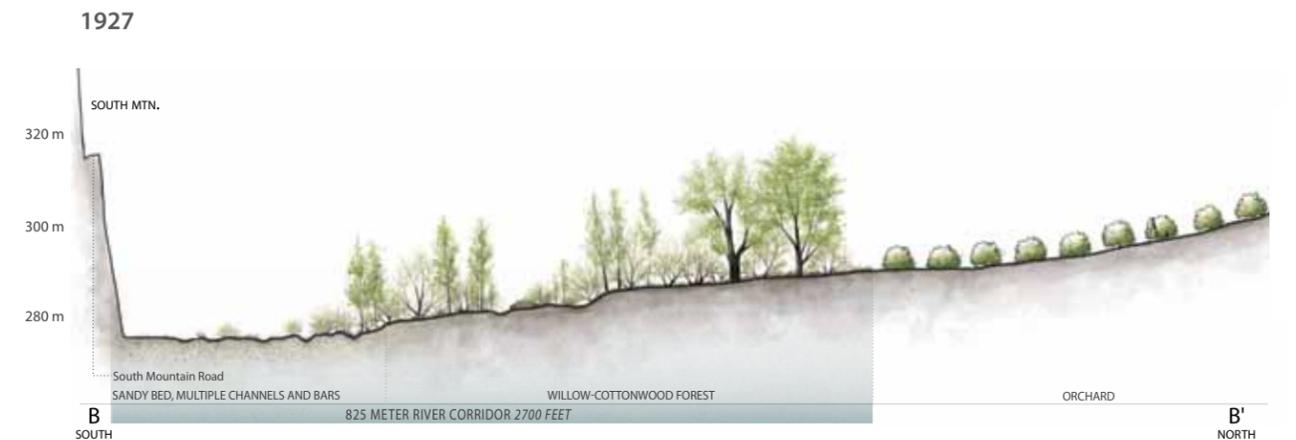
**Fig. 3.46. Historical cross-sections at Santa Paula, 1853-2005.** This series of cross-sections shows the Santa Clara River east of the Santa Paula Creek confluence, where the south bank of the river abuts South Mountain. The transect is in a perennial reach of rising groundwater, characterized in the 19th century by extensive willow-cottonwood forests and freshwater wetlands. Substantial willow-cottonwood forest remains in the area today, though much diminished from former extent. The earliest cross-section is derived from a composite of GLO surveys spanning the second half of the 19th century. Cross-sections are drawn with 5x vertical exaggeration. (Norris 1853; Hoffman 1868b; Thompson 1869; Barry 1892a; Fairchild Aerial Surveys 1927, courtesy of Whittier College; USDA 2005; Stillwater Sciences and URS Corporation 2007. Cross-sections produced by Jen Natali)

By the time the 1927 aerial photos were taken, some of the cottonwood and willow forest had been cleared and drained, and replaced with bottomland farms and orchards. Substantial dense riparian forest remained, though the river corridor width shrunk by just over 30%.

By 2005, the formerly 3,900 foot wide river corridor had been constrained to about 1,600 feet across, an overall loss of 58%. Orchards and other agricultural developments have replaced much of the former forest.

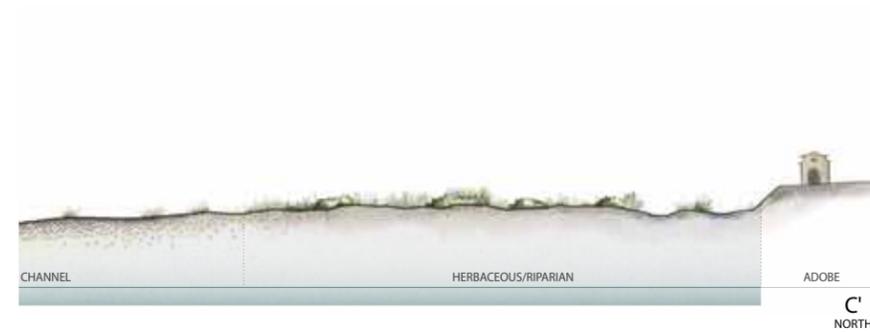
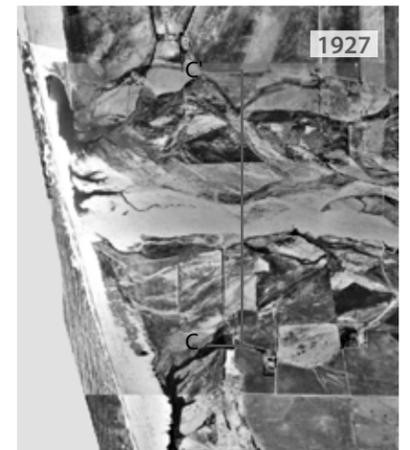
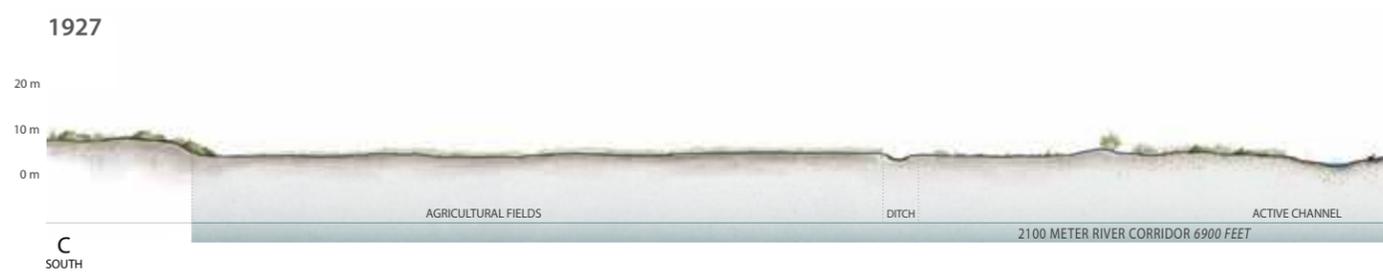
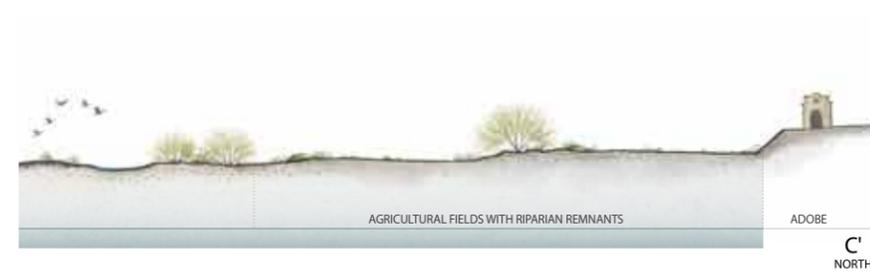
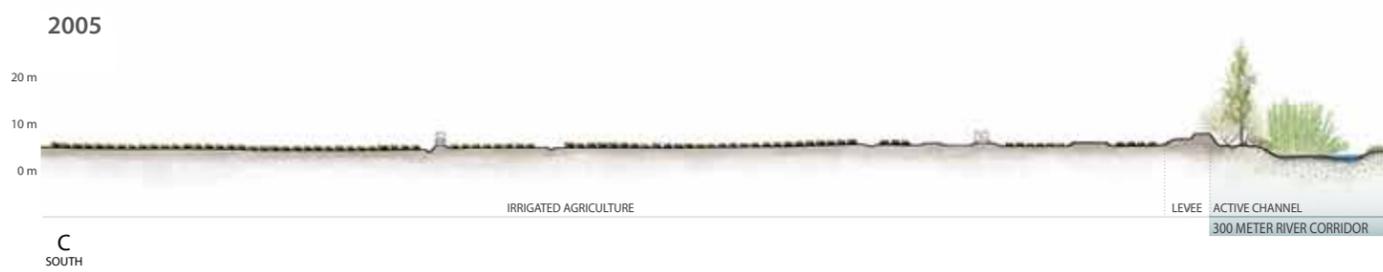
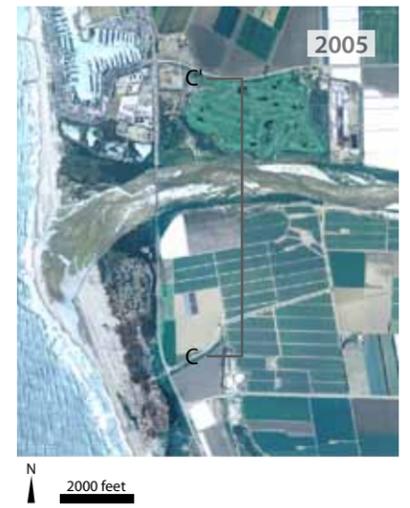
**Fig. 3.47. Historical cross-sections at the Santa Clara River mouth, 1855-2005.** This time series shows the Santa Clara River at its mouth, about 3.5 miles downstream from the Highway 101 bridge. A large willow-cottonwood forest and wetland complex dominated the left bank (south side) of the river from above the bridge all the way to the river mouth, a distance of over four miles. Very little of this once-expansive forest remains today. The earliest cross-section is derived from GLO notes and the mid-19th century T-sheet drawn for the river mouth by the U.S. Coast Survey. Cross-sections are drawn with 5x vertical exaggeration. (Hancock 1854; Johnson 1855c, courtesy of the National Oceanographic and Atmospheric Administration; Fairchild Aerial Surveys 1927, courtesy of Whittier College; USDA 2005; Stillwater Sciences and URS Corporation 2007. Cross-sections produced by Jen Natali)

Over 70 years later, in 1927, most of West Grove had been cleared for agriculture. Broad floodplain areas on both sides of the active channel were subdivided into farmland, and irrigation ditches and levees are evident. However, patterns visible on the aerial affirm that much of this area (particularly on the south side) continued to be regularly flooded. By 2005 levees bound the river, including a levee on the south side of the river originally built by the Army Corps in 1961 (Stillwater Sciences 2007b). Levees and land use constrain the formerly 6,900 foot wide river to a 1,000 foot corridor. Intensive agriculture and the Olivas Park golf course inhabit the former floodplain. Herbaceous cover, willow-cottonwood forest, and invasive *Arundo donax* flank the mainstem.

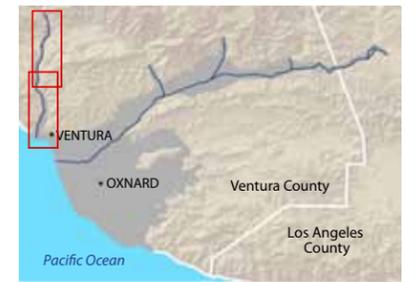
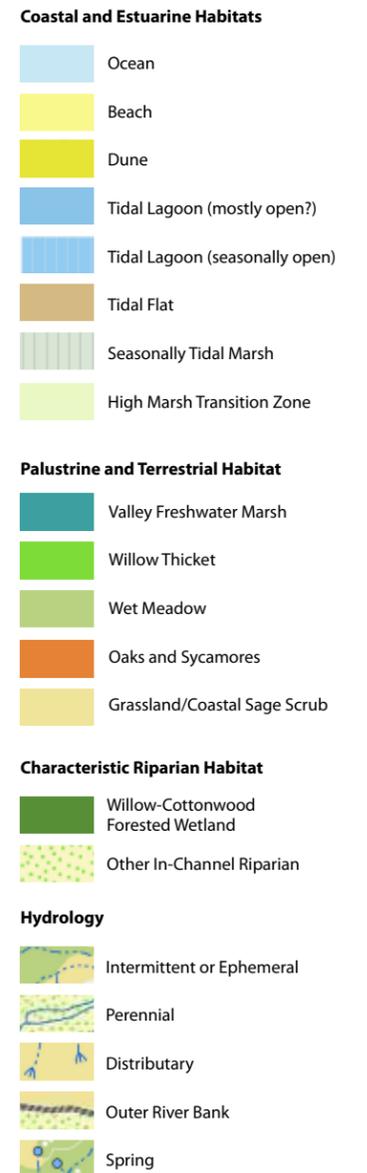
Legend for Fig. 4.3 (map on following page).

**Fig. 4.3. Historical habitats of the Ventura River valley, early 1800s.** The Ventura River corridor was broad, in places occupying a large proportion of the valley floor. Live oaks, sycamores, and scrub were prevalent in the upper valley, while grassland was more common in the lower valley.

We mapped three types of habitats on the Ventura valley floor: grassland/coastal sage scrub, oaks and sycamores, and valley freshwater marsh (fig. 4.3). Grassland/coastal sage scrub was the most prevalent habitat type. In contrast to the Santa Clara River valley, which was dominated by grassland/coastal sage scrub, our mapping suggests that oaks and sycamores composed a relatively high proportion of the Ventura River valley floor. Only one freshwater marsh (17 acres) was mapped in the project area, occupying a depression to the east of the Ventura River and demarcating a former route of the river.

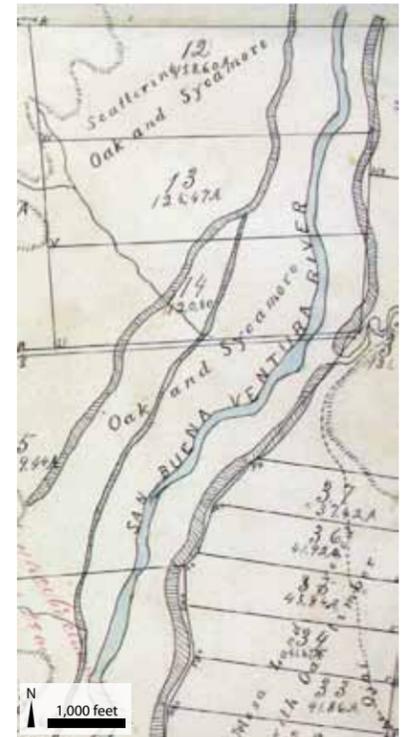
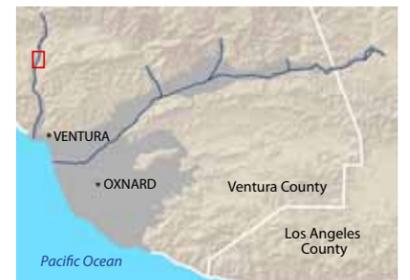
**Fig. 4.4. Ventura River in the vicinity of present day Oak View, 1876.** This late-1800s map depicts sycamores and oaks occupying the river corridor, as well as "scattering oak and sycamore" on the valley floor between the high bank and the scrub-covered mountains to the west. (Hare 1876, courtesy of the Ventura County Surveyor's Office)

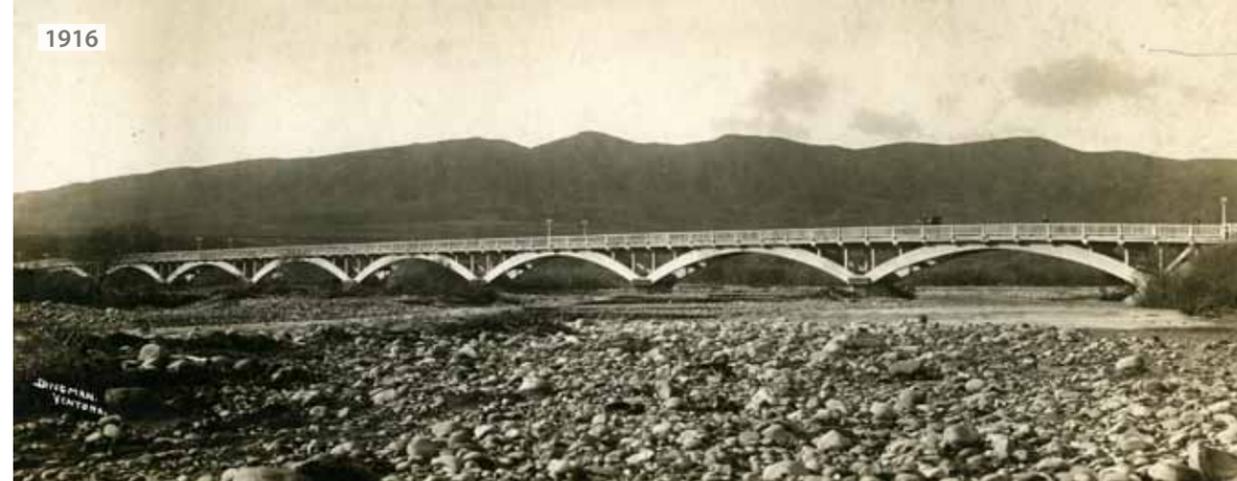
**Fig. 4.8.** These images of the Ventura River at Foster Park (top, ca. 1906) and at Main Street in Ventura (bottom, 1916) show the abundant cobbles and boulders characteristic of the river bed even nearly at the estuary. (Unknown ca. 1906, courtesy of Craig Held; Unknown 1916, courtesy of the Museum of Ventura County)

river show coarse substrate on the river bed (fig. 4.8). While some of these photographs were taken after floods and thus may somewhat overemphasize the relative proportion of cobbles and boulders to finer substrate, they still reveal an overall trend toward coarse bed material.

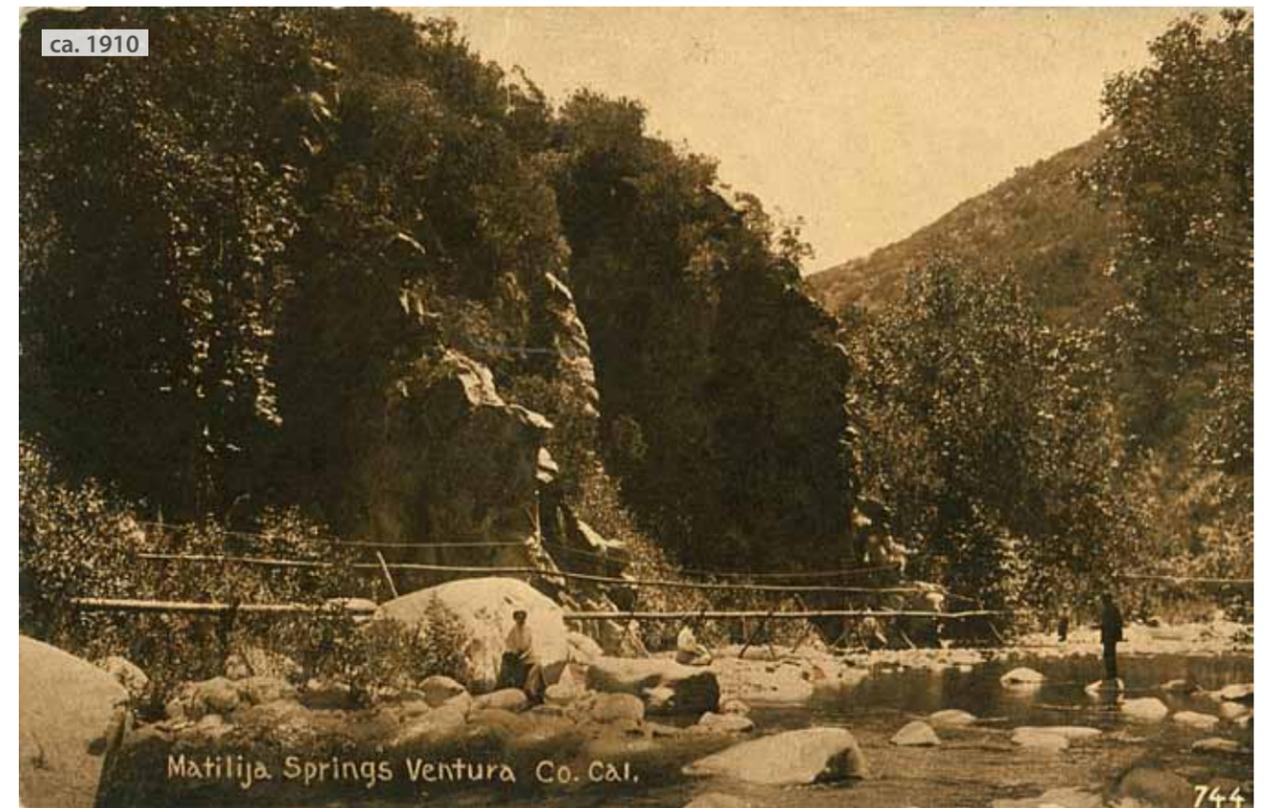
**Fig. 4.10. Two views of the upper Ventura River, ca. 1910.** These two postcards, both dating from the first years of the 20th century, show the boulder-filled channel of the river in lower Matilija Canyon. The photograph at top was taken at Matilija Hot Springs, just below Matilija dam. The photograph at right was taken less than a half mile downstream. Note the narrow fringe of mulefat, willow scrub, and trees (likely alder, cottonwood, and sycamore). (Unknown ca. 1910b, d)

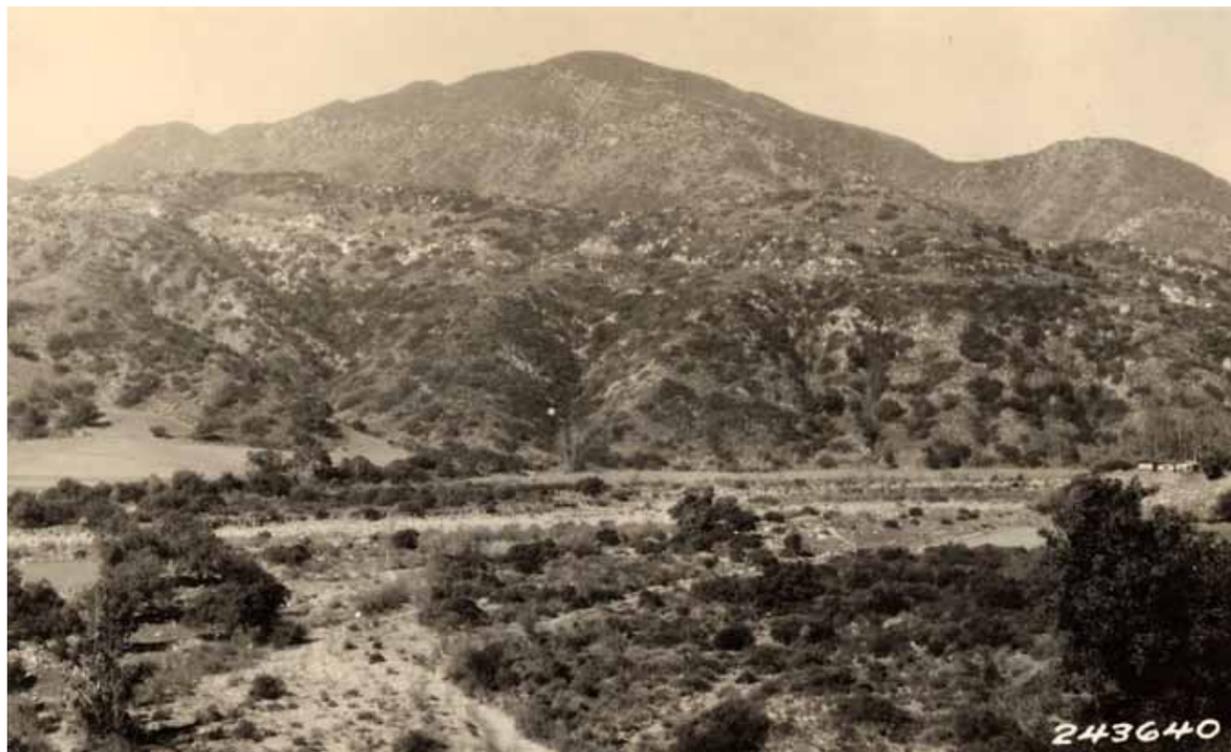
**Fig. 4.11.** “Looking west across Ventura River, mouth of Matilija Canyon,” February 1930. This photograph, part of the Wieslander Vegetation Type Mapping Project of the late 1920s and early 1930s, shows low scrub flanking riverwash along a shallow, broad channel in the intermittent reach of the river. It was taken approximately one mile below the mouth of Matilija canyon, looking west toward the site of the current Robles Diversion Dam (Capelli pers. comm.). (Clar 1930, courtesy of the Marian Koshland Bioscience and Natural Resources Library, UC Berkeley)

The presence of scrub and trees (overwhelmingly live oaks and sycamores) in this reach is described by a number of narrative and textual accounts. The upper portion of the reach, at the transition to a broad, washy river from Matilija Canyon, was especially commented upon (fig. 4.11). Sheridan (1886) described that the “river rushes out across a broad sycamore dotted flat” from the canyon, and Roberts (1886) described the river here as “overgrown with brush, sycamores, and oaks.” The early presence of oaks and sycamores is corroborated by GLO survey notes, which describe a “timbered bottom” and “bottom land with heavy oak & sycamore timber” (Norway 1877). The few GLO bearing trees documented in this reach also generally support this description (two live oaks 10 and 48 inches in diameter, and one sycamore 20 inches in diameter; Norway 1877).

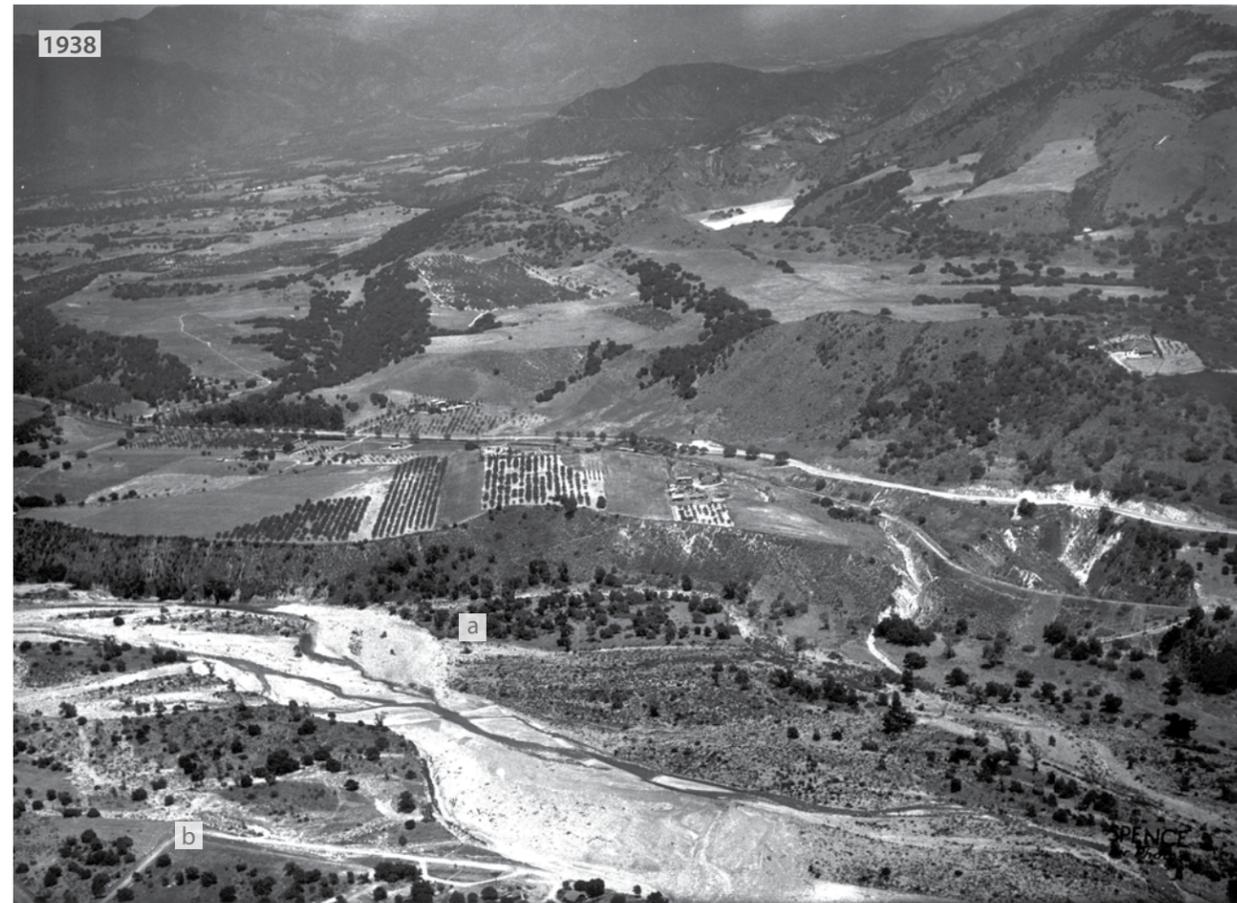
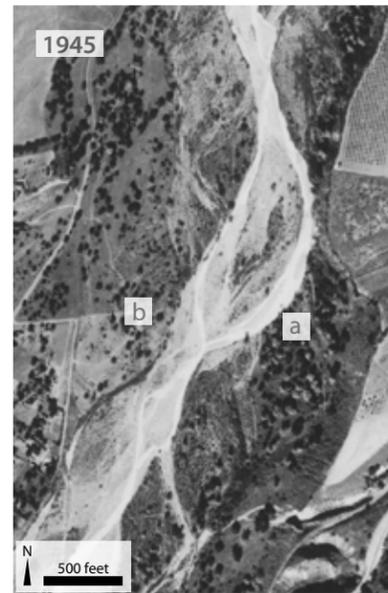
**Fig. 4.13. Ventura River at Live Oak Acres.** The oblique aerial photograph (top), taken in June 1938, shows characteristic riparian patterns in the Oak View reach. Sparsely vegetated riverwash composes the active channel, flanked by dense scrub on bottomlands. Further away from the active channel, more mature live oaks colonized higher river surfaces. Seven years later, the aerial photograph of the same place in 1945 (left) shows similar patterns of riverwash, scrub, and trees. (Spence Air Photos 1938, courtesy of the Benjamin and Gladys Thomas Air Photo Archives, UCLA Department of Geography; Ventura County 1945, courtesy of UCSB Map and Imagery Library)

Oaks (Hoffmann 1932b), and slender woolly buckwheat (*Eriogonum gracile*) and chaparral yucca (*Hesperoyucca whipplei*) were collected in the river near Oak View (Pollard 1963a, 1969). Mulefat was also documented (*Baccharis salicifolia*; Pollard 1944). These records imply the presence of alluvial scrub; it is likely that a mixture of willow and alluvial scrub was present through this reach (fig. 4.13).

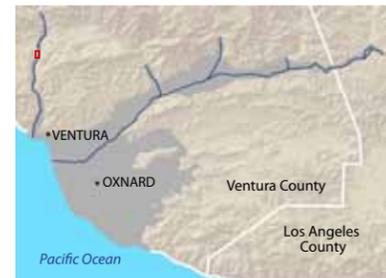
**Fig. 4.14. Dense riparian corridor along the Ventura River, ca. 1840.** An early depiction of the Ventura River for three miles below Foster Park shows continuous riparian forest flanking the river, of variable—and in many places, substantial—width. A small area of oaks is shown along one portion of the river (below the “I”); the small check marks that line the river are interpreted as mixed riparian forest. (U.S. District Court ca. 1840b, courtesy of The Bancroft Library, UC Berkeley)

Strongly supporting the concept of dense riparian forest in this reach, an 1840s *diseño* of the Cañada Larga ranch shows a continuous riparian corridor stretching the three miles from near Foster Park to Gosnell Hill/Cañada de San Joaquin (fig. 4.14). The riparian corridor is shown of variable width, including a short reach of oaks south of Cañada Larga and a lot of other trees (interpreted as willow-cottonwood forest). This map is supported by

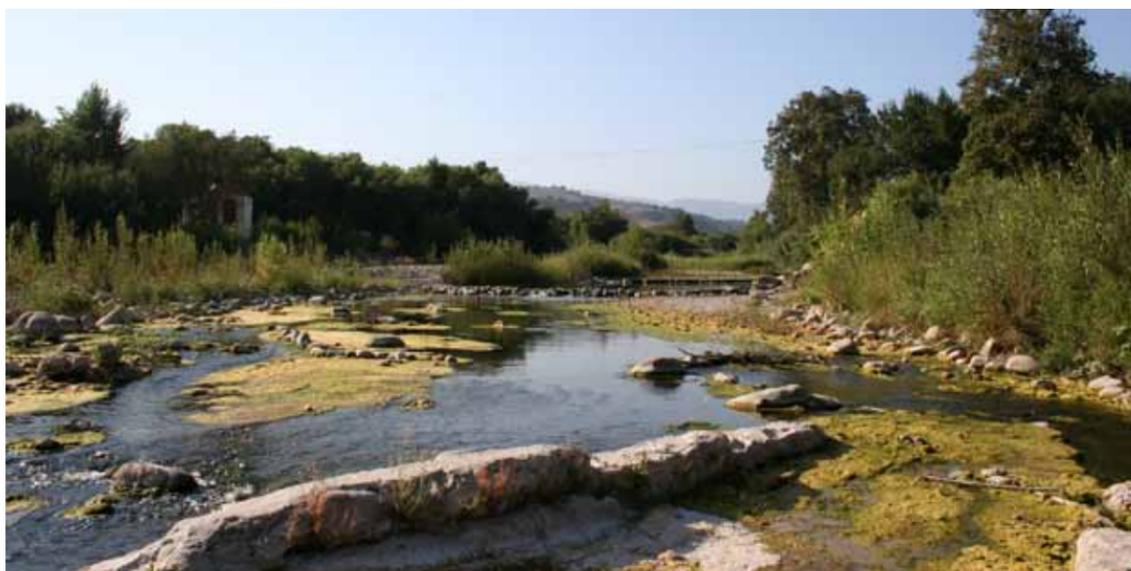
**Fig. 4.15. Ventura River at Foster Park looking north from the bridge, July 2008.** Cottonwoods and willows flank the river, and willows, mulefat, and *Arundo* colonize coarse bars and islands.

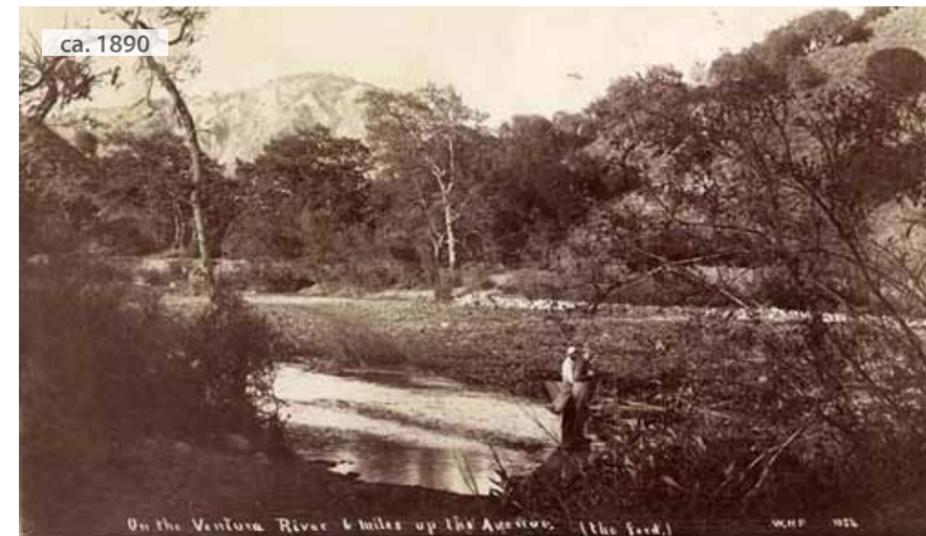
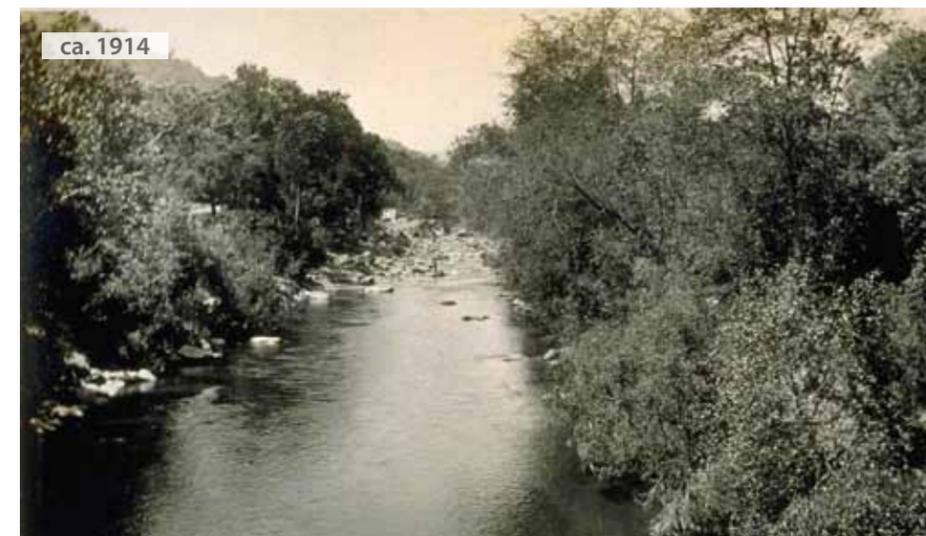
**Figure 4.16. Three images of riparian vegetation near Foster Park/Casitas, ca. 1890-1914.** Top: “On the Ventura River 6 miles up the Avenue (the ford),” ca. 1890. Middle: “Looking up Ventura River from the Bridge,” ca. 1914. Bottom: “Casitas – View of Ventura River Crossing,” ca. 1914. These images show three versions of the riparian corridor in the vicinity of Foster Park, including sycamore, live oak, willow, cottonwood, and alder. (Fletcher ca. 1890, courtesy of the California State Library; Unknown ca. 1914a and 1914b, courtesy of The Bancroft Library, UC Berkeley)

Within the lower perennial reach of the Ventura River, Foster Park was particularly noted and admired for its riparian trees. The park, created in 1908, is the site of many of the historical data describing the Ventura River, including photographs, specimen records, and textual descriptions. According to one historian, the Foster Park area had been used by both Chumash and Mission fathers (Sheridan 1926). Images of this area show thick stands of trees and scrub growing over cobbles along the river, similar to today (figs. 4.15, 4.16).

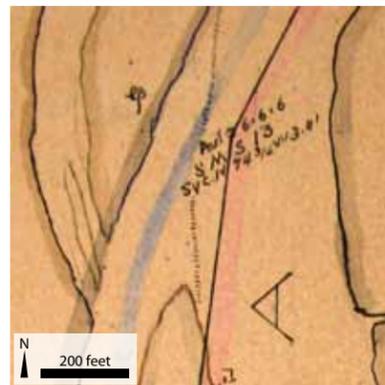
**Fig. 4.18. Sycamore on island in the Ventura River, 1894.** West of lower Ventura Avenue (and just above the persistent wetland riparian area at the river mouth), this small depiction shows a 24 inch diameter sycamore above the active channel of the river. (Barry 1894, courtesy of the Ventura County Surveyor's Office)

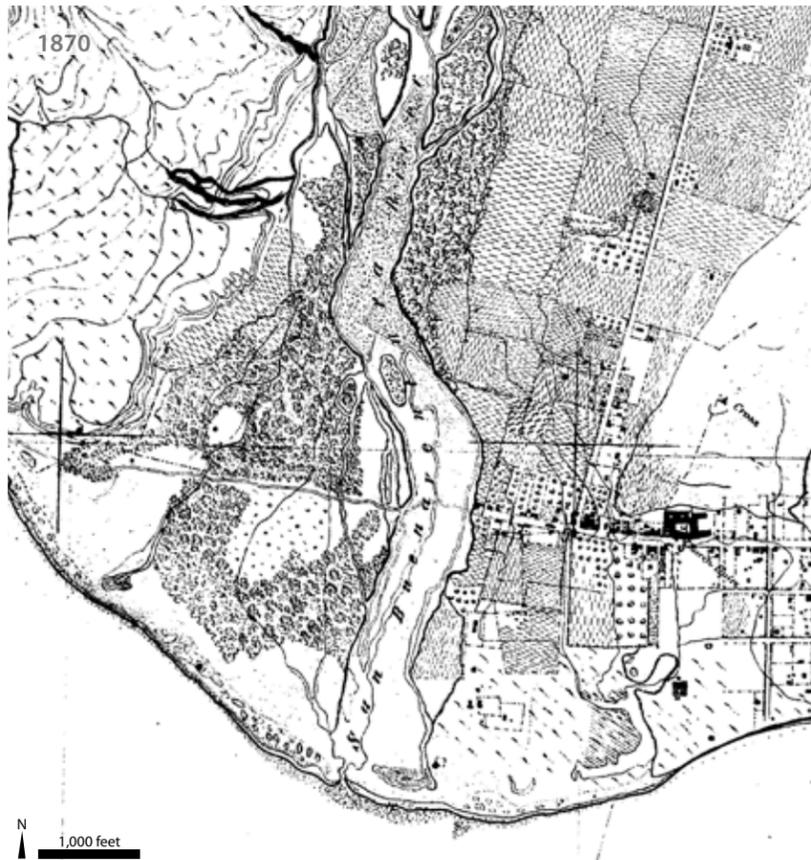
**Fig. 4.20. Riparian forest at the mouth of the Ventura River, 1855 and 1870.** While the initial survey of the Ventura River mouth by the U.S. Coast Survey (top right) provides evidence of the extent of willow-cottonwood forest at the mouth of the river, the re-survey 15 years later (bottom right) shows that, although trees have been scoured near the main channel, the feature transcended the floods of 1861-2. Dense trees near the mouth of the river taper towards the northern edge of the map. (The freshwater wetland marking a former river route can be seen on the earlier map just north of the nascent city of San Buenaventura; it was almost completely gone by 1870.) (Johnson 1855c, Greenwell and Forney 1870; courtesy of NOAA)

The most persuasive evidence, however, comes from an early T-sheet and resurvey depicting vegetation at the river mouth (Johnson 1855c, Greenwell and Forney 1870; figs. 4.19, 4.20). Since these maps bracket the huge floods of 1861-2, they offer significant evidence of the feature’s resilience over time. For a detailed discussion of more recent ecological characteristics of the Ventura River mouth and estuary, see Ferren et al. (1990).

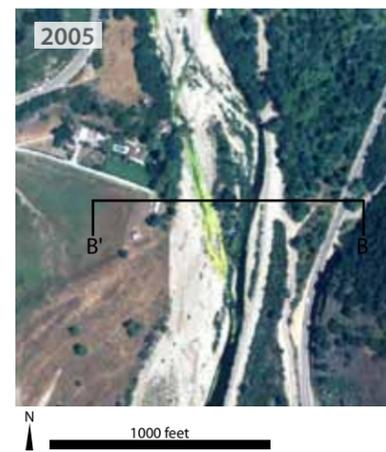
**Fig. 4.24. Historical cross-sections at Casitas, 1877-2005.** This series of cross-sections shows the Ventura River south of the San Antonio Creek confluence. The transect is in a reach with perennial flow, a relatively narrow river corridor (in comparison to other reaches of the river), and historically abundant live oak and sycamore. Like the Meiners Oaks reach to the north, this reach has retained many of its historical characteristics. Cross-sections are drawn with 5x vertical exaggeration. (Norway 1877; USDA 1945, courtesy of the UC Santa Barbara Map and Imagery Library; USDA 2005. Cross-sections produced by Jen Natali)

On August 3 and 4, 1877, surveyor W.H. Norway walked this transect; his survey forms the basis of the earliest cross section. Norway described the active channel as “riverwash” 460 feet wide, with a low-flow channel 16 feet wide carrying summer water toward the ocean. (This is especially notable given that 1877 was a severe drought year in the region.) On the eastern side of the river between the active channel and the hills, he noted “heavy oak & sycamore timber” on the “bottomland” surface. He also documented early modifications, including the wagon road connecting Ventura and Ojai and paralleling the river on the western side, and a fence separating agricultural fields from the river on the west bank.

Surprisingly, aerial photos from 1945 show evidently little change in riparian composition and river corridor extent from the snapshot provided by Norway in the late 1870s. The wagon road route remained, replaced by a branch line of the Southern Pacific Railroad. Broad, dense riparian forest still characterized the eastern bank. The most severe modifications occurred in the second half of the 20th century, when a levee on the west bank was constructed and the wagon road remnant transformed into several highways, including Highway 33 and the Ojai Valley Trail Road. Significant riparian forest (willows near the channel, and oaks and sycamores on the eastern floodplain) remains, though it is bisected by the Ojai Valley Trail and Highway 33.

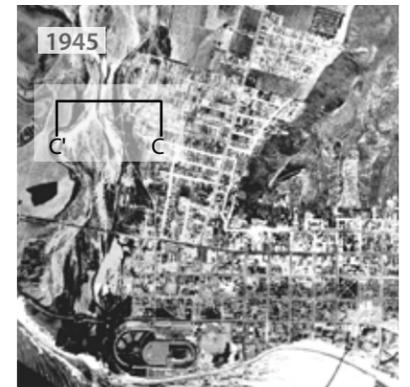
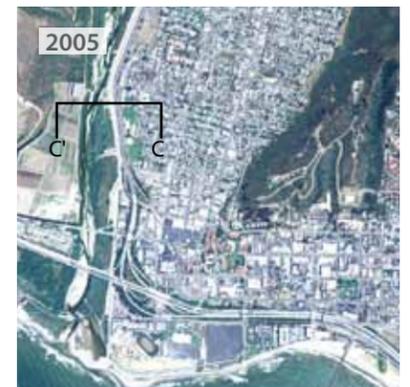
**Fig. 4.25. Historical cross-sections at the Ventura River mouth, 1853-2005.** This time series shows the Ventura River at its mouth, about ½ mile upstream from the Highway 101 bridge. The area was dominated by broad willow-cottonwood forest and shallow, multi-thread distributary channels. By the early 20th century, the floodplain had been converted into a much narrower, leveed channel to make way for northward expansion from the town of Ventura. The earliest cross-section is derived from GLO notes and the mid-19th century T-sheet drawn of the river mouth by the U.S. Coast Survey. Cross-sections are drawn with 5x vertical exaggeration. (Norris 1853, Johnson 1855c, courtesy of the National Oceanographic and Atmospheric Administration; Fairchild Aerial Surveys 1927, courtesy of Whittier College; USDA 2005. Cross-sections produced by Jen Natali)

river corridor. This may be a snapshot of a post-flood period of rebuilding, or it may be the beginning of a rapid urbanization of the lower watershed. By 2005, the city of Ventura had expanded fully into the floodplain of the river, fortified by a levee and bounded by the Ojai Freeway. *Arundo donax* has established on both sides of the narrowed river corridor; it was described as “well established for many miles along the river” as early as 1945 (Henry Pollard, in Ferren et al. 1990). Industrial agriculture and nurseries have replaced pasture on the west bank of the river.

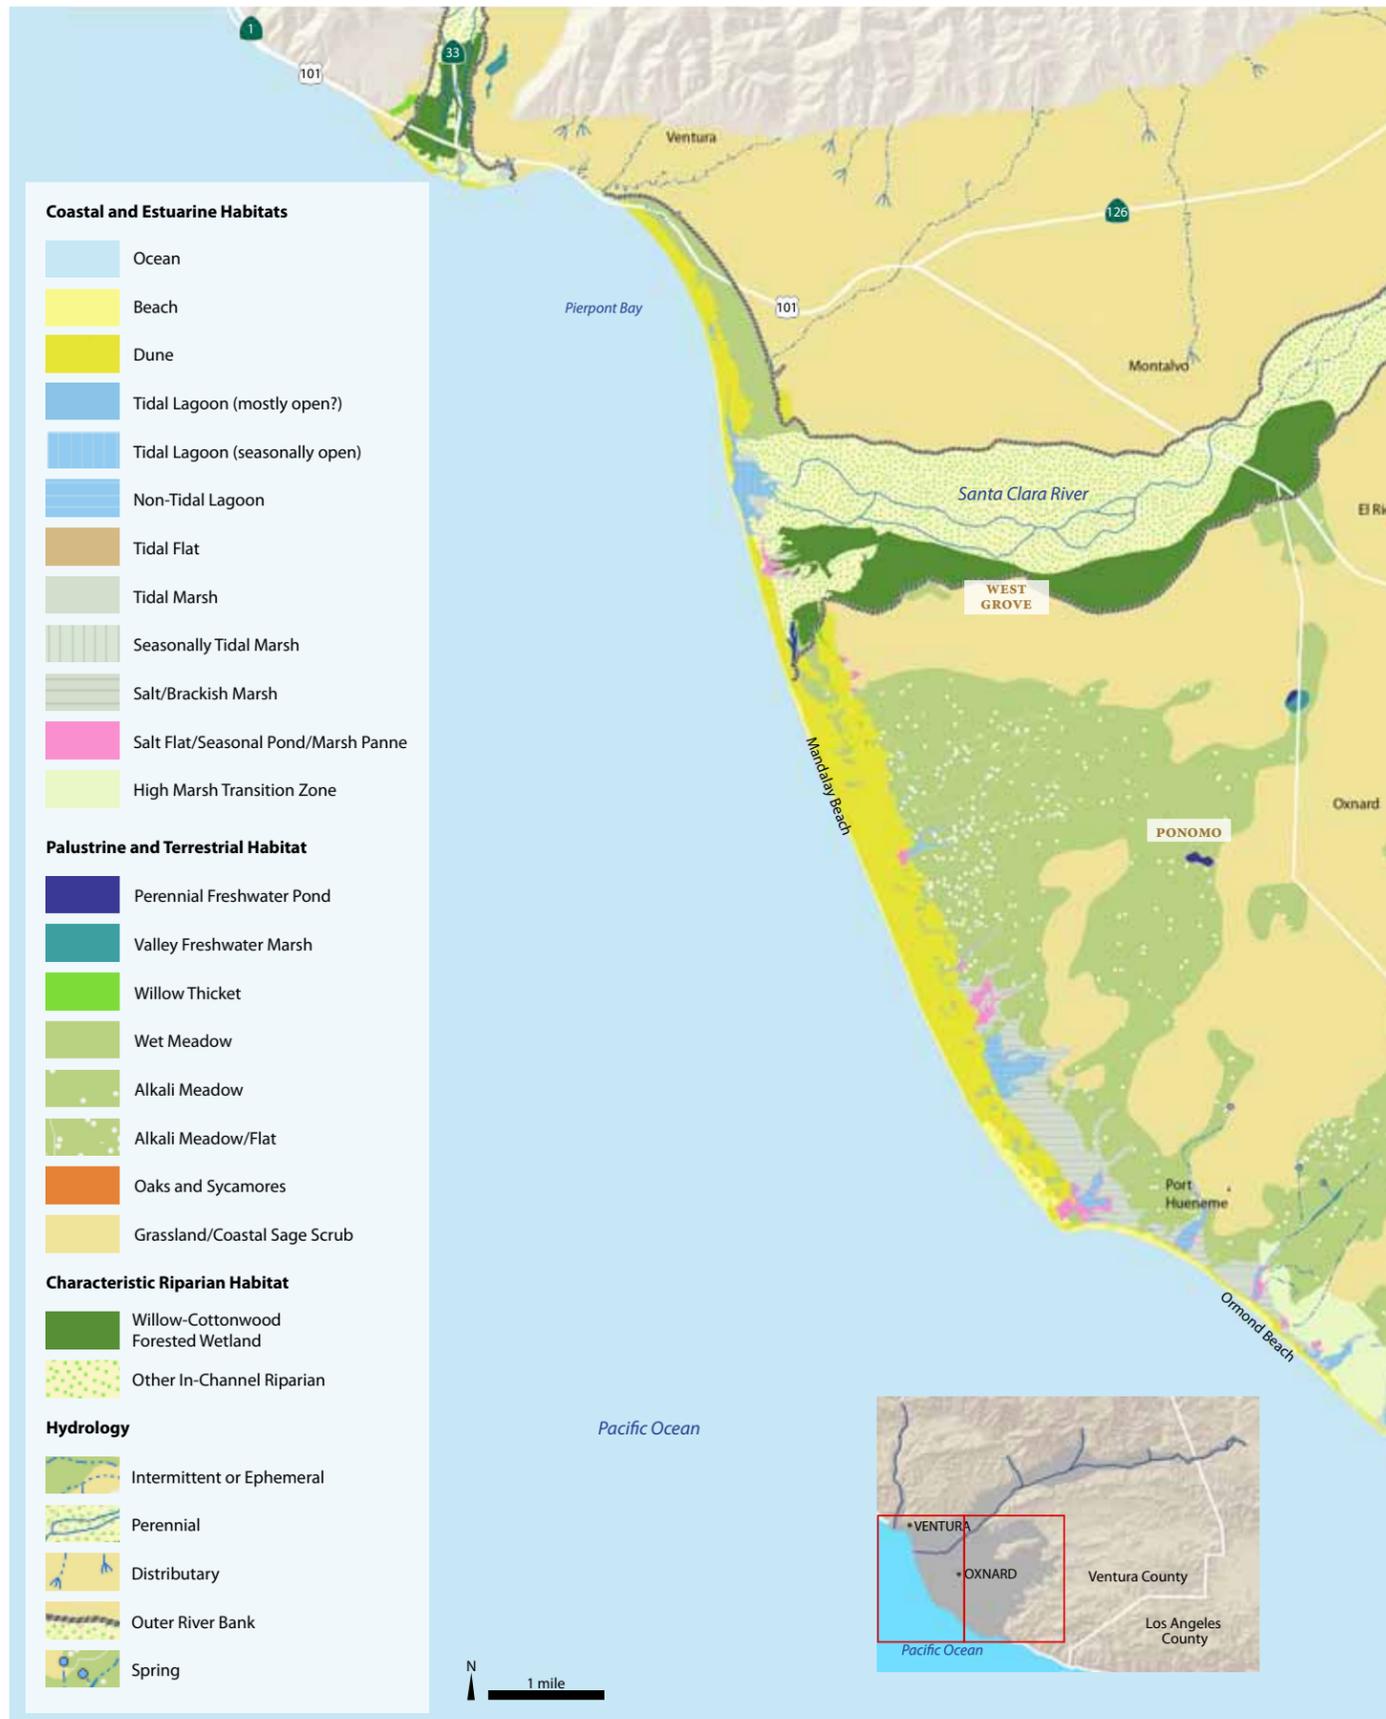
**Fig. 5.2. Historical habitats of the Oxnard Plain, early 1800s.** Alkali meadows, alkali flats, and tidal habitats occupy the lowest topography of the plain, and were formed from both tidal flows and seasonal evaporation. Freshwater inputs to the plain as precipitation, creek flow, and springs created zones of freshwater influence in the form of freshwater marshes and ponds, such as along the margin of the Santa Monica Mountains. Lastly, broad natural levees marking former routes of the Santa Clara River created higher zones of grassland and coastal sage scrub to the west of the Camarillo Hills. These mosaics intersected the shoreline habitats discussed in the next chapter.

The Oxnard Plain is a remarkably flat (under 1% slope), broad, surface, with 111 square miles sloping very gently from the hills to the coastline. With further examination, the plain reveals subtle variations in topography, soils, and hydrology that supported diverse natural habitats (fig. 5.2). We discuss these overarching factors broadly below.

Though low-lying alkali meadow lands dominated much of the Oxnard Plain, higher, better-drained dryland habitats predominated on the northeastern plain (around the Camarillo Hills) and in broad fingers stretching south from the Santa Clara River, including El Rio and much of present-day Oxnard (see fig. 5.2). These coarser, higher deposits south of the river were built up by the Santa Clara River itself, and mark former courses of the river from a time when its outlet was near Mugu Lagoon or, more recently, Point Hueneme.

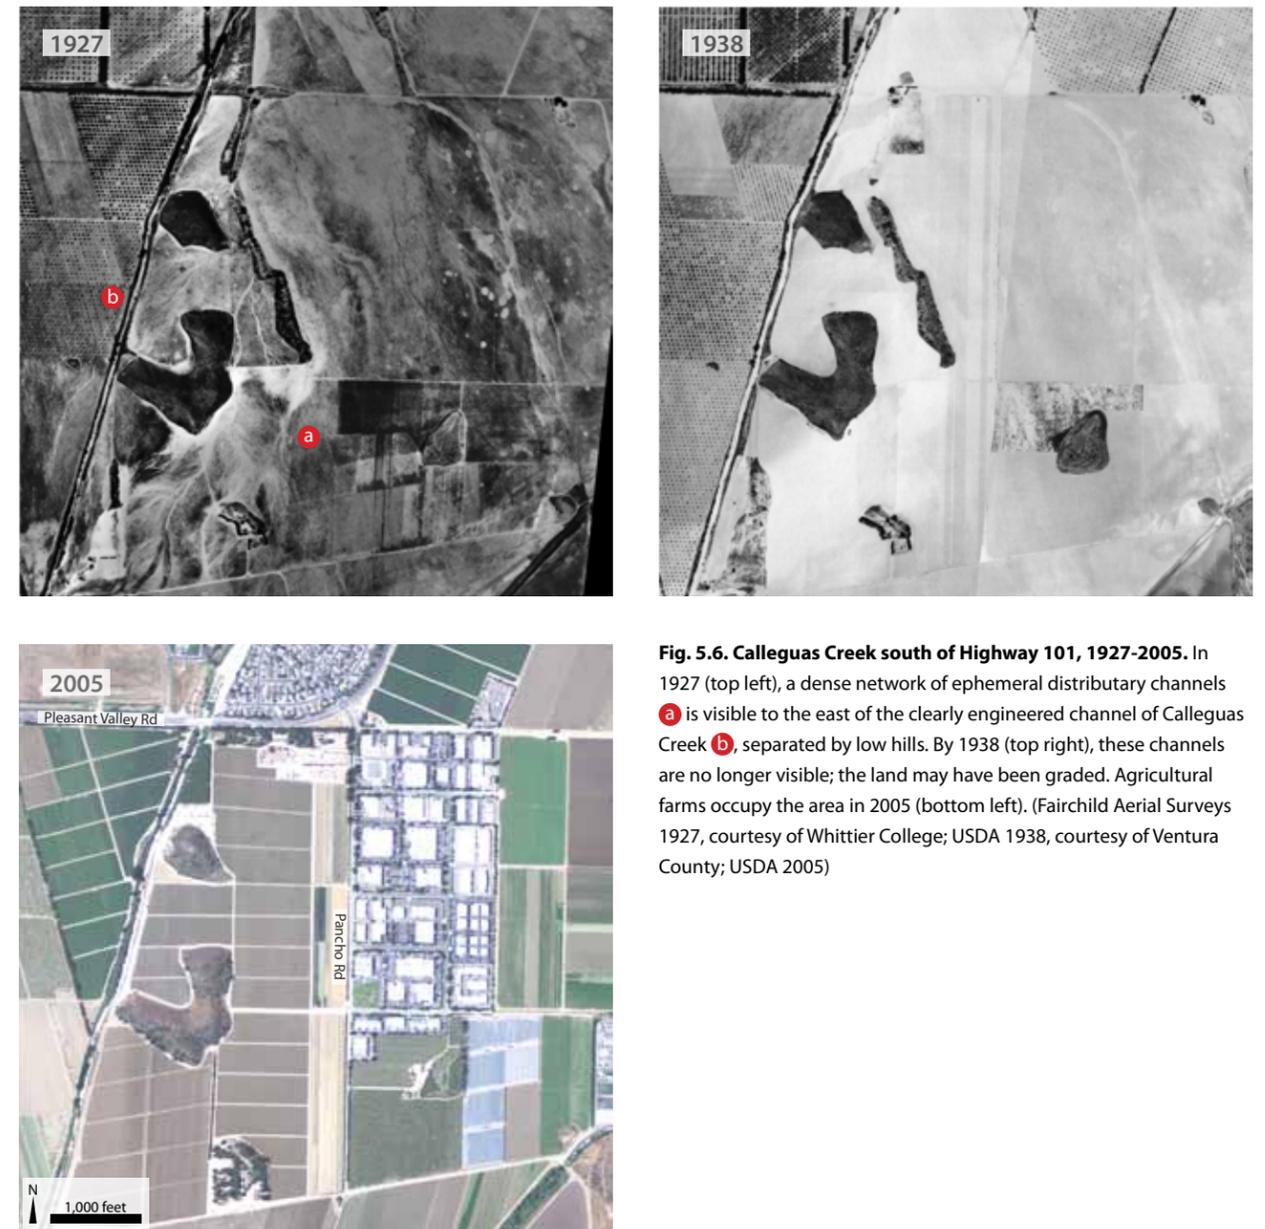
**Fig. 5.6. Calleguas Creek south of Highway 101, 1927-2005.** In 1927 (top left), a dense network of ephemeral distributary channels **a** is visible to the east of the clearly engineered channel of Calleguas Creek **b**, separated by low hills. By 1938 (top right), these channels are no longer visible; the land may have been graded. Agricultural farms occupy the area in 2005 (bottom left). (Fairchild Aerial Surveys 1927, courtesy of Whittier College; USDA 1938, courtesy of Ventura County; USDA 2005)

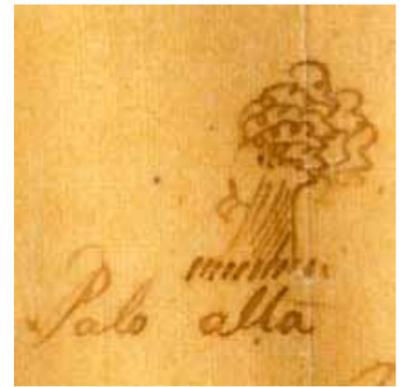
**Fig. 5.9. Lone sycamore tree on the Oxnard Plain near Camarillo, ca. 1840.** This was one of the few large trees on the eastern Oxnard Plain. It was used as a lookout in the 19th century by ranchers looking for their lost cattle. By the early 20th century, it had been cut down. (U.S. District Court ca. 1840e, courtesy of The Bancroft Library, UC Berkeley)

On the eastern side of the Oxnard Plain near Camarillo, one sycamore in particular was recognized as an important feature: the Palo Alto (fig. 5.9). The Palo Alto, or tall tree, was the name of a lone sycamore near Camarillo.

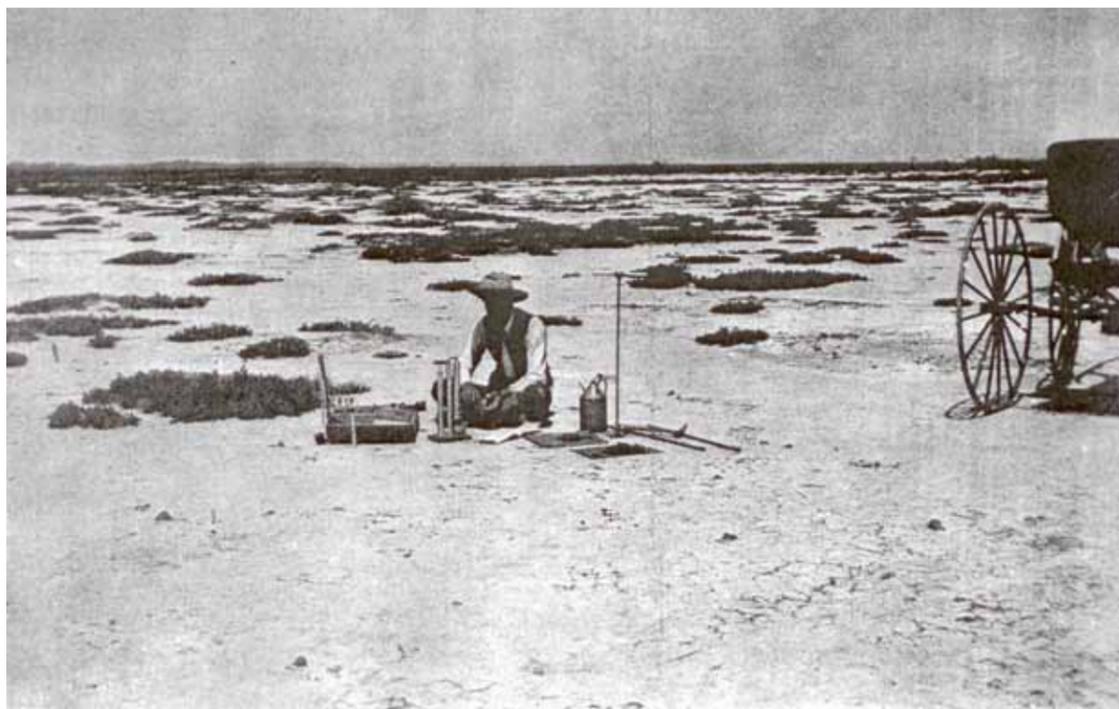
**Fig. 5.12. “Alkali flat in the Delta portion of the Ventura area,” ca. 1901.** This turn of the century photograph of the Oxnard Plain shows what the soil survey terms “alkali flat,” a region with >1% alkalinity. Some alkali vegetation is shown among substantial bare, cracked ground. (Holmes and Mesmer 1901c)

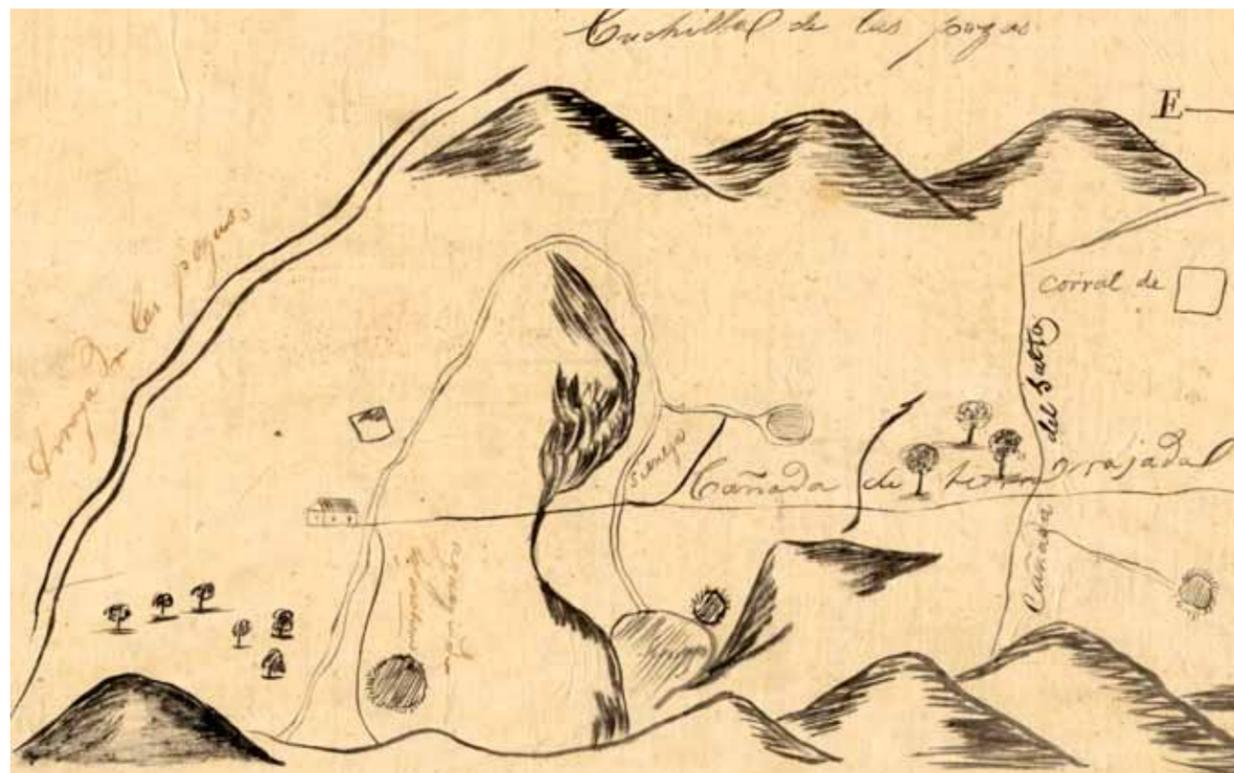
**Fig. 5.15.** While this ca. 1840s *diseño* is very schematic, it provides a generalized picture of the landscape of springs and wetlands present between Calleguas Creek (“Arroyo de las Pozas”) and the Santa Monica Mountains. It depicts springs (shown as dark circles with small radiating lines) flowing into small creeks and wetlands (labeled “sienega” [sic]). One wetland shown is up against the base of the hills, while the other is just upstream of the confluence of two creeks. (U.S. District Court ca. 1840a, courtesy of The Bancroft Library, UC Berkeley)

is roughly drawn, it does depict the same pattern shown on our habitat map, suggesting that these wetlands and springs were persistent, historical features.
