## **HISTORICAL ECOLOGY of the lower Santa Clara River, Ventura River, and Oxnard Plain: an analysis of terrestrial, riverine, and coastal habitats**

HISTORICAL ECOLOGY PROGRAM  
CONTRIBUTION NO. 641 • AUGUST 2011

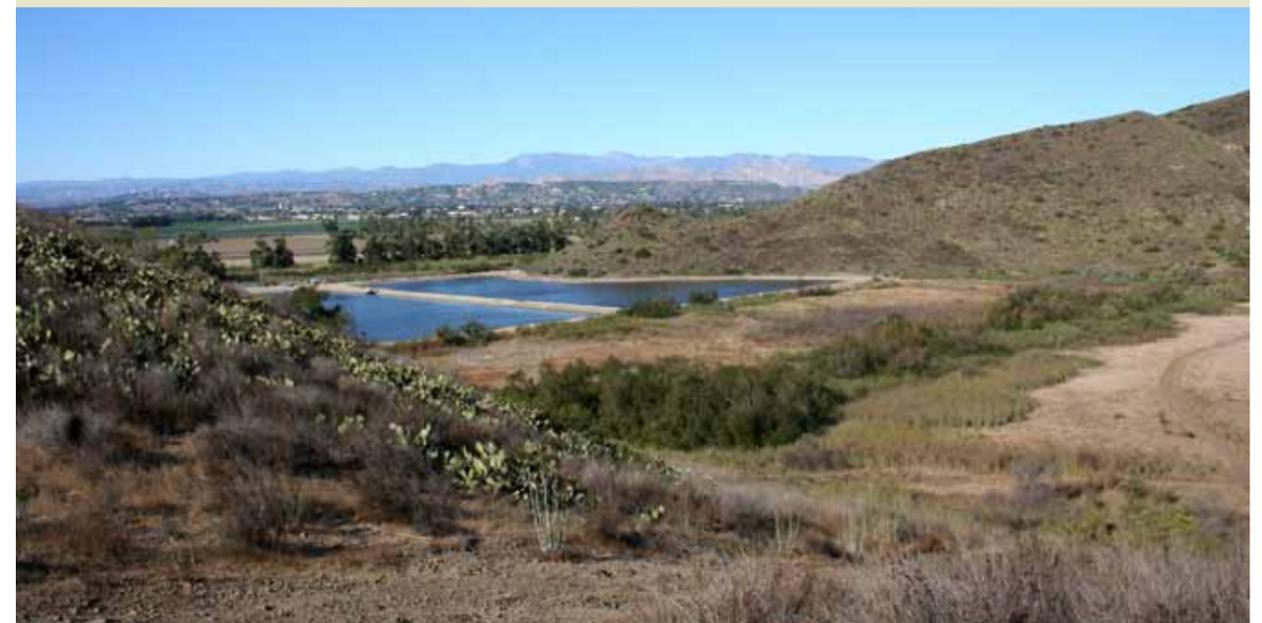
**Fig. 5.17. Camrosa Water District storage ponds, 2008.** The area behind these storage ponds, formerly the site of a freshwater marsh complex, may be a potential location for wetland habitat restoration.

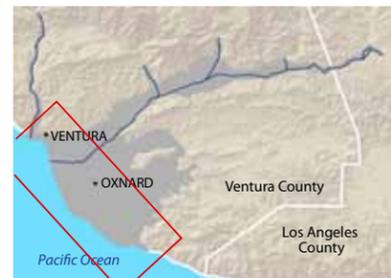
**Fig. 6.2. Habitats of the Ventura County shoreline, early 1800s.** At least three general types of coastal systems, or coastal archetypes, can be identified along the Ventura shoreline: freshwater-brackish estuaries associated with the Santa Clara and Ventura river mouths, dune-dammed non-tidal lagoon systems (with associated salt/brackish marsh and salt flats) marking former Santa Clara River mouths, and the large coastal wetland system at Point Mugu.

Nineteenth century Ventura County exhibited a complex and heterogeneous shoreline, with a variety of habitats and morphologies associated with different estuarine and wetland systems and different formative processes (fig. 6.2). At the Ventura River mouth, willow-cottonwood forest transitioned into a small, intermittently closed lagoon, while a culturally significant beach-dammed freshwater wetland complex occupied a former river mouth to the east. A distinctive seasonal wetland area—the Pierpont lowlands—extended in a broad arc from Ventura to the Santa Clara River mouth, nearly connecting the eastern edge of the Ventura River corridor to the northwestern edge of the Santa Clara River (they were separated by less than one mile). Here sand dunes trapped Santa Clara River floodwaters and valley seepage in a recently prograded portion of the shoreline, creating a large area of seasonally inundated meadow. At the Santa Clara River mouth, willow swamps bordered a small seasonal estuary similar in form and function to the Ventura River delta (and including a freshwater wetland complex, McGrath Lake). To the south, a series of at least nine elongate lagoons—some brackish, some saline—incised the Oxnard Plain shoreline, marking former mouths of the meandering Santa Clara River. Usually blocked from the tides by substantial beaches and dunes, the water source for these lagoons was a varying mix of saline (through dune overwash and seepage) and fresh water (from precipitation, runoff, and springs). As a result, the lagoon complexes supported a gradient of heterogeneous habitats ranging from freshwater to brackish to saline, including vegetated marsh, salt flat, and open water. At the southern edge of the Oxnard Plain, Mugu Lagoon represented by far the largest coastal wetland system in the county, with extensive subtidal, tidal flat, tidal marsh, and salt flat habitat.

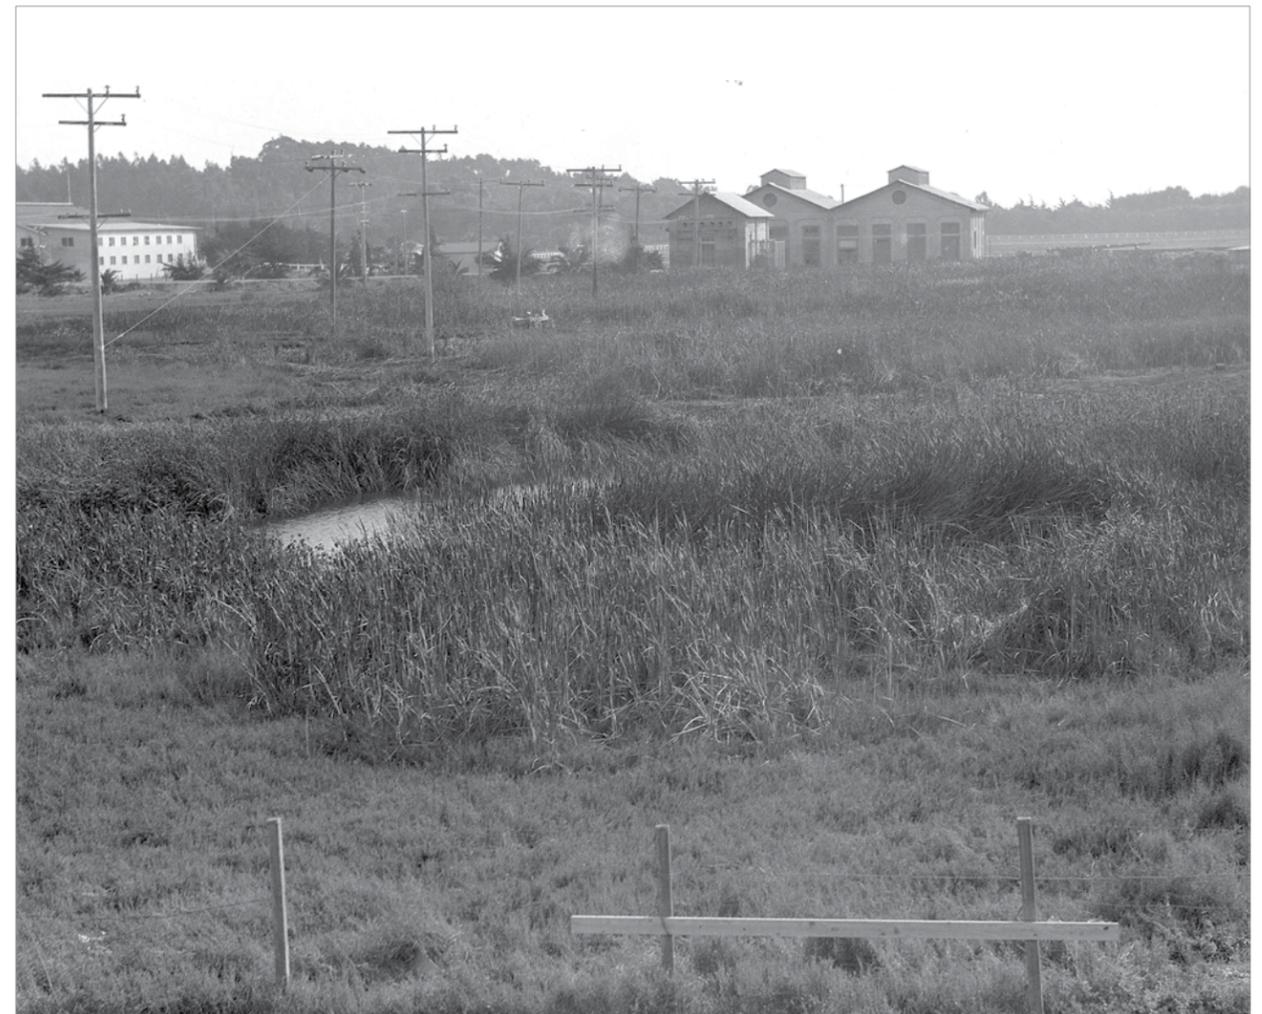
**Fig. 6.5. Tsikatskats, the lake at the end of Figueroa Street.** This photograph, taken in the fall of 1923, shows the remnant of what was once a well known brackish lake in the Ventura River floodplain. What are likely cattails (*Typha latifolia*) are visible in the foreground, along with stands of alkali bulrush (*Scirpus [Bolboschoenus] maritimus*) and bulrush/tule (*Scirpus [Schoenoplectus] californicus*; see particularly the matted vegetation to the right of the open water). Pickleweed (*Salicornia virginica*) dominates the foreground. (Harrington 1923b, courtesy of the Smithsonian Institution; plant interpretation, Baye pers. comm.)

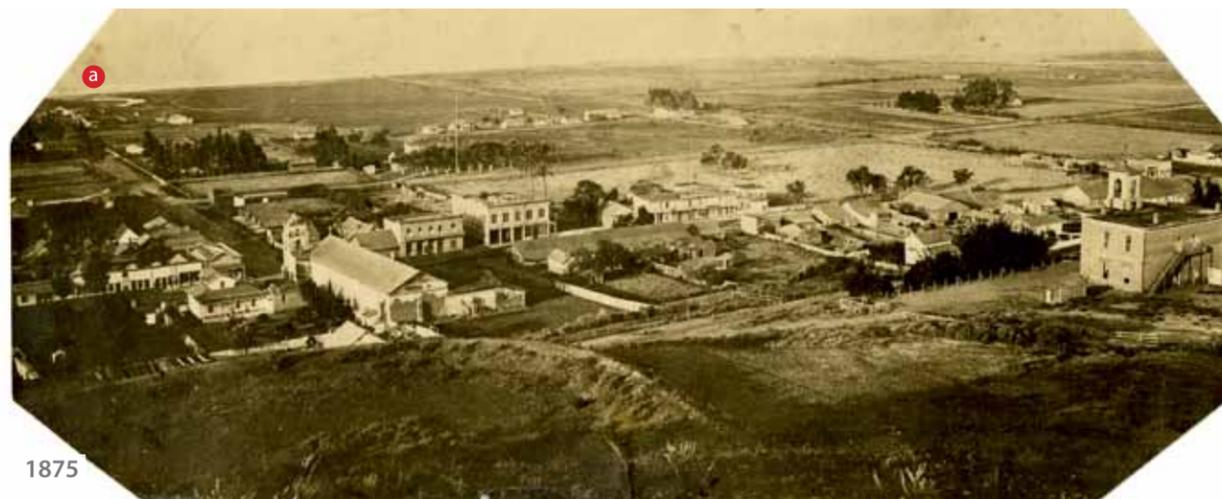
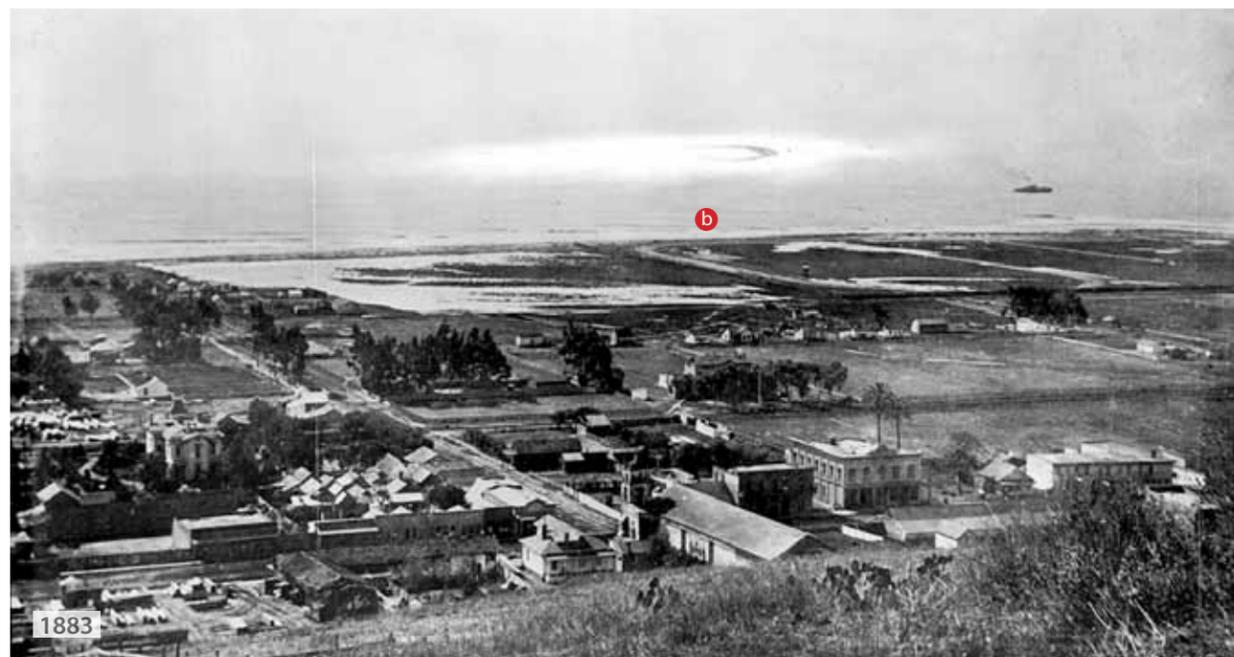
**Fig. 6.6. Two views looking across the city of Ventura to the shoreline.** A circa 1875 image (top), taken from the hill behind Mission San Buenaventura facing southwest, shows the low floodplain area east of the Ventura River. A portion of what is likely Tsikatskats lake can be seen in the distance, at **a**. A nearly identical view (below), taken about eight years later, shows the same area in flood. What appears to be a small seasonal pond or panne, corresponding in shape to one depicted on the T-sheet 28 years earlier, can be seen at **b**. (This feature is visible on fig. 6.3 as the leftmost salt flat/seasonal pond/marsh panne, shown in pink.) (Unknown ca. 1875, Pierce ca. 1883; courtesy of the California Historical Society)

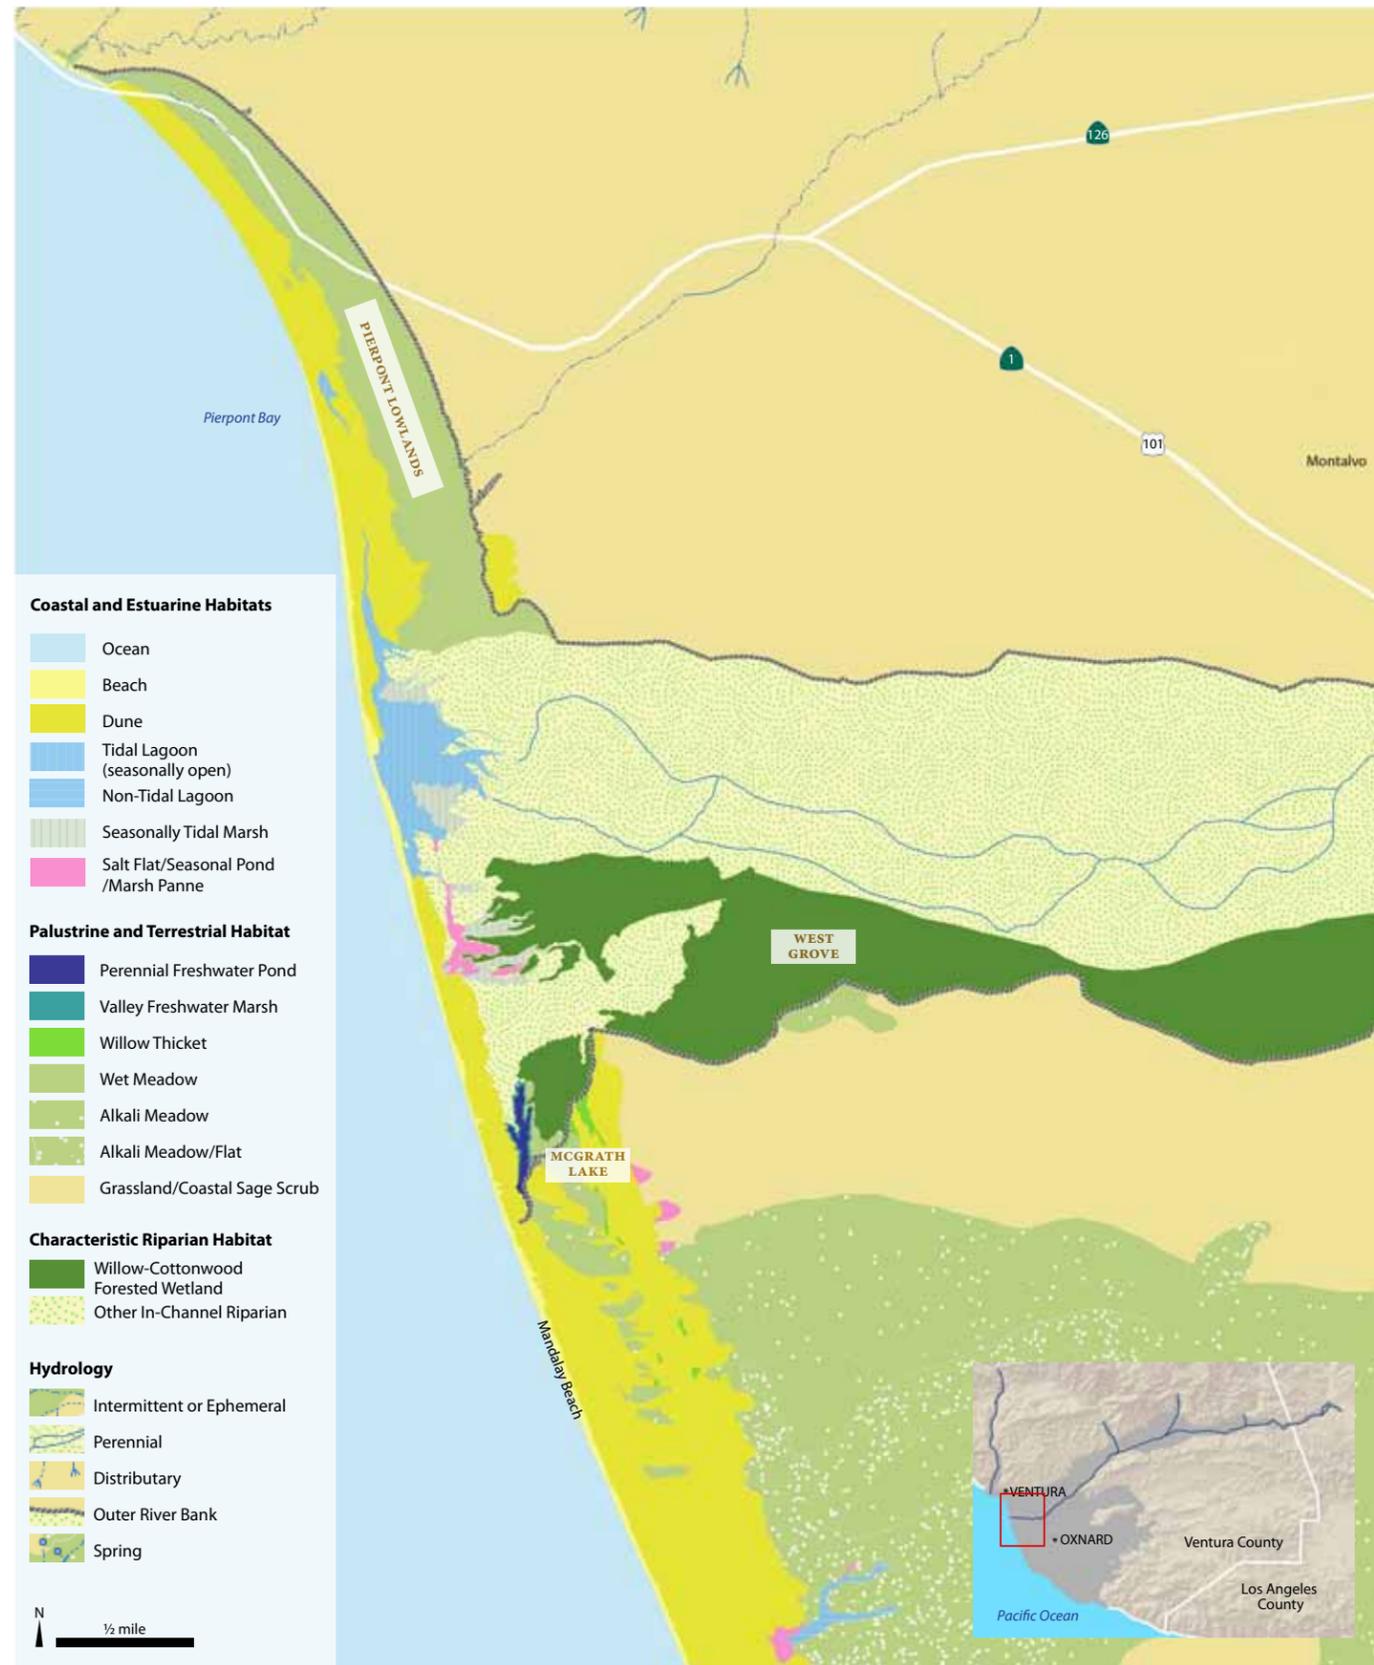
**Fig. 6.7. Habitats of the Santa Clara River mouth, early 1800s.** A seasonally open tidal lagoon, tidal marsh, alkali meadows, and salt flats, as well as abundant freshwater habitats (wet meadows, willow-cottonwood forests, and a freshwater lake/surrounding marsh) characterized the mouth.

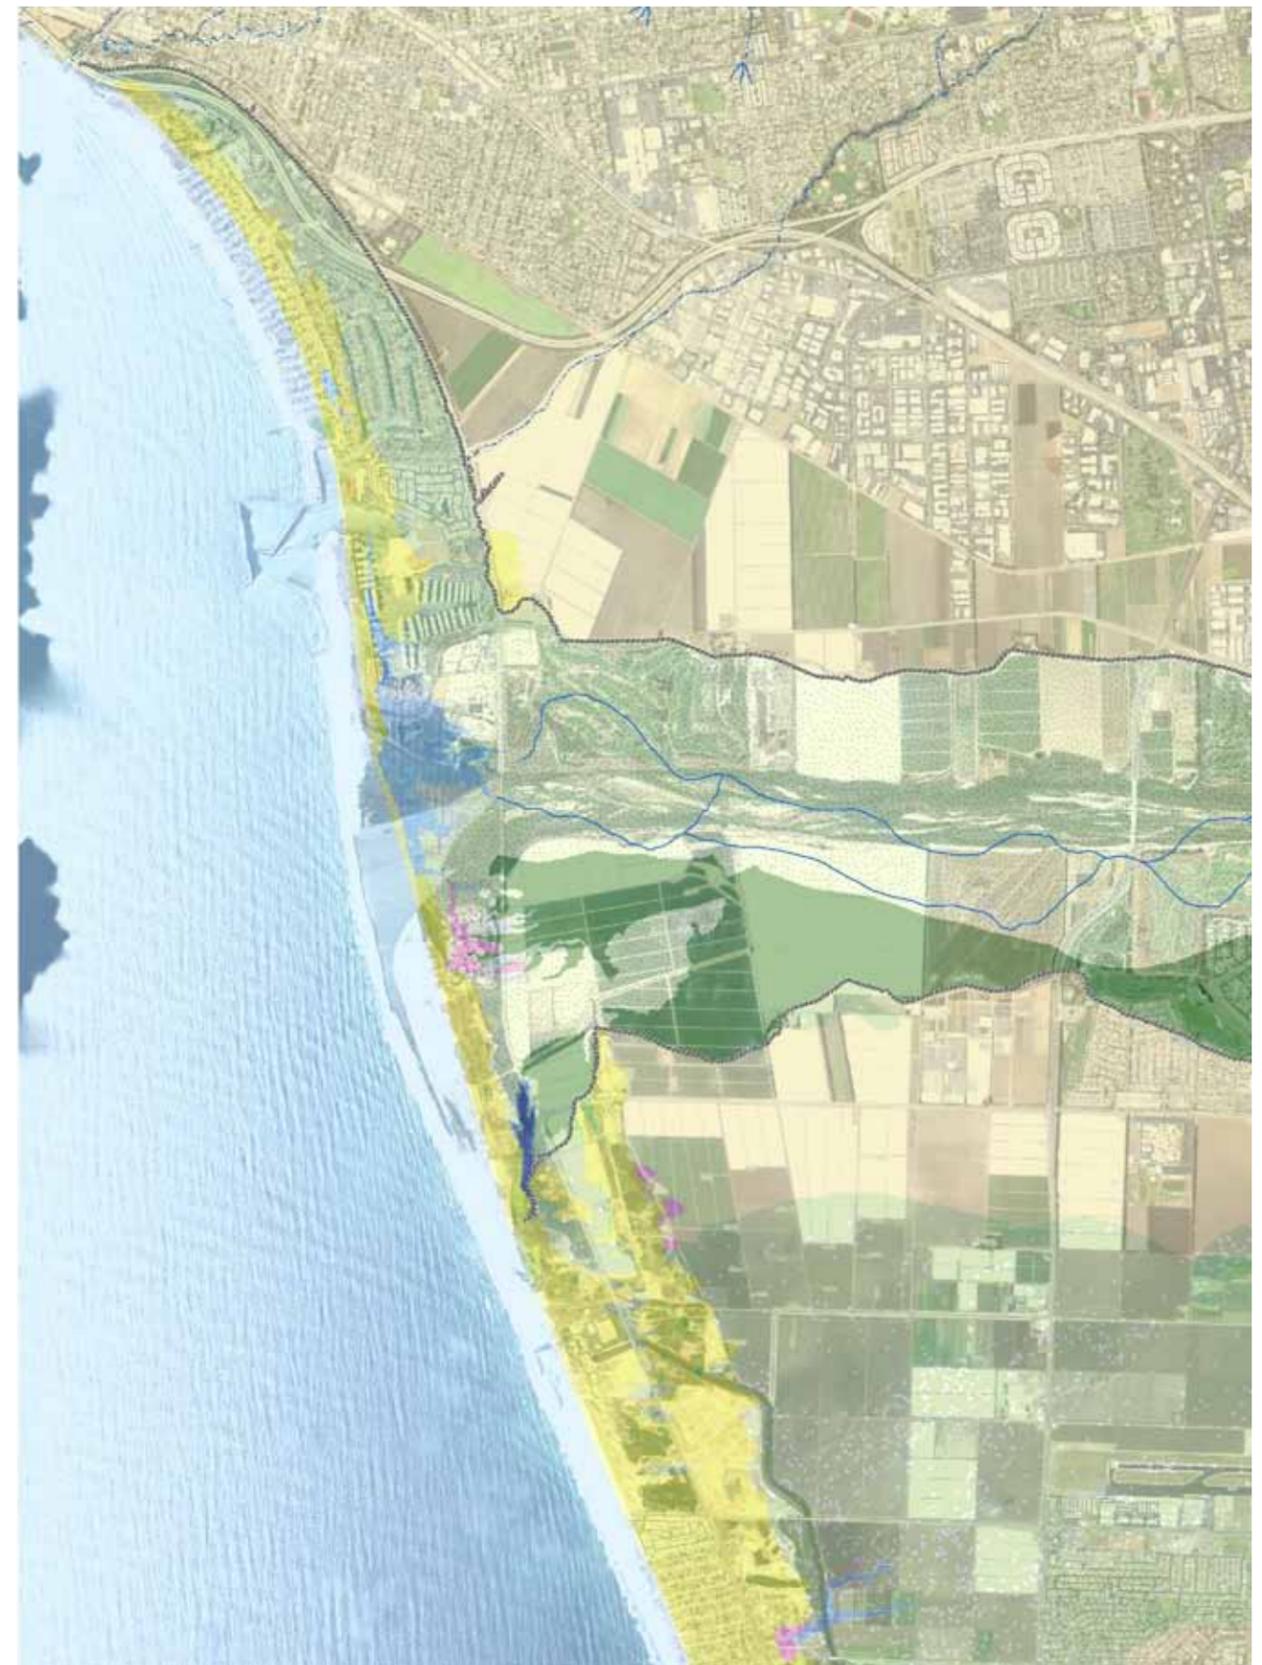
**Fig. 6.8. Habitats of the Santa Clara River mouth,** here overlaid on a modern aerial image, illustrate the former extent of estuarine and riparian habitats. (USDA 2009)

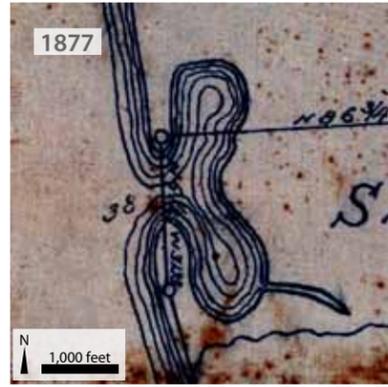
**Fig. 6.9. Seasonally tidal lagoon at the mouth of the Santa Clara River, 1877.** An early depiction of the lagoon open to the ocean. (Stow 1877, courtesy of the Museum of Ventura County)

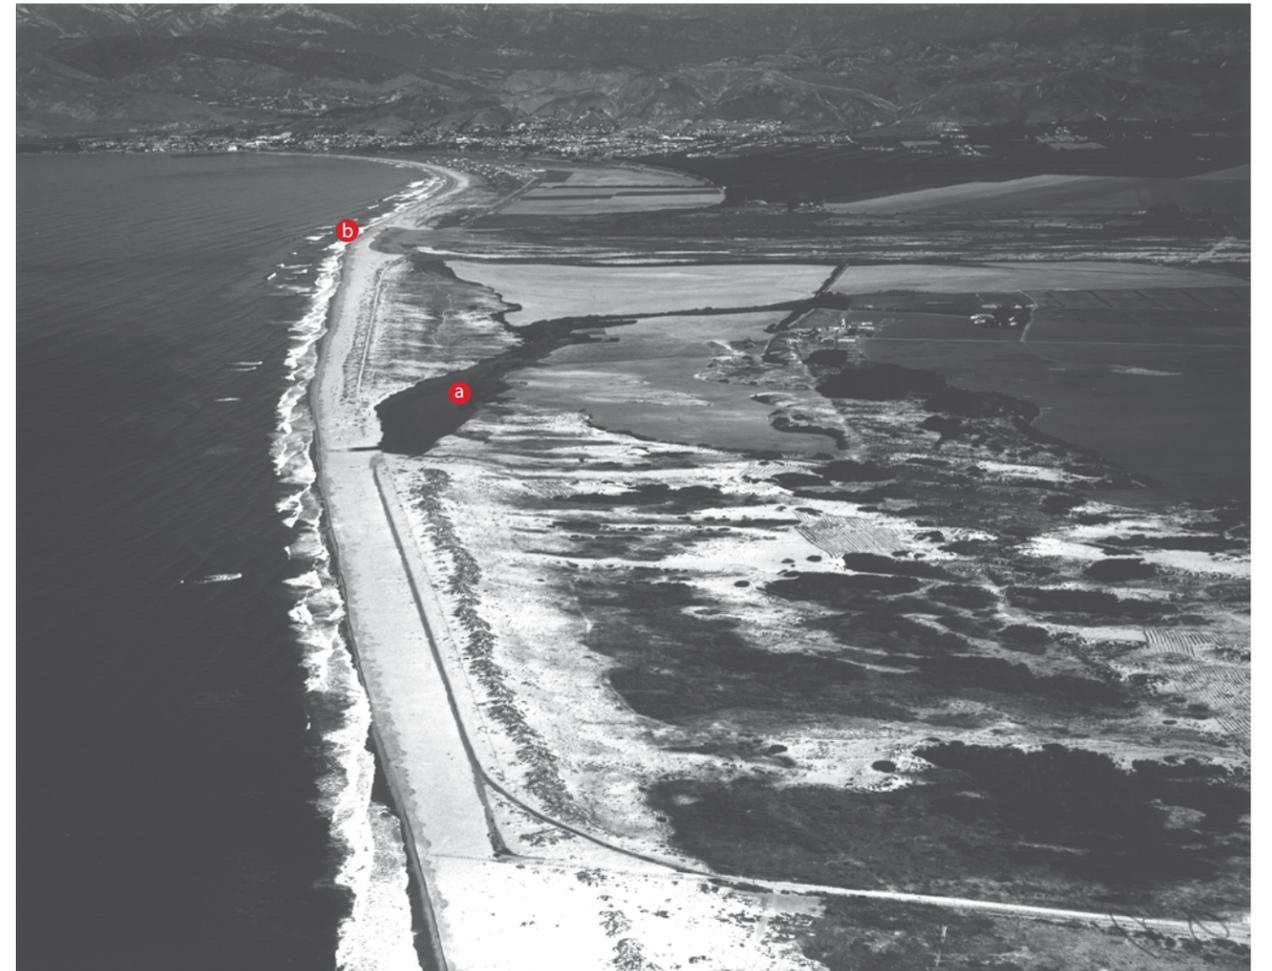
**Fig. 6.11. This 1947 view** of the coastline around the Santa Clara River mouth shows McGrath Lake (a) to the south of the closed river mouth (b) and the Pierpont lowlands to the north, together composing the low, broad floodplain of the river at its mouth. The city of Ventura can be seen in the background. (Spence Air Photos 1947, courtesy of the Benjamin and Gladys Thomas Air Photo Archives, UCLA Department of Geography)

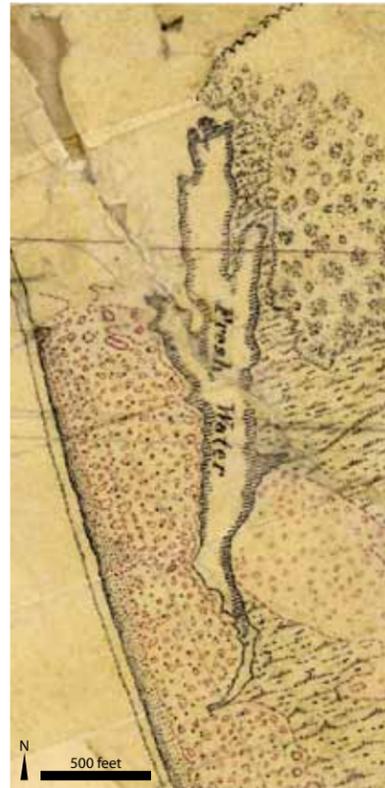
**Fig. 6.12. McGrath Lake, 1855.** The lake occurs at the boundary of two T-sheets, and is mapped by both. On this sheet, covering the area from McGrath Lake to Hueneme, the lake is labeled “fresh water,” a rarity on the Oxnard Plain. (Johnson 1855b, courtesy of the National Oceanic and Atmospheric Administration)

McGrath Lake is one of the few remaining coastal water bodies on the Oxnard Plain shoreline, though its origins are different than the mostly closed, brackish/saline tidal lagoons historically to the south (and derived from ancient river flows). Unlike these lagoons, McGrath was a freshwater lake, with hydrologic inputs derived primarily from active surface flows from the Santa Clara River and groundwater. The lake is shown on the region’s T-sheet, labeled “fresh water” (Johnson 1855b; fig. 6.12). The lake as shown here was 8 acres, with 5 acres of fringing freshwater marsh. The lake occurred in a low spot between parallel ridges of sand dunes, and was also surrounded by willow thickets and seasonally inundated grassland. Cooper

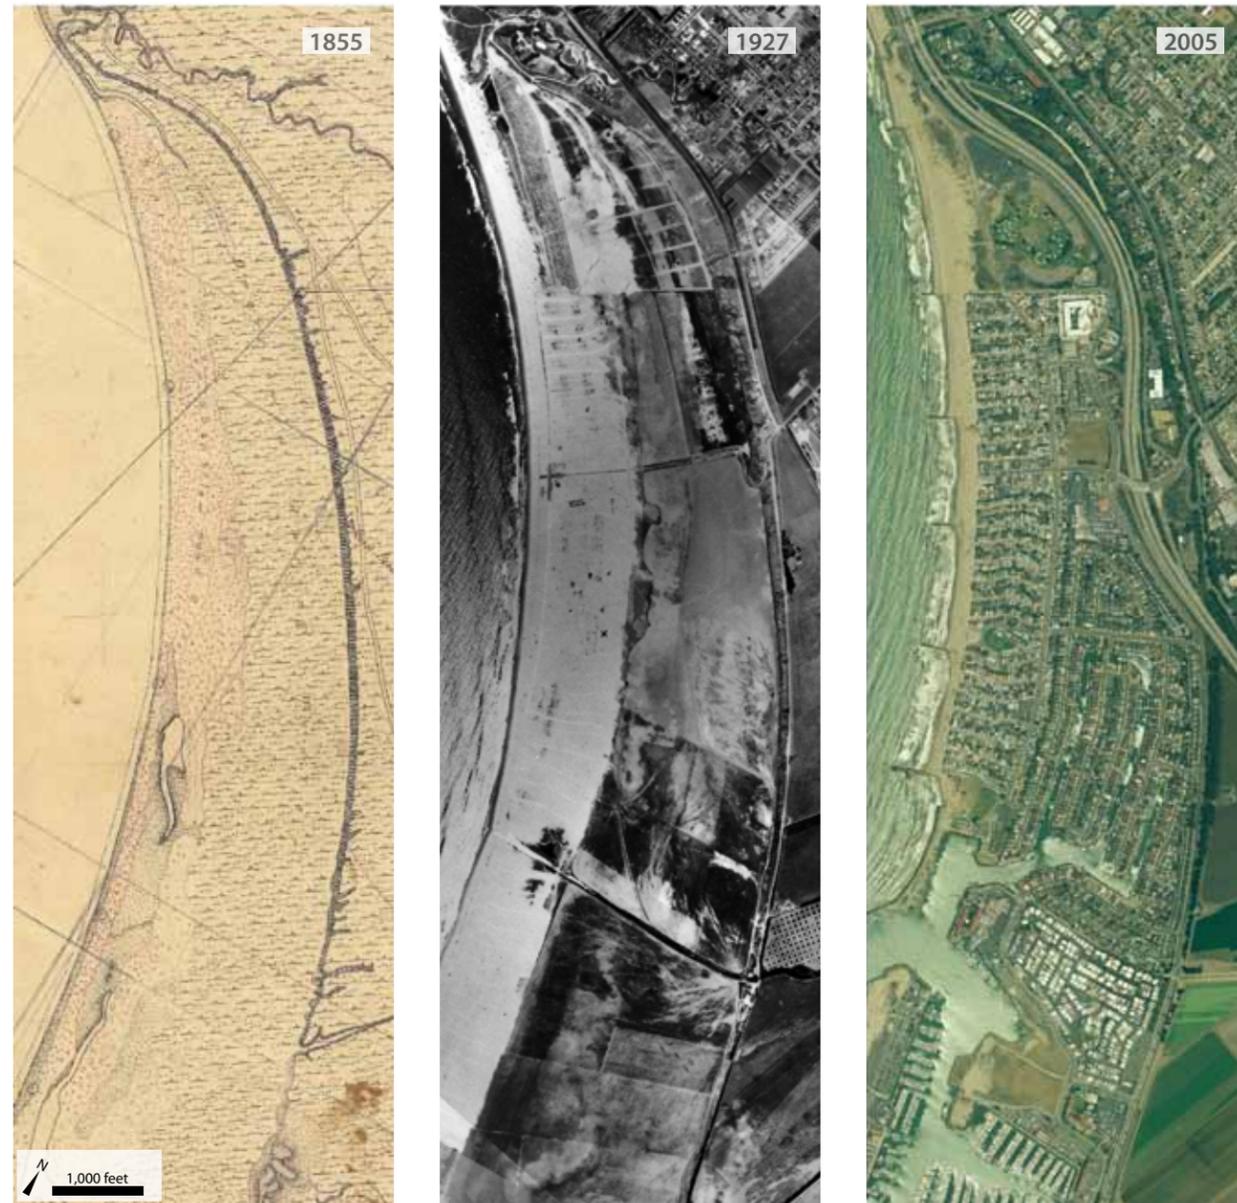
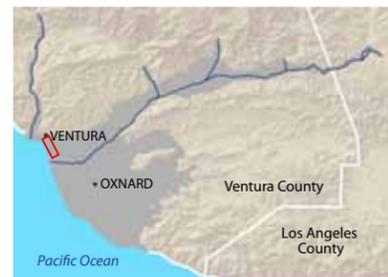
**Fig. 6.14. Between 1855 and 2005, the seasonally inundated lowlands** at Pierpont have been heavily developed. The beginnings of a street grid can faintly be seen on the historical aerial in the dunes (middle); this same street pattern has persisted to the present day (right). Today, this area includes the Ventura Harbor. Note that a subdivision shown on the northern part of the Pierpoint lowlands is now part of San Buenaventura State Beach. (Johnson 1855c, courtesy of the National Oceanographic and Atmospheric Administration; Fairchild Aerial Surveys 1927, courtesy of Whittier College; USDA 2005)

To the north of the mainstem Santa Clara River, the Pierpont lowlands were a broad, low coastal flat extending more than 2.5 miles northward, nearly to the Ventura River, and comprising the westernmost extent of the Santa Clara River delta (fig. 6.14). Located between sand dunes and a bluff marking a former coastline, the flat trapped water from the Santa Clara River during floods, creating a large area of seasonally inundated wet meadow. This feature of the Pierpont area is captured by the early T-sheet survey, where “overflowed during winter” is written across the entire plain. The feature is a result of progradation, as Ventura River sediments were deposited north of the convex Santa Clara River mouth (Putnam 1942).

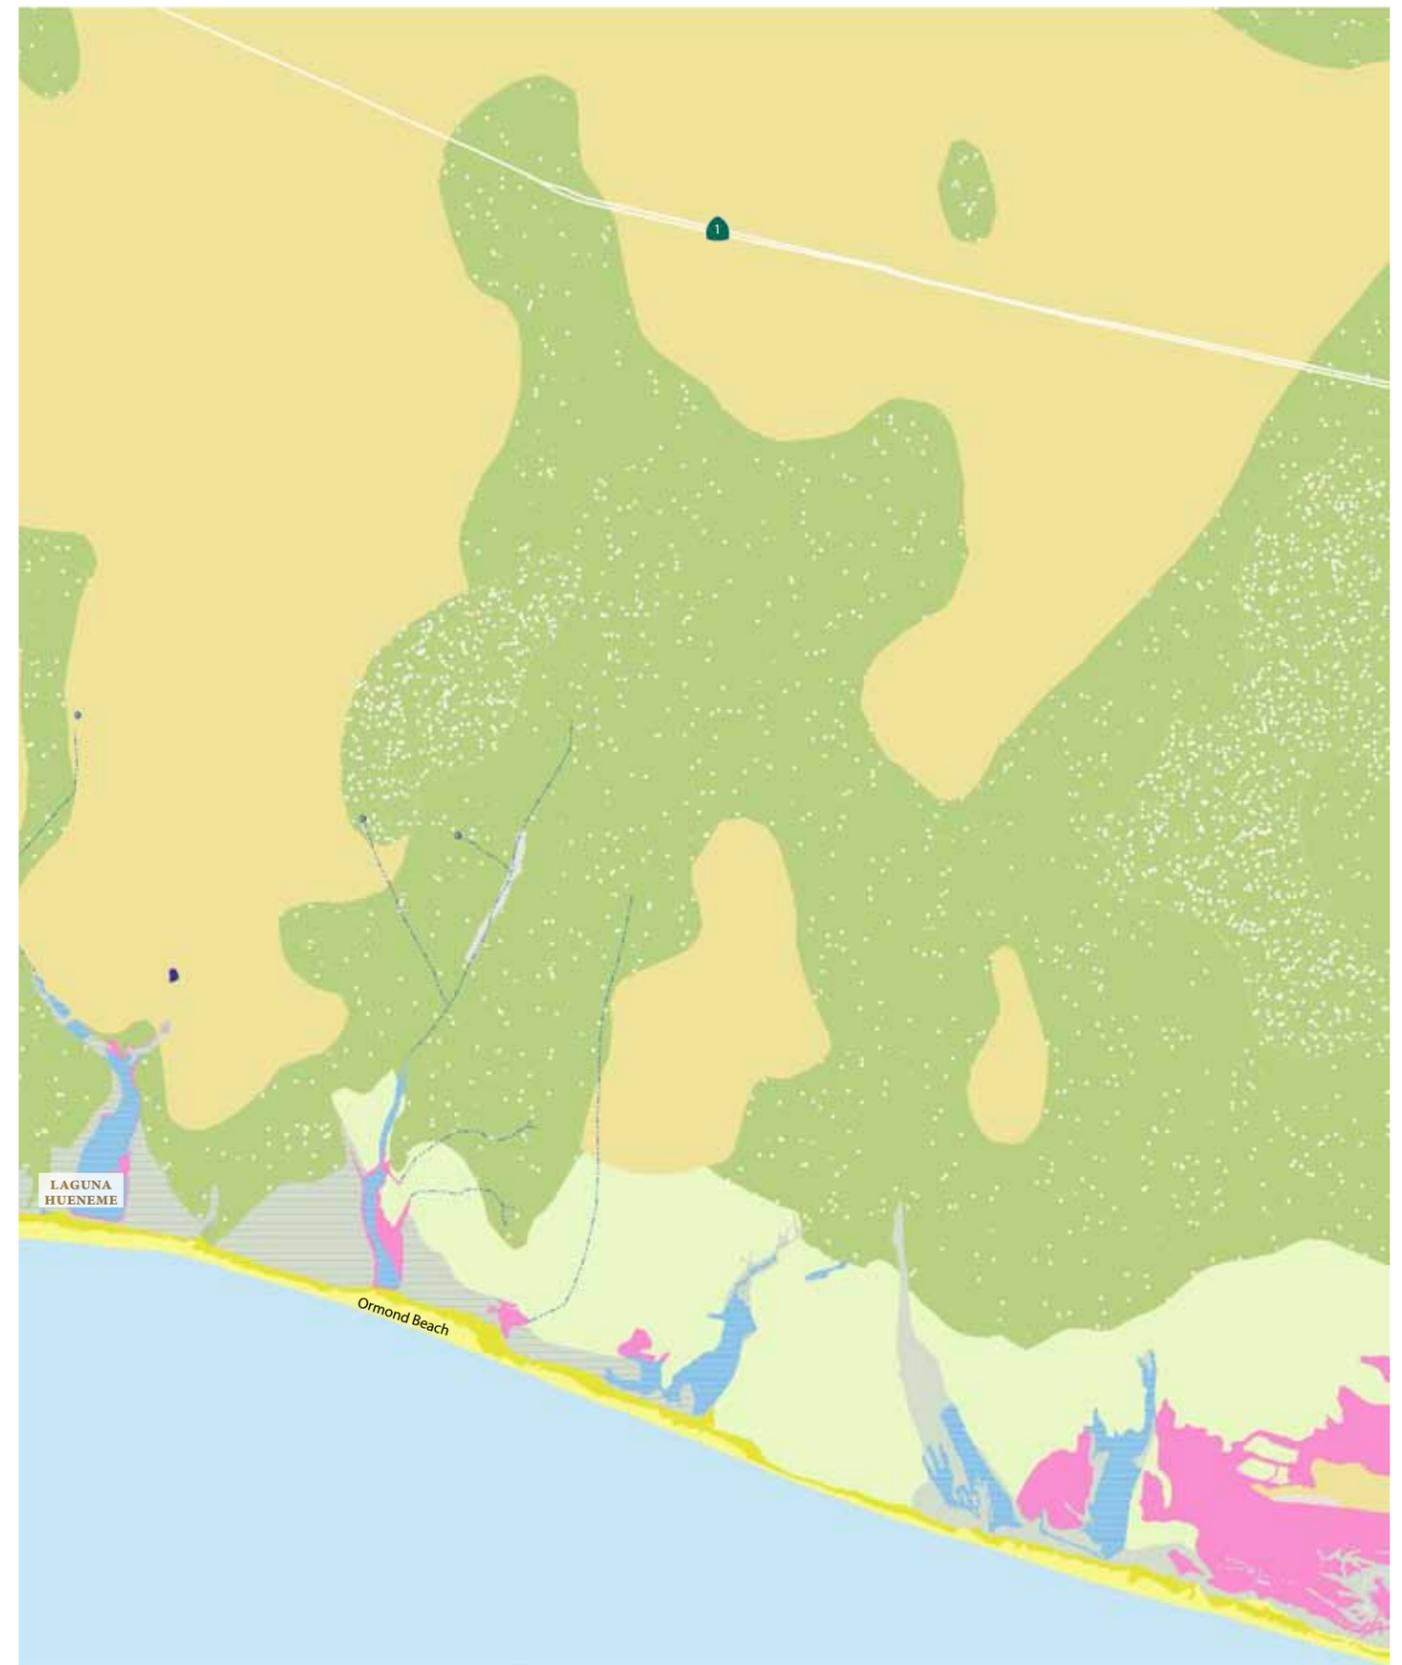
**Fig. 6.15. A series of backbarrier lagoons, salt flats, and marshes** stretched from south of the Santa Clara River mouth all the way to Mugu Lagoon (the western edge of which is at the right edge of this spread). Separated from the ocean by often extensive dunes, these systems were characterized by variable salinity, seasonality, and habitat proportions. (See fig. 6.24 for the modern aerial of this area.)

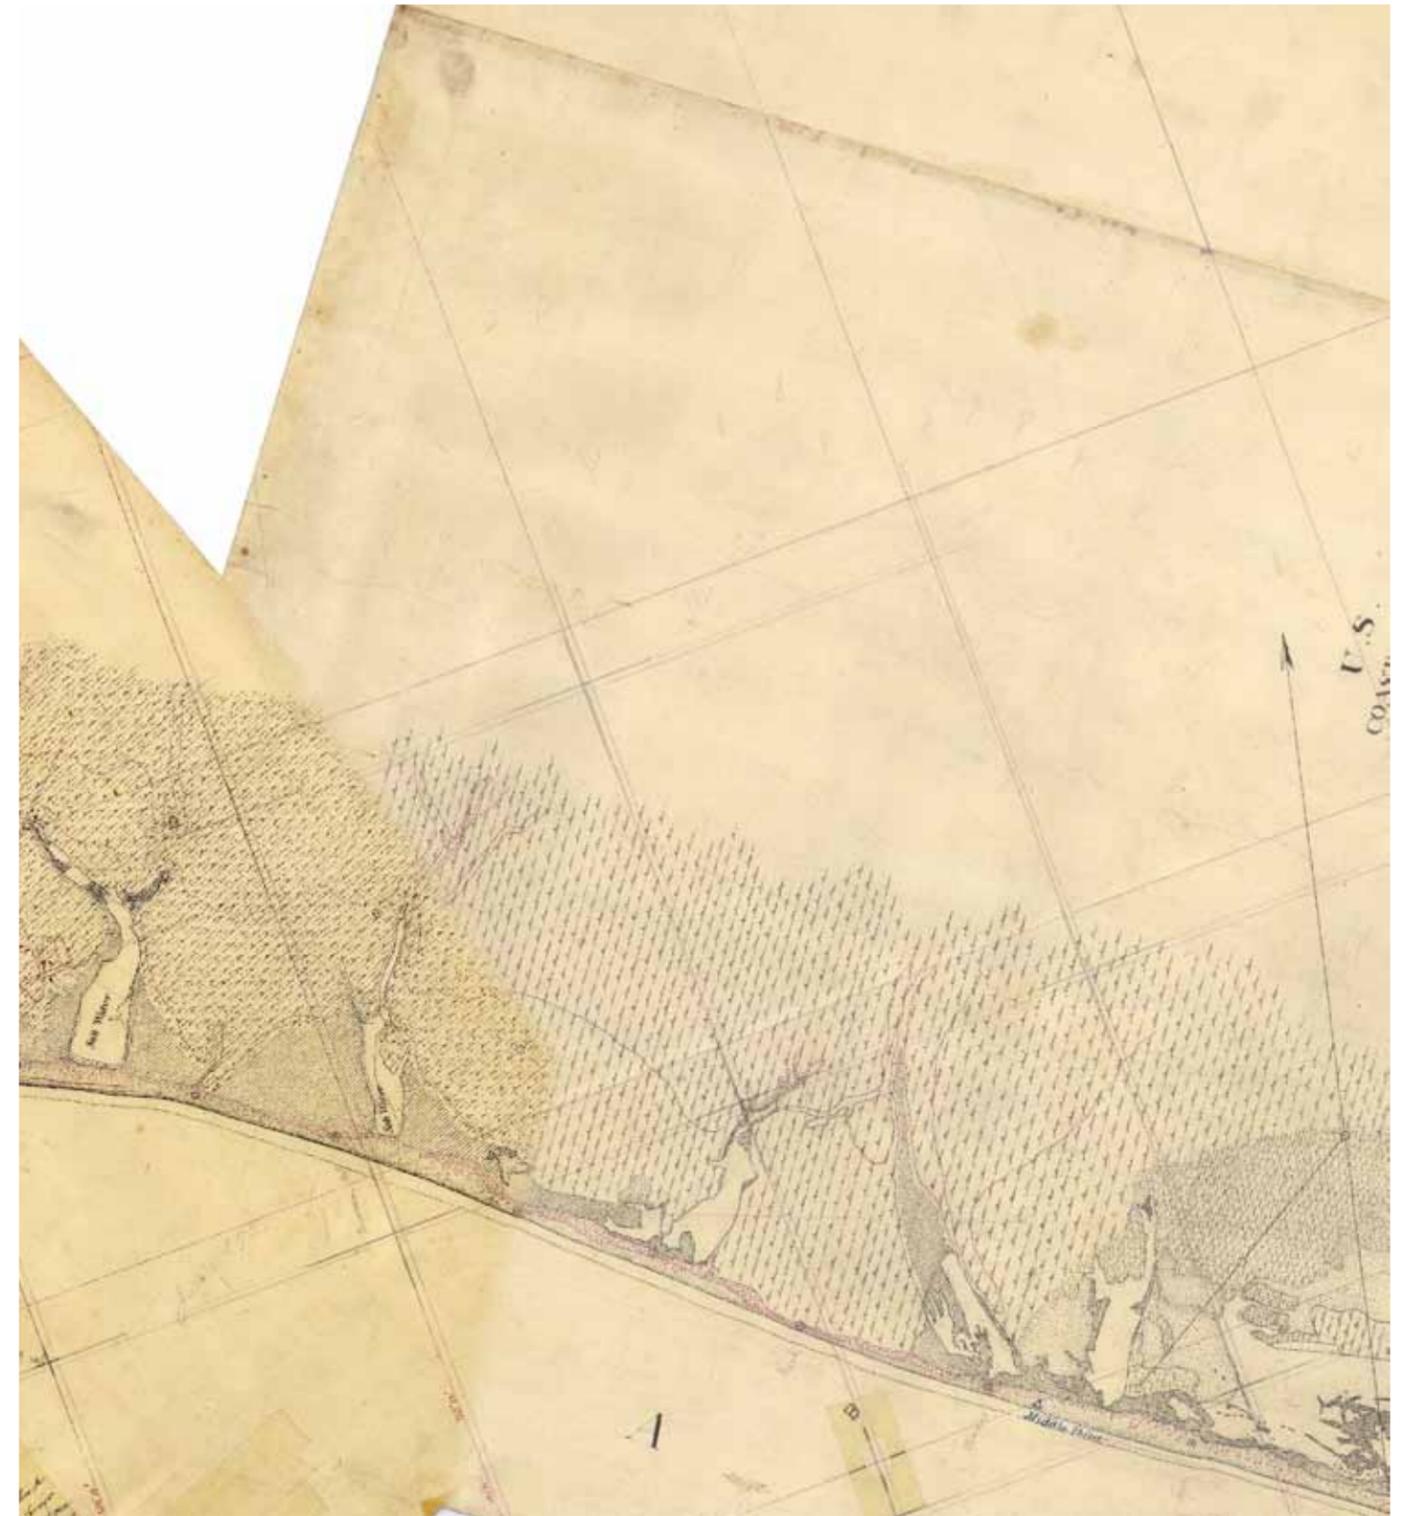
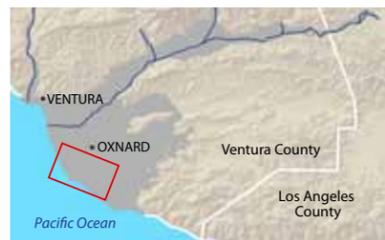
**Fig. 6.16.** The earliest detailed surveys of the Ventura shoreline, completed in 1855 and 1857, show the coastal wetlands with impressive precision. (Johnson 1855b and Johnson 1857, courtesy of the National Oceanographic and Atmospheric Administration)

By far the most detailed depiction of the suite of coastal lagoons is provided by a set of USCS T-sheets produced in the summers of 1855 and 1857, the maps upon which the bulk of our own historical habitat mapping is based (Johnson 1855b,c and Johnson 1857; fig. 6.16; see Grossinger 2011 for more discussion of these sources). These early surveys depict the lagoons as a series of open water/salt flat/marsh complexes separated from the ocean by sand dunes, which range from 300 to 3,300 feet wide and with high points consistently above 60 feet in elevation northwest of Hueneme. None of the lagoons are shown with a tidal outlet, and the lagoons' square-end shapes and the presence of the wide, vegetated barrier dunes suggests that these systems opened relatively infrequently. These systems, though

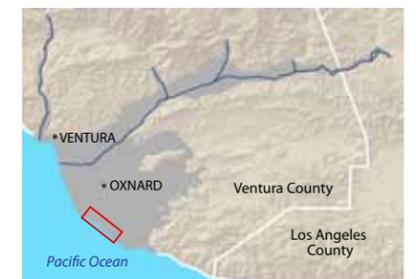
**Fig. 6.19. Coastal lagoons near Point Hueneme, 1870.** Four lagoons between Point Hueneme (at left) and Mugu Lagoon (western edge visible as “mud flat” at right). Though we mapped each feature as a non-tidal lagoon, note the labels on the lagoons—meaningfully, each of the four lagoons is labeled slightly differently. The Salinas was so known because of its use as a collection site for salt in the 19th century, suggesting substantial hypersaline and salt flat components. Similarly, the “dry pond,” though it would not have dried out completely every year, may have been shallower than adjacent lagoons. The “Laguna Hueneme” was well known for its freshwater inputs. The “salt pond” was found at the mouth of what is known today as the Oxnard Industrial Drain at Ormond Beach. Despite outward similarity, this map suggests substantial variation in hydrology and habitats across systems. (Bard 1870b, courtesy of The Bancroft Library, UC Berkeley)

These general observations are corroborated by annotations on an early map, which identifies some lagoons as “salt ponds” and another as “dry pond” (Bard 1870a; fig. 6.19). Remarkably, the T-sheet also has annotations describing summer conditions, written in exceptionally faint pencil within some of the lagoons and seasonal ponds. A few (for example, two seasonal ponds south of modern-day Channel Island Boulevard) are labeled “dry,” another portion of one as “salt land” (perhaps marking an exposed portion of the lagoon), while others are labeled “salt water.”

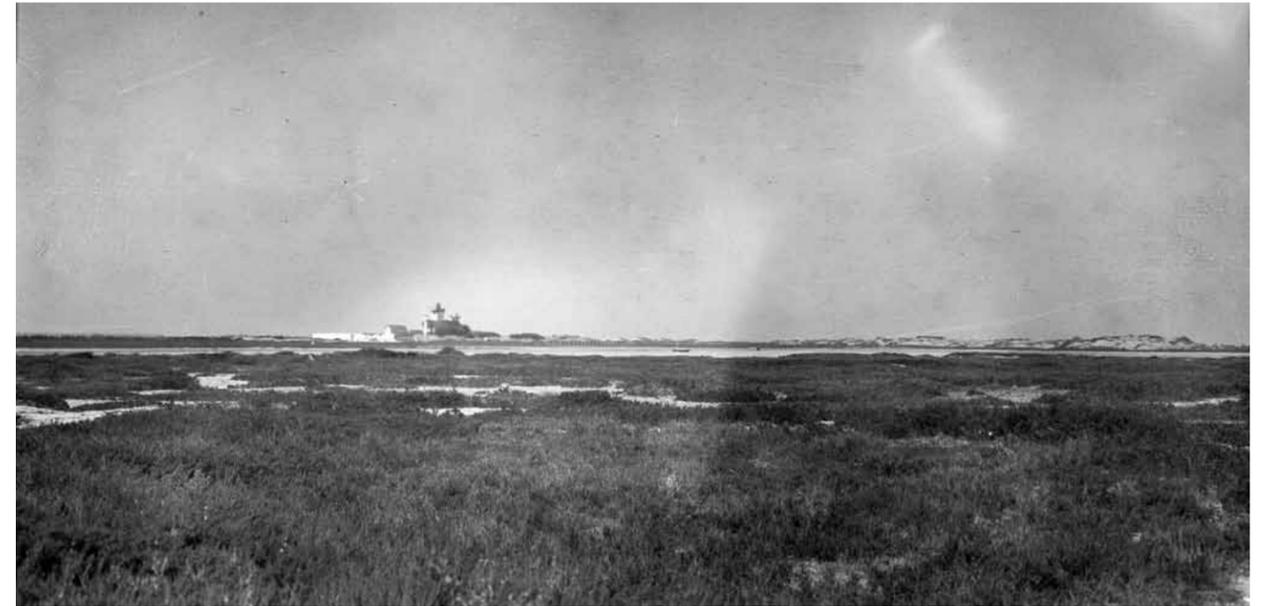
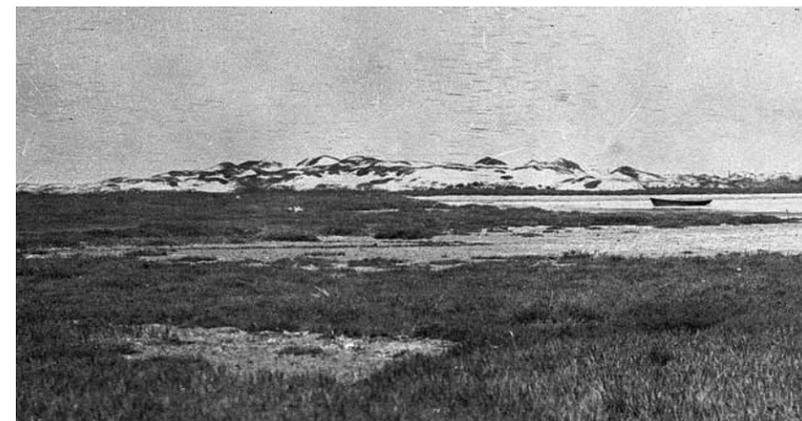
**Fig. 6.21. The Salinas, 1913.** These two images provide two different views of the Salinas lagoon, formerly located where the port is now. The view is generally southwest; high dunes (top and middle) and the Point Hueneme lighthouse (top; built in 1874) can be seen in the background. In the foreground, extensive salt marsh (mainly pickleweed, probably with some salt grass component and visible pannes) stretches toward the lake. A small boat (detail; at left) can be seen on the lagoon in both pictures, indicating some depth. (Harrington 1913b,d; courtesy of the Smithsonian Institution)

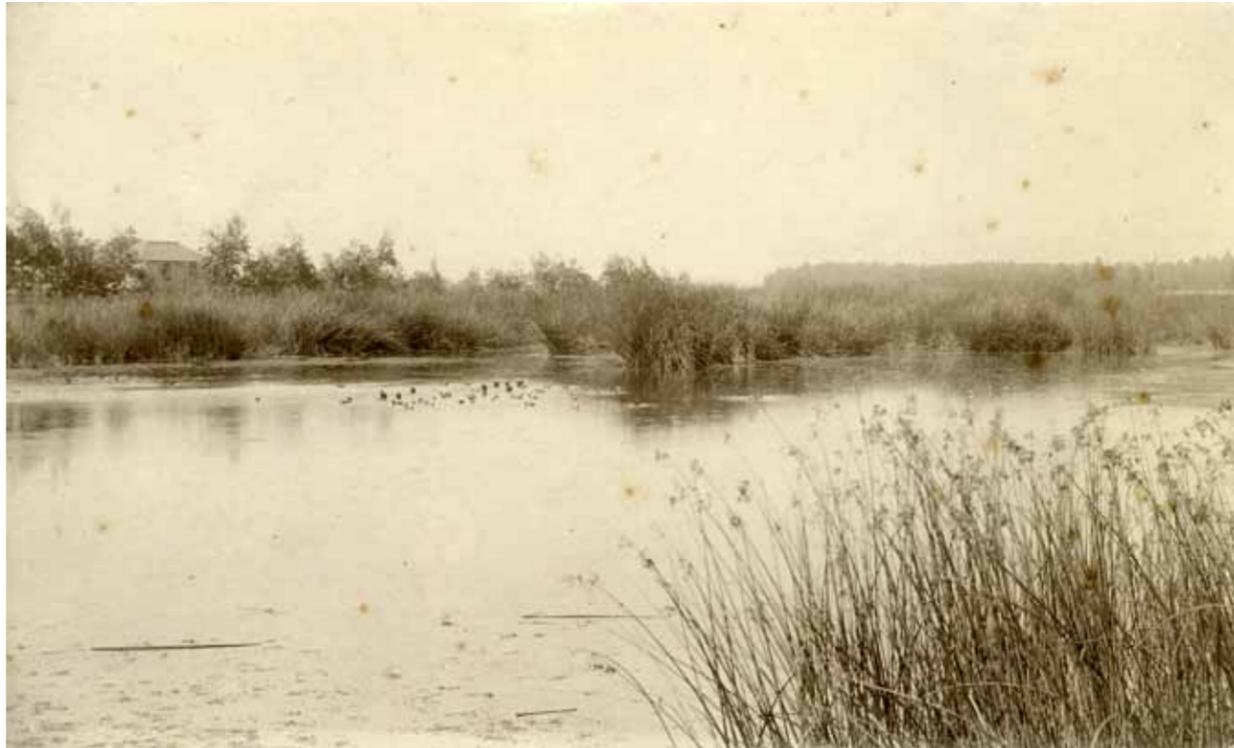
**Fig. 6.22. “Duck shoot near Hueneme,” ca. 1889.** This image shows a portion of Laguna Hueneme in the late 19th century. The lagoon is surrounded by tule (likely *Scirpus [Schoenoplectus] californicus*). What is likely sago pondweed (*Potamogeton pectinatus/ Stuckenia pectinata*) can be seen in the foreground (Collins pers. comm.). This photograph, also included as a lithograph in an 1889 article in *Overland Monthly and Out West* magazine on traveling in Ventura County, matches the description included in that article well: “spears of purple reeds [likely tule], with flocks of wild duck plowing luminous furrows across its steel-gray floor” (Eames 1889). (Brewster ca. 1889, courtesy of the Museum of Ventura County)

Despite this, the lagoon was still considered to be a “salty” lagoon, labeled “salt water” on the T-sheet and described as salty in court testimony: “though the Hueneme is fed by fresh water springs” (Johnson 1855b, Reed 1871). It is likely that portions of the lagoon (for example, closest to the shore) were saline, while other portions further upslope were brackish. An early image of a portion of the lagoon shows abundant tule fringing the water (fig. 6.22).
