## **HISTORICAL ECOLOGY of the lower Santa Clara River, Ventura River, and Oxnard Plain: an analysis of terrestrial, riverine, and coastal habitats**

HISTORICAL ECOLOGY PROGRAM  
CONTRIBUTION NO. 641 • AUGUST 2011

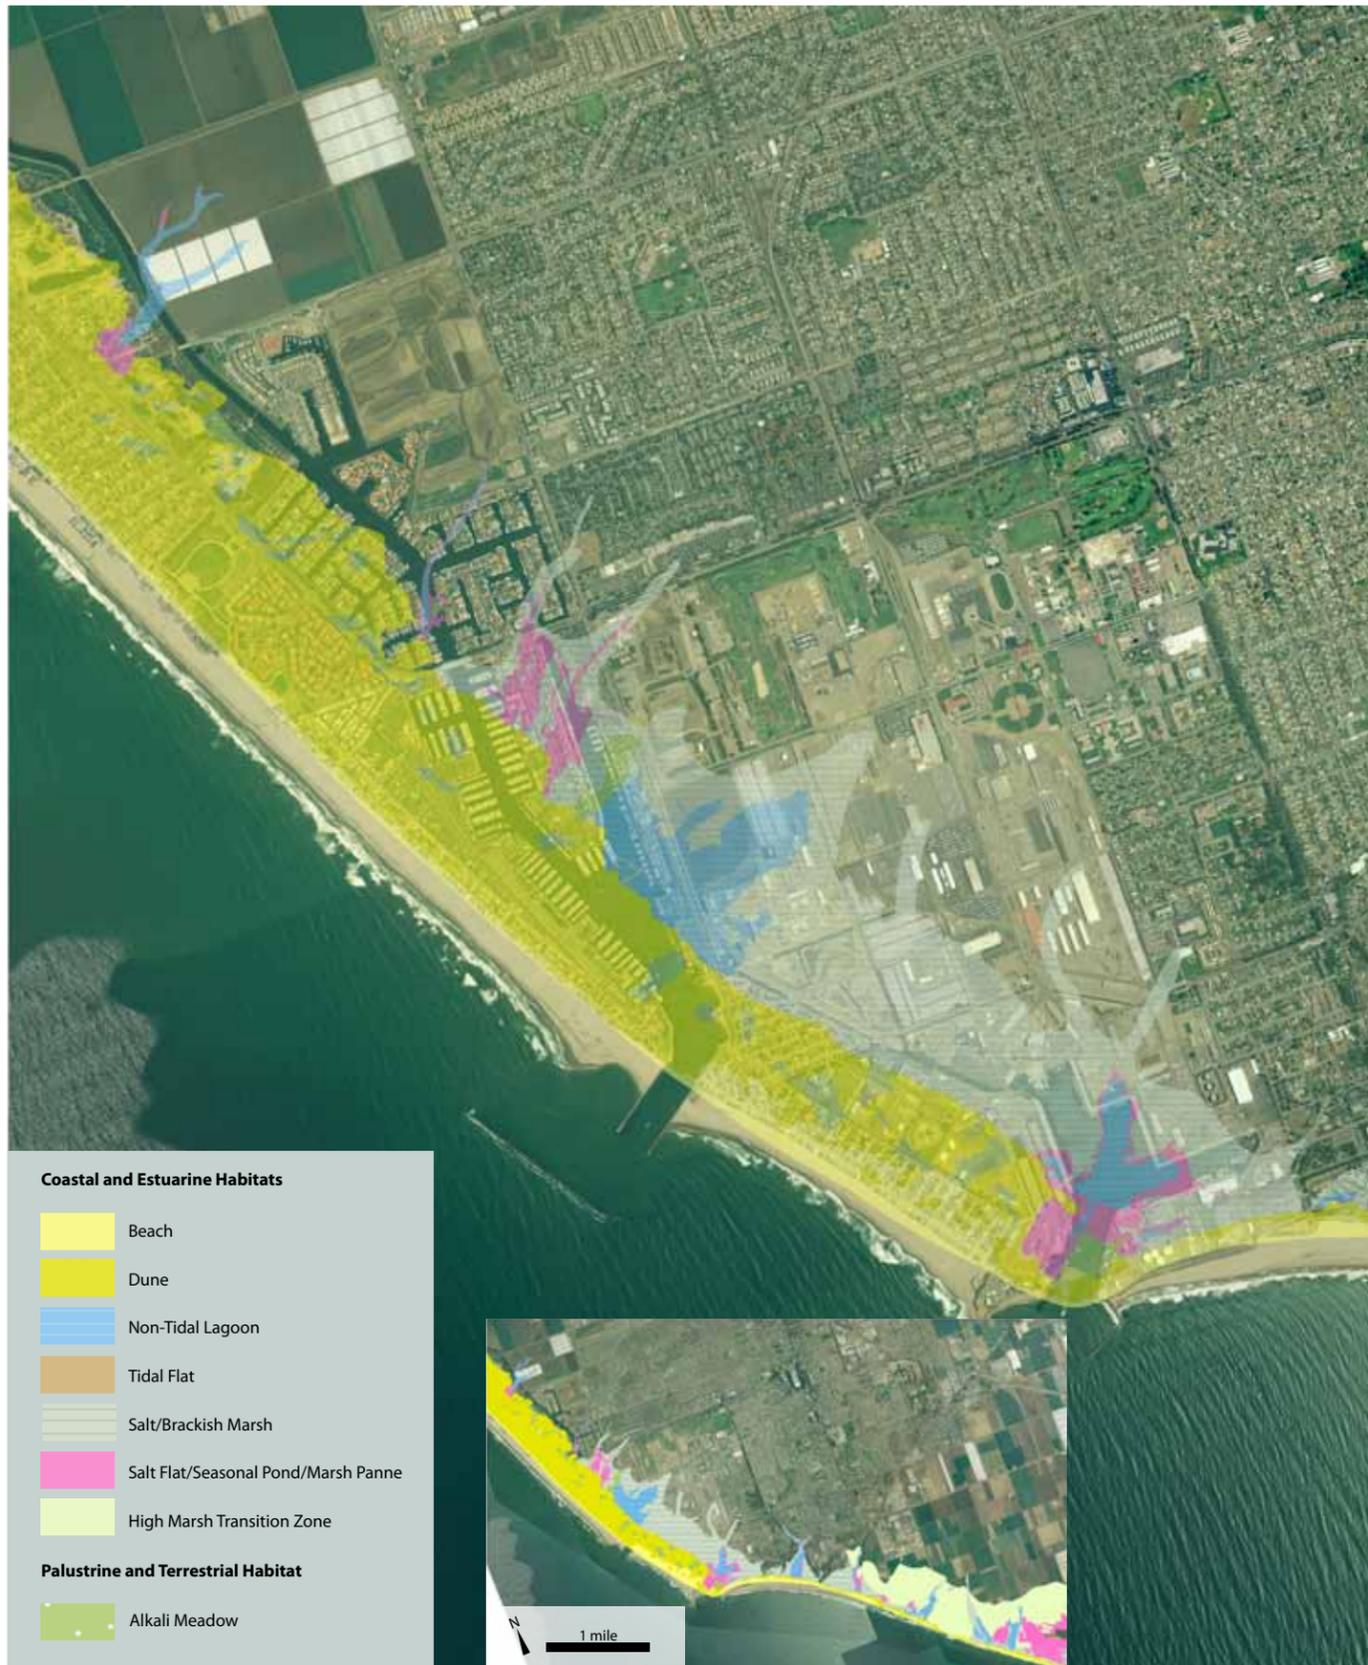
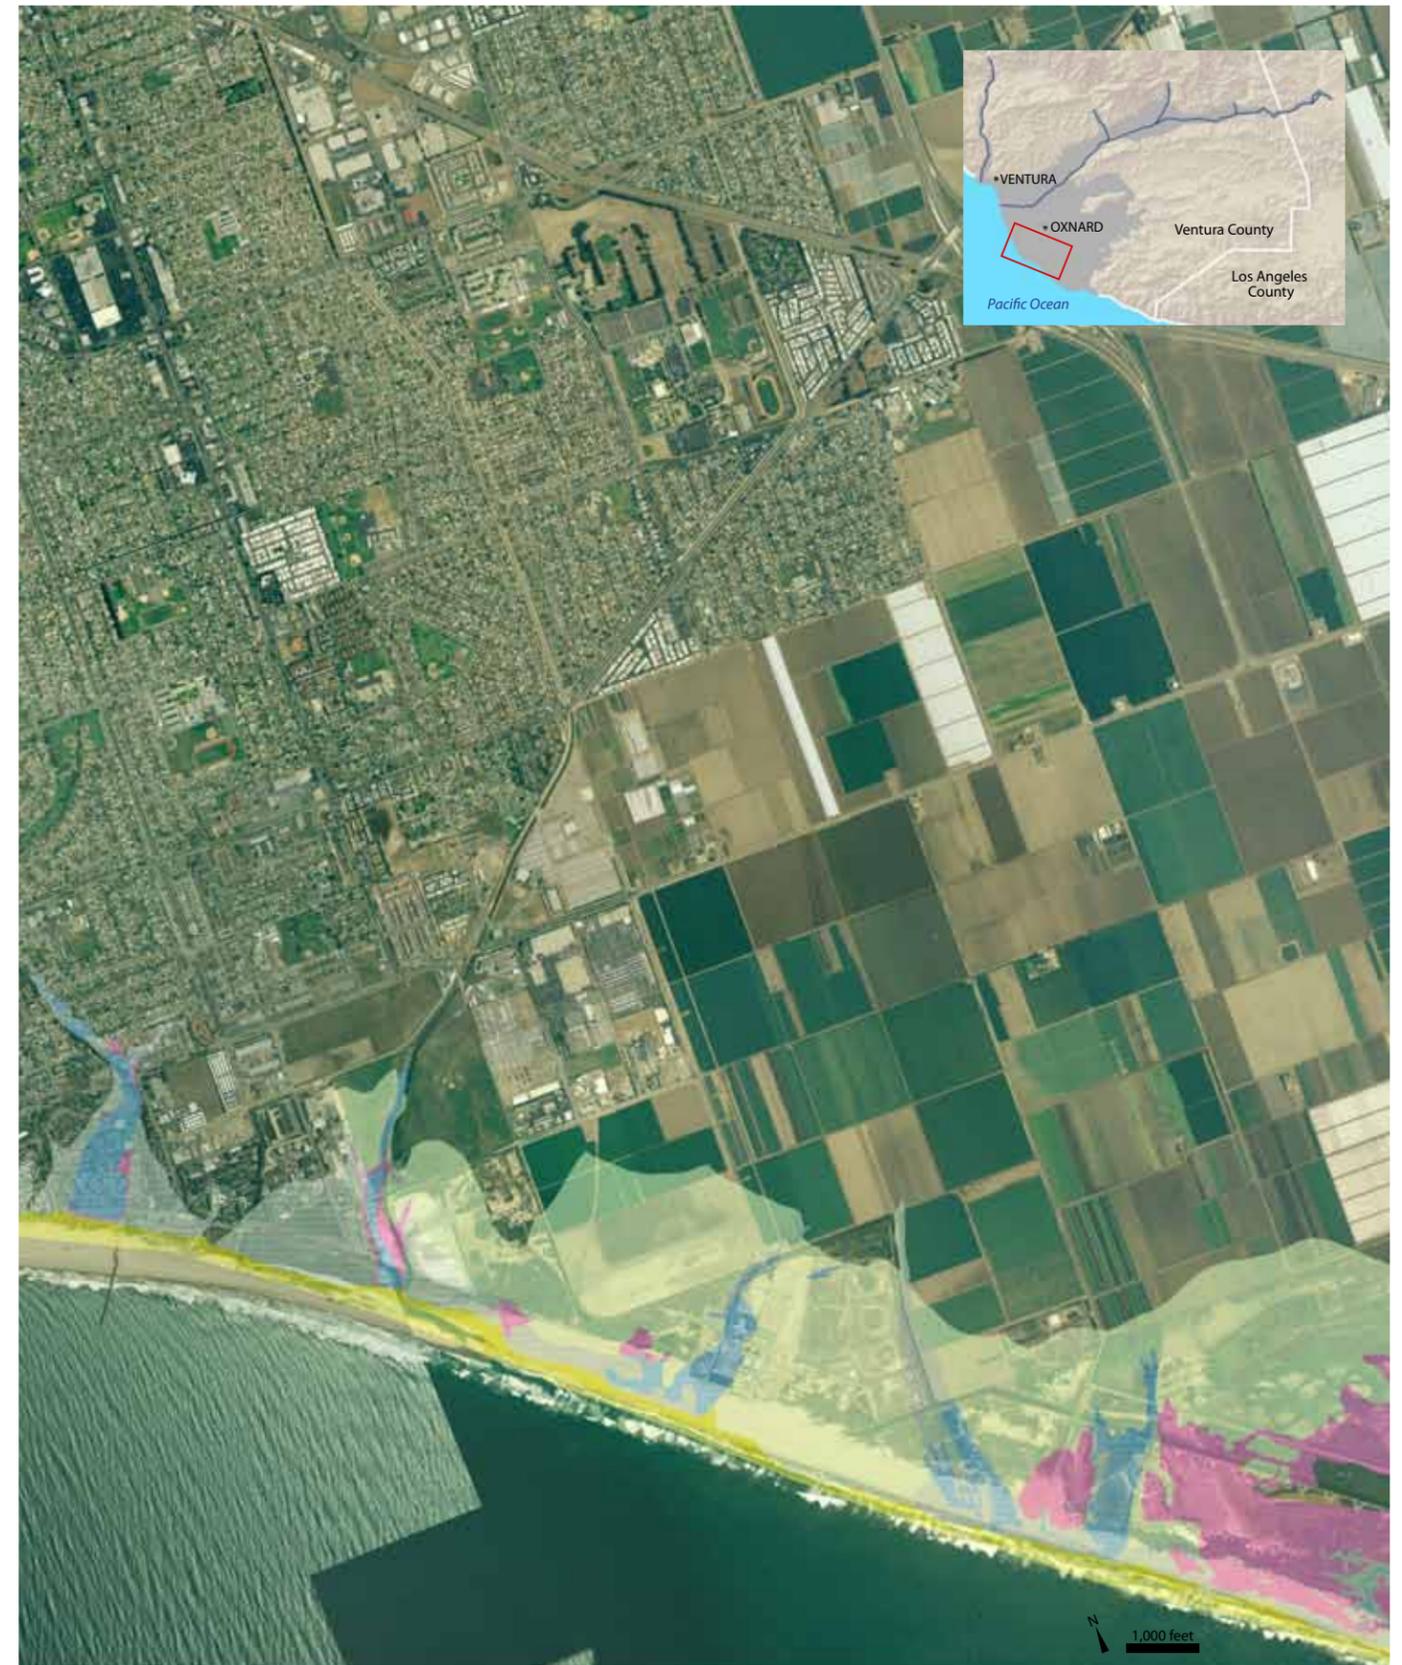
**Fig. 6.24. Oxnard Plain shoreline, 2005.** By 2005, most traces of the former lagoon complexes have been erased. A few markers remain, such as sloughs near Ormond Beach that used to empty into lagoons (portions of which have been repurposed as the Oxnard Industrial Drain and the Hueneme Drain). A lagoon similar to former features has formed to the east of Laguna Hueneme at Ormond Beach. (USDA 2005)

Most traces of the other lagoon complexes have been completely obliterated over the past 100 years (figs. 6.23 and 6.24). Much of this change had already happened by the early 1930s, by which time a five mile long drainage ditch, stretching from south of the Santa Clara River all the way to its outlet at Hueneme and bisecting the former locations of many of the coastal lagoons, had been constructed to drain the area.

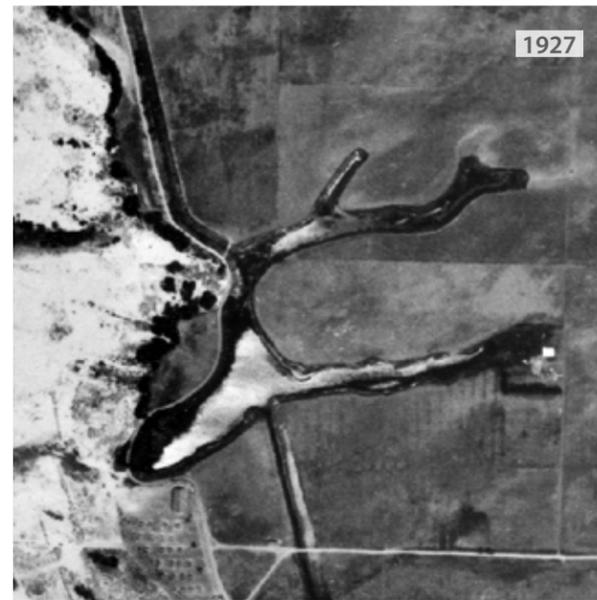
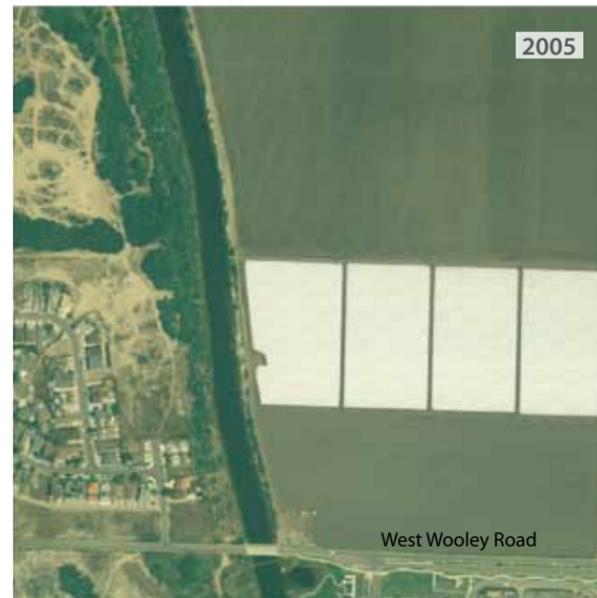
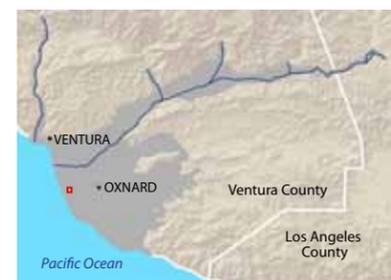
**Fig. 6.25.** In 1855, a small (14 acre) coastal lagoon was recorded by the U.S. Coast Survey, at what is now the end of West Wooley Road at Mandalay Bay (top left). Nearly 80 years later, in the descriptive report accompanying the T-sheet resurvey, the cartographers note that a drainage ditch (visible here on the aerials; top right) “has drained the salt pond shown on the former work... although the general shape as a dry hole is still apparent” (bottom left; Kelsh and Green 1934c). By 2005 all traces of the lagoon have been erased: only the drainage ditch remains (bottom right). (Johnson 1855b, courtesy of the National Oceanic and Atmospheric Administration; Fairchild Aerial Surveys 1927, courtesy of Whittier College; Kelsh 1933b; courtesy of IMC; USDA 2005)

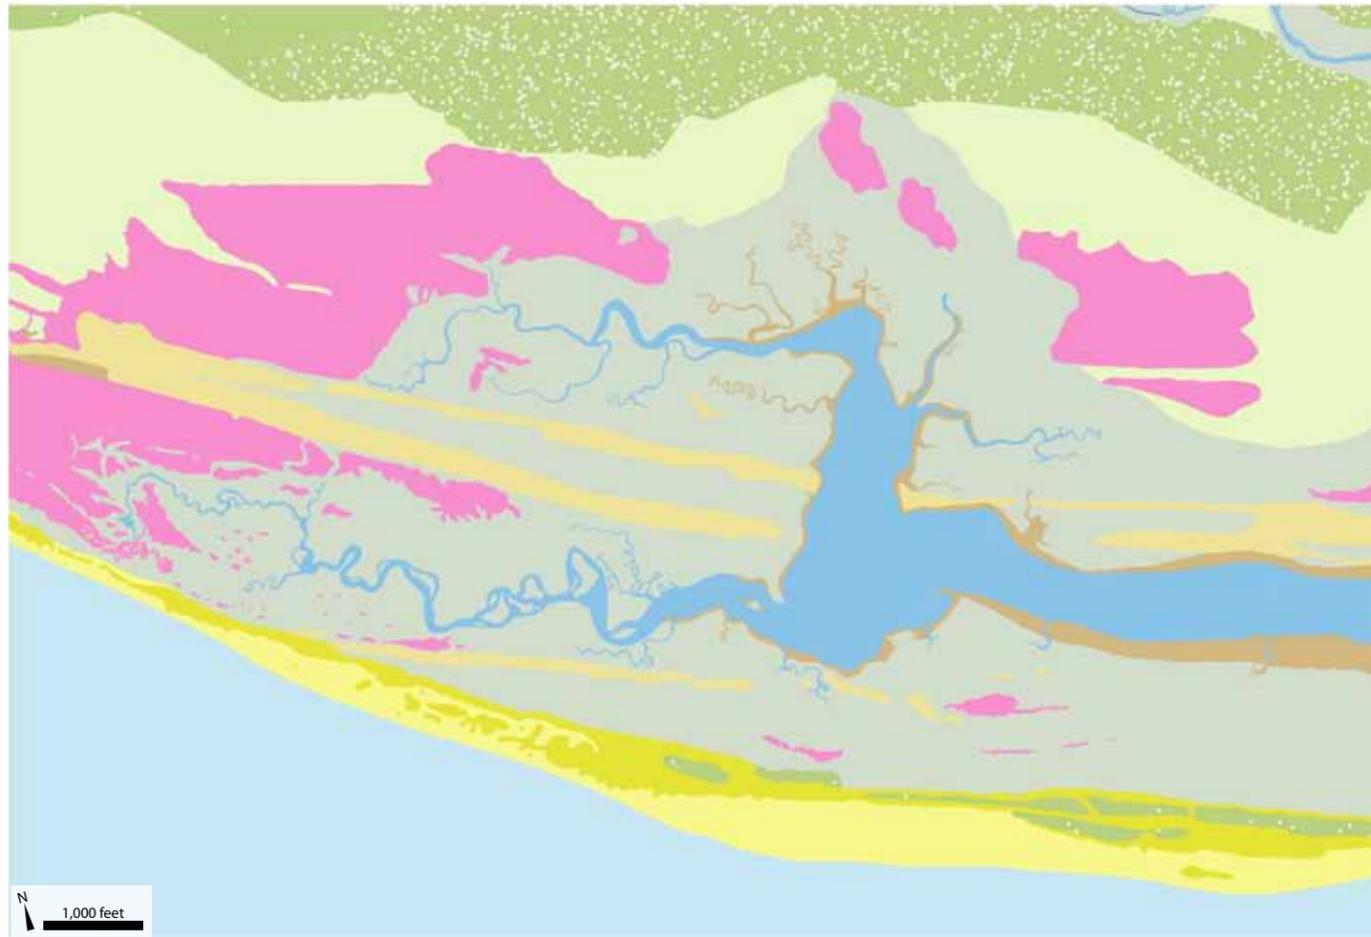
**Fig. 6.26. Habitats of Mugu Lagoon, early 1800s.** The historical habitat mosaic surrounding Mugu Lagoon included substantial amounts of subtidal habitat, tidal flat, tidal marsh, tidal channels, marsh pannes, salt flat, vegetated former dune strands, and high marsh-alkali meadow transitional zones.

The historical habitat mosaic at Mugu Lagoon included substantial amounts of subtidal habitat, tidal flat, tidal marsh, tidal channels, salt pannes/seasonal ponds, salt flat/playa, vegetated former dune strands, and high marsh-alkali meadow transitional zones (fig. 6.26). Most of these features are shown in detail in the 1857 US Coast Survey T-sheet (Johnson 1857; fig. 6.27). The predominant habitat type at this time was tidal marsh (58%), with the remainder of the area distributed among subtidal water (14%), tidal flat (12%), salt flat/marsh panne (10%), and open water ponds (5%).

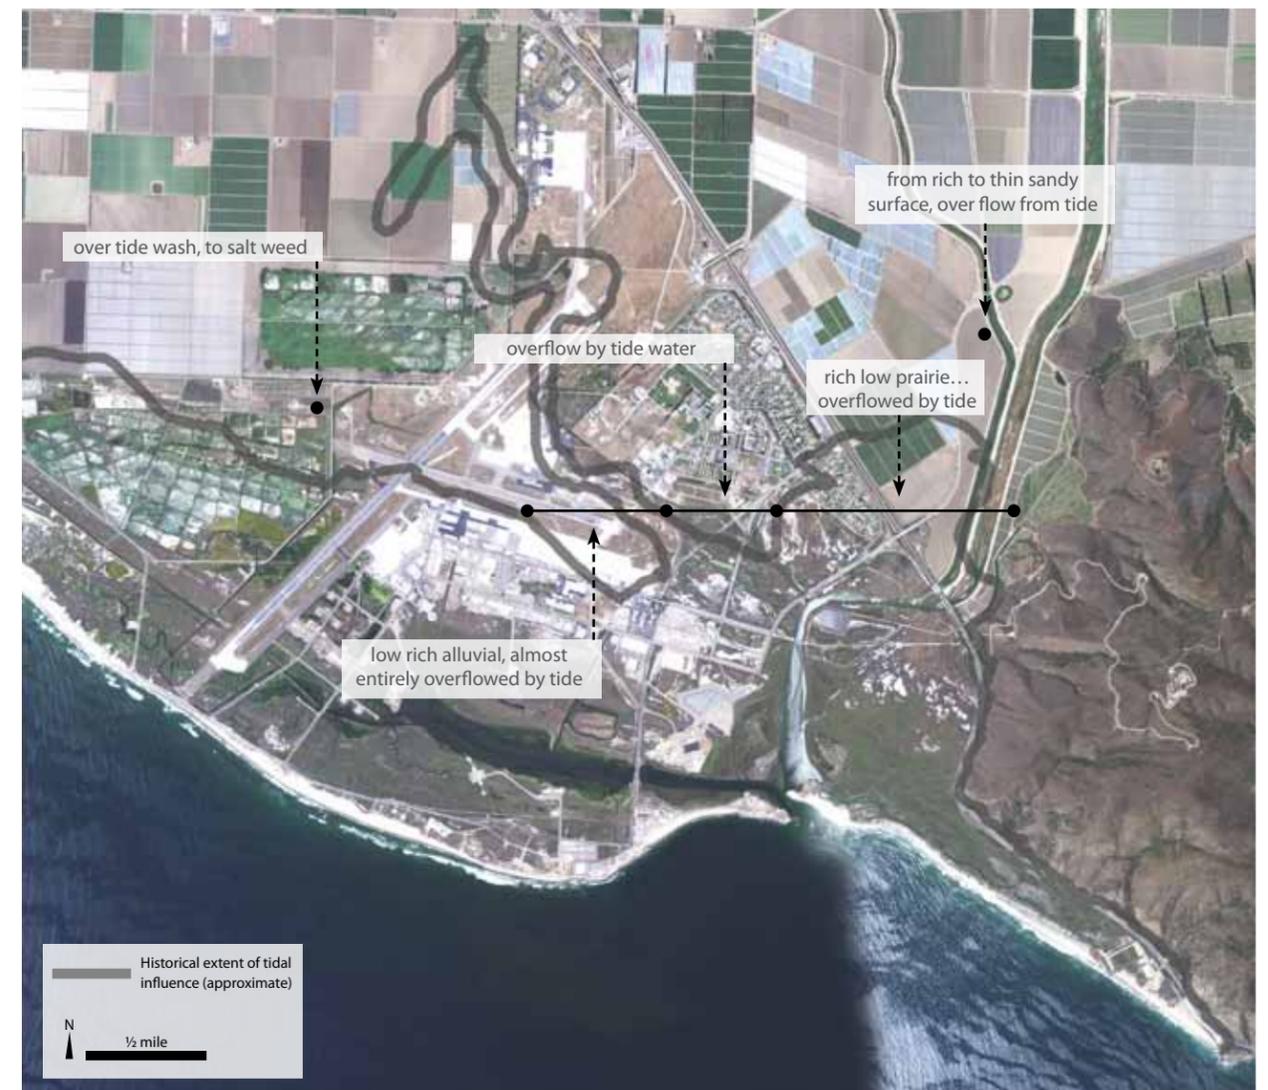
**Fig. 6.28. Historical extent of tidal influence at Point Mugu, early 1800s.** The Mugu Lagoon wetland complex, including high marsh transition zone areas, extended quite far inland in the 19th century compared to its current extent. Early surveyor’s notes hint that the tidal zone may have extended even further inland, as shown by the excerpts above. Excerpts along the survey line refer to a line segment rather than an individual point. (USDA 2009)

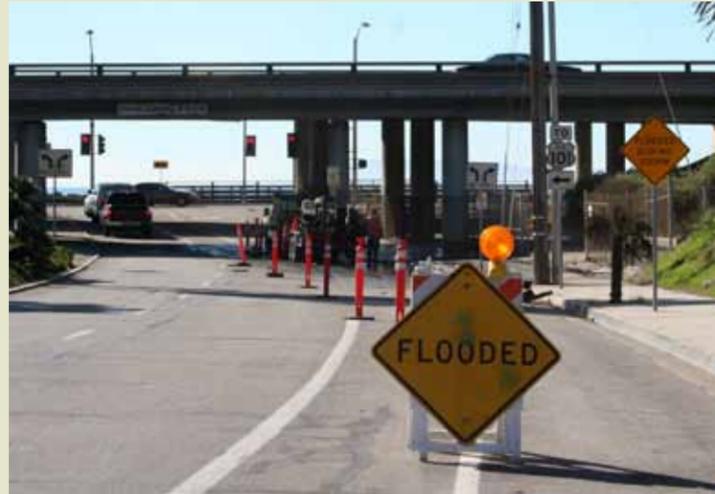
**Fig. 6.29. San Jon Road at Highway 101,** looking west. Areas of the Pierpont lowland are still susceptible to flooding, as shown in this December 2008 photograph.

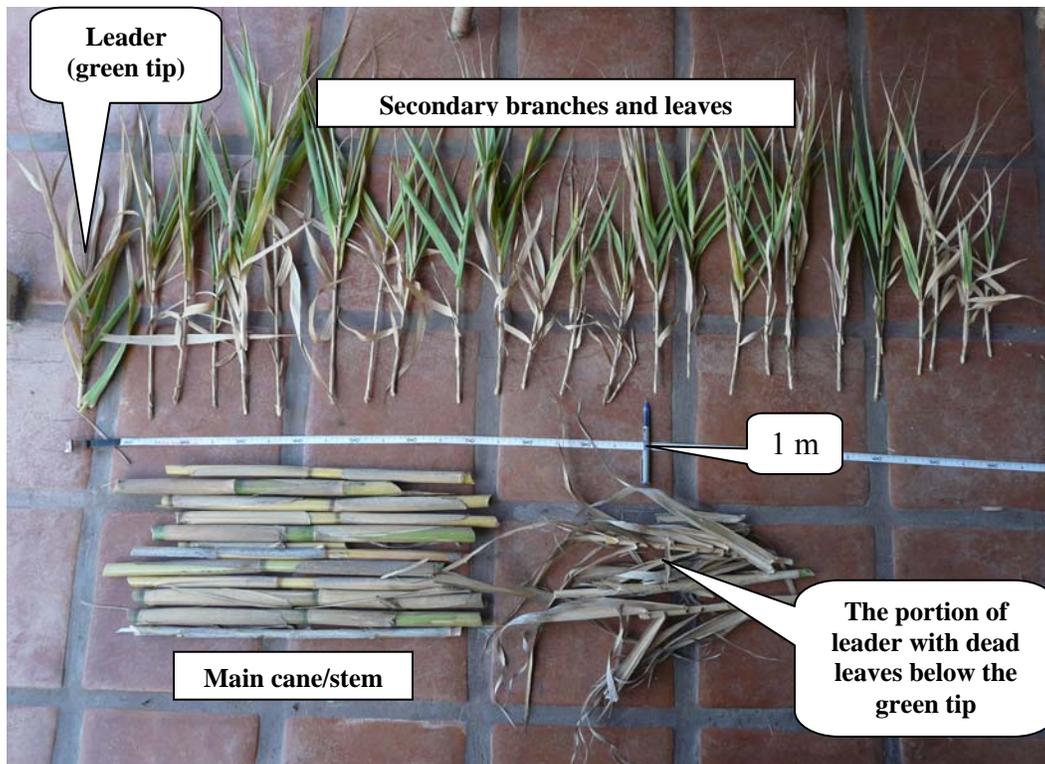
**Figure 2-4.** A single older cane with all secondary branches (25), leader, and main stem. This was cane SD#1b from the San Diego River with a height of 8.1m.

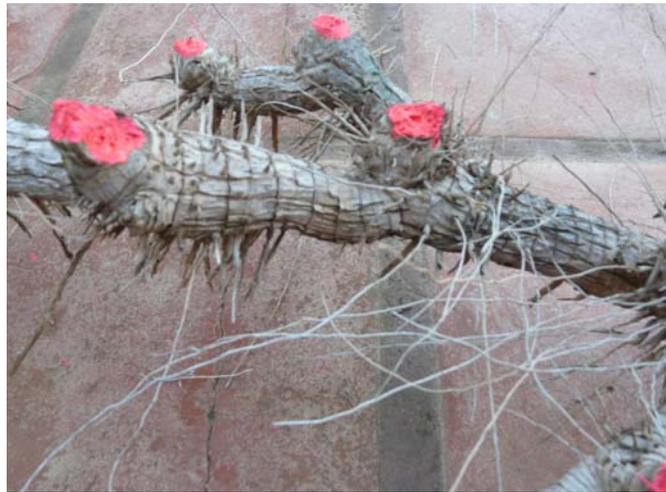
**Figure 2-10.** Close-up of slightly desiccated *Arundo* rhizome. The cane emergence points at the nodes are painted red, and long thin roots are visible.

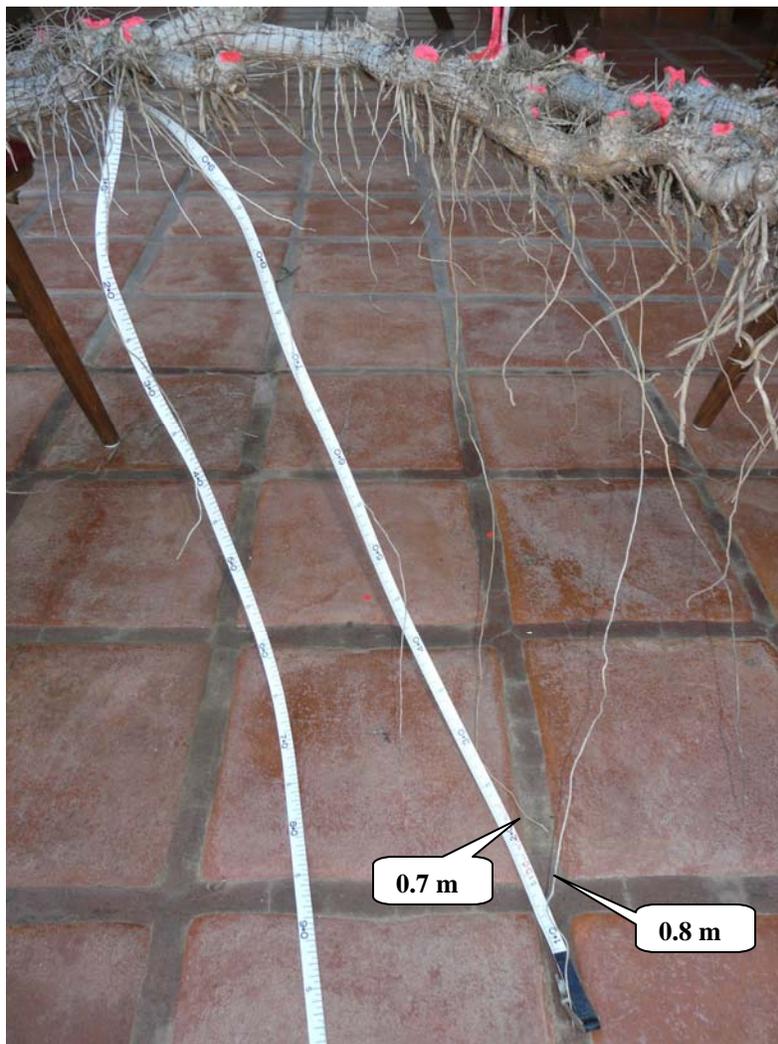
**Figure 2-11.** Rhizome network showing root length of up to 80 cm. This was a dislodged rhizome network scoured out by flood action, so many of the roots have already been broken off, but it gives an idea of root density (near the rhizome) and length.

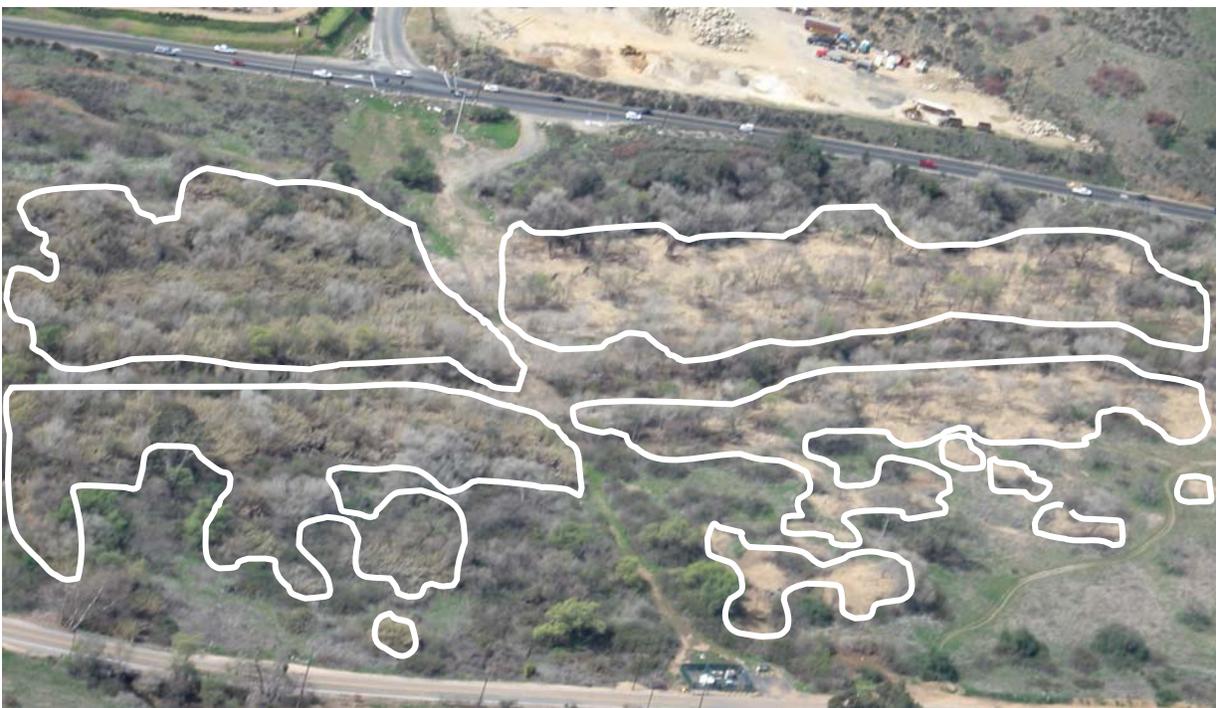
**Figure 2-14.** Oblique aerial photo showing patchiness of *Arundo* stands, particularly farther from the low-flow channel.

Greater patchiness means greater edge area composed of *Arundo* cover without actual canes emerging. The left side of image is unmowed/reduced *Arundo* and the right is immediately after reduction/mowing (San Luis Rey River 2007, J. Giessow).

The second area that has no canes in the aerial canopy of a stand occurs as alleys or gaps and is less predictable to specific locations of the stand (Figures 2-12 & 14). These areas are important in mid to large-sized stands that often form as multiple clumps grow into each other. As the stands grow older, these 'alleys' or gaps fill in. *Arundo* stands older than 10 to 15 years have fewer and fewer areas within the stand that have no canes. *Arundo* stands older than 20 years are difficult to sample internally, as these areas are not accessible from the ground. Old *Arundo* stands are more easily traversed across the top of the canopy than on the ground, where cane density precludes movement (Figures 2-15 & 16). Vegetation sampling crews on the Santa Margarita River could walk across the *Arundo* canopy for hundreds of meters in 1996 (Cummins pers. comm. 1998).

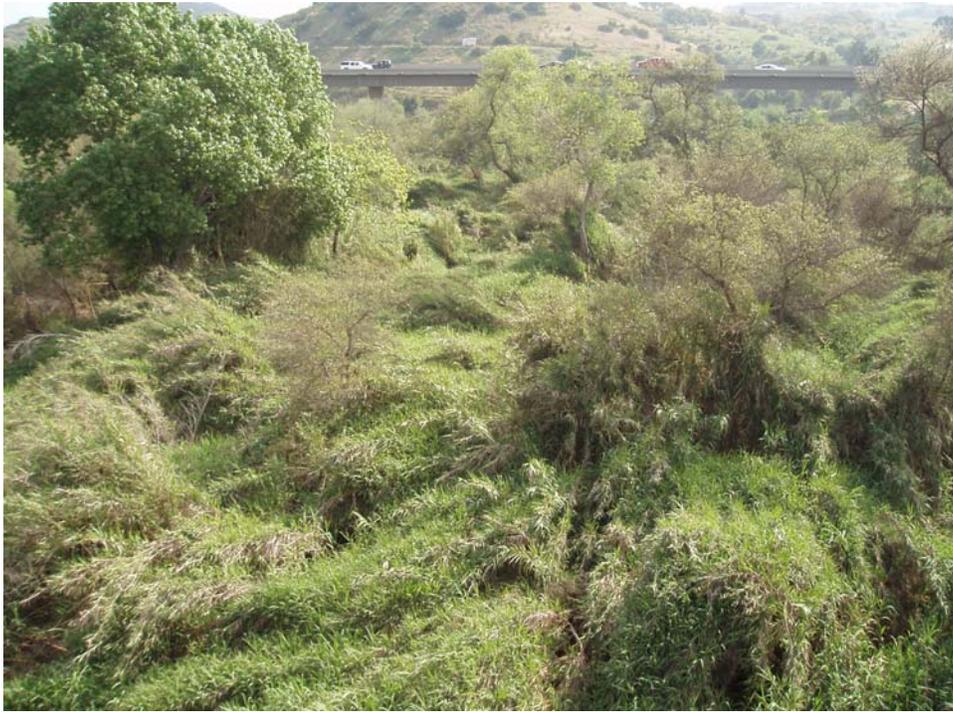
**Figure 2-15.** View from bridge over San Luis Rey River showing the top of a mature *Arundo* stand. This stand is >10 years old, > 9 m height, and 100% cover. Note the high amount of leaf surface area and non-vertical (nearly horizontal) position of the upper portion of the canes with secondary branches.

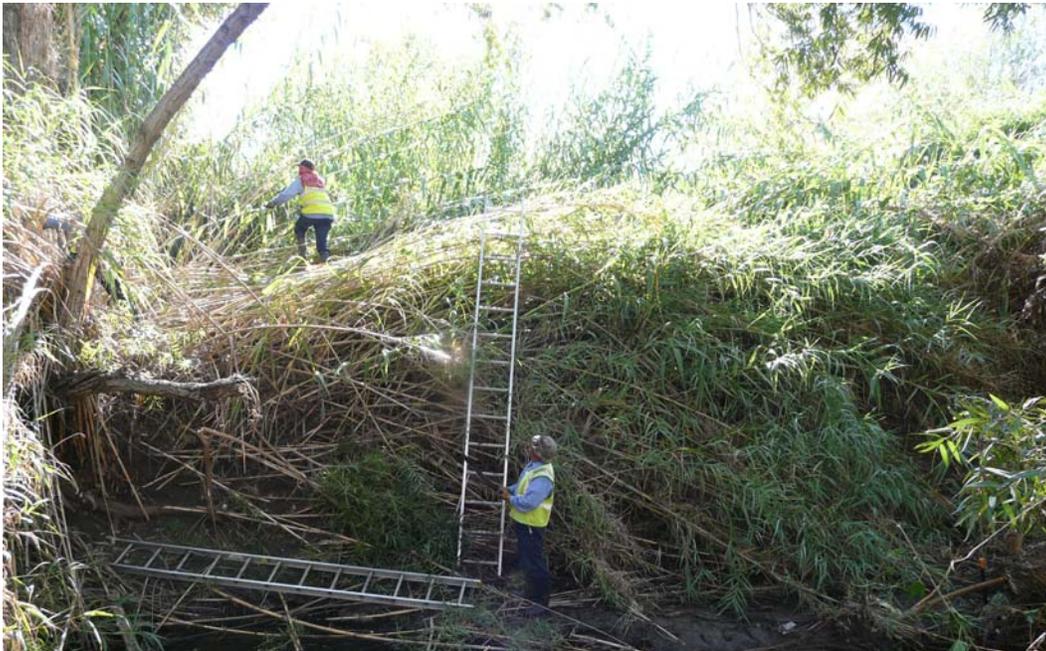
**Figure 2-16.** *Arundo* stand being prepared for foliar herbicide treatment. The crew is pushing the stand away from the native trees. *Arundo* canes are supporting the worker on the left. Canes are 8-9 m long and density is typical of a mature stand (about 40 canes/m<sup>2</sup>). San Diego River, Giessow 2010.

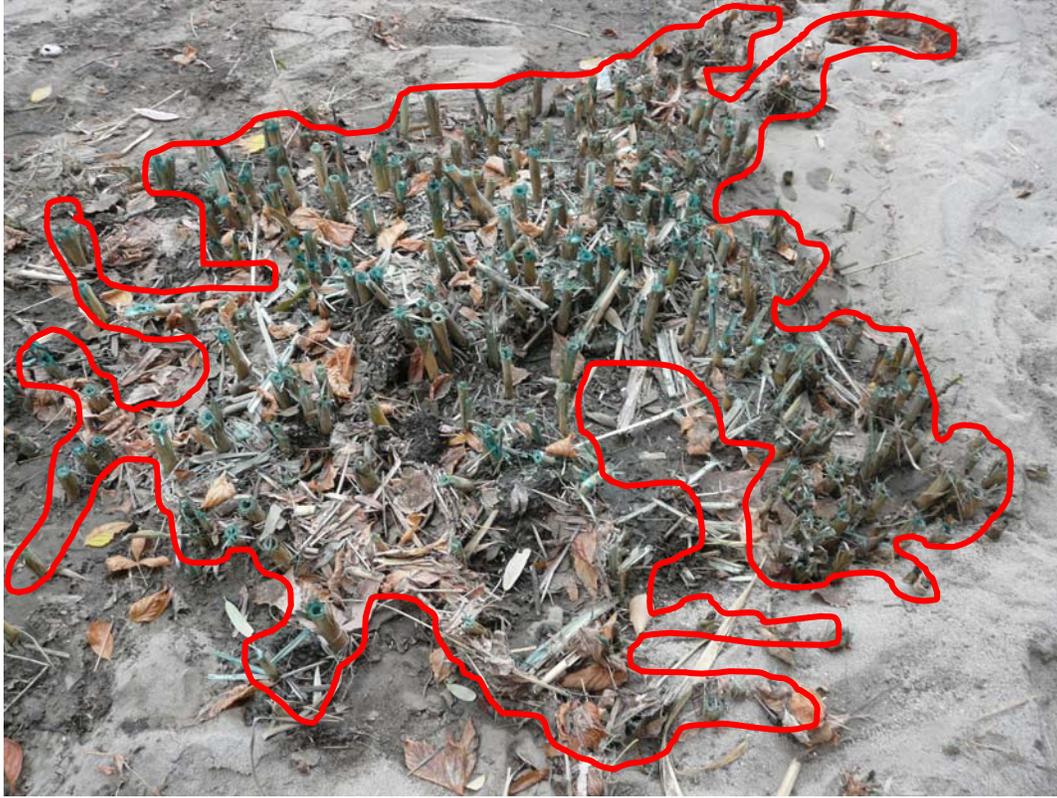
**Figure 2-17.** A cut *Arundo* clump showing uneven cane density.

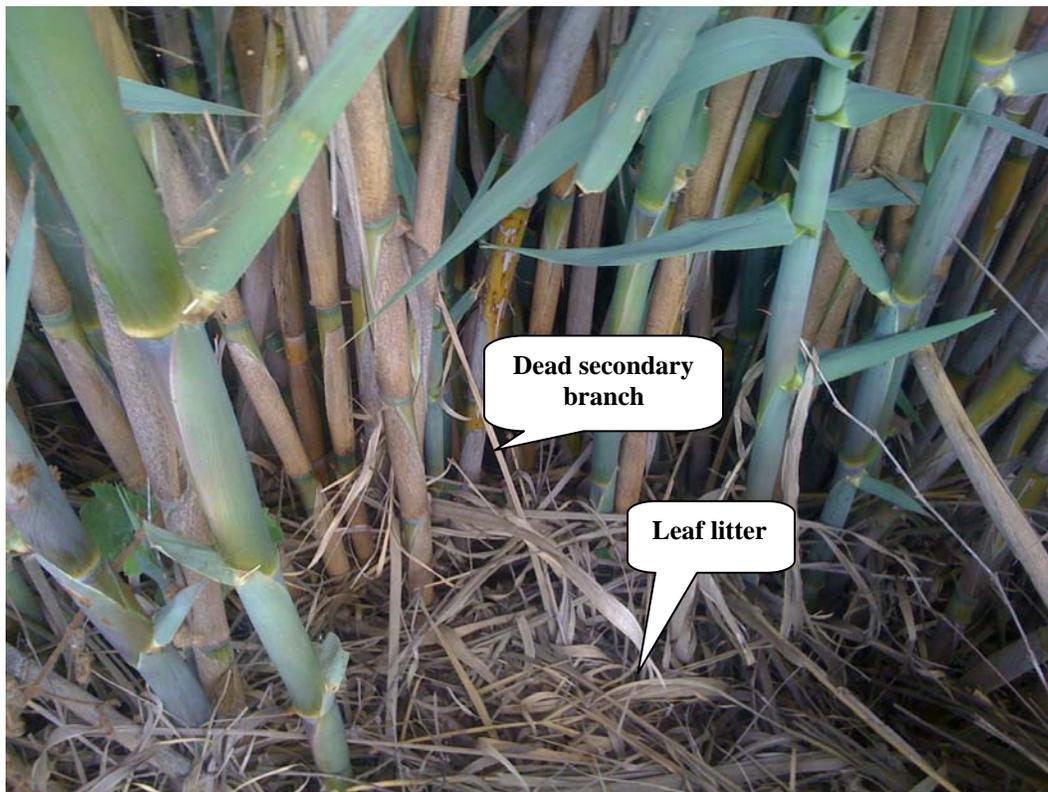
**Figure 2-18.** Cane density and dead leaf litter within a dense *Arundo* stand.

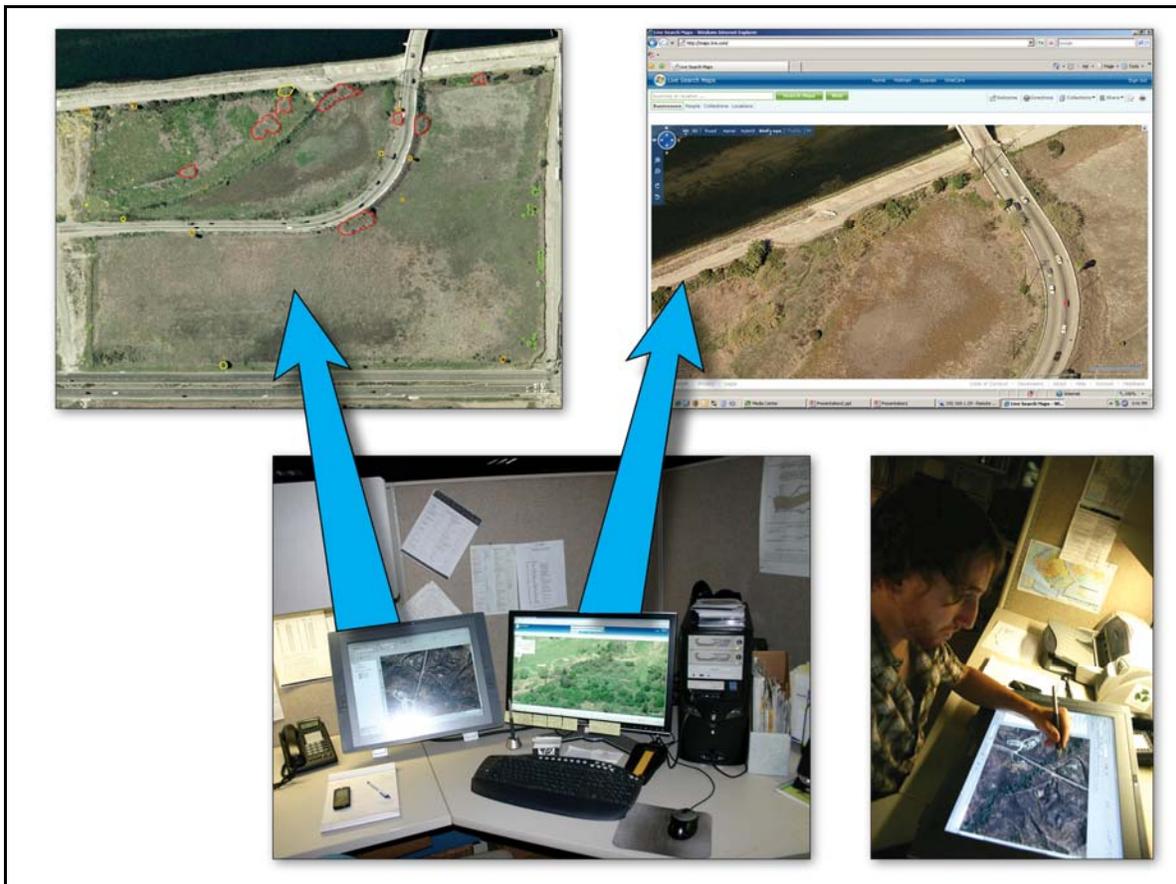
**Figure 3-2.** In-office surveys using a dual-monitor workstation.

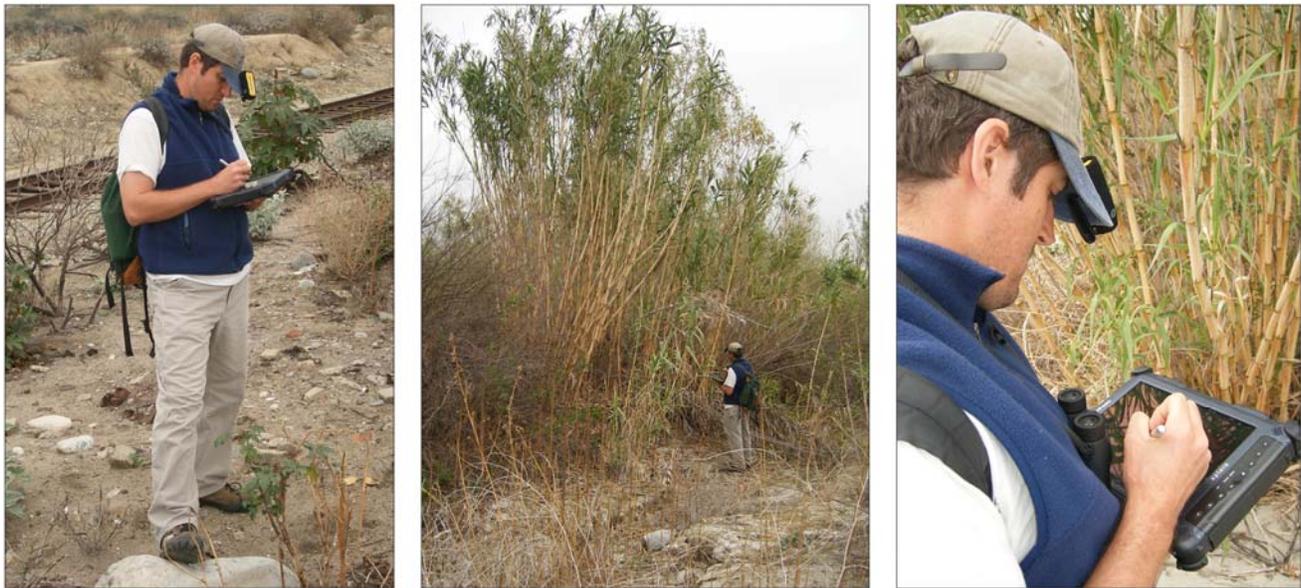
After the initial survey of a watershed was completed, the data was “checked out” of the GIS database and transferred to a ruggedized tablet PC. The field tablets used for this project (Xplore’s iX104c3) were outfitted with GPS receivers (mounted or bluetooth) with an accuracy of 2-5 m (with real-time corrections) (Figure 3-3). The most current vertical aerial photography from the GIS database was also transferred onto the tablet as a base layer for the field mapping software. ESRI’s ArcPad 8.0 was chosen as the mapping application because of its seamless integration between the field computers and central database back in the office. Toolbars in ArcPad were customized to optimize the time spent collecting data in the field.

**Figure 3-3.** Field surveys with ruggedized tablet PCs and integrated GPS.

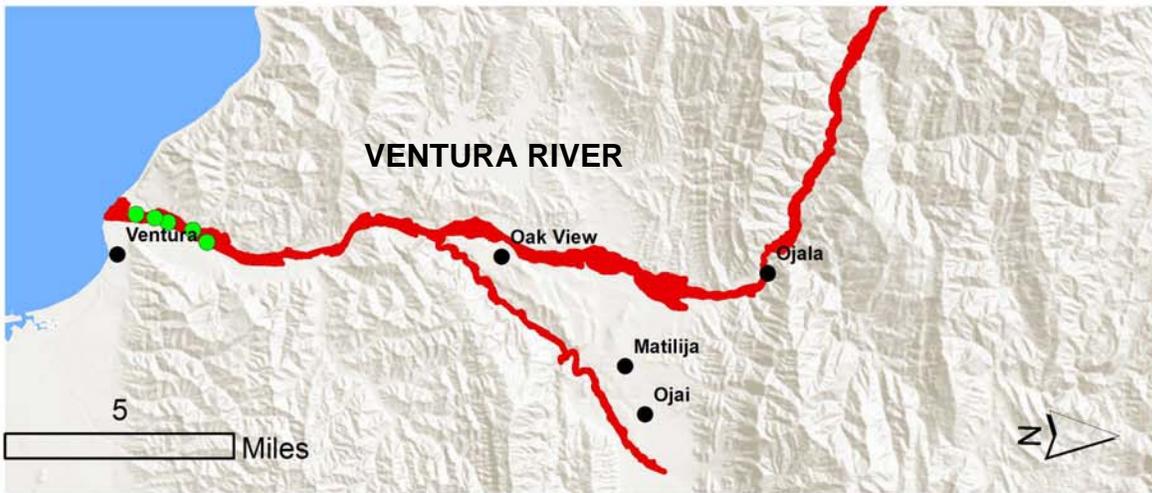
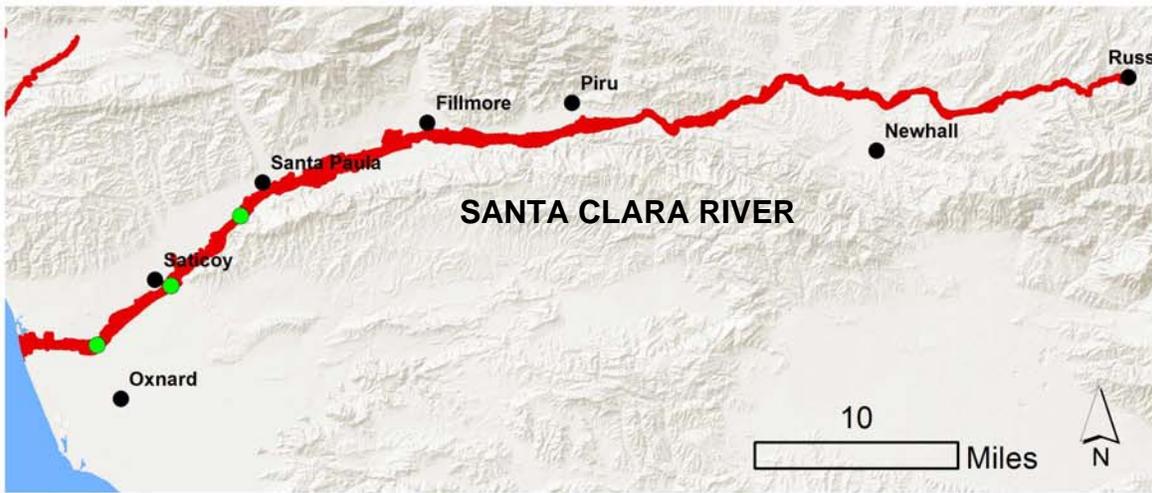
**Figure 5-2.1.** Location of the Area of Interest and cross-sections (northern watersheds).

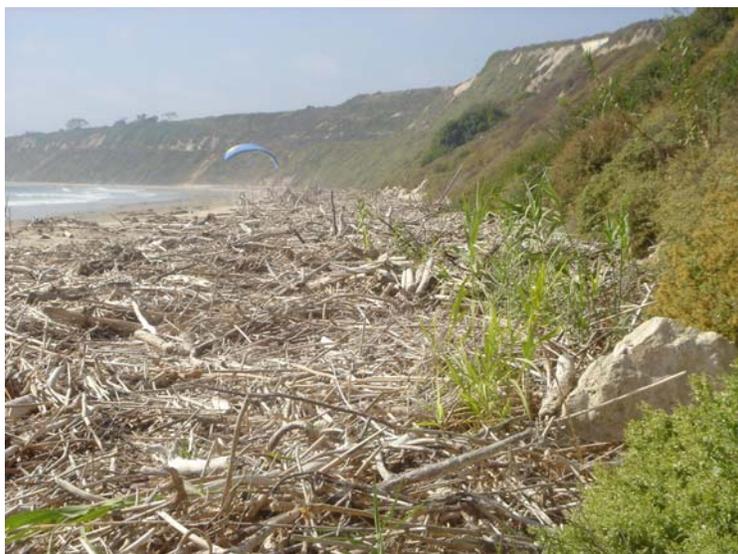
**Figure 5-2.30.** In Santa Barbara County, *Arundo* washes down the Santa Clara River and accumulates on Rincon Beach, blocking access for beachgoers and increasing the cost of beach maintenance. Photo by David Chang.

*Arundo* biomass on beaches following flow events is a recurring impact (Figure 5-2.30 & 5-2.31). In many areas, particularly from Santa Monica to San Diego, biomass is cleared by Municipal, County and State workers using tractors, loaders and sweepers. Estimating the magnitude and cost of these efforts is complicated due to their periodic nature, in addition to a large range in the amount of material. *Arundo* biomass is not the only material discharged by river flow events. There are also other non-native plants, native plants and refuse. It is not unusual for more than 80% of the material to be *Arundo* biomass near heavily invaded watersheds (San Luis Rey, Santa Margarita, Santa Clara, Ventura). Two of these systems will have lower *Arundo* biomass yields in the future as most *Arundo* has been removed (San Luis Rey, Santa Margarita). Santa Ana has lower *Arundo* discharge than other systems because most *Arundo* is present above the Prado Dam. Small and mid-sized watersheds may discharge large amounts of *Arundo* material, particularly watersheds in the Los Angeles basin (Douce 1993).

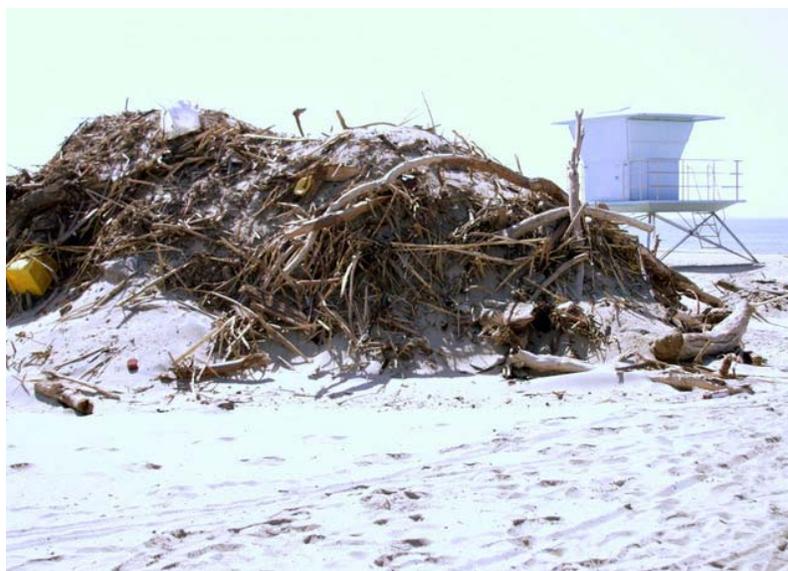
**Figure 5-2.31.** *Arundo* and other biomass washed onto the beach in Long Beach after a large flow event on the Los Angeles/San Gabriel River. Photo by Drew Ready.

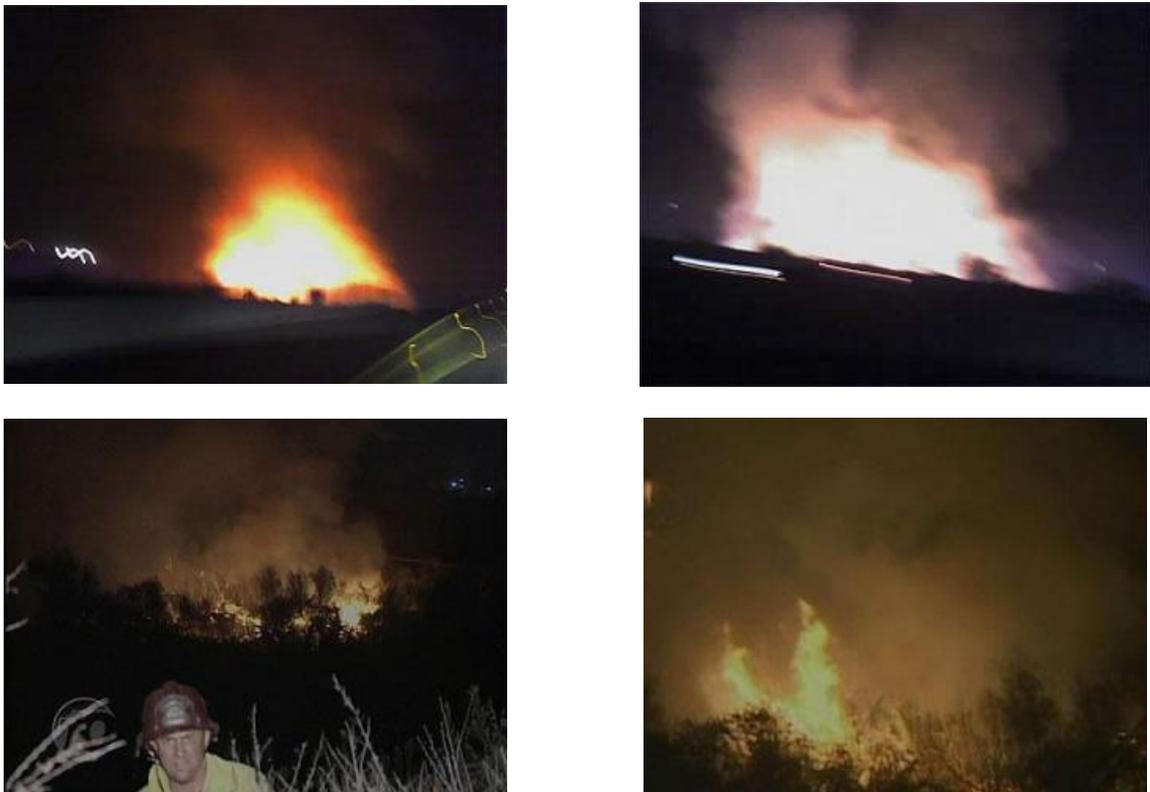
**Figure 6-2.** This fire started in *Arundo* at night during a light rain in October 2006. Photos from San Diego News outlets (Fires SLR#1-3).

Three fires (SLR #1 to 3) occurred near the river mouth between October 2006 and March 2007 (Figures 6-2, 6-12 to 14). These fires were reported in local newspapers and observed by Jason Giessow (this study). Fire suppression clear zones as well as fuel break strips were created to contain the fire (Figures 6-13&14). The ignition source for at least one fire was believed to be an arsonist. Transient use of the area was also high. The fires burned a total of 27.7 acres, and 5.6 acres of habitat were cleared during fire suppression activities (Table 6-3).

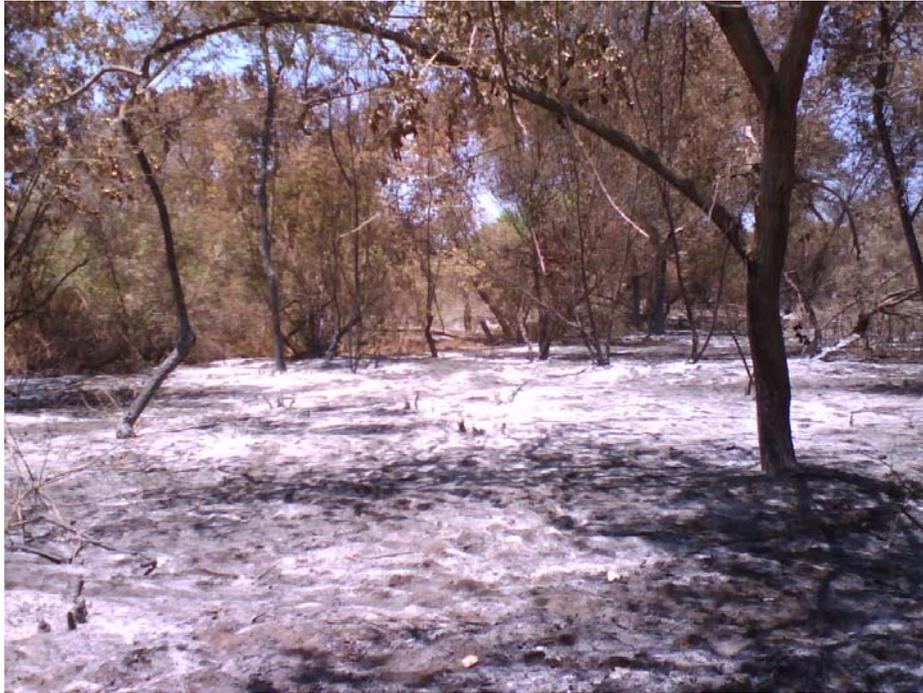
**Figure 6-3.** Burned *Arundo* stands on the San Luis Rey River (Fire SLR #6).

The large amount of biomass per unit area along with a favorable structure for burning generates fires that burn intensively. This is illustrated by fire behavior and an examination of post-fire site conditions. Low intensity fires leave unburned material. Ash levels and color can also be used to gauge fire intensity. *Arundo* fires usually leave little unburned biomass and ash is usually white (Figures 6-3 & 4, also section 6.4 photos).

A large fire occurred on June 17, 2007 near Gird Road and Highway 76 (SLR #5; Figures 6-3 & 4, 6-12 & 16). This struck during high fire season and burned a larger area than the other fires on the river. The fire was 64.31 acres in size and fire suppression activities disturbed an additional 0.90 acres. This fire had active suppression, but would likely have been much larger were it not for a vertical 30-foot river bank that served as a natural fuel break on the southern edge of the fire line. The ignition source was likely a campfire related to cannabis cultivation within the central portion of the *Arundo* stand (Figure 6-10). Irrigation tubing was observed leading into the stand area from the river.
