## **HISTORICAL ECOLOGY of the lower Santa Clara River, Ventura River, and Oxnard Plain: an analysis of terrestrial, riverine, and coastal habitats**

HISTORICAL ECOLOGY PROGRAM  
CONTRIBUTION NO. 641 • AUGUST 2011

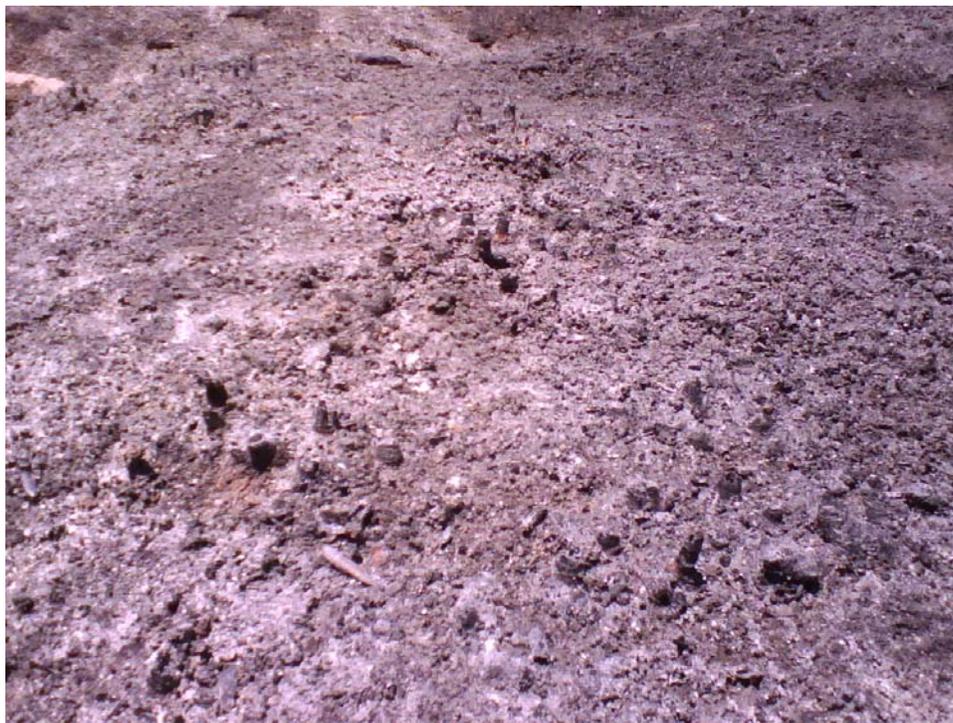
**Figure 6-4.** Burned *Arundo* stands on the San Luis Rey River (Fire SLR #6).

The large amount of biomass per unit area along with a favorable structure for burning generates fires that burn intensively. This is illustrated by fire behavior and an examination of post-fire site conditions. Low intensity fires leave unburned material. Ash levels and color can also be used to gauge fire intensity. *Arundo* fires usually leave little unburned biomass and ash is usually white (Figures 6-3 & 4, also section 6.4 photos).

A large fire occurred on June 17, 2007 near Gird Road and Highway 76 (SLR #5; Figures 6-3 & 4, 6-12 & 16). This struck during high fire season and burned a larger area than the other fires on the river. The fire was 64.31 acres in size and fire suppression activities disturbed an additional 0.90 acres. This fire had active suppression, but would likely have been much larger were it not for a vertical 30-foot river bank that served as a natural fuel break on the southern edge of the fire line. The ignition source was likely a campfire related to cannabis cultivation within the central portion of the *Arundo* stand (Figure 6-10). Irrigation tubing was observed leading into the stand area from the river.

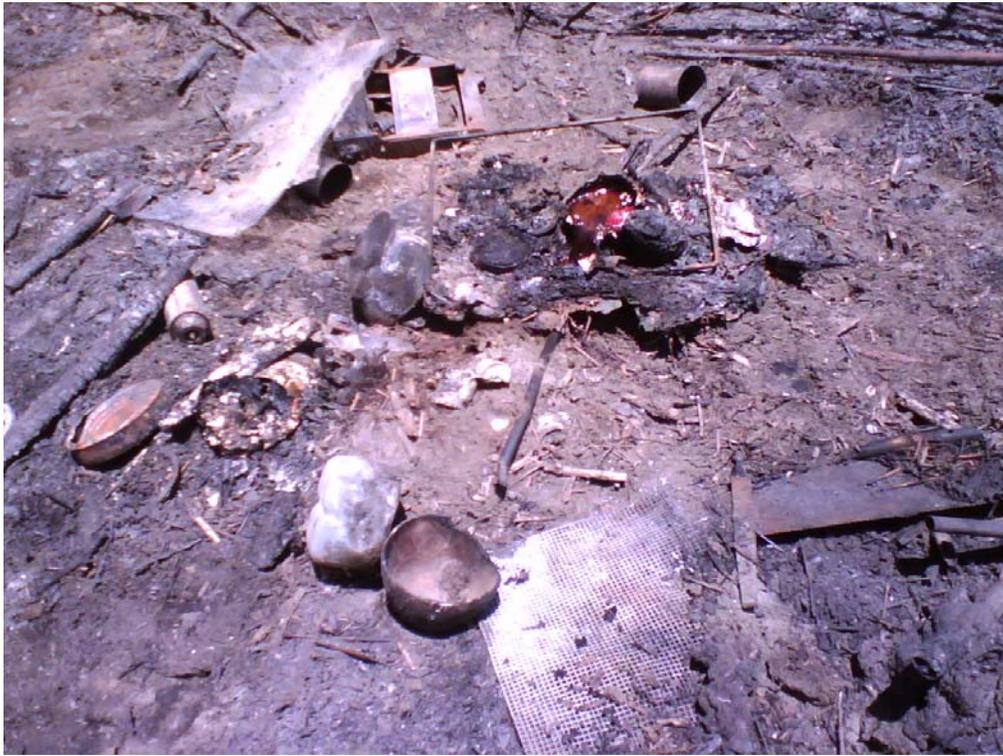
**Figure 6-10.** Open fire associated with workers of a cannabis plantation. This was the ignition source of a wildfire that started within *Arundo* on the San Luis Rey River (Fire SLR #6).

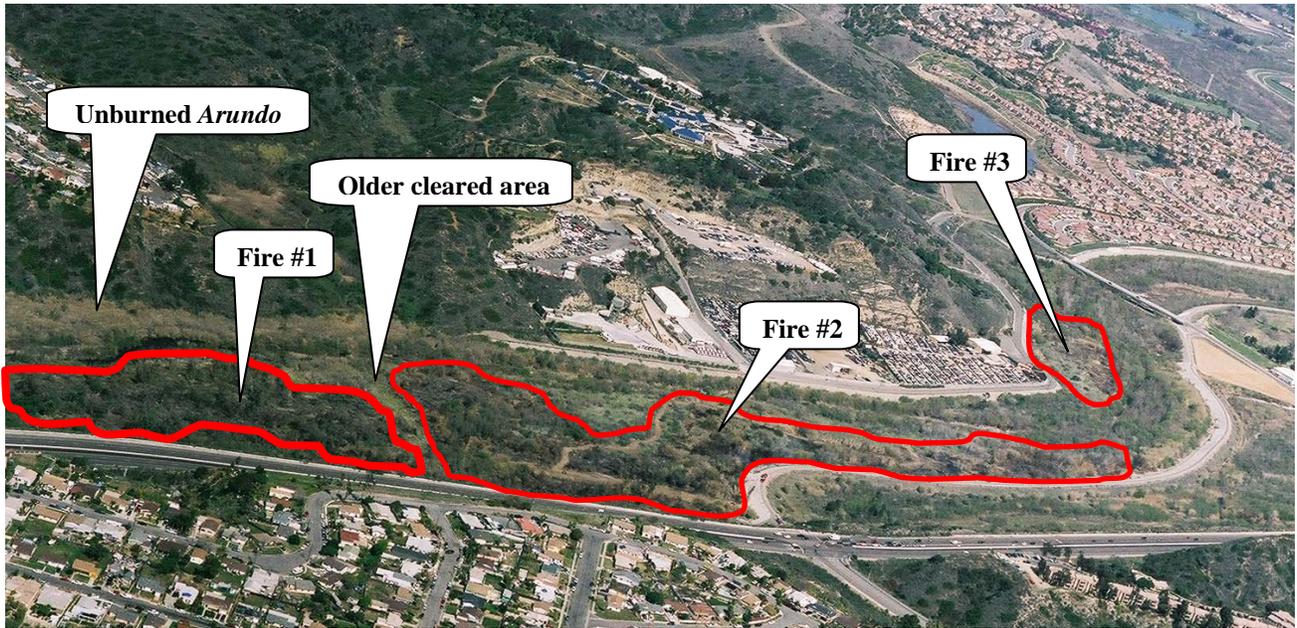
**Figure 6-13.** Footprint of fires # SLR 1-3 on the San Luis Rey River.

Three fires (SLR #1 to 3) occurred near the river mouth between October 2006 and March 2007 (Figures 6-2, 6-12 to 14). These fires were reported in local newspapers and observed by Jason Giessow (this study). Fire suppression clear zones as well as fuel break strips were created to contain the fire (Figures 6-13&14). The ignition source for at least one fire was believed to be an arsonist. Transient use of the area was also high. The fires burned a total of 27.7 acres, and 5.6 acres of habitat were cleared during fire suppression activities (Table 6-3).

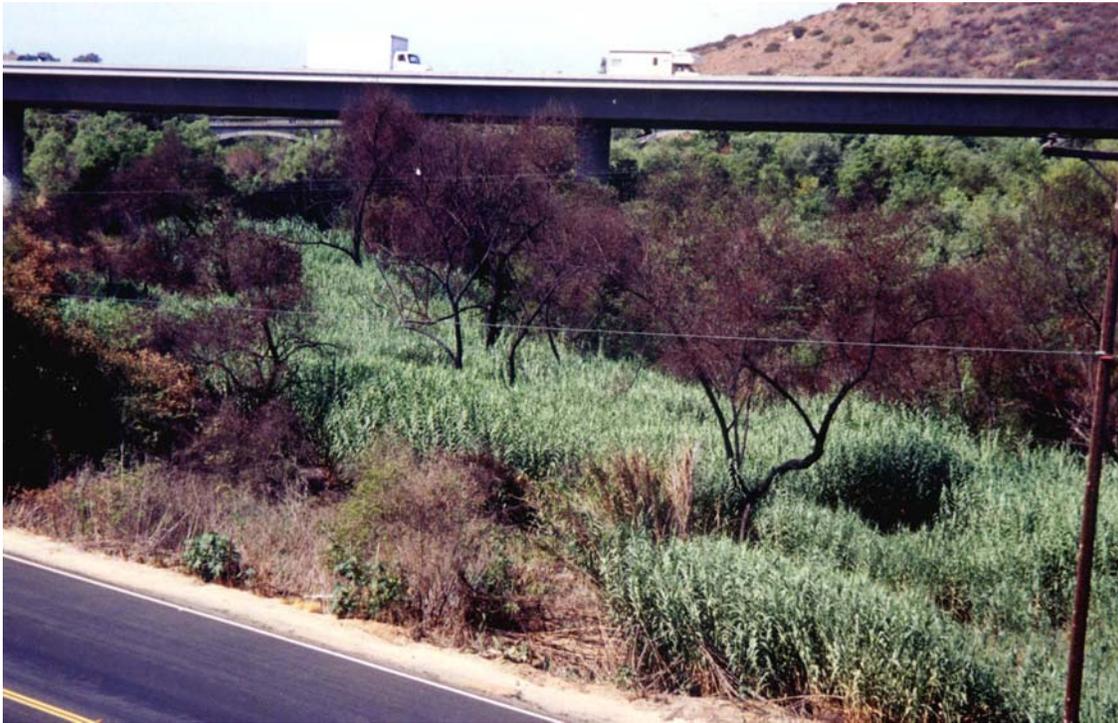
**Figure 6-15.** *Arundo* resprouting after a fire on the San Luis Rey River. Native trees are either dead, or still dormant (Fire SLR #5).

Proceeding upstream, the next fire (SLR #4) occurred at the Highway 76 bridge over the San Luis Rey River near East Vista Way in June 2005. This fire burned 1.40 acres (Figures 6-12 & 15). No specific ignition source was identified, but it was likely either a discarded cigarette from the highway overpass or a transient camp. Both uses occur in that specific area. No fire lines were cut around the fire because the river channel and a road surrounded it.

*Arundo* stands have high fuel loads and a tall growth form. Infestations of *Arundo* mixed with native species spread fire vertically into the canopy of riparian trees, as well as burning trunks (Figures 6-15 to 17 & 6-20; Ambrose and Rundel 2007). After a fire, *Arundo* immediately (1-2 weeks) begins regrowth from its rhizomes, whereas native riparian plants can remain dormant for several months. High mortality of native trees and shrubs is frequent in comparison to *Arundo*. Furthermore, *Arundo* grows much faster than native plants, up to 3-4 times faster than native riparian plants after fire on the Santa Clara River (Ambrose and Rundel 2007). A year after the fire, *Arundo* dominated the area, comprising 99% relative cover and a 24% increase in relative cover compared to pre-fire conditions (Ambrose and Rundel 2007).

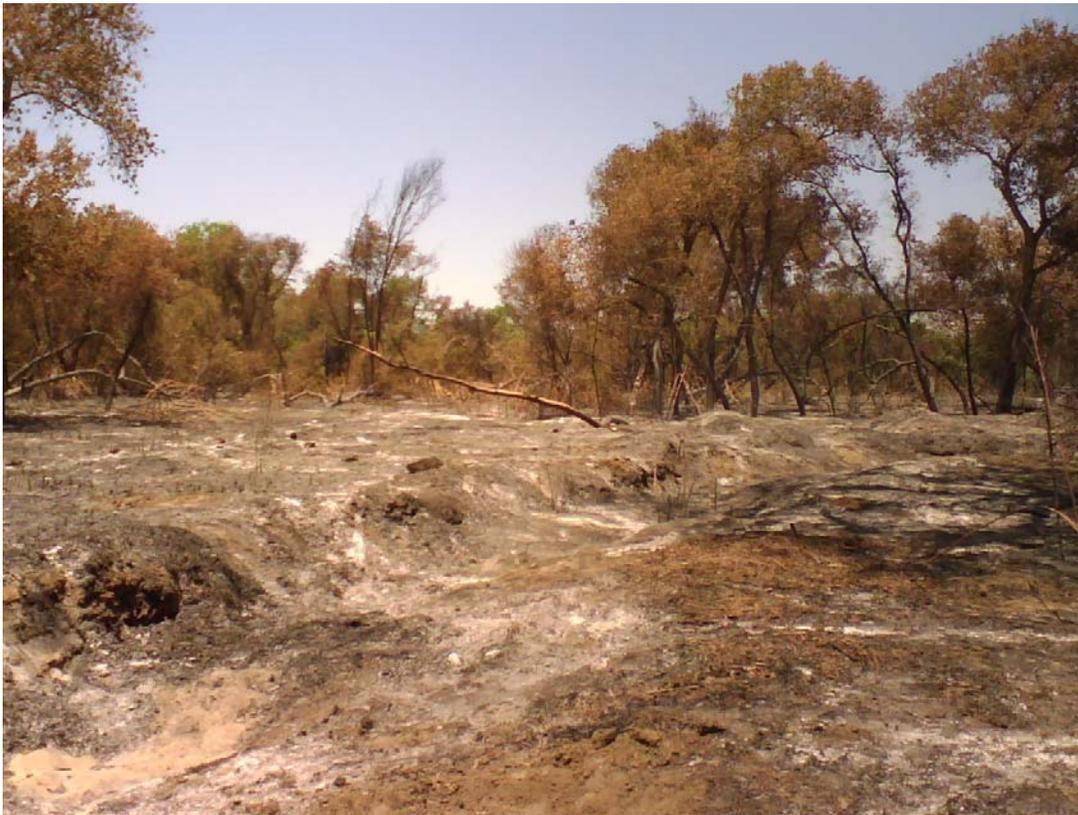
**Figure 6-16.** Immediately after a fire that burned an *Arundo* stand on the San Luis Rey River, leaving only ash and very little unburned material (Fire SLR #6).

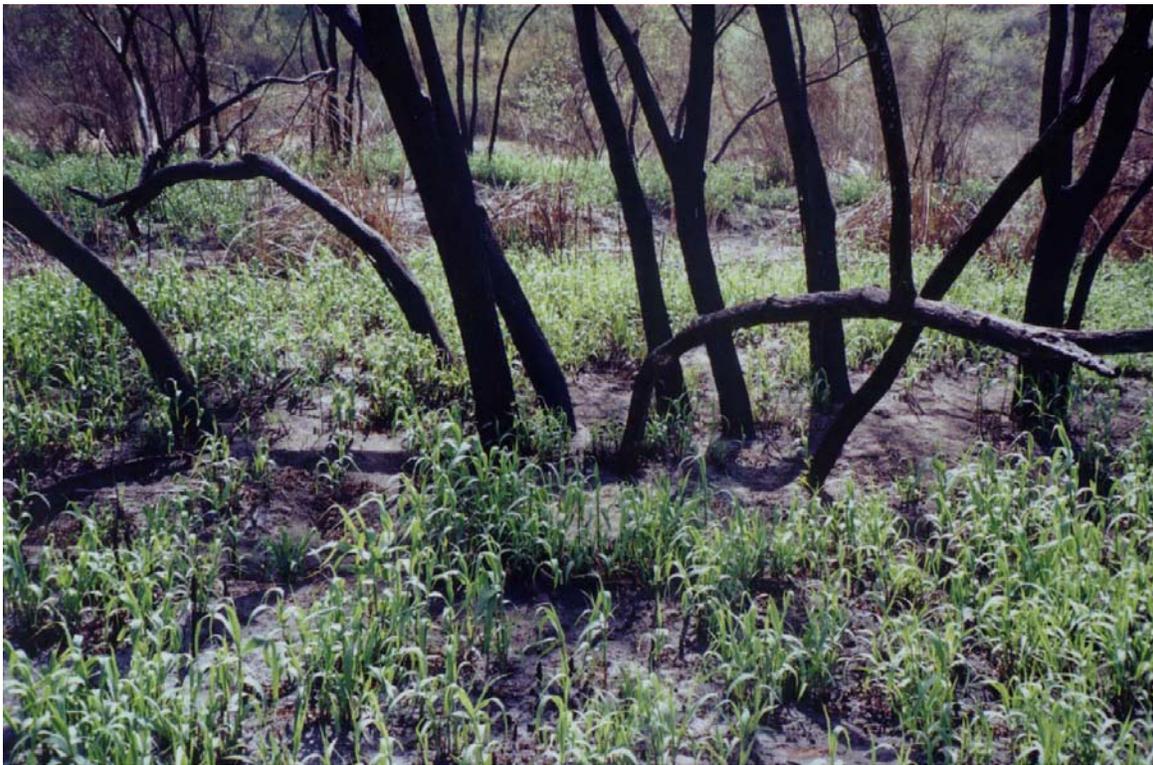
**Figure 6-17.** Shortly after a fire through *Arundo*-infested riparian habitat on the San Luis Rey River. This demonstrates the quick and dense resprouting of *Arundo* before any native vegetation (Fire SLR #7).

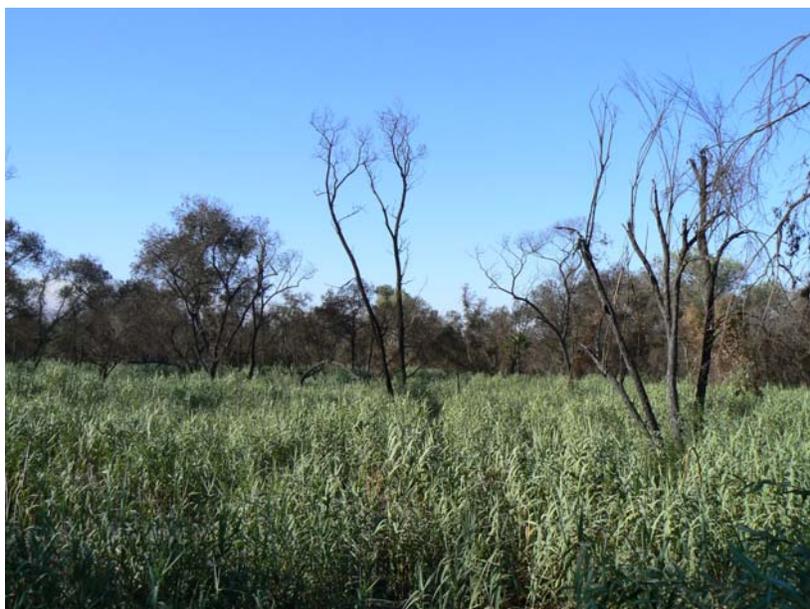
**Figure 6-20.** *Arundo* one year after a fire, already 2-3 feet high, at the site of fire SLR #6.
