Advisory
July 22, 2005

DWR Responds to Wheeler Island Levee Break

SACRAMENTO-The Department of Water Resources (DWR) is providing emergency response assistance at Wheeler Island in the Suisun Marsh following a levee break yesterday afternoon which sent water pouring in from adjacent Honker Bay.

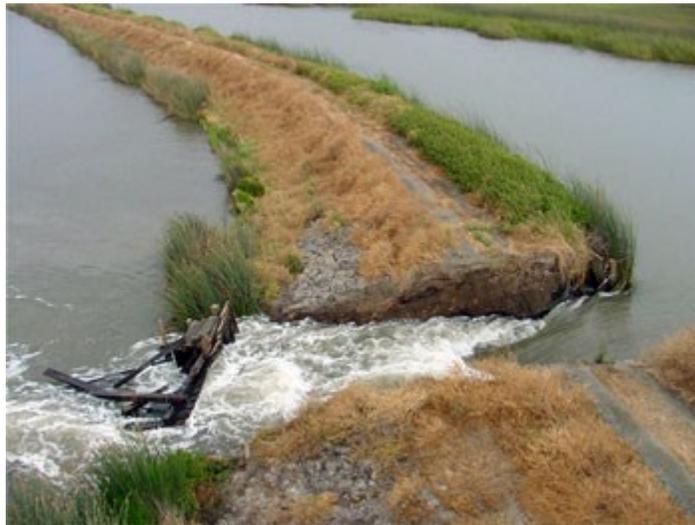
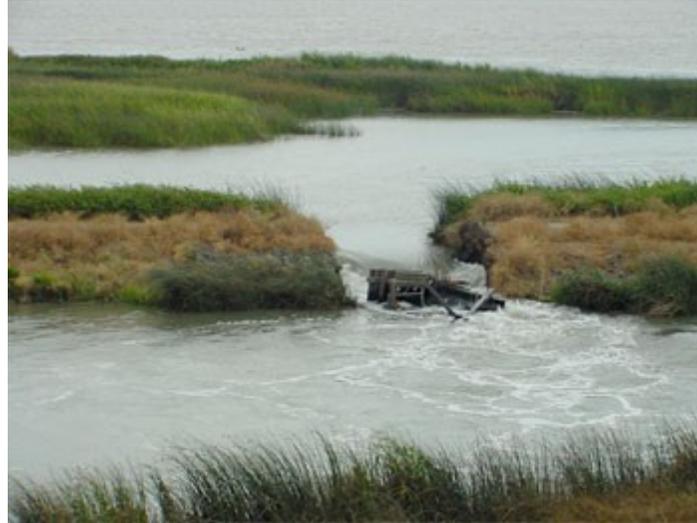
DWR began receiving reports around 2:30 p.m. Thursday regarding a 20 to 25 foot breach at the 1,000 acre Island just north of Pittsburg and south of the Grizzly Island Wildlife Refuge. There are no residences or other significant structures on the island, which is described as a "marshy" area commonly flooded to low levels for duck hunting purposes.

DWR staff visited the remote site by helicopter shortly after the initial levee failure reports. The breach is relatively small and is not expanding rapidly. It is also in the general area where levee overtopping and limited breaches last January caused limited flooding of the island. DWR provided financial assistance for approximately \$100,000 worth of emergency repairs at that time. Early estimates to repair the current break are in the \$50,000 range.

It is not known what caused the levee to give way; however, the breach location is at a site where a drainage/irrigation pipe appeared to have been previously constructed.

Reclamation district officials have asked for State levee program emergency funds to close the breach as soon as possible and DWR executives have agreed. Without levee repairs, water would slowly fill the island and partially inundate the State Water Project's Roaring River levee, possibly causing wave wash erosion.

The San Rafael-based company Dutra Materials was expected to begin repairing the levee sometime today.
