Montebello Vista Park

- ❖ Irrigation System Observations
- ❖ Review of Water Use
- ❖ Estimated Water Budget
- ❖ Potential for Savings

Site Visit: January 18, 2008

Address: Montebello and Capistrano Drives, Suisun City

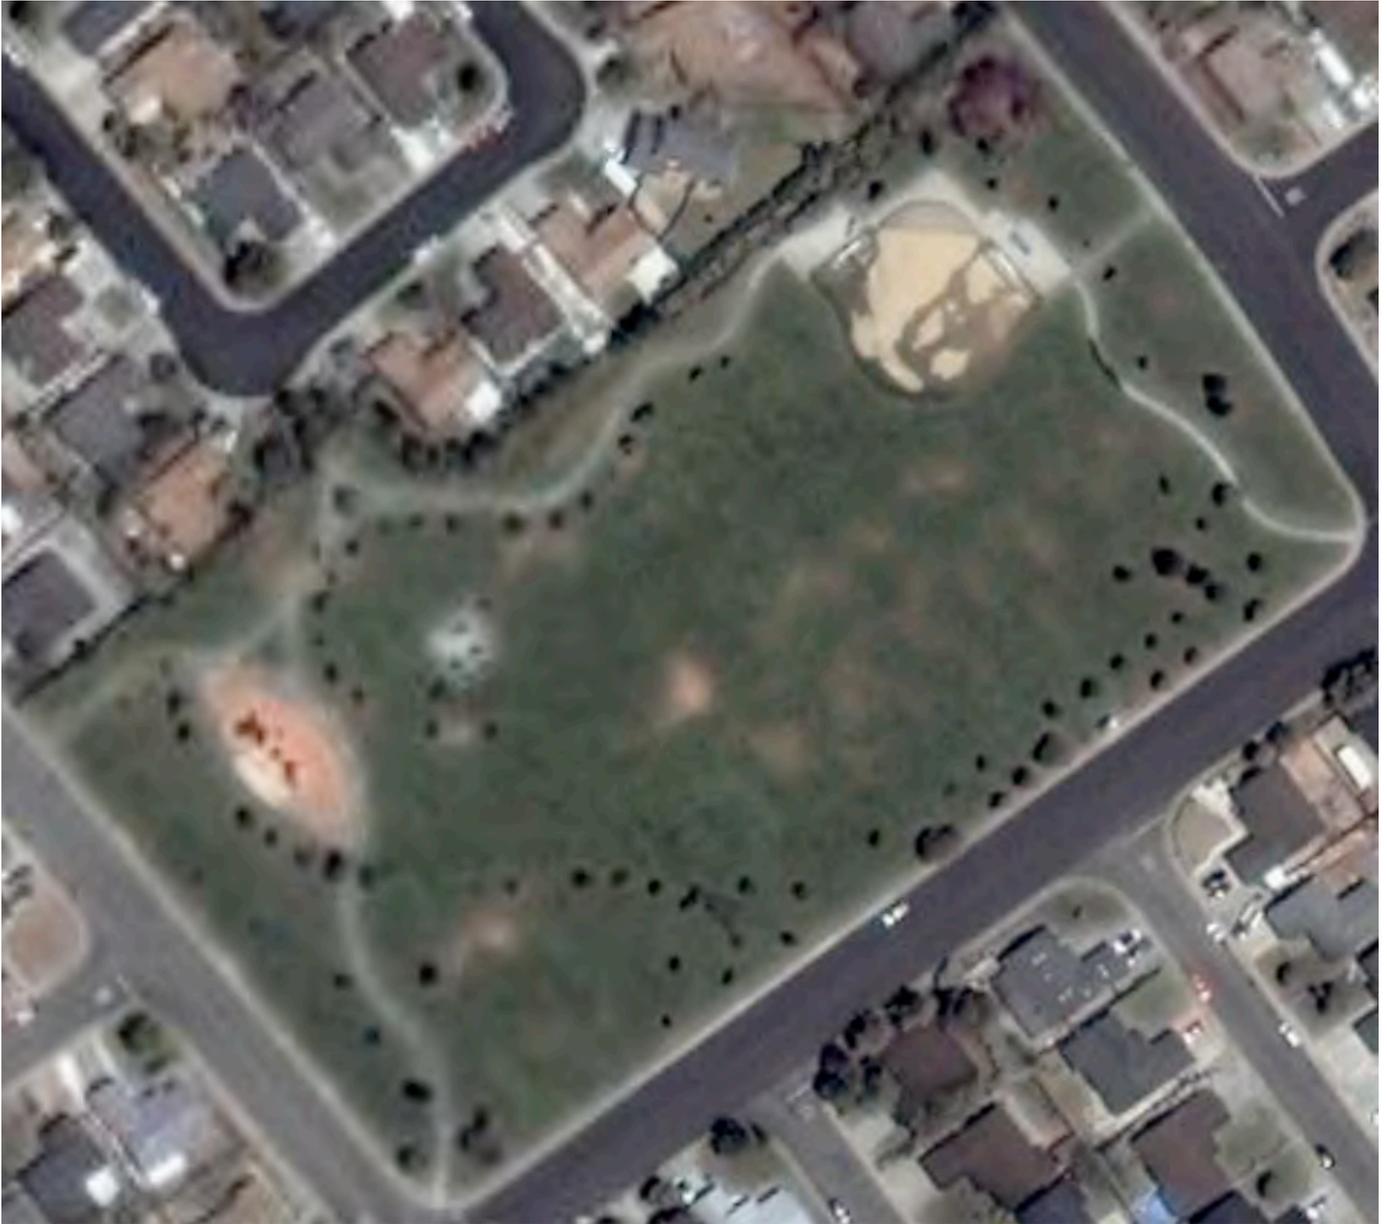
The irrigated area measurements used in this analysis are based on an aerial photograph.

<i>Irrigated Area</i>	<i>Square Feet</i>	<i>Acres</i>
<i>Ornamental Turf</i>	226,000	5.19
<i>Gound Cover/Shrub</i>	8,000	.18
TOTAL	234,000	5.37

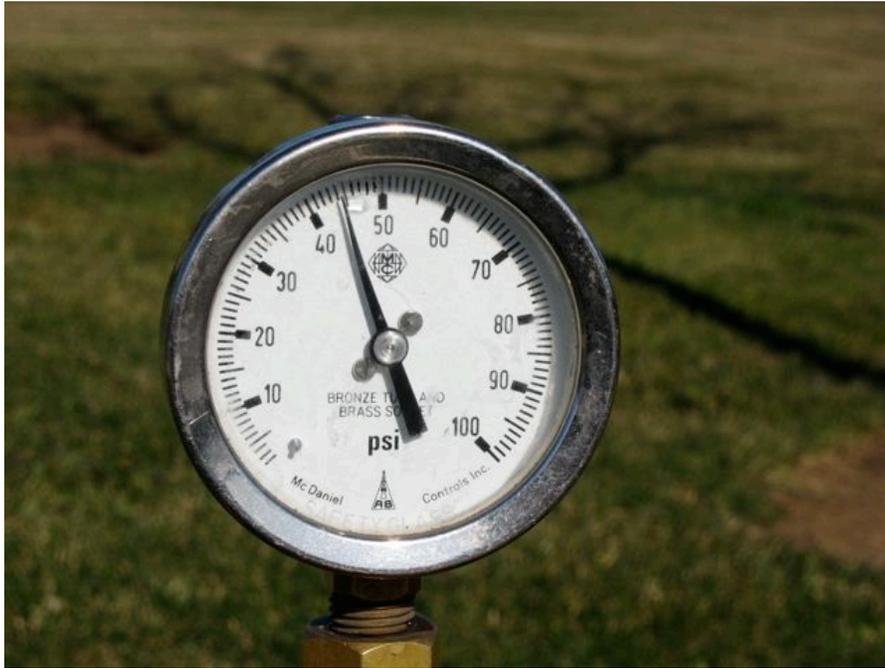
Problem: Critically low mains pressure can cause poor uniformity and low precipitation rates.

2. Nozzle selection for large turf rotor sprinklers is critical. With this site's average Head-to-Head spacing of 42 feet, the suggested nozzle for Hunter I-40 heads would be #41 or 42. Mixed sprinkler types -- PGP, I-25 and I-40's on the same valve -- pose additional challenges for nozzle selection and radius.

Solution: Note suggestions for re-nozzling rotor sprinklers.

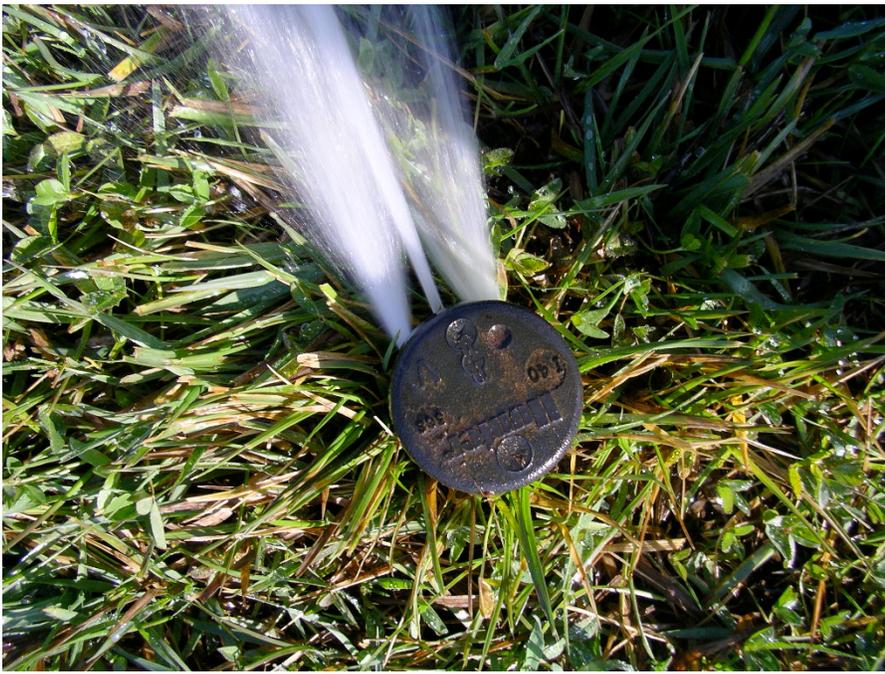
Problem: Note the differences in the size of the main nozzle stream in the two photos on this page.

Solution: Ensure Hunter PGP I-25 and I-40 rotor sprinklers have balanced nozzles.

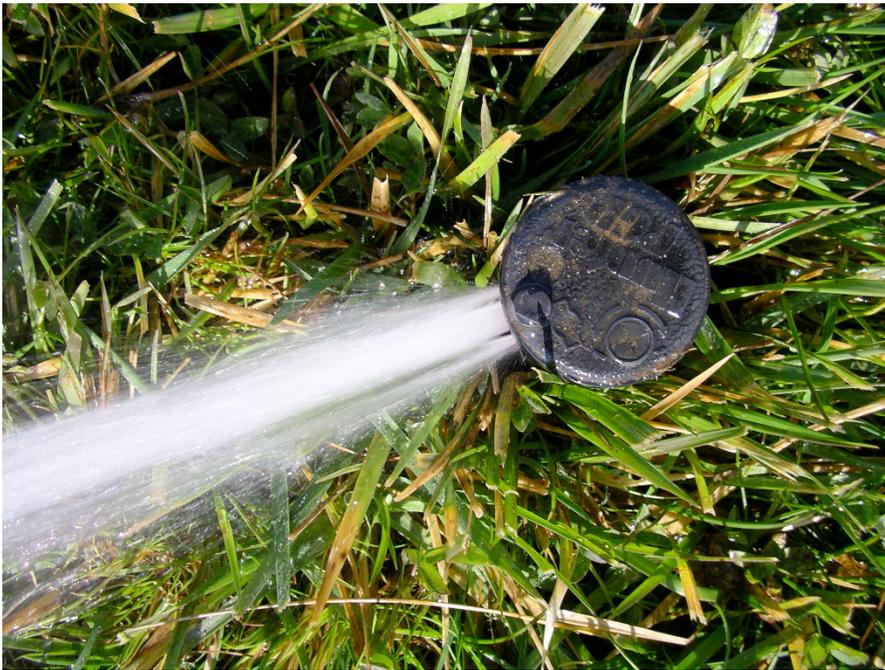
Problem: Nozzle size varied through the site.

Solution: See explanation above.

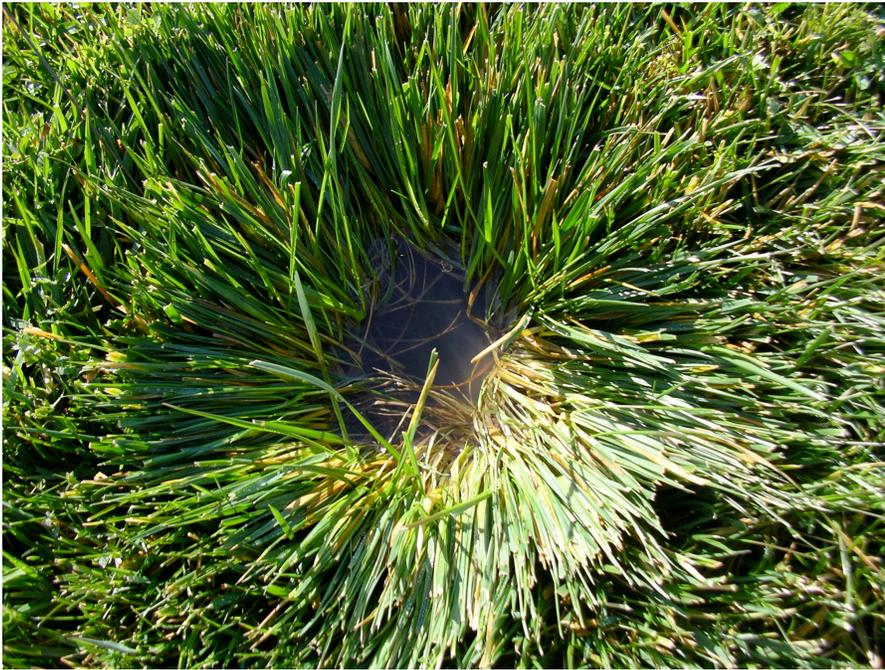
Problem: Rotor sprinkler set too low in the turf causes accumulation of water around the head. This creates soft soil which can further destabilize the head. In addition the nozzle retention screw is splitting the main stream of water.

3. The range adjustment screw (nozzle retention screw) of large rotor sprinklers should not be used to split the water stream of the main nozzle except for a few sprinklers close to the edge of irrigated areas where range reduction is required.

Solution: Raise the sprinkler to grade which allows spray to clear surrounding turf. Set the retention screw to barely touch the water stream.

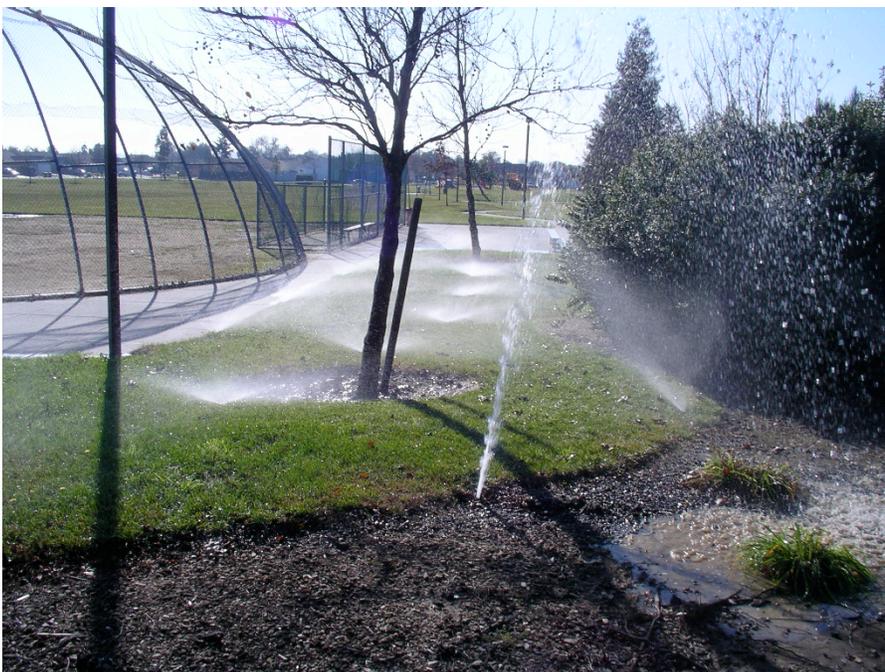
Problem: Even with damaged sprinkler this station still has excessive pressure.

6. Ensure all sprinklers are at grade to avoid interception of spray by turf.
7. Reduce pressure in popup spray stations from the too-high 50 psi to 30 psi.

Solution: Reduce pressure to 30 psi (using a pressure gauge and the flow control stem at the valve) and repair all damaged sprinklers.

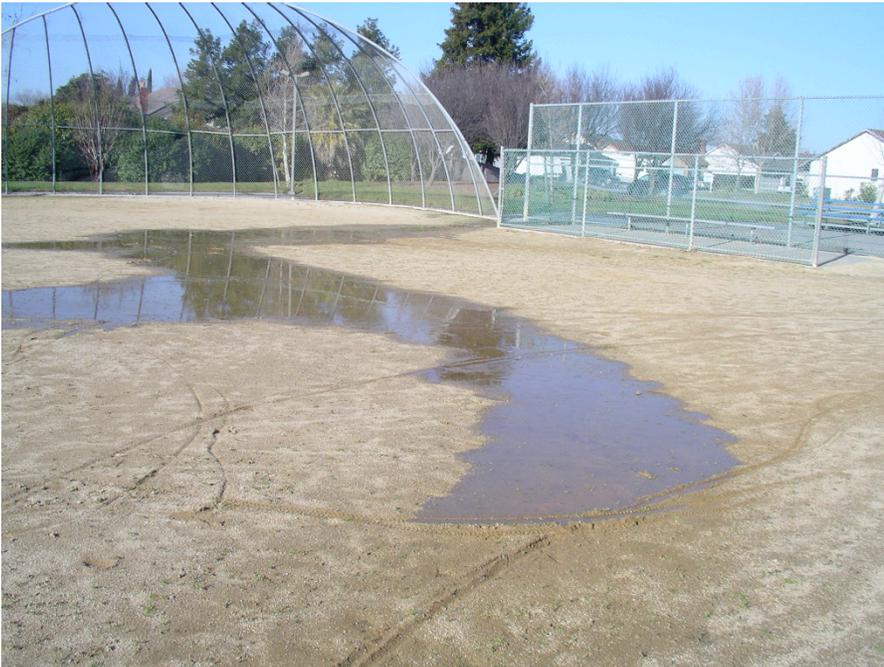
Problem: Ground level view of the leaks depicted above.

Solution: Note above.
