Exhibit I

Crawford/Alvarado Dive Reports

TECHNICAL UNDERWATER INSPECTION TEAM

DIVE REPORT

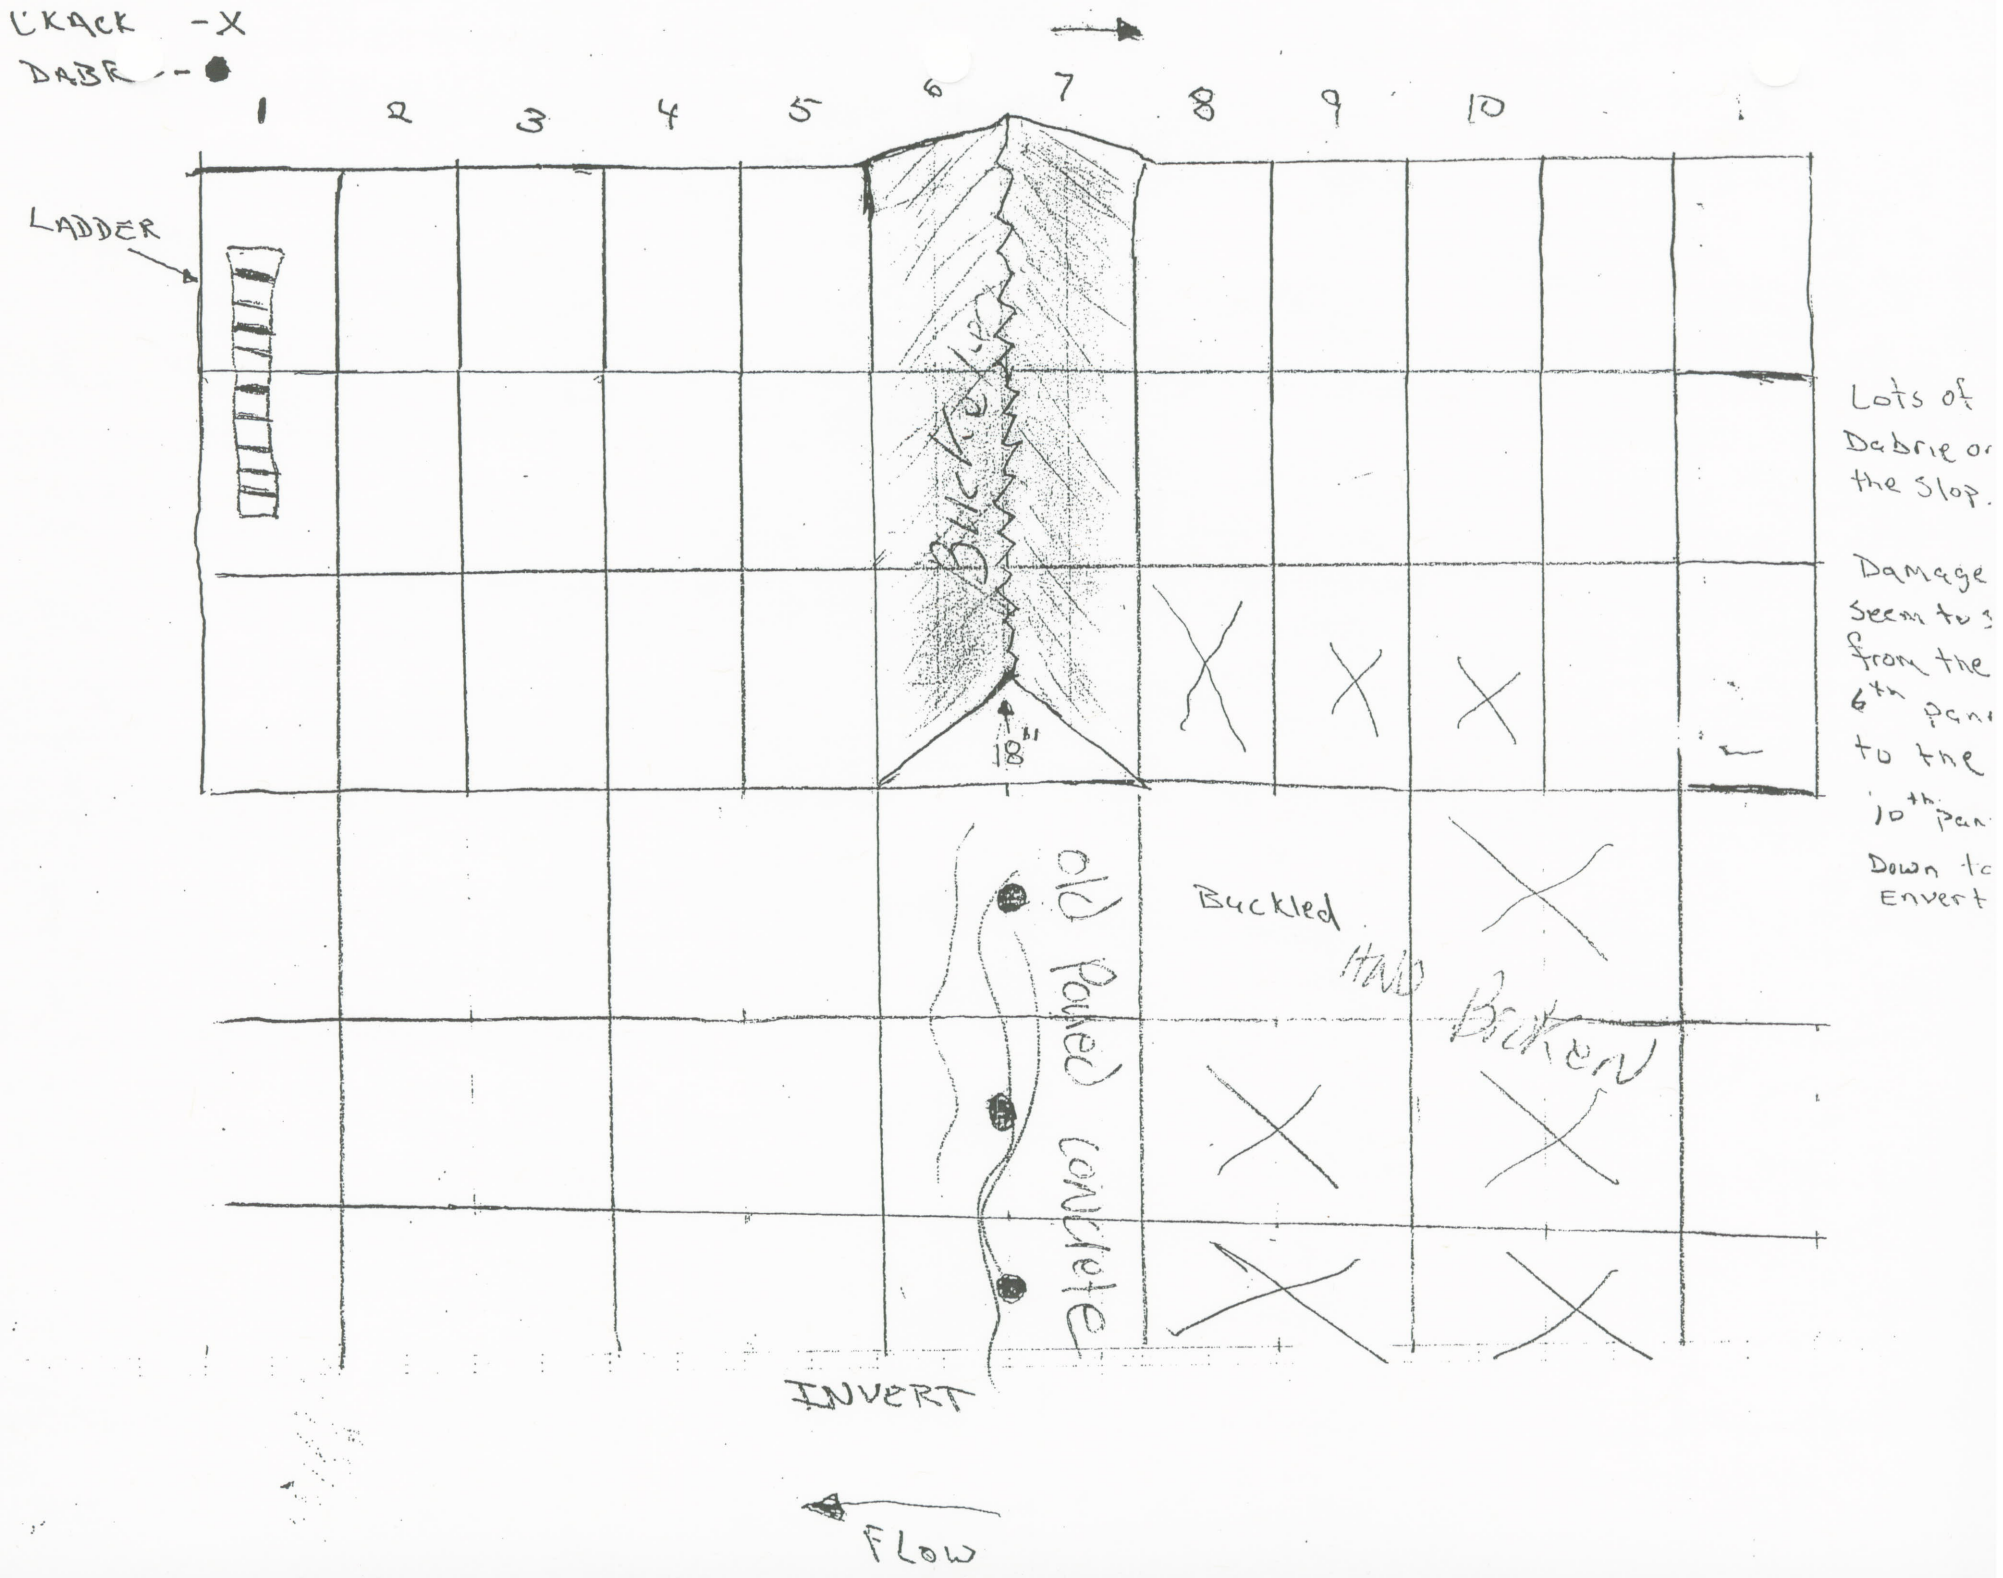
Inspect Liner on Right Bank From visual Damage to top two Panels 5 Panels wide down to invert. (see Drawing)

CRACK -X
DABR --●
1
2
3
4
5
6
7
8
9
10
LADDER
Buckled
18"
old Paved concrete
Buckled
Had
Broken
INVERT
FLOW
Lots of
Debrie o
the Slop
Damage
Seem to
from the
6th pan
to the
10th pan
Down to
Envert

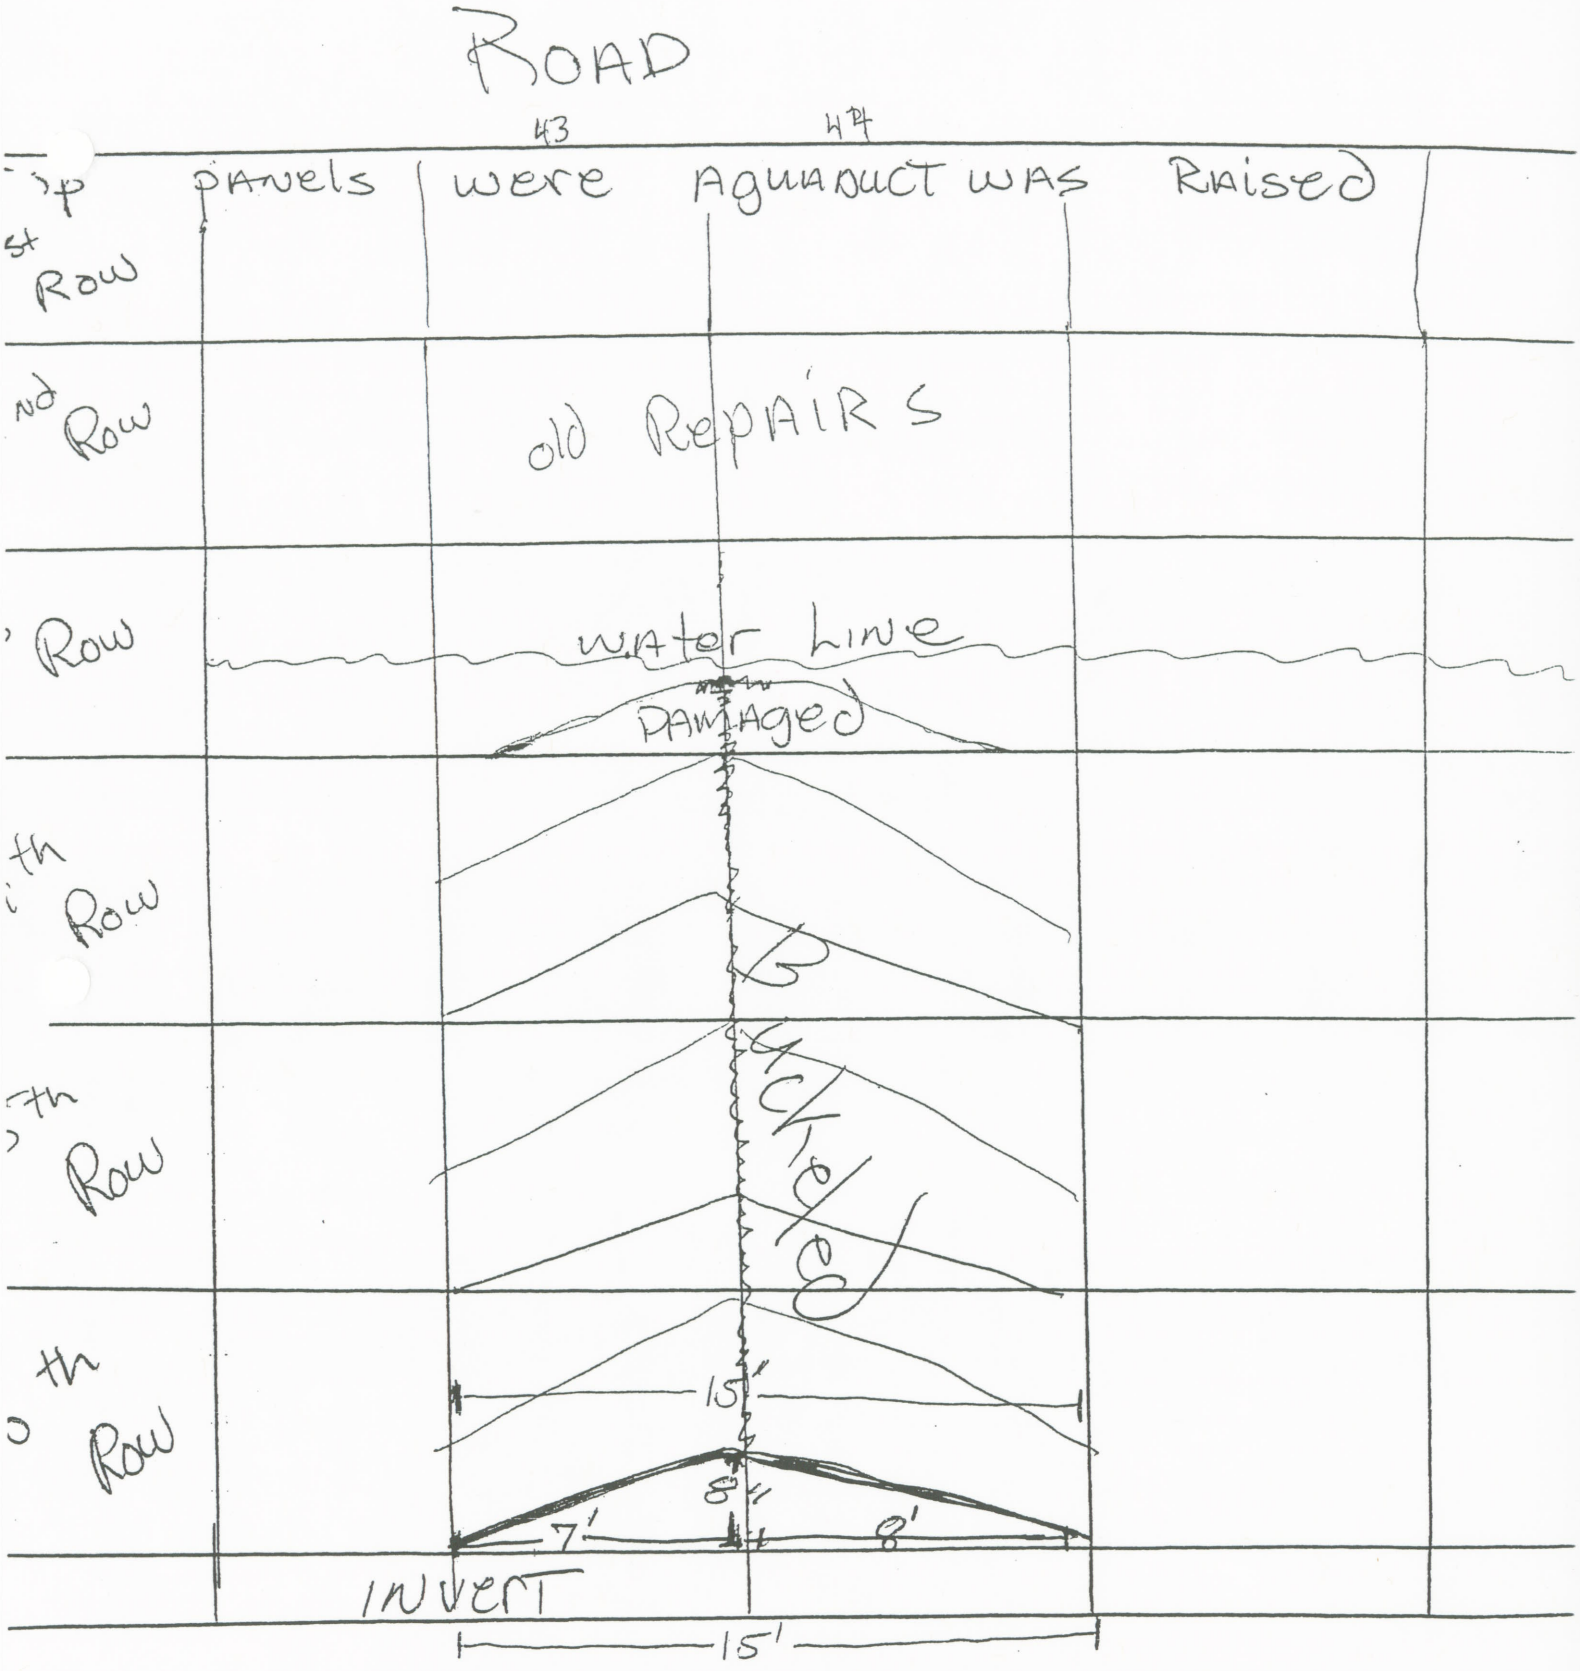
started at Ladder, Both Side's. 43 Pawels From the Ladder on the left Bank is some old Damage visiable From the Top. Under water the Panel is Buckeled All the way Down to the invert. (see Drawing) All other Panel's Look good no Damage Both Side's we looked at 100 Pawels, From Ladder to Pipeline, Both Side's, From invert to surface.

8" Gap at invert
1" to 2" Gap all Along TOP of Buckel.

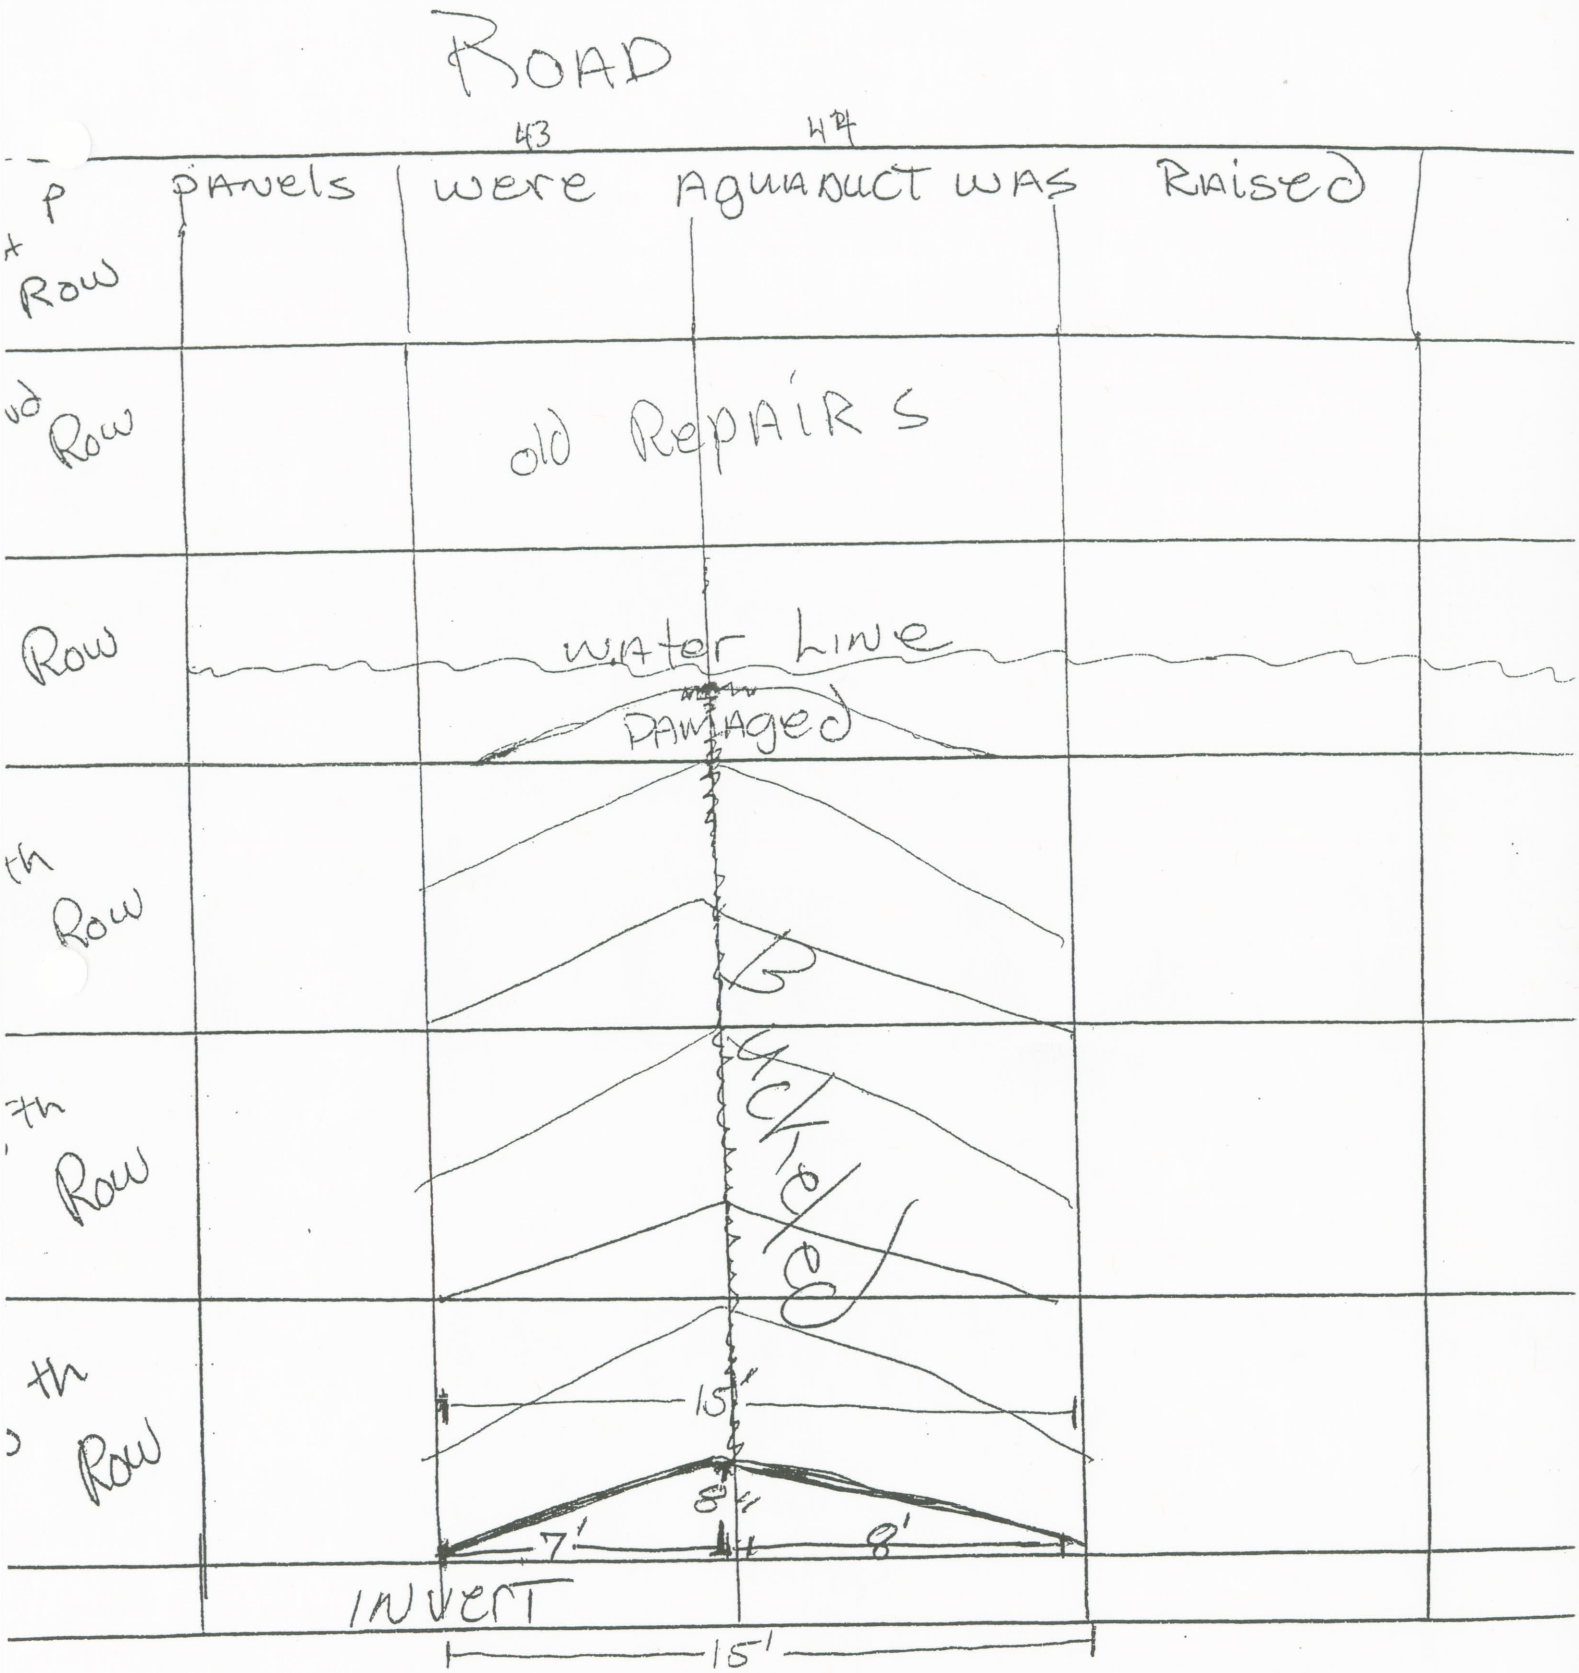
started at Ladder, Both Side's. 43 Pawels From the Ladder on the left Bank is some old Damage visiable From the Top. under water the Panel is Buckeled all the way DOWN to the invert. (see DRAWING) All other Pawel's Look good no DAMAGE Both Side's we looked at 100 Pawels From Ladder to Pipeline, Both Side's, From invert to surface.

8" Gap at invert
1" to 2" Gap all Along TOP of Buckel.

Buckel
