CENTRAL VALLEY FLOOD MANAGEMENT PLANNING PROGRAM

Flood Control System Status Report Appendix A – Levee Status

December 2011

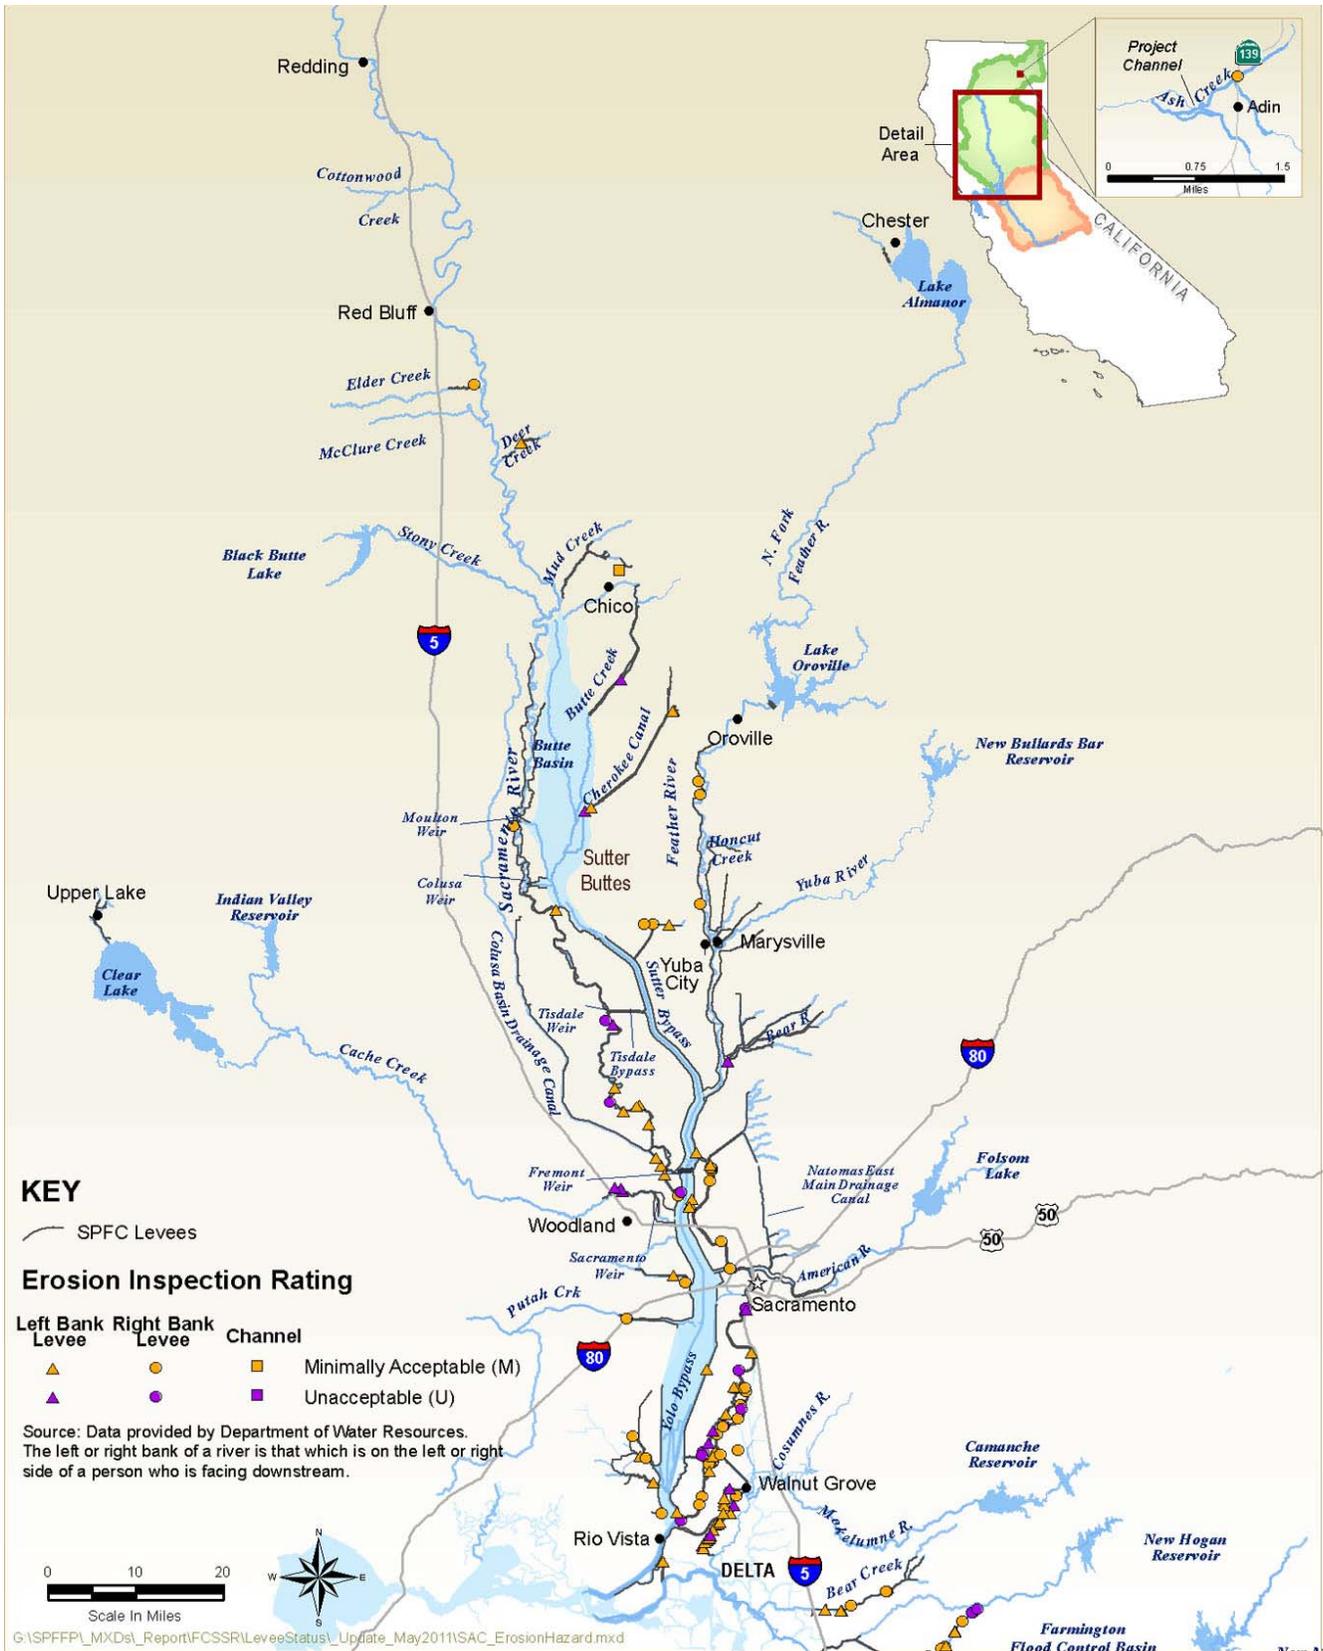
Figure A-21. 2009 Erosion Inspection Ratings in Sacramento River Watershed

Visual inspections provide limited information on levee conditions related to erosion. A typical levee inspection occurs from the crown of the levee, but erosion on the slope and beyond is sometimes not visible from this vantage point. In addition, thick vegetation and wide berms can also obstruct an inspector’s view of an erosion site. Erosion surveys conducted by boat can improve on these limitations, but both the levee inspections and erosion surveys are limited to what is visible above the waterline from the top of the levee.
