## 4.0 Levee Status

## Flood Control System Status Report

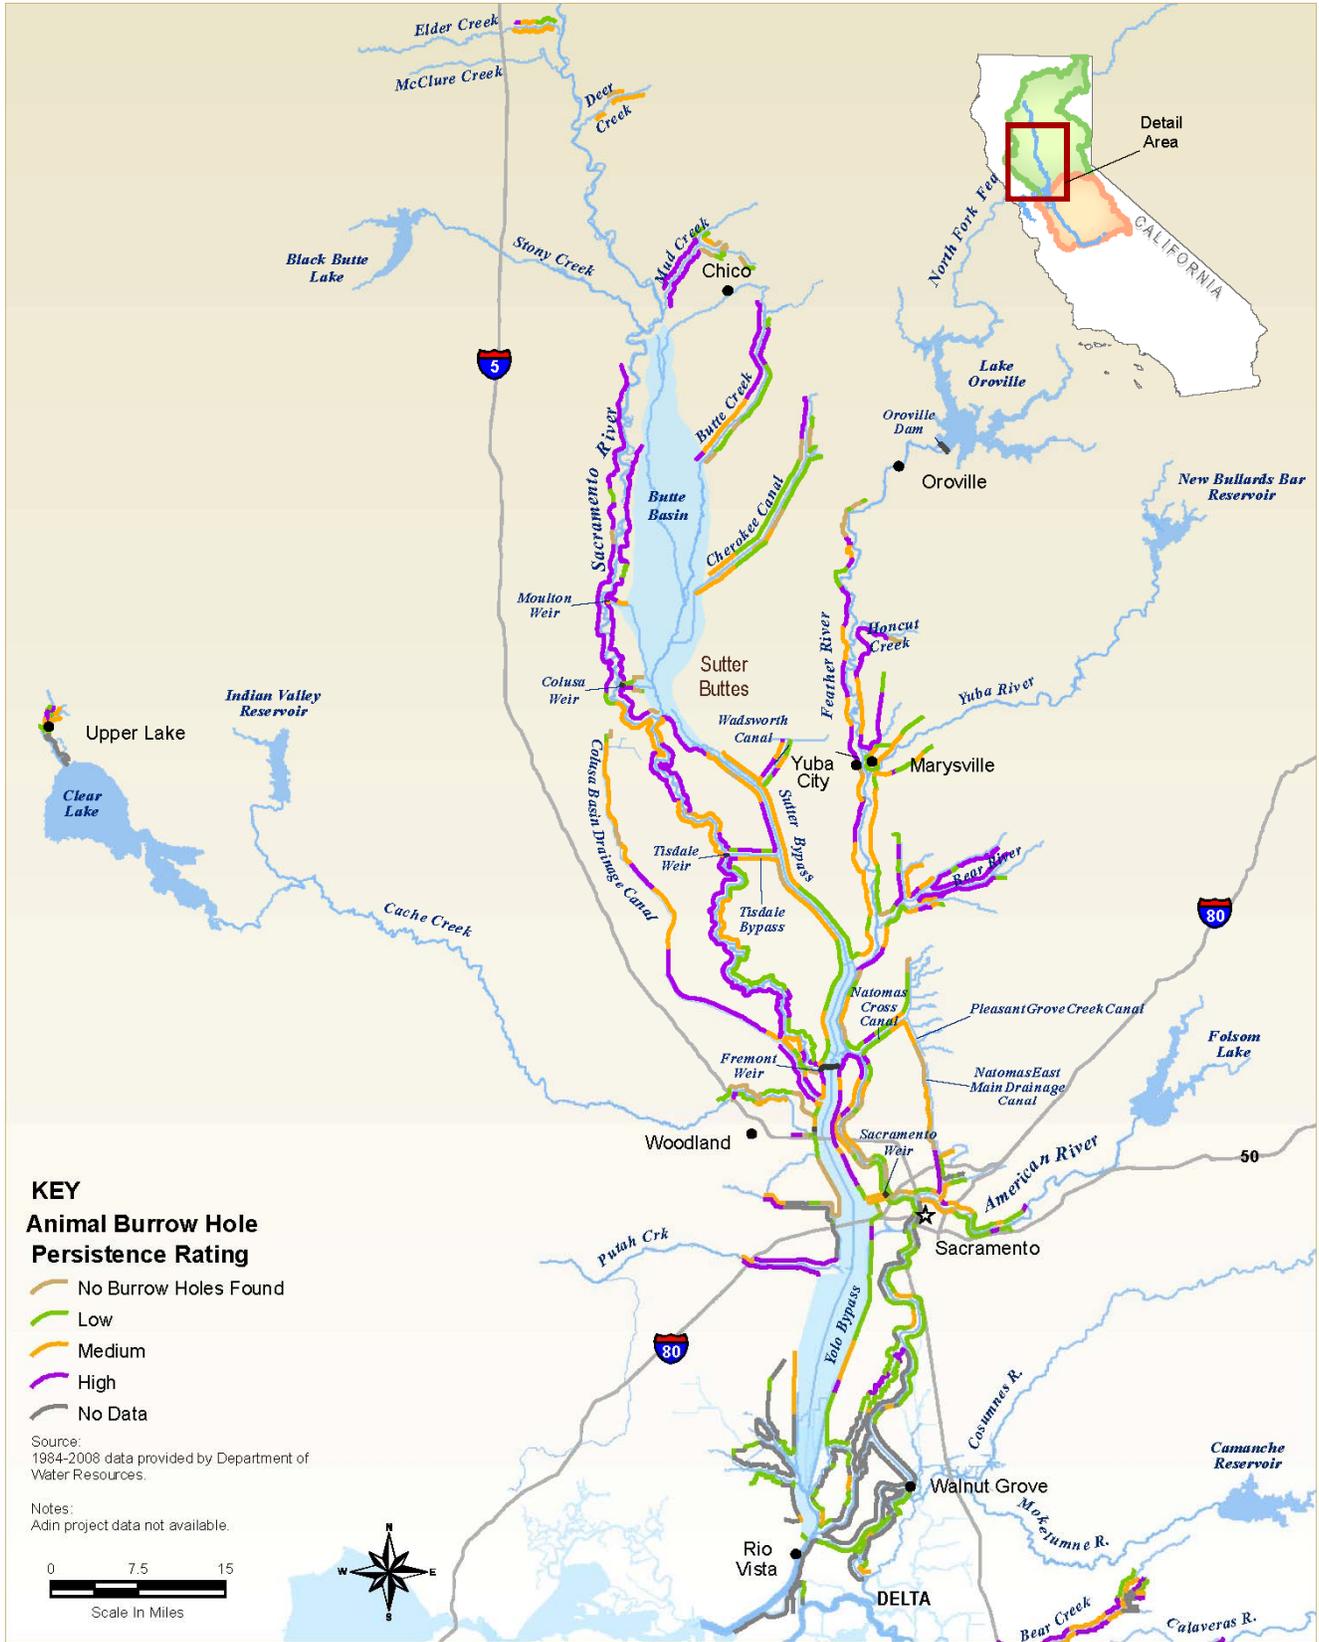
**Figure 4-23. Animal Burrow Hole Persistence in Sacramento River Watershed**

Figures 4-23 and 4-24 show results for the DWR Animal Burrow Hole Persistence Study for the Sacramento and San Joaquin river watersheds, respectively (DWR, 2009b). More than one-third of the 1,459 miles of SPFC levees studied had high persistence (at least eight reported incidences of burrowing activity over the 21-year study span of inspection results).

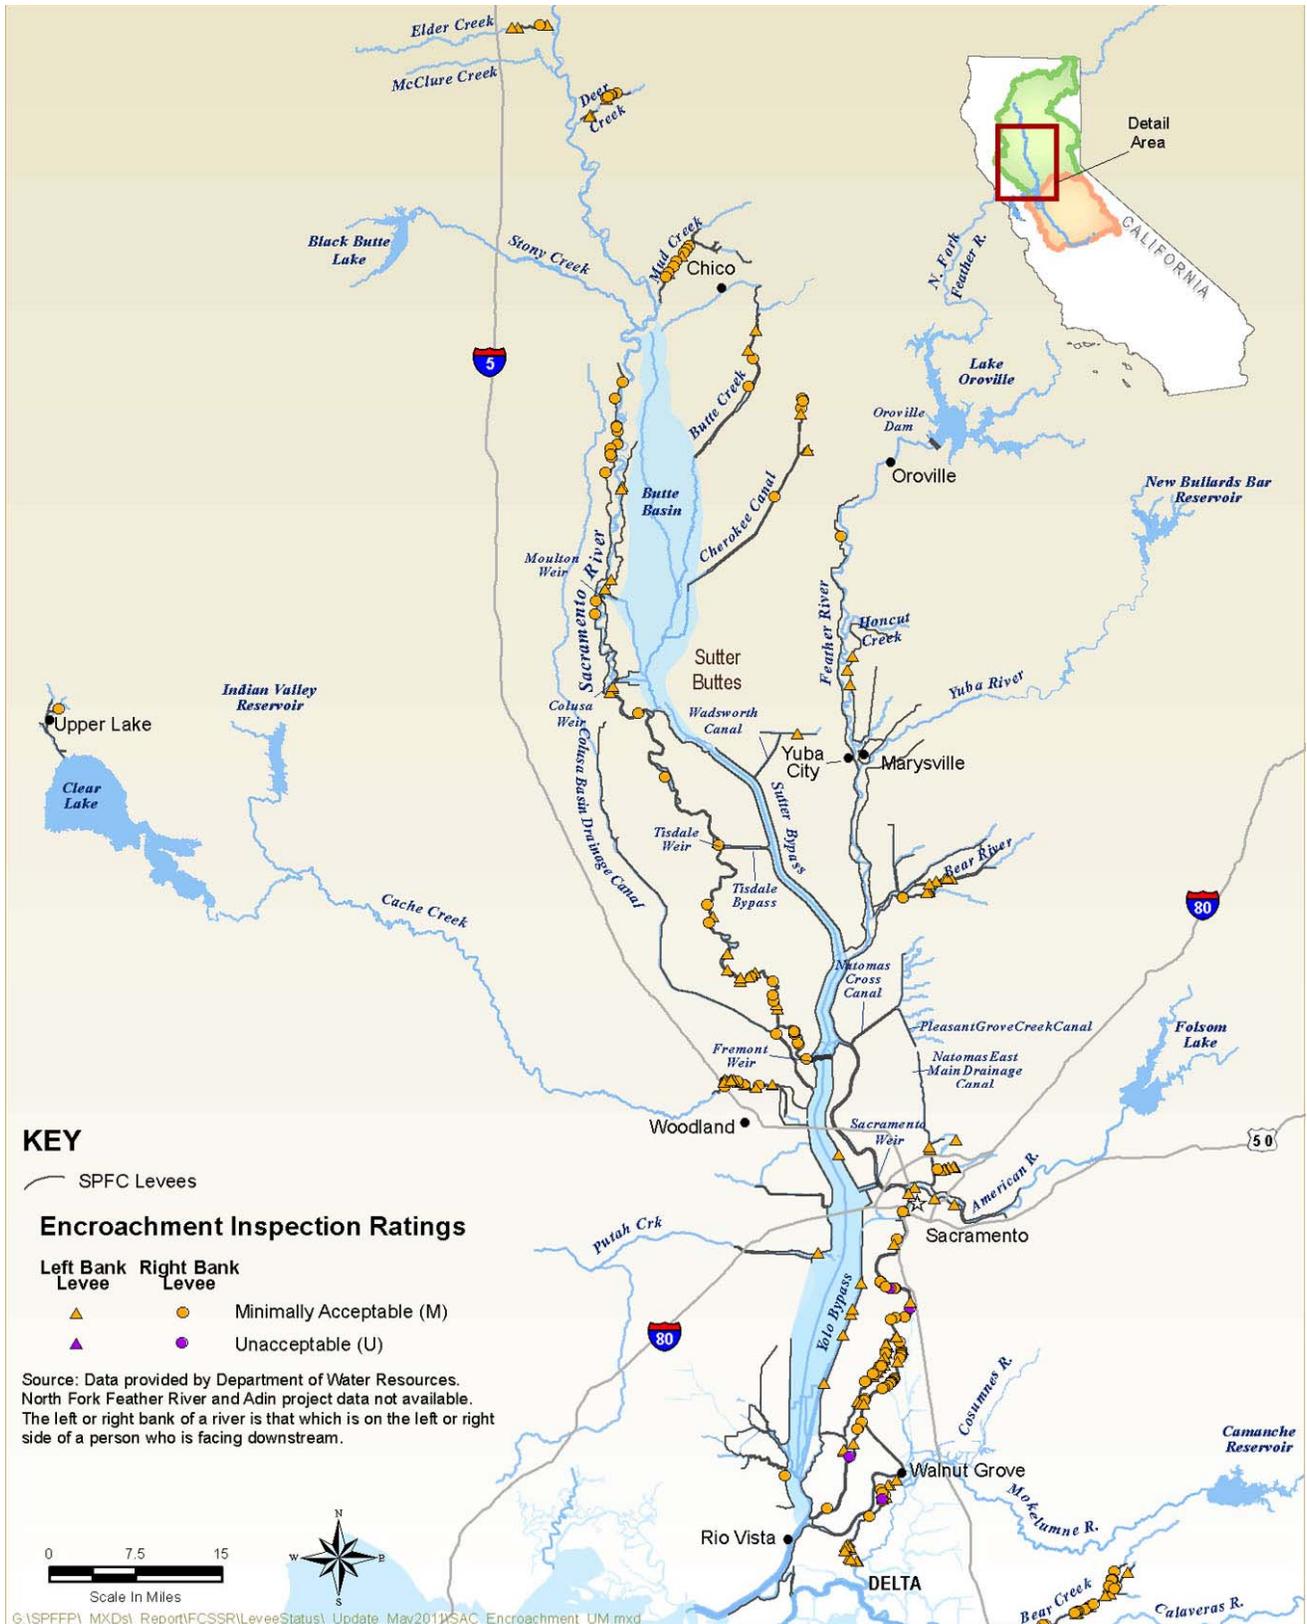
**Figure 4-25. 2009 Encroachment Inspection Ratings in Sacramento River Watershed (Threats to Levee Integrity)**

Minimally Acceptable and Unacceptable ratings are shown in Figures 4-25 and 4-26. Inspection results include 536 encroachment sites identified as minor threats to levee integrity (i.e., Minimally Acceptable) and 15 encroachment sites identified as major threats to levee integrity (i.e., Unacceptable). Encroachment sites may consist of multiple individual encroachments.<sup>4</sup>

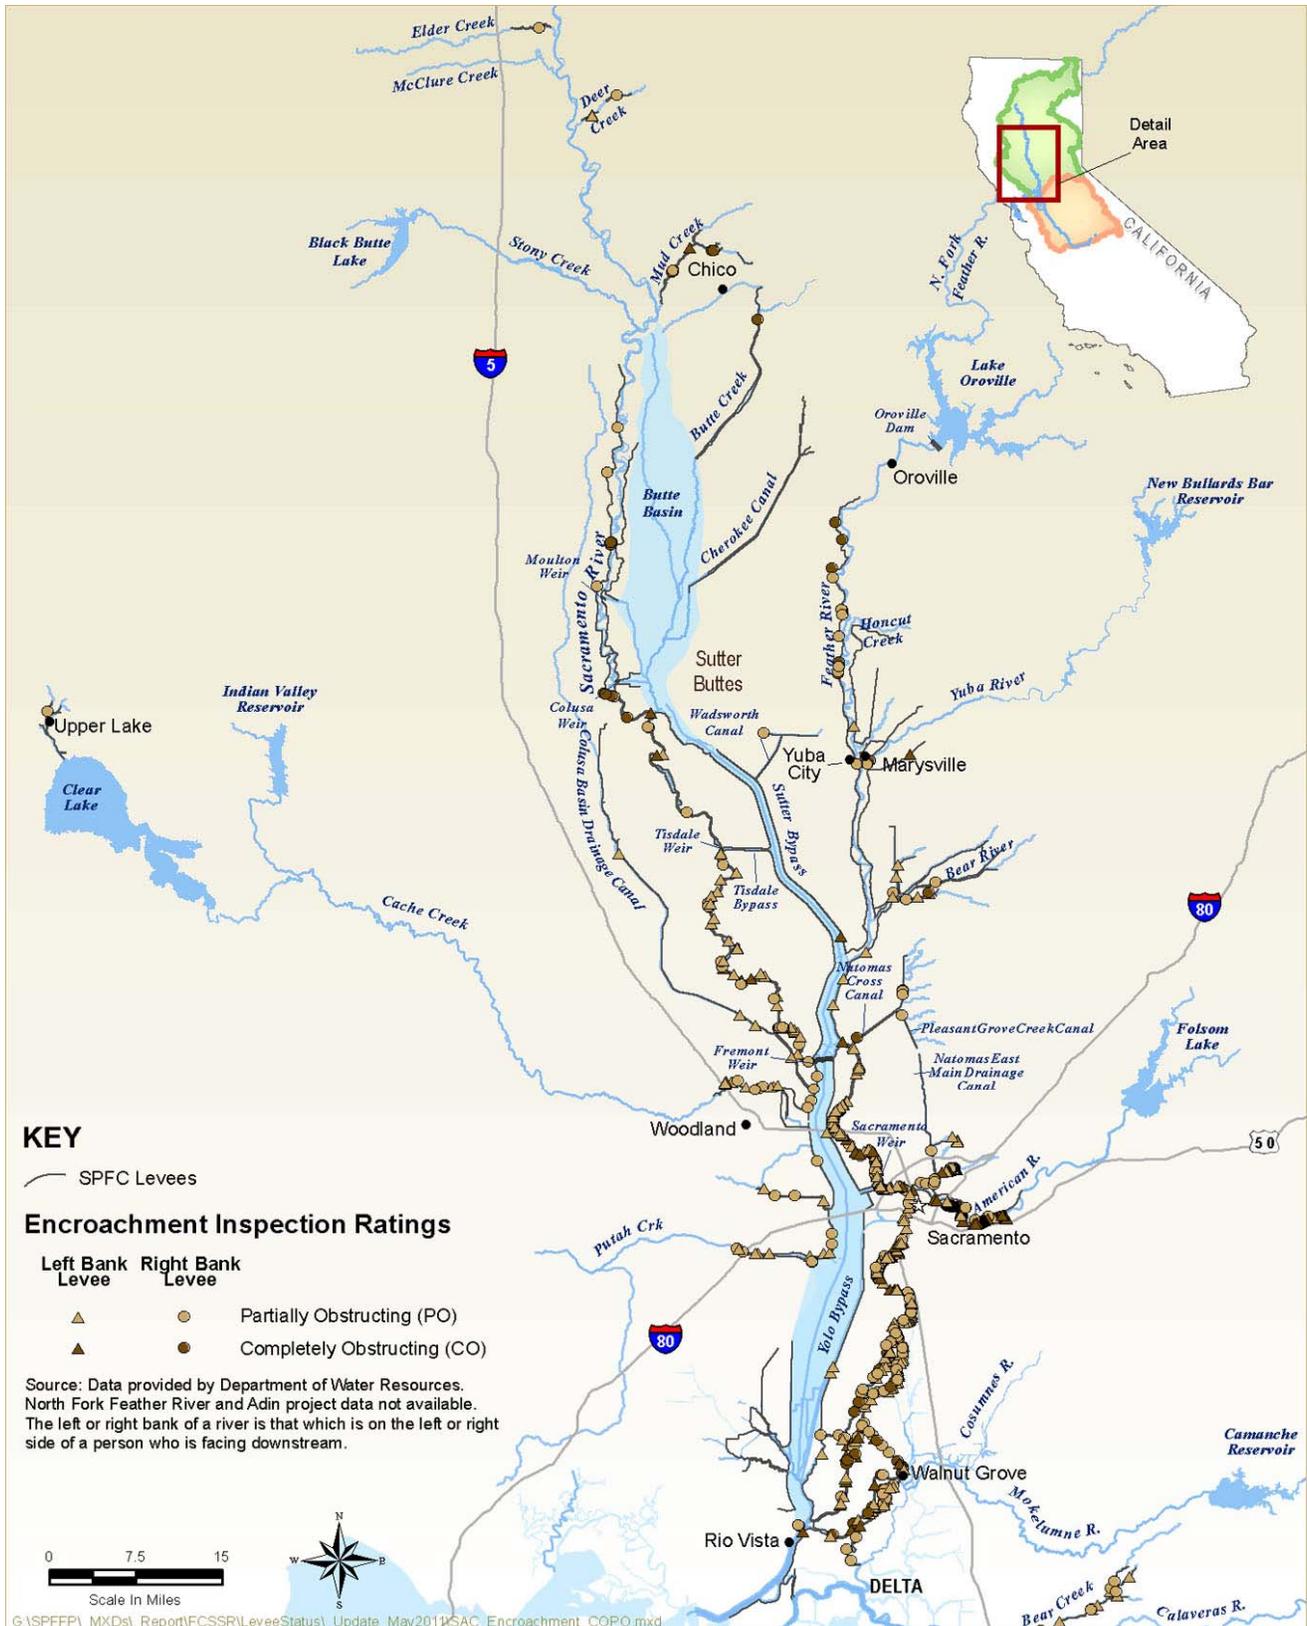
**Figure 4-27. 2009 Encroachment Inspection Ratings in Sacramento River Watershed (Obstructions to Visibility and Access)**

Partially Obstructing and Completely Obstructing ratings are shown in Figures 4-27 and 4-28. Inspection results include 354 encroachment sites found to partially obstruct visibility and access to levees and 869 encroachment sites found to completely obstruct visibility and access.
