Clover Creek – Millville Diversion Fish Passage Project

Preliminary Engineering Technical Report

April 2013

Technical Information Record (TIR) – NRO-2013-01

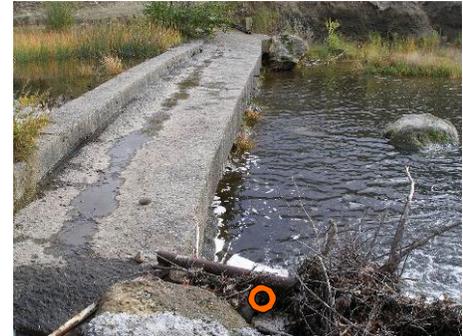
Figure 4: Millville Dam Site on opposite site take from top of diversion- November, 2008

Based on the jointed- natural fractures and recent past loss of thicker sandstone beds, the thinner layer of sandstone layers located upstream are only short term bed control for the extreme incisional long profile adjustment that will occur shortly after the dam diversion removal.

I believe large rock footers (4 feet or greater diameter of a basalt type or other high density rock) or double-set footers would sustain the high stage flows while easily allowing for salmonid passage for fall chinook and summer steelhead. I would recommend that the step-pool cross vane style checks Figure 5 below considered as an alternative. Preferably maintain a range 1.0 ft of drop or less from cross vane to cross vane. If gaps in header rocks are used then it is recommended that a second set of footer by used. There should be no gaps on vane arms (Figure 6). Cross-vanes with longer arm length and multiple steps can be used.

Because Clover Creek is an entrenched F1-F6 stream type it is essential to build rock keys to the top of the banks instead of just the sills as indicated in Figures 5 and 6.

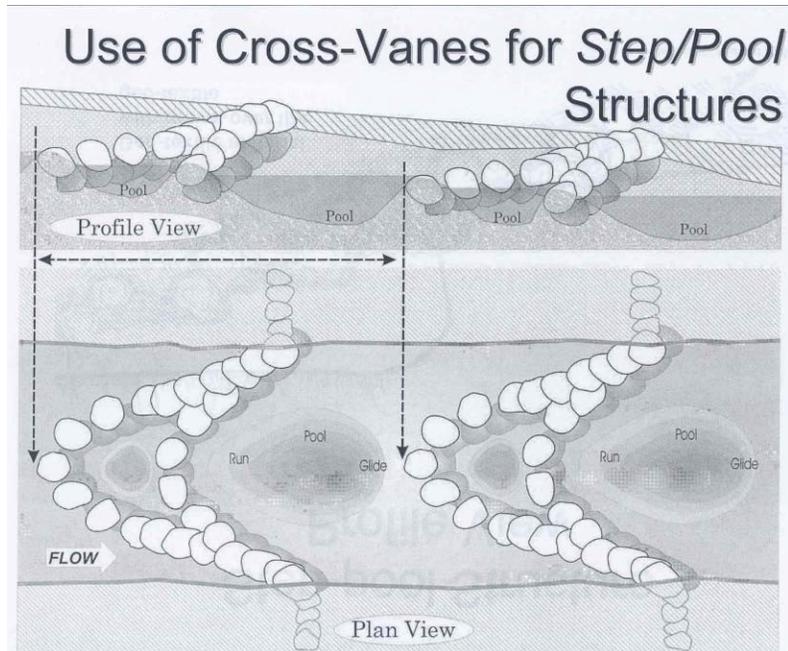
Figure 5: Cross-vane step-pool structures – can use double footer set and/or multiple cross steps with longer vane arms

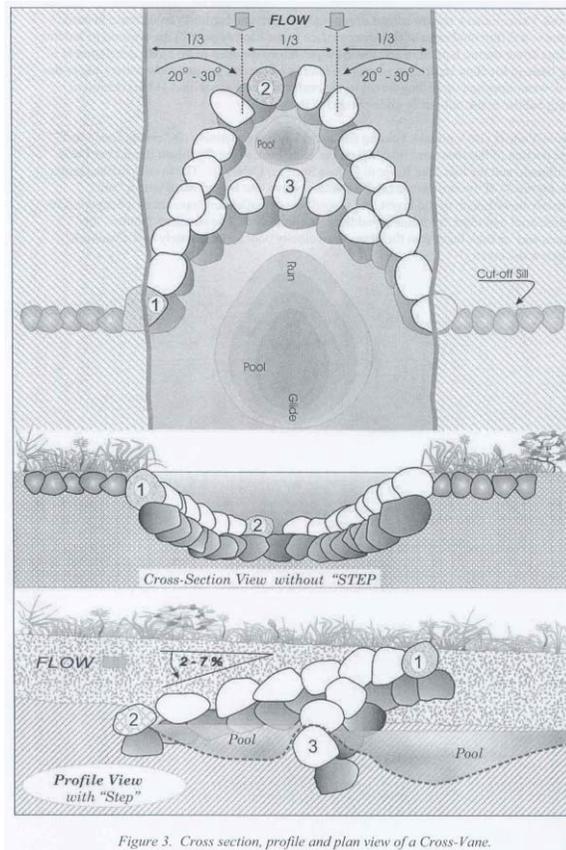
Figure 6: Cross section: profile and plan view of a cross vane

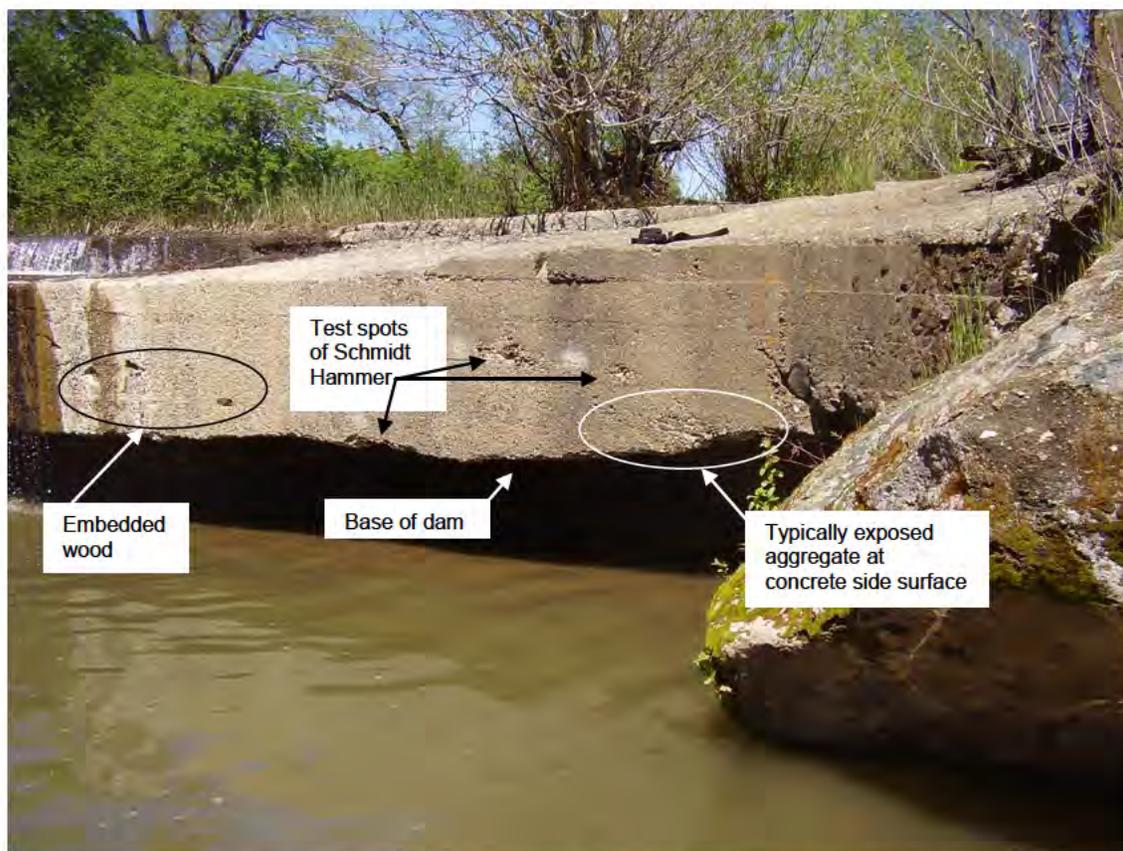
Photo 7 - Millville Diversion Dam at Left Bank, 4/20/12

At the dam, apparent erosion on the exposed side and top concrete surfaces of the dam was observed, as shown in Photos 5 and 7. The erosion was most pronounced on the top surface, as shown in Photo 5, and less pronounced on the side surface. Two lines of exposed, corroded longitudinal rebar were also observed running along the top surface; corroded transverse reinforcement at about a foot on center was also observed between the longitudinal rebar.

To estimate the dam's concrete compressive strength, readings were taken using a Schmidt Hammer. Due to limited availability of dry, smooth concrete surfaces, readings were limited to three spots, as shown in Photo 7. Also shown in Photo 7 are three pieces of embedded wood observed at the downstream side surface of the dam.

The Schmidt Hammer (Model N/NR) test readings taken on the dam are summarized in Table 1. The average compressive strength of concrete was determined to be approximately 4,070 psi.

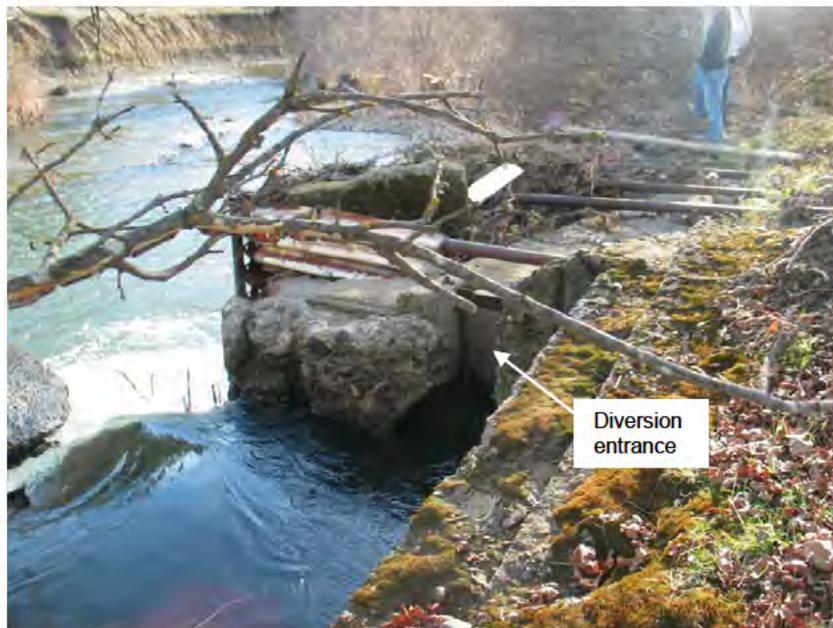
Photo 8 - Millville Diversion Dam at Right Bank, 2012 (Source: NRO)

During the site visit, the DFG representative identified the approximate alignment of the proposed new fish ladder to be downstream of the dam and along the right bank. The representative said that the fish ladder alignment may either cut through the diversion entrance or go around the diversion entrance through the right embankment. Furthermore, a fish screen at the diversion entrance may need to be provided if the water diversion facilities and siphon are not abandoned. See Photo 8.

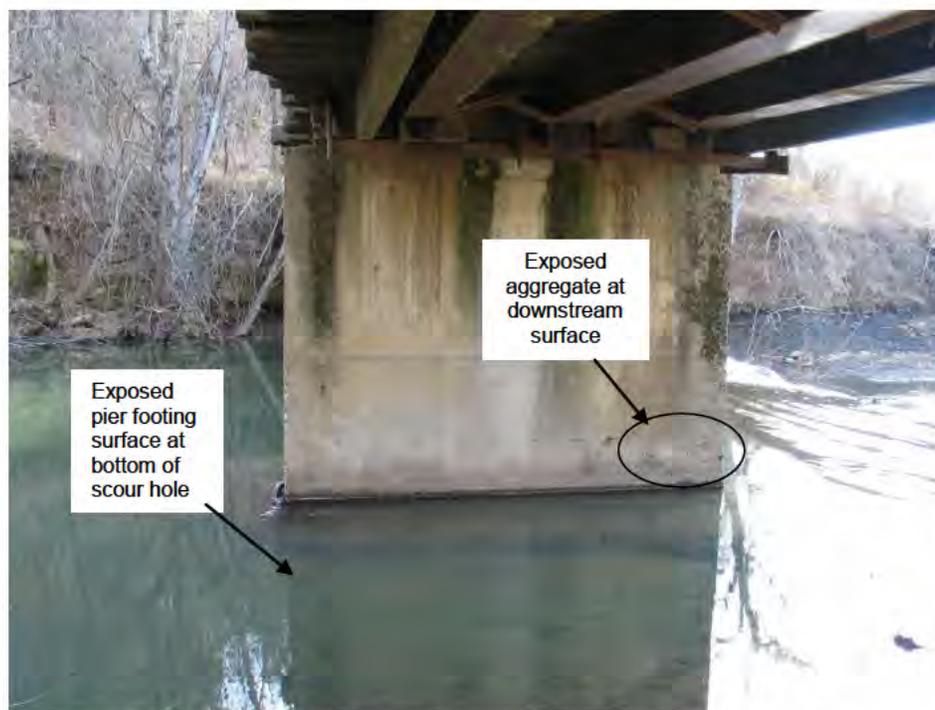
Photo 9 – Millville Bridge Center Pier, 2012 (Source: NRO)

At the downstream end of the center pier, apparent erosion was observed on the exposed surface (see Photo 9). The scour hole was also observed around the center pier, as shown in Photo 9. The apparent surface of the pier footing was observed at the bottom of the scour hole.

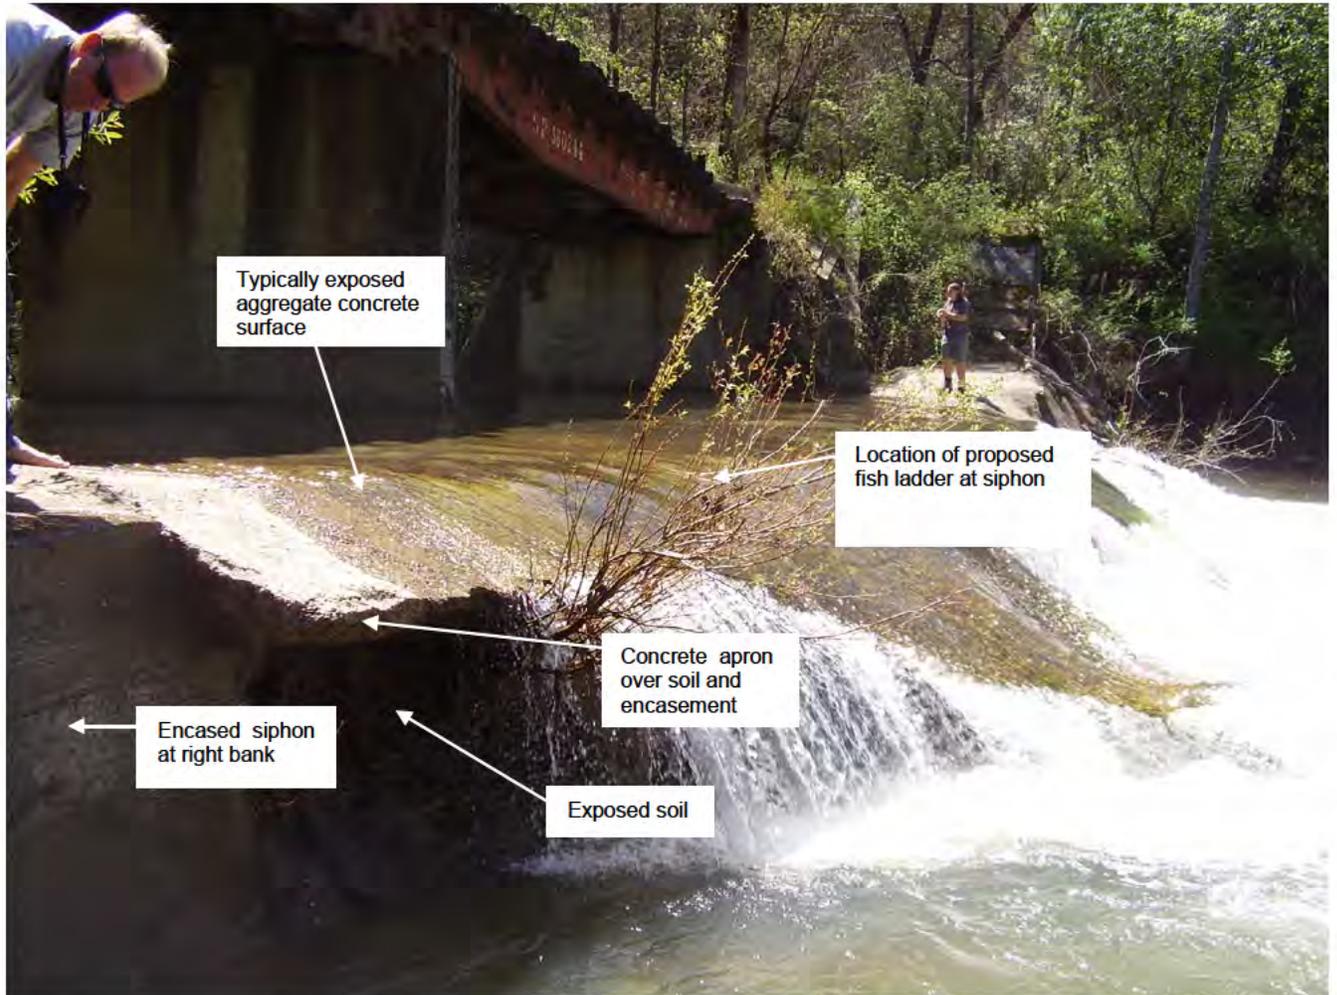
Photo 10 – Millville Bridge and Inverted Siphon, 5/20/12

Located immediately downstream of the bridge is the inverted siphon. Because most of the siphon encasement was submerged by creek flow, the extent of the erosion around the siphon encasement could not be examined. As shown in Photo 10, the creek appears to be flowing over a concrete apron which covers the streambed soil and the encasement. Apparent erosion was observed on most of the apron surface whereby large areas had exposed aggregate.

Due to limited availability of dry, smooth concrete surfaces on the encasement structure, Schmidt Hammer testing was limited to a small area at the right bank. It was not clear whether the area of concrete was part of the original 10-foot by 5-foot encasement or a later concrete placement. (During the site visit, a person who identified himself as the owner of the siphon and bridge said that, over the years, concrete material has been placed over the original encasement as protection measures against erosion. He said that he was not able to determine if the testing area was part of the original encasement, explaining that the subsequent concrete placements had occurred before he became owner of the structures.)

NRO staff identified the approximate location of the proposed fish passage facilities at the siphon, as shown in Photo 10. NRO indicated that only a fish ladder would be required at this site. In order to construct the fish ladder, portions of the encasement, as well as concrete apron and underlying soil, may need to be removed.

The Schmidt Hammer test readings taken at the siphon encasement are summarized in Table 2. The average compressive strength of concrete was determined to be approximately 5,170 psi.

NRO staff indicates that when the siphon is in use water leaks through the encasement.

Preliminary estimation of the encasement's concrete compressive strength was inconclusive. Recommend further testing to determine the structural adequacy of the existing concrete before structurally attaching new structures.
