Sacramento River, RM 55.2L

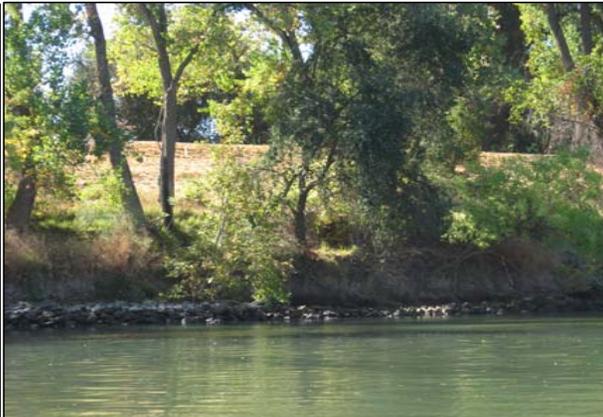
Criteria	Score	Notes
Bank Slope	2	2:1 slope
Berm Width - Estimated	5	0 to 15 ft of berm
Soil Type	4	sands and silts
Velocity	3	4.8 ft/s
Economic Factor	20	Sacramento
Bank Stability	6	tree hazards and slumping
Erosion Hazard	40

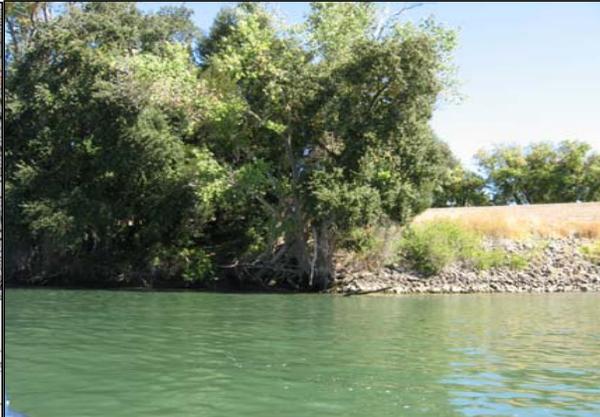
Sacramento River, RM 49.7L

Criteria	Score	Notes
Bank Slope	3	1.5:1 slope
Berm Width - Estimated	2	10 ft of berm
Soil Type	5	silts
Velocity	4	5.6 ft/s (UNET)
Economic Factor	20	Sacramento
Bank Stability	6	tree hazards, and slumping
Erosion Hazard	40

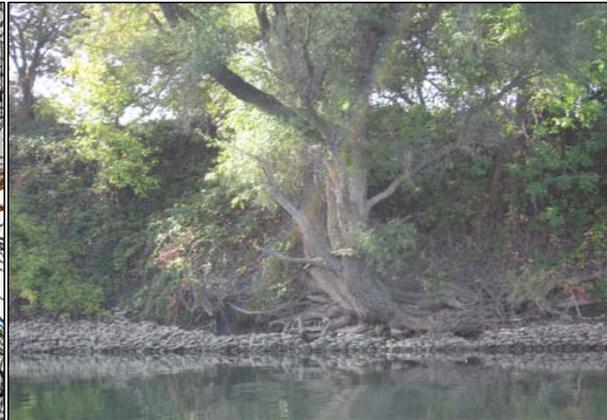
Lower American River, RM 2.8L

Criteria	Score	Notes
Bank Slope	4	1:1 slope
Berm Width - Estimated	2	10 to 20 ft
Soil Type	4	sands and silts
Velocity	3	3.4 ft/s
Economic Factor	20	Sacramento
Bank Stability	7	tree hazards, caves, and slumping
Erosion Hazard	40

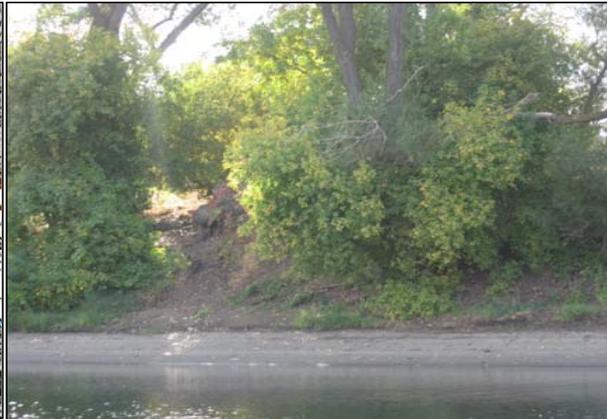
Lower American River, RM 0.3L

Criteria	Score	Notes
Bank Slope	3	1.5:1 slope
Berm Width - Estimated	3	6 to 30 ft
Soil Type	4	clays and silts
Velocity	4	5.2 ft/s
Economic Factor	20	Sacramento
Bank Stability	6	tree hazards, slumping
Erosion Hazard	40

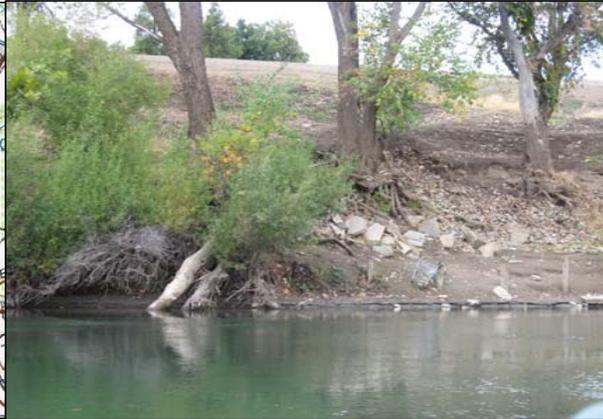
Criteria	Score	Notes
Bank Slope	4	1:1 slope
Berm Width - Estimated	5	0 to 10 ft of berm
Soil Type	4	sands and silts
Velocity	3	4.0 ft/s
Economic Factor	17	Yuba City
Bank Stability	7	tree hazards, caves, and slumping
Erosion Hazard	40

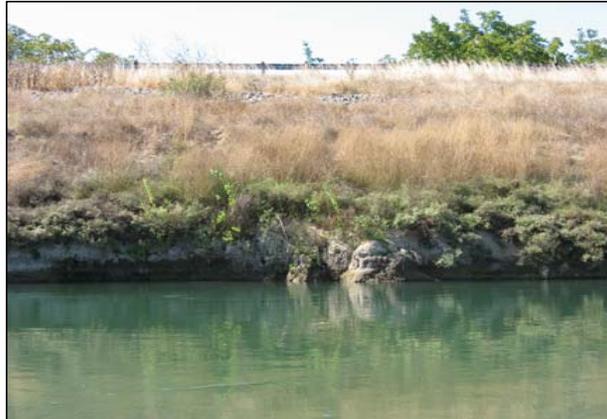
Sacramento River, RM 177.8R

Criteria	Score	Notes
Bank Slope	3	1.5:1 slope
Berm Width - Estimated	5	no berm
Soil Type	2	clays and silts
Velocity	4	5.3 ft/s
Economic Factor	19	Colusa Basin
Bank Stability	4	vertical sections and slumping
Erosion Hazard	37

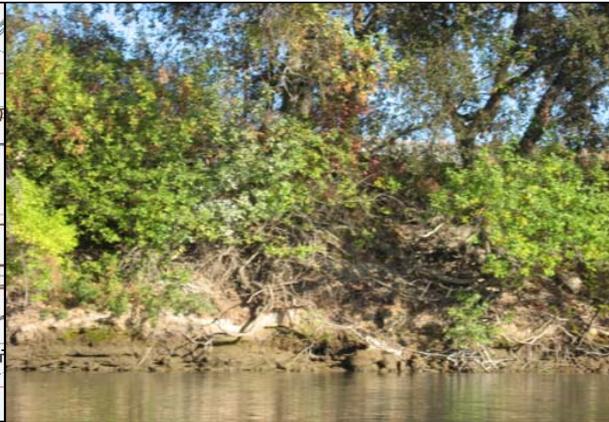
Criteria	Score	Notes
Bank Slope	4	less than 1:1 slope
Berm Width - Estimated	0	30 ft
Soil Type	4	sands and silts
Velocity	4	5.0 ft/s
Economic Factor	18	Natomas
Bank Stability	7	tree hazards, caves, slumping, and seepage
Erosion Hazard	37

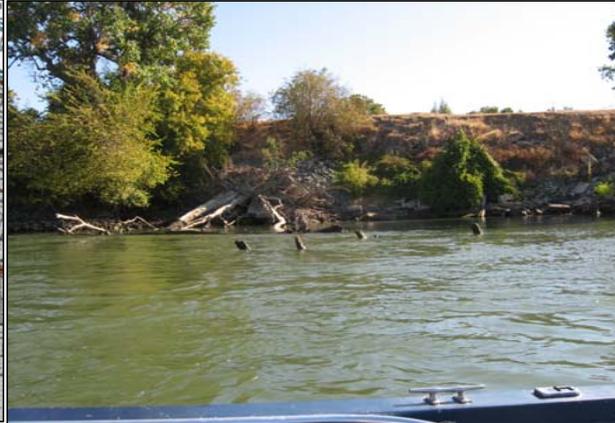
Criteria	Score	Notes
Bank Slope	3	1.5:1 slope
Berm Width - Estimated	0	125 ft
Soil Type	4	sands and silts
Velocity	4	5.1 ft/s
Economic Factor	20	Sacramento
Bank Stability	6	tree hazards and slumping
Erosion Hazard	37

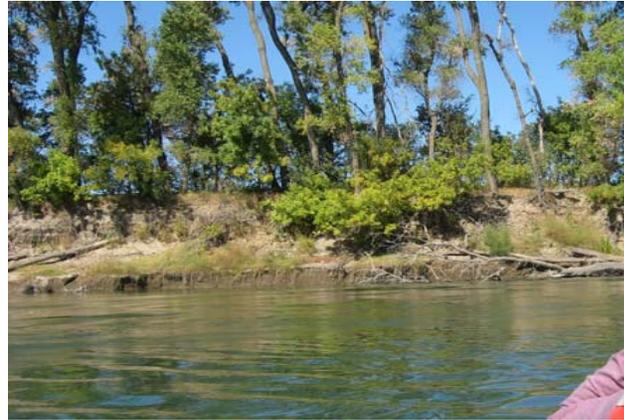
Sacramento River, RM 114.5R

Criteria	Score	Notes
Bank Slope	4	1:1 slope
Berm Width - Estimated	0	30 ft
Soil Type	4	sands and silts
Velocity	3	4.3 ft/s
Economic Factor	19	Colusa Basin
Bank Stability	6	tree hazards and slumping
Erosion Hazard	36

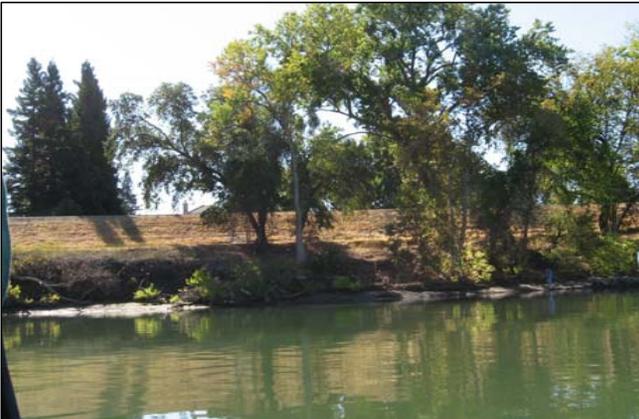
Sacramento River, RM 52.3L

Criteria	Score	Notes
Bank Slope	3	1.5:1 slope
Berm Width - Estimated	3	5 to 10 ft
Soil Type	4	sands and silts
Velocity	4	5.9 ft/s
Economic Factor	20	Sacramento
Bank Stability	2	tree hazards and caves
Erosion Hazard	36

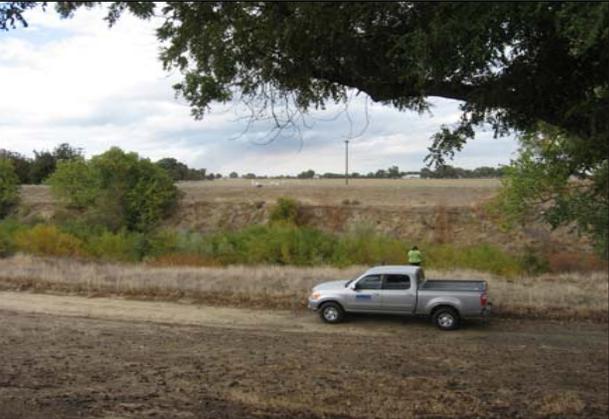
Criteria	Score	Notes
Bank Slope	4	less than 1:1
Berm Width - Estimated	2	10 to 25 ft
Soil Type	4	sands and silts
Velocity	4	6 ft/s
Economic Factor	15	Yolo
Bank Stability	7	tree hazards, caves, tension cracks, and slumping
Erosion Hazard	36

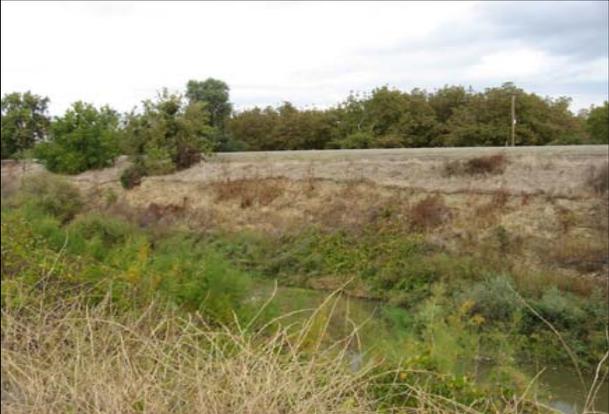
Criteria	Score	Notes
Bank Slope	4	1:1 slope
Berm Width - Estimated	2	15 to 30 ft
Soil Type	4	sands and silts
Velocity	4	6.5 ft/s
Economic Factor	15	Yolo
Bank Stability	7	caves, tension cracks, and slumping
Erosion Hazard	36

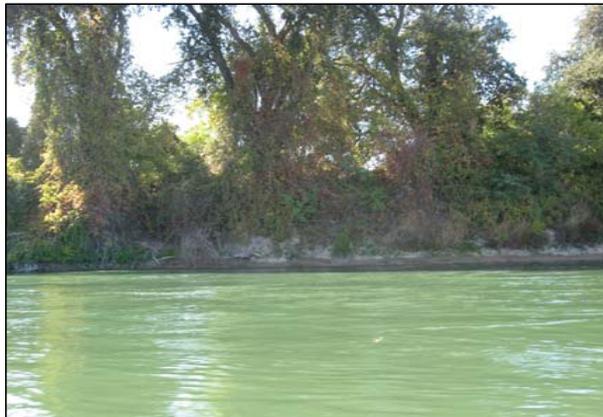
Sacramento River, RM 157.7R

Criteria	Score	Notes
Bank Slope	4	less than 1:1 slope, near vertical
Berm Width - Estimated	0	50 ft
Soil Type	2	clays and silts
Velocity	4	5.7 ft/s
Economic Factor	19	Colusa Basin
Bank Stability	6	animal burrows and slumping
Erosion Hazard	35

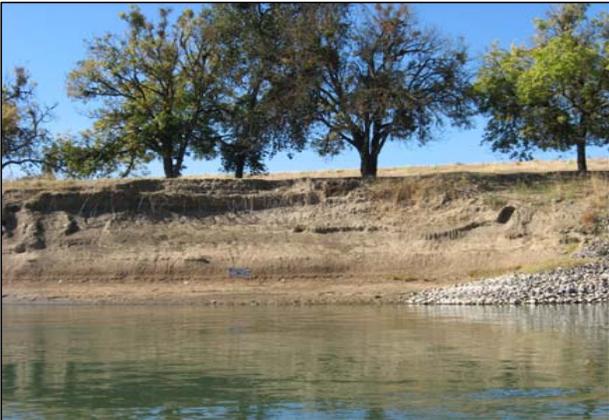
Sacramento River, RM 136.9R

Criteria	Score	Notes
Bank Slope	4	1:1 slopes
Berm Width - Estimated	0	30 ft
Soil Type	2	clays and silts
Velocity	3	4.7 ft/s
Economic Factor	19	Colusa Basin
Bank Stability	7	tree hazards, caves, and slumping
Erosion Hazard	35

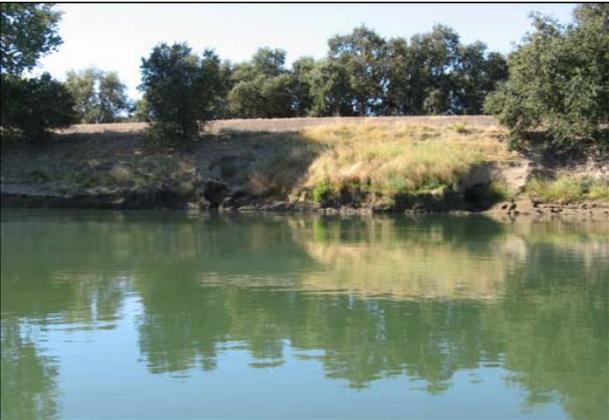
Sacramento River, RM 136.7R

Criteria	Score	Notes
Bank Slope	3	1.5:1 slope
Berm Width - Estimated	0	30 ft
Soil Type	2	clays and silts
Velocity	4	5.2 ft/s
Economic Factor	19	Colusa Basin
Bank Stability	7	tree hazards, caves, and slumping
Erosion Hazard	35

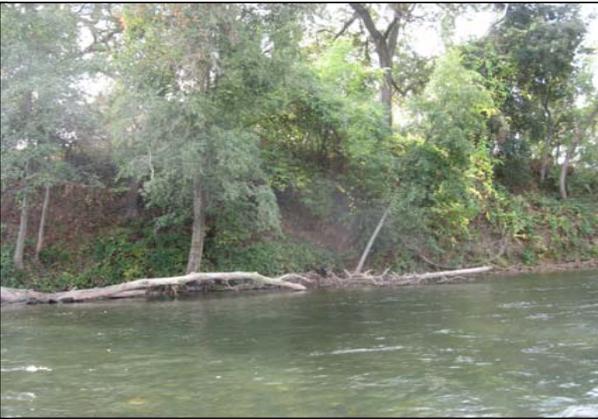
Criteria	Score	Notes
Bank Slope	5	near vertical slope
Berm Width - Estimated	2	15 to 20 ft
Soil Type	4	sands and silts
Velocity	3	3.9 ft/s
Economic Factor	20	Sacramento
Bank Stability	1	tree hazards
Erosion Hazard	35

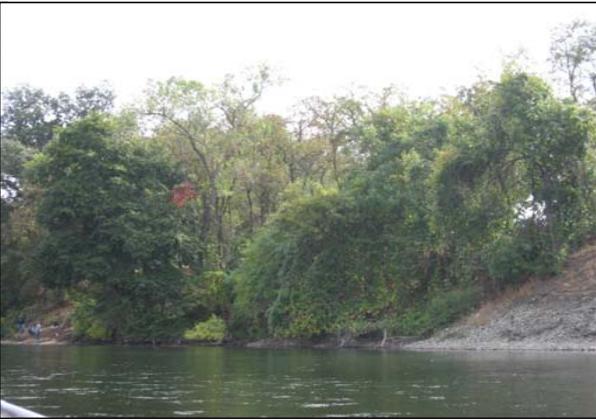
Criteria	Score	Notes
Bank Slope	3	1.5:1 slope
Berm Width - Estimated	2	10 to 15 ft
Soil Type	4	sands and silts
Velocity	5	8.7 ft/s
Economic Factor	20	Sacramento
Bank Stability	1	tree hazards
Erosion Hazard	35

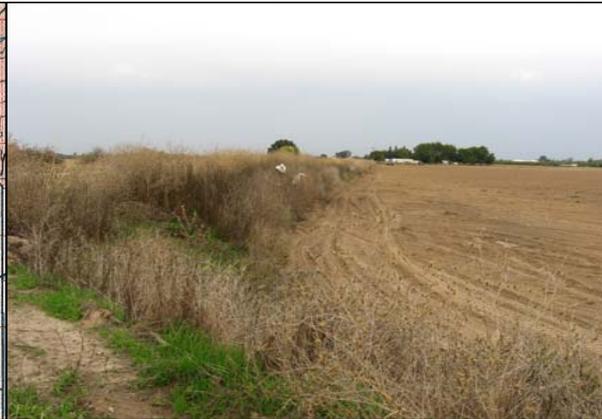
Criteria	Score	Notes
Bank Slope	5	near vertical
Berm Width - Estimated	5	no berm
Soil Type	4	sands and silts
Velocity	0	water does not reach bank
Economic Factor	15	Plumis Lake
Bank Stability	6	animal burrows and slumping
Erosion Hazard	35

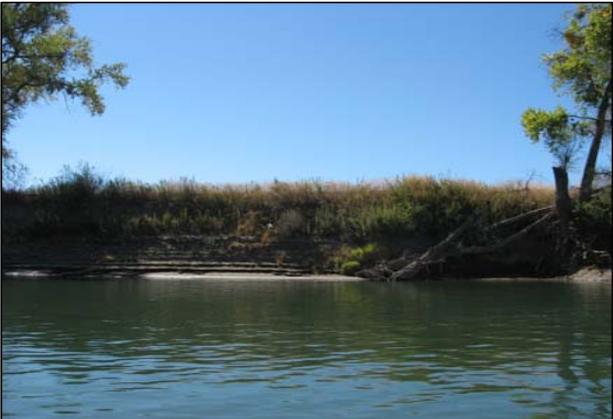
Criteria	Score	Notes
Bank Slope	3	1.5:1 slope
Berm Width - Estimated	0	40 ft
Soil Type	2	clays and silts
Velocity	4	5.5 ft/s
Economic Factor	19	Colusa Basin
Bank Stability	6	tree hazards and slumping
Erosion Hazard	34

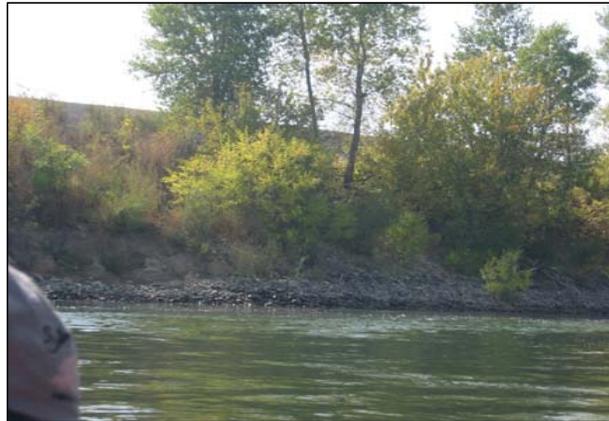
Sacramento River, RM 101.3R

Criteria	Score	Notes
Bank Slope	4	1:1 slope
Berm Width - Estimated	2	greater than 10 ft
Soil Type	2	clays and silts
Velocity	3	3.2 ft/s
Economic Factor	19	Colusa Basin
Bank Stability	4	slumping
Erosion Hazard	34

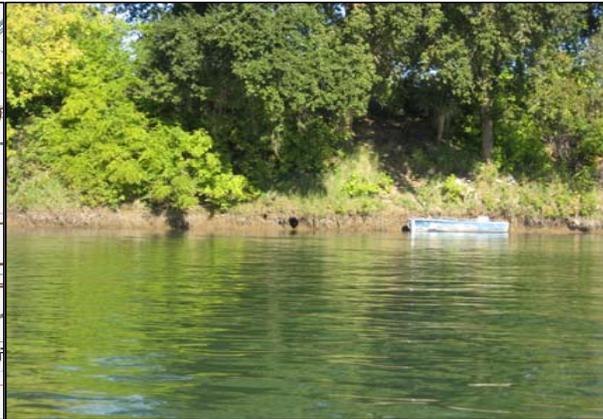
Sacramento River, RM 78.8L

Criteria	Score	Notes
Bank Slope	3	1.5:1 slope
Berm Width - Estimated	0	35 ft
Soil Type	4	sands and silts
Velocity	3	4.8 ft/s
Economic Factor	18	Natomas
Bank Stability	6	tree hazards, and seepage
Erosion Hazard	34

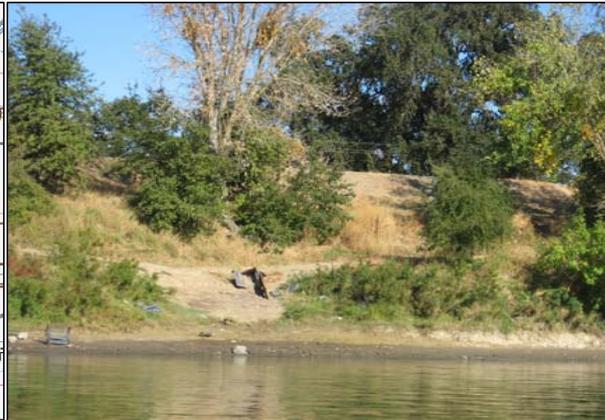
Sacramento River, RM 78.3L

Criteria	Score	Notes
Bank Slope	1	2.5:1 slope
Berm Width - Estimated	2	15 ft
Soil Type	4	sands and silts
Velocity	3	4.9 ft/s
Economic Factor	18	Natomas
Bank Stability	6	tree hazards, and seepage
Erosion Hazard	34

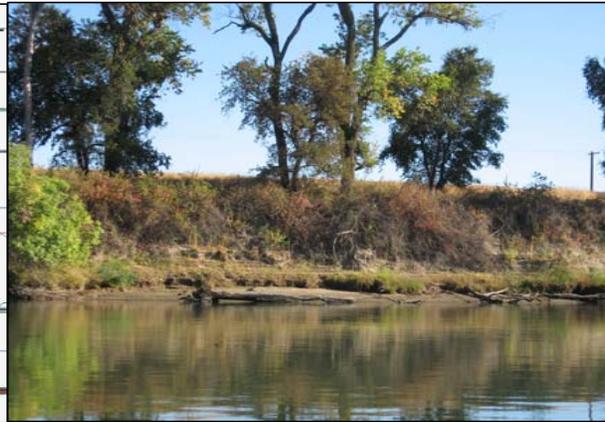
Sacramento River, RM 73.5L

Criteria	Score	Notes
Bank Slope	4	1:1 slope
Berm Width - Estimated	0	30 to 50 ft
Soil Type	2	clays and silts
Velocity	3	4.7 ft/s
Economic Factor	18	Natomas
Bank Stability	7	tree hazards, caves, and slumping
Erosion Hazard	34

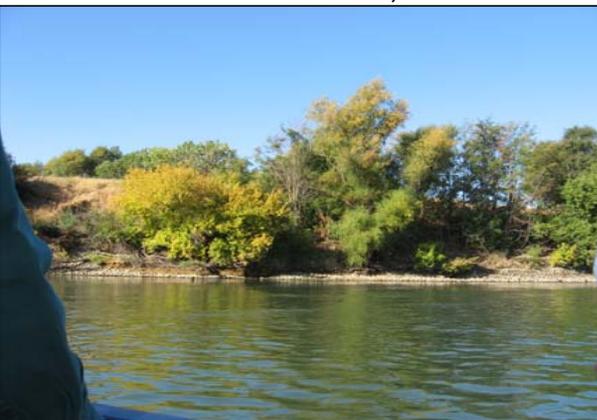
Criteria	Score	Notes
Bank Slope	3	1.5:1 slope
Berm Width - Estimated	5	0 to 10 ft
Soil Type	4	sands and silts
Velocity	4	5.16 ft/s
Economic Factor	11	South West Sacramento
Bank Stability	7	tree hazards, caves, and slumping
Erosion Hazard	34

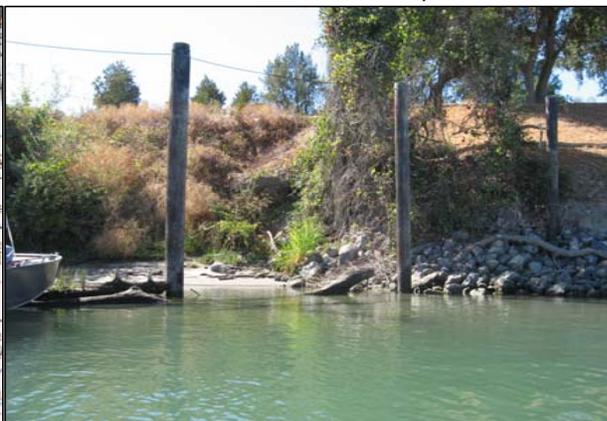
Sacramento River, RM 42.7R

Criteria	Score	Notes
Bank Slope	3	1.5:1 slope
Berm Width - Estimated	5	no berm
Soil Type	4	sands and silts
Velocity	4	5.4 ft/s
Economic Factor	12	Clarksburg
Bank Stability	6	tree hazards and slumping
Erosion Hazard	34

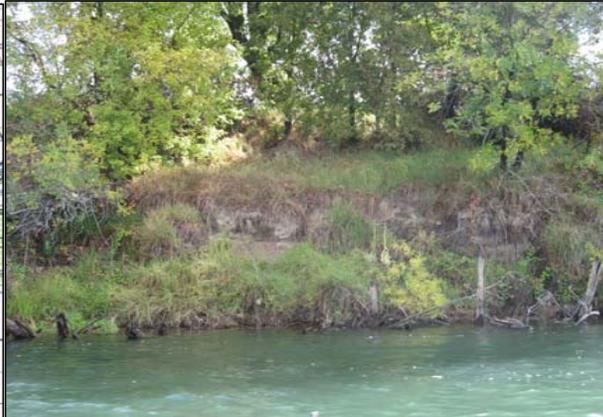
Criteria	Score	Notes
Bank Slope	4	1:1 slope of less
Berm Width - Estimated	0	50 ft
Soil Type	4	sands and silts
Velocity	4	5.3 ft/s
Economic Factor	15	Plumis Lake
Bank Stability	7	tree hazards, caves, slumping, and seepage history
Erosion Hazard	34

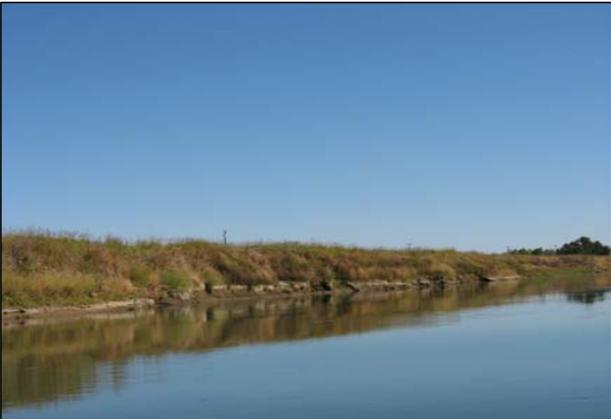
Sacramento River, RM 116.5L

Criteria	Score	Notes
Bank Slope	3	1.5:1 slope
Berm Width - Estimated	2	10 ft
Soil Type	4	sands and silts
Velocity	3	4.0 ft/s
Economic Factor	14	Sutter Basin
Bank Stability	7	beaver holes, tension cracks, and slumping
Erosion Hazard	33

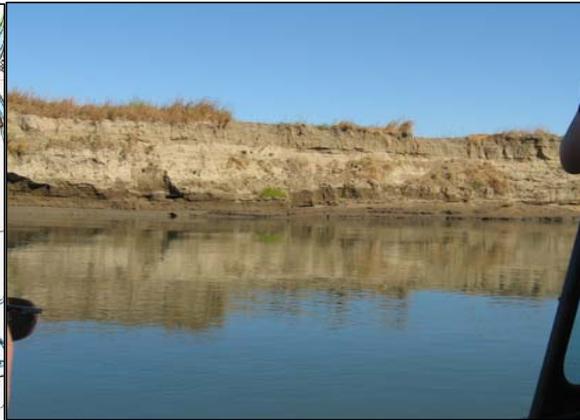
Site Location Map

Criteria	Score	Notes
Bank Slope	5	near vertical
Berm Width - Estimated	0	40 to 50 ft
Soil Type	4	sands and silts
Velocity	3	3.2 ft/s
Economic Factor	14	Sutter Basin
Bank Stability	7	tree hazards, tension cracks, and slumping
Erosion Hazard	33

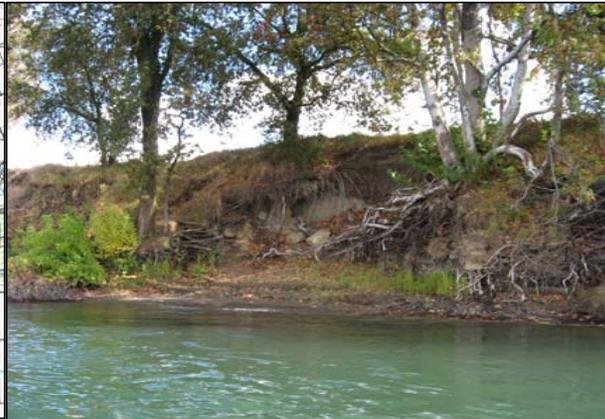
Site Location Map

Criteria	Score	Notes
Bank Slope	4	1:1 slope
Berm Width - Estimated	0	50 ft
Soil Type	4	sands and silts
Velocity	3	4.6 ft/s
Economic Factor	15	Plumis Lake
Bank Stability	7	tree hazards, slumping, and seepage
Erosion Hazard	33

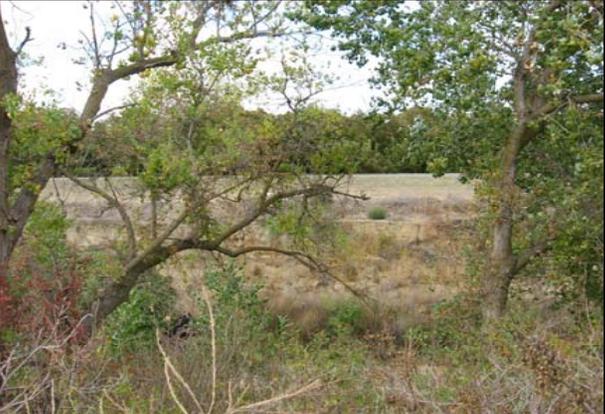
Site Location Map

Criteria	Score	Notes
Bank Slope	4	1:1 or less slope
Berm Width - Estimated	2	15 to 30 ft
Soil Type	4	sands and silts
Velocity	4	5.9 ft/s
Economic Factor	15	Yolo
Bank Stability	4	Slumping
Erosion Hazard	33

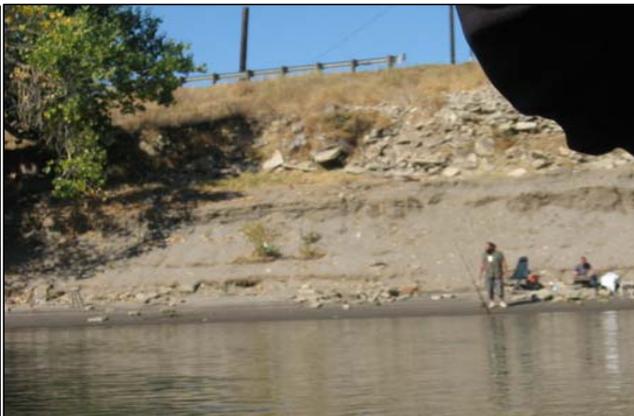
Site Location Map

Criteria	Score	Notes
Bank Slope	4	1:1 slope
Berm Width - Estimated	3	5 ft
Soil Type	4	sands and silts
Velocity	4	6.0 ft/s
Economic Factor	11	South West Sacramento
Bank Stability	6	tree hazards and slumping
Erosion Hazard	32

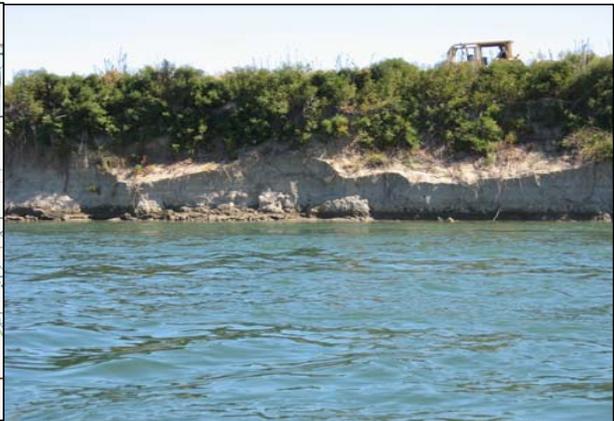
Site Location Map

Criteria	Score	Notes
Bank Slope	5	vertical banks
Berm Width - Estimated	0	30 ft
Soil Type	2	clays with some silts
Velocity	4	5.64 ft/s
Economic Factor	13	Butte Basin
Bank Stability	7	caves, slumping, and tension cracks
Erosion Hazard	31

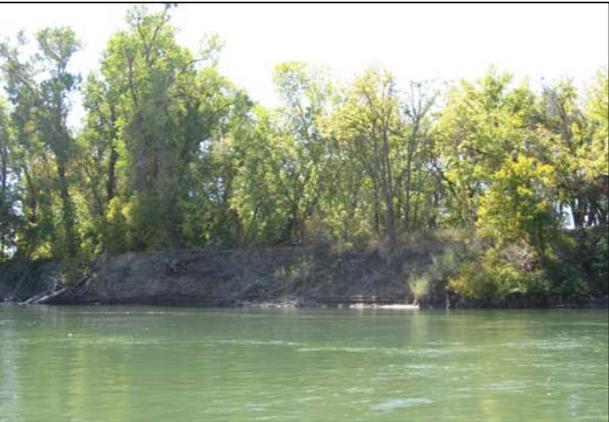
Site Location Map

Criteria	Score	Notes
Bank Slope	2	2:1 slope
Berm Width - Estimated	0	35 ft
Soil Type	2	clays and silts
Velocity	2	2.9 ft/s
Economic Factor	19	Colusa Basin
Bank Stability	6	tree hazards and slumping
Erosion Hazard	31

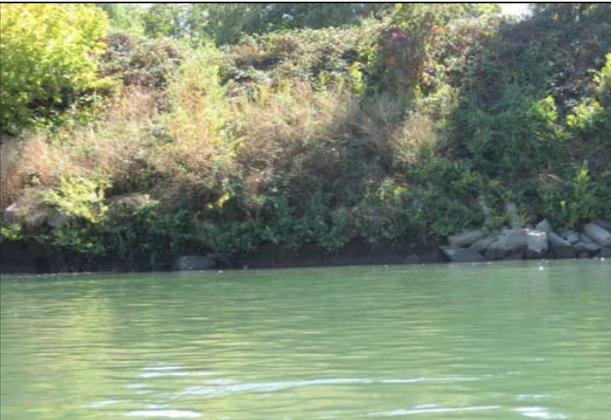
Site Location Map

Criteria	Score	Notes
Bank Slope	4	less than 1:1 slope
Berm Width - Estimated	2	15 ft
Soil Type	2	clays and silts
Velocity	4	5.3 ft/s
Economic Factor	19	Colusa Basin
Bank Stability	0	no stability issues
Erosion Hazard	31

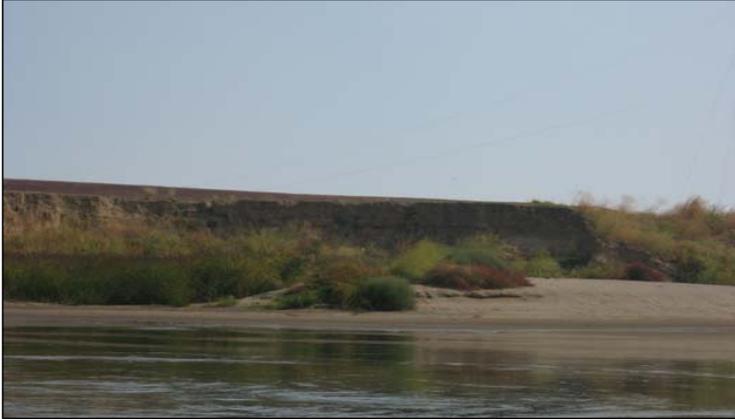
Site Location Map

Criteria	Score	Notes
Bank Slope	4	1:1 to 1.5:1 slope
Berm Width - Estimated	1	25 ft
Soil Type	4	sands and silts
Velocity	4	3.5 ft/s, plus eddy
Economic Factor	14	Sutter Basin
Bank Stability	4	slumping
Erosion Hazard	31

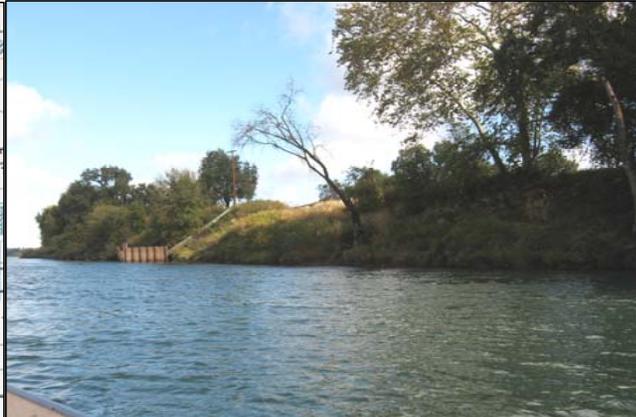
Site Location Map

Criteria	Score	Notes
Bank Slope	4	1:1 slope
Berm Width - Estimated	2	15 ft
Soil Type	4	sands and silts
Velocity	4	5.5 ft/s
Economic Factor	10	Verona
Bank Stability	7	tree hazards, slumping, and seepage
Erosion Hazard	31

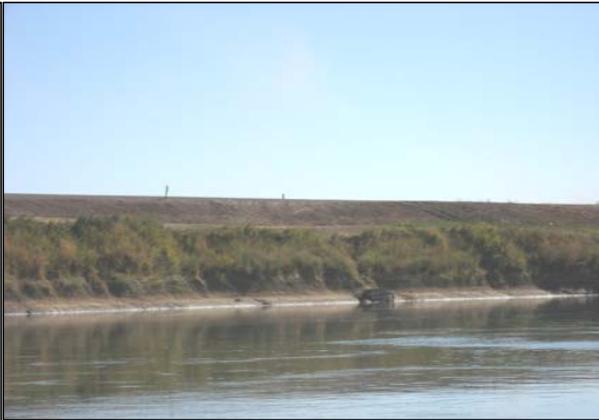
Site Location Map

Criteria	Score	Notes
Bank Slope	3	1.5:1 slope
Berm Width - Estimated	2	15 ft
Soil Type	4	sands and silts
Velocity	3	3.4 ft/s
Economic Factor	12	Sutter Basin
Bank Stability	6	tension cracks and slumping
Erosion Hazard	30

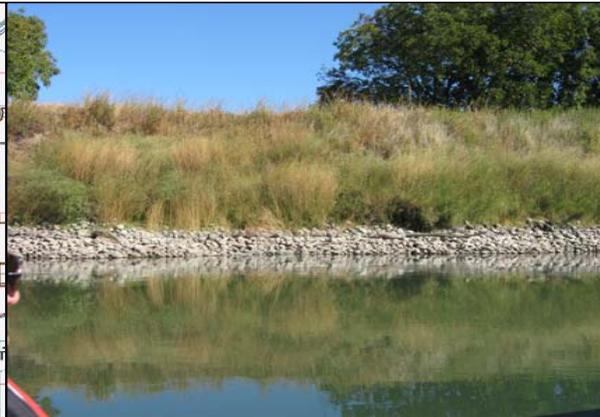
Site Location Map

Criteria	Score	Notes
Bank Slope	3	1.5:1 slope
Berm Width - Estimated	0	30 to 50 ft
Soil Type	4	sands and silts
Velocity	3	3.4 ft/s
Economic Factor	14	Sutter Basin
Bank Stability	6	caves and slumping
Erosion Hazard	30

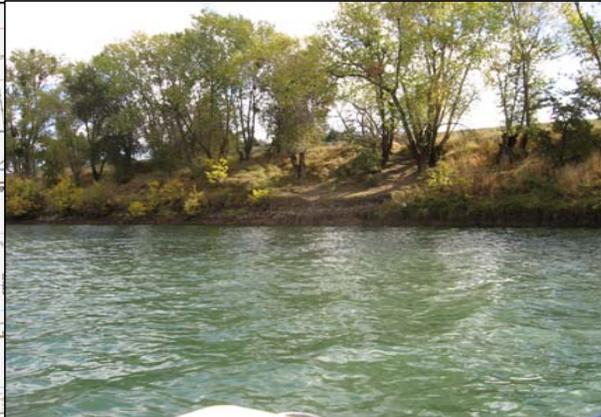
Site Location Map

Criteria	Score	Notes
Bank Slope	1	2.5:1 slope
Berm Width - Estimated	3	about 5 ft
Soil Type	4	sands and silts with cobbles underneath
Velocity	5	9.97 ft/s
Economic Factor	10	Verona
Bank Stability	7	tree hazards, slumping, and seepage
Erosion Hazard	30

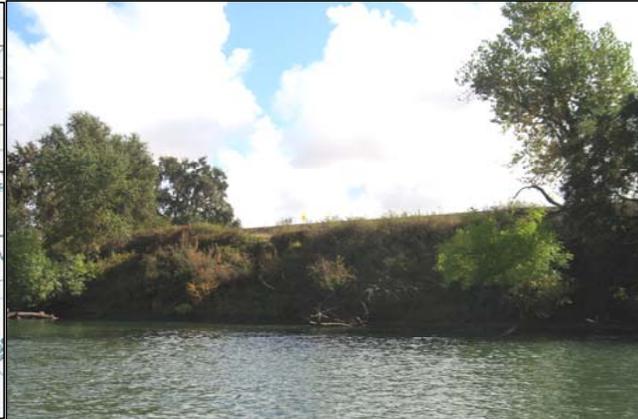
Site Location Map

Criteria	Score	Notes
Bank Slope	4	1:1 slope
Berm Width - Estimated	1	25 to 30 ft
Soil Type	4	sands and silts
Velocity	4	7.1 ft/s
Economic Factor	10	Verona
Bank Stability	7	tree hazards, caves, and seepage
Erosion Hazard	30

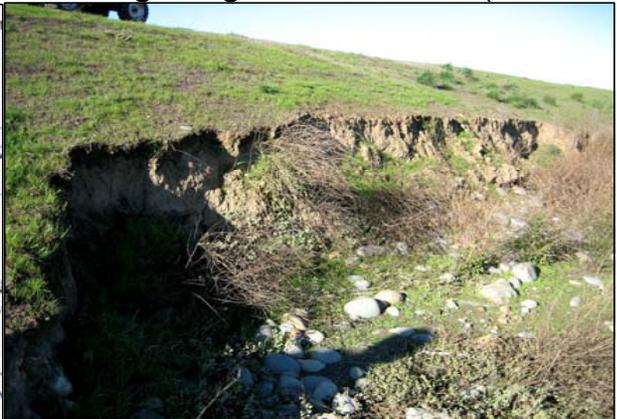
Site Location Map

Criteria	Score	Notes
Bank Slope	2	2:1 slope
Berm Width - Estimated	5	no berm
Soil Type	2	clays and silts
Velocity	0	0.1 ft/s
Economic Factor	15	Yolo
Bank Stability	6	tension cracks and slumping
Erosion Hazard	30

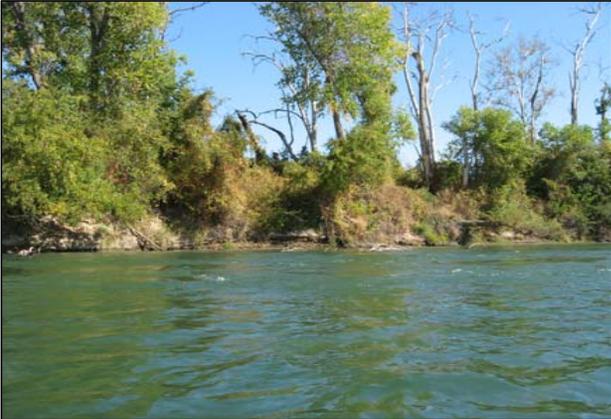
Site Location Map

Criteria	Score	Notes
Bank Slope	3	1.5:1 slope
Berm Width - Estimated	0	60 ft
Soil Type	2	clays and silts
Velocity	5	10.1 ft/s
Economic Factor	13	Butte Basin
Bank Stability	6	tree hazards and slumping
Erosion Hazard	29

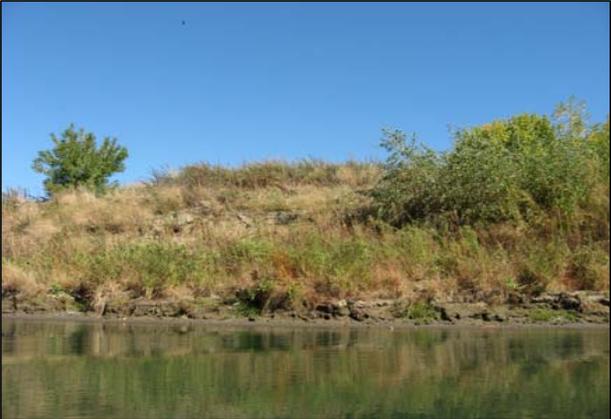
Site Location Map

Criteria	Score	Notes
Bank Slope	1	2.5:1 slope
Berm Width - Estimated	0	30 ft
Soil Type	2	clays and silts
Velocity	3	4.9 ft/s
Economic Factor	19	Colusa Basin
Bank Stability	4	slumping
Erosion Hazard	29

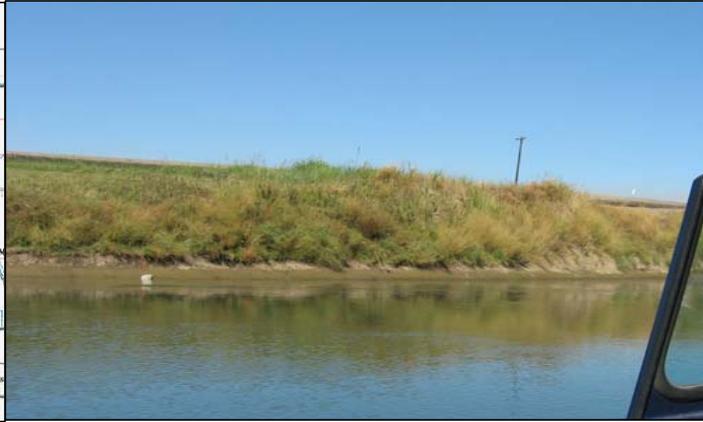
Site Location Map

Criteria	Score	Notes
Bank Slope	4	1:1 slope
Berm Width - Estimated	0	30 ft
Soil Type	4	sands and silts
Velocity	3	3.2 ft/s
Economic Factor	12	Sutter Basin
Bank Stability	6	caves and slumping
Erosion Hazard	29

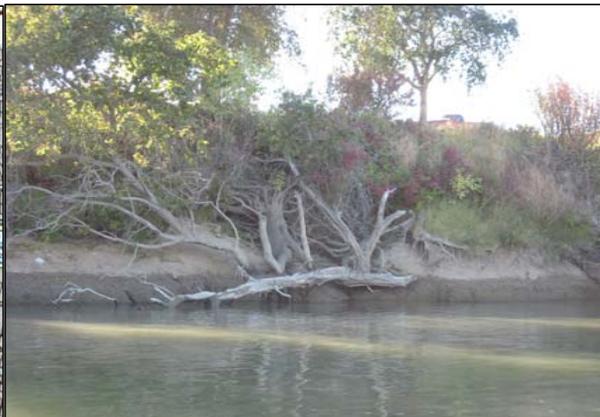
Site Location Map

Criteria	Score	Notes
Bank Slope	3	1.5:1 slope
Berm Width - Estimated	2	less than 20 ft
Soil Type	2	clays and silts
Velocity	3	3.1 ft/s
Economic Factor	13	West Sacramento
Bank Stability	6	tree hazards and slumping
Erosion Hazard	29

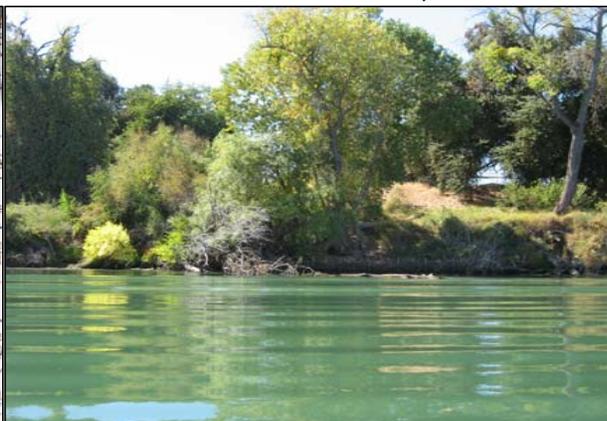
Site Location Map

Criteria	Score	Notes
Bank Slope	3	1.5:1 slope
Berm Width - Estimated	5	no berm
Soil Type	4	sands and silts
Velocity	4	5.1 ft/s
Economic Factor	12	Clarksburg
Bank Stability	1	tree hazards
Erosion Hazard	29

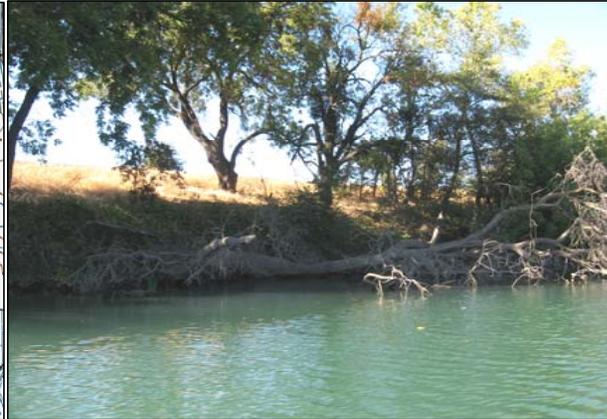
Site Location Map

Criteria	Score	Notes
Bank Slope	4	1:1 slope
Berm Width - Estimated	5	no berm
Soil Type	1	clay
Velocity	2	3.0 ft/s
Economic Factor	12	Clarksburg
Bank Stability	5	tree hazards, slumping
Erosion Hazard	29

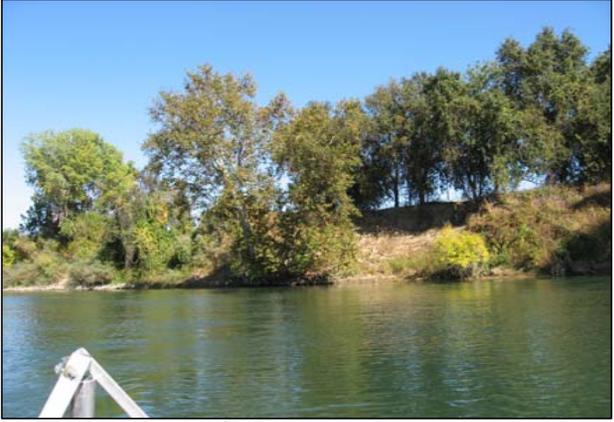
Site Location Map

Criteria	Score	Notes
Bank Slope	3	1.5:1 slope
Berm Width - Estimated	0	30 ft
Soil Type	2	clays and silts
Velocity	3	4.6 ft/s
Economic Factor	13	Butte Basin
Bank Stability	7	tree hazards, animal burrows, and slumping
Erosion Hazard	28

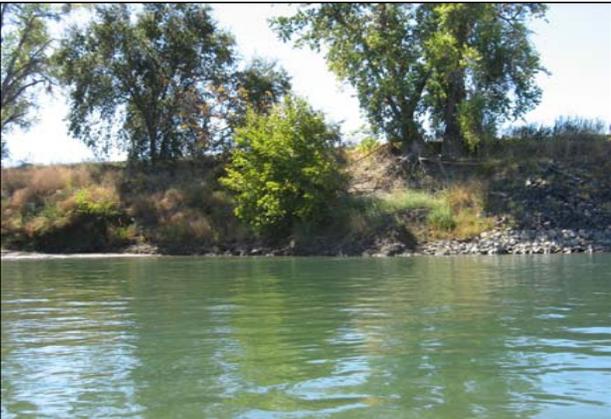
Site Location Map

Criteria	Score	Notes
Bank Slope	2	2:1 slope
Berm Width - Estimated	0	40 ft
Soil Type	2	clays and silts
Velocity	4	5 ft/s
Economic Factor	19	Colusa Basin
Bank Stability	1	tree hazards
Erosion Hazard	28

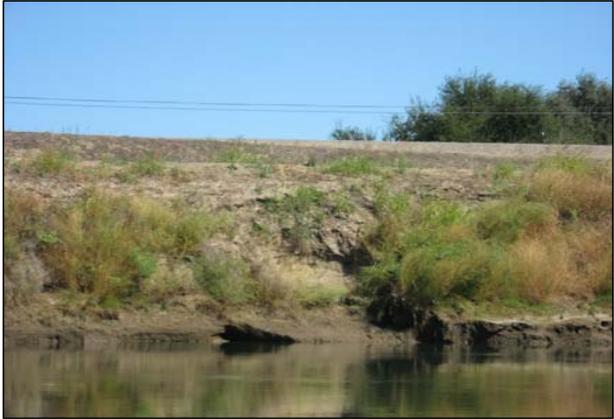
Site Location Map

Criteria	Score	Notes
Bank Slope	3	1.5:1 slope
Berm Width - Estimated	0	30 ft
Soil Type	4	sands and silts
Velocity	3	4.3 ft/s
Economic Factor	14	sutter Basin
Bank Stability	4	slumping
Erosion Hazard	28

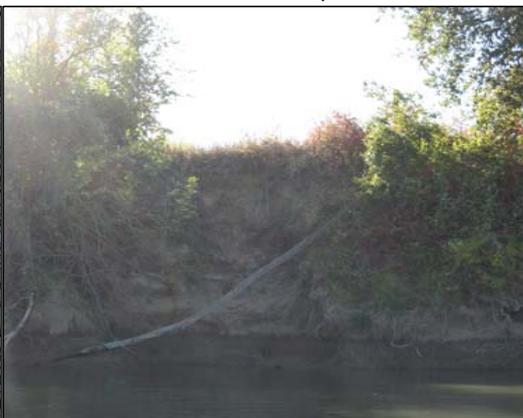
Site Location Map

Criteria	Score	Notes
Bank Slope	3	1.5:1 slope
Berm Width - Estimated	2	less than 20 ft
Soil Type	2	clays and silts
Velocity	2	2.9 ft/s
Economic Factor	13	West Sacramento
Bank Stability	6	tree hazards and slumping
Erosion Hazard	28

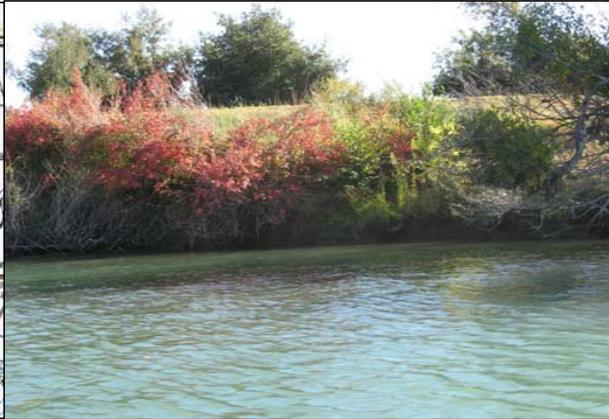
Site Location Map

Criteria	Score	Notes
Bank Slope	4	1:1 slope
Berm Width - Estimated	5	0 to 50 ft
Soil Type	2	clays and silts
Velocity	4	5.1 ft/s
Economic Factor	7	Isleton
Bank Stability	6	tree hazards and slumping
Erosion Hazard	28

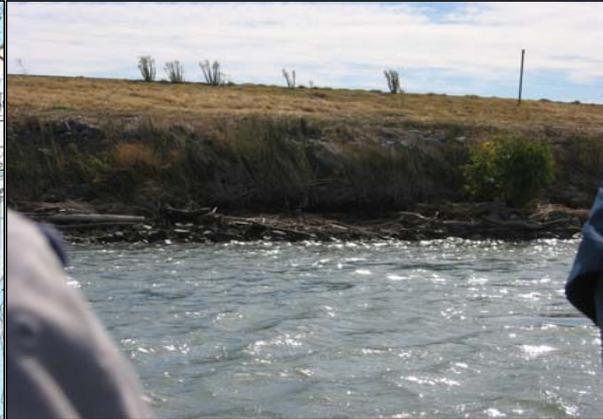
Site Photograph

Criteria	Score	Notes
Bank Slope	4	1:1 slope
Berm Width - Estimated	5	no berm
Soil Type	4	sands and silts
Velocity	4	7.0 ft/s
Economic Factor	7	Iselton
Bank Stability	4	slumping
Erosion Hazard	28

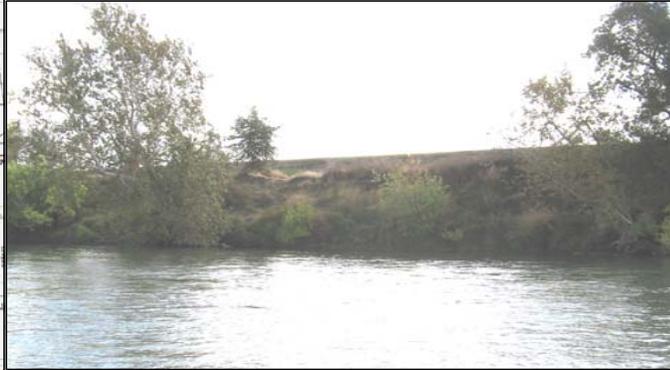
Site Photograph

Criteria	Score	Notes
Bank Slope	2	2:1 slope
Berm Width - Estimated	1	25 to 30 ft
Soil Type	4	sands and silts
Velocity	5	10.6 ft/s
Economic Factor	10	Verona
Bank Stability	6	slumping and seepage
Erosion Hazard	28

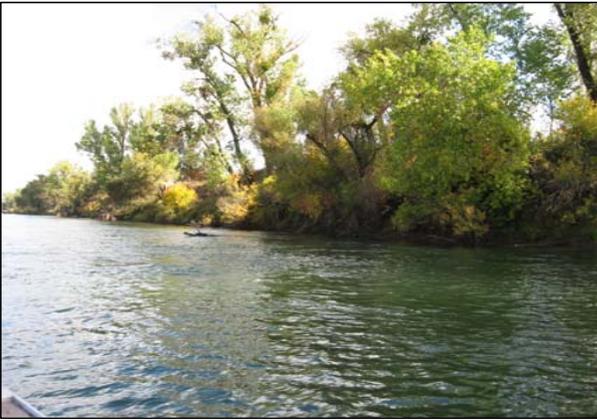
Site Photograph

Criteria	Score	Notes
Bank Slope	3	1.5:1 slope
Berm Width - Estimated	0	greater than 30 ft
Soil Type	4	sands and silts
Velocity	5	8.8 ft/s
Economic Factor	10	Verona
Bank Stability	6	tree hazards, and seepage
Erosion Hazard	28

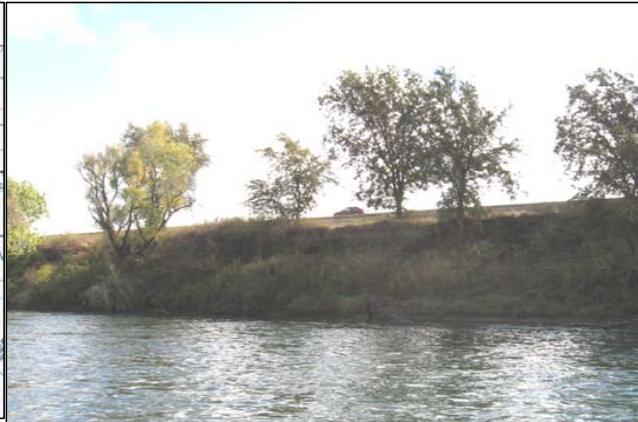
Site Photograph

Criteria	Score	Notes
Bank Slope	3	1.5:1 slope
Berm Width - Estimated	0	30 ft
Soil Type	4	sands and silts
Velocity	4	7.2 ft/s
Economic Factor	10	Verona
Bank Stability	7	tree hazards, caves, and seepage
Erosion Hazard	28

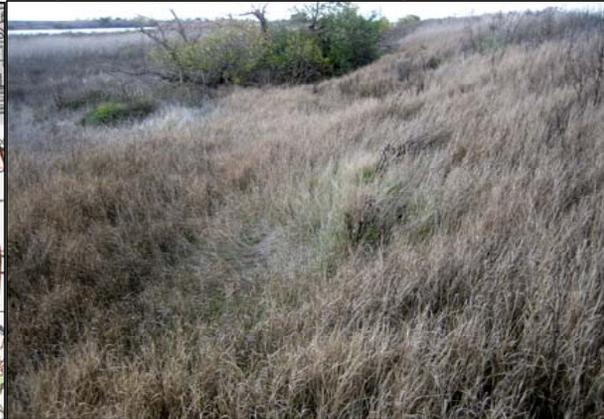
Site Photograph

Criteria	Score	Notes
Bank Slope	2	2:1 slope
Berm Width - Estimated	5	no berm
Soil Type	2	clays and silts
Velocity	1	1.3 ft/s
Economic Factor	12	Clarksburg
Bank Stability	6	tension cracks and slumping
Erosion Hazard	28

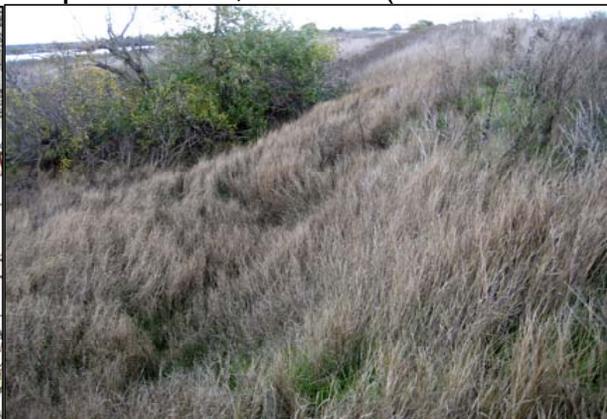
Site Photograph

Criteria	Score	Notes
Bank Slope	2	2:1 slope
Berm Width - Estimated	5	no berm
Soil Type	2	clays and silts
Velocity	1	1.3 ft/s
Economic Factor	12	Clarksburg
Bank Stability	6	tension cracks and slumping
Erosion Hazard	28

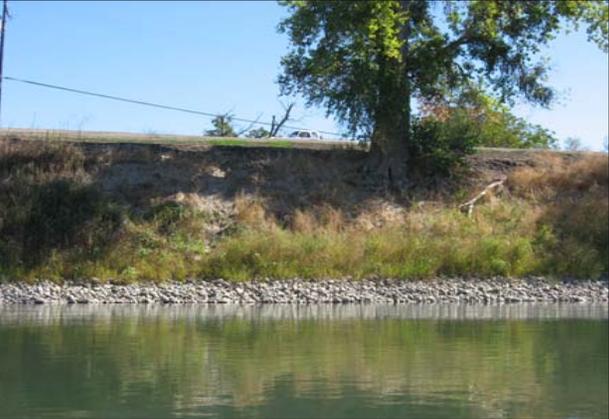
Site Photograph

Criteria	Score	Notes
Bank Slope	3	1.5:1 slope
Berm Width - Estimated	5	0 to 60 ft
Soil Type	2	clays and silts
Velocity	2	2.9 ft/s
Economic Factor	9	Tisdale
Bank Stability	6	tree hazards and slumping
Erosion Hazard	27

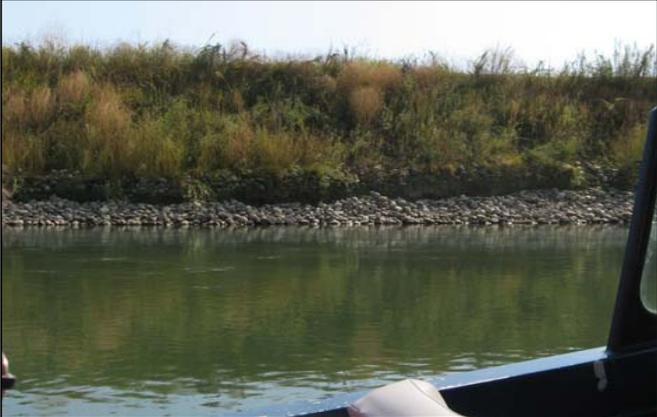
Site Photograph

Criteria	Score	Notes
Bank Slope	3	1.5:1 slope
Berm Width - Estimated	0	35 ft
Soil Type	4	sands and silts
Velocity	2	2.2 ft/s
Economic Factor	14	Sutter Basin
Bank Stability	4	slumping
Erosion Hazard	27

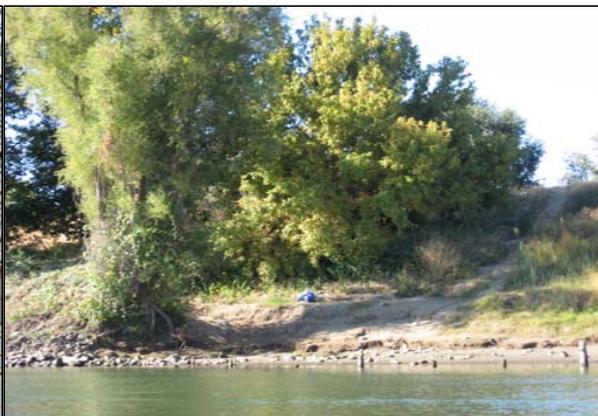
Site Photograph

Criteria	Score	Notes
Bank Slope	2	2:1 slope
Berm Width - Estimated	5	0 to 10 ft
Soil Type	4	sands and silts
Velocity	4	5.0 ft/s
Economic Factor	11	South West Sacramento
Bank Stability	1	tree hazards
Erosion Hazard	27

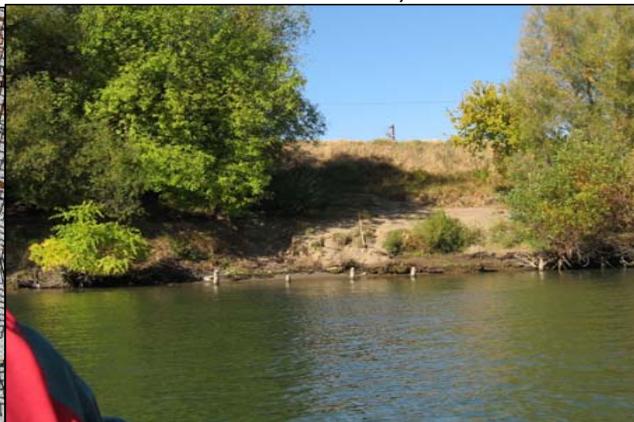
Site Photograph

Criteria	Score	Notes
Bank Slope	3	1.5:1 slope
Berm Width - Estimated	0	3 to 40 ft
Soil Type	4	sands and silts
Velocity	3	4.88 ft/s
Economic Factor	11	South West Sacramento
Bank Stability	6	tree hazards and slumping
Erosion Hazard	27

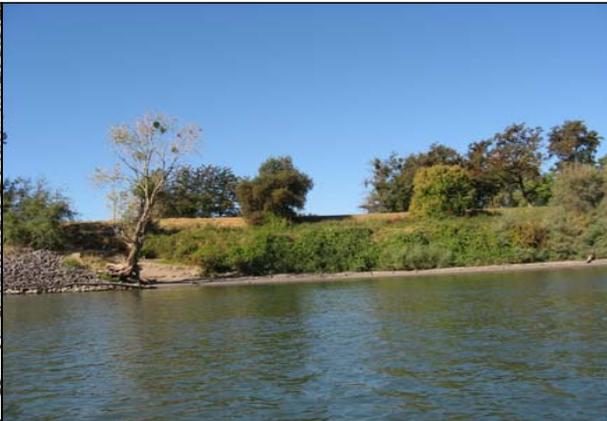
Site Photograph

Criteria	Score	Notes
Bank Slope	3	1.5:1 slope
Berm Width - Estimated	1	25 ft
Soil Type	2	clays and silts
Velocity	4	5.11 ft/s
Economic Factor	11	South West Sacramento
Bank Stability	6	caves and slumping
Erosion Hazard	27

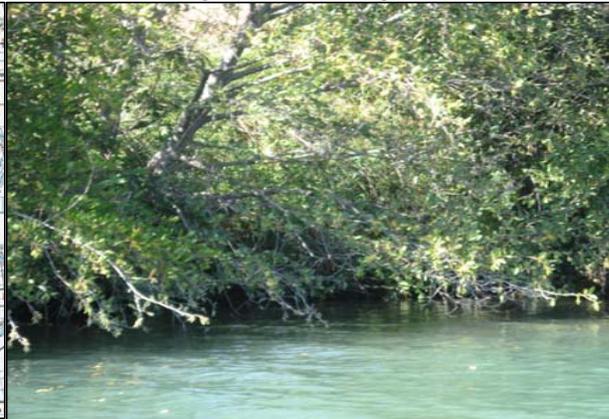
Site Photograph

Criteria	Score	Notes
Bank Slope	4	1:1 slope
Berm Width - Estimated	3	5 ft
Soil Type	4	sands and silts
Velocity	3	3.9 ft/s
Economic Factor	7	Iselton
Bank Stability	6	tree hazards and slumping
Erosion Hazard	27

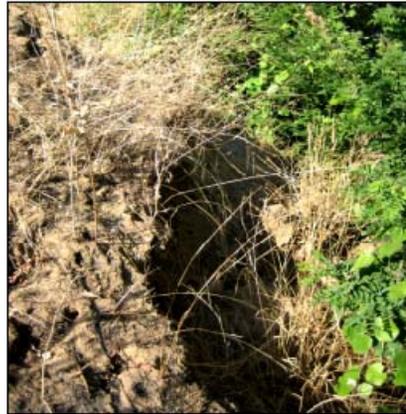
Site Photograph

Criteria	Score	Notes
Bank Slope	5	Some vertical sections
Berm Width - Estimated	2	15 to 30 ft
Soil Type	2	Clays and Silts
Velocity	2	2.8 ft/s
Economic Factor	10	Verona
Bank Stability	6	Seepage History and beaver holes
Erosion Hazard	27

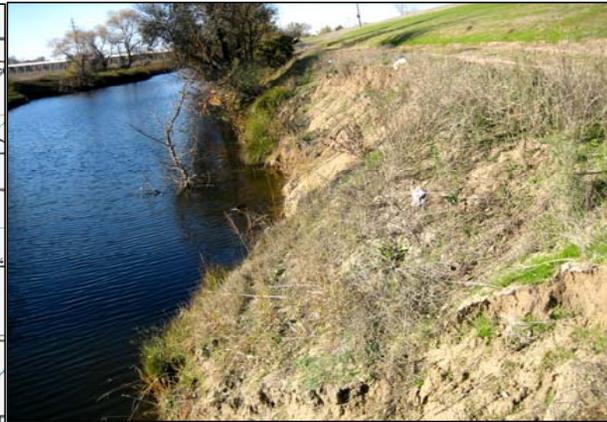
Site Photograph

Criteria	Score	Notes
Bank Slope	4	1:1 slope
Berm Width - Estimated	3	5 to 6 ft of berm
Soil Type	4	sands and silts
Velocity	2	3.0 ft/s
Economic Factor	8	Sutter Town
Bank Stability	6	vertical sections and slumping
Erosion Hazard	27

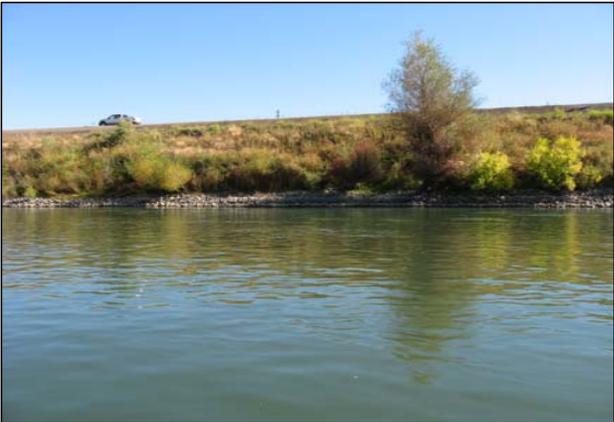
Site Photograph

Criteria	Score	Notes
Bank Slope	4	1:1 slope
Berm Width - Estimated	5	no berm
Soil Type	2	clays and silts
Velocity	2	2.6 ft/s
Economic Factor	9	Tisdale
Bank Stability	4	slumping
Erosion Hazard	26

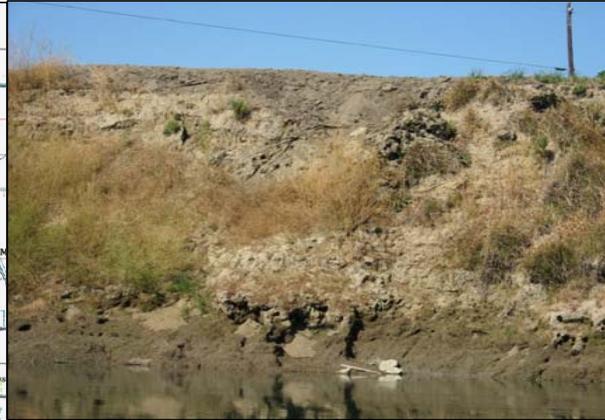
Site Photograph

Criteria	Score	Notes
Bank Slope	3	1.5:1 slope
Berm Width - Estimated	0	30 ft
Soil Type	4	sands and silts
Velocity	3	3.4 ft/s
Economic Factor	12	Sutter Basin
Bank Stability	4	slumping
Erosion Hazard	26

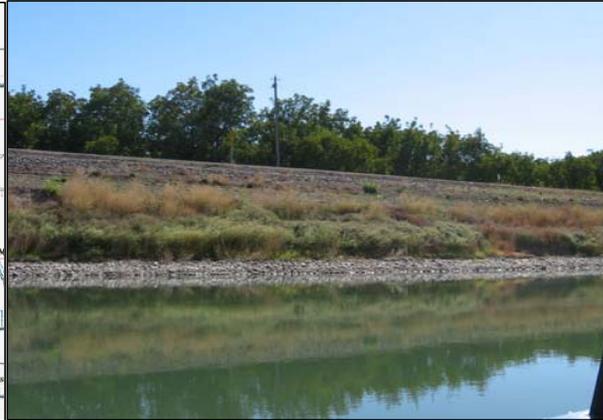
Site Photograph

Criteria	Score	Notes
Bank Slope	2	2:1 slope
Berm Width - Estimated	5	0 to 15 ft
Soil Type	4	sands and silts
Velocity	3	3.3 ft/s
Economic Factor	12	Sutter Basin
Bank Stability	0	no stability issues
Erosion Hazard	26

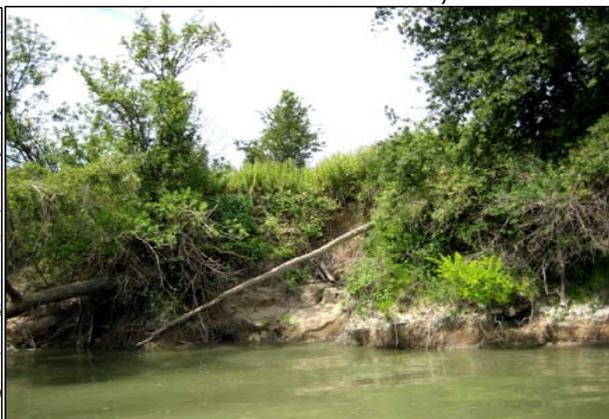
Site Photograph

Criteria	Score	Notes
Bank Slope	4	1:1 slope
Berm Width - Estimated	1	25 ft
Soil Type	4	sands and silts
Velocity	4	5.1 ft/s
Economic Factor	6	Elkhorn
Bank Stability	7	tree hazards, caves, and slumping
Erosion Hazard	26

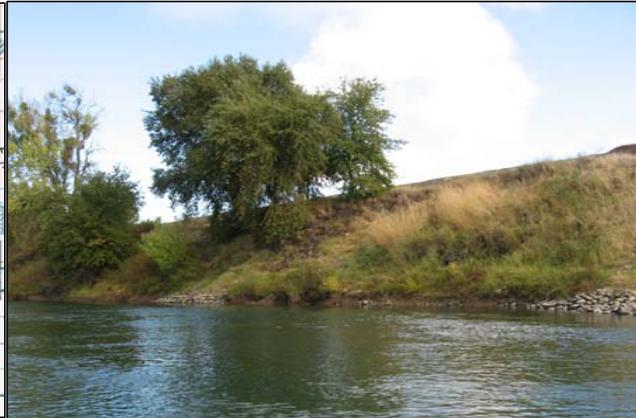
Site Photograph

Criteria	Score	Notes
Bank Slope	1	2.5:1 slope
Berm Width - Estimated	2	15 ft of berm
Soil Type	3	sands
Velocity	3	4.8 ft/s
Economic Factor	10	Verona
Bank Stability	7	tree hazards, slumping, seepage history
Erosion Hazard	26
