Sacramento River, RM 55.2L

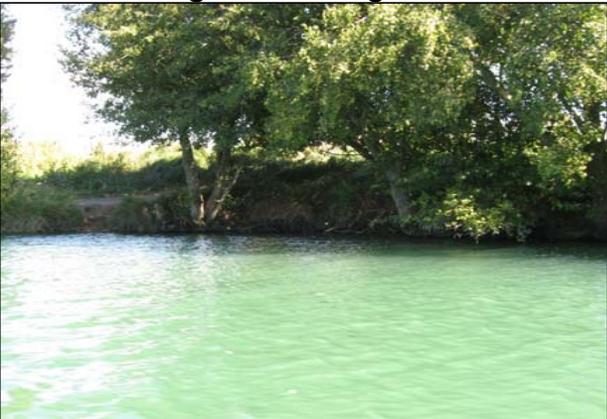
Site Photograph

Criteria	Score	Notes
Bank Slope	3	1.5:1 slope
Berm Width - Estimated	4	less than 5 ft
Soil Type	4	sands and silts
Velocity	3	3.9 ft/s
Economic Factor	5	Tyler Island
Bank Stability	6	tree hazards, slumping
Erosion Hazard	25

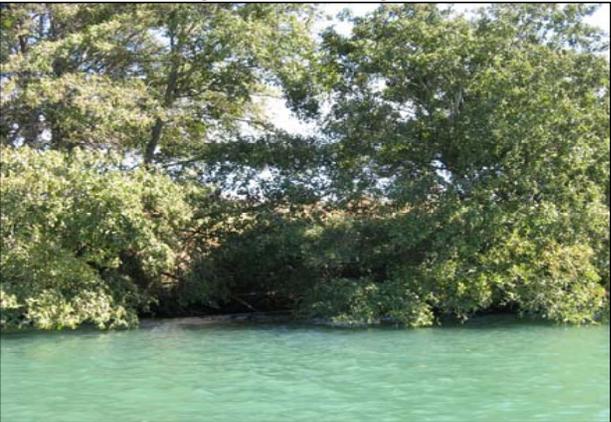
Site Photograph

Criteria	Score	Notes
Bank Slope	3	1.5:1 slope
Berm Width - Estimated	4	less than 5 ft
Soil Type	4	sands and silts
Velocity	3	4.0 ft/s
Economic Factor	5	Tyler Island
Bank Stability	6	tree hazards, slumping
Erosion Hazard	25

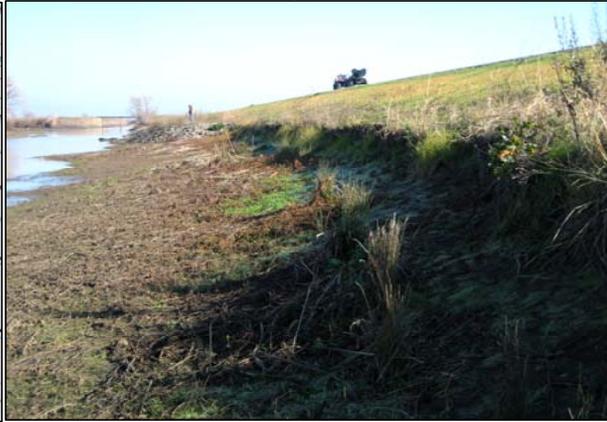
Site Photograph

Criteria	Score	Notes
Bank Slope	1	2.5:1 slope
Berm Width - Estimated	5	no berm
Soil Type	2	silts and clays
Velocity	4	6 ft/s
Economic Factor	9	Biggs
Bank Stability	4	slumping
Erosion Hazard	25

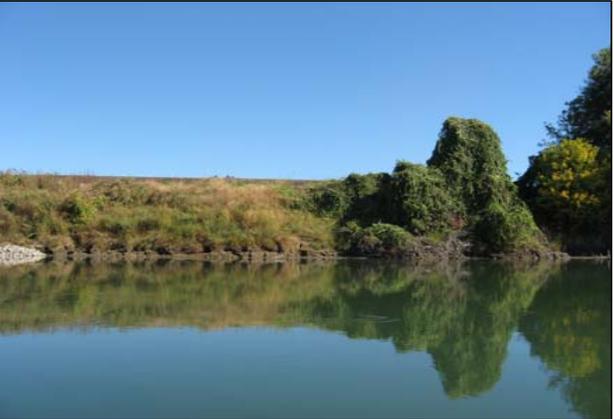
Site Photograph

Criteria	Score	Notes
Bank Slope	2	2:1 slope
Berm Width - Estimated	1	25 ft
Soil Type	2	clays and silts
Velocity	4	5.0 ft/s
Economic Factor	9	Tisdale
Bank Stability	6	caves and slumping
Erosion Hazard	24

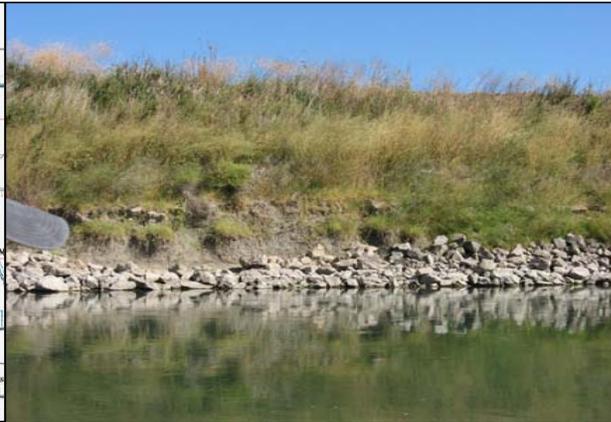
Site Photograph

Criteria	Score	Notes
Bank Slope	4	1:1 slope
Berm Width - Estimated	2	10 ft
Soil Type	4	sands and silts
Velocity	2	2.7 ft/s
Economic Factor	12	Sutter Basin
Bank Stability	0	no stability issues
Erosion Hazard	24

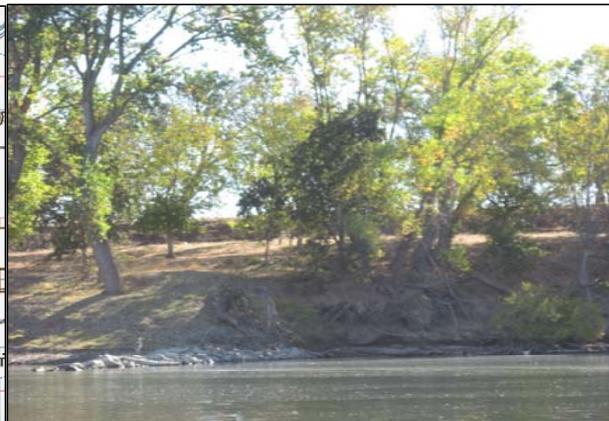
Site Photograph

Criteria	Score	Notes
Bank Slope	3	1.5:1 slope
Berm Width - Estimated	1	25 to 30 ft
Soil Type	2	clays and silts
Velocity	5	5.0 ft/s plus eddy from adjacent rock
Economic Factor	6	Elkhorn
Bank Stability	7	tree hazards, caves, and slumping
Erosion Hazard	24

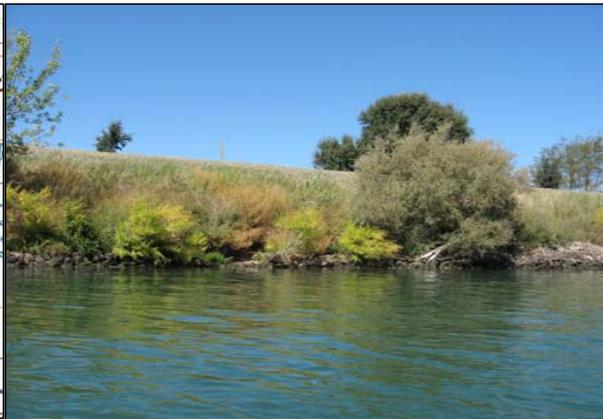
Site Photograph

Criteria	Score	Notes
Bank Slope	3	1.5:1 slopes
Berm Width - Estimated	5	no berm
Soil Type	4	sands and silts
Velocity	4	6.5 ft/s
Economic Factor	6	Courtland
Bank Stability	2	caves
Erosion Hazard	24

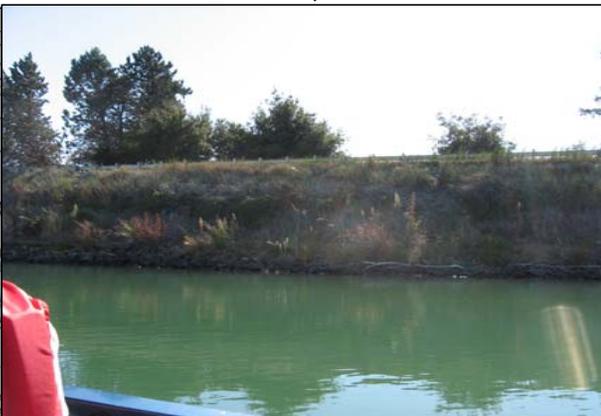
Criteria	Score	Notes
Bank Slope	3	1.5:1 slope
Berm Width - Estimated	5	no berm
Soil Type	4	sands and silts
Velocity	4	5.2 ft/s
Economic Factor	8	Grand Island
Bank Stability	0	no stability issues
Erosion Hazard	24

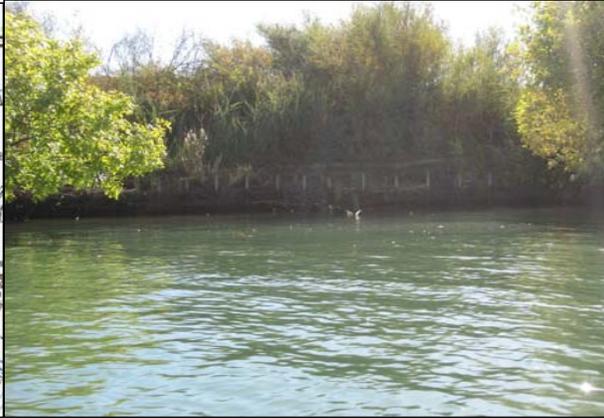
Criteria	Score	Notes
Bank Slope	4	1:1 slope
Berm Width - Estimated	2	10 ft
Soil Type	2	clays and silts
Velocity	3	4.5 ft/s
Economic Factor	7	Isleton
Bank Stability	6	tree haszards and slumping
Erosion Hazard	24

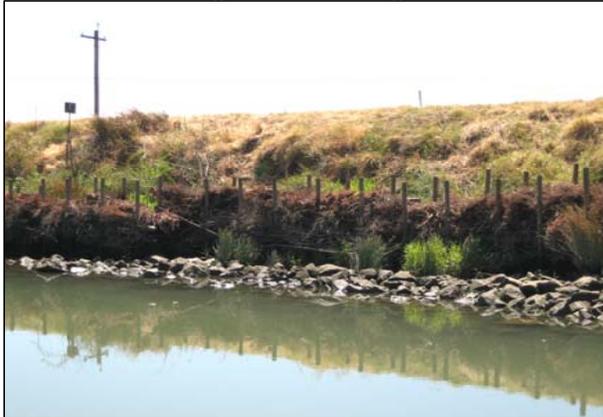
Georgiana Slough, RM 4L

Criteria	Score	Notes
Bank Slope	4	1:1 slope
Berm Width - Estimated	4	less than 5 ft
Soil Type	4	sands and silts
Velocity	3	3.8 ft/s
Economic Factor	5	Tyler Island
Bank Stability	4	slumping
Erosion Hazard	24

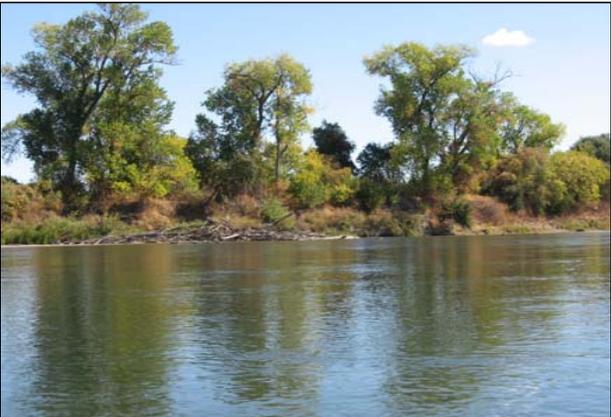
Sacramento River, RM 168.3L

Criteria	Score	Notes
Bank Slope	2	2:1 slope
Berm Width - Estimated	0	30 ft
Soil Type	4	sands and silts
Velocity	3	4.8 ft/s
Economic Factor	13	Butte Basin
Bank Stability	1	tree hazards
Erosion Hazard	23

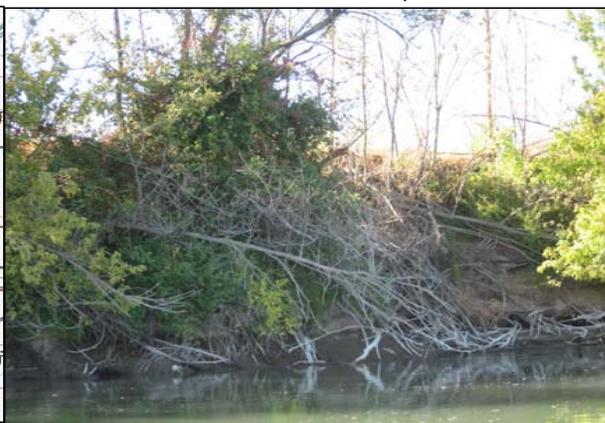
Sacramento River, RM 75.3R

Criteria	Score	Notes
Bank Slope	4	less than 1:1
Berm Width - Estimated	0	30 to 50 ft
Soil Type	2	clays and silts
Velocity	4	5.0 ft/s
Economic Factor	6	Elkhorn
Bank Stability	7	tree hazards, caves, and slumping
Erosion Hazard	23

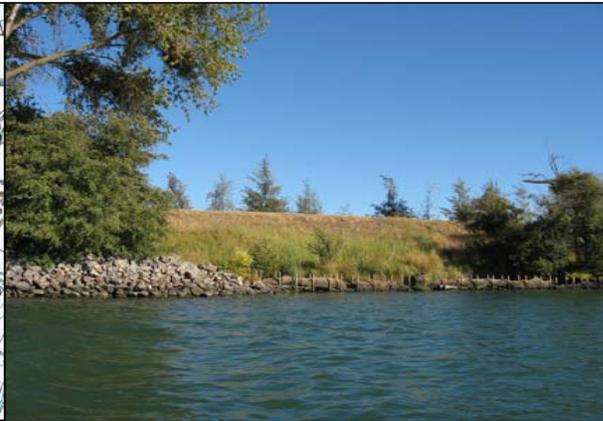
Sacramento River, RM 22.7L

Criteria	Score	Notes
Bank Slope	3	1.5:1 slope
Berm Width - Estimated	5	no berm
Soil Type	4	sands and silts
Velocity	3	4.8 ft/s
Economic Factor	7	Isleton
Bank Stability	1	tree hazards
Erosion Hazard	23

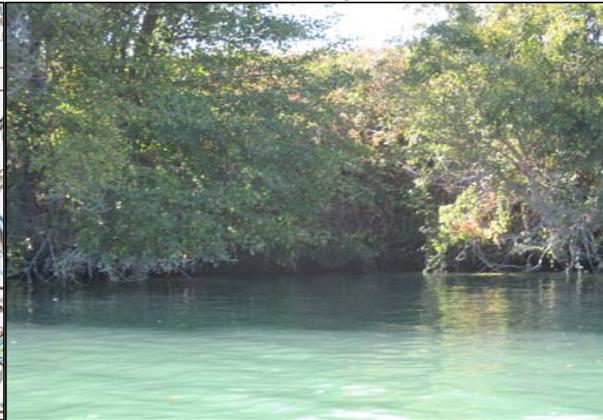
Sutter Slough, RM 24.7R

Criteria	Score	Notes
Bank Slope	2	2:1 slope
Berm Width - Estimated	3	5 ft
Soil Type	2	clays and silts
Velocity	3	4.7 ft/s
Economic Factor	12	Clarksburg
Bank Stability	1	tree hazards
Erosion Hazard	23

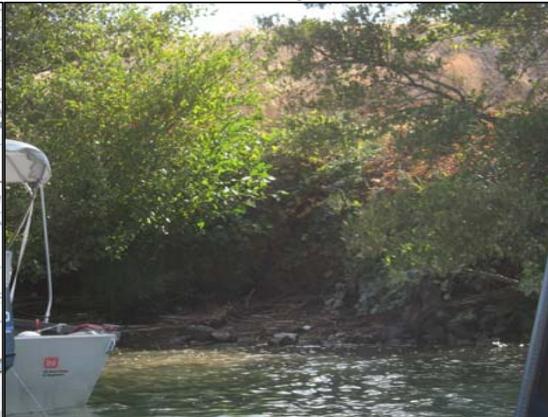
Cache Slough, RM 15.9L

Criteria	Score	Notes
Bank Slope	2	2:1 slope
Berm Width - Estimated	4	3 to 6 ft
Soil Type	2	clays and silts
Velocity	5	10.9 ft/s
Economic Factor	4	Ryer Island
Bank Stability	6	slumping, beaver holes
Erosion Hazard	23

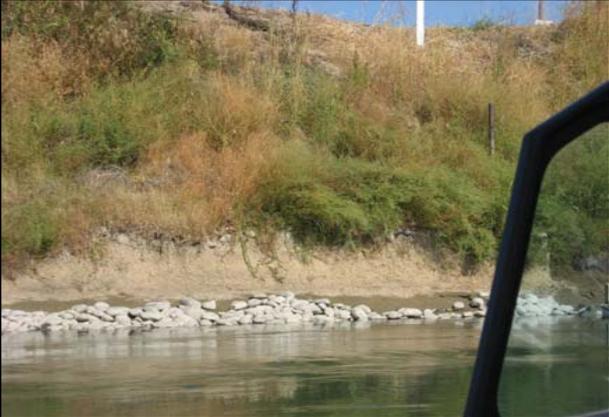
Sacramento River, RM 104.5L

Criteria	Score	Notes
Bank Slope	3	1.5:1 slope
Berm Width - Estimated	0	40 ft
Soil Type	4	sands and silts
Velocity	1	1.7 ft/s
Economic Factor	14	Sutter Basin
Bank Stability	0	no stability issues
Erosion Hazard	22

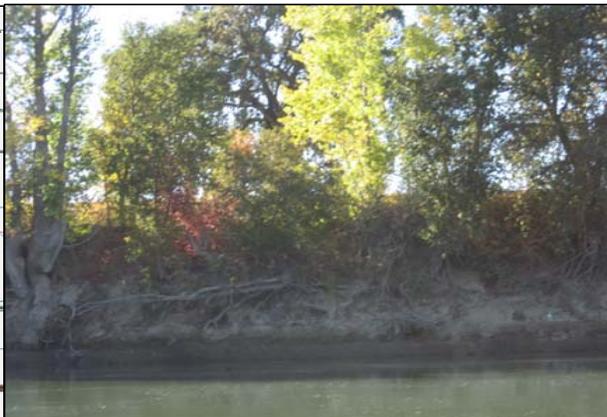
Sacramento River, RM 74.4R

Criteria	Score	Notes
Bank Slope	3	1.5:1 or less
Berm Width - Estimated	1	25 to 50 ft
Soil Type	2	clays and silts
Velocity	4	5.7 ft/s
Economic Factor	6	Elkhorn
Bank Stability	6	caves and slumping
Erosion Hazard	22

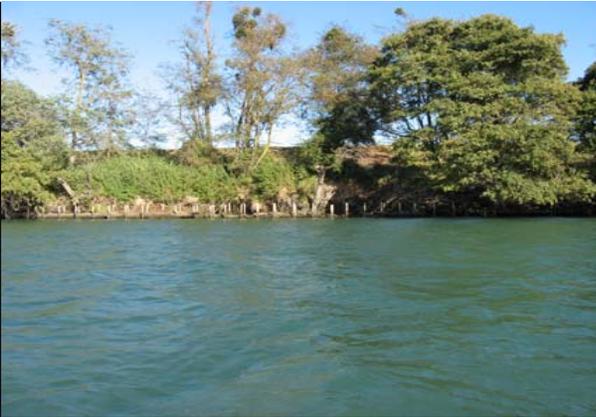
Sacramento River, RM 23.2L

Criteria	Score	Notes
Bank Slope	4	1:1 slope
Berm Width - Estimated	2	10 ft berm
Soil Type	4	sands and silts
Velocity	3	4.2 ft/s
Economic Factor	7	Isleton
Bank Stability	2	tree hazards and caves
Erosion Hazard	22

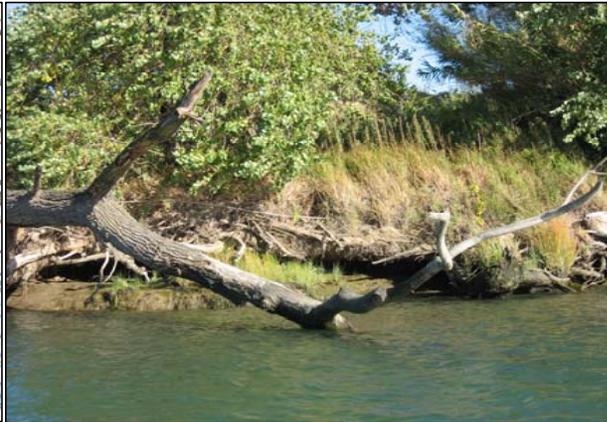
Sacramento River, RM 22.5L

Criteria	Score	Notes
Bank Slope	4	1:1 slope
Berm Width - Estimated	2	10 ft
Soil Type	4	sands and silts
Velocity	3	5.4 ft/s
Economic Factor	7	Isleton
Bank Stability	2	caves
Erosion Hazard	22

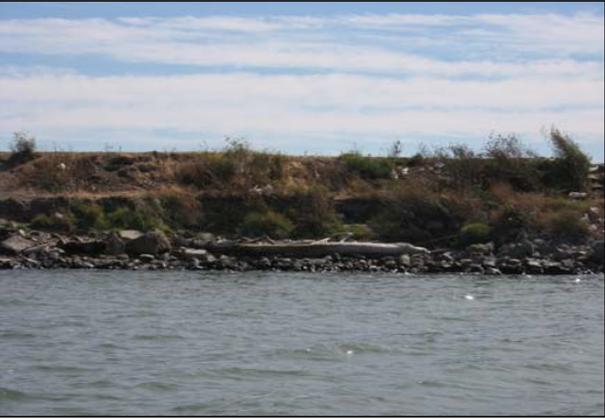
Sacramento River, RM 8.0L

Criteria	Score	Notes
Bank Slope	5	near vertical
Berm Width - Estimated	5	no berm
Soil Type	4	sands and silts
Velocity	4	5.1 ft/s
Economic Factor	4	Sherman Island
Bank Stability	0	no stability issues
Erosion Hazard	22

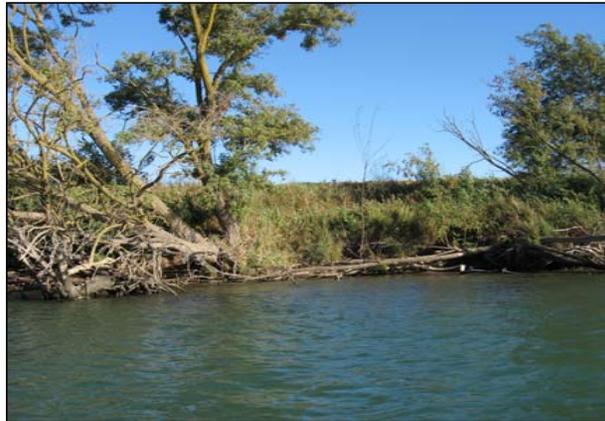
Sacramento River, RM 21.5L

Criteria	Score	Notes
Bank Slope	3	1.5:1 slope
Berm Width - Estimated	3	5 ft
Soil Type	4	sands and silts
Velocity	4	4.3 ft/s
Economic Factor	7	Isleton
Bank Stability	1	tree hazards
Erosion Hazard	22

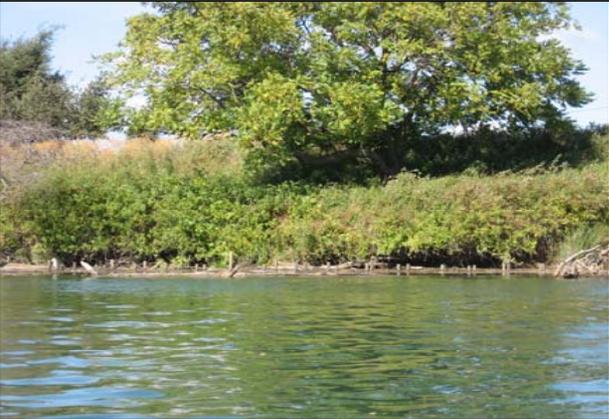
Georgiana Slough, RM 9.3L

Criteria	Score	Notes
Bank Slope	4	1:1 slope
Berm Width - Estimated	2	10 ft
Soil Type	4	silts and sands
Velocity	1	1.1 ft/s
Economic Factor	5	Tyler Island
Bank Stability	6	tree hazards and slumping
Erosion Hazard	22

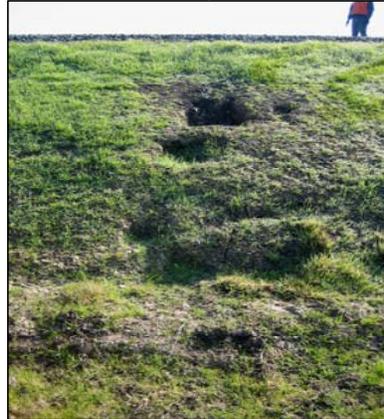
Cherokee Canal, LM 14.0 (DWR MA 13 Unit 2 East)

Criteria	Score	Notes
Bank Slope	1	2.5:1 slope
Berm Width - Estimated	5	no berm
Soil Type	2	silts and clays
Velocity	3	4.0 ft/s
Economic Factor	9	Biggs
Bank Stability	2	Piping Holes
Erosion Hazard	22

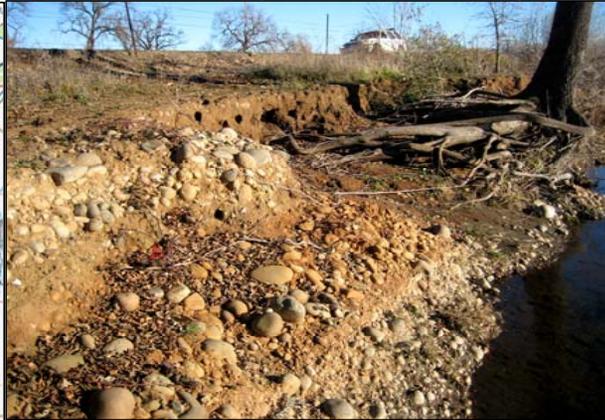
Deer Creek, LM 0.9 (Tehama County Unit 2 North)

Criteria	Score	Notes
Bank Slope	5	near vertical
Berm Width - Estimated	2	10 to 15 ft
Soil Type	3	sands and cobbles
Velocity	4	~5+ ft/s
Economic Factor	1	minimal flooding
Bank Stability	7	tree hazards, animal holes, and slumping
Erosion Hazard	22

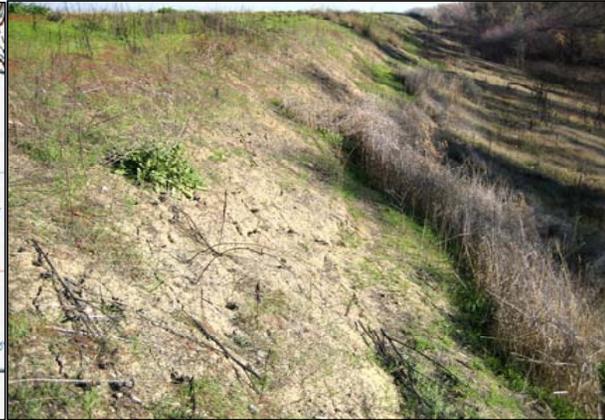
Natomas Cross Canal, LM 3.0 (RD 1001 Unit 5 North)

Criteria	Score	Notes
Bank Slope	3	1.5:1 slope
Berm Width - Estimated	0	40 ft of berm
Soil Type	2	silts with some clays
Velocity	1	1.5 ft/s
Economic Factor	10	Verona
Bank Stability	6	tension cracks and slumping
Erosion Hazard	22

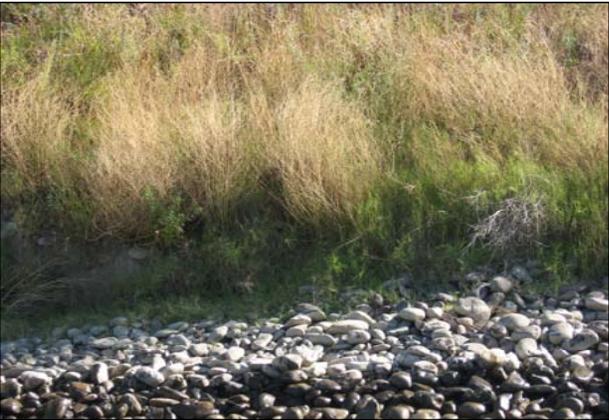
Sacramento River, RM 136.6L

Criteria	Score	Notes
Bank Slope	3	1.5:1 slope
Berm Width - Estimated	0	30 ft
Soil Type	2	clays and silts
Velocity	3	4.9 ft/s
Economic Factor	9	Tisdale
Bank Stability	4	slumping
Erosion Hazard	21

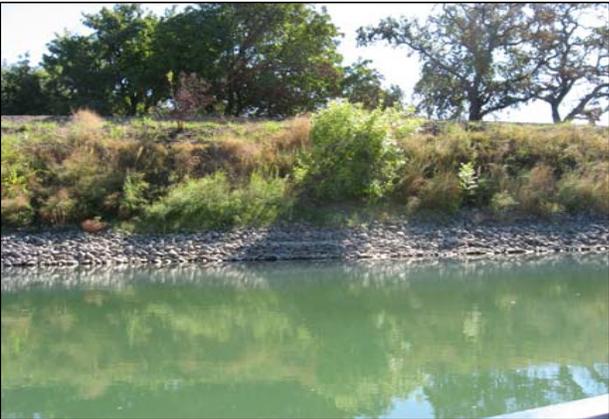
Sacramento River, RM 133.8L

Criteria	Score	Notes
Bank Slope	3	1.5:1 slope
Berm Width - Estimated	1	greater than 20 ft
Soil Type	1	clays and rounded stone
Velocity	3	4.9 ft/s
Economic Factor	9	Tisdale
Bank Stability	4	slumping
Erosion Hazard	21

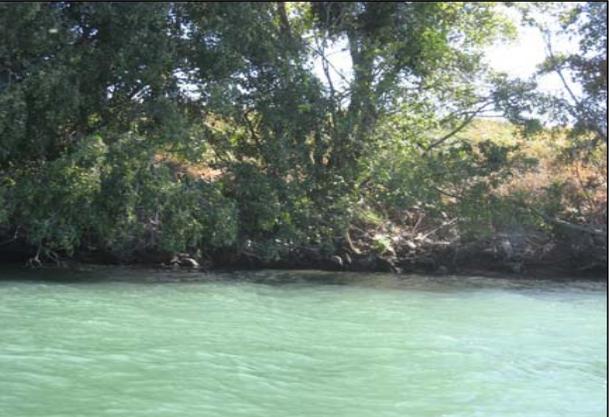
Georgiana Slough, RM 8.3L

Criteria	Score	Notes
Bank Slope	3	1.5:1 slope
Berm Width - Estimated	2	15 ft
Soil Type	4	sands and silts
Velocity	3	3.7 ft/s
Economic Factor	5	Tyler Island
Bank Stability	4	slumping
Erosion Hazard	21

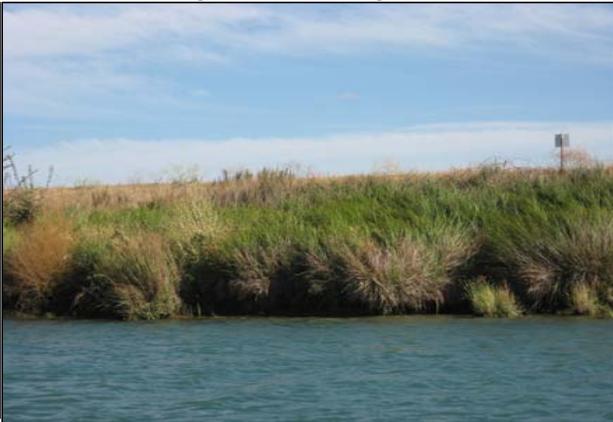
Georgiana Slough, RM 5.3L

Criteria	Score	Notes
Bank Slope	3	1.5:1 or less
Berm Width - Estimated	4	less than 5 ft
Soil Type	4	sands and silts
Velocity	3	3.9 ft/s
Economic Factor	5	Tyler Island
Bank Stability	2	tree hazards, and caves
Erosion Hazard	21

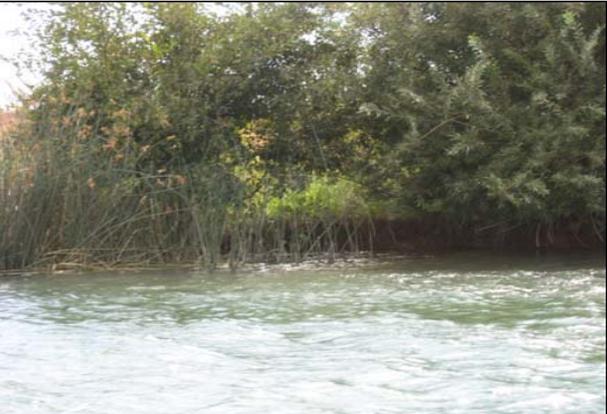
Georgiana Slough, RM 2.5L

Criteria	Score	Notes
Bank Slope	1	2.5:1 slope
Berm Width - Estimated	4	less than 5 ft
Soil Type	4	sands and silts
Velocity	3	3.9 ft/s
Economic Factor	5	Tyler Island
Bank Stability	4	slumping
Erosion Hazard	21

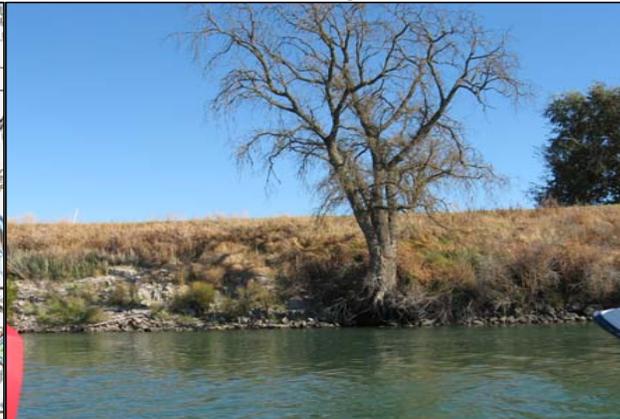
Sutter Slough, RM 26.5L

Criteria	Score	Notes
Bank Slope	3	1.5:1 slope
Berm Width - Estimated	5	no berm
Soil Type	2	clays and silts
Velocity	4	5.6 ft/s
Economic Factor	1	Sutter Island
Bank Stability	6	tree hazards, and slumping
Erosion Hazard	21

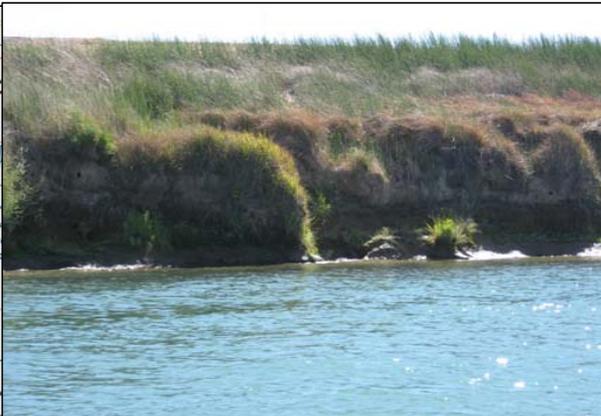
Sacramento River, RM 35.4R

Criteria	Score	Notes
Bank Slope	2	2:1 slopes
Berm Width - Estimated	5	no berm
Soil Type	4	sands and silts
Velocity	4	6.5 ft/s
Economic Factor	1	Merritt Island
Bank Stability	4	slumping
Erosion Hazard	20

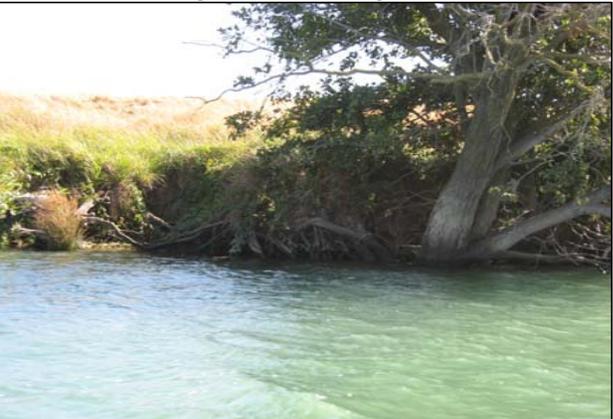
Georgiana Slough, RM 6.6L

Criteria	Score	Notes
Bank Slope	4	1:1 slope
Berm Width - Estimated	2	10 ft
Soil Type	4	sands and silts
Velocity	3	3.8 ft/s
Economic Factor	5	Tyler Island
Bank Stability	2	tree hazard, caves
Erosion Hazard	20

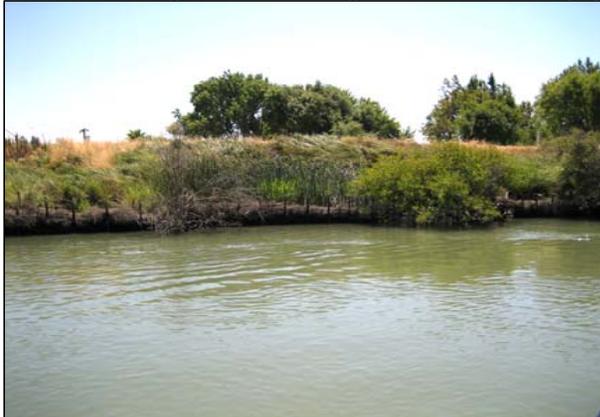
Georgiana Slough, RM 3.7L (a)

Criteria	Score	Notes
Bank Slope	2	2:1 slope
Berm Width - Estimated	4	less than 5 ft
Soil Type	4	sands and silts
Velocity	3	4.0 ft/s
Economic Factor	5	Tyler Island
Bank Stability	2	beaver holes
Erosion Hazard	20

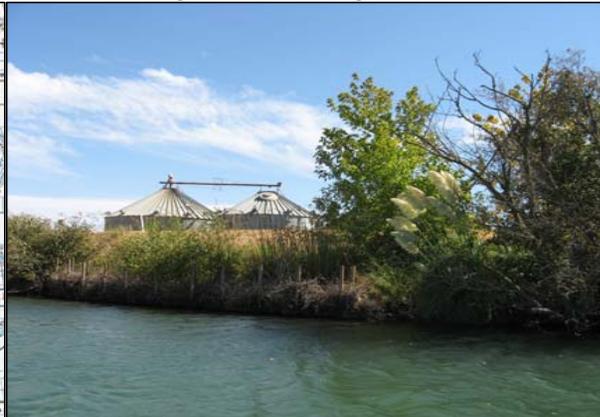
Georgiana Slough, RM 3.7L (b)

Criteria	Score	Notes
Bank Slope	2	2:1 slope
Berm Width - Estimated	4	less than 5 ft
Soil Type	4	sands and silts
Velocity	3	4.0 ft/s
Economic Factor	5	Tyler Island
Bank Stability	2	beaver holes
Erosion Hazard	20

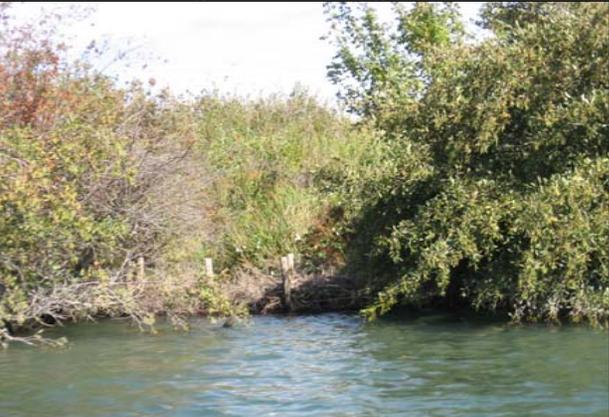
Georgiana Slough, RM 3.6L

Criteria	Score	Notes
Bank Slope	2	2:1 slope
Berm Width - Estimated	4	less than 5 ft
Soil Type	4	sands and silts
Velocity	3	4.6 ft/s
Economic Factor	5	Tyler Island
Bank Stability	2	tree hazards, beaver holes
Erosion Hazard	20

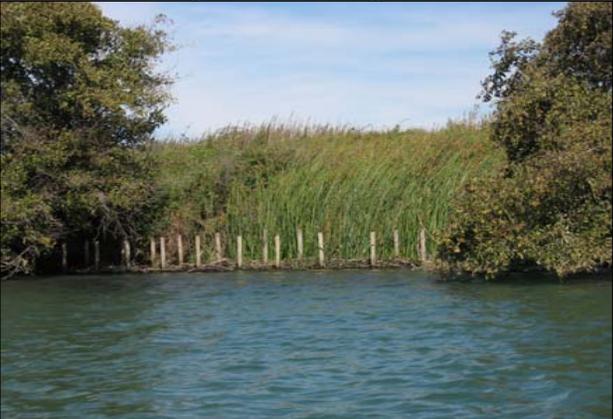
Georgiana Slough, RM 1.7L

Criteria	Score	Notes
Bank Slope	2	2:1 slope
Berm Width - Estimated	4	less than 5 ft
Soil Type	4	sands and silts
Velocity	3	4.0 ft/s
Economic Factor	5	Tyler Island
Bank Stability	2	tree hazards, caves
Erosion Hazard	20

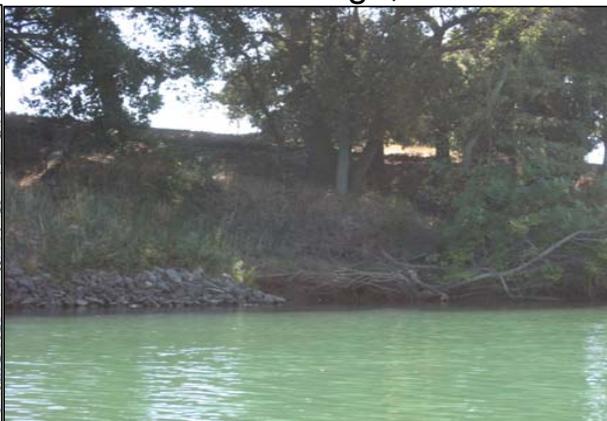
Steamboat Slough, RM 26.0L

Criteria	Score	Notes
Bank Slope	3	1.5:1 slope
Berm Width - Estimated	3	5 ft
Soil Type	2	clays and silts
Velocity	3	4.8 ft/s
Economic Factor	8	Grand Island
Bank Stability	1	tree hazards
Erosion Hazard	20

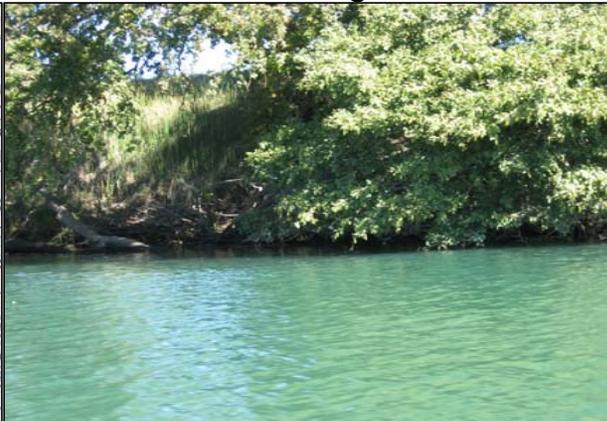
Steamboat Slough, RM 25.0L

Criteria	Score	Notes
Bank Slope	3	1.5:1 slope
Berm Width - Estimated	3	5 ft
Soil Type	2	clays and silts
Velocity	3	4.5 ft/s
Economic Factor	8	Grand Island
Bank Stability	1	tree hazards
Erosion Hazard	20

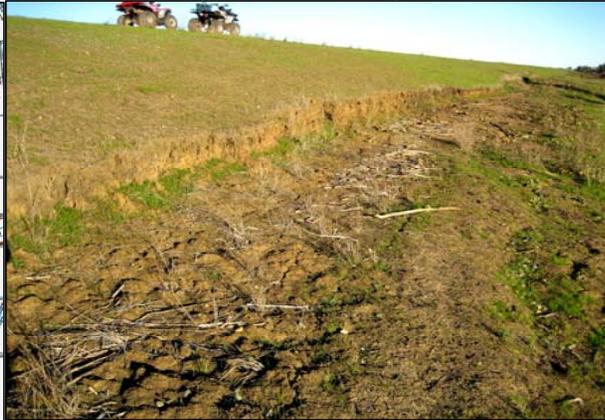
Willow Slough, LM 6.9 (DWR Unit 2 South)

Criteria	Score	Notes
Bank Slope	2	2:1 slope
Berm Width - Estimated	5	no berm
Soil Type	2	silts and clays
Velocity	0	0.2 ft/s
Economic Factor	7	Davis
Bank Stability	4	slumping
Erosion Hazard	20

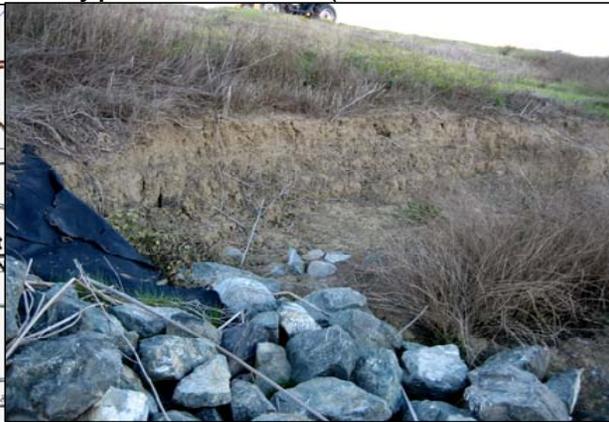
Criteria	Score	Notes
Bank Slope	2	2:1 slope
Berm Width - Estimated	5	no berm
Soil Type	4	sands and silts
Velocity	1	1.5 ft/s
Economic Factor	2	Knights Landing
Bank Stability	6	tension cracks and slumping
Erosion Hazard	20

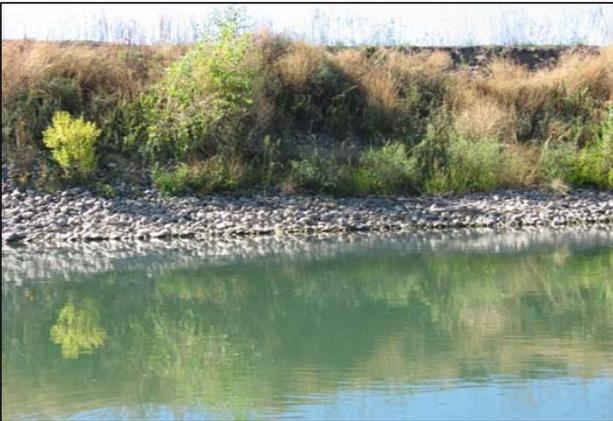
Sacramento River, RM 133.0L

Criteria	Score	Notes
Bank Slope	2	2:1 slope
Berm Width - Estimated	0	30 ft
Soil Type	1	clays and rounded stone
Velocity	3	4.9 ft/s
Economic Factor	9	Tisdale
Bank Stability	4	slumping
Erosion Hazard	19

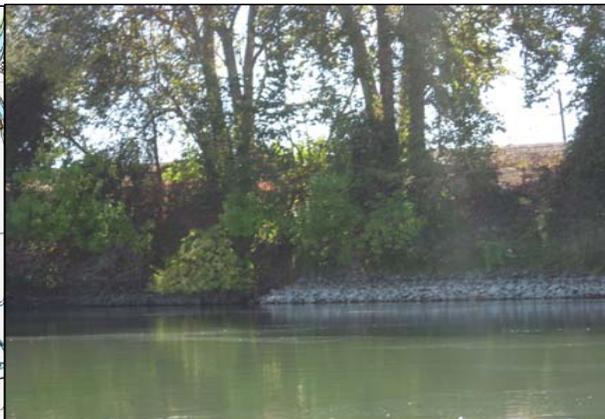
Sacramento River, RM 86.9R

Criteria	Score	Notes
Bank Slope	3	1.5:1 slope
Berm Width - Estimated	1	25 to 30 ft
Soil Type	4	sands and silts
Velocity	3	3.2 ft/s
Economic Factor	2	Knight's Landing
Bank Stability	6	tree hazards and slumping
Erosion Hazard	19

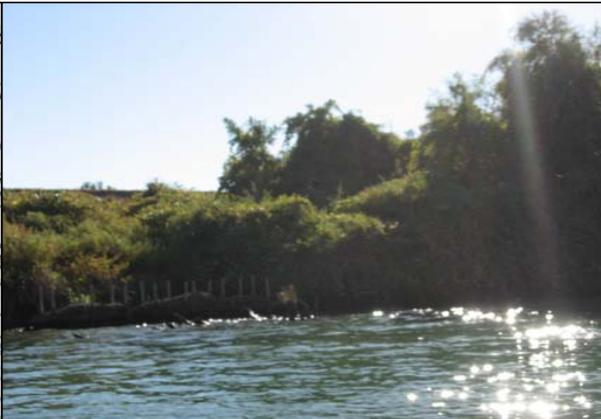
Sacramento River, RM 24.8L

Criteria	Score	Notes
Bank Slope	2	2:1 slope
Berm Width - Estimated	2	10 ft
Soil Type	4	sands and silts
Velocity	3	4.5 ft/s
Economic Factor	7	Isleton
Bank Stability	1	tree hazards
Erosion Hazard	19

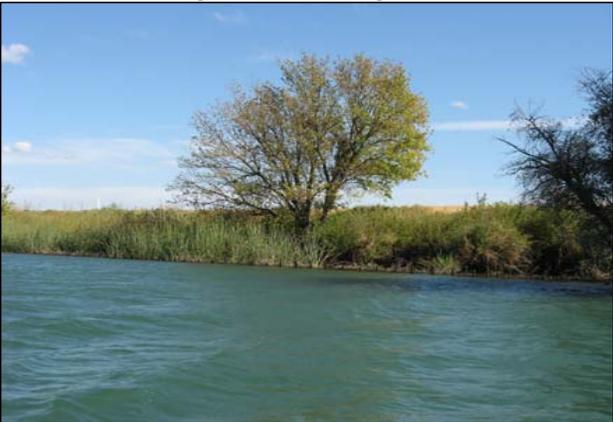
Georgiana Slough, RM 6.4L

Criteria	Score	Notes
Bank Slope	3	1.5:1 slope
Berm Width - Estimated	2	10 ft
Soil Type	4	sands and silts
Velocity	3	3.8 ft/s
Economic Factor	5	Tyler Island
Bank Stability	2	tree hazard, caves
Erosion Hazard	19

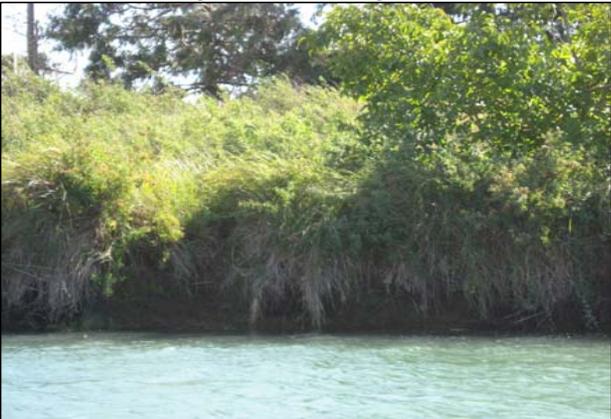
Georgiana Slough, RM 6.1L

Criteria	Score	Notes
Bank Slope	3	1.5:1 slope
Berm Width - Estimated	2	10 ft
Soil Type	4	sands and silts
Velocity	3	3.8 ft/s
Economic Factor	5	Tyler Island
Bank Stability	2	tree hazard, caves
Erosion Hazard	19

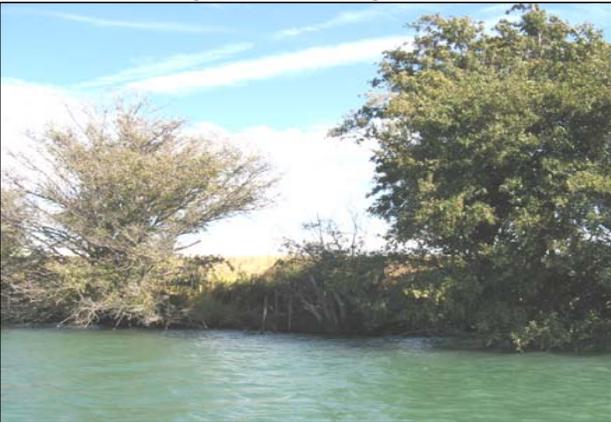
Georgiana Slough, RM 4.3L

Criteria	Score	Notes
Bank Slope	3	1.5:1 slope
Berm Width - Estimated	4	less than 5 ft
Soil Type	4	sands and silts
Velocity	3	4.0 ft/s
Economic Factor	5	Tyler Island
Bank Stability	0	no stability issues
Erosion Hazard	19

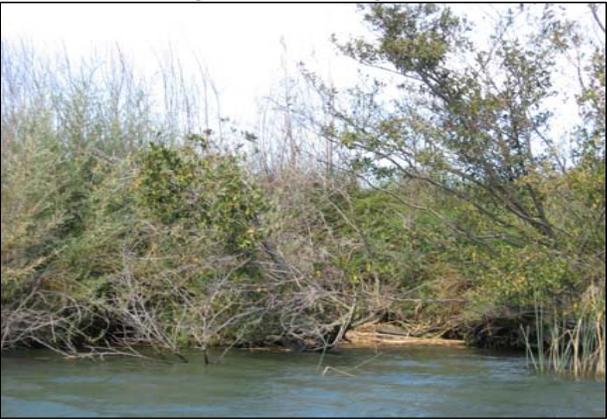
Georgiana Slough, RM 0.3L

Criteria	Score	Notes
Bank Slope	3	1.5:1 slope
Berm Width - Estimated	4	less than 5 ft
Soil Type	4	sands and silts
Velocity	3	4.6 ft/s
Economic Factor	5	Tyler Island
Bank Stability	0	no stability issues
Erosion Hazard	19

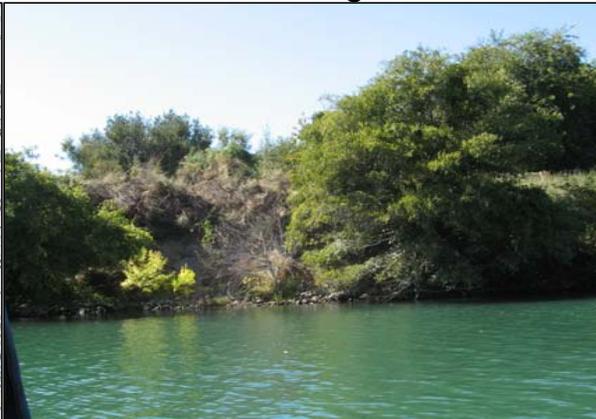
Criteria	Score	Notes
Bank Slope	4	1:1 slope
Berm Width - Estimated	3	5 ft
Soil Type	2	clays and silts
Velocity	3	4.7 ft/s
Economic Factor	1	Sutter Island
Bank Stability	6	tree hazards and slumping
Erosion Hazard	19

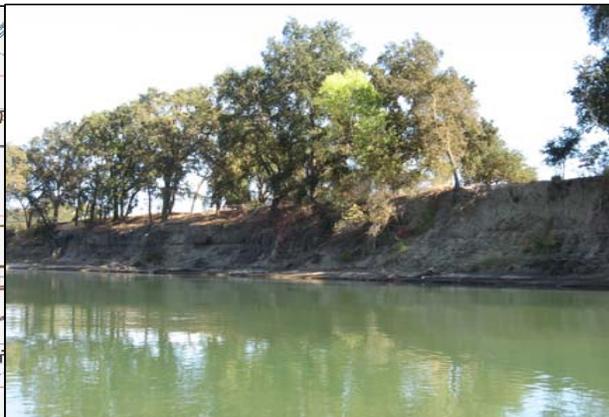
Site Photograph

Criteria	Score	Notes
Bank Slope	5	vertical bank
Berm Width - Estimated	0	40 to 50 ft
Soil Type	4	sands and silts
Velocity	2	2.2 ft/s
Economic Factor	0	Bypass
Bank Stability	7	tree hazards, tension cracks, and slumping
Erosion Hazard	18

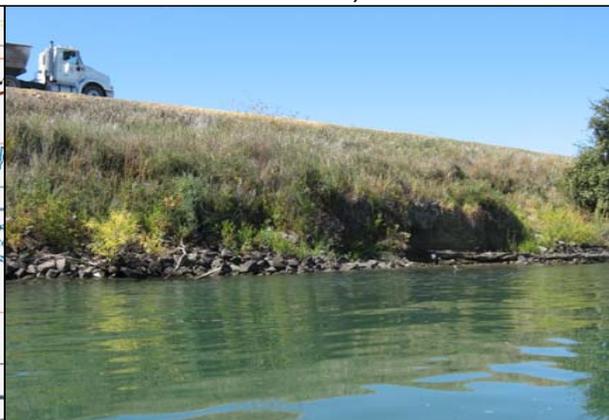
Site Photograph

Criteria	Score	Notes
Bank Slope	3	1.5:1 slope
Berm Width - Estimated	4	less than 5 ft
Soil Type	2	clays and silts
Velocity	4	5.5 ft/s
Economic Factor	1	Merritt Island
Bank Stability	4	slumping
Erosion Hazard	18

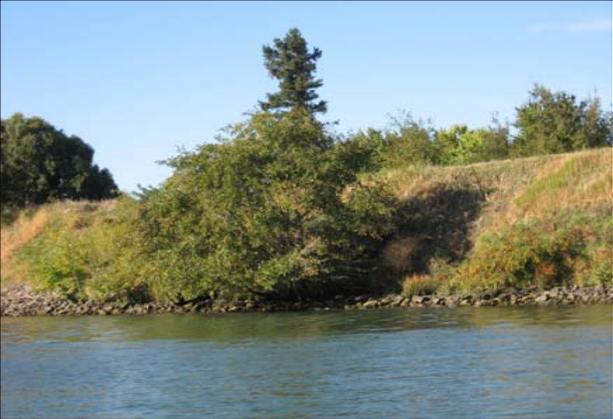
Site Photograph

Criteria	Score	Notes
Bank Slope	4	1:1 slope
Berm Width - Estimated	5	no berm
Soil Type	2	clays and silts
Velocity	3	3.7 ft/s
Economic Factor	4	Ryer Island
Bank Stability	0	no stability issues
Erosion Hazard	18

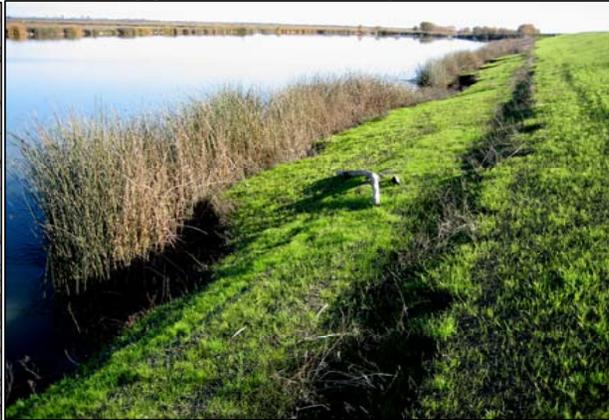
Site Photograph

Criteria	Score	Notes
Bank Slope	0	3:1 slope
Berm Width - Estimated	5	no berm
Soil Type	2	clays and silts
Velocity	1	1.5 ft/s
Economic Factor	4	Willow Slough
Bank Stability	6	tension cracks and slumping
Erosion Hazard	18

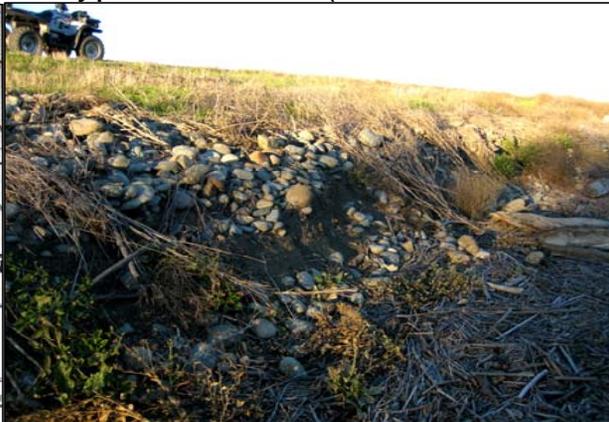
Site Photograph

Criteria	Score	Notes
Bank Slope	2	2:1 slope
Berm Width - Estimated	5	no berm
Soil Type	4	sands and silts
Velocity	1	1.5 ft/s
Economic Factor	2	Knights Landing
Bank Stability	4	slumping
Erosion Hazard	18

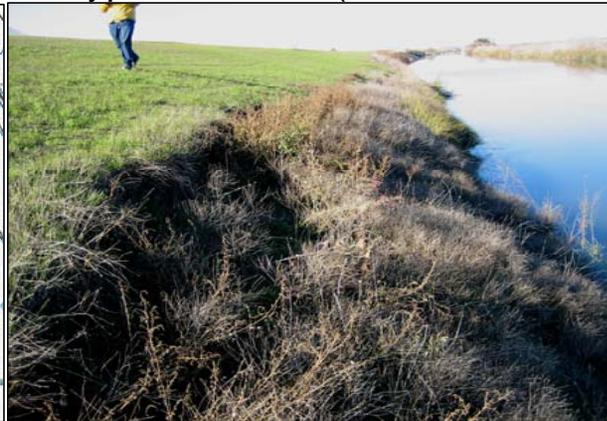
Site Photograph

Criteria	Score	Notes
Bank Slope	0	3:1 slope
Berm Width - Estimated	5	no berm
Soil Type	2	clays and silts
Velocity	1	1.5 ft/s
Economic Factor	4	Willow Slough
Bank Stability	6	tension cracks and slumping
Erosion Hazard	18

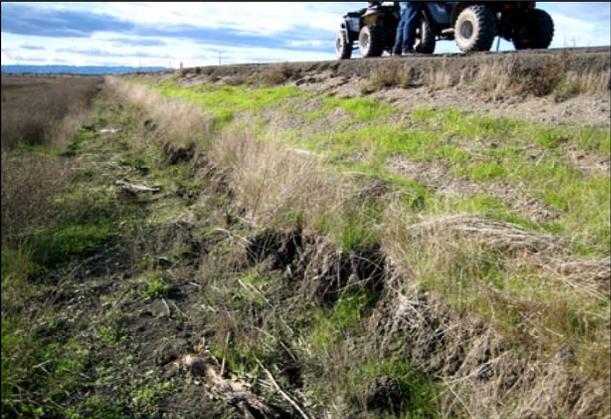
Site Photograph

Criteria	Score	Notes
Bank Slope	3	1.5:1 slope
Berm Width - Estimated	5	no berm
Soil Type	2	clays and silts
Velocity	0	0.5 ft/s
Economic Factor	4	Willow Slough
Bank Stability	4	slumping
Erosion Hazard	18

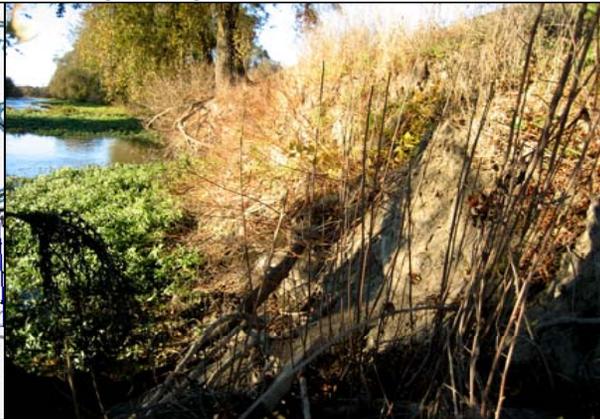
Site Photograph

Criteria	Score	Notes
Bank Slope	2	2:1 slope
Berm Width - Estimated	5	no berm
Soil Type	2	silts with some clays
Velocity	0	0.1 ft/s
Economic Factor	2	Knights Landing
Bank Stability	7	pipng holes, tension cracks, and slumping
Erosion Hazard	18

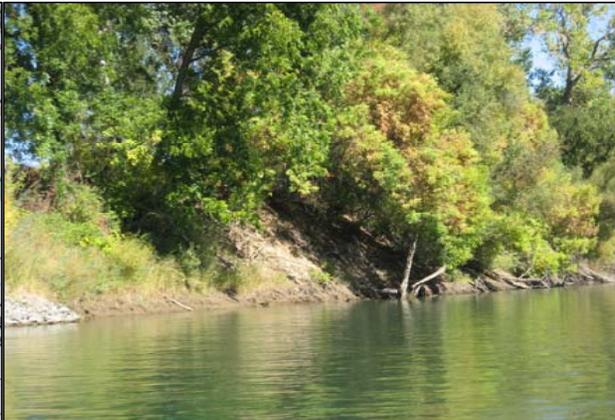
Site Photograph

Criteria	Score	Notes
Bank Slope	2	2:1 slope
Berm Width - Estimated	0	30 ft
Soil Type	2	clays and silts
Velocity	3	4.8 ft/s
Economic Factor	9	Tisdale
Bank Stability	1	tree hazards
Erosion Hazard	17

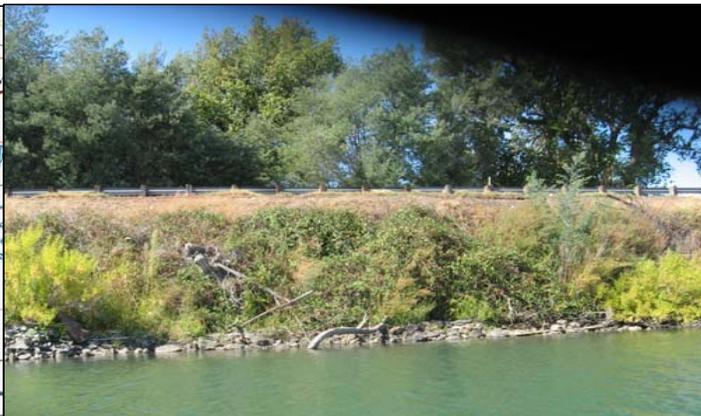
Site Photograph

Criteria	Score	Notes
Bank Slope	3	1.5:1 slopes
Berm Width - Estimated	5	no berm
Soil Type	4	sands and silts
Velocity	4	5.9 ft/s
Economic Factor	1	Merritt Island
Bank Stability	0	no stability issues
Erosion Hazard	17

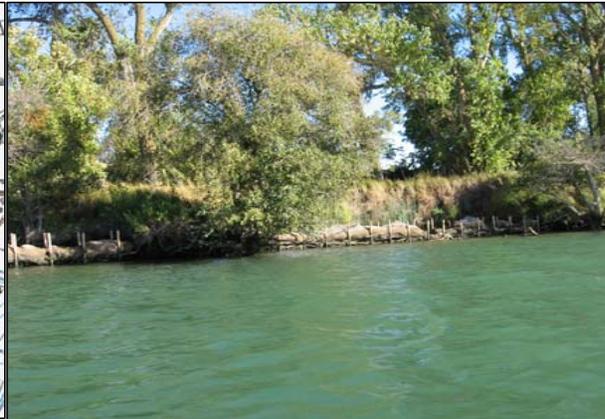
Site Photograph

Criteria	Score	Notes
Bank Slope	2	2:1 slope
Berm Width - Estimated	0	30 to 50 ft
Soil Type	4	sands and silts
Velocity	3	4.2 ft/s
Economic Factor	7	Isleton
Bank Stability	1	tree hazards
Erosion Hazard	17

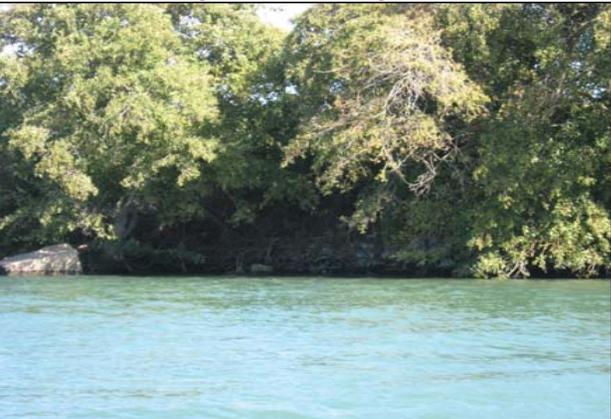
Site Photograph

Criteria	Score	Notes
Bank Slope	3	1.5:1 slope
Berm Width - Estimated	1	15 ft
Soil Type	4	sands and silts
Velocity	3	3.8 ft/s
Economic Factor	5	Tyler Island
Bank Stability	1	tree hazards
Erosion Hazard	17

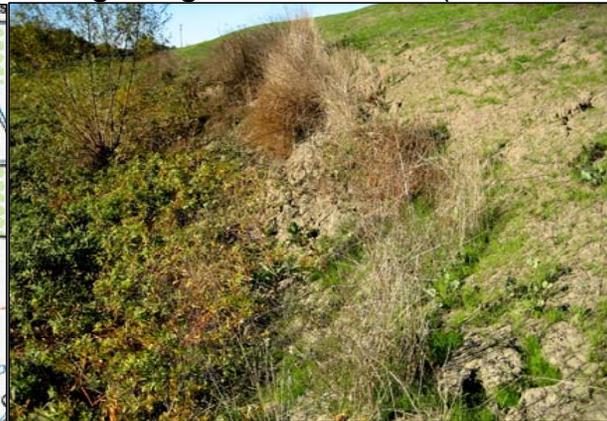
Site Photograph

Criteria	Score	Notes
Bank Slope	2	2:1 slope
Berm Width - Estimated	5	0 to 5 ft of berm
Soil Type	2	clays and silts
Velocity	0	0.1 ft/s
Economic Factor	2	Knights Landing
Bank Stability	6	tension cracks and slumping
Erosion Hazard	17

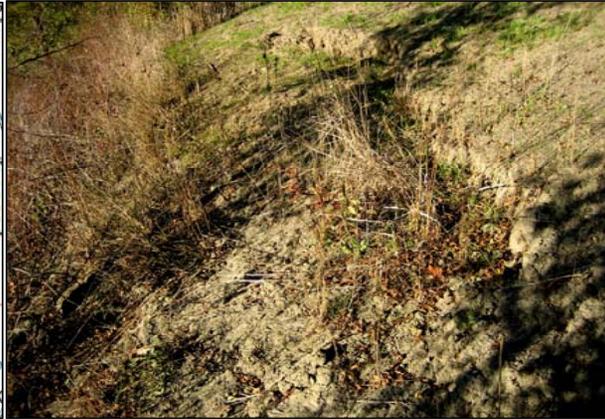
Site Photograph

Criteria	Score	Notes
Bank Slope	2	2:1 slope
Berm Width - Estimated	5	no berm
Soil Type	2	silts with some clays
Velocity	0	0.1 ft/s
Economic Factor	2	Knights Landing
Bank Stability	6	tension cracks and slumping
Erosion Hazard	17

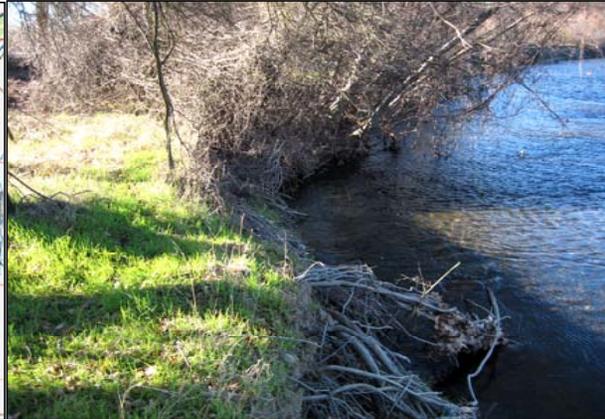
Site Photograph

Criteria	Score	Notes
Bank Slope	2	2:1 slope
Berm Width - Estimated	2	10 to 15 ft
Soil Type	3	sands and cobbles
Velocity	2	3.0 ft/s
Economic Factor	1	minimal flooding
Bank Stability	6	tree hazards and slumping
Erosion Hazard	16

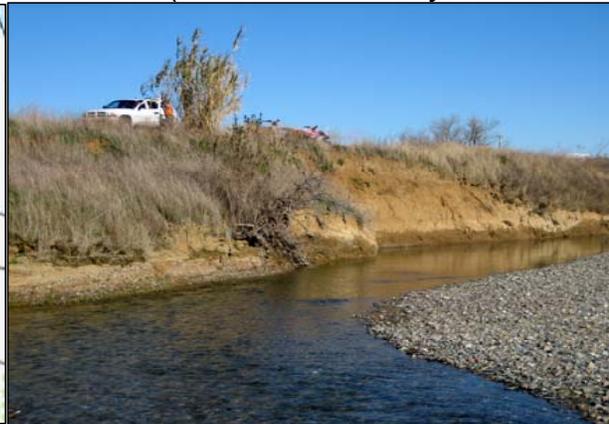
Site Photograph

Criteria	Score	Notes
Bank Slope	4	less than 1:1 slope
Berm Width - Estimated	1	25 to 30 ft
Soil Type	2	clays and silts
Velocity	2	3.0 ft/s
Economic Factor	1	minimal impact
Bank Stability	6	animal holes and slumping
Erosion Hazard	16

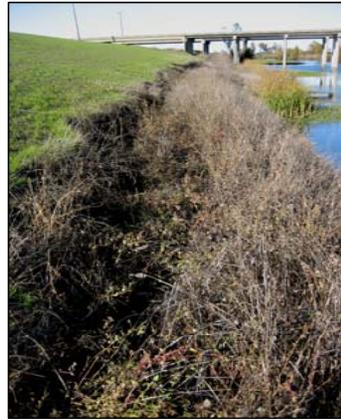
Site Photograph

Criteria	Score	Notes
Bank Slope	0	3:1 slope
Berm Width - Estimated	5	no berm
Soil Type	2	clays and silts
Velocity	1	1.5 ft/s
Economic Factor	2	Woodland
Bank Stability	6	tension cracks and slumping
Erosion Hazard	16

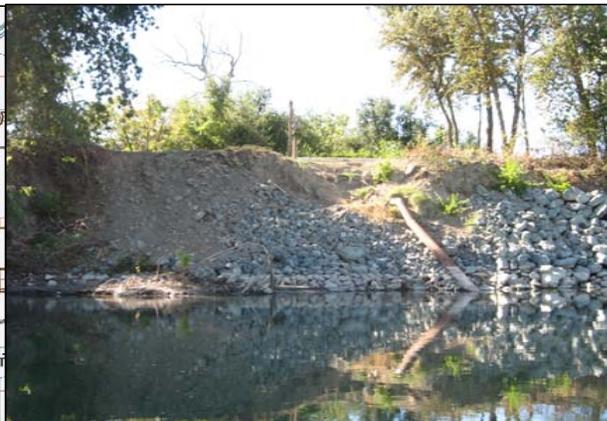
Site Photograph

Criteria	Score	Notes
Bank Slope	2	2:1 slope
Berm Width - Estimated	3	8 to 10 ft
Soil Type	4	sands and silts
Velocity	3	3.4 ft/s
Economic Factor	2	Knight's Landing
Bank Stability	1	tree hazards
Erosion Hazard	15

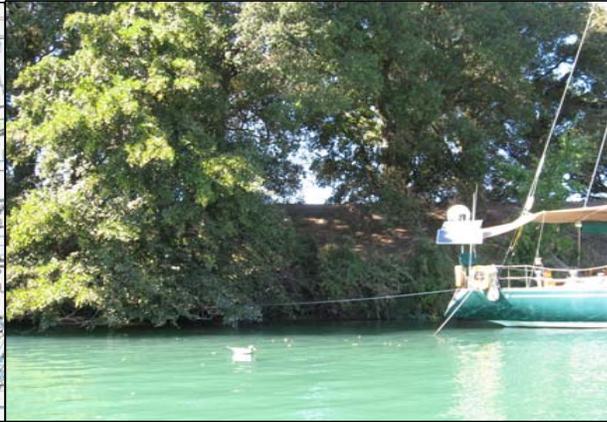
Site Photograph

Criteria	Score	Notes
Bank Slope	3	1.5:1 slope
Berm Width - Estimated	5	no berm
Soil Type	2	clays and silts
Velocity	3	4.87 ft/s
Economic Factor	1	Sutter Island
Bank Stability	1	tree hazards
Erosion Hazard	15

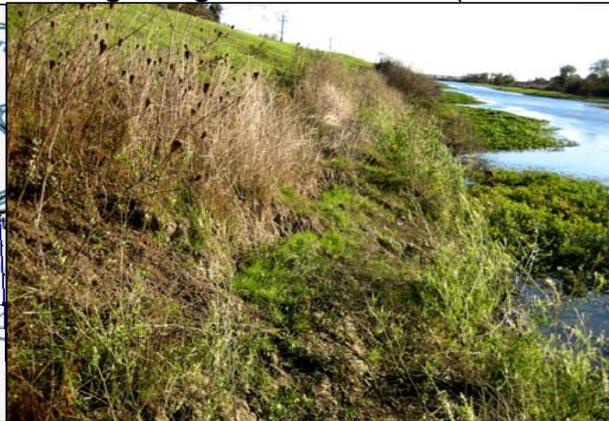
Site Photograph

Criteria	Score	Notes
Bank Slope	2	2:1 slope
Berm Width - Estimated	5	no berm
Soil Type	2	silts with some clays
Velocity	0	0.1 ft/s
Economic Factor	2	Knights Landing
Bank Stability	4	slumping
Erosion Hazard	15

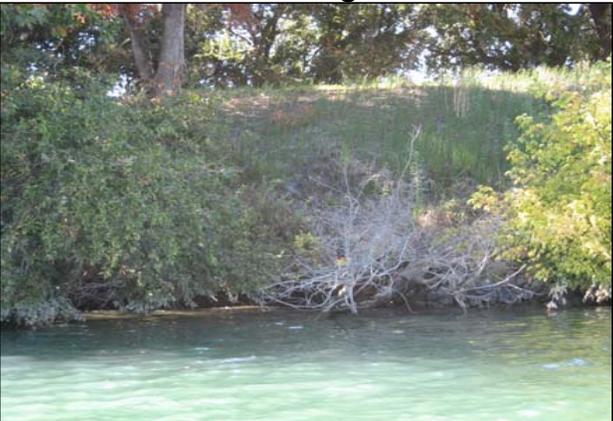
Site Photograph

Criteria	Score	Notes
Bank Slope	4	1:1 slope
Berm Width - Estimated	3	5 ft
Soil Type	2	clays and silts
Velocity	3	4.5 ft/s
Economic Factor	1	Sutter Island
Bank Stability	1	tree hazards
Erosion Hazard	14

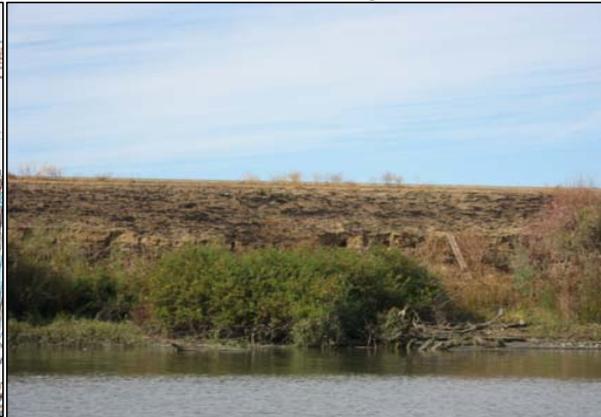
Site Photograph

Criteria	Score	Notes
Bank Slope	2	2:1 slope
Berm Width - Estimated	5	no berm
Soil Type	2	clays and silts
Velocity	0	0.27 ft/s
Economic Factor	1	Hastings Tract
Bank Stability	4	slumping
Erosion Hazard	14

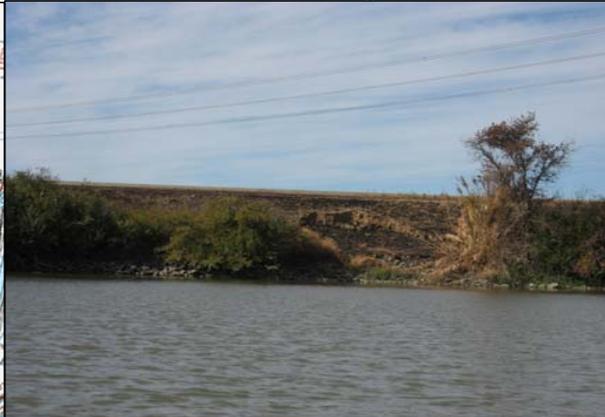
Site Photograph

Criteria	Score	Notes
Bank Slope	1	2.5:1 slope
Berm Width - Estimated	5	no berm
Soil Type	2	clays and silts
Velocity	0	less than 1 ft/s
Economic Factor	1	Hastings Tract
Bank Stability	4	slumping
Erosion Hazard	13
