Sacramento River, RM 55.2L

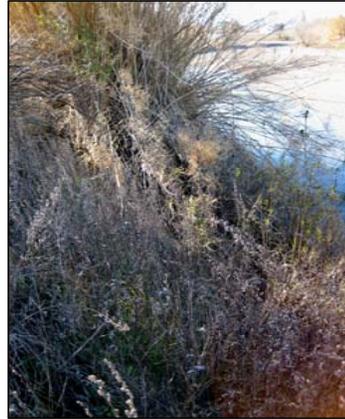
Site Photograph

Criteria	Score	Notes
Bank Slope	3	1.5:1 slope
Berm Width - Estimated	1	25 to 30 ft
Soil Type	2	clays and silts
Velocity	2	3.0 ft/s
Economic Factor	1	minimal impact
Bank Stability	4	slumping
Erosion Hazard	13

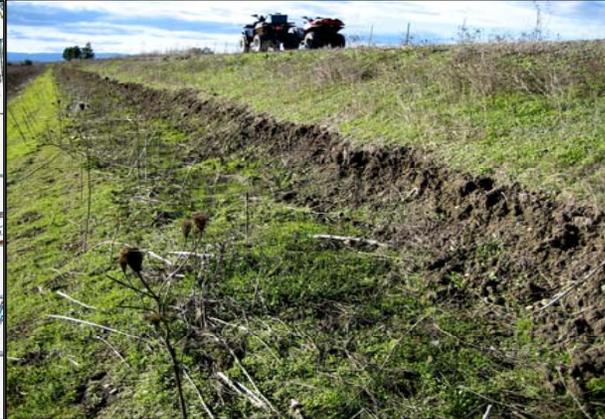
Site Photograph

Criteria	Score	Notes
Bank Slope	2	2:1 slope
Berm Width - Estimated	5	no berm
Soil Type	2	clays and silts
Velocity	0	0.6 ft/s
Economic Factor	4	Willow Slough
Bank Stability	0	no stability issues
Erosion Hazard	13

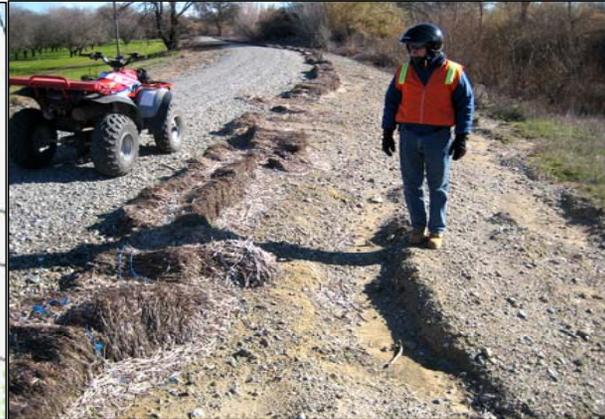
Site Photograph

Criteria	Score	Notes
Bank Slope	2	2:1 slope
Berm Width - Estimated	2	10 ft
Soil Type	2	clays and gravels
Velocity	2	3.0 ft/s
Economic Factor	1	minimal impact
Bank Stability	0	no stability issues
Erosion Hazard	9
