Sacramento River, RM 57.2R

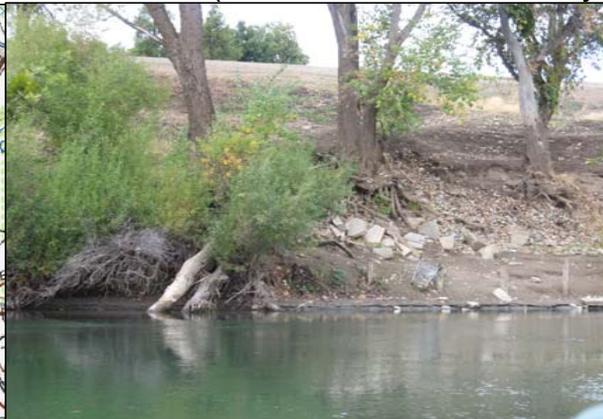
Site Photograph

Criteria	Score	Notes
Bank Slope	4	1:1 slope
Berm Width - Estimated	5	0 to 10 ft of berm
Soil Type	4	sands and silts
Velocity	3	4.0 ft/s
Bank Stability	7	tree hazards, caves, and slumping
Erosion Hazard	23

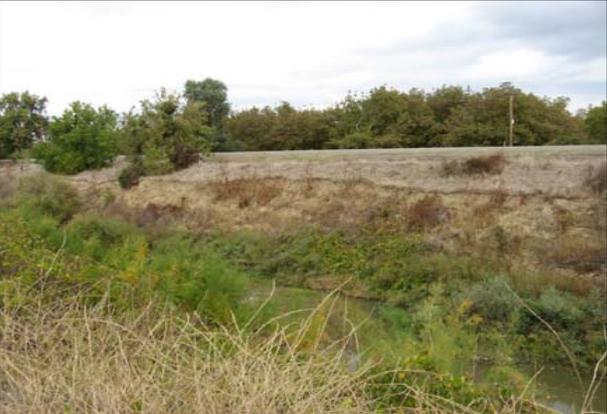
Site Photograph

Criteria	Score	Notes
Bank Slope	4	1:1 slope
Berm Width - Estimated	2	15 to 30 ft
Soil Type	4	sands and silts
Velocity	4	6.5 ft/s
Bank Stability	7	caves, tension cracks, and slumping
Erosion Hazard	21

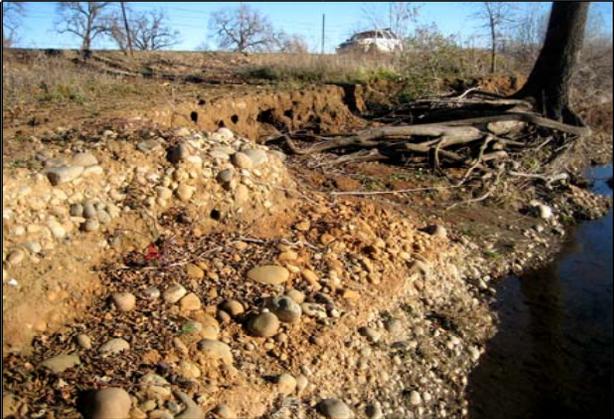
Site Photograph

Criteria	Score	Notes
Bank Slope	5	near vertical
Berm Width - Estimated	2	10 to 15 ft
Soil Type	3	sands and cobbles
Velocity	4	5 ft/s
Bank Stability	7	tree hazards, animal holes, and slumping
Erosion Hazard	21

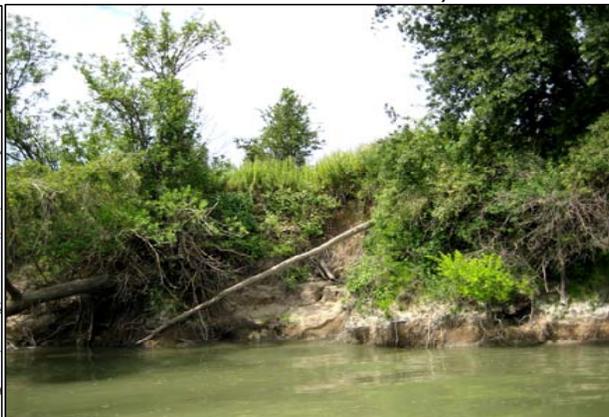
Site Photograph

Criteria	Score	Notes
Bank Slope	4	1:1 slope
Berm Width - Estimated	1	25 ft
Soil Type	4	sands and silts
Velocity	4	5.1 ft/s
Bank Stability	7	tree hazards, caves, and slumping
Erosion Hazard	20

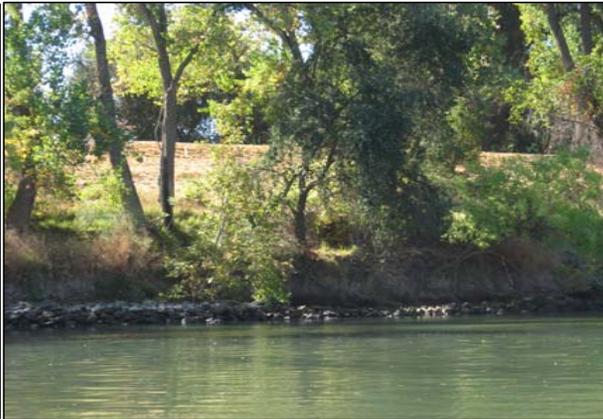
Site Photograph

Criteria	Score	Notes
Bank Slope	2	2:1 slope
Berm Width - Estimated	5	0 to 15 ft of berm
Soil Type	4	sands and silts
Velocity	3	4.8 ft/s
Bank Stability	6	tree hazards and slumping
Erosion Hazard	20

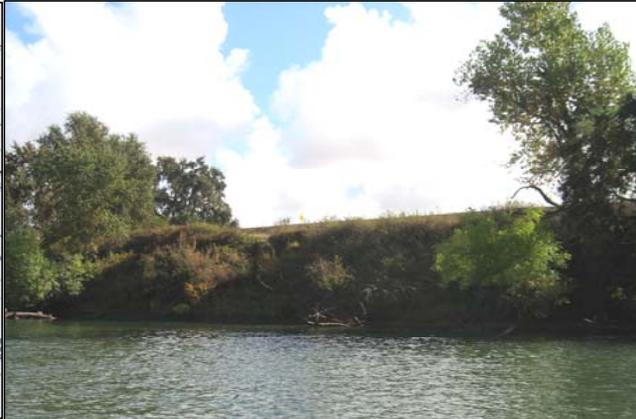
Site Photograph

Criteria	Score	Notes
Bank Slope	4	1:1 slope
Berm Width - Estimated	1	25 to 30 ft
Soil Type	4	sands and silts
Velocity	4	7.1 ft/s
Bank Stability	7	tree hazards, caves, and seepage
Erosion Hazard	20

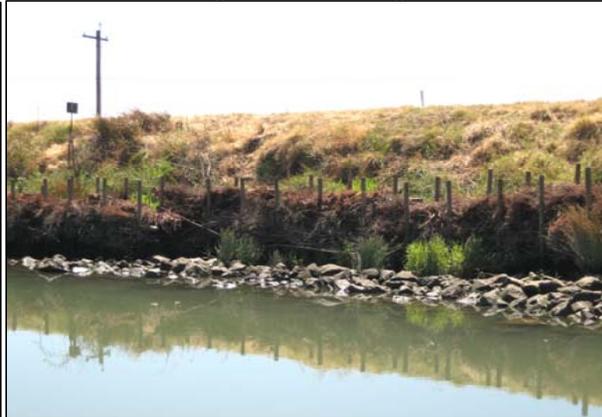
Site Photograph

Criteria	Score	Notes
Bank Slope	4	1:1 slope
Berm Width - Estimated	4	less than 5 ft
Soil Type	4	sands and silts
Velocity	3	3.8 ft/s
Bank Stability	4	slumping
Erosion Hazard	19

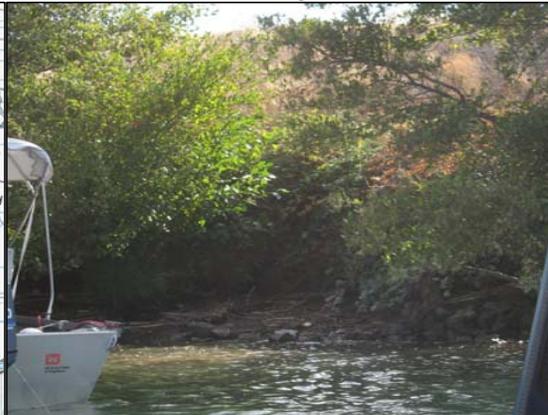
Site Photograph

Criteria	Score	Notes
Bank Slope	2	2:1 slope
Berm Width - Estimated	4	3 to 6 ft
Soil Type	2	clays and silts
Velocity	5	10.9 ft/s
Bank Stability	6	slumping, beaver holes
Erosion Hazard	19

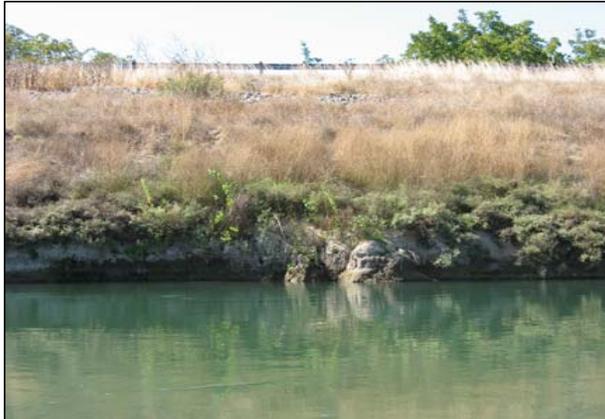
Site Photograph

Criteria	Score	Notes
Bank Slope	3	1.5:1 slope
Berm Width - Estimated	5	no berm
Soil Type	2	clays and silts
Velocity	4	5.3 ft/s
Bank Stability	4	vertical sections and slumping
Erosion Hazard	18

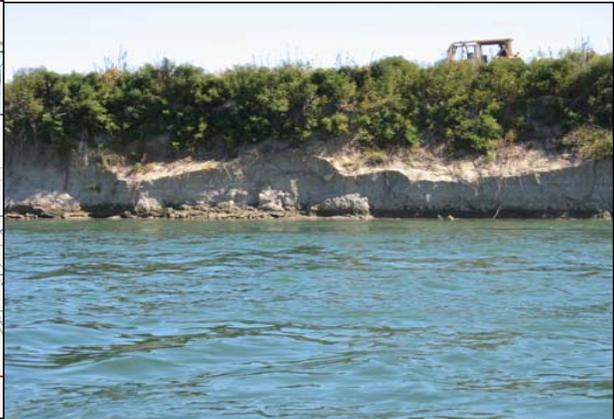
Site Photograph

Criteria	Score	Notes
Bank Slope	5	vertical banks
Berm Width - Estimated	0	30 ft
Soil Type	2	clays with some silts
Velocity	4	5.64 ft/s
Bank Stability	7	caves, slumping, and tension cracks
Erosion Hazard	18

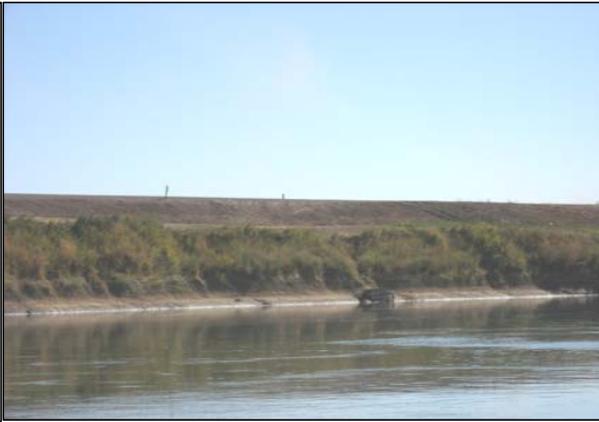
Site Photograph

Criteria	Score	Notes
Bank Slope	3	1.5:1 slope
Berm Width - Estimated	2	15 ft
Soil Type	4	sands and silts
Velocity	3	3.4 ft/s
Bank Stability	6	tension cracks and slumping
Erosion Hazard	18

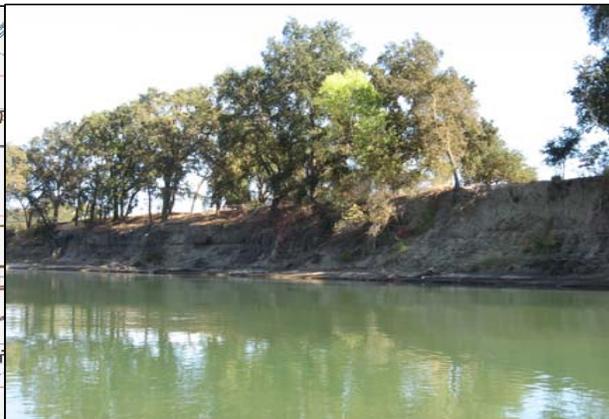
Site Photograph

Criteria	Score	Notes
Bank Slope	5	vertical bank
Berm Width - Estimated	0	40 to 50 ft
Soil Type	4	sands and silts
Velocity	2	2.2 ft/s
Bank Stability	7	tree hazards, tension cracks, and slumping
Erosion Hazard	18

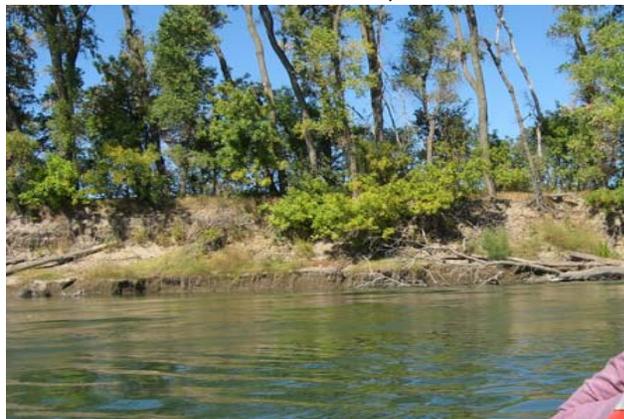
Site Photograph

Criteria	Score	Notes
Bank Slope	4	1:1 slope
Berm Width - Estimated	0	30 ft
Soil Type	4	sands and silts
Velocity	3	4.3 ft/s
Bank Stability	6	tree hazards and slumping
Erosion Hazard	17

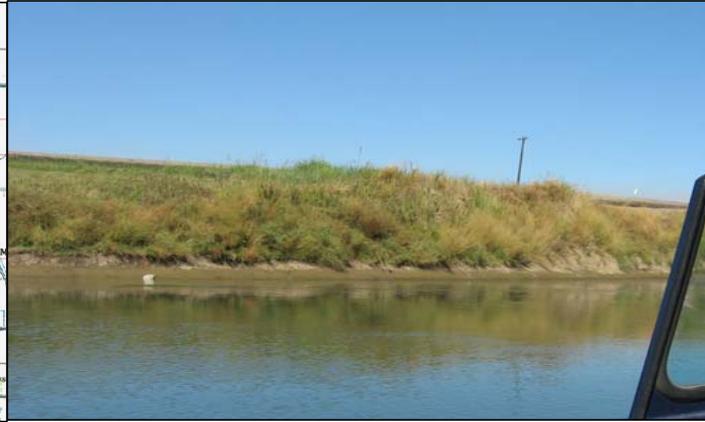
Site Photograph

Criteria	Score	Notes
Bank Slope	4	1:1 slope
Berm Width - Estimated	0	30 ft
Soil Type	4	sands and silts
Velocity	3	3.2 ft/s
Bank Stability	6	caves and slumping
Erosion Hazard	17

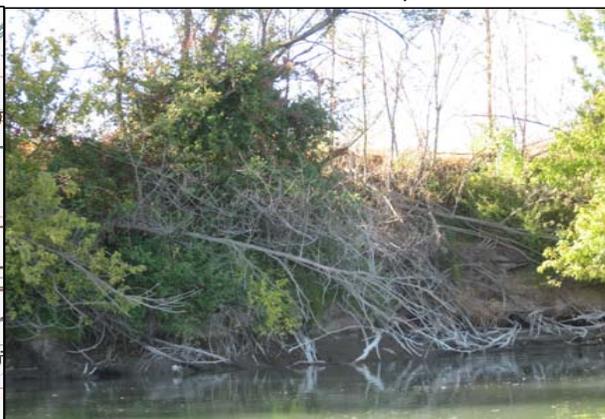
Site Photograph

Criteria	Score	Notes
Bank Slope	4	less than 1:1
Berm Width - Estimated	0	30 to 50 ft
Soil Type	2	clays and silts
Velocity	4	5.0 ft/s
Bank Stability	7	tree hazards, caves, and slumping
Erosion Hazard	17

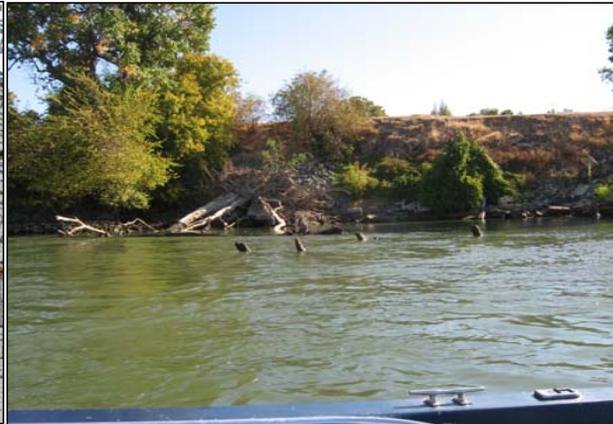
Site Photograph

Criteria	Score	Notes
Bank Slope	3	1.5:1 slope
Berm Width - Estimated	0	125 ft
Soil Type	4	sands and silts
Velocity	4	5.1 ft/s
Bank Stability	6	tree hazards and slumping
Erosion Hazard	17

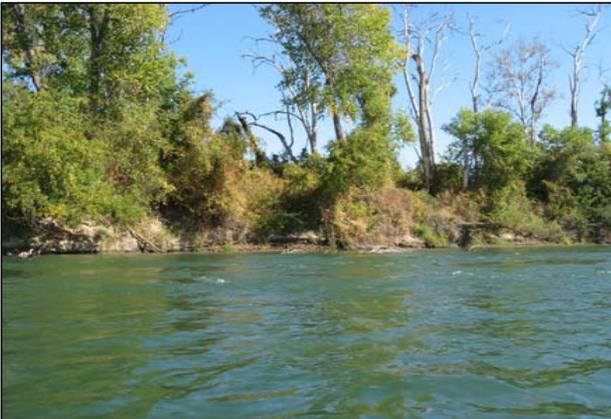
Sacramento River, RM 163.0L

Criteria	Score	Notes
Bank Slope	3	1.5:1 slope
Berm Width - Estimated	0	60 ft
Soil Type	2	clays and silts
Velocity	5	10.1 ft/s
Bank Stability	6	tree hazards and slumping
Erosion Hazard	16

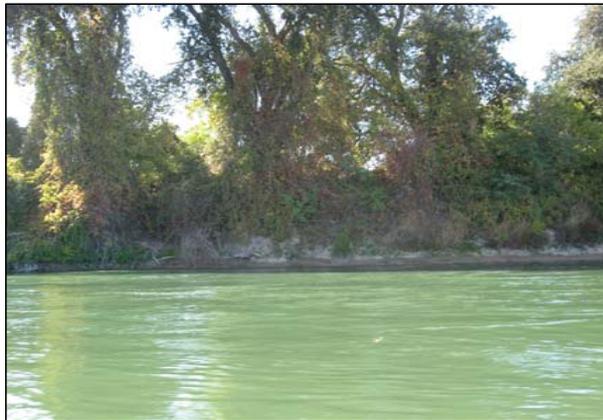
Sacramento River, RM 157.7R

Criteria	Score	Notes
Bank Slope	4	less than 1:1 slope, near vertical
Berm Width - Estimated	0	50 ft
Soil Type	2	clays and silts
Velocity	4	5.7 ft/s
Bank Stability	6	animal burrows and slumping
Erosion Hazard	16

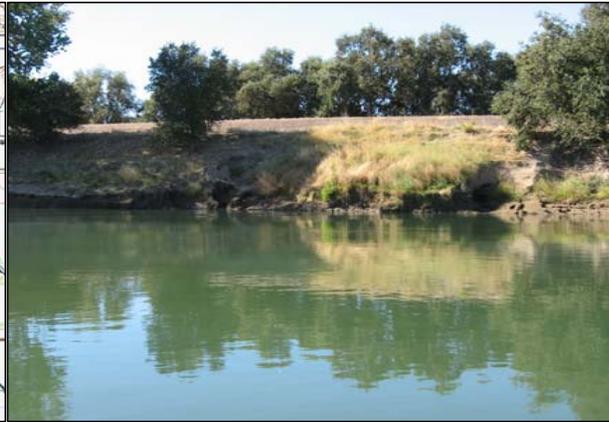
Sacramento River, RM 136.7R

Criteria	Score	Notes
Bank Slope	3	1.5:1 slope
Berm Width - Estimated	0	30 ft
Soil Type	2	clays and silts
Velocity	4	5.2 ft/s
Bank Stability	7	tree hazards, caves, and slumping
Erosion Hazard	16

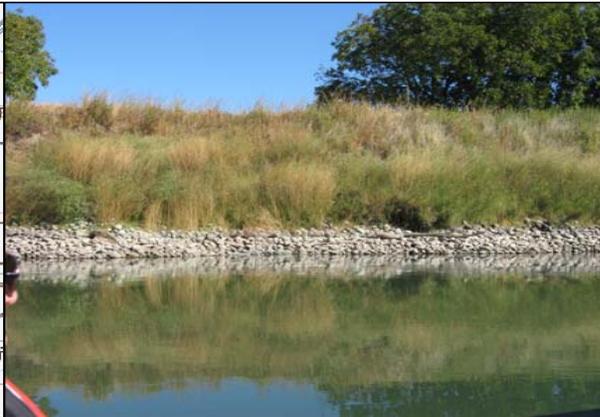
Sacramento River, RM 86.3L

Criteria	Score	Notes
Bank Slope	3	1.5:1 slope
Berm Width - Estimated	0	30 to 50 ft
Soil Type	4	sands and silts
Velocity	3	3.4 ft/s
Bank Stability	6	caves and slumping
Erosion Hazard	16

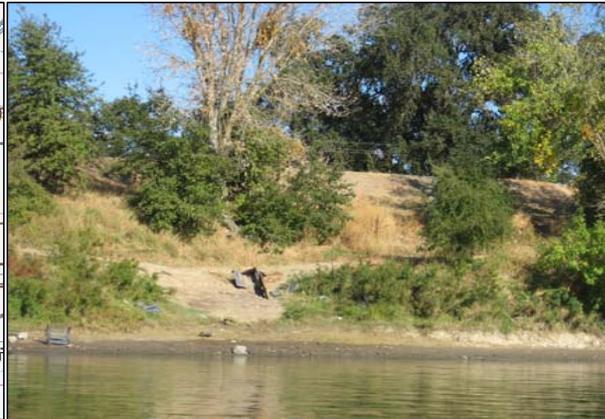
Sacramento River, RM 78.3L

Criteria	Score	Notes
Bank Slope	1	2.5:1 slope
Berm Width - Estimated	2	15 ft
Soil Type	4	sands and silts
Velocity	3	4.9 ft/s
Bank Stability	6	tree hazards, and seepage
Erosion Hazard	16

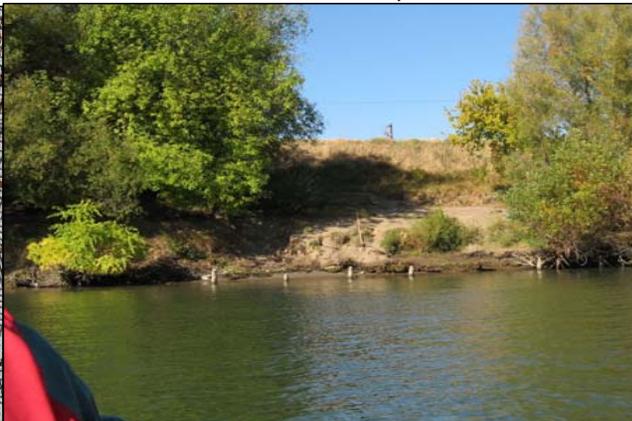
Criteria	Score	Notes
Bank Slope	3	1.5:1 slope
Berm Width - Estimated	0	3 to 40 ft
Soil Type	4	sands and silts
Velocity	3	4.88 ft/s
Bank Stability	6	tree hazards and slumping
Erosion Hazard	16

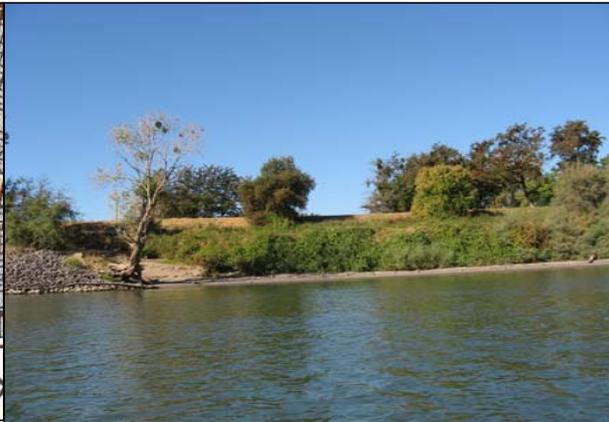
Sacramento River, RM 56.5R

Criteria	Score	Notes
Bank Slope	3	1.5:1 slope
Berm Width - Estimated	1	25 ft
Soil Type	2	clays and silts
Velocity	4	5.11 ft/s
Bank Stability	6	caves and slumping
Erosion Hazard	16

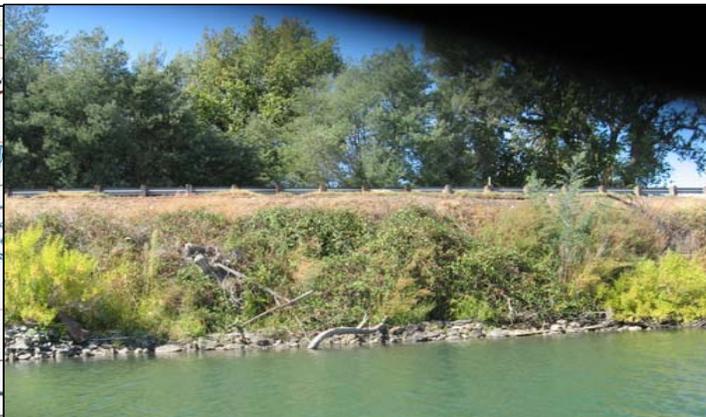
Criteria	Score	Notes
Bank Slope	3	1.5:1 slopes
Berm Width - Estimated	5	no berm
Soil Type	4	sands and silts
Velocity	4	5.9 ft/s
Bank Stability	0	no stability issues
Erosion Hazard	16

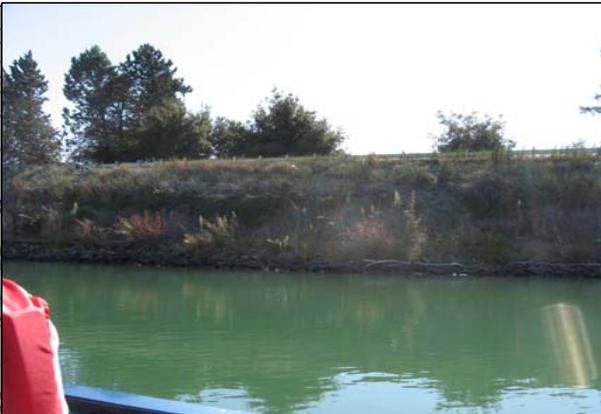
Sacramento River, RM 31.6R

Criteria	Score	Notes
Bank Slope	3	1.5:1 slope
Berm Width - Estimated	5	no berm
Soil Type	4	sands and silts
Velocity	4	5.2 ft/s
Bank Stability	0	no stability issues
Erosion Hazard	16

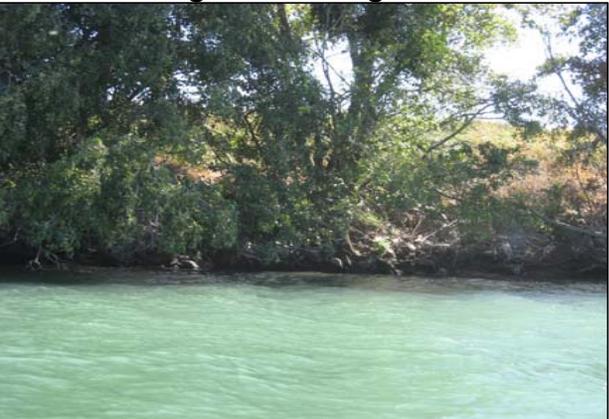
Georgiana Slough, RM 8.3L

Criteria	Score	Notes
Bank Slope	3	1.5:1 slope
Berm Width - Estimated	2	15 ft
Soil Type	4	sands and silts
Velocity	3	3.7 ft/s
Bank Stability	4	slumping
Erosion Hazard	16

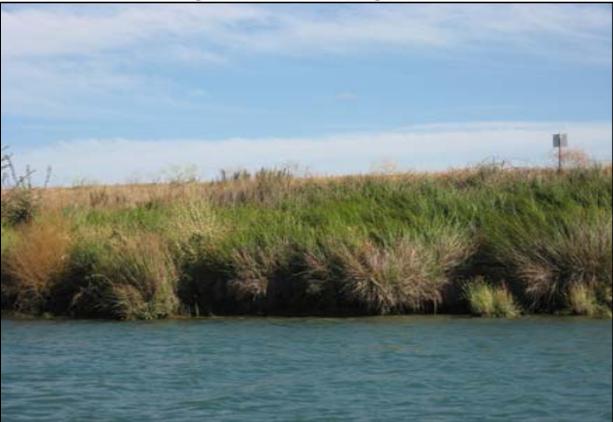
Georgiana Slough, RM 5.3L

Criteria	Score	Notes
Bank Slope	3	1.5:1 or less
Berm Width - Estimated	4	less than 5 ft
Soil Type	4	sands and silts
Velocity	3	3.9 ft/s
Bank Stability	2	tree hazards, and caves
Erosion Hazard	16

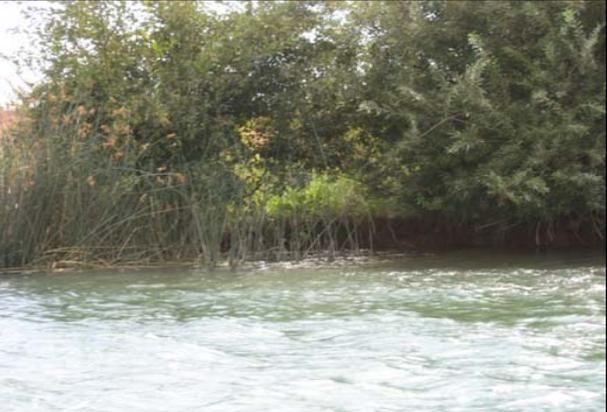
Georgiana Slough, RM 2.5L

Criteria	Score	Notes
Bank Slope	1	2.5:1 slope
Berm Width - Estimated	4	less than 5 ft
Soil Type	4	sands and silts
Velocity	3	3.9 ft/s
Bank Stability	4	slumping
Erosion Hazard	16

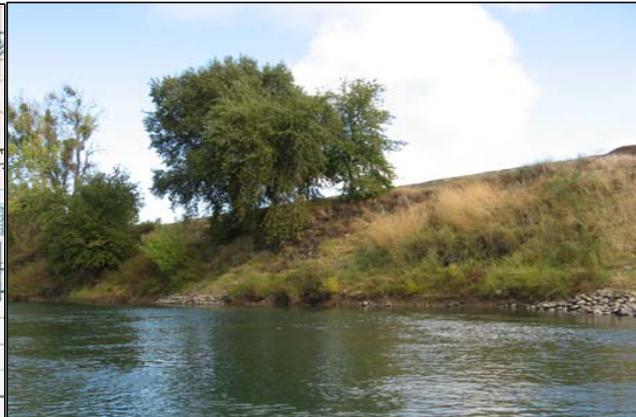
Feather River, RM 0.6L

Criteria	Score	Notes
Bank Slope	1	2.5:1 slope
Berm Width - Estimated	2	15 ft of berm
Soil Type	3	sands
Velocity	3	4.8 ft/s
Bank Stability	7	tree hazards, slumping, seepage history
Erosion Hazard	16

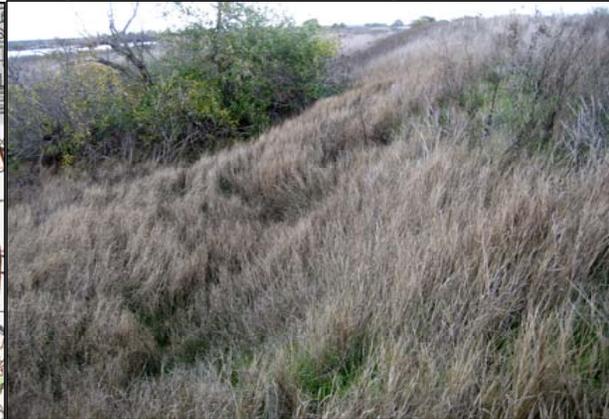
Site Photograph

Criteria	Score	Notes
Bank Slope	2	2:1 slope
Berm Width - Estimated	5	no berm
Soil Type	2	clays and silts
Velocity	1	1.3 ft/s
Bank Stability	6	tension cracks and slumping
Erosion Hazard	16

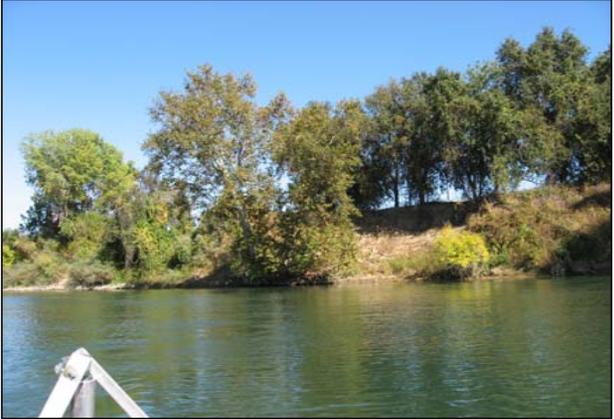
Site Photograph

Criteria	Score	Notes
Bank Slope	3	1.5:1 slope
Berm Width - Estimated	0	30 ft
Soil Type	2	clays and silts
Velocity	3	4.6 ft/s
Bank Stability	7	tree hazards, animal burrows, and slumping
Erosion Hazard	15

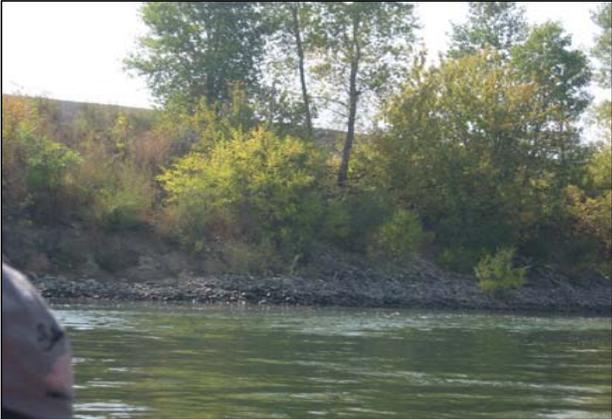
Site Photograph

Criteria	Score	Notes
Bank Slope	4	1:1 slope
Berm Width - Estimated	2	greater than 10 ft
Soil Type	2	clays and silts
Velocity	3	3.2 ft/s
Bank Stability	4	slumping
Erosion Hazard	15

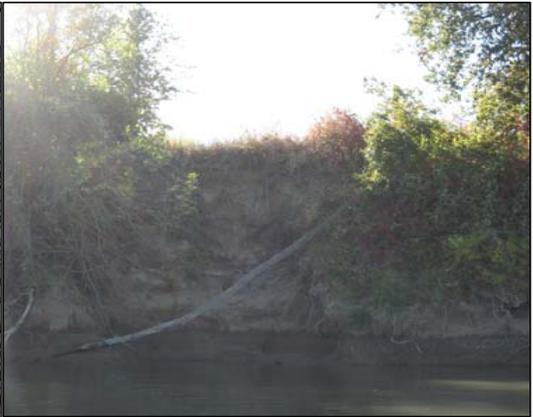
Site Photograph

Criteria	Score	Notes
Bank Slope	3	1.5:1 slope
Berm Width - Estimated	2	less than 20 ft
Soil Type	2	clays and silts
Velocity	2	2.9 ft/s
Bank Stability	6	tree hazards and slumping
Erosion Hazard	15

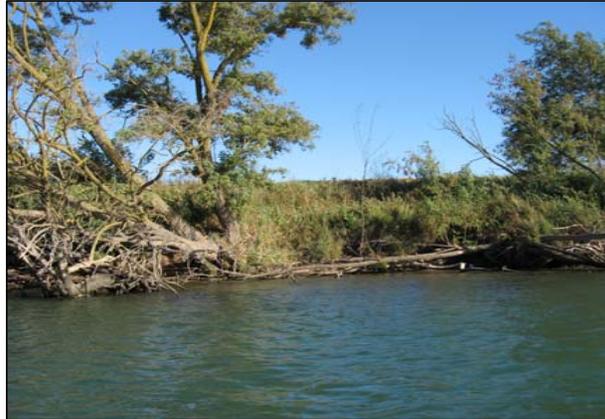
Site Photograph

Criteria	Score	Notes
Bank Slope	3	1.5:1 slope
Berm Width - Estimated	3	5 ft
Soil Type	4	sands and silts
Velocity	4	4.3 ft/s
Bank Stability	1	tree hazards
Erosion Hazard	15

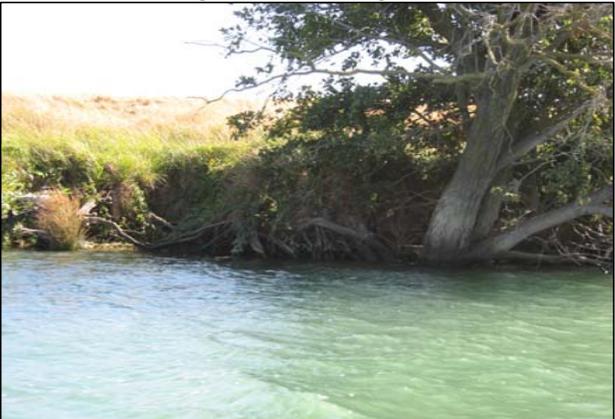
Site Photograph

Criteria	Score	Notes
Bank Slope	4	1:1 slope
Berm Width - Estimated	2	10 ft
Soil Type	4	sands and silts
Velocity	3	3.8 ft/s
Bank Stability	2	tree hazard, caves
Erosion Hazard	15

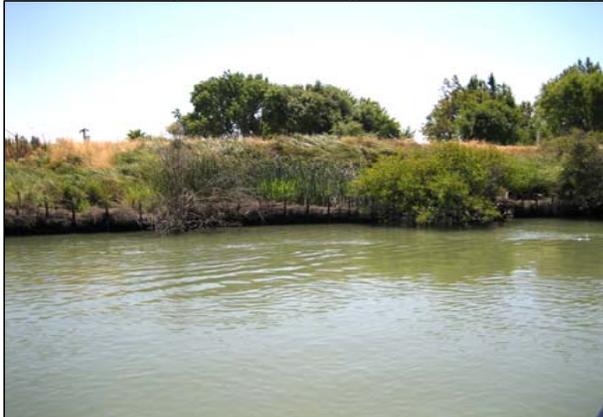
Site Photograph

Criteria	Score	Notes
Bank Slope	2	2:1 slope
Berm Width - Estimated	4	less than 5 ft
Soil Type	4	sands and silts
Velocity	3	4.0 ft/s
Bank Stability	2	beaver holes
Erosion Hazard	15

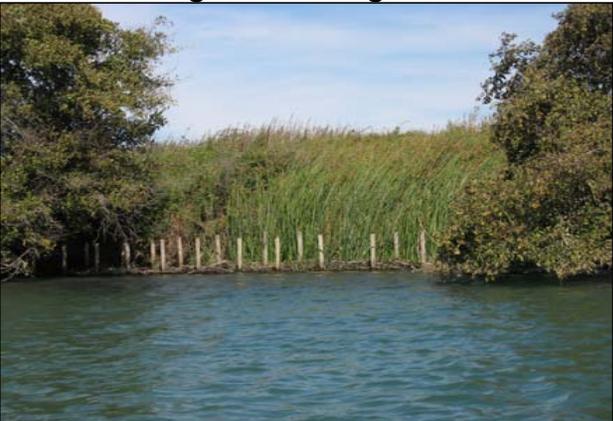
Site Photograph

Criteria	Score	Notes
Bank Slope	2	2:1 slope
Berm Width - Estimated	4	less than 5 ft
Soil Type	4	sands and silts
Velocity	3	4.0 ft/s
Bank Stability	2	tree hazards, caves
Erosion Hazard	15

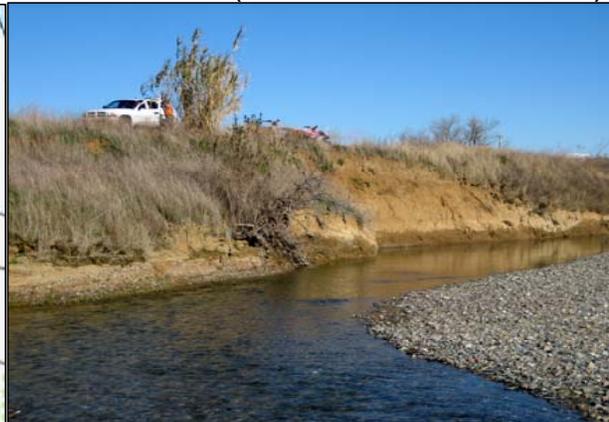
Site Photograph

Criteria	Score	Notes
Bank Slope	4	less than 1:1 slope
Berm Width - Estimated	1	25 to 30 ft
Soil Type	2	clays and silts
Velocity	2	3.0 ft/s
Bank Stability	6	animal holes and slumping
Erosion Hazard	15

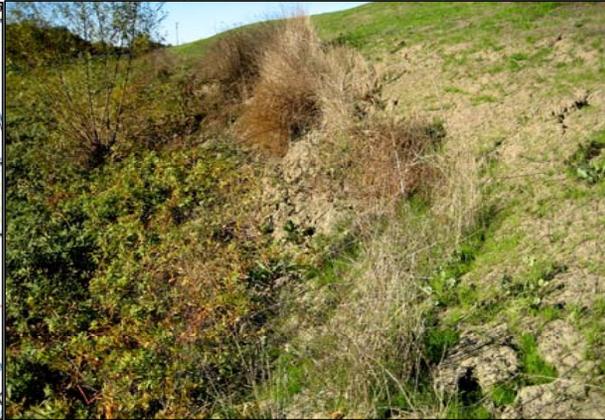
Site Photograph

Criteria	Score	Notes
Bank Slope	2	2:1 slope
Berm Width - Estimated	5	0 to 5 ft of berm
Soil Type	2	clays and silts
Velocity	0	0.1 ft/s
Bank Stability	6	tension cracks and slumping
Erosion Hazard	15

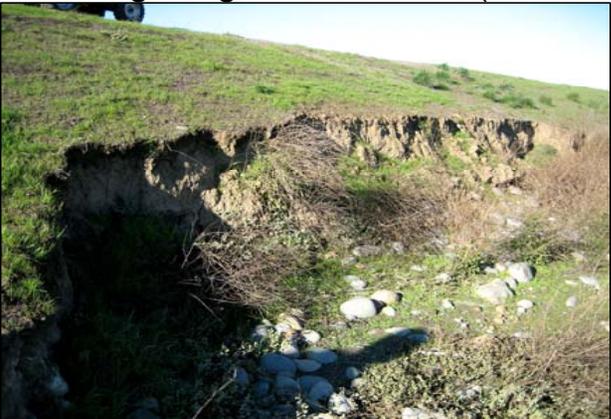
Site Photograph

Criteria	Score	Notes
Bank Slope	2	2:1 slope
Berm Width - Estimated	5	no berm
Soil Type	2	clays and silts
Velocity	0	0.1 ft/s
Bank Stability	6	tension cracks and slumping
Erosion Hazard	15

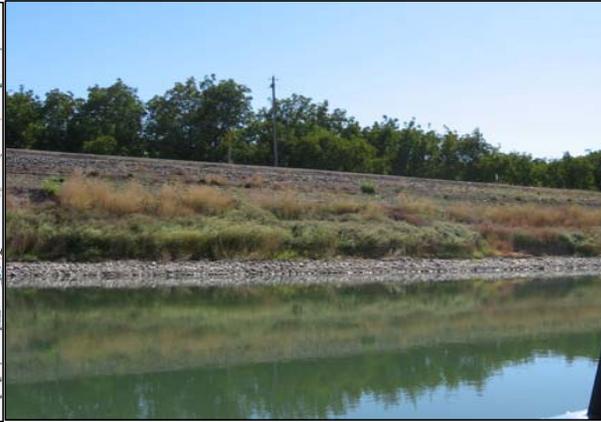
Site Photograph

Criteria	Score	Notes
Bank Slope	2	2:1 slope
Berm Width - Estimated	5	0 to 15 ft
Soil Type	4	sands and silts
Velocity	3	3.3 ft/s
Bank Stability	0	no stability issues
Erosion Hazard	14

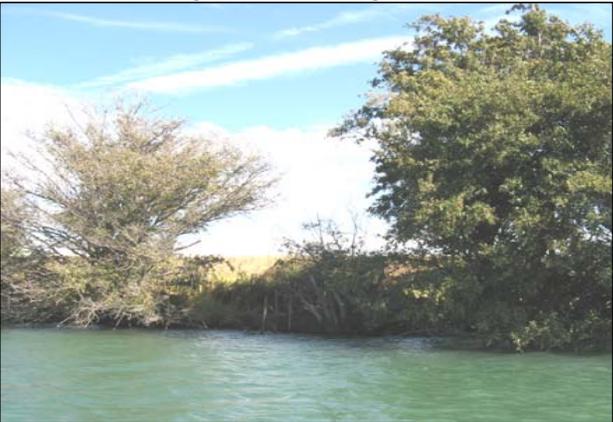
Site Photograph

Criteria	Score	Notes
Bank Slope	3	1.5:1 slope
Berm Width - Estimated	4	less than 5 ft
Soil Type	4	sands and silts
Velocity	3	4.0 ft/s
Bank Stability	0	no stability issues
Erosion Hazard	14

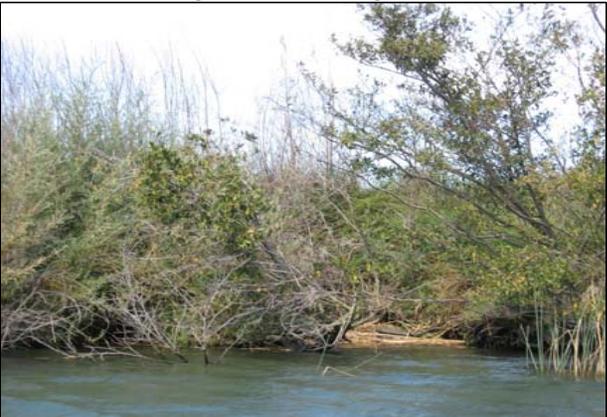
Site Photograph

Criteria	Score	Notes
Bank Slope	3	1.5:1 slope
Berm Width - Estimated	4	less than 5 ft
Soil Type	4	sands and silts
Velocity	3	4.6 ft/s
Bank Stability	0	no stability issues
Erosion Hazard	14

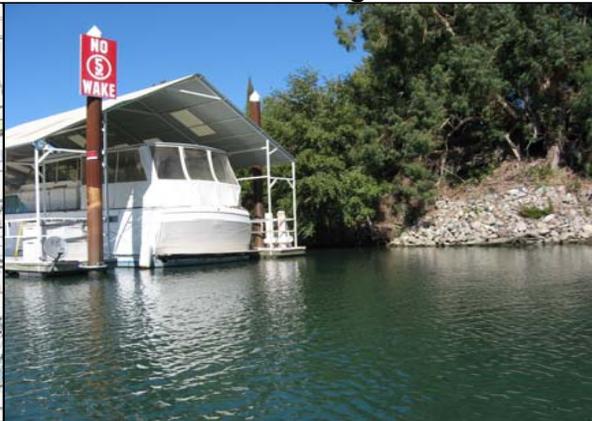
Site Photograph

Criteria	Score	Notes
Bank Slope	3	1.5:1 slope
Berm Width - Estimated	5	no berm
Soil Type	2	clays and silts
Velocity	3	4.7 ft/s
Bank Stability	1	tree hazards
Erosion Hazard	14

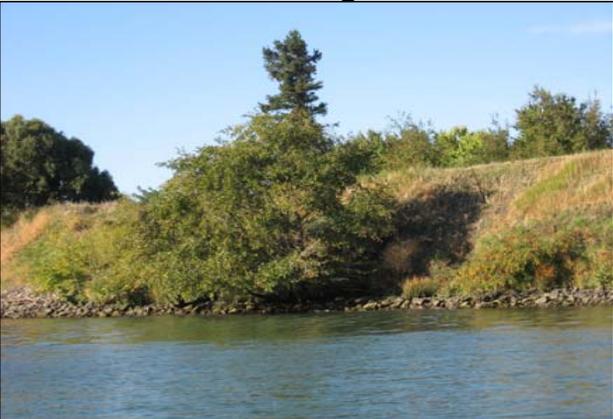
Site Photograph

Criteria	Score	Notes
Bank Slope	4	1:1 slope
Berm Width - Estimated	5	no berm
Soil Type	2	clays and silts
Velocity	3	3.7 ft/s
Bank Stability	0	no stability issues
Erosion Hazard	14

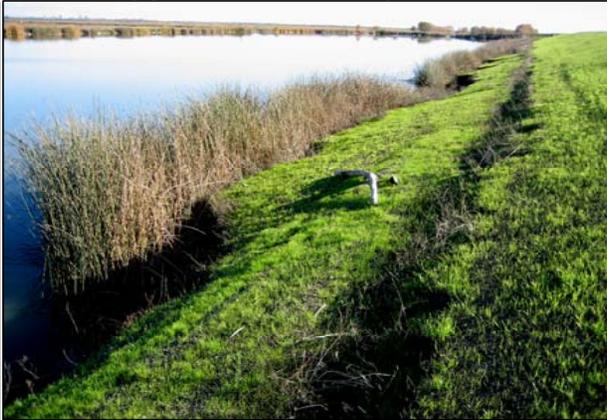
Site Photograph

Criteria	Score	Notes
Bank Slope	0	3:1 slope
Berm Width - Estimated	5	no berm
Soil Type	2	clays and silts
Velocity	1	1.5 ft/s
Bank Stability	6	tension cracks and slumping
Erosion Hazard	14

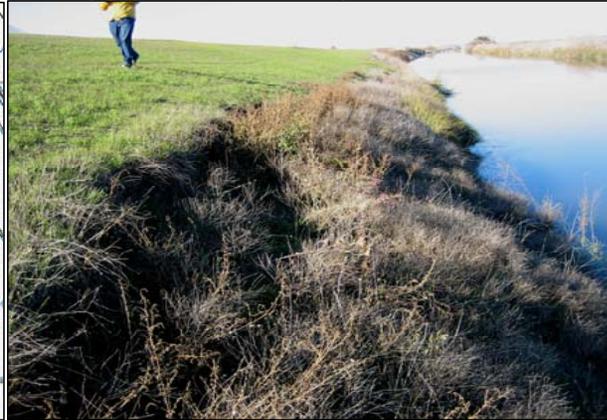
Site Photograph

Criteria	Score	Notes
Bank Slope	0	3:1 slope
Berm Width - Estimated	5	no berm
Soil Type	2	clays and silts
Velocity	1	1.5 ft/s
Bank Stability	6	tension cracks and slumping
Erosion Hazard	14

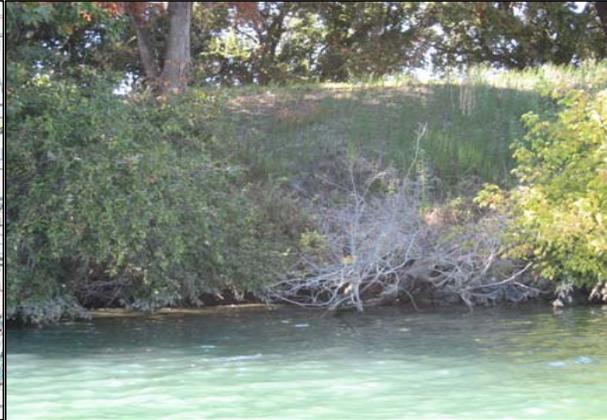
Site Photograph

Criteria	Score	Notes
Bank Slope	4	1:1 slope
Berm Width - Estimated	3	5 ft
Soil Type	2	clays and silts
Velocity	3	4.5 ft/s
Bank Stability	1	tree hazards
Erosion Hazard	13

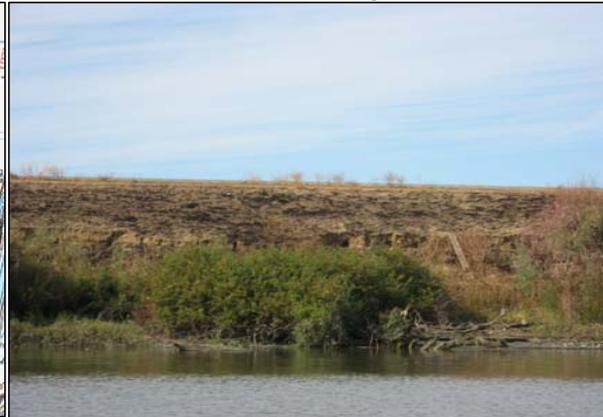
Site Photograph

Criteria	Score	Notes
Bank Slope	2	2:1 slope
Berm Width - Estimated	5	no berm
Soil Type	2	clays and silts
Velocity	0	0.27 ft/s
Bank Stability	4	slumping
Erosion Hazard	13

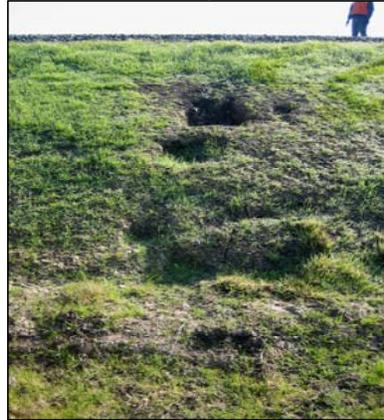
Site Photograph

Criteria	Score	Notes
Bank Slope	1	2.5:1 slope
Berm Width - Estimated	5	no berm
Soil Type	2	silts and clays
Velocity	3	4.0 ft/s
Bank Stability	2	Piping Holes
Erosion Hazard	13

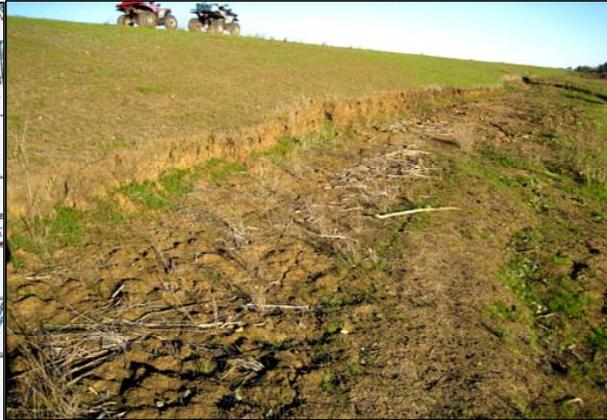
Site Photograph

Criteria	Score	Notes
Bank Slope	2	2:1 slope
Berm Width - Estimated	5	no berm
Soil Type	2	silts and clays
Velocity	0	0.2
Bank Stability	4	slumping
Erosion Hazard	13

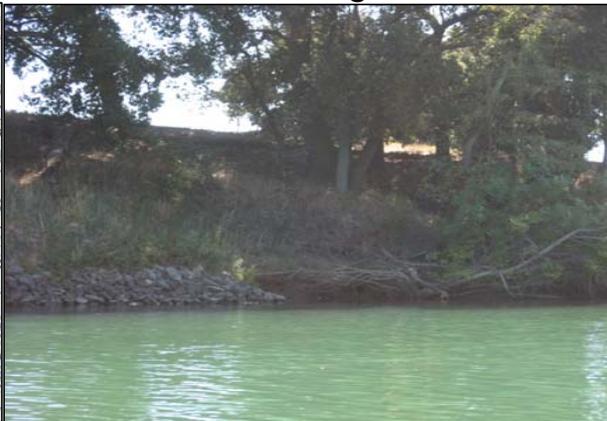
Site Photograph

Criteria	Score	Notes
Bank Slope	3	1.5:1 slope
Berm Width - Estimated	3	5 ft
Soil Type	2	clays and silts
Velocity	3	4.8 ft/s
Bank Stability	1	tree hazards
Erosion Hazard	12

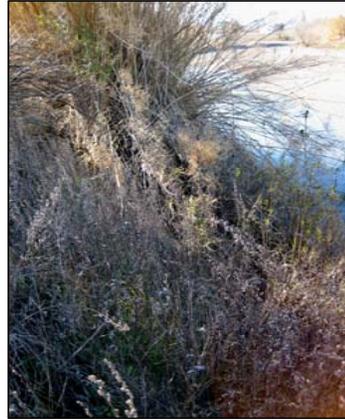
Site Photograph

Criteria	Score	Notes
Bank Slope	3	1.5:1 slope
Berm Width - Estimated	1	25 to 30 ft
Soil Type	2	clays and silts
Velocity	2	3.0 ft/s
Bank Stability	4	slumping
Erosion Hazard	12

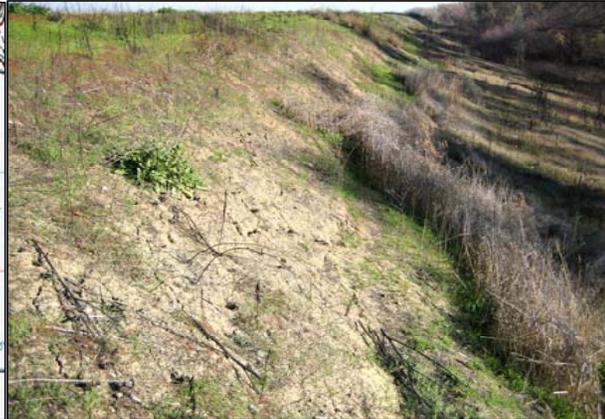
Site Photograph

Criteria	Score	Notes
Bank Slope	3	1.5:1 slope
Berm Width - Estimated	0	40 ft of berm
Soil Type	2	silts with some clays
Velocity	1	1.5 ft/s
Bank Stability	6	tension cracks and slumping
Erosion Hazard	12

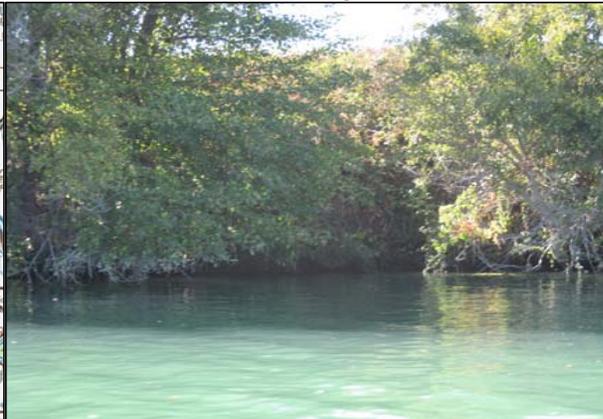
Site Photograph

Criteria	Score	Notes
Bank Slope	2	2:1 slope
Berm Width - Estimated	3	5 ft
Soil Type	2	clays and silts
Velocity	3	4.7 ft/s
Bank Stability	1	tree hazards
Erosion Hazard	11

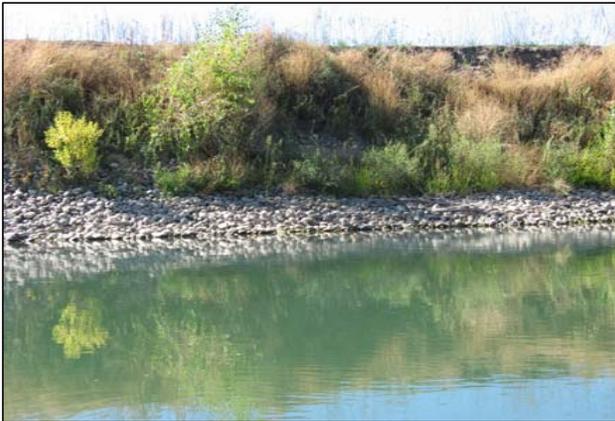
Site Photograph

Criteria	Score	Notes
Bank Slope	2	2:1 slope
Berm Width - Estimated	0	30 ft
Soil Type	1	clays and rounded stone
Velocity	3	4.9 ft/s
Bank Stability	4	slumping
Erosion Hazard	10

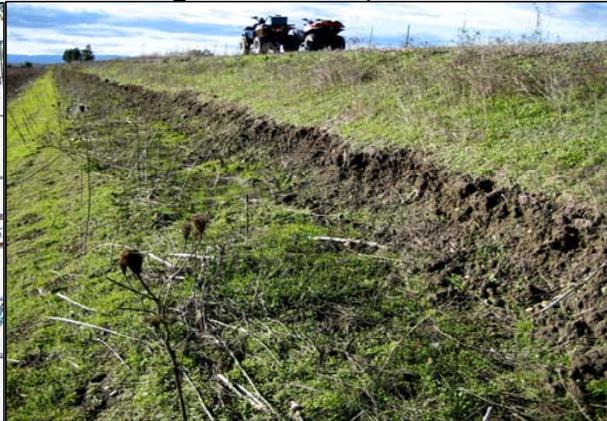
Site Photograph

Criteria	Score	Notes
Bank Slope	2	2:1 slope
Berm Width - Estimated	5	no berm
Soil Type	2	clays and silts
Velocity	0	0.6 ft/s
Bank Stability	0	no stability issues
Erosion Hazard	9

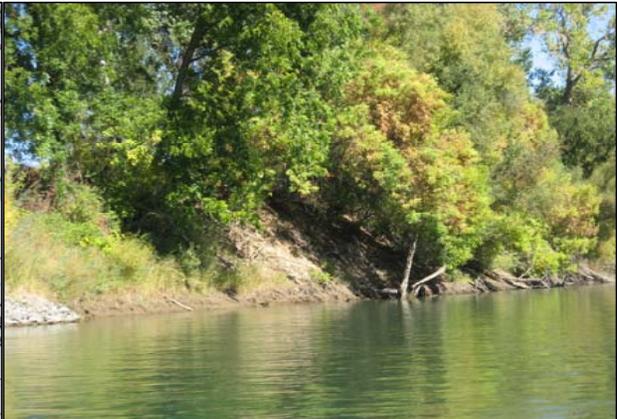
Site Photograph

Criteria	Score	Notes
Bank Slope	2	2:1 slope
Berm Width - Estimated	0	30 ft
Soil Type	2	clays and silts
Velocity	3	4.8 ft/s
Bank Stability	1	tree hazards
Erosion Hazard	8

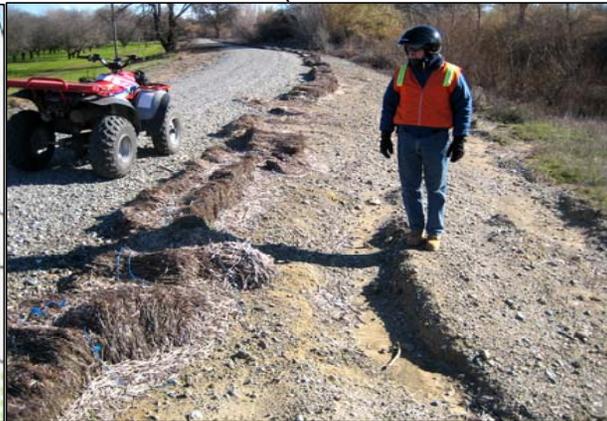
Site Photograph

Criteria	Score	Notes
Bank Slope	2	2:1 slope
Berm Width - Estimated	2	10 ft
Soil Type	2	clays and gravels
Velocity	2	3.0 ft/s
Bank Stability	0	no stability issues
Erosion Hazard	8
