# UNDERWATER INSPECTION AND VELOCITY SURVEY OF THE DOS AMIGOS PUMPING PLANT TRASHRACKS AND FOREBAY

February 21 and 22, 2007

U.S. Bureau of Reclamation  
March 2007

Subject: Underwater Inspection and Velocity Survey of the  
Dos Amigos Pumping Plant Trashracks and Forebay  
February 21 and 22, 2007

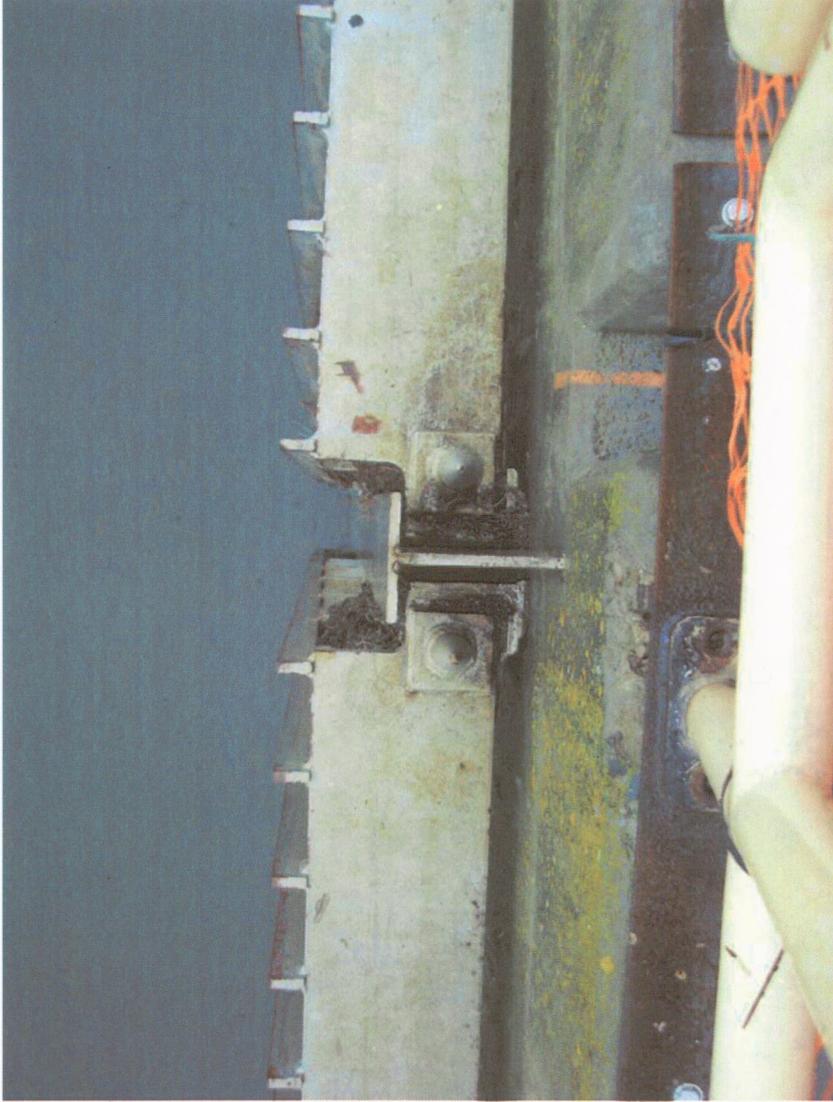
Photo 14

View looking directly down on the top of two trashrack panels showing a trashrack guide at photo center.

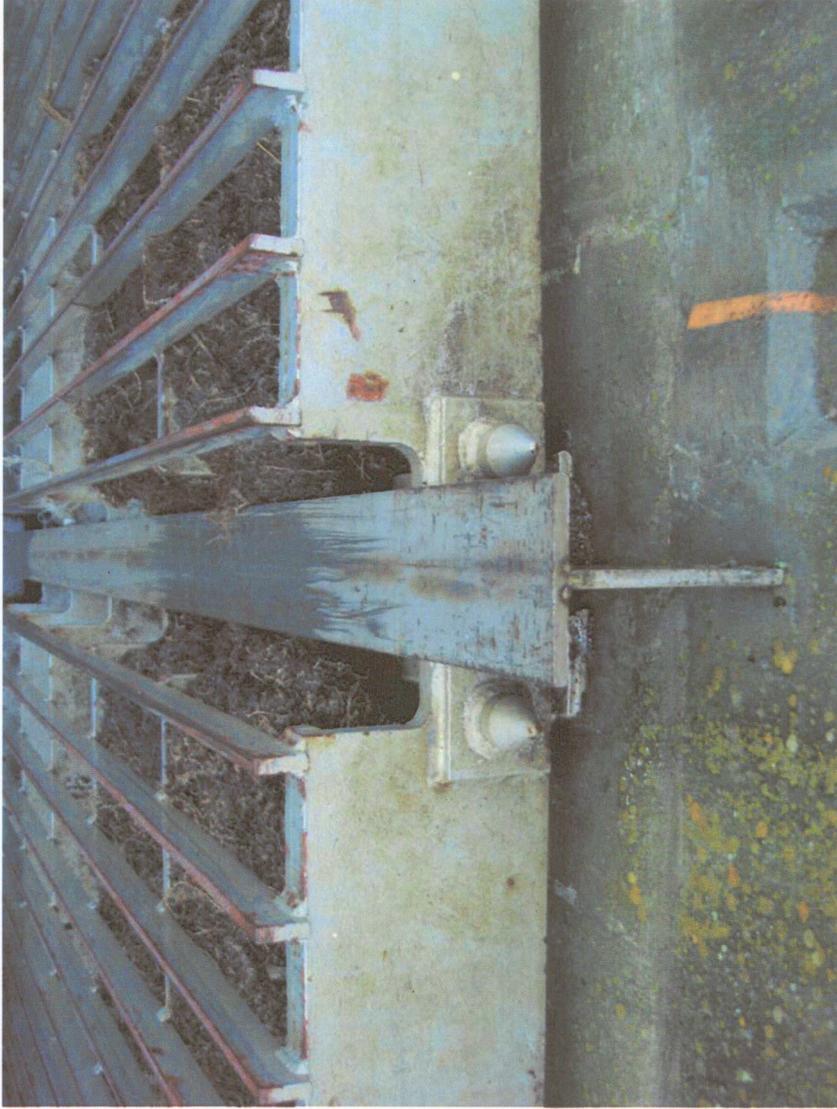
Photo 15

View looking down and toward the two trashrack panels shown in Photo 14. The upper 4 feet of each trashrack panel is thoroughly plugged with water weed.

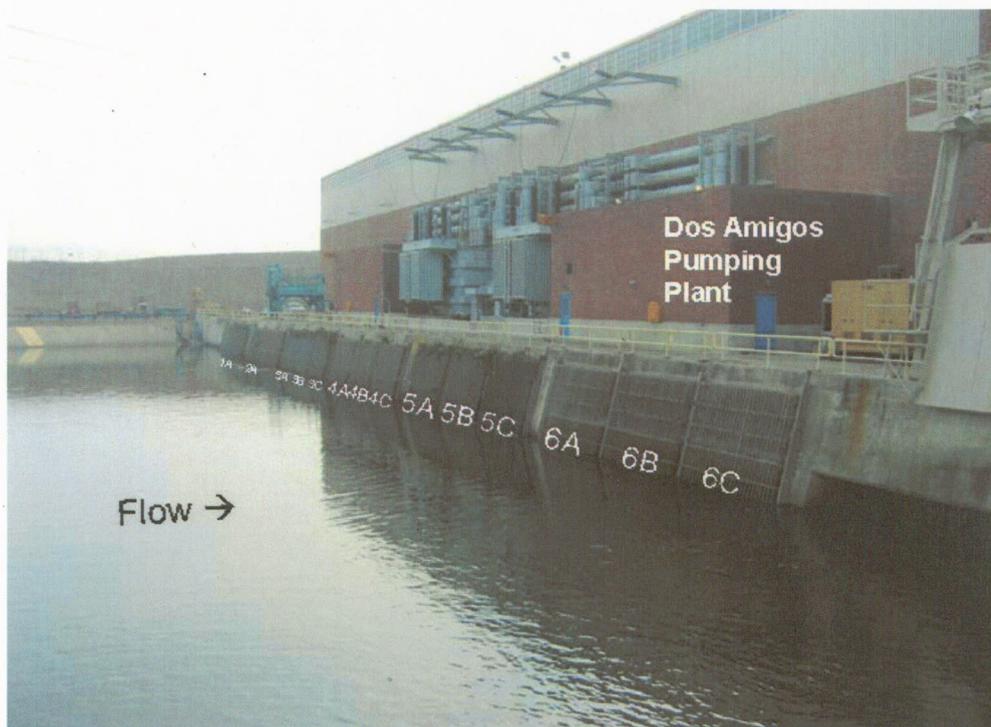
Figure 1. Photograph of the Dos Amigos Pumping Plant Forebay with the six trash rack bays with the identification scheme used in this report.

The pumping plant has a debris problem generated by aquatic weeds being transported from the O'Neill forebay reservoir. The aquatic debris accumulates on the Dos Amigos trash racks and causes significant head differential across the trash racks of operating units. On February 21, 2007 at 1:00 p.m. the head differential across the Unit 5 trash racks was 4.5 ft. The trash rake cleaning system was down for maintenance during our site visit. The project had been using a construction backhoe to remove floating debris from the pumping plant forebay. Aquatic debris was observed to accumulate on the operating pumps. When pumping was transferred from one unit to another, the back flow from the unit shutting down would wash debris 30 to 50 ft into the forebay. This debris

would then migrate toward the operating unit(s). The back flow appeared to effectively remove all surface debris that had accumulated. It usually took about one hour for most of the available aquatic debris to accumulate on the Unit 5 trash racks (figure 2).

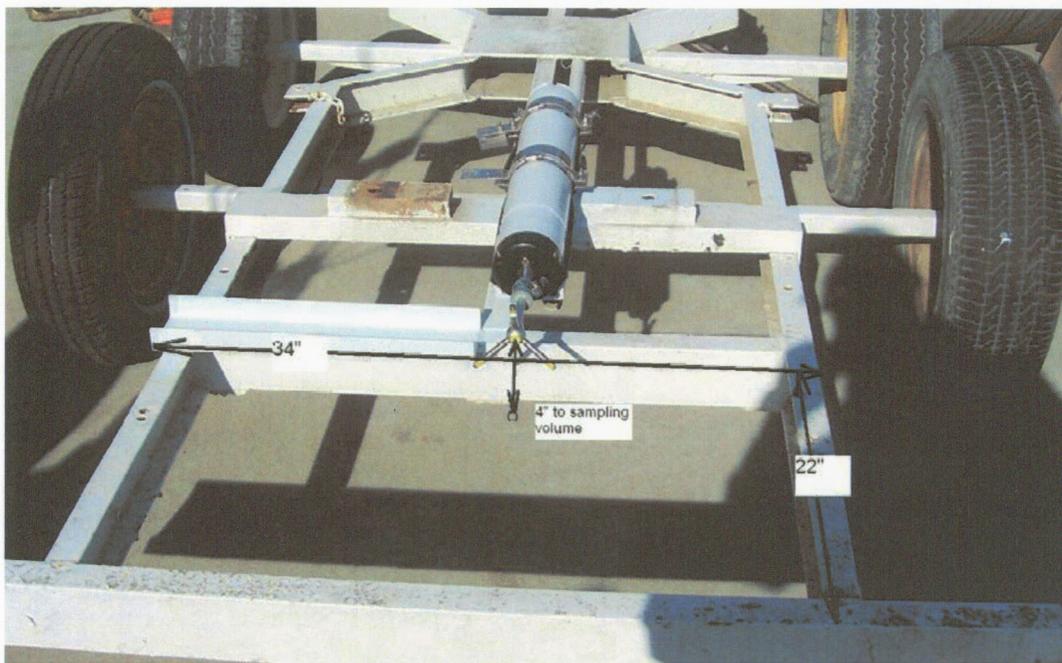
Figure 3. Photograph of Argonaut-ADV mounted within a 34" by 22" clear area in a dual-axle trailer. For this mount, the ADV sampling volume was offset about 22 inches above the roadway. The sampling volume is located about 4 inches below the acoustic transducer and about 11 inches from the end of the trailer.

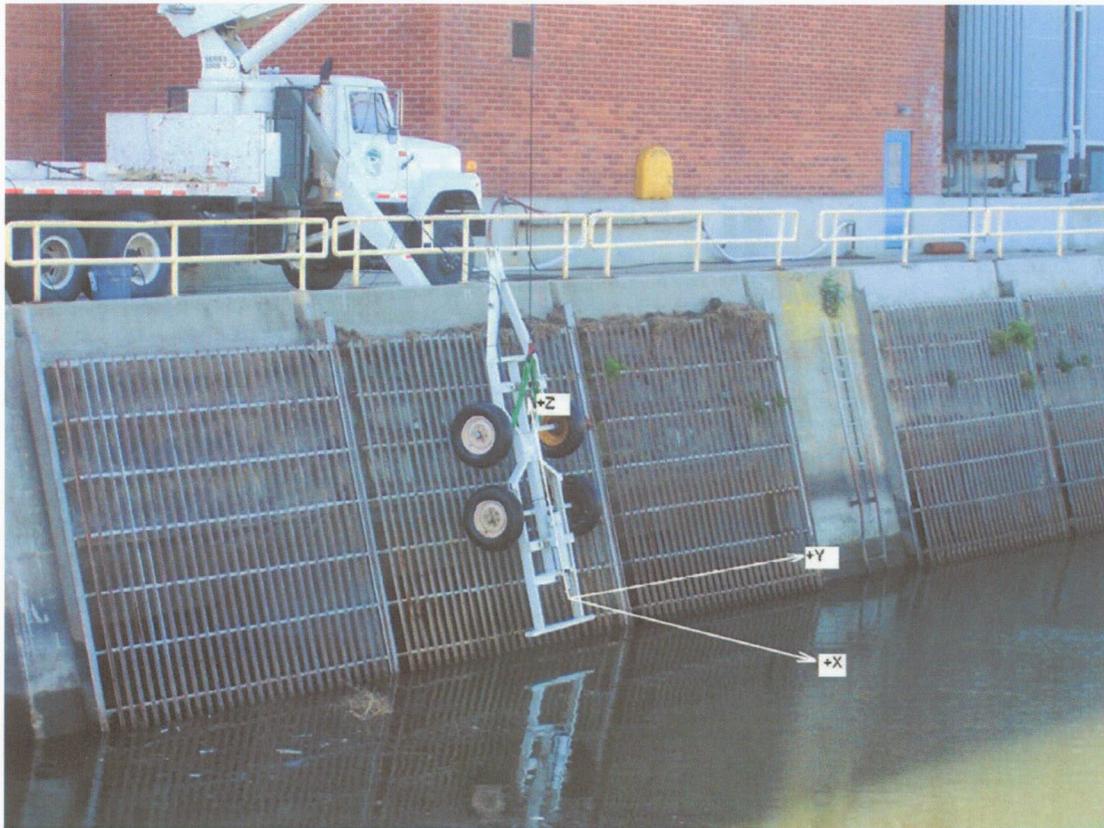
Figure 4. Photograph of the truck-mounted crane, trailer, Argonaut-ADV, and the x,y,z coordinate system. The trailer is located near the center of rack 1B.

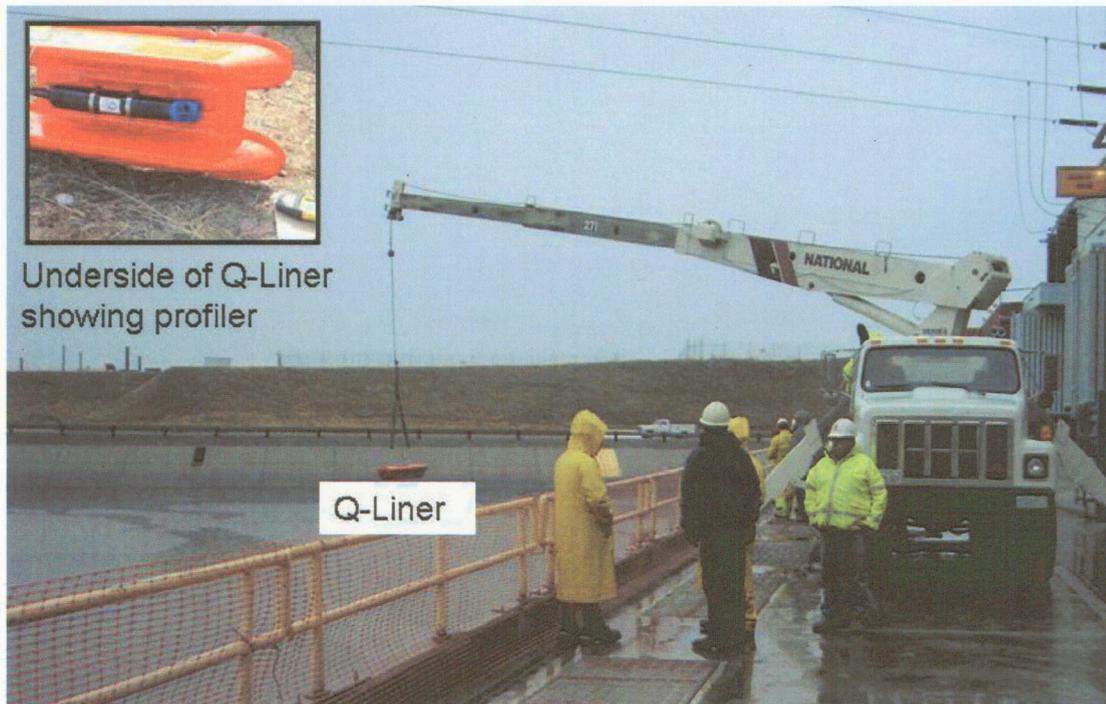
Figure 5. Photograph of the Q-Liner and crane setup used to measure approach velocities toward Unit 5 trash racks. The Q-Liner was oriented perpendicular to the trash rack using tag-lines (not shown).
