State of California
THE RESOURCES AGENCY
Department of Water Resources

BULLETIN No. 116-5

THE ALASKAN EARTHQUAKE

OCTOBER 1965

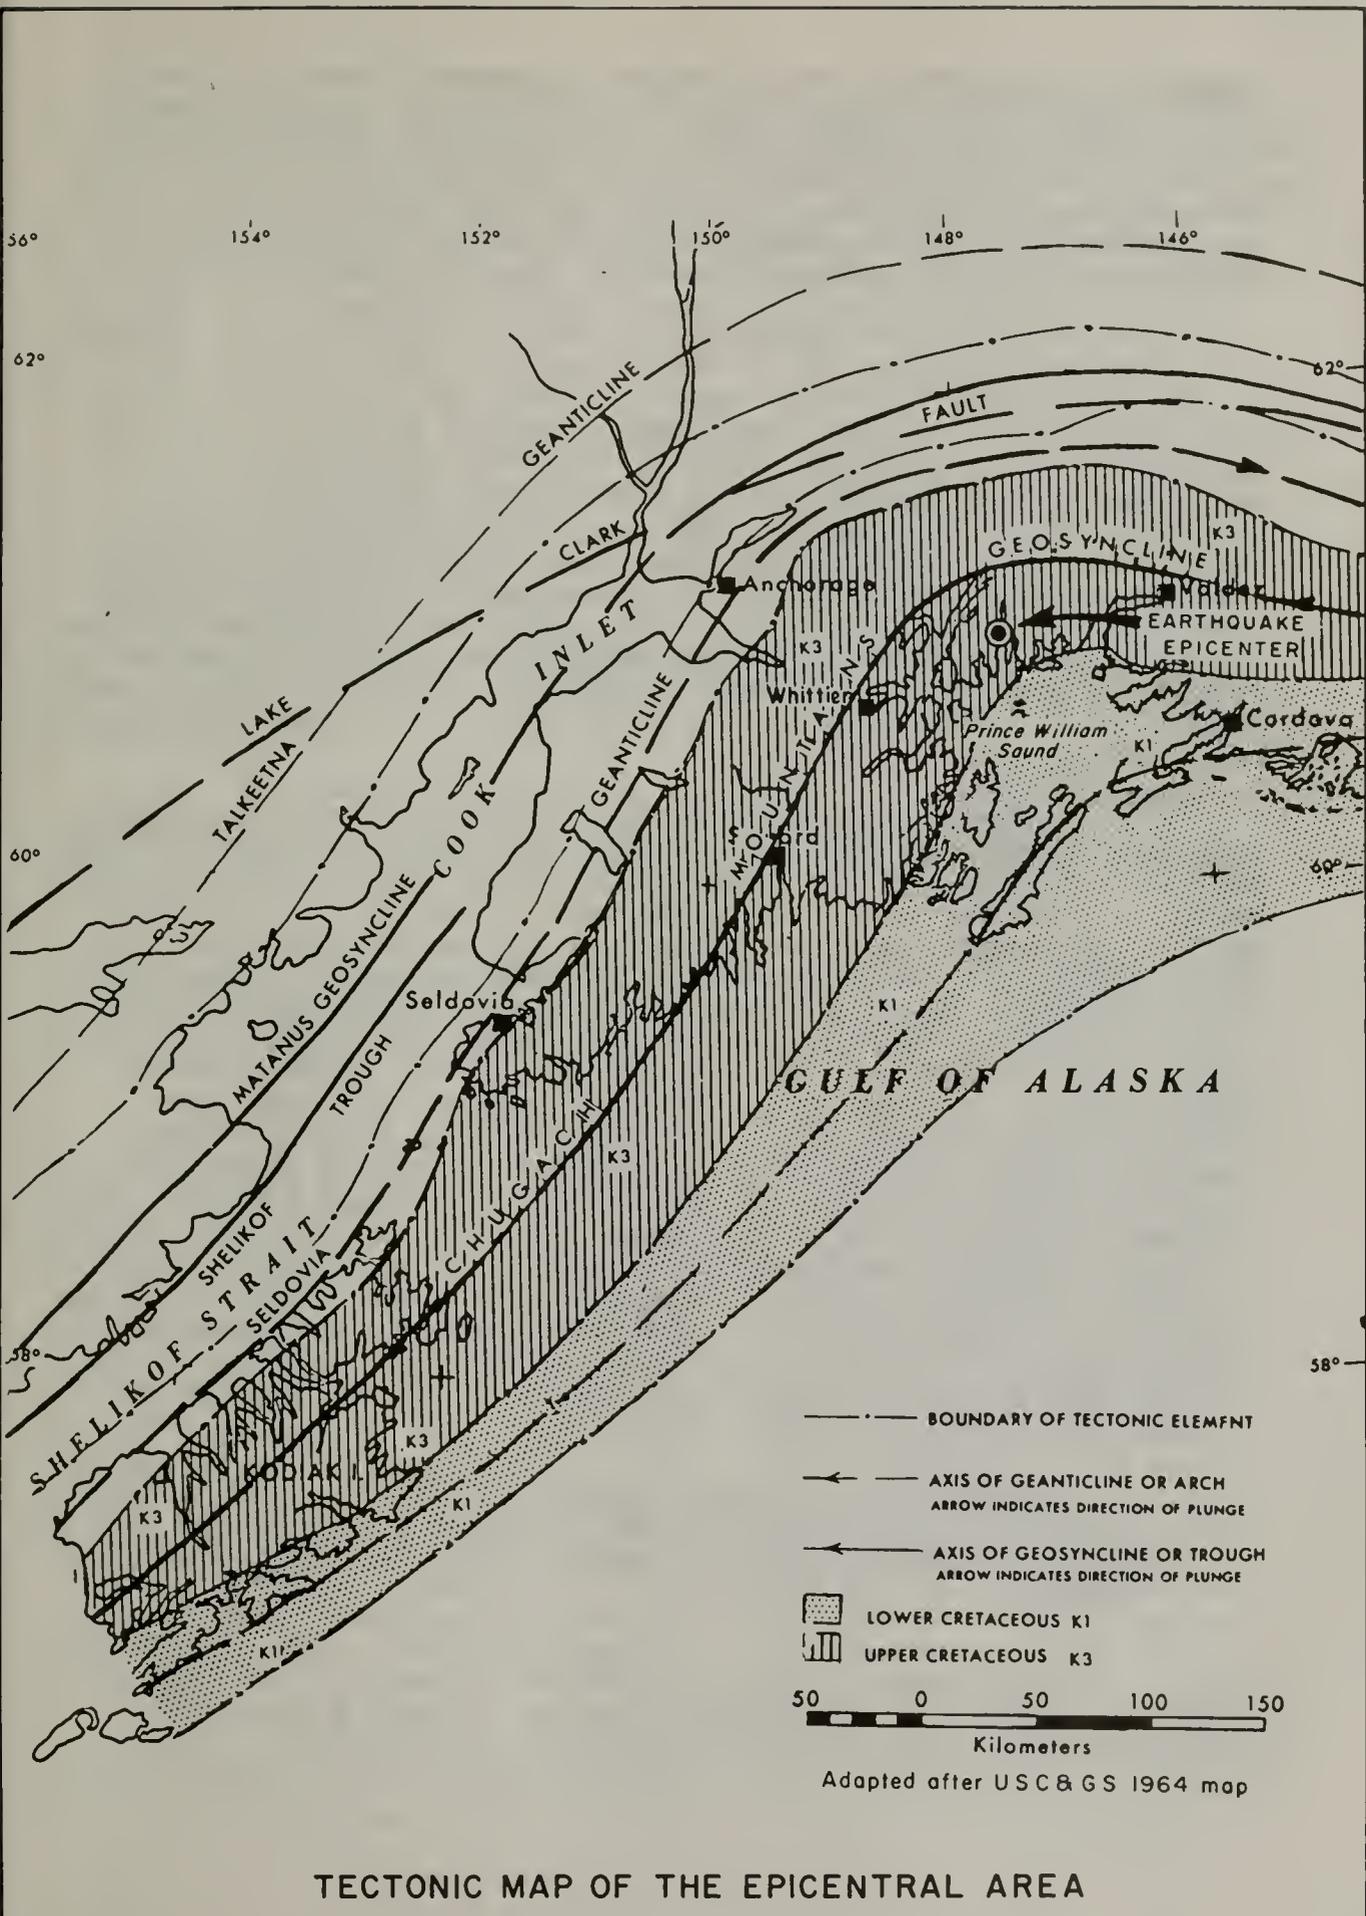
TECTONIC MAP OF THE EPICENTRAL AREA

formed of sedimentary rocks folded in geosynclinal and geanticlinal structures. Major faults parallel the axes of these major folds in the earth's crust. On the east side of the Gulf of Alaska the general trend of major geologic structures is to the northwest. As shown in Figure 2, these major geologic structures bend around Prince William Sound to a southwest trend, merging with the structural trend of the Aleutian Islands.

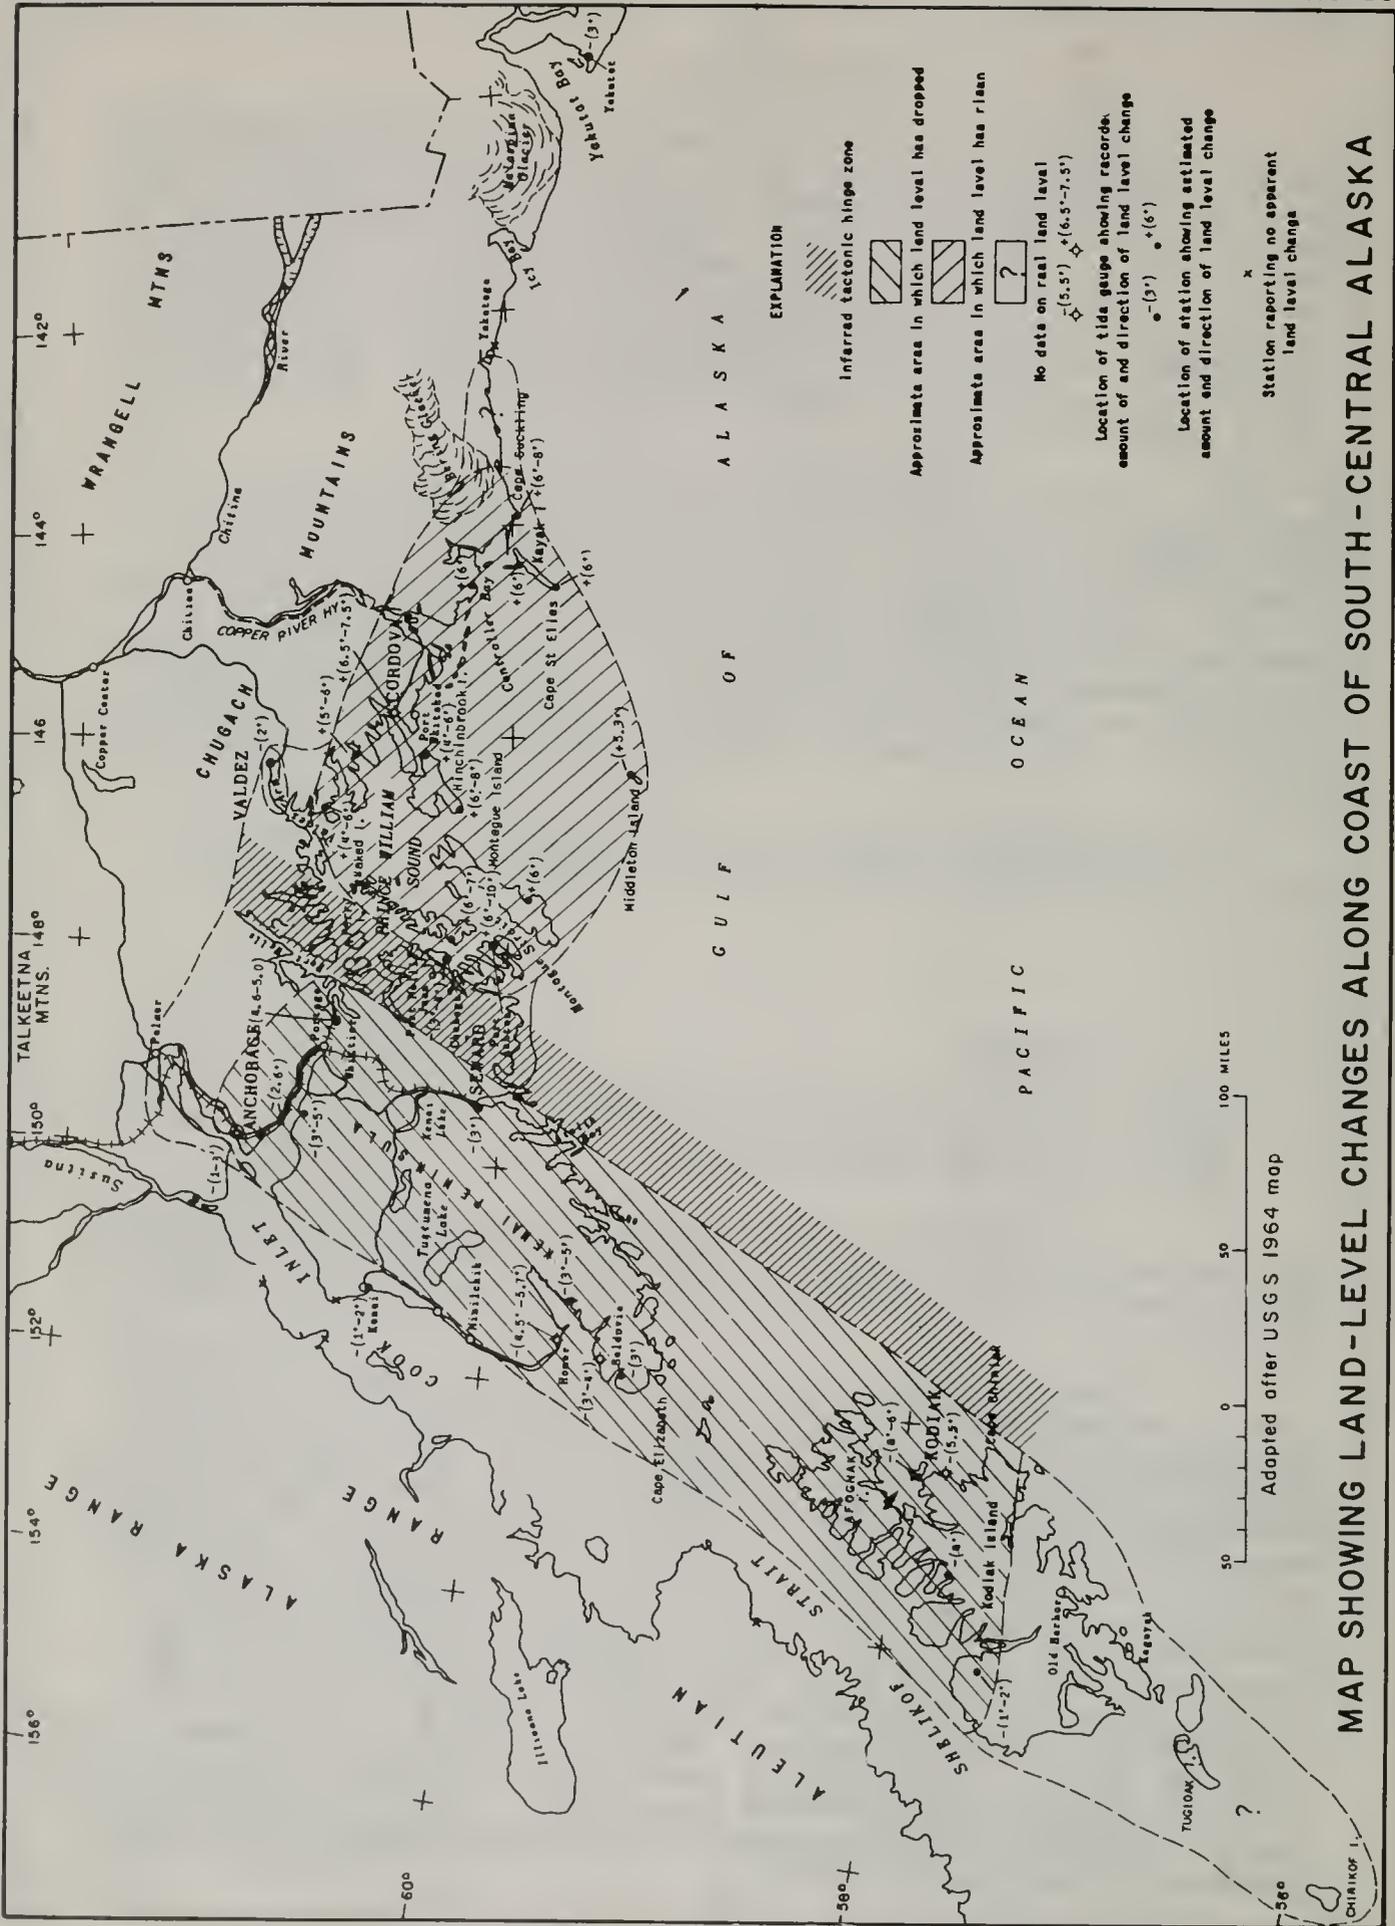
Preliminary estimates by the U. S. Geological Survey indicated that 34,000 square miles of the earth's crust was affected by tectonic uplift or subsidence. The original estimate of the area is shown on Figure No. 5. From subsequent studies, not yet concluded, it appears that an area of approximately 600 miles long and 20 to 60 miles wide on the north side of the trench was depressed and an area of approximately 600 miles long and up to 100 miles wide on the southerly side of the trench was uplifted. Rough estimates indicate that approximately 43,000 square miles were affected by subsidence, and 40,000 square miles affected by uplift, making a total affected area of 83,000 square miles, equivalent to approximately half the area of the State of California. Maximum tectonic subsidence indicated by the tide gages was 5.6 feet at Womans Bay on Kodiak Island; whereas maximum tectonic uplift of 33 feet was measured on Montague Island.
