# Banks Organic Carbon

# Banks Pumping

### Gianelli Organic Carbon and Pumping/Generating:

## Jones organic carbon and pumping

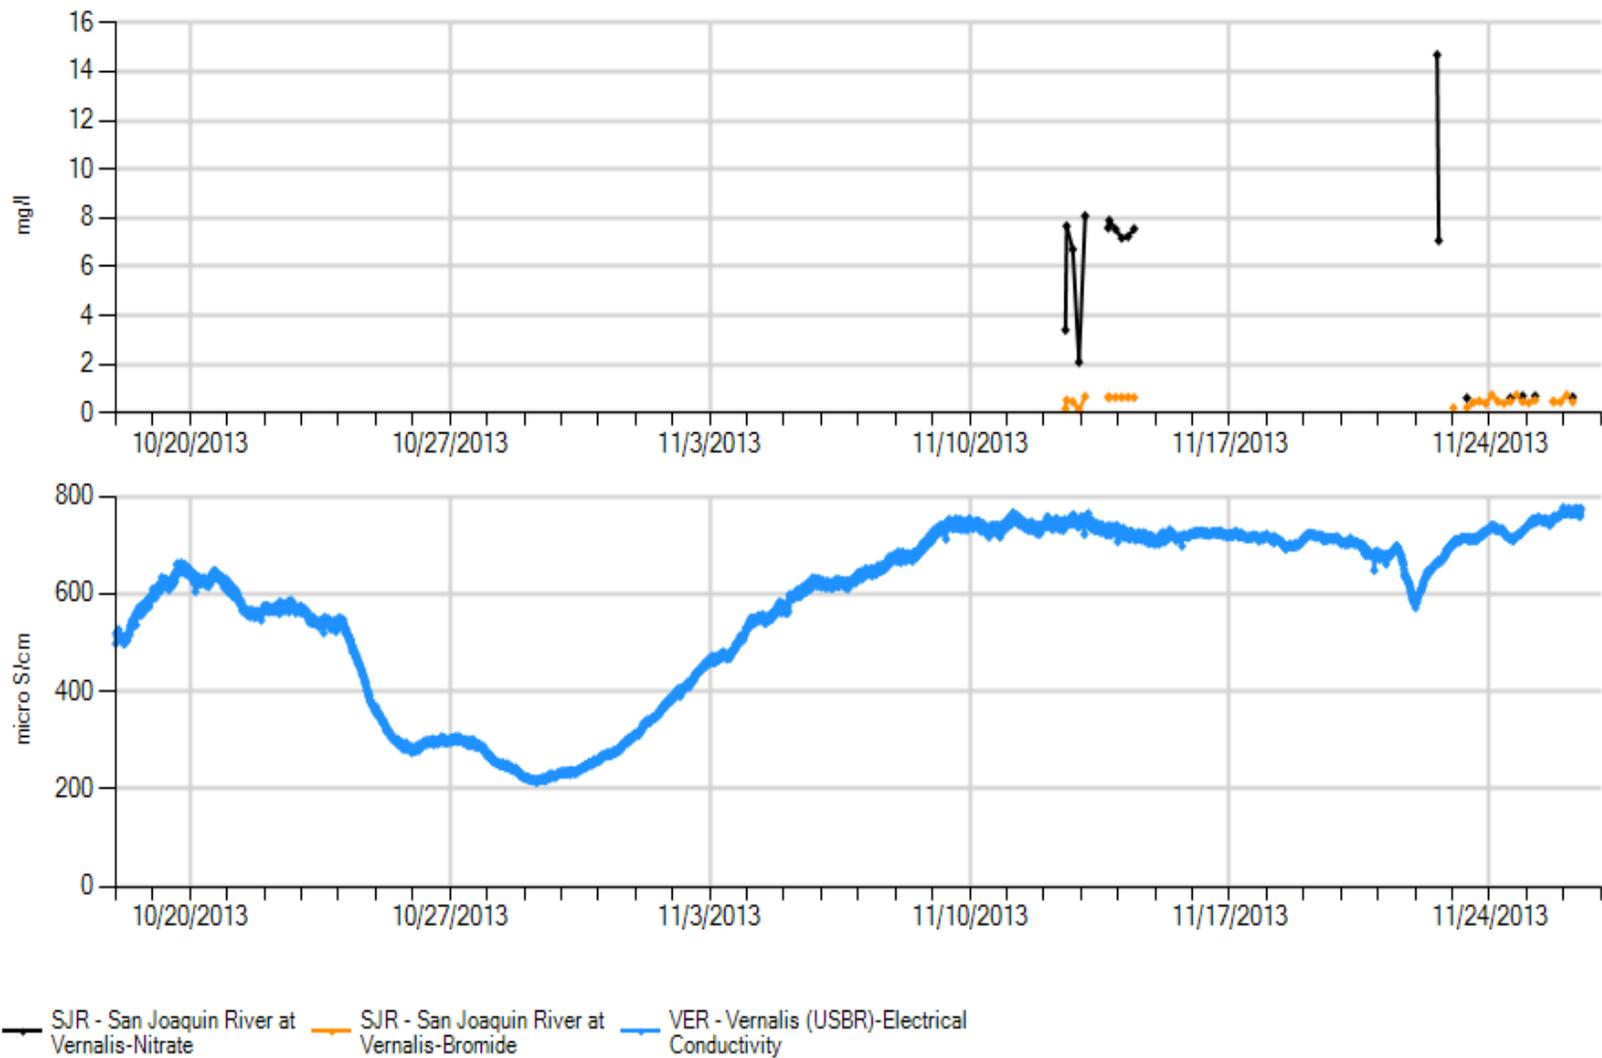
The Dionex has been non-operational since mid-October, from a series of events. On 10/13, the analytical and guard columns were changed, but the instrument would not finish the necessary calibration sequence because of an error in the software. The Thermo-Fisher/Dionex tech made a site visit on 10/31 to diagnose the previously unseen issue, but did not make much progress by the end of the day. In the meantime, Mark was able to trace the error to a Windows 7 printer update/Chromeleon software interface issue, and fixed the problem by disabling certain features of the software. On 11/13, the calibration showed a problem with the bromide concentration of the stock standards made for the Dionex. The standards were made using an older formula that only contained half of the necessary bromide. On 11/18, the new standards were installed but there were problems with one of the peristaltic pumps not delivering enough standard to the dilution vessel for calibration. The peristaltic tubing was worn-out and a new length was procured and installed on 11/21. The analyzer calibrated on Friday 11/22 and ran over the weekend. After a QA/QC site visit on Monday 11/25, the anion data was set to report the morning of 11/26.

IC Instrument down from 10/14 until 11/26. No good anion data.
