# REPAIR, EVALUATION, MAINTENANCE, AND REHABILITATION RESEARCH PROGRAM

TECHNICAL REPORT REMR-EI-5

## THE EFFECTS OF VEGETATION ON THE STRUCTURAL INTEGRITY OF SANDY LEVEES

Final Report

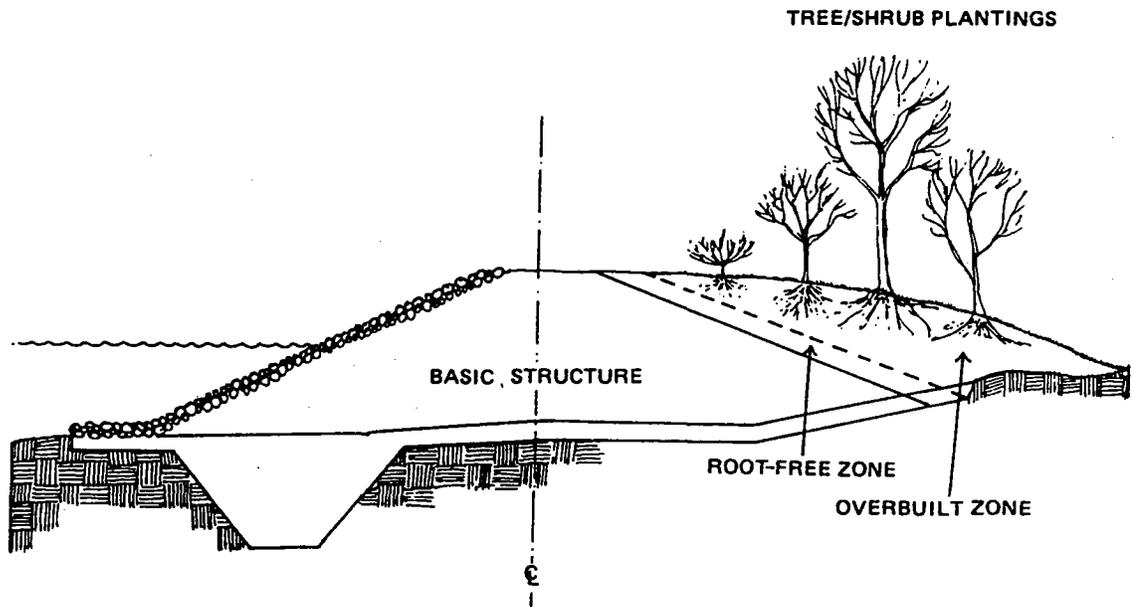
Figure 1. Cross section of an overbuilt levee

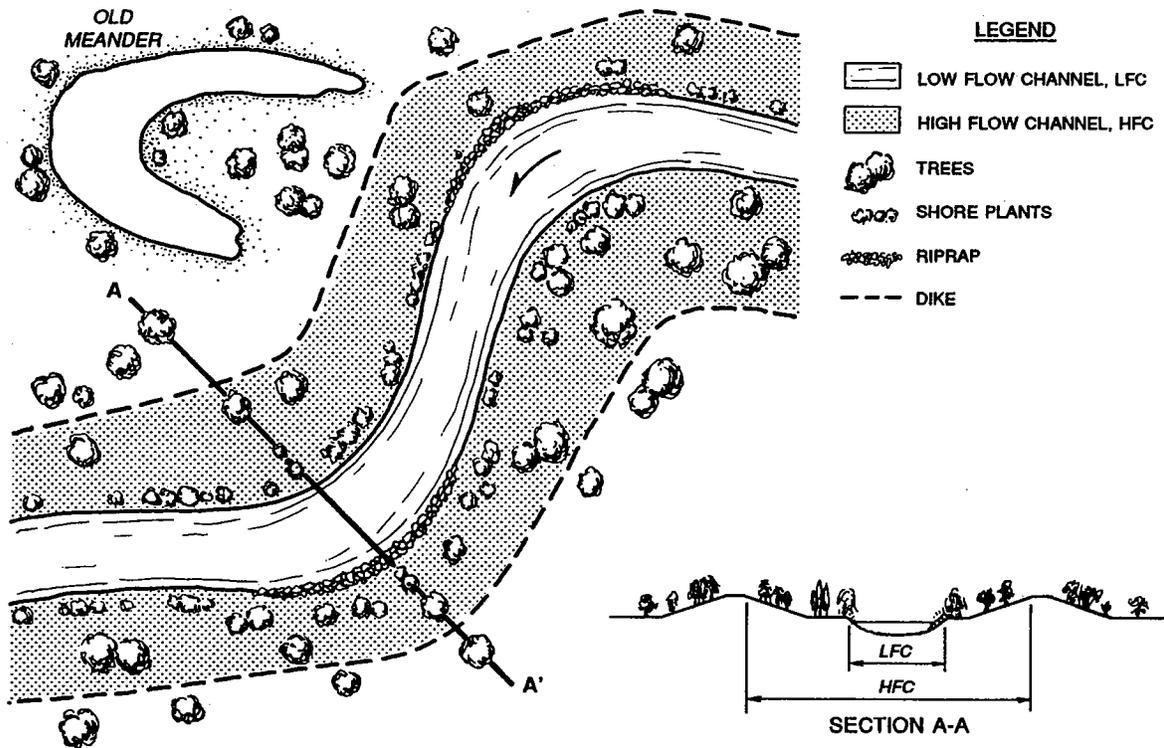
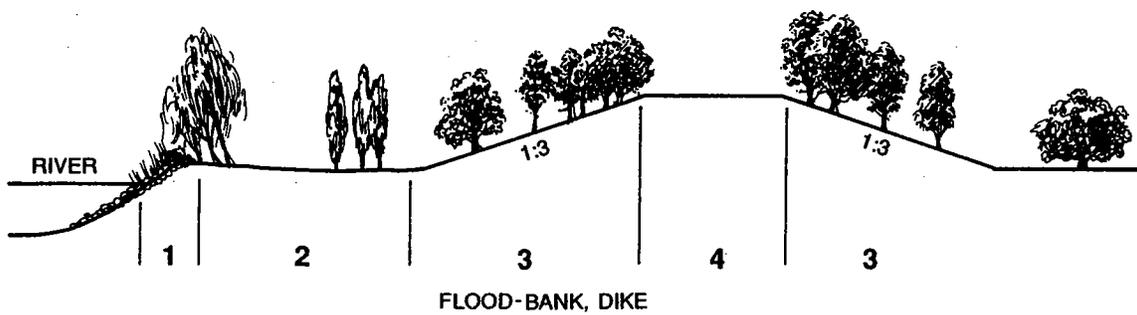
IDEALIZED DIAGRAM SHOWING THE CONCEPT OF "NATURAL RIVER ENGINEERING" BEING PRACTICED IN BAVARIA, WEST GERMANY.

1. SHORE PLANTS; REEDS, LARGE SEDGES, ETC. PLANTED IN RIPRAP.
2. TREES (NEAR WATER TABLE) POPULAR, ALDER, WILLOW, ETC.
3. TREES (HIGHER, LESS WET SITES) OAK, MAPLE, ASH, ETC.
4. GRASS

Figure 2. Use of vegetation on flood dikes in Bavaria, West Germany (after Keller and Brookes 1984)

18. In European practice, vegetation is promoted as a means of stabilizing streambanks and levee slopes. In Bavaria, West Germany, a common design practice is to construct widely spaced, vegetated levees as shown in Figure 2. A mixture of plants, including reeds, grasses, and trees, is used with riprap and other standard engineering control measures to retard erosion (Keller and Brookes 1984).

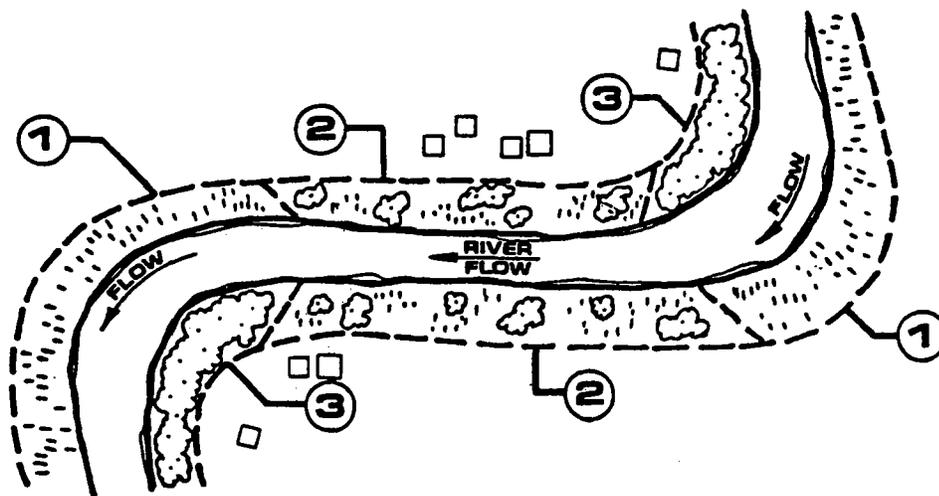
- ① Areas of HIGH potential damage, such as the outside of river bends, historically flooded areas, or levees adjacent to residences and critical use facilities should be cleared of trees and brush which could obstruct access for inspection and repair. In these levee sections, only grass and small forbs would be permitted.

- ② Areas of INTERMEDIATE damage potential such as relatively level, straight reaches and gentle bends could be selectively cleared, leaving clumps or strips of vegetation while allowing unimpeded access for inspection and repair. The type, amount and distribution of this vegetation would be carefully coordinated with the Corps of Engineers to insure levee integrity.

- ③ Areas of LOW potential damage, i.e., the inside portion of river bends, levees which are seldom damaged or which protect large areas of undeveloped or relatively low value land could be maintained in a manner which would leave most levee vegetation intact, removing only that vegetation which could constitute a threat to the levee or impede levee accessibility.

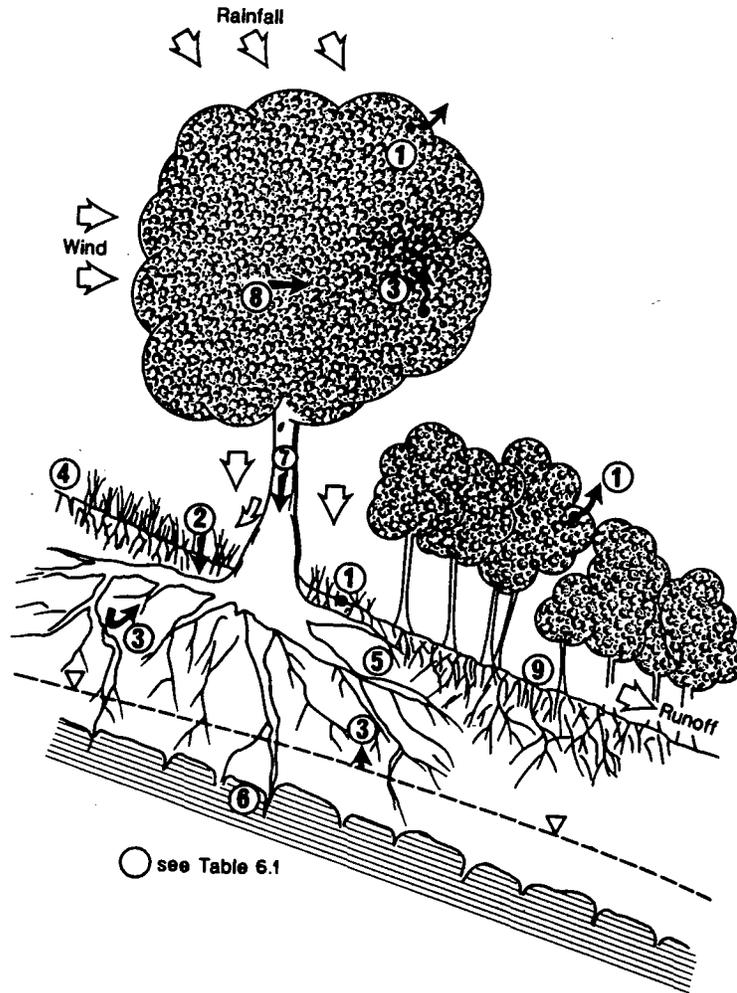
<i>Hydrological Mechanisms</i>	<i>Influence</i>
1 Foliage intercepts rainfall, causing absorptive and evaporative losses that reduce rainfall available for infiltration.	B
2 Roots and stems increase the roughness of the ground surface and the permeability of the soil, leading to increased infiltration capacity.	A
3 Roots extract moisture from the soil which is lost to the atmosphere via transpiration, leading to lower pore-water pressures.	B
4 Depletion of soil moisture may accentuate desiccation cracking in the soil, resulting in higher infiltration capacity.	A
 <i>Mechanical Mechanisms</i>	
5 Roots reinforce the soil, increasing soil shear strength.	B
6 Tree roots may anchor into firm strata, providing support to the upslope soil mantle through buttressing and arching.	B
7 Weight of trees surcharges the slope, increasing normal and downhill force components.	A/B
8 Vegetation exposed to the wind transmits dynamic forces into the slope.	A

9 Roots bind soil particles at the ground surface, reducing their susceptibility to erosion.	B
Legend: A – Adverse to stability B – Beneficial to stability

31. The effects of vegetation on slope stability are best documented in the soil conservation and forest engineering literature. Greenway (1987) has provided a good summary of the hydromechanical influences of vegetation as related to mass stability. These influences are depicted schematically in Figure 4 and tabulated according to whether they exert a beneficial or adverse effect. The most obvious way in which woody vegetation enhances mass stability is via root reinforcement. Extensive laboratory studies (Gray and Ohashi 1983; Gray and Maher 1989) on fiber-reinforced sands indicate that small amounts of fiber can provide substantial increases in shear strength. These findings have been corroborated by field tests on root-permeated soils (Endo and Tsuruta 1969; Ziemer 1981; Riestenberg and Sovonick-Dunford 1983).

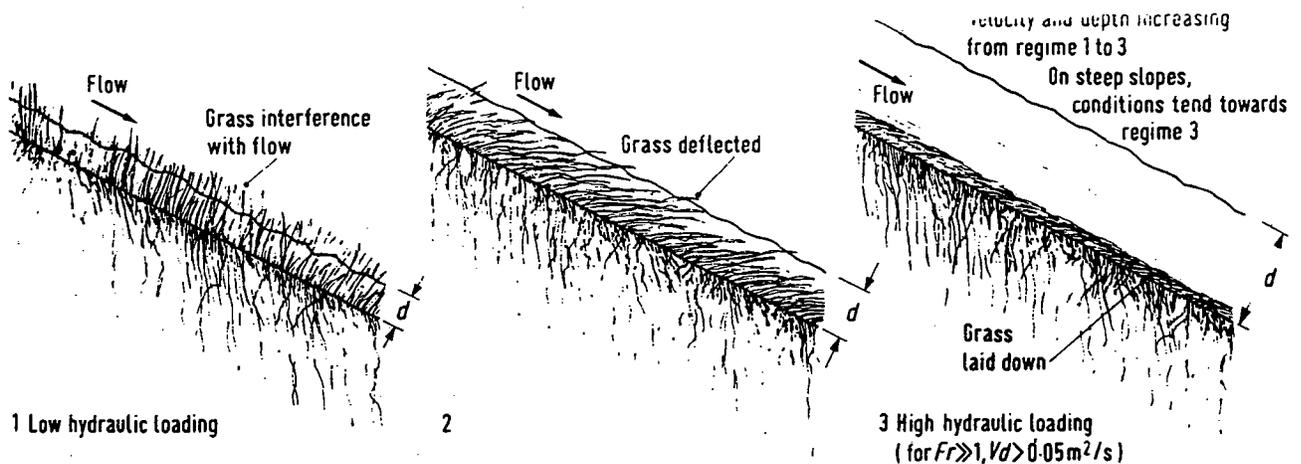
Figure 5. Effect of hydraulic loading on a grassed surface (from Hewlett, Boorman, and Bramley 1987)

In flow regime 1, the flow depth is significantly less than the height of the vegetation, which is not deflected, and the velocity at the soil surface is low due to the interference effect of the vegetation. In flow regime 2, the combined effect of increasing flow velocity and depth causes the vegetation to deflect and oscillate in the flow. In regime 3, the velocity is high enough to flatten the vegetation and a relatively smooth, stationary surface is presented to the flow. The effect of this laydown is to armor the surface and to assist in reducing local surface irregularities which might otherwise be subject to high drag forces during floods.

physically hold soil particles in place. The extent to which vegetation provides these benefits depends upon the surface area of vegetation presented to the flow and the flexibility of the stems (Kouwen and Li 1980). Dense grass swards and low shrubs which extend numerous, non-rigid branches and leaves into the flow are the most effective in this regard. Uniformly rooted grasses (as opposed to tussocks) and supple, young willows have proven to be valuable for erosion protection (Parsons 1963; Seibert 1968). In large, wide-leveed rivers, this additional channel roughness will have a negligible effect on the stage of the design flood. In the case of a grassed surface, the hydraulic roughness depends upon the physical characteristics of the grass sward such as its height, stiffness and density, and its interaction with the flow. This interaction can be divided into three basic regimes (Hewlett, Boorman, and Bramley 1987) as shown schematically in Figure 5.

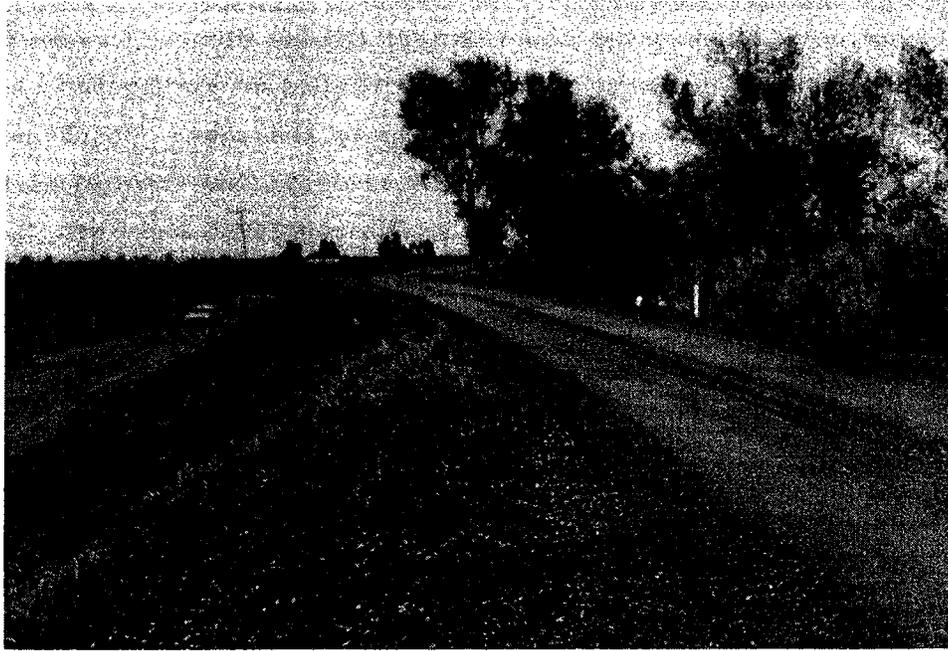
Figure 7. General view of levee at study site showing vegetation growing on riverward side and burned-over slope on landward side

58. The levee embankment is composed primarily of sandy soils which support mature, 30+-year-old cottonwoods and valley oaks. Black locust, shrubby willows, wild rose, and poison oak make up the balance of the woody plant community growing on the levee. Burning is used to maintain the levee vegetation at its current levels. The fire environment can significantly modify or change levee vegetation. Unfortunately, reliable information on the frequency and timing of burning was not readily available. Only limited information was gathered about the extent to which past burning practices might have altered the vegetative spectrum and other conditions, e.g., root structure and distribution, relative to that which would exist under natural succession. California ground squirrel burrows are ubiquitous in the levee. A general view of the levee illustrating some of the aforementioned features is shown in Figure 7.

59. The steeper, xeric landward slope of the levee generally faces to the west and receives not only the afternoon sun but also the force of occasional strong winds. Additionally, this face of the levee is burned annually to help prevent field fires (see Figure 7). Little grew in this harsh

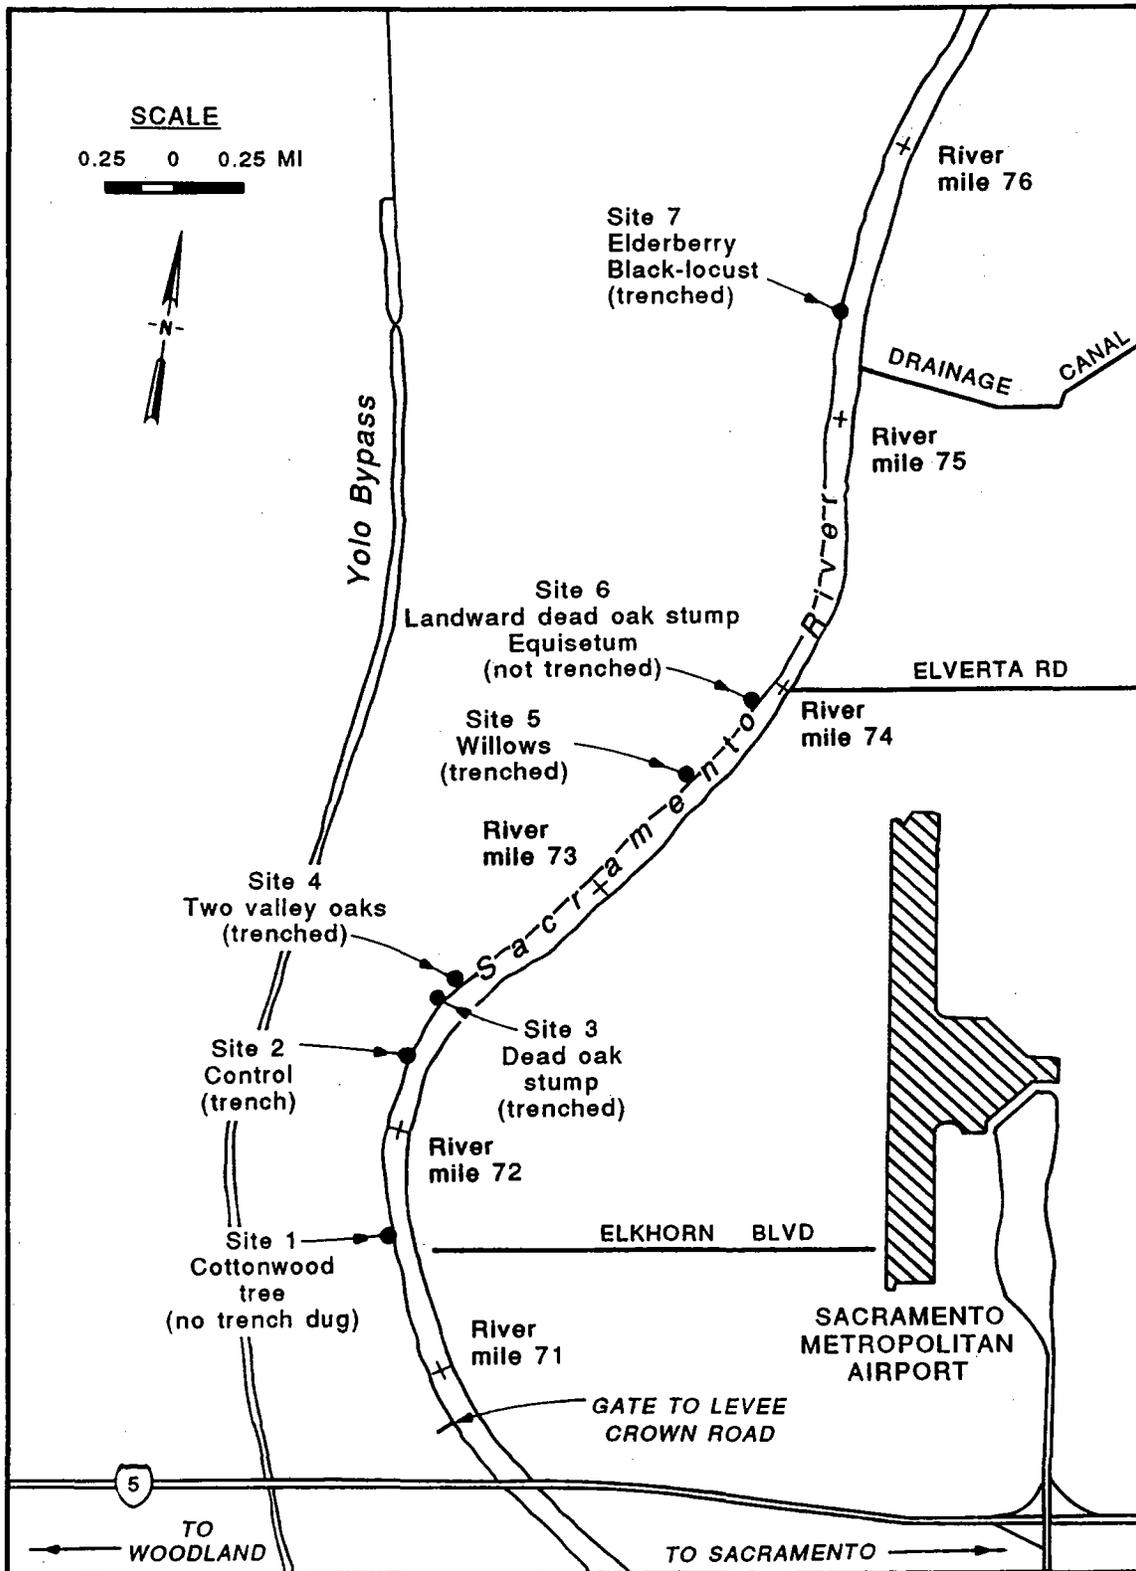
Figure 8. Location of trench sites for determination of root and biopore distribution associated with different types of vegetation

63. The distribution of roots and biopores at various locations in the levee was determined using an adaptation of the profile-wall method (Bohm 1979). This method requires the excavation of a narrow trench in order to expose and map roots, pedotubules, conduits, and other inclusions that intersect the vertical face of the trench. The trench sites were selected so that the root architecture and distribution of the principal woody species of interest growing on the levee could be mapped. Each trench site was located in an area dominated by the following woody species: live and dead valley oaks (*Quercus lobata*) willow (*Salix hindsiana*) elderberry (*Sambucus mexicana*), and black locust (*Robinia pseudoacacia*). In addition a control site consisting of herbaceous cover and low shrubs was also trenched. A total of seven sites were thus identified and selected for trenching; their location is noted on Figure 8. Site No. 1 (cottonwood) was not trenched simply because of time limitations.

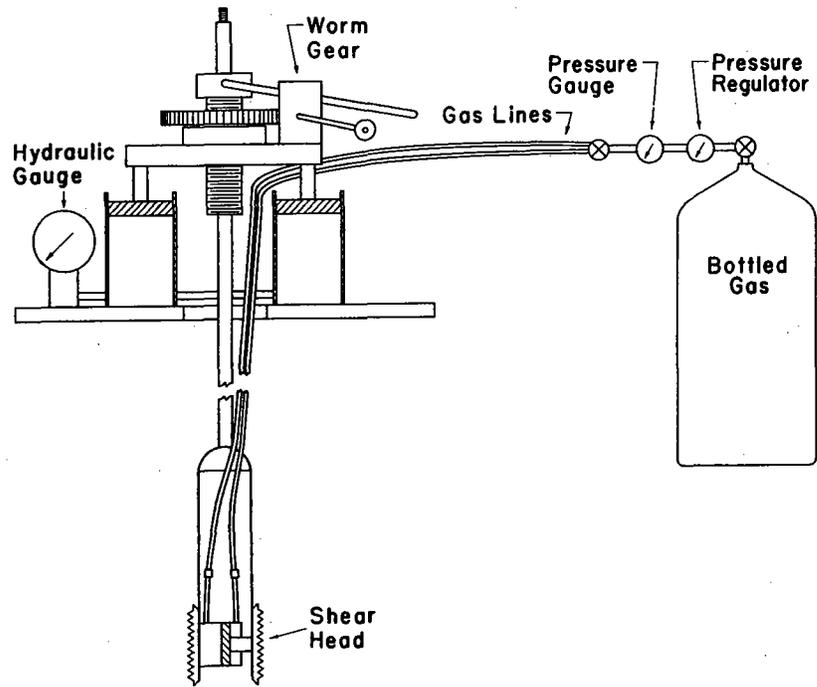
PULLING DEVICE

CONSOLE

Figure 10. Schematic illustration of Iowa borehole direct shear device (from Wineland 1975)

borehole, direct shear device (Wineland 1975; Handy 1986). Shear strength can be determined rapidly as a function of depth with this device without the need to obtain samples. The borehole shear test consists of augering a pilot hole and then reaming to a diameter of 3 in. in order to create a borehole with smooth sides. A small pneumatic piston with serrated shearing heads at either end is then lowered down the borehole to the depth of interest. The serrated heads are next expanded out against the sides of the hole with a known normal stress. After an appropriate consolidation interval, the heads are pulled up the hole, thus creating a shearing stress. The tangential or shearing stress is recorded by means of a force platform at the surface which transfers the tensile force in the pulling rods to hydraulic cells which record the shearing stress at the serrated heads in the borehole as shown schematically in Figure 10. A photograph of a borehole shear test set up at a levee site is shown in Figure 11.

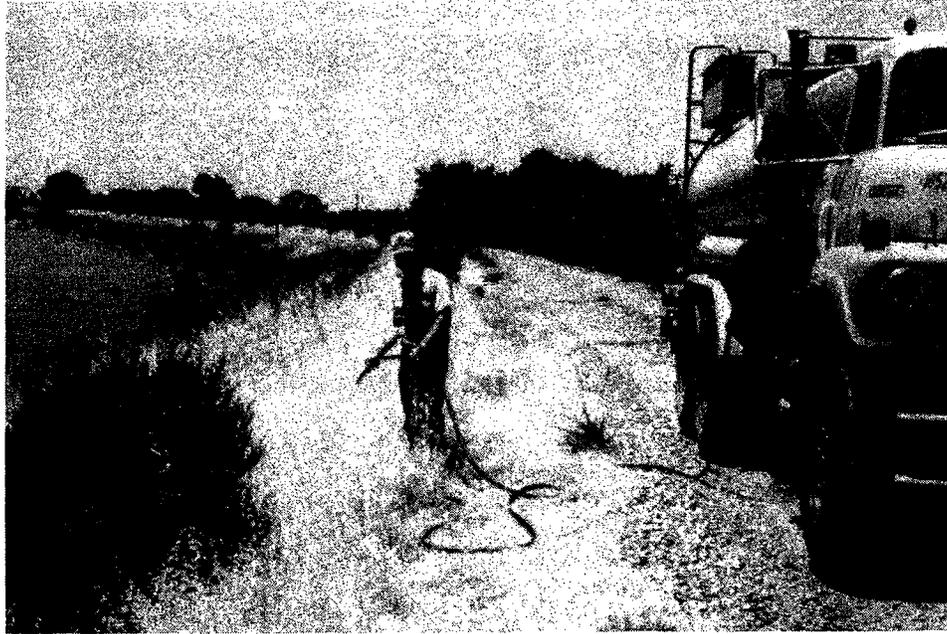
Figure 12. Watering truck and spray hose employed to wet site prior to excavation

76. Because of the loose, sandy nature of the levee soils it was necessary to water the site before excavation could proceed. Watering developed sufficient capillary cohesion in the soil to permit trenching without collapse of the vertical face of the trench. An 8,000-gal watering truck and spray hose (see Figure 12) were employed for this purpose. The live oak site required four truckloads of water before sufficient capillary cohesion developed over the entire trench site.

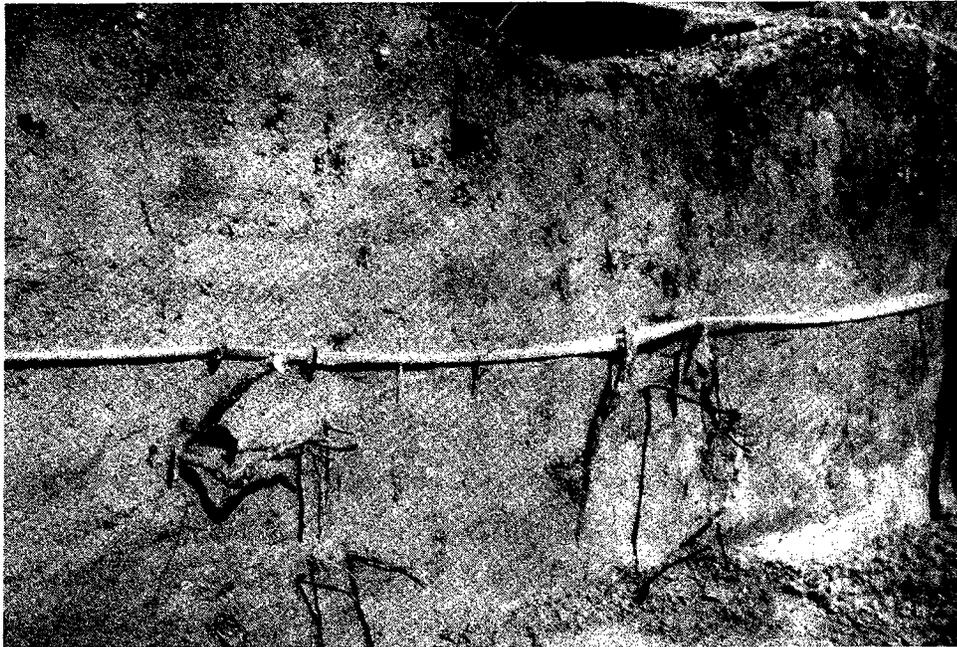
Figure 14. View of trench showing vertical mapping face and roots protruding from trench sides (burrow is visible in upper center of photo)

78. After the backhoe work, the soil along the trench sides was trimmed back to the mapping face using hand tools. A square-nosed shovel was used for rough trimming followed by smoothing with a mason's trowel. Roots were cut back to the finished face with either a pruning saw or shears. Mist spraying was employed periodically to keep the face moist and to prevent sloughing or ravelling. Hand trimming was done in two stages. The upper half of the trench was finished first, leaving a ledge on which to rest the mapping apparatus. General views of the trench layout and finishing operations prior to mapping are shown in Figures 13 and 14.

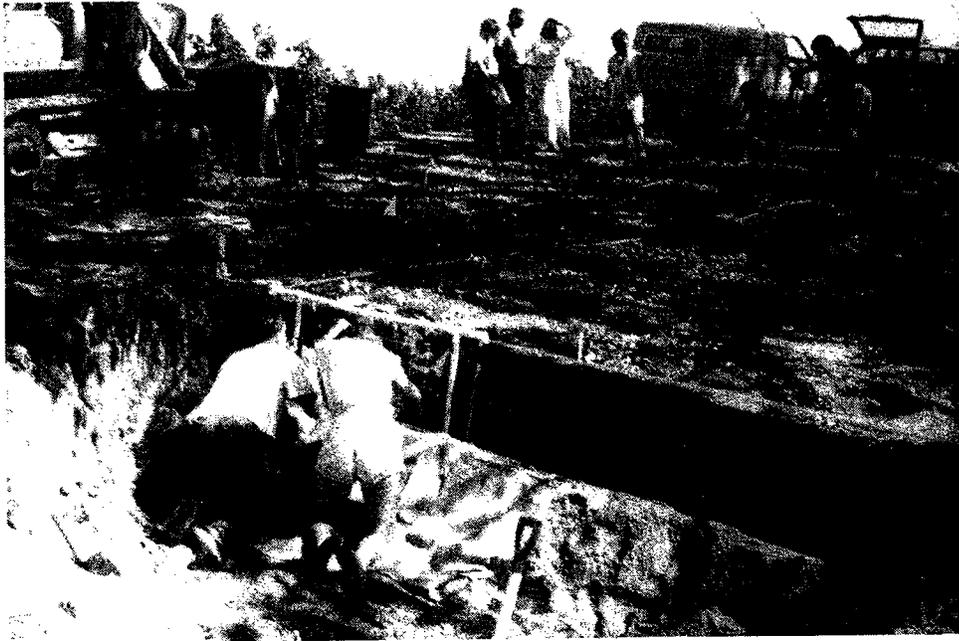
Figure 15. Mapping in progress along upper half of trench face at valley oak site (mapping frame is resting on mid-height ledge)

features mapped directly on the acetate. Mapping was done along the upper half of the trench by successively moving the frame along the ledge and advancing the acetate roll to a new position. After the upper half was mapped, the ledge at midheight was trimmed away, and the bottom half mapped in a similar fashion. Views of a mapping operation in progress are shown in Figures 15 and 16.

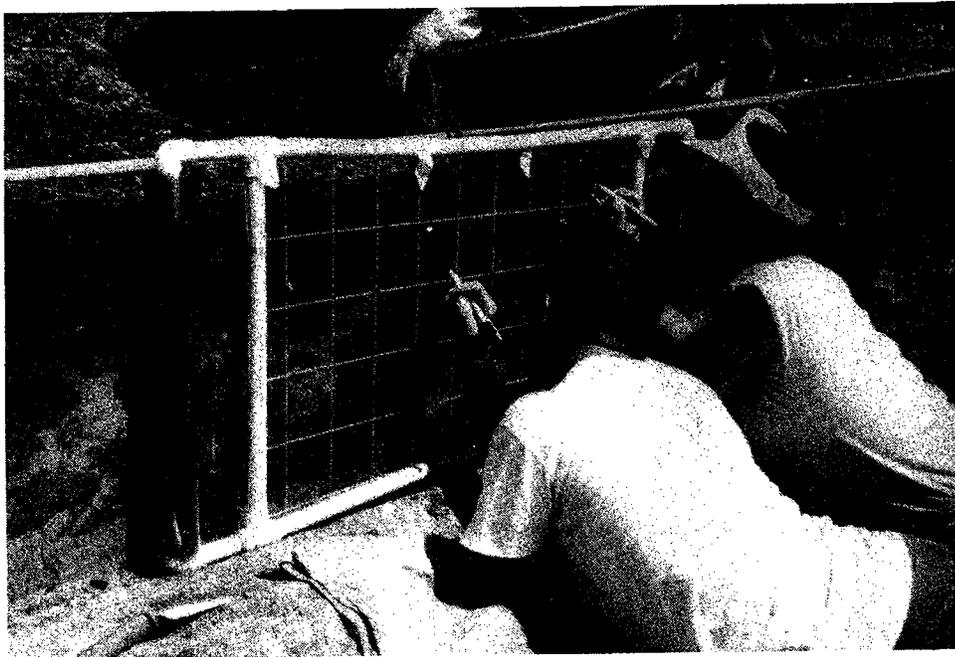
Figure 16. Closeup view of mapping frame showing acetate sheet, take-up and supply holders, and string grid

79. Mapping procedure. The roots were mapped on an acetate overlay held on a portable PVC mapping frame. The tubular frames were rectangular in shape with a mapping area 1.0 m by 0.5 m. Strings were strung across the frame on a 10-cm grid spacing. The string grid greatly facilitated keeping track of features as they were mapped and also maintaining correct placement of the mapping frame. Removable holders were placed at each end of the frame for both take-up and supply of the acetate rolls. The frames were pressed against the smoothed, vertical face of the trench, and roots plus other

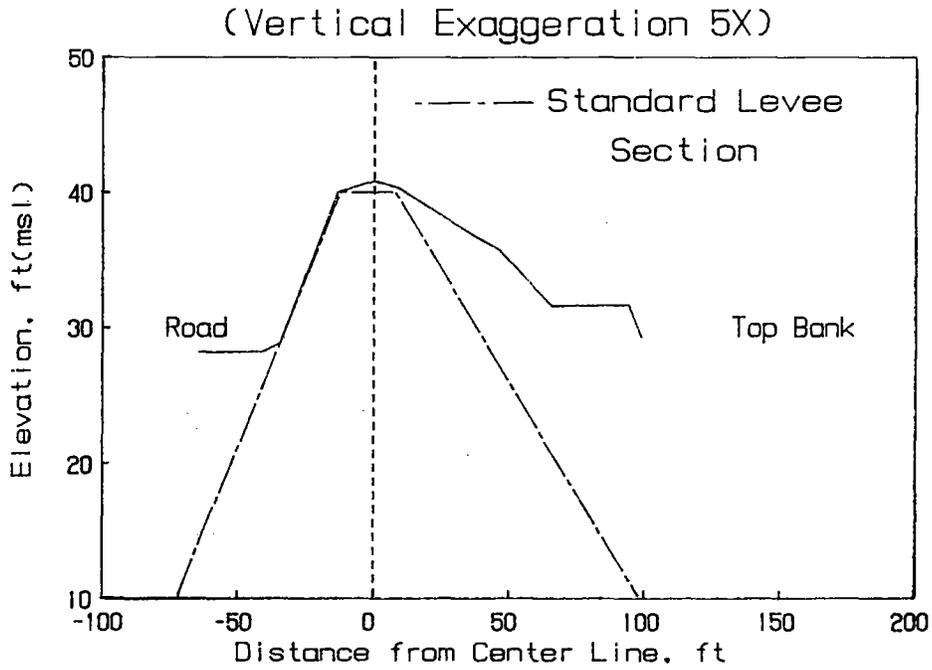
Figure 17. Levee cross-section profile, control site (site 2)

83. Levee cross sections surveyed at each of the trench sites are shown in Figures 17 through 20. The standard levee section is superimposed on these diagrams for comparison. In general the actual cross sections closely matched the standard section. In some locations, e.g., sites 2-4, the riverward slope is less steep than the standard 3:1 slope. A relatively flat terrace of varying width separated the riverward toe of the levee from the top of the riverbank.

119. Standardized levee geometry. A standardized levee profile or geometry was adopted for the seepage analyses, as shown in Figure 52. The same side slopes and crest width specified in the standard levee sections shown in Figures 17 through 20 were retained for the seepage analyses. The embankment height was set at 20 ft. A 20-ft levee height with the use of 1-ft nodal spacings facilitated calculations in the seepage simulation. The actual

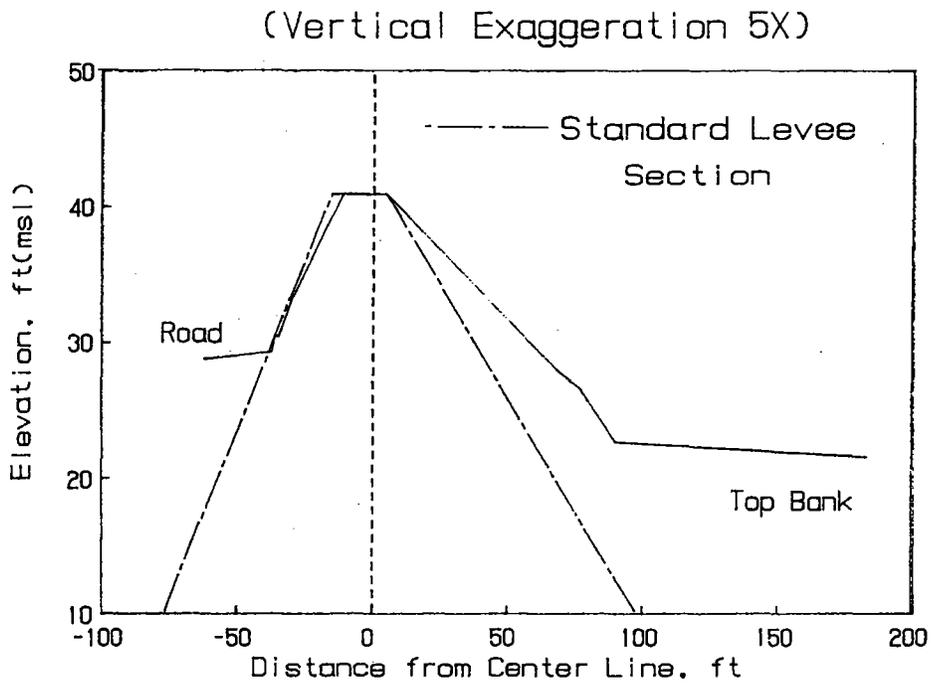
Figure 18. Levee cross-section profile, live oak site (site 4)

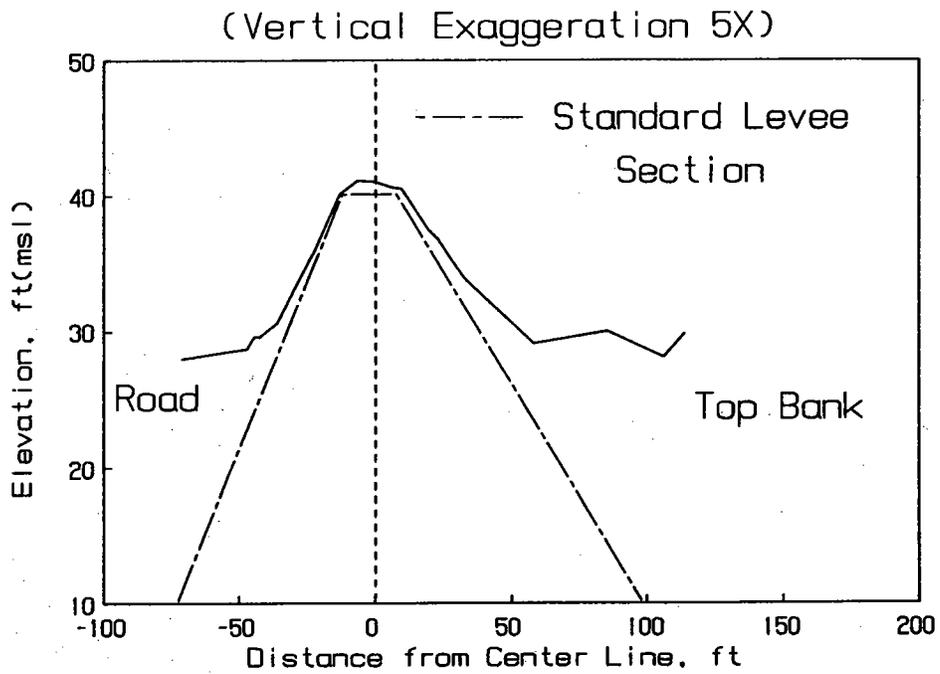
Figure 19. Levee cross-section profile, willow site (site 5)

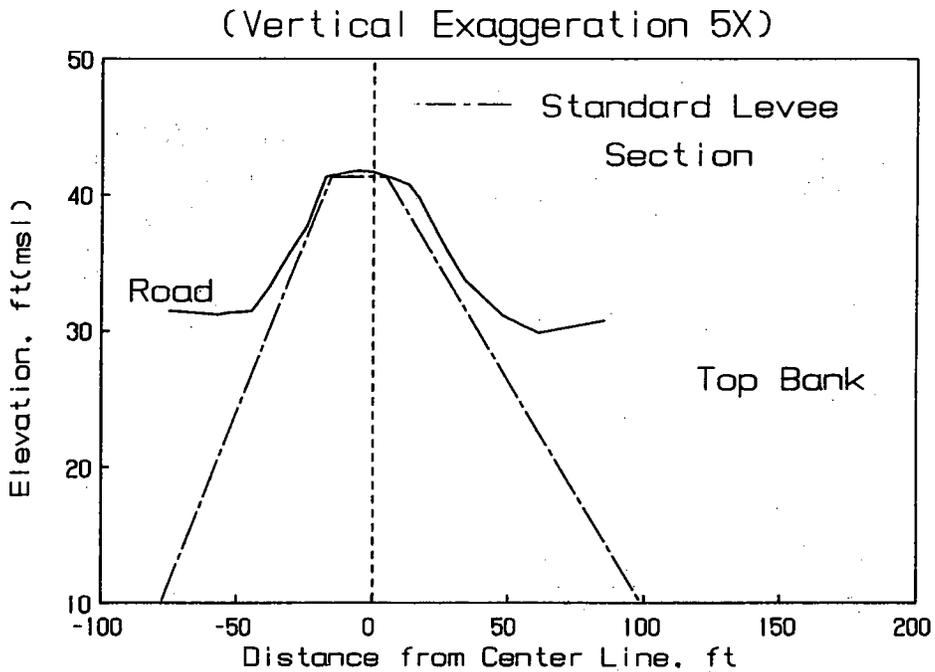
Figure 20. Levee cross-section profile, elderberry site (site 7)

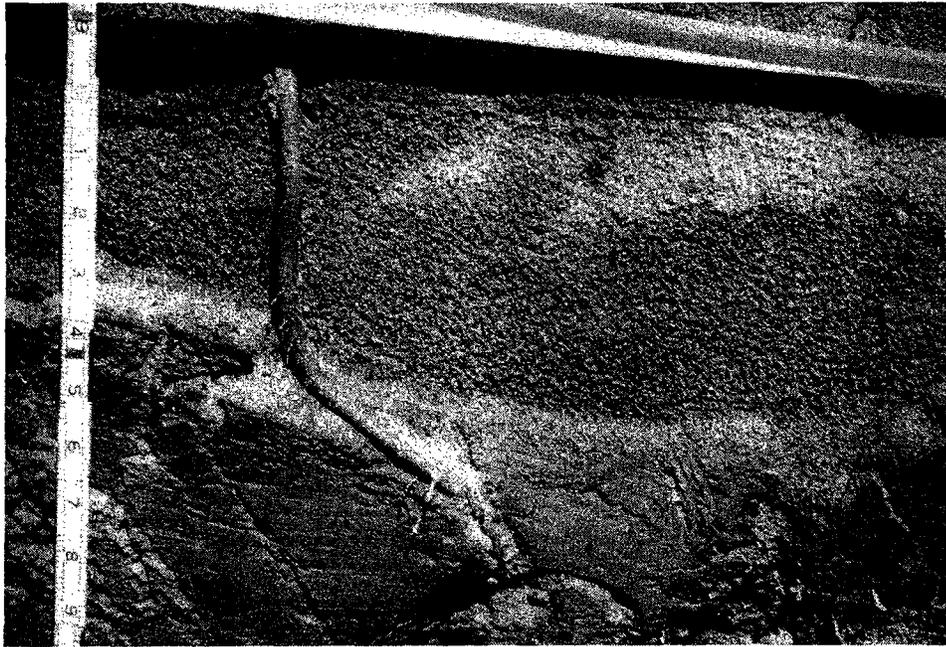
Figure 21. Fissure in large clay clod or inclusion that has been permeated by a tree root

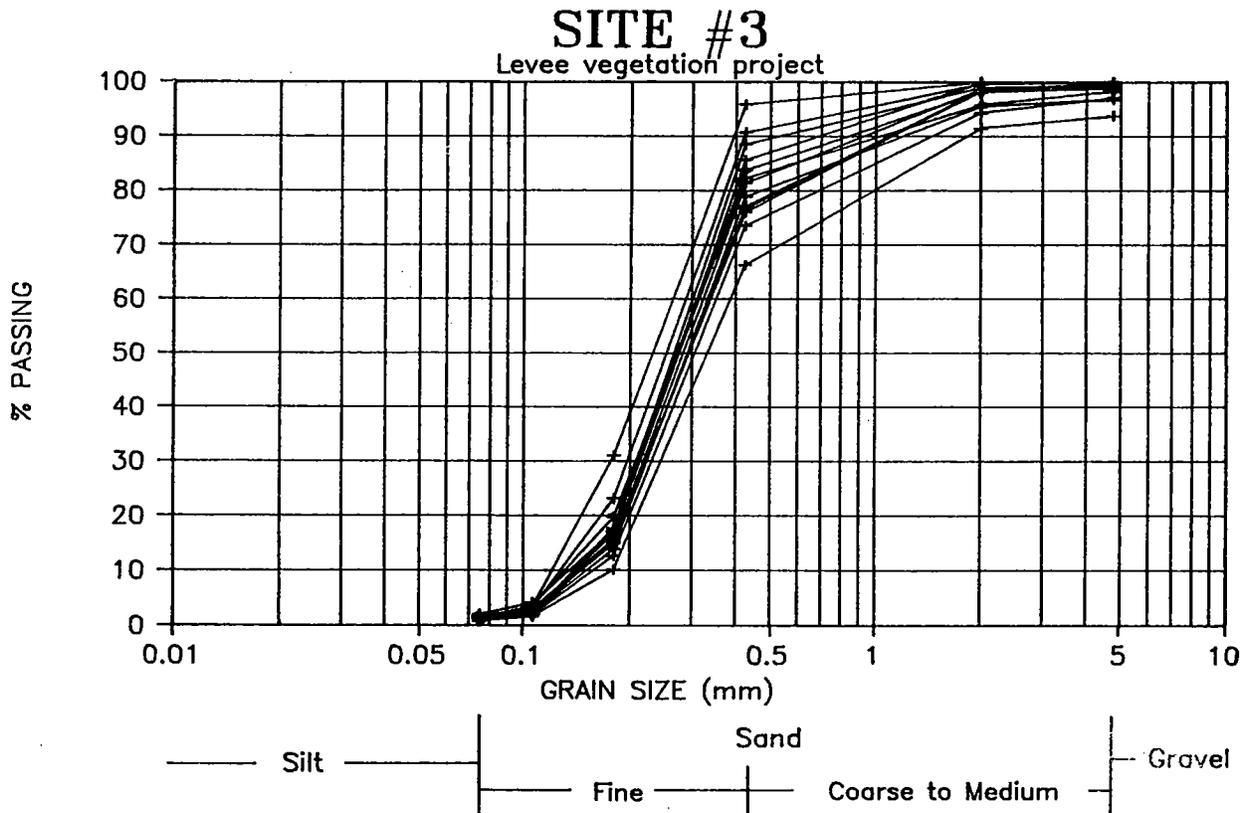
The Unified Soil Classification system designation for the levee soil is SP. The gradation curves shown in Figure 23 for samples from site 3 are typical.

Figure 23. Grain size distribution curves for levee samples from site 3 (samples obtained from different boring locations and depths at site)

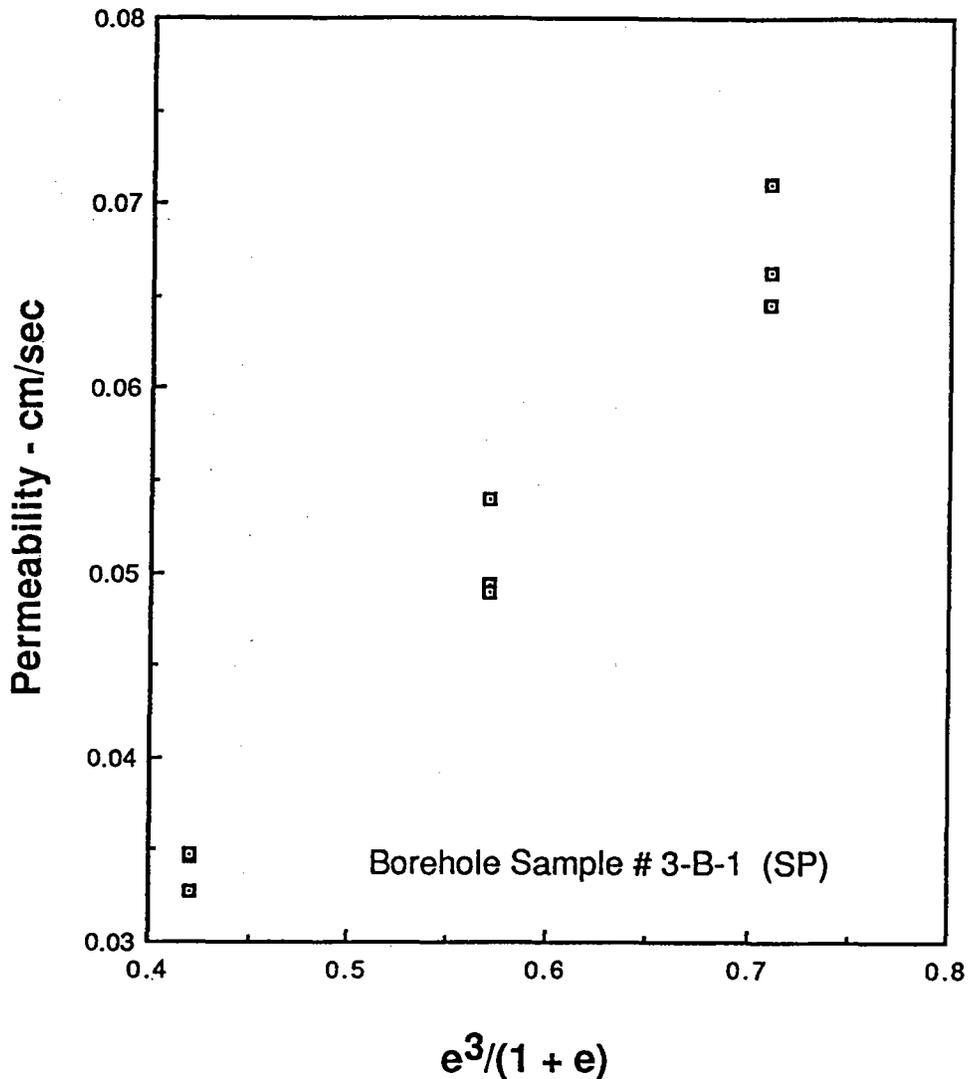
Figure 24. Typical functional relationship between permeability and void ratio for sandy levee samples

87. Permeability. The permeability of selected reconstituted samples of dry, sandy levee soil was determined using a gas permeameter. The permeability ranged from 0.03 to 0.07 cm/sec depending upon the void ratio. This permeability range is typical for a medium sand, and is consistent with the results of the gradation analyses. The sandy soil obeyed the Kozeny-Karman equation which predicts a linear relation between permeability ( $K$ ) and  $(e^3/1+e)$ ; where  $e$  is the void ratio. This functional relationship is shown plotted in Figure 24 for one of the samples that was tested.

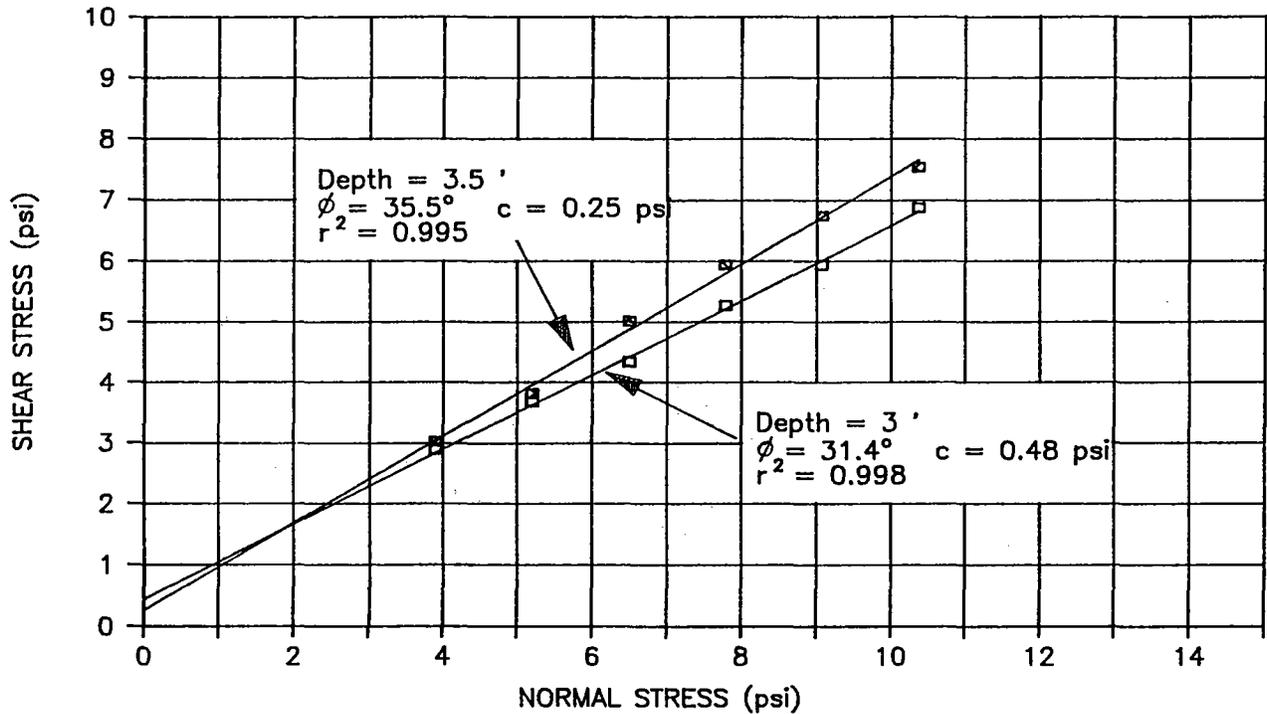
Figure 25. Example of failure envelopes obtained from Iowa borehole shear test borings at site 3

hole, direct shear device. Failure envelopes were obtained rapidly as a function of depth and checked on site. Typical failure envelopes for two depths in a test boring at Site 3 are shown in Figure 25.

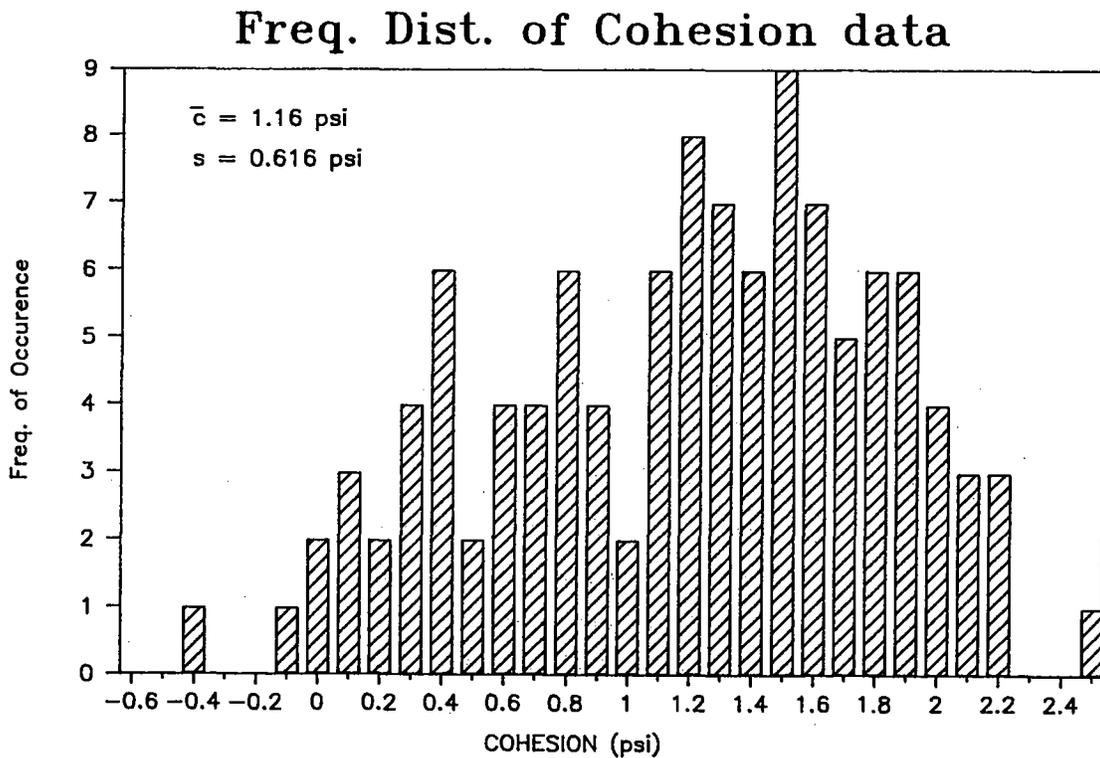
Figure 26. Frequency distribution of cohesion values obtained from all borehole shear test borings

89. The frequency distribution for both the cohesion and friction values from all borings are shown in Figures 26 and 27, respectively. The averages of all borings on the levee are:

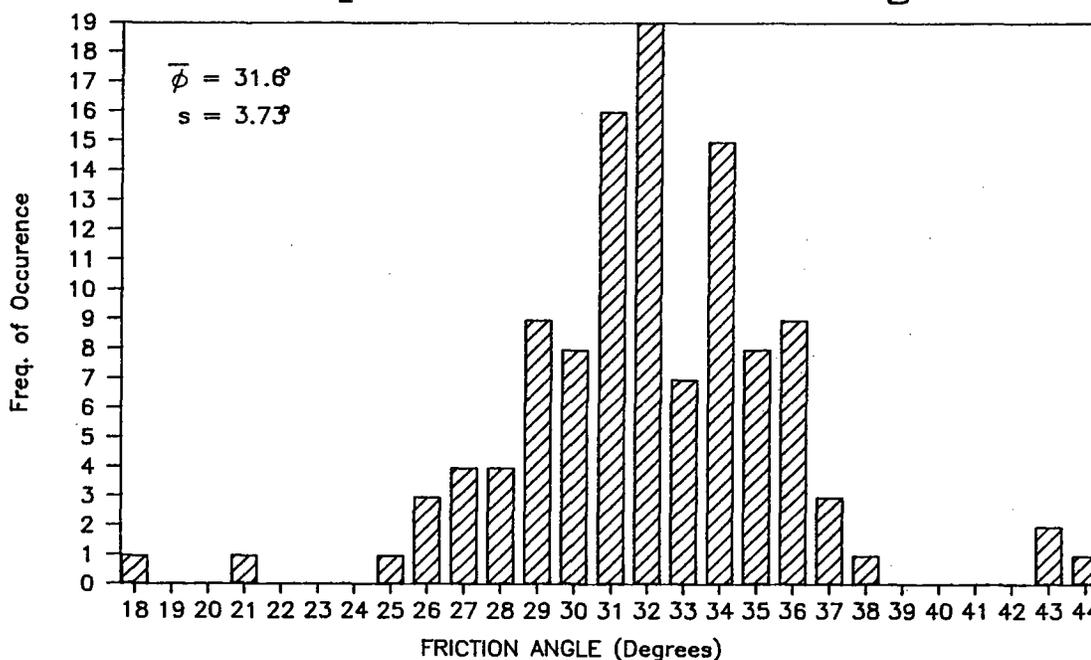
Figure 27. Frequency distribution of friction values obtained from all borehole shear test borings

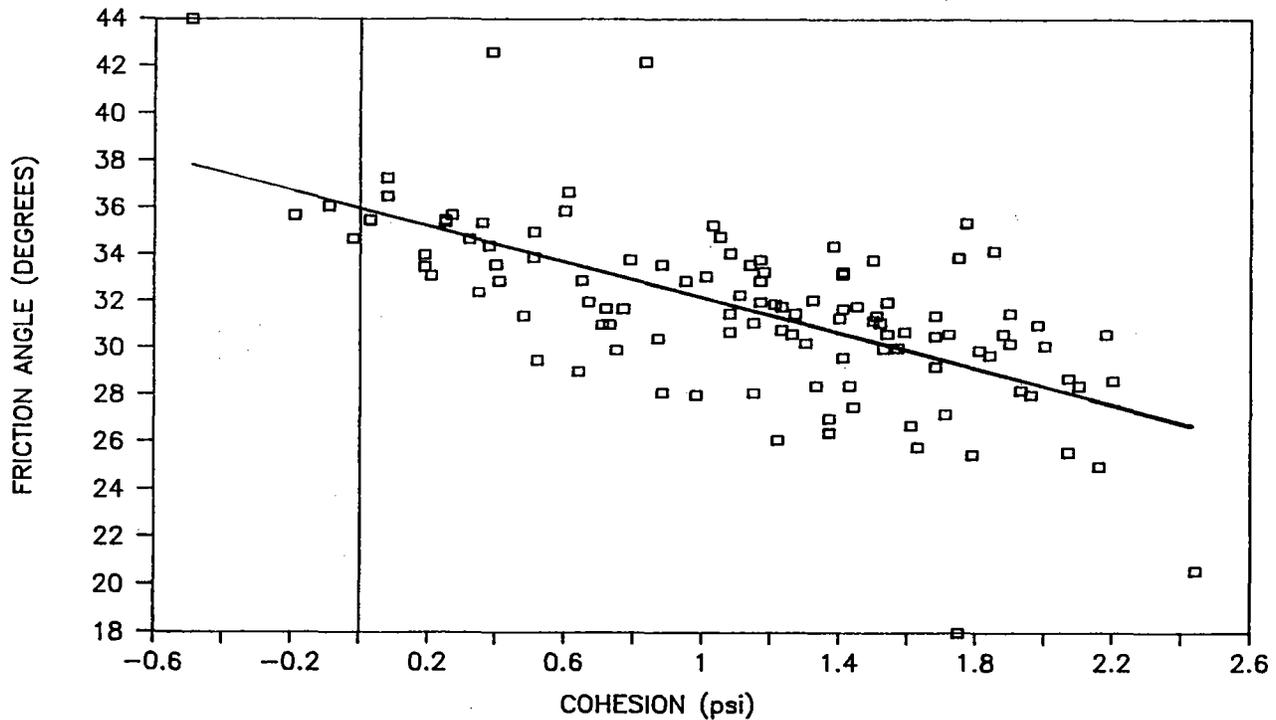
Figure 28. Friction vs. cohesion results for all test borings showing best-fit linear regression curve

general higher values of friction were observed where cohesion was low and vice versa. A plot of friction versus cohesion for all results (test borings) is shown in Figure 28. A linear regression analysis ( $R = 0.645$ ) of this data yielded the following relationship.
