# REPAIR, EVALUATION, MAINTENANCE, AND REHABILITATION RESEARCH PROGRAM

TECHNICAL REPORT REMR-EI-5

## THE EFFECTS OF VEGETATION ON THE STRUCTURAL INTEGRITY OF SANDY LEVEES

Final Report

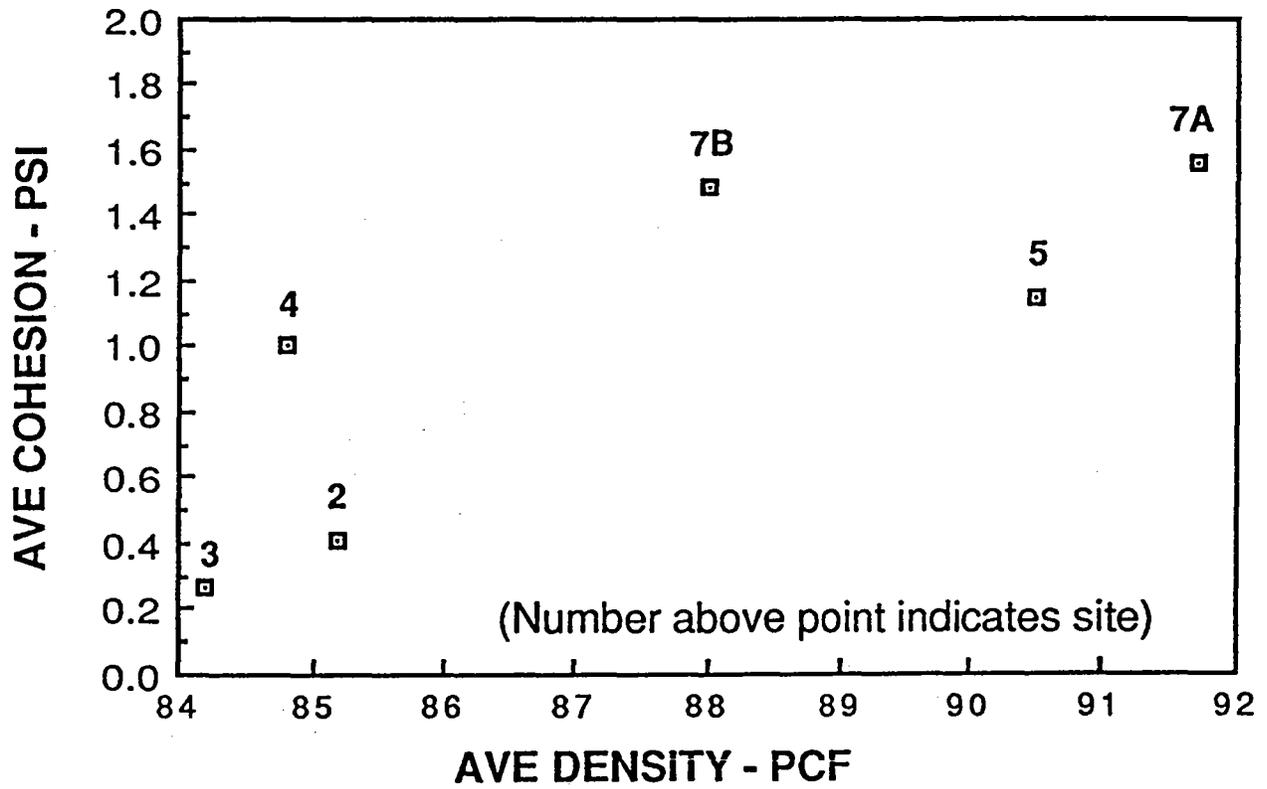
Figure 29. Average site cohesion versus average site soil density for in situ levee soils

90. High cohesion values were associated with soil samples having a higher content of fines. As noted previously, these same samples also tended to have higher densities. Not surprisingly, therefore, a correlation was also observed between average site cohesion and average site density. Cohesion increases with increasing density as shown in Figure 29. The number above each point in the plot corresponds to the site number. The sites with large amounts of fines (sites 5, 7A, and 7B) exhibit the highest cohesion and soil density, whereas sites with lesser amounts of fines (sites 2, 3, and 4) have lower cohesions and densities.

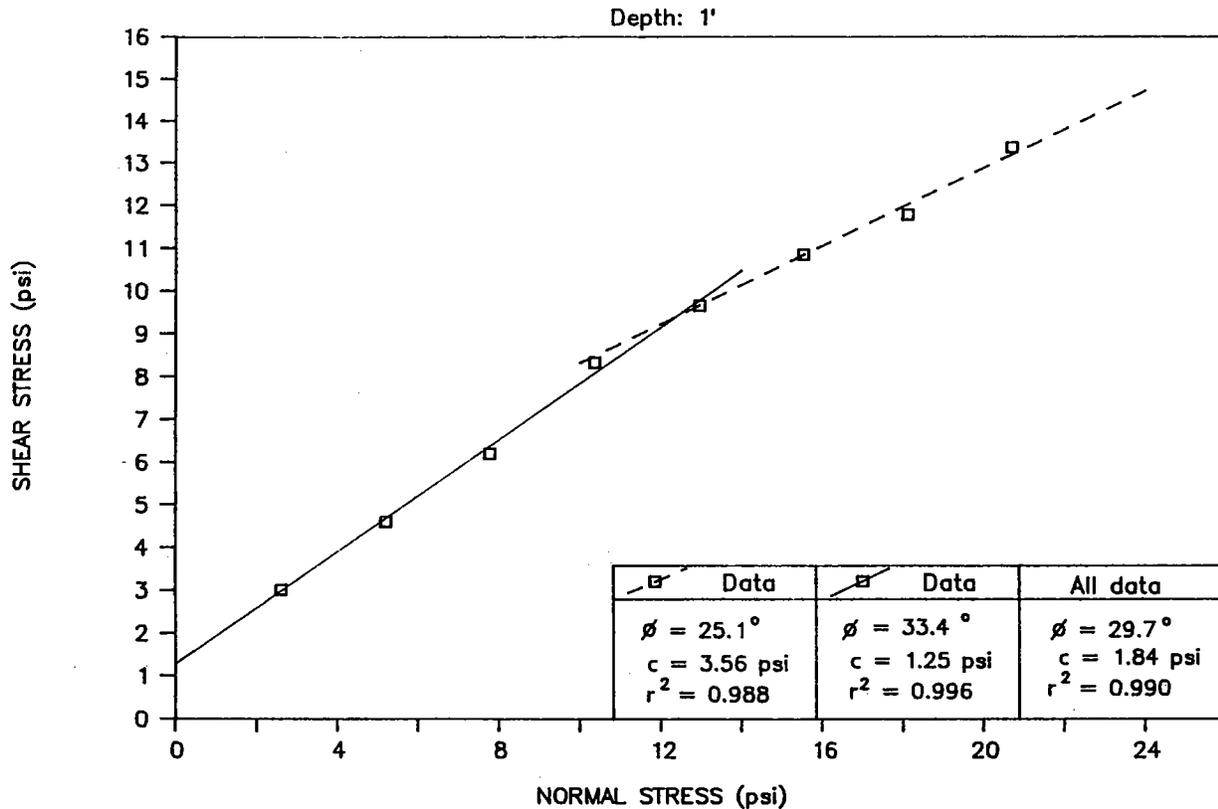
Figure 31. Bilinear failure envelope obtained in borehole shear test at site 4

91. Some evidence of root reinforcement was observed in the failure envelopes of a few test borings using the bore hole shear device. A photograph of a test boring site illustrating the extent of root permeation around the former bore hole is shown in Figure 30. The Iowa bore hole shear device is not ideally suited or designed to detect and measure root reinforcement influences on shear strength because the roots no longer penetrate fully across the failure surface after boring and reaming a hole to accommodate the shear head. Nevertheless, root/fiber reinforcement effects still manifested themselves in the form of bilinear or curved-linear failure envelopes in some instances, as illustrated in Figure 31. A distinct bilinear failure envelope was observed at a depth of 1 ft at this location (site 4).

92. Bilinear or curved-linear failure envelopes are typical of fiber reinforced sands as demonstrated by the work of Gray and Al-Refaei (1986); Gray and Maher (1989). Their work indicated that failure envelopes become strongly bilinear, as opposed to curved-linear, as the gradation and angularity of soil particles increase. The vertical displacement of the failure envelope above the reference or unreinforced envelope can be interpreted as a

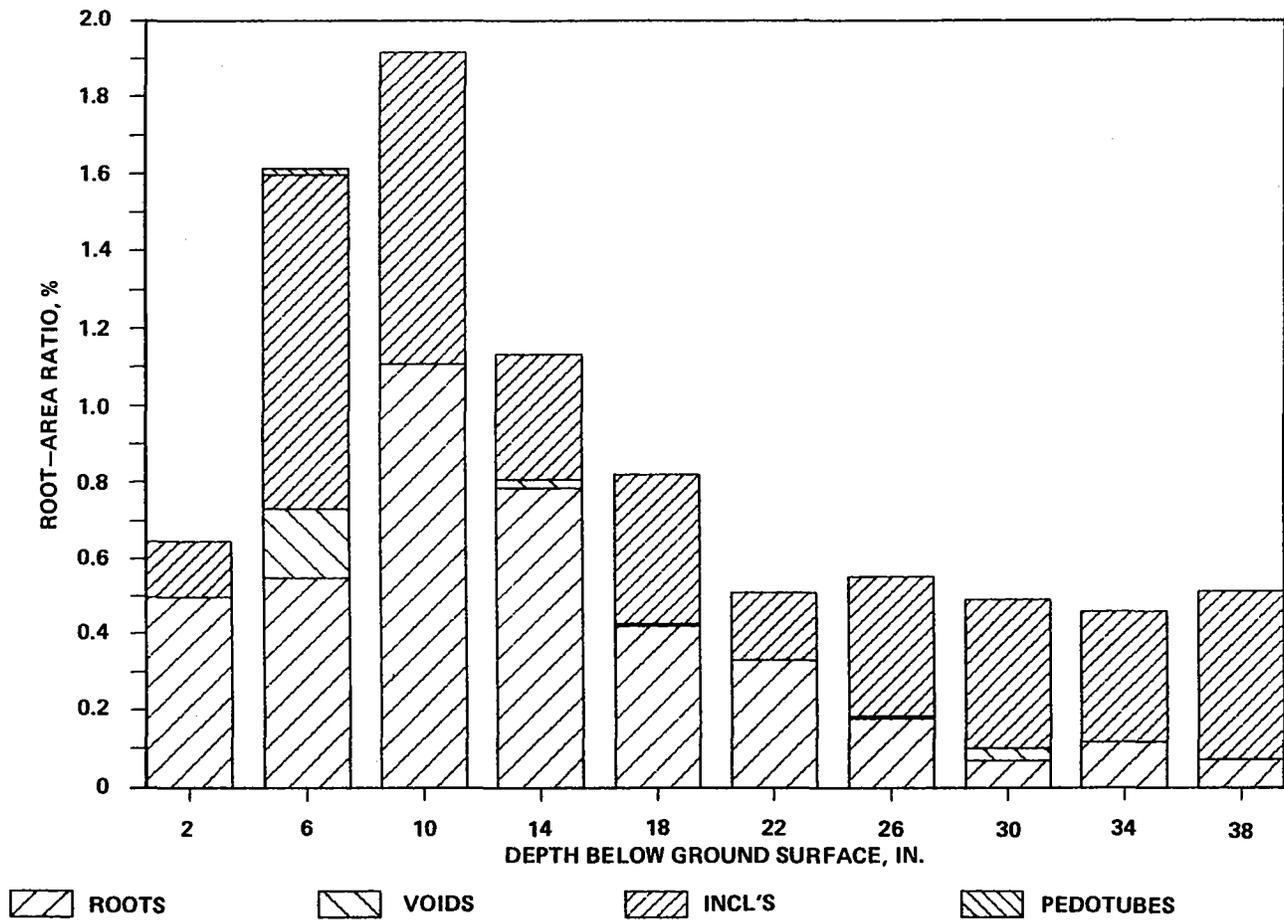
Figure 32. Total area ratio vs. depth, perpendicular trench, elderberry site (site 7)

97. Total area ratio profiles. The belowground mapping results are presented in several ways. Histograms or frequency distributions of all mapped features (roots, voids, pedotubules, and mineral inclusions) were prepared from the acetate overlay used in the field mapping program. The occurrence of these features is reported as an "area ratio," i.e., the percent of the trench face or cross-sectional area occupied by a particular feature. Typical histograms for the perpendicular and parallel trenches, respectively, showing the area ratios for different features as a function of depth at the elderberry site (site 7) are shown in Figures 32 and 33. Total area ratio histograms for the other sites are collected in Appendix A. An area ratio histogram for all features and depths as a function of position along the trench in the perpendicular trench arm at the elderberry site is shown in Figure 34. The bulge or peak in the histogram at mid-distance simply reflects the proximity of the plant stems at this position and the greater concentration of roots close to the stems.

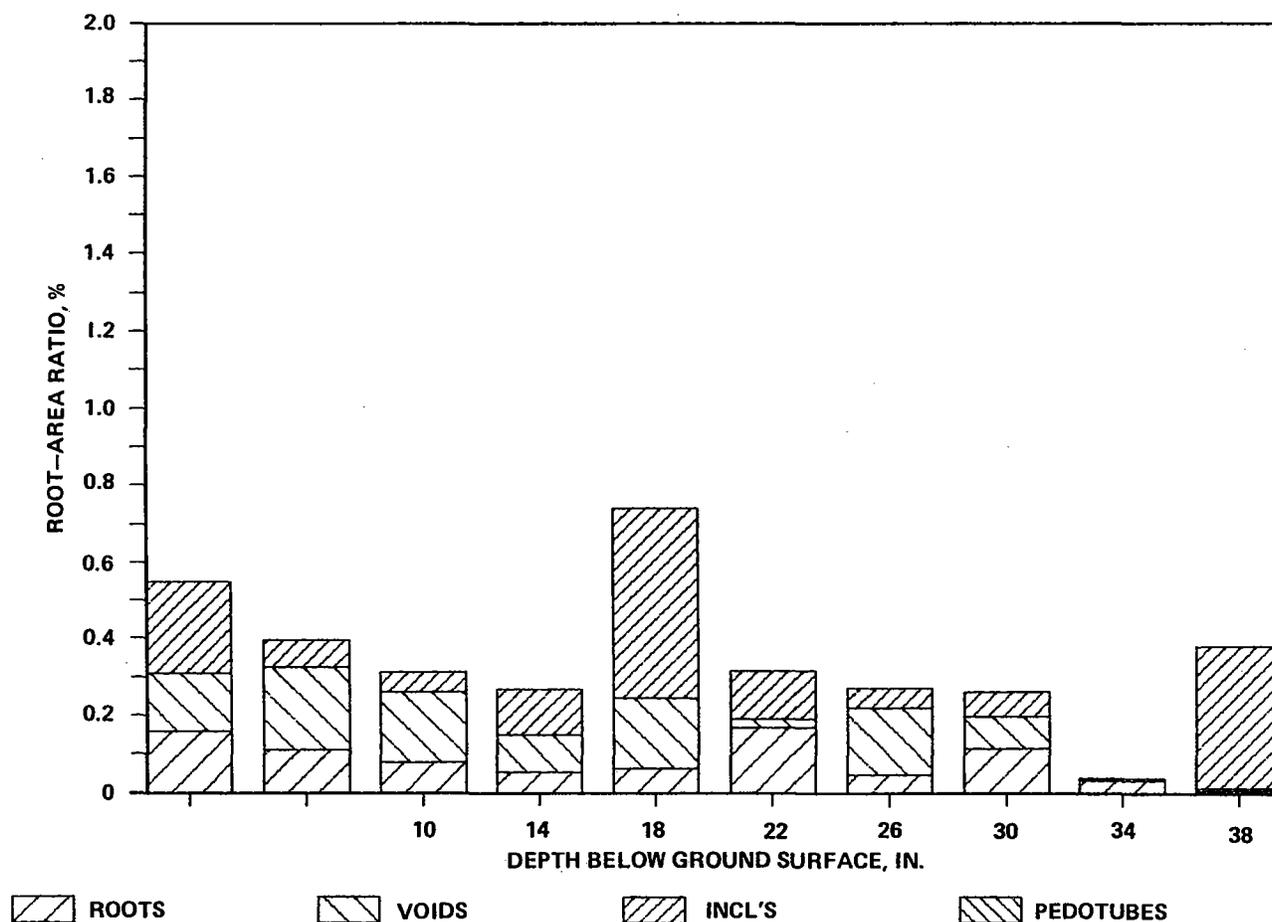
Figure 33. Total area ratio vs. depth, parallel trench, elderberry site (site 7)

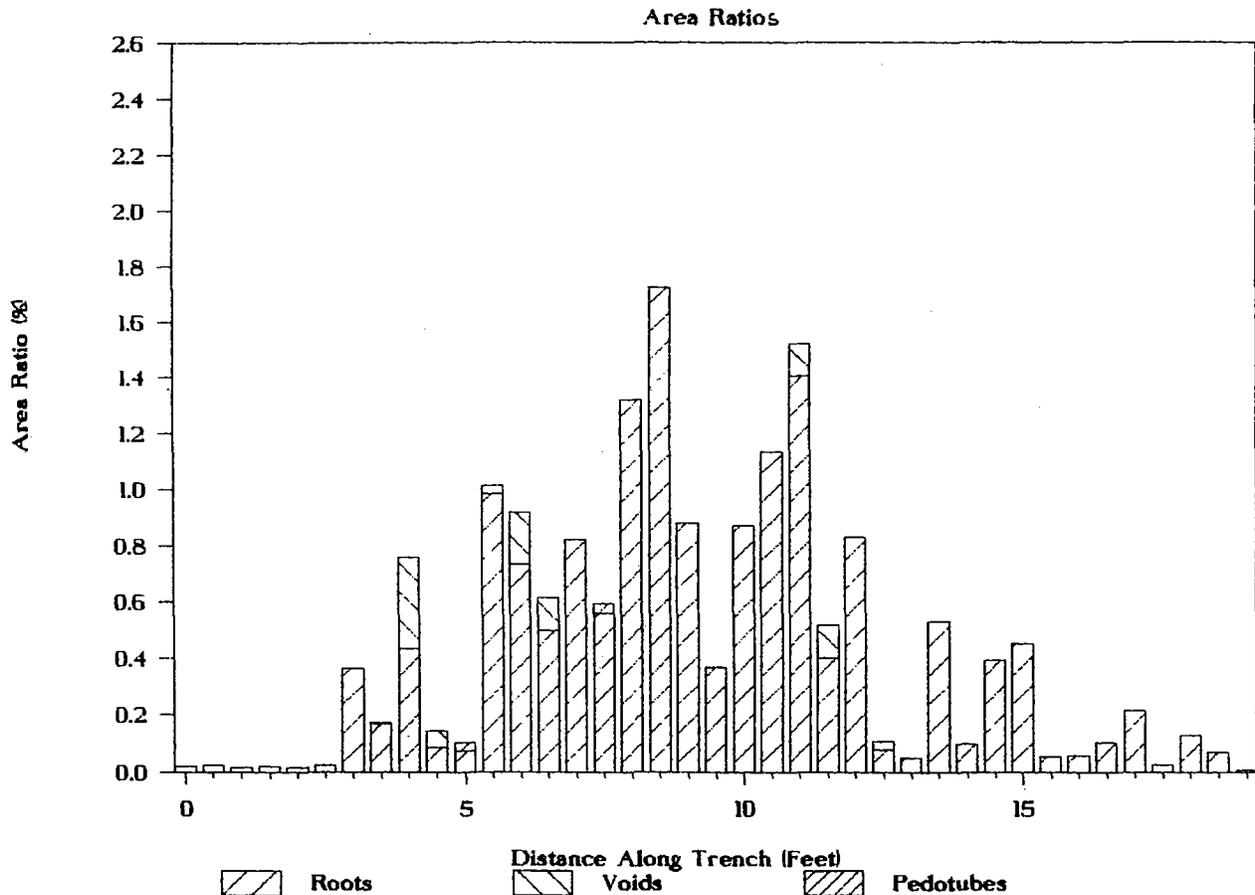
Figure 34. Total area ratio versus distance along trench, all depths, perpendicular trench, elderberry site

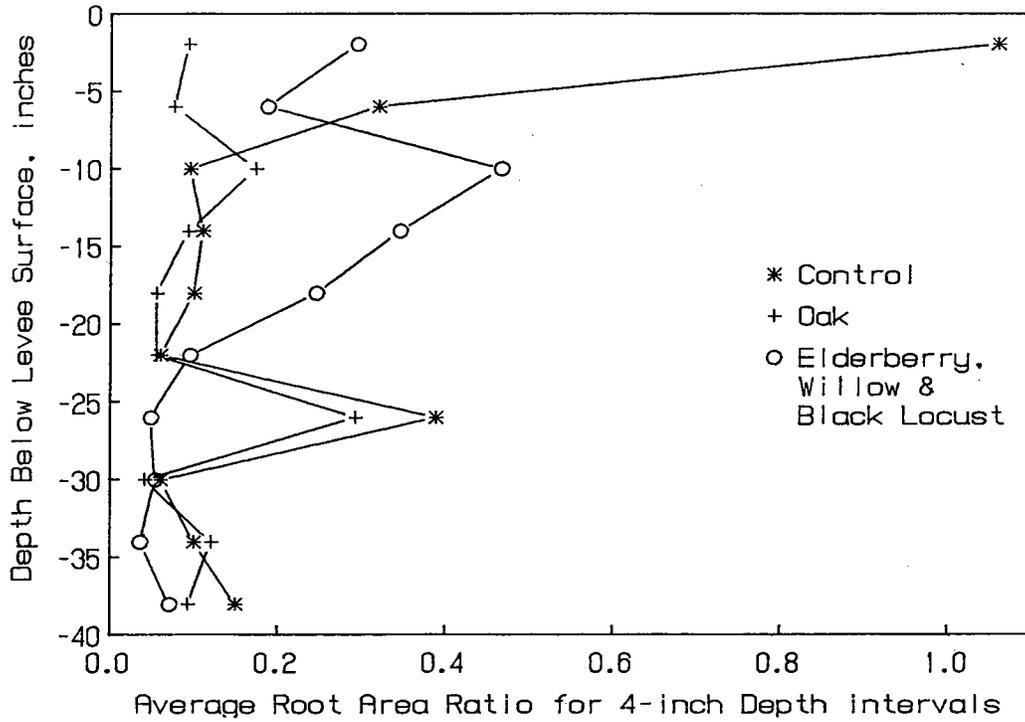
Figure 35. Average RAR profiles for control, oak and elderberry/willow/black locust trench sites

99. The RARs tended to decrease with depth in nearly every case. This trend is shown in Figures 35 through 37. Average RAR versus depth is shown in Figure 35 for the control, oak, and elderberry/willow/black locust sites.

123. The impact of a modified surface layer or "skin" on either the riverward or landward slope with a different hydraulic conductivity ( $K_1$ ) than the central core of the levee ( $K_2$ ) was modelled by replacing the surface of a homogeneous levee with a 1-ft-thick modified layer. Most of the root biomass of plants is located very close to the surface, as shown in Figures 35 to 38.

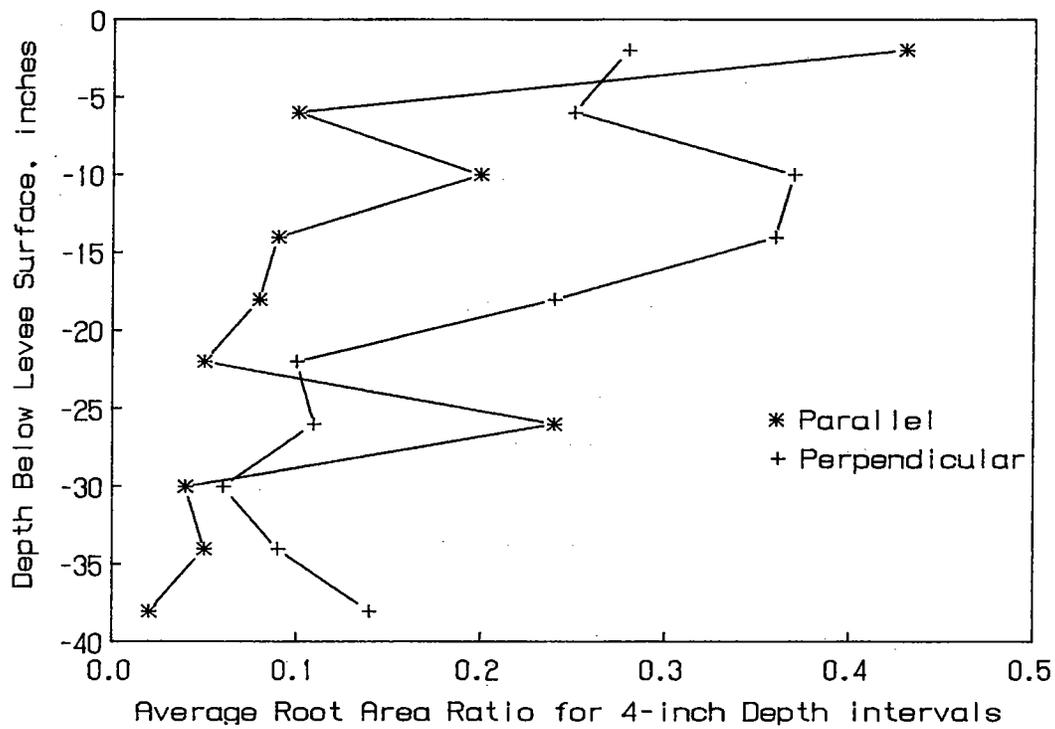
Figure 36. Average RAR profiles for parallel and perpendicular trenches, all sites, arithmetic scale

Figures 36 and 37 show RAR-depth profiles for all sites (species) plotted on arithmetic and logarithmic scales, respectively. Average RARs decreased to less than 0.1 percent in all cases at depths greater than 40 in. These root distributions and concentrations are consistent with trends and values reported in the horticultural literature. A plot of RAR versus depth for the elderberry site at the parallel and perpendicular mapping trenches is shown in Figure 38. Root concentrations decreased approximately exponentially with depth at the perpendicular trench which passed close to the centers of the stems, whereas root concentrations tended to decrease linearly with depth in the parallel trench which was located at the drip line of the bushes. These root distributions were used later to estimate likely rooting contributions to shear strength.

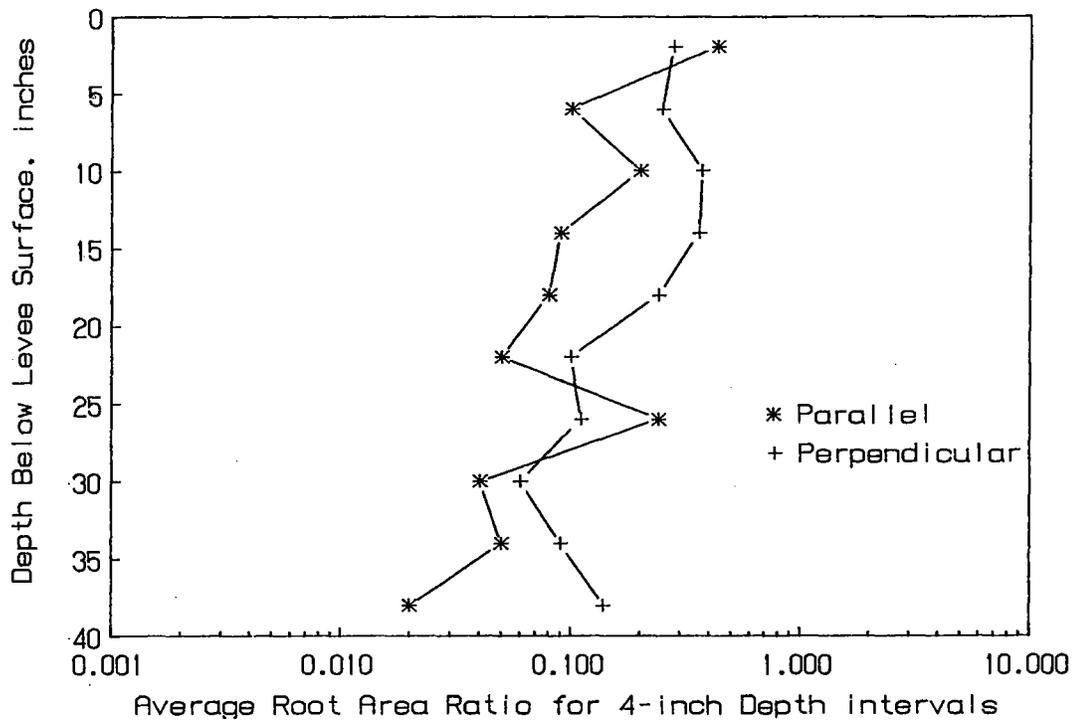
Figure 37. Average RAR profiles for parallel and perpendicular trenches, all sites, logarithmic scale

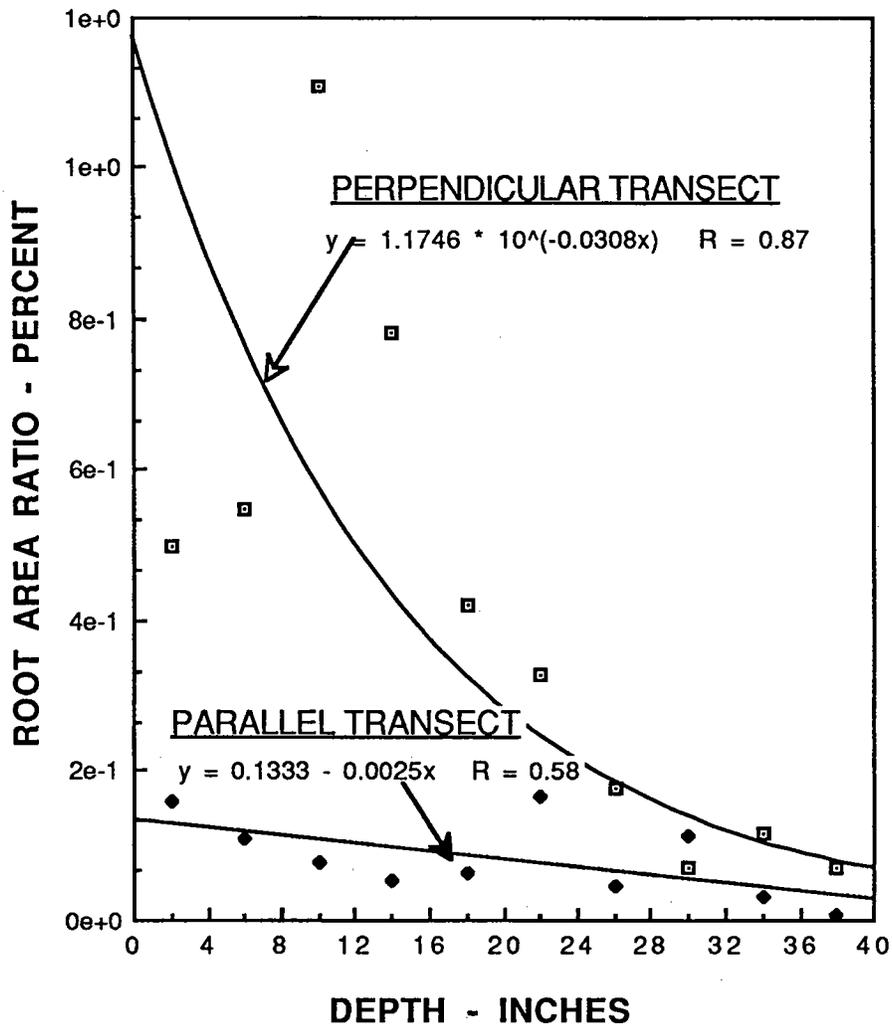
Figure 38. Functional relationship between RAR and depth in perpendicular and parallel transects, respectively, elderberry site (site 7)

141. RAR-versus-depth curves shown in Figure 38 for the elderberry site were used to estimate the likely root cohesion ( $c_R$ ) as a function of depth.

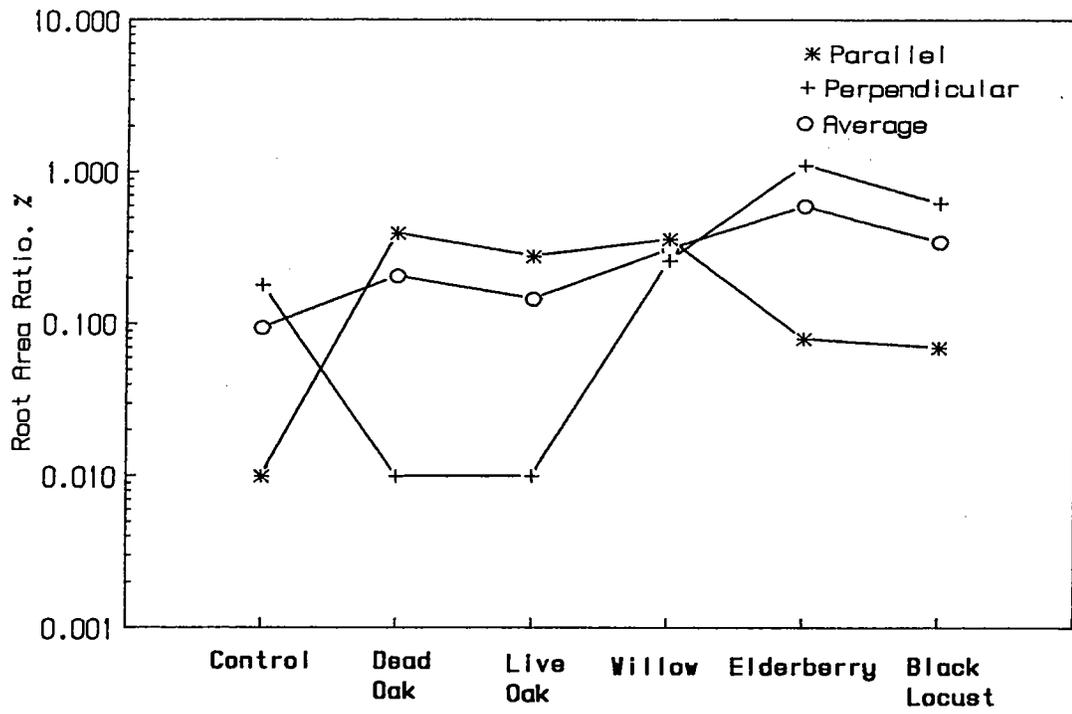
Figure 39. The RAR versus species for 8- to 12-in. depth interval

100. The RAR is plotted versus species for different depth intervals in Figures 39 through 41. Flat, horizontal curves would indicate that no one species produces more roots than another. No consistent pattern or trend emerges from these plots...in the sense that one species can be said to have much higher root area ratios over its entire rooted depth compared to other species. The elderberry site tended to exhibit slightly higher ratios over its entire rooted depth compared to the other species but this result was biased somewhat by the location of the perpendicular trench close to the centers of the elderberry bush stems. Plots of RAR's versus species for different depth intervals for the other sites are collected in Appendix B.

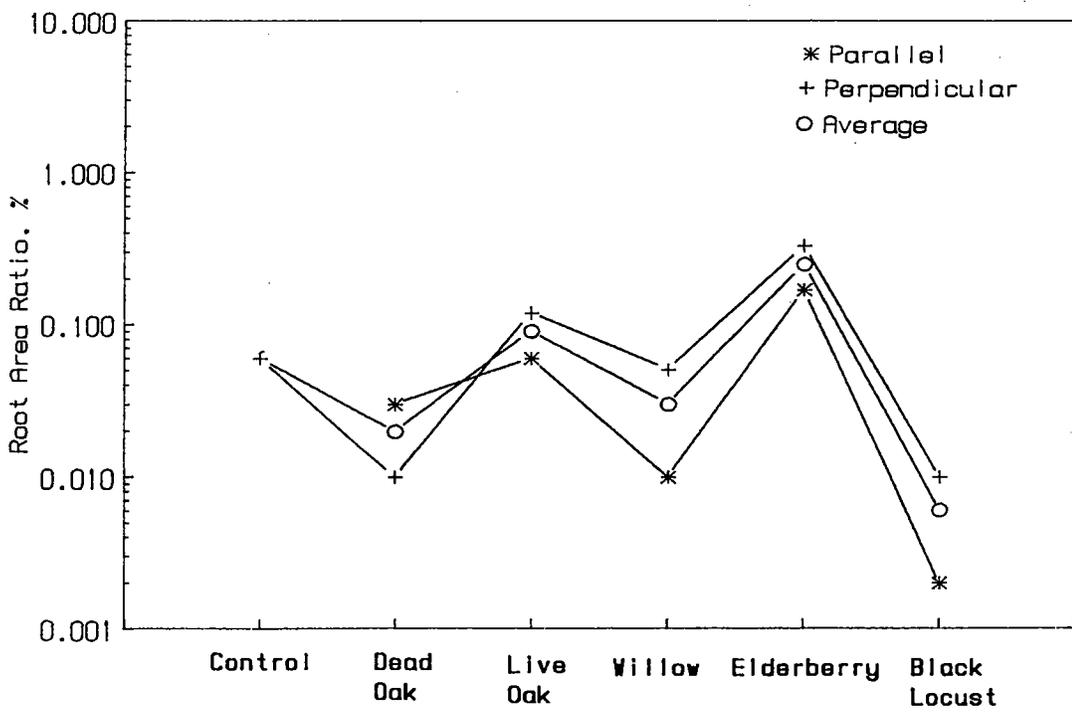
Figure 40. The RAR versus species for 20- to 24-in. depth interval

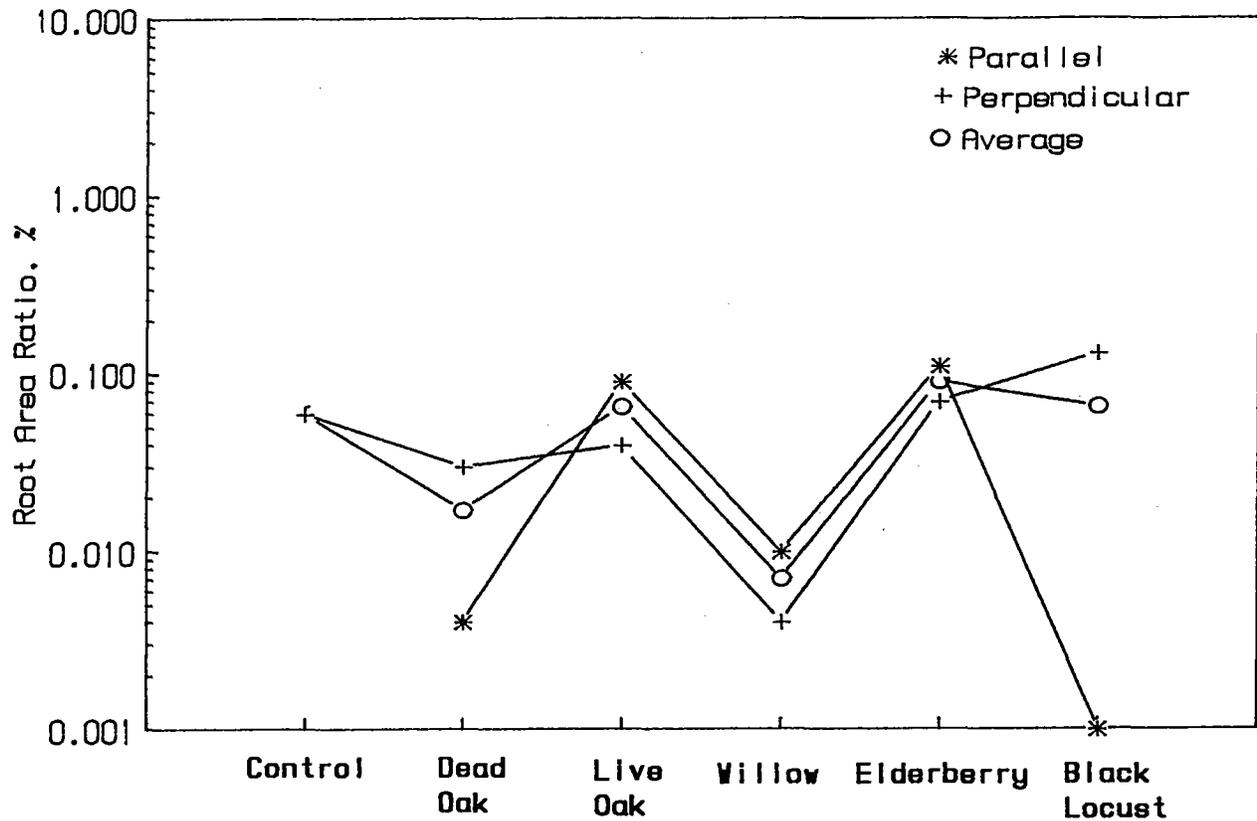
Figure 41. The RAR versus species for 28- to 32-in. depth interval trees growing in a colluvial layer of soil on a steep, slide-prone slope. They hand-excavated the root systems and measured root areas in horizontal planes as a function of depth. Their root area ratio profiles were very similar to those obtained in the present study. This finding suggests that root distributions obtained by the profile-wall method should provide reasonable estimates of root area ratios (on horizontal surfaces) with depth as well. Further study is required on this point, however, in view of the root structure revealed during the excavation of the dead oak stump.

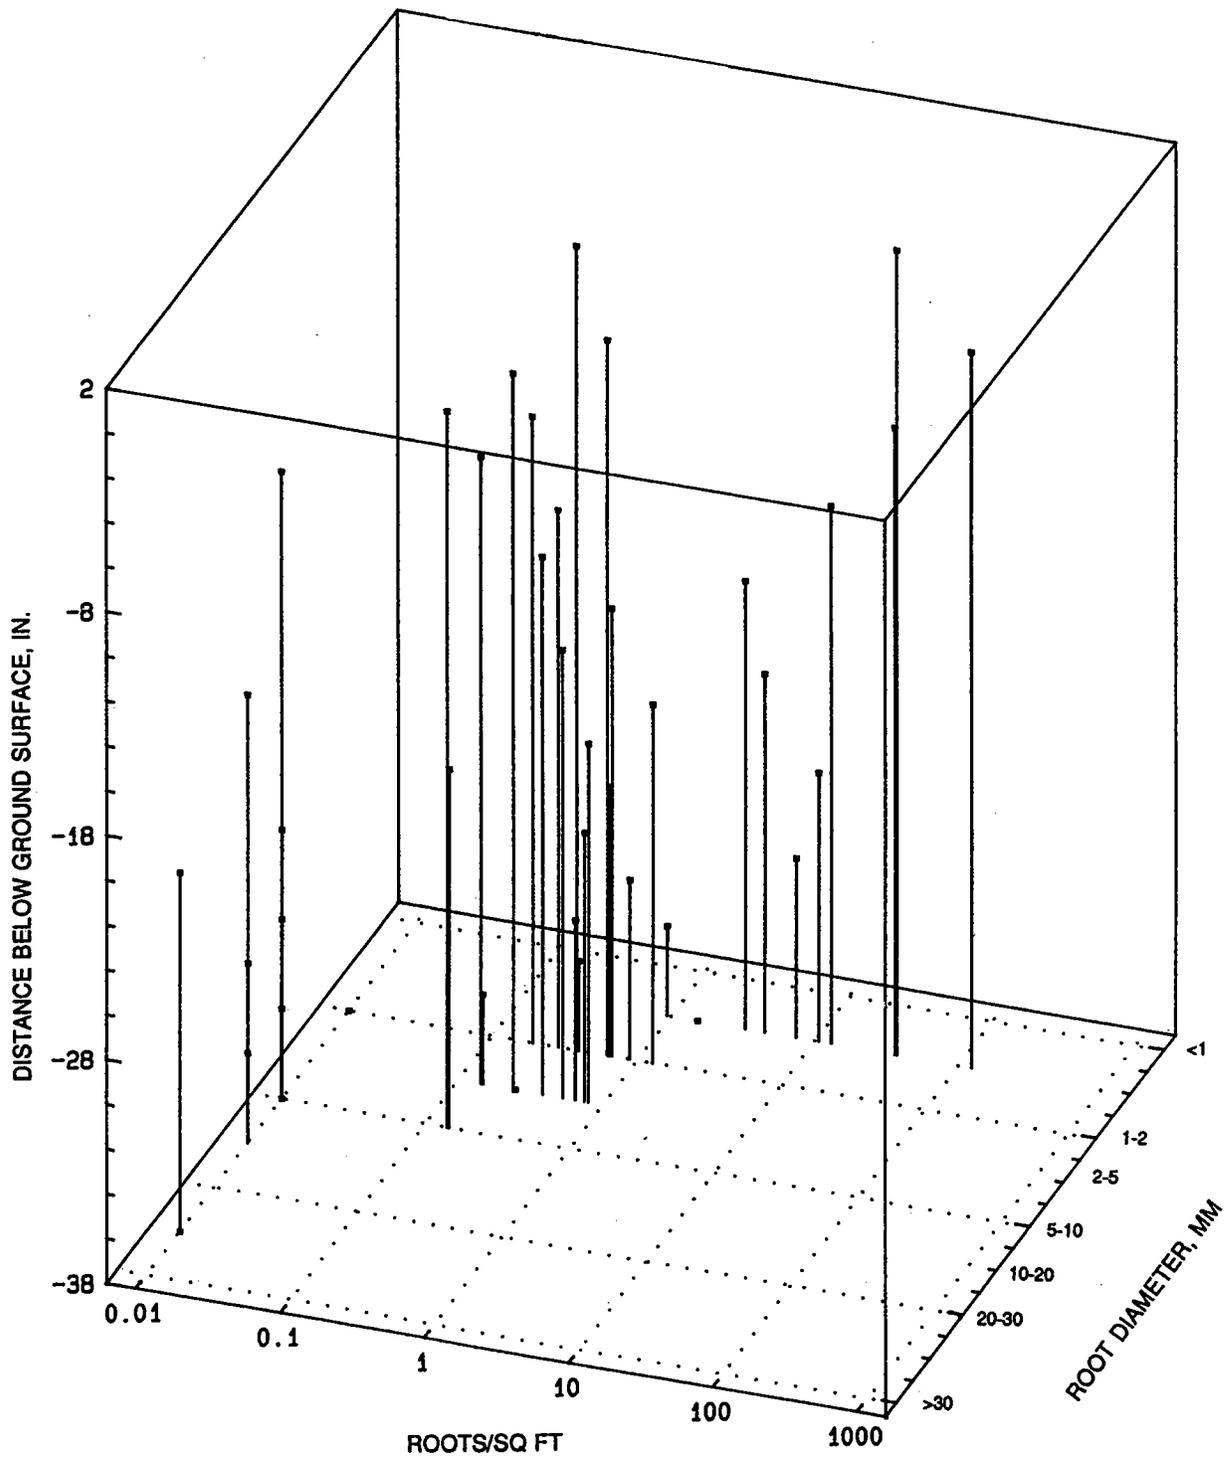
Figure 42. Root size frequency distribution, parallel trench, live oak site (site 4)

recorded directly on the acetate overlays during the field mapping program. Root size distribution plots are shown in a 3-D format in Figures 42 and 43 for parallel trenches at the live oak and elderberry sites, respectively. These two sites represent two extremes of woody vegetation, namely, large mature trees versus low shrubby bushes. Both trenches also were located at the drip line or crown edge. The root area ratio profiles for these two sites are similar in trend; however, the oak site has almost twice the total root area (summed over all depth intervals) as the elderberry site. This difference is due to the presence in general of larger roots at the oak site as can be seen by comparing Figures 42 and 43 and noting the greater number of roots in the larger size classes (classes 1-3) at the live oak site. Root size distribution plots for the other sites are collected in Appendix C.

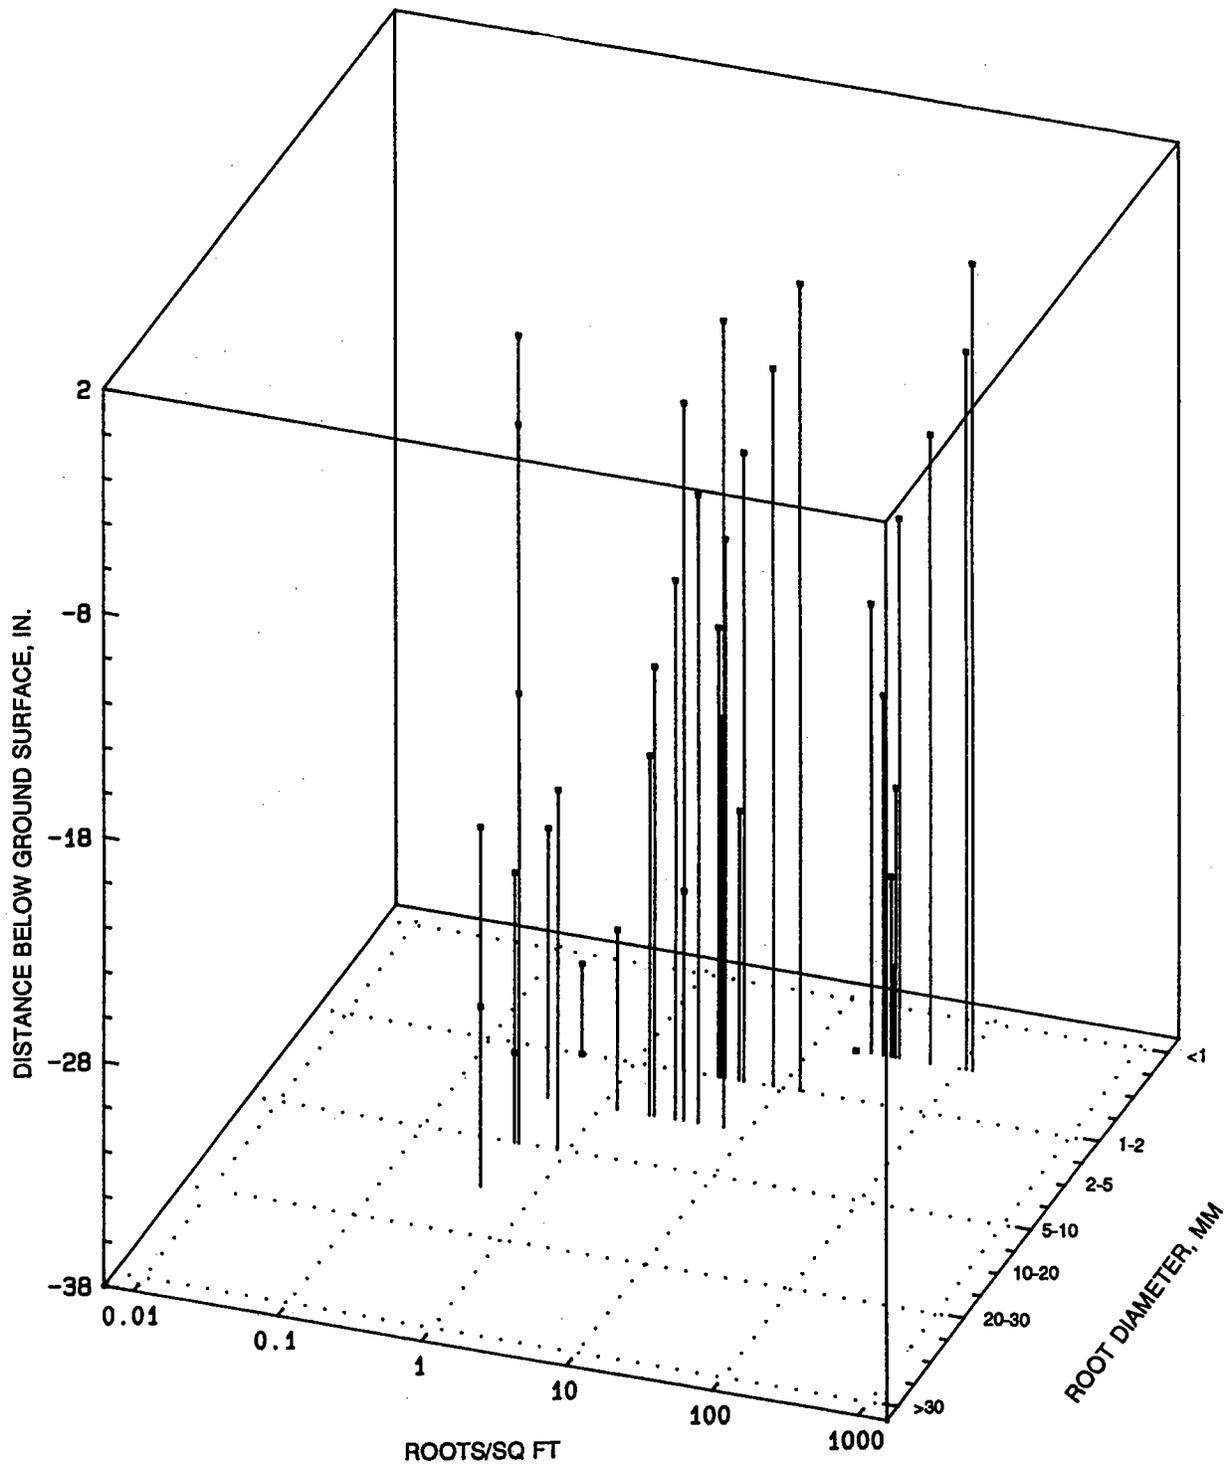
Figure 43. Root size frequency distribution, parallel trench, elderberry site (site 7)

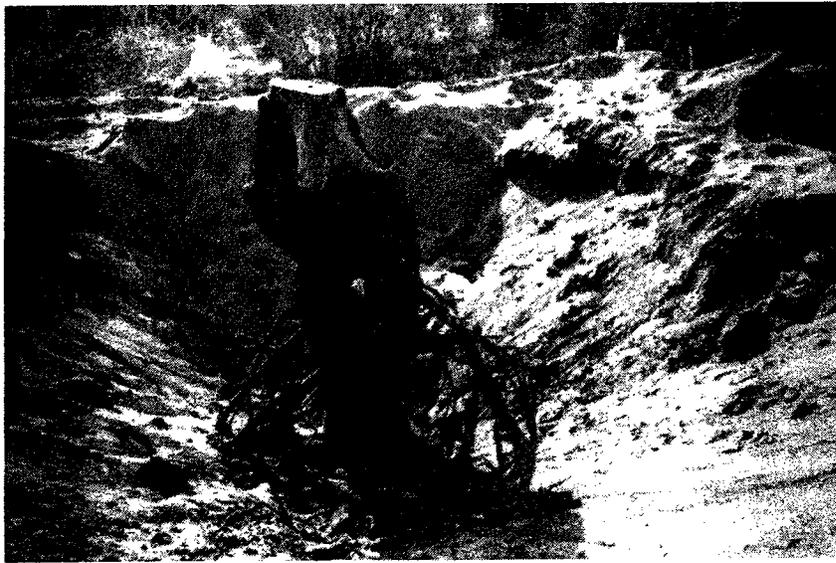
Figure 44. Photograph showing root structure and architecture of dead oak stump excavated in sandy levee, site 2

103. The root architecture of the oak was characterized by a massive, central tap root and a series of lateral roots radiating from the main tap root at a depth below the ground surface of approximately 0.6 to 1.2 m. A photograph of the excavated stump is shown in Figure 44. The most interesting and significant feature of the laterals was the angle at which they radiated away from the central tap root with respect to the ground surface. Most of these lateral roots angled down sharply rather than growing out in a quasi-horizontal attitude characteristic of lateral roots. This structure explains in part the paucity of roots exposed in the vertical mapping faces of the trenches around the oak trees at their drip lines. This structure is also consistent with the adaptability of the oaks to the levee environment and extreme droughtiness of the sandy soils that comprise the levee. The lateral

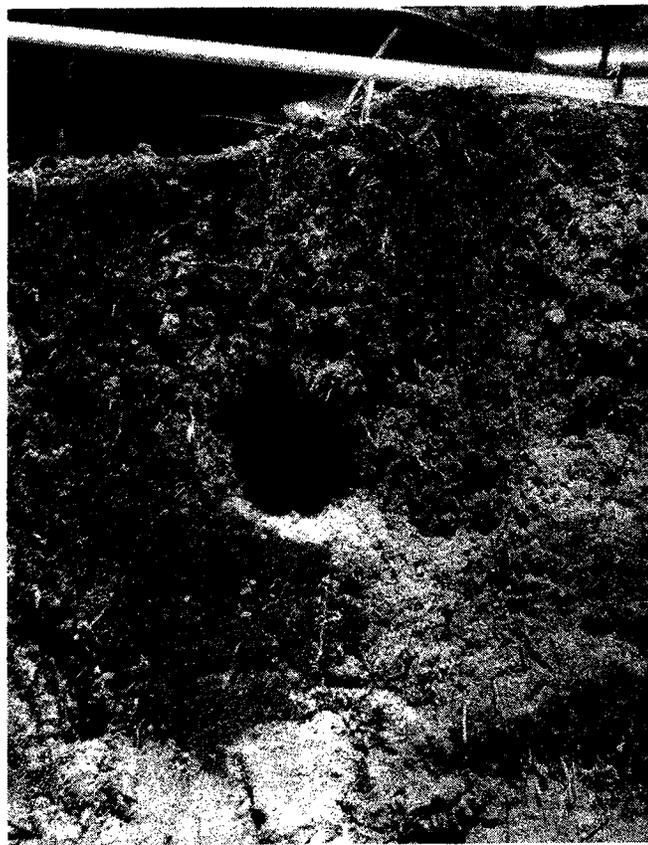
Figure 45. Photograph of ground squirrel burrows exposed in trench face at live oak site (site 4)

105. Void and pedotubule distribution. Voids and pedotubules that were exposed in the trench faces were also mapped along with roots. Unlike intact roots, open voids or conduits in a levee represent a clear and immediate danger from the point of view of a piping or internal erosion failure. Voids or holes created by burrowing rodents were easily identified in the trench faces by their size, shape, and form. An example of a ground squirrel burrow exposed in the trench face at site 4 is shown in Figure 45. These burrow holes occurred at all depths. A burrow hole located at the bottom of the

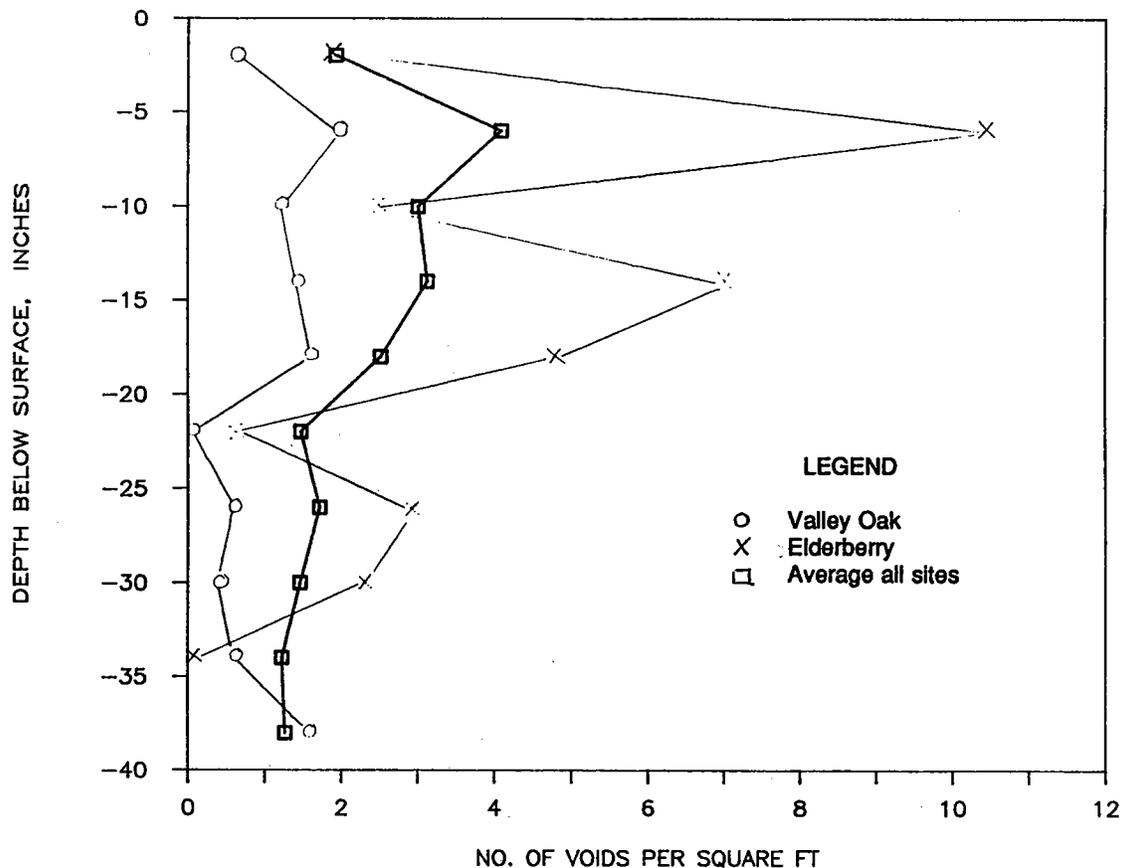
Figure 48. Void density versus depth for various trench sites

The number of voids per square foot reaches a maximum at a depth of 6 in. and then decreases with depth to some minimum value. The number of voids per square foot tends to exceed the average at the elderberry site, and drops below the average at the live oak site. This finding can be explained as follows: voids at the elderberry site are smaller and more numerous as a result of insect activity, whereas the voids at the live oak site tend to be larger and less numerous as a result of animal (ground squirrel) burrowing. An examination of the total area ratio profiles--which include void area ratios--reveals that the live oak site had a total or combined void area ratio of 4.7 percent versus 1.3 percent for the elderberry site. This finding also supports the position that voids are less numerous but much larger on average at the oak site compared to the elderberry site.

107. Void versus depth profiles were plotted for each site. The void density versus depth is shown plotted in Figure 48 for the elderberry and live oak sites. The average void count for all sites is also plotted on Figure 48.

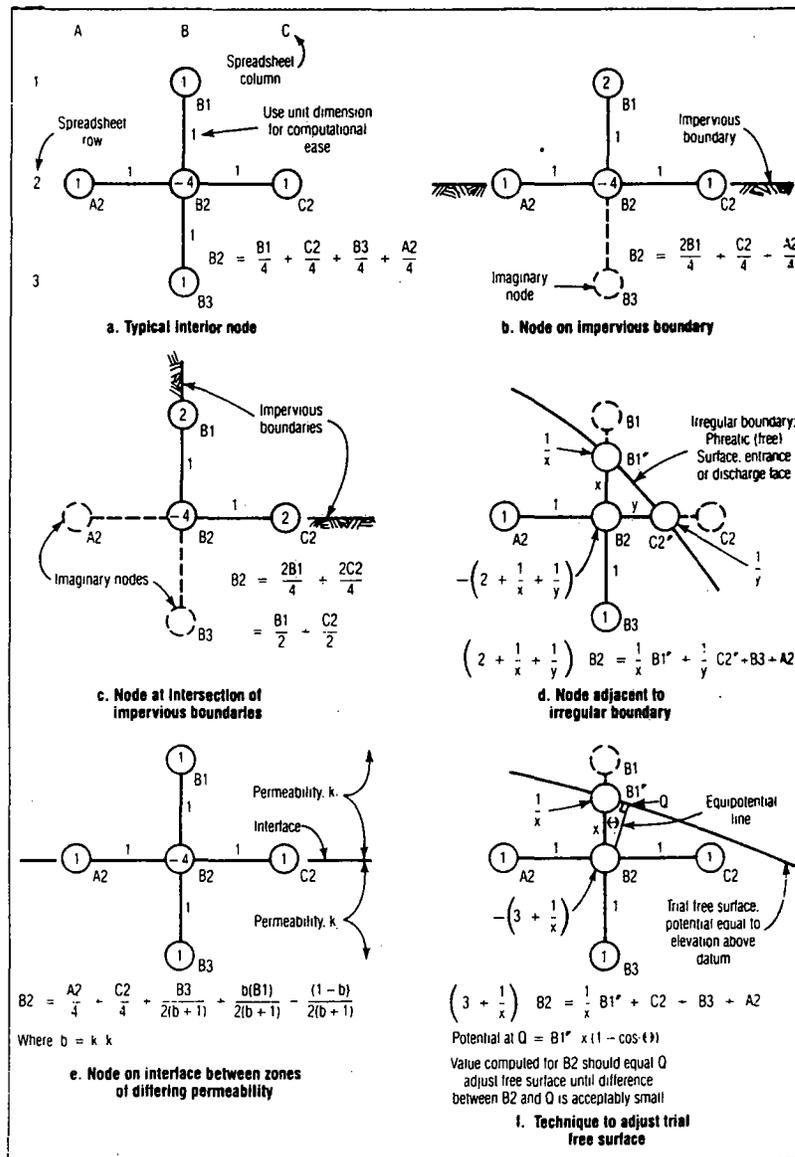
Figure 50. Summary of typical hydraulic head relationships for interior nodes, nodes adjacent to or on a boundary, and nodes on an interface between materials of different permeability (after Kleiner, 1985)

115. Steady state seepage flow through an earthen levee must satisfy the equation governing the distribution of hydraulic potential, viz., the Laplace equation, at every point. The finite difference method essentially consists of subdividing the flow region into a series of nodes or grid points and determining the appropriate finite difference equation for the hydraulic head at each point. The head at each point can be expressed in terms of the heads at surrounding or adjoining nodal points. Typical nodal relationships or rules for calculating the head at interior nodes, nodes adjacent to or on a boundary, and nodes on an interface between material of different permeability, are summarized in Figure 50.

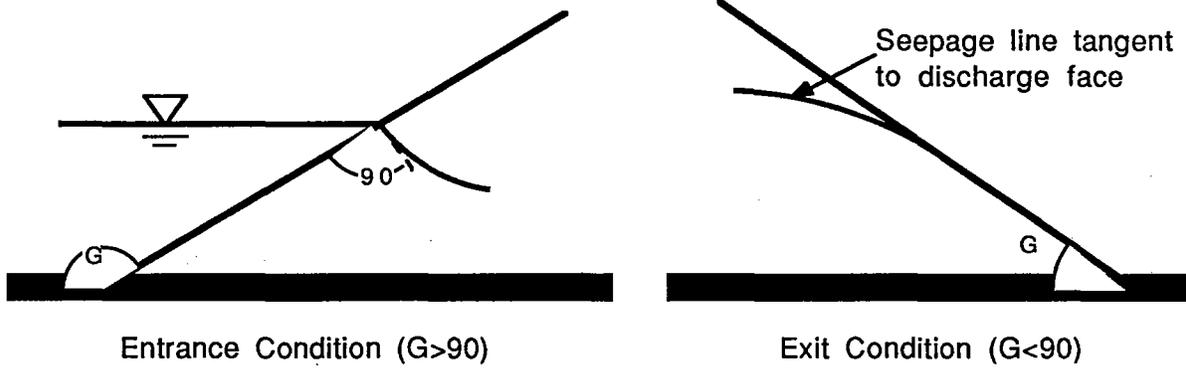
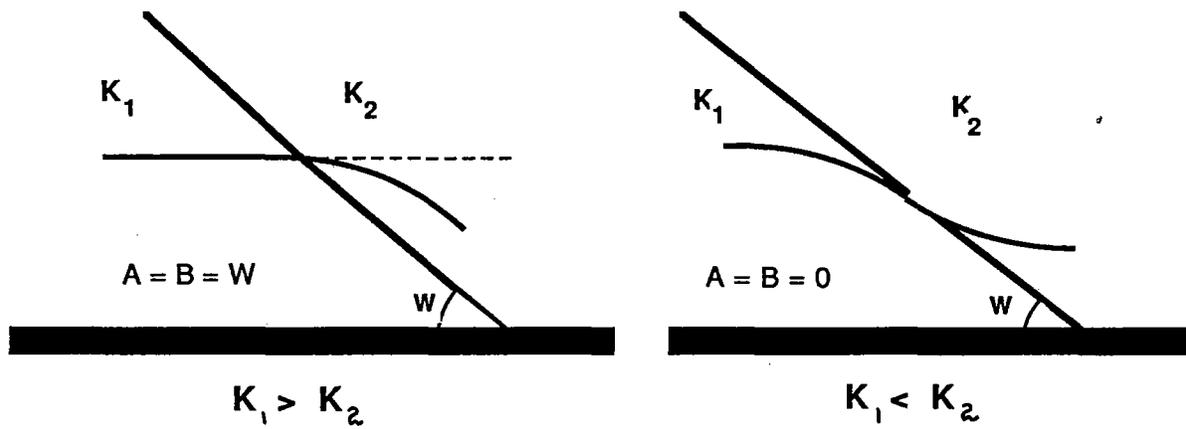
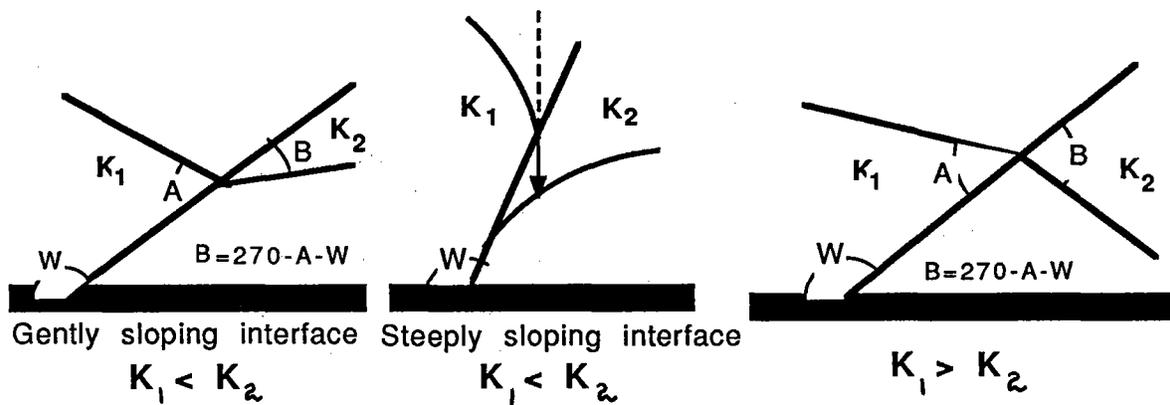
### ENTRANCE/EXIT CONDITIONS

### INTERFACE TRANSFER CONDITIONS ( $W < 90$ )

### INTERFACE TRANSFER CONDITIONS ( $W > 90$ )

Figure 51. Entrance, discharge, and transfer conditions for phreatic surface during seepage flow through a levee

117. The orientation of the phreatic surface in unconfined seepage through an embankment or levee depends upon a number of factors. The influence of entrance, discharge, and interface transfer conditions relevant to seepage flow through a levee are summarized in Figure 51.

118. The effect of a permeability discontinuity upon the change in direction of phreatic surface at the interface depends upon both the permeability ratio ( $K_1/K_2$ ) and the orientation of the interface ( $W$ ) as shown in Figure 51. The direction of the line of seepage must satisfy the Forcheimer relationship, viz.,

where: A and B are angles of incidence and departure, respectively, of the seepage line with respect to the interface. In addition to the Forcheimer relationship, the direction of the line of seepage must also satisfy the condition  $B = 270 - A - W$  for the cases noted in Figure 51.

124. The first task was to determine the influence of a surface layer or skin on the location of the phreatic surface as shown schematically in Figure 54. This was accomplished by following the transfer condition rules summarized earlier in Figure 51. The "skin" was assumed to be either more or less permeable than the core by a factor of 10. The subsequent influence on the location and orientation of the phreatic surface as a result of this permeability contrast is depicted schematically in Figure 55.
